ECMC
Environmental
Field Inspection

© 05-Jan-26 12:57:29
Piece of 3" fiberglass flowline east of KPK Facility 2

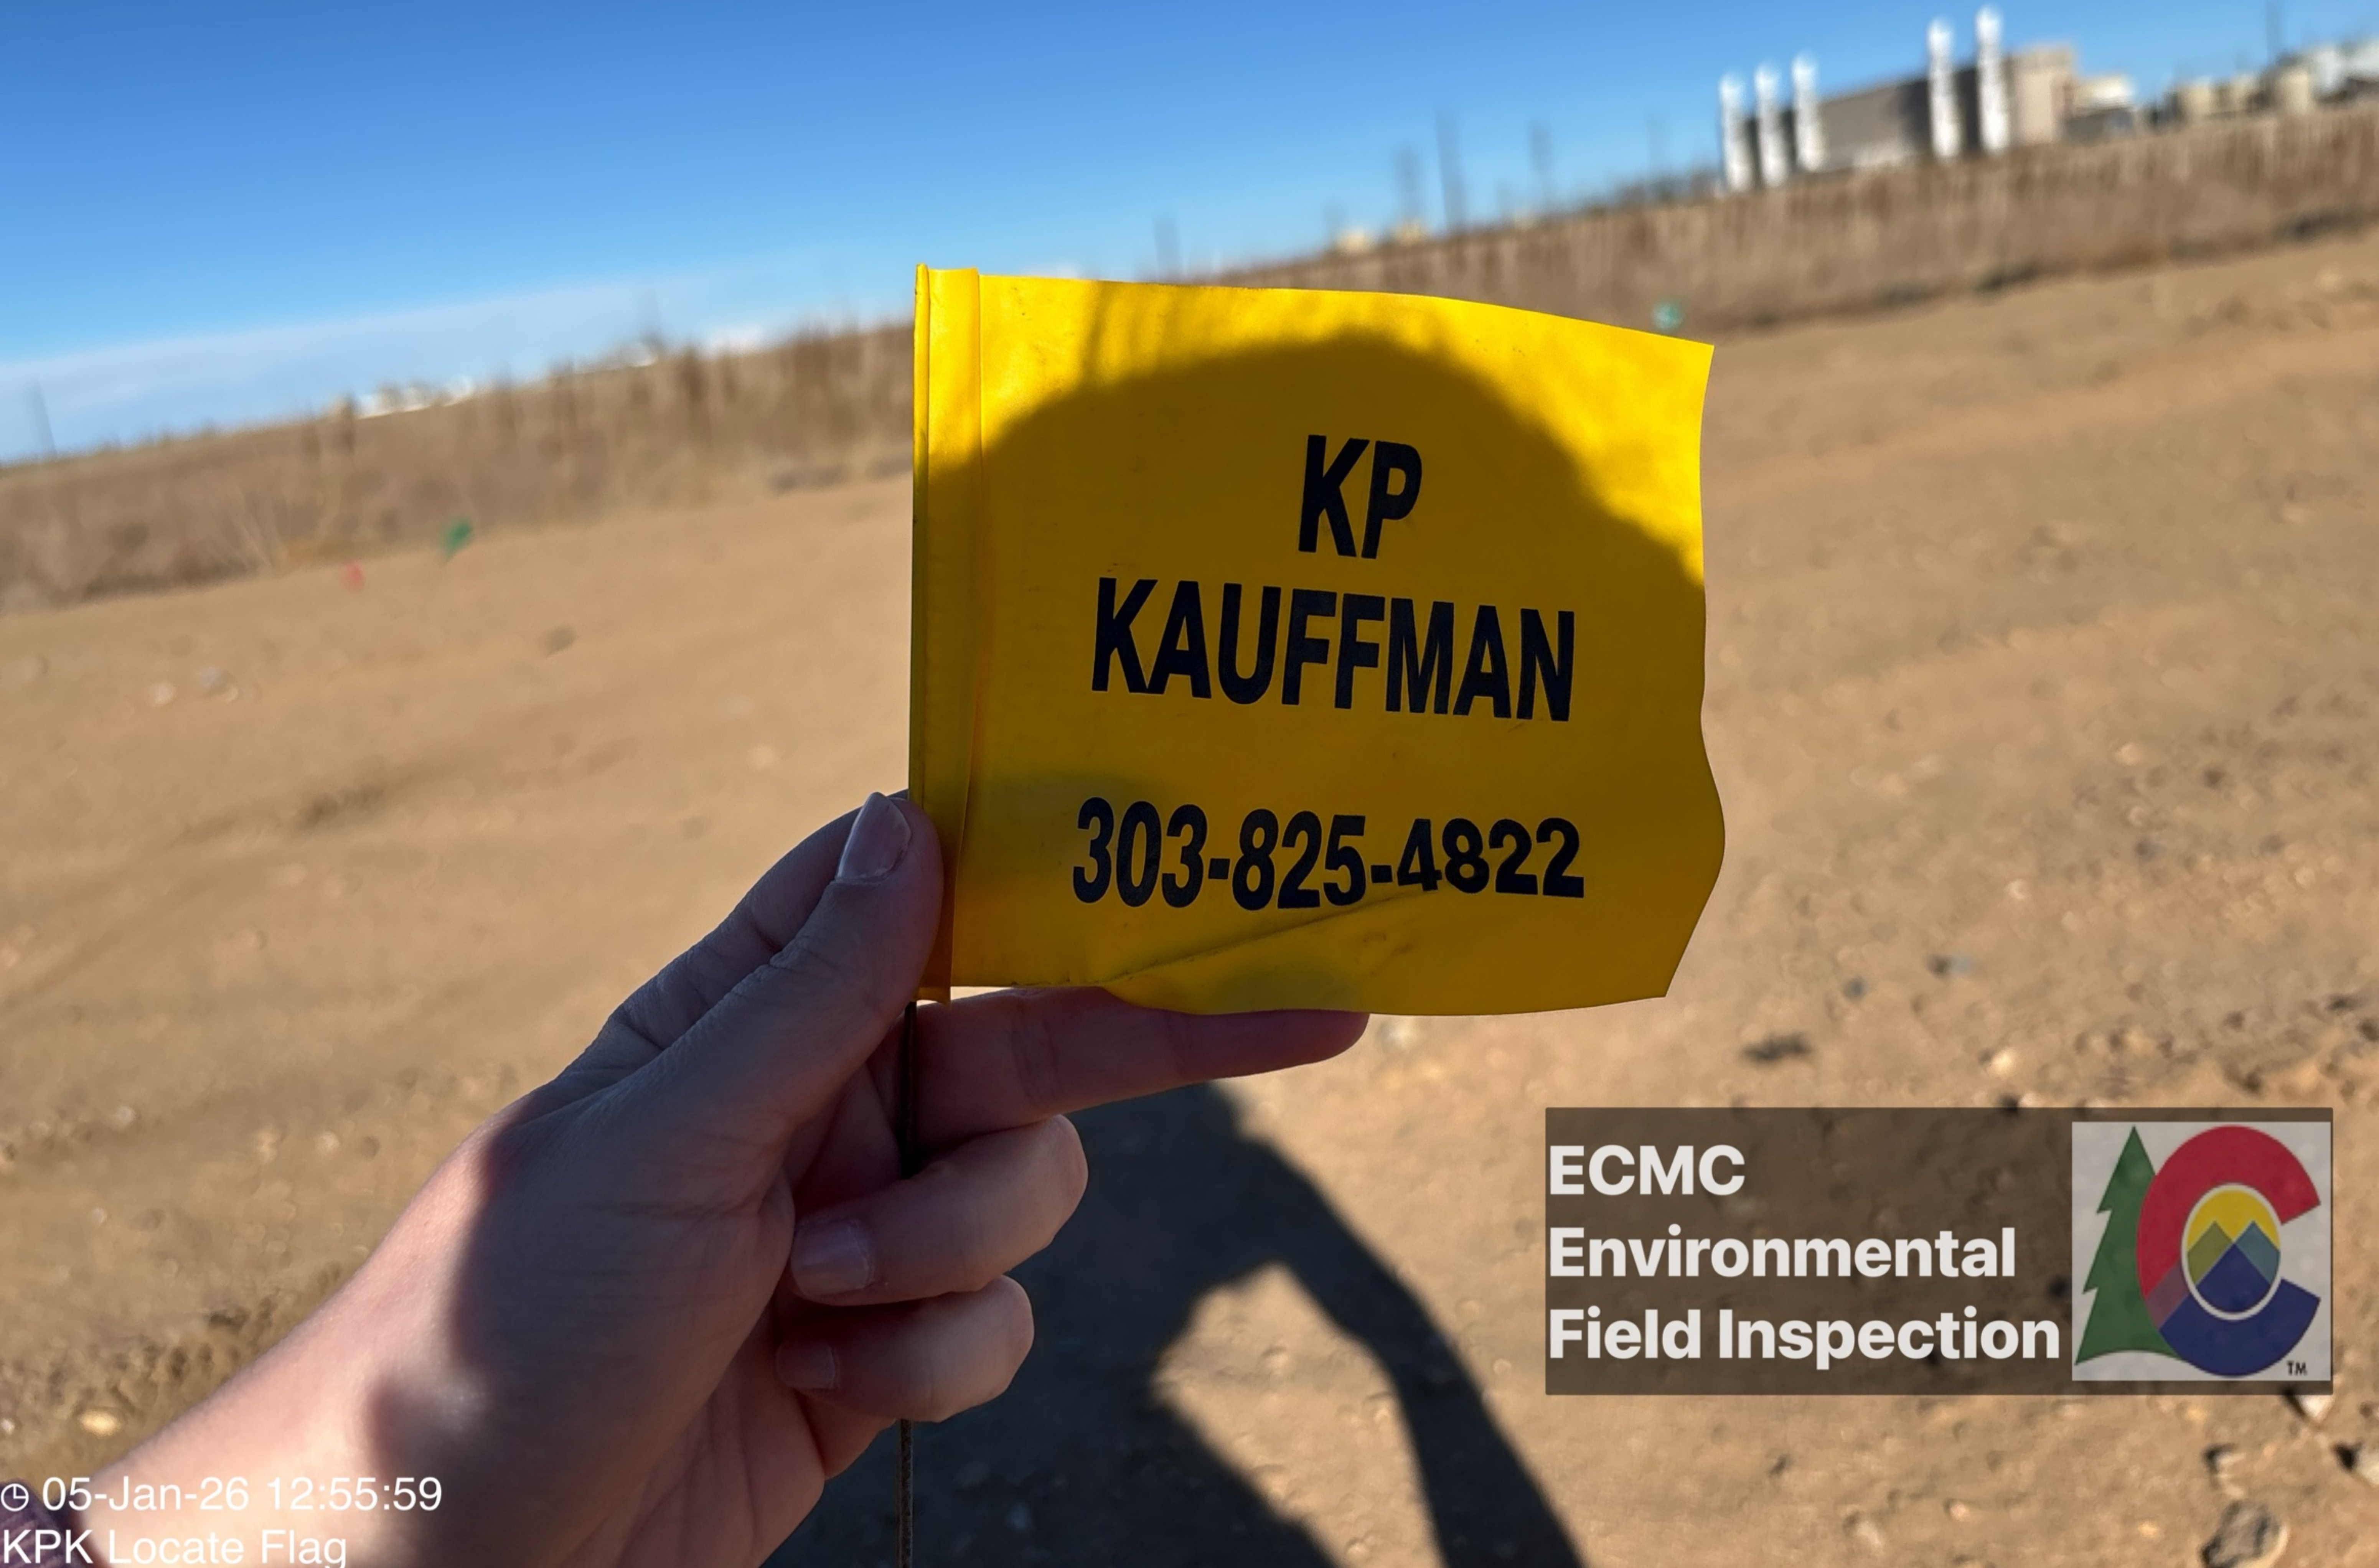
© 05-Jan-26 12:55:59
KPK Locate Flag

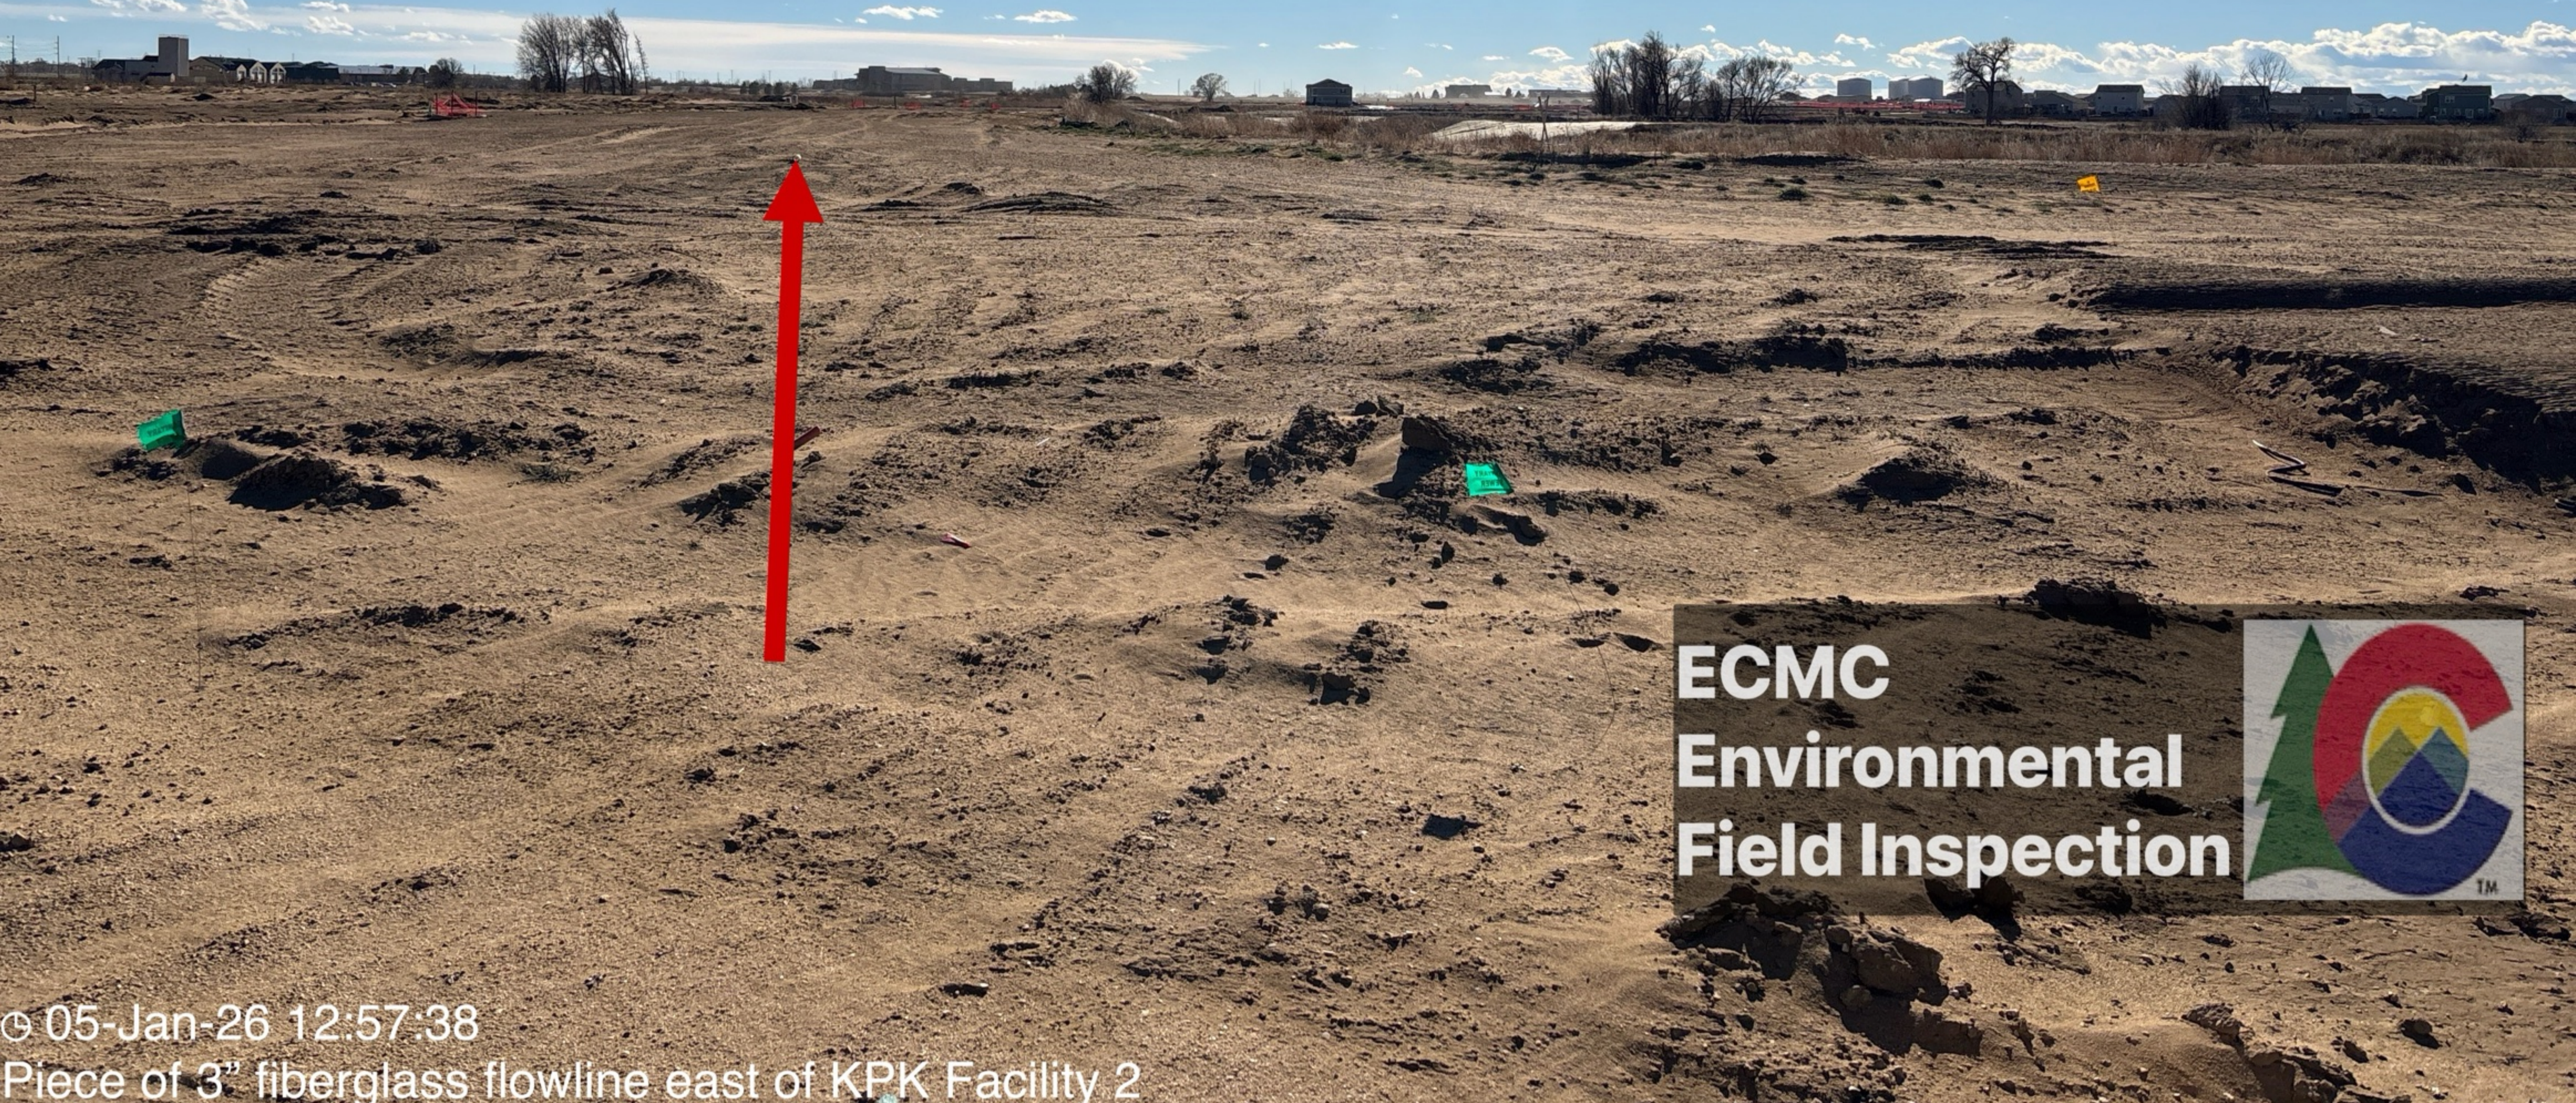
© 05-Jan-26 12:57:38
Piece of 3" fiberglass flowline east of KPK Facility 2

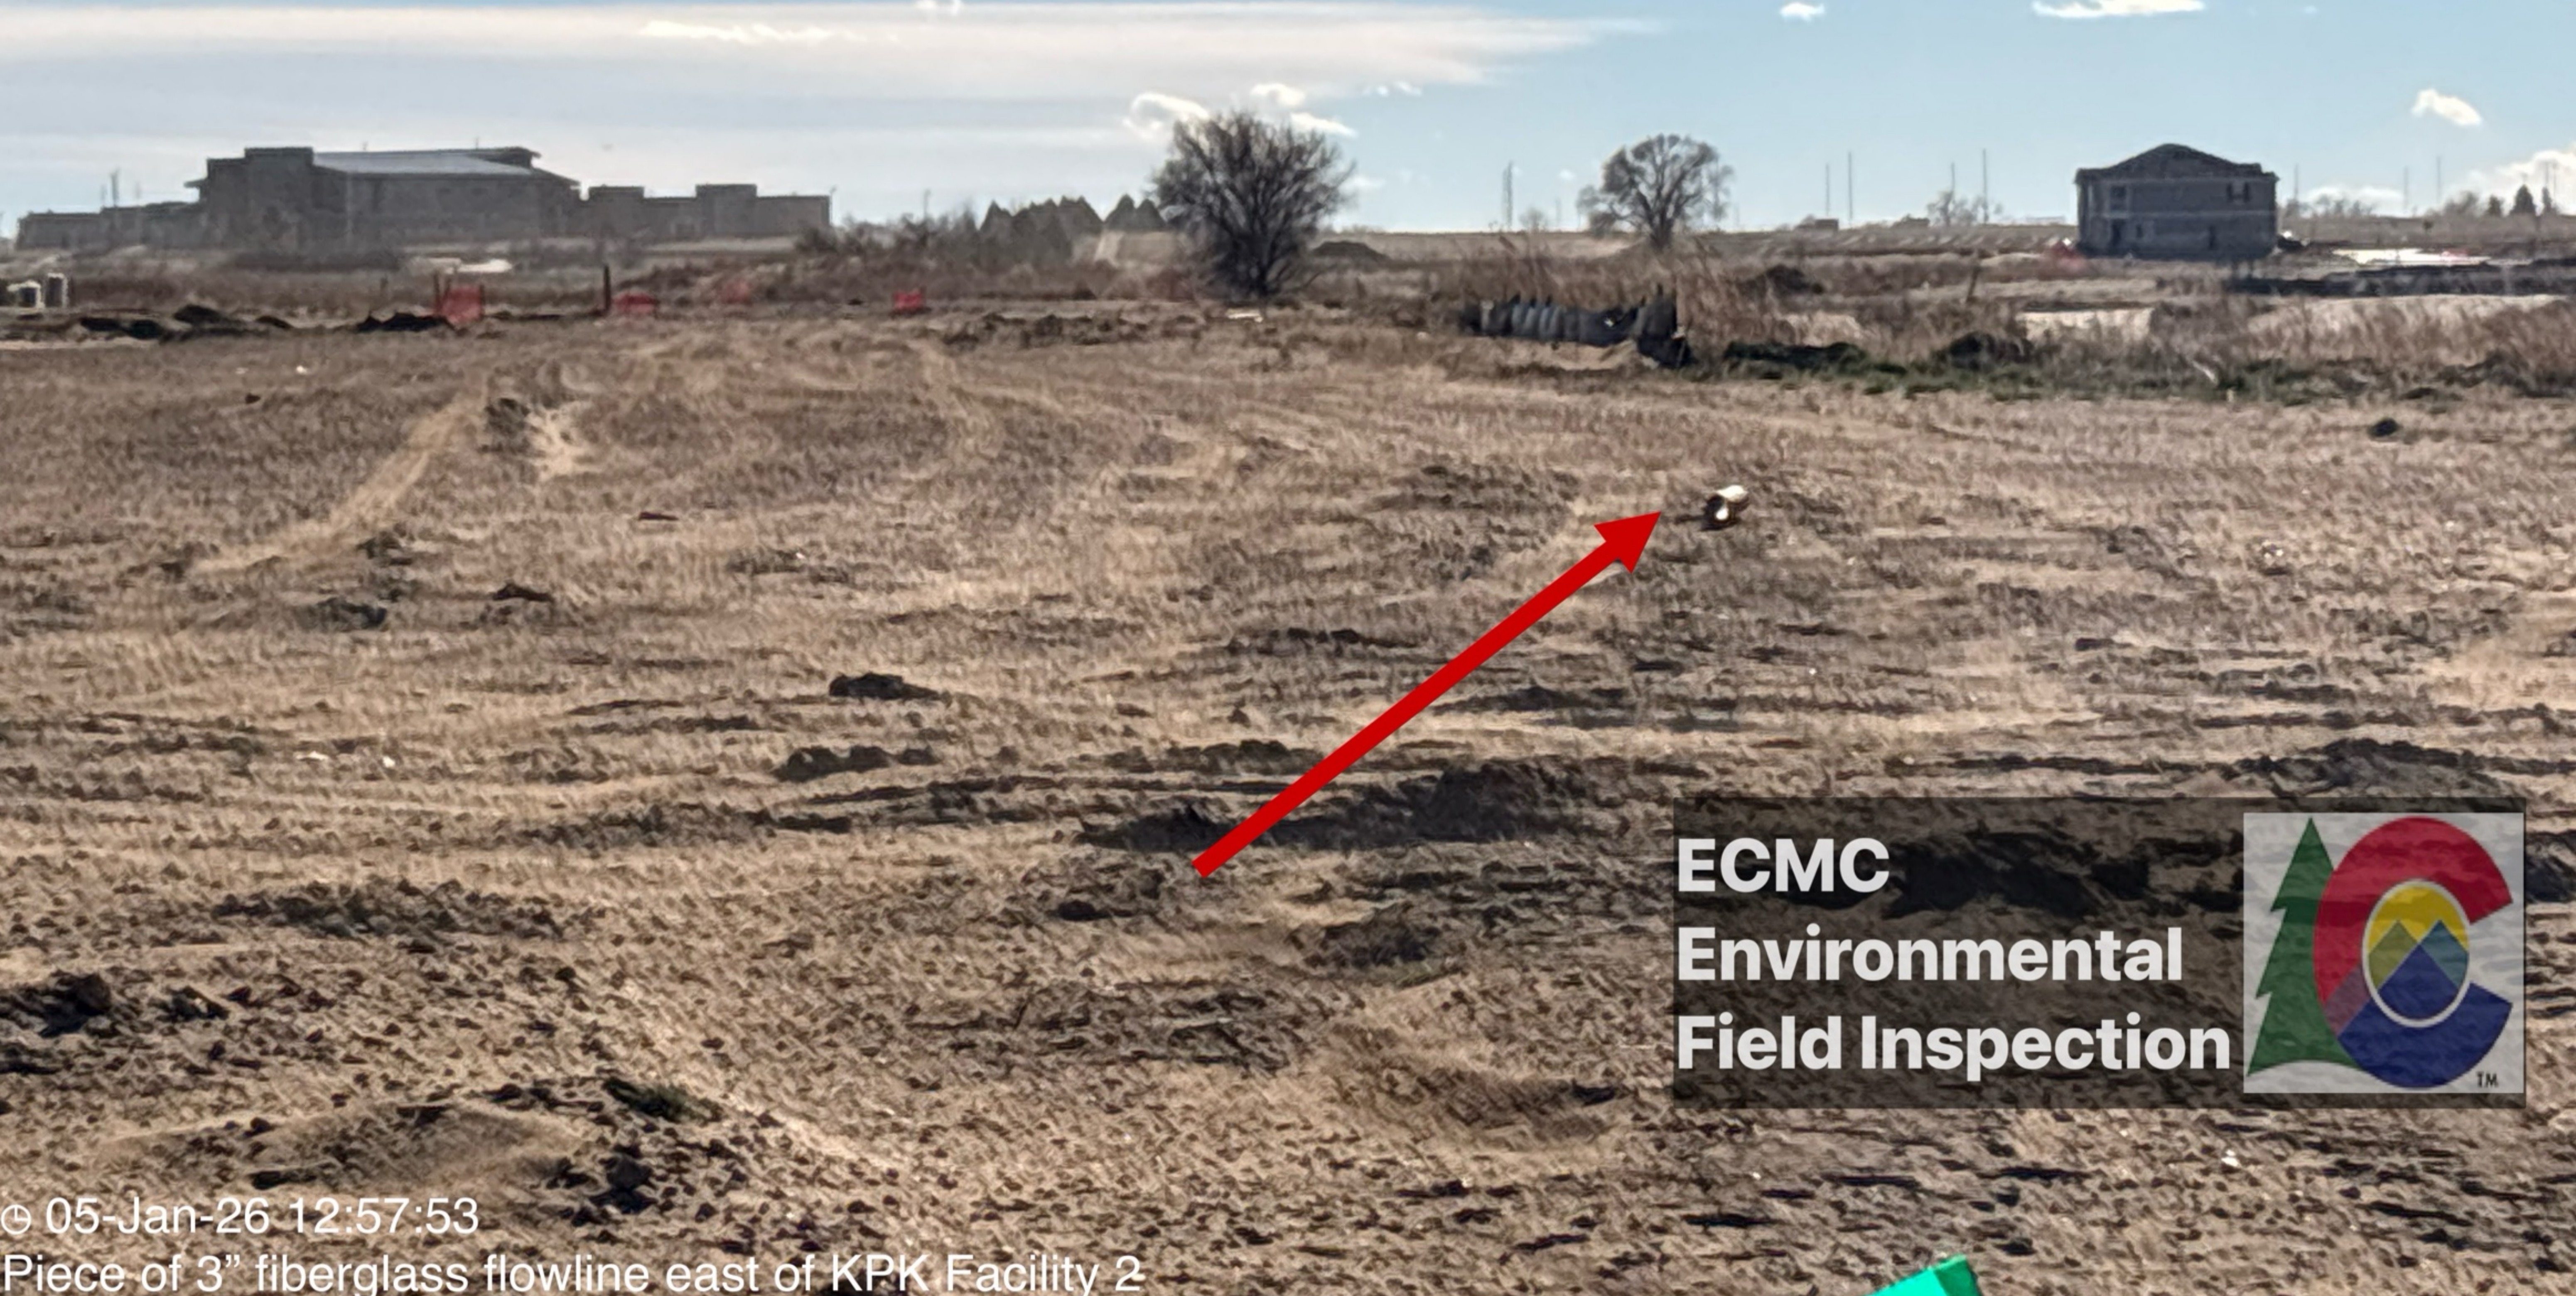
© 05-Jan-26 12:57:53
Piece of 3" fiberglass flowline east of KPK Facility 2

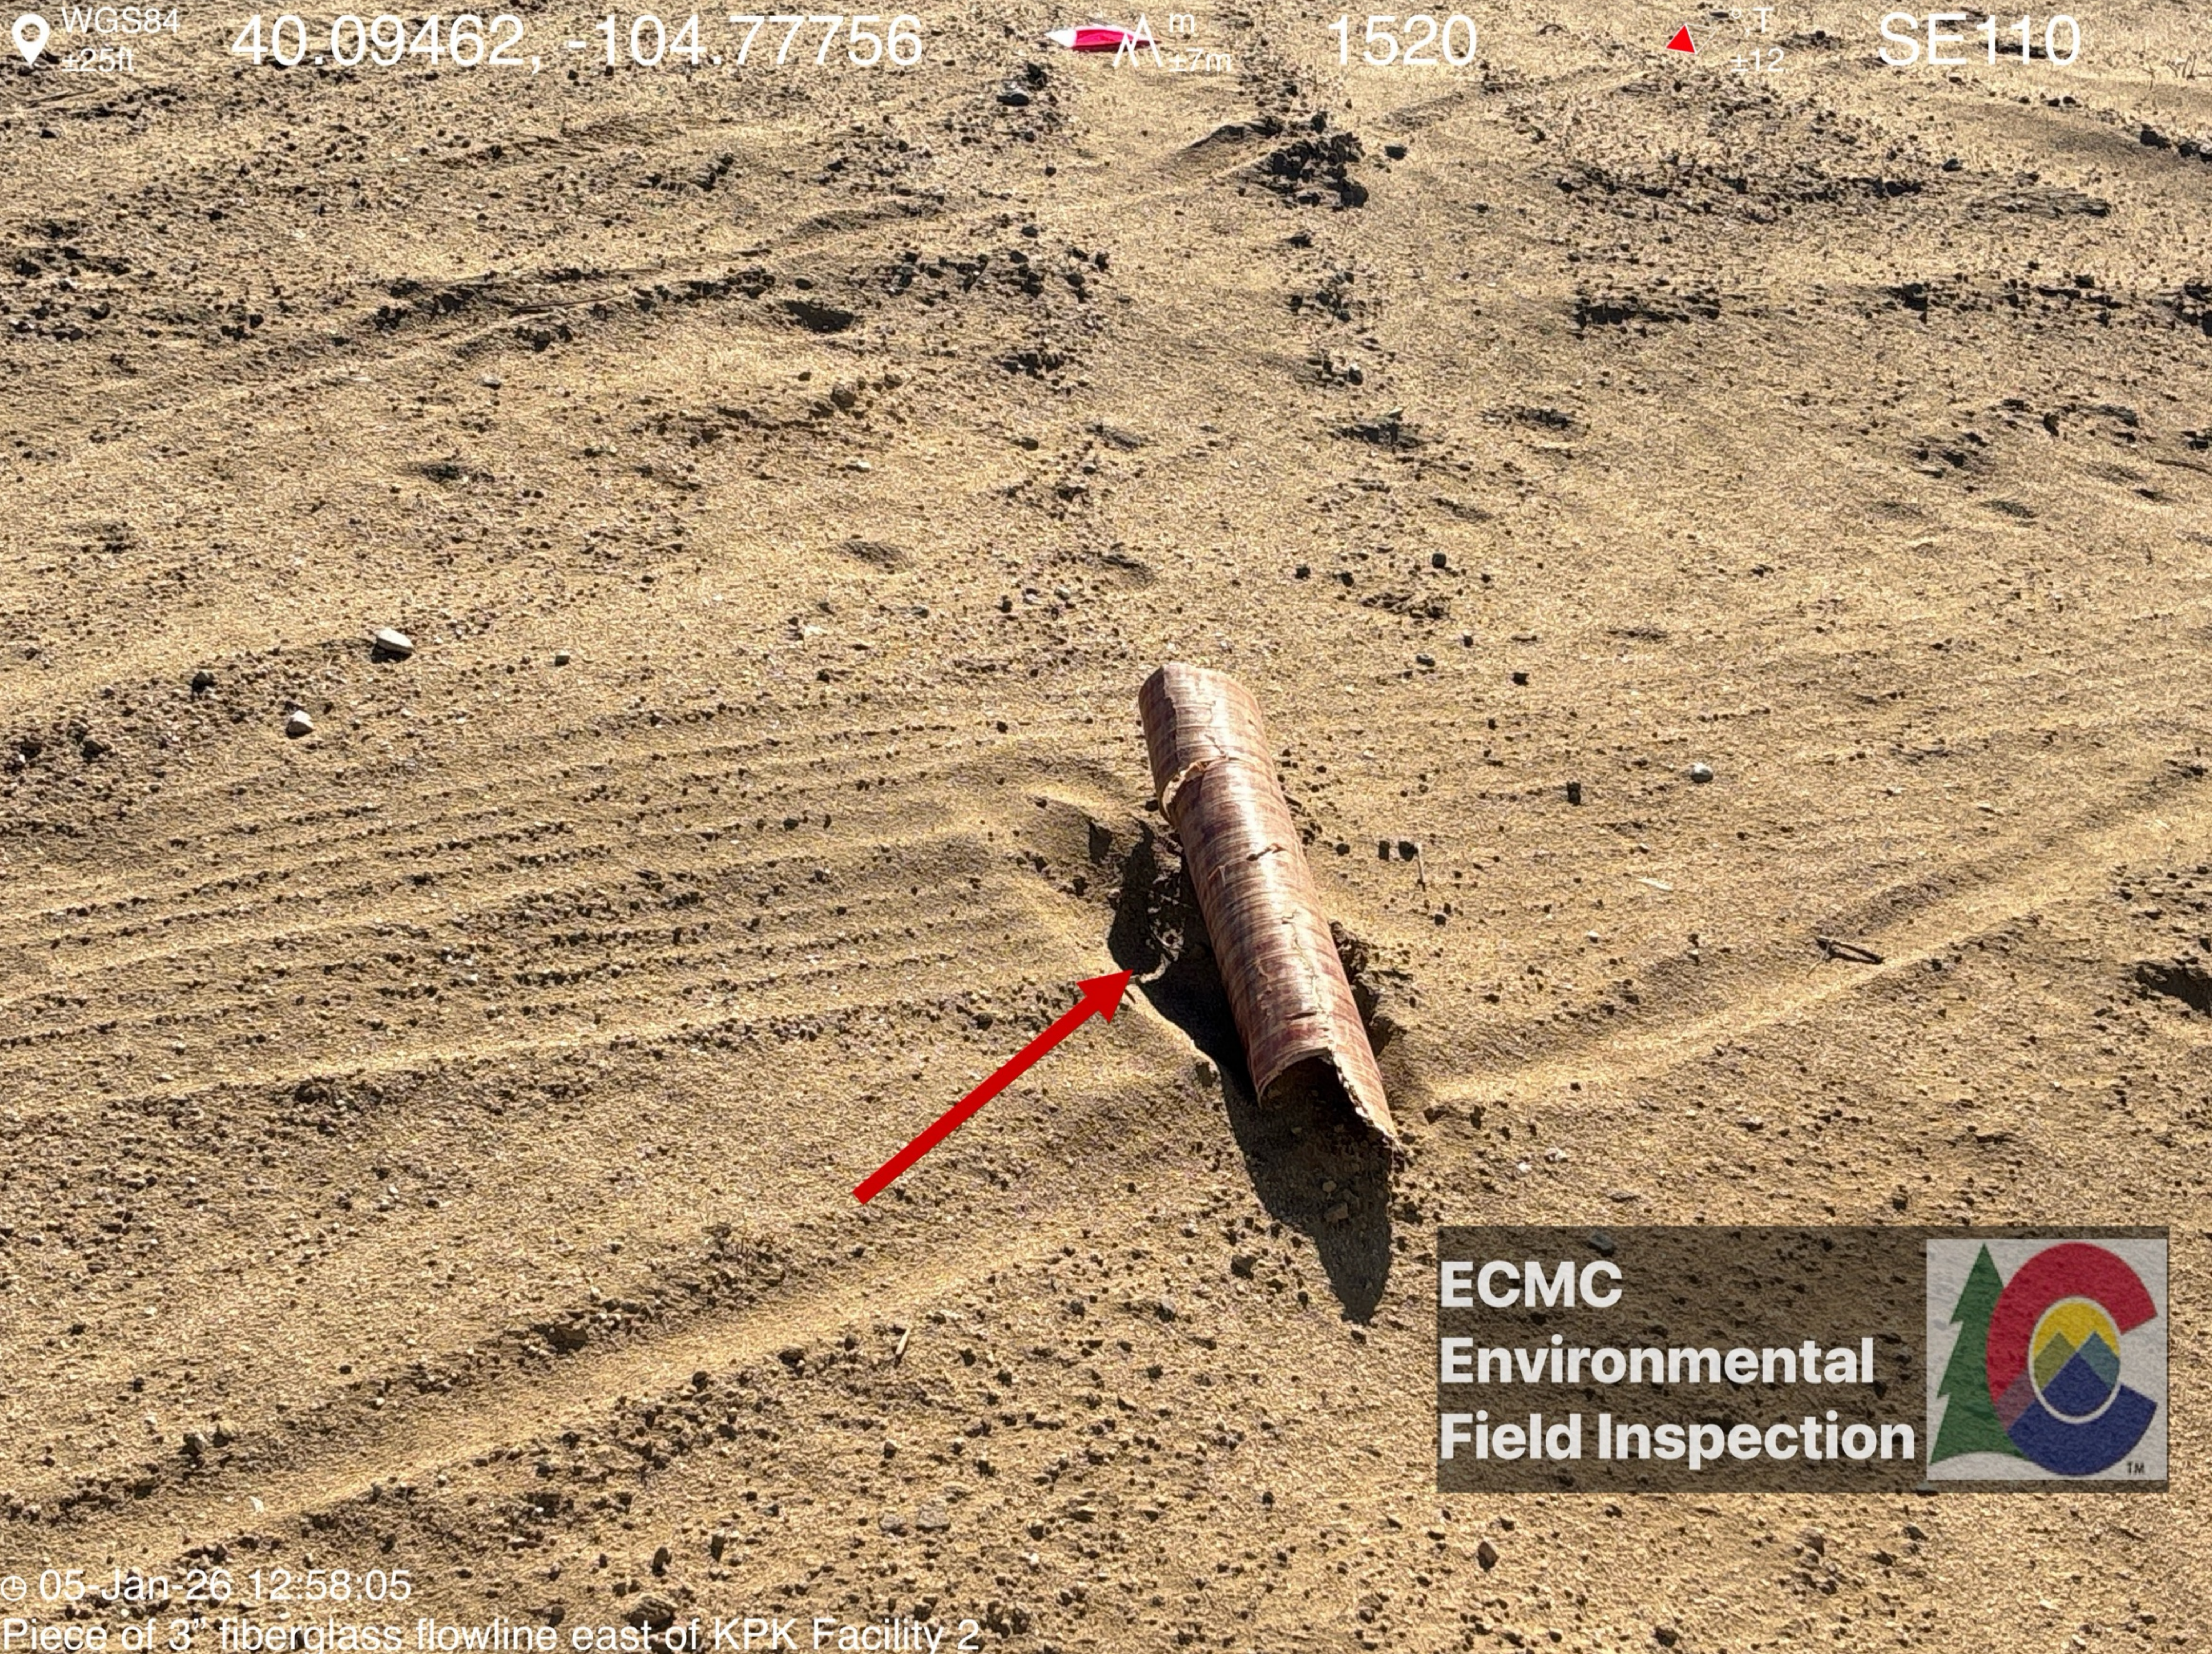
© 05-Jan-26 12:58:05
Piece of 3" fiberglass flowline east of KPK Facility 2

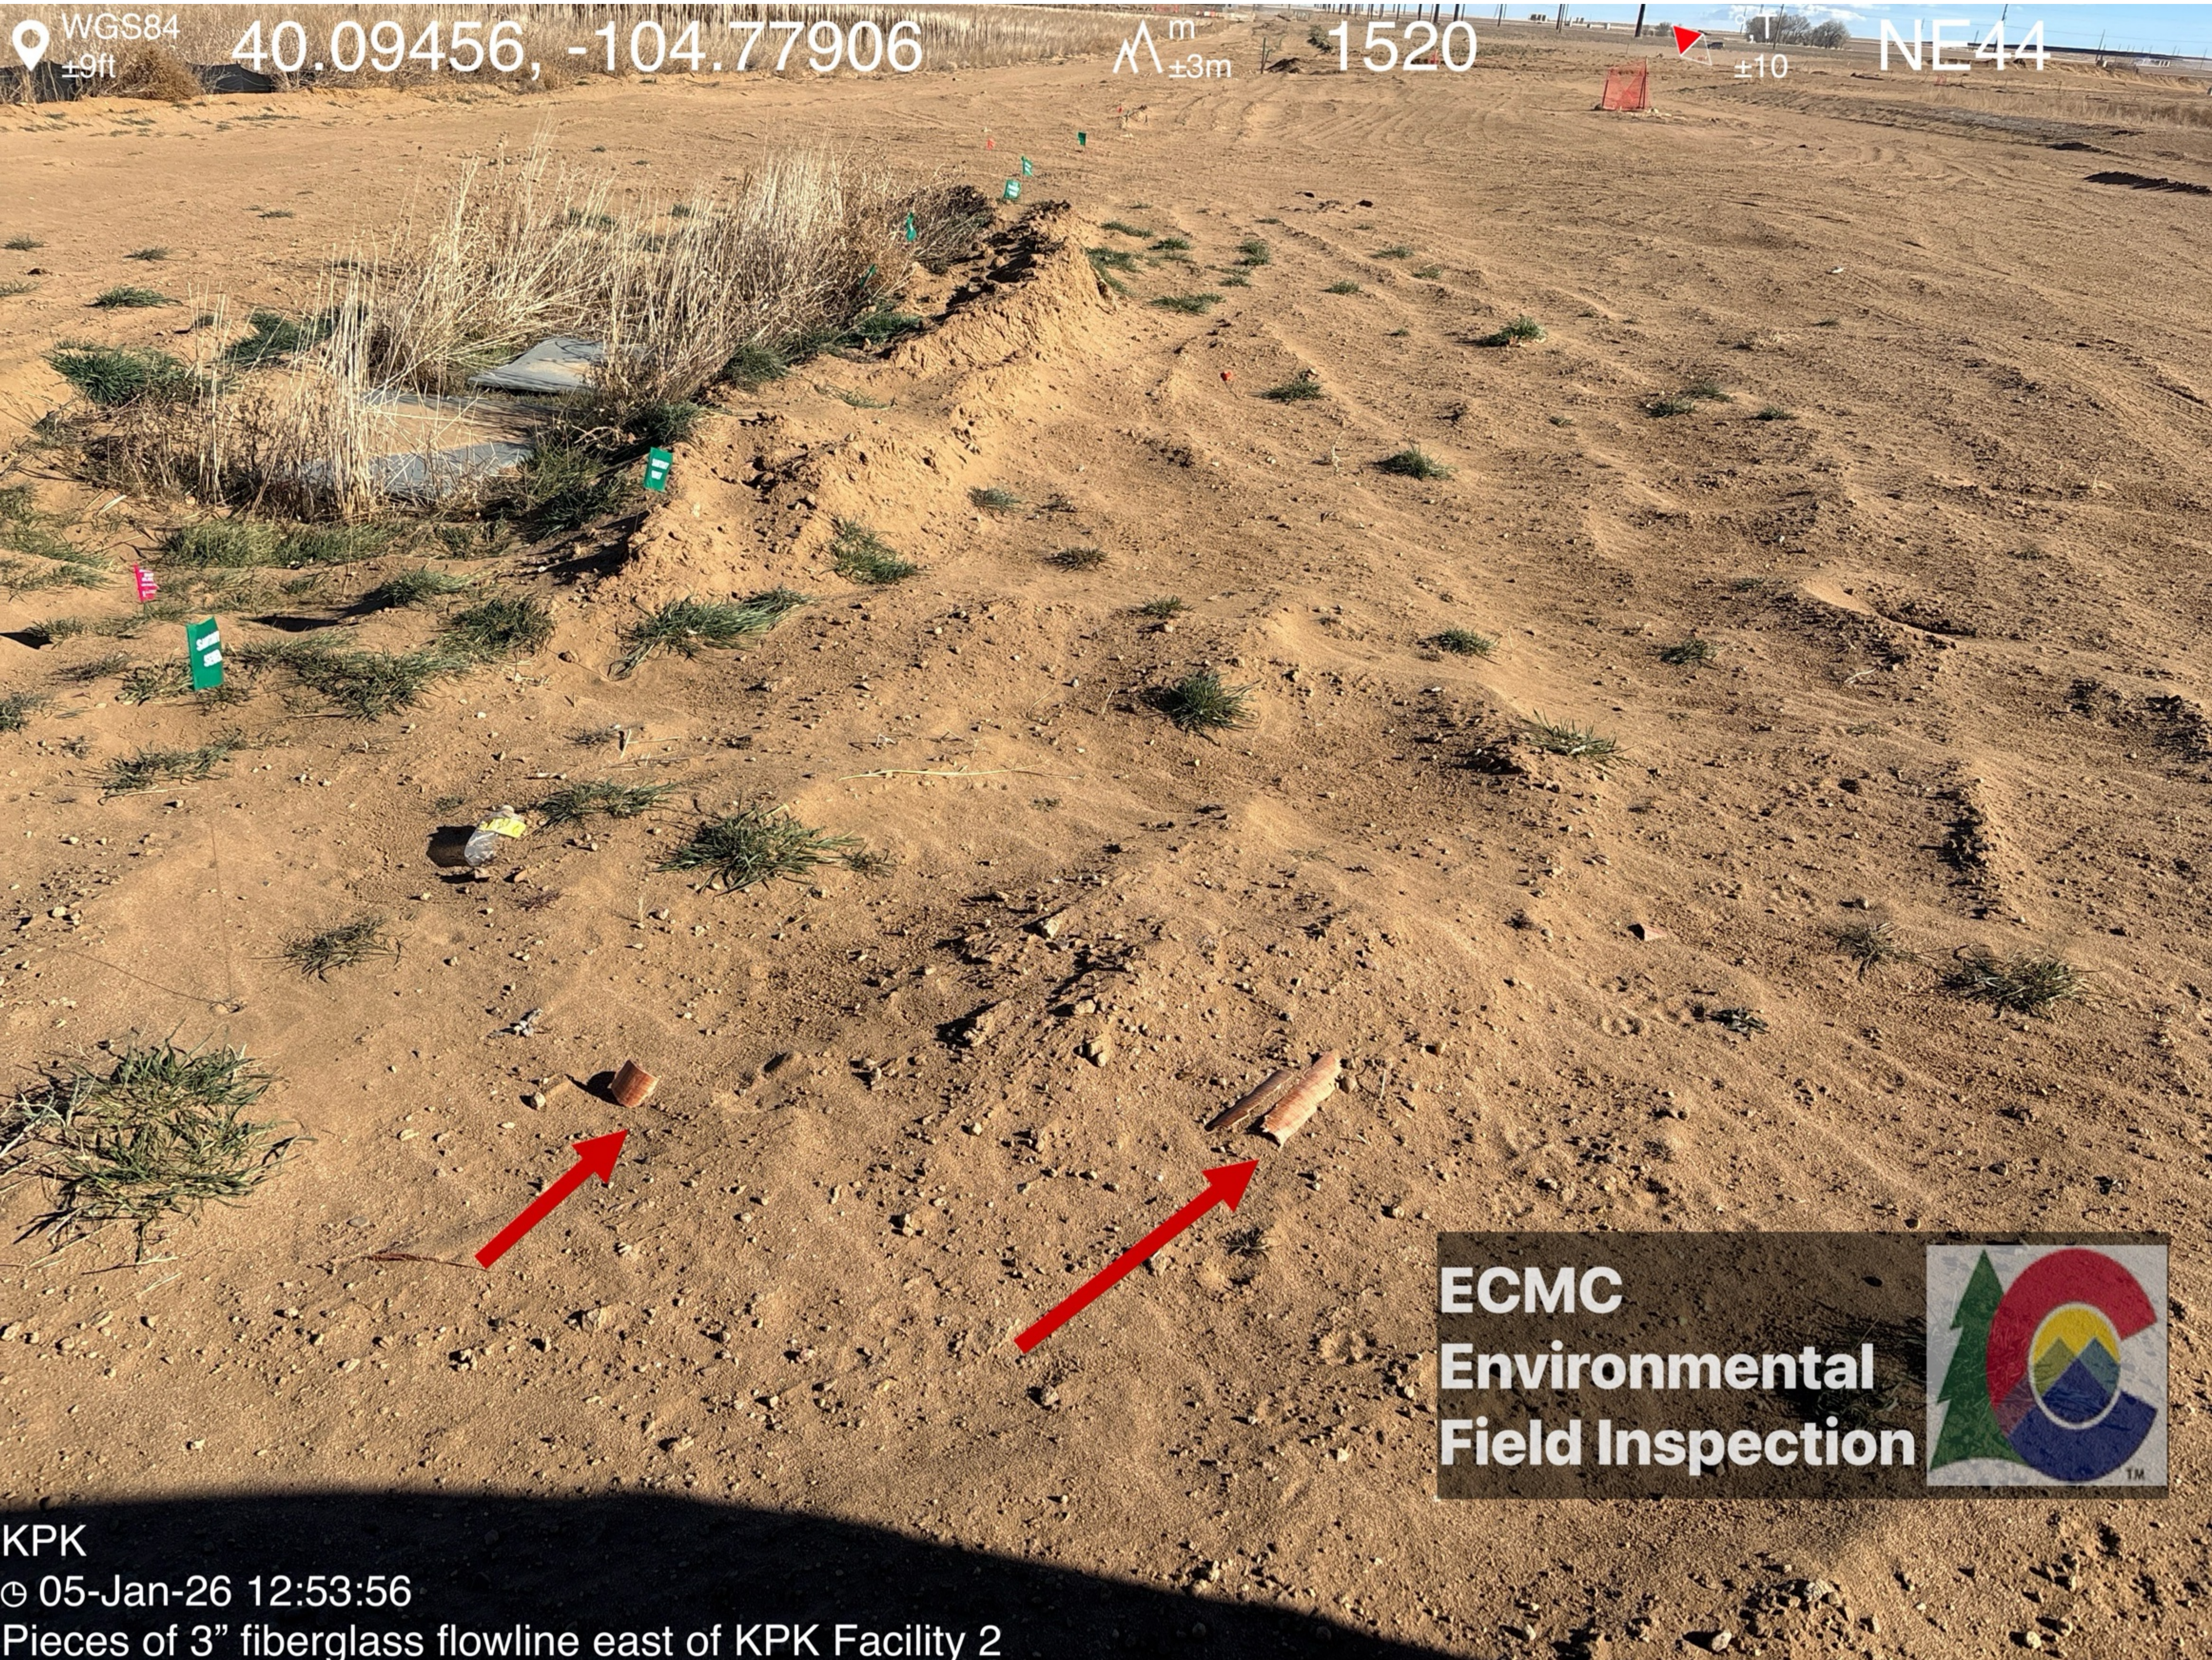
KPK
© 05-Jan-26 12:53:56
Pieces of 3" fiberglass flowline east of KPK Facility 2

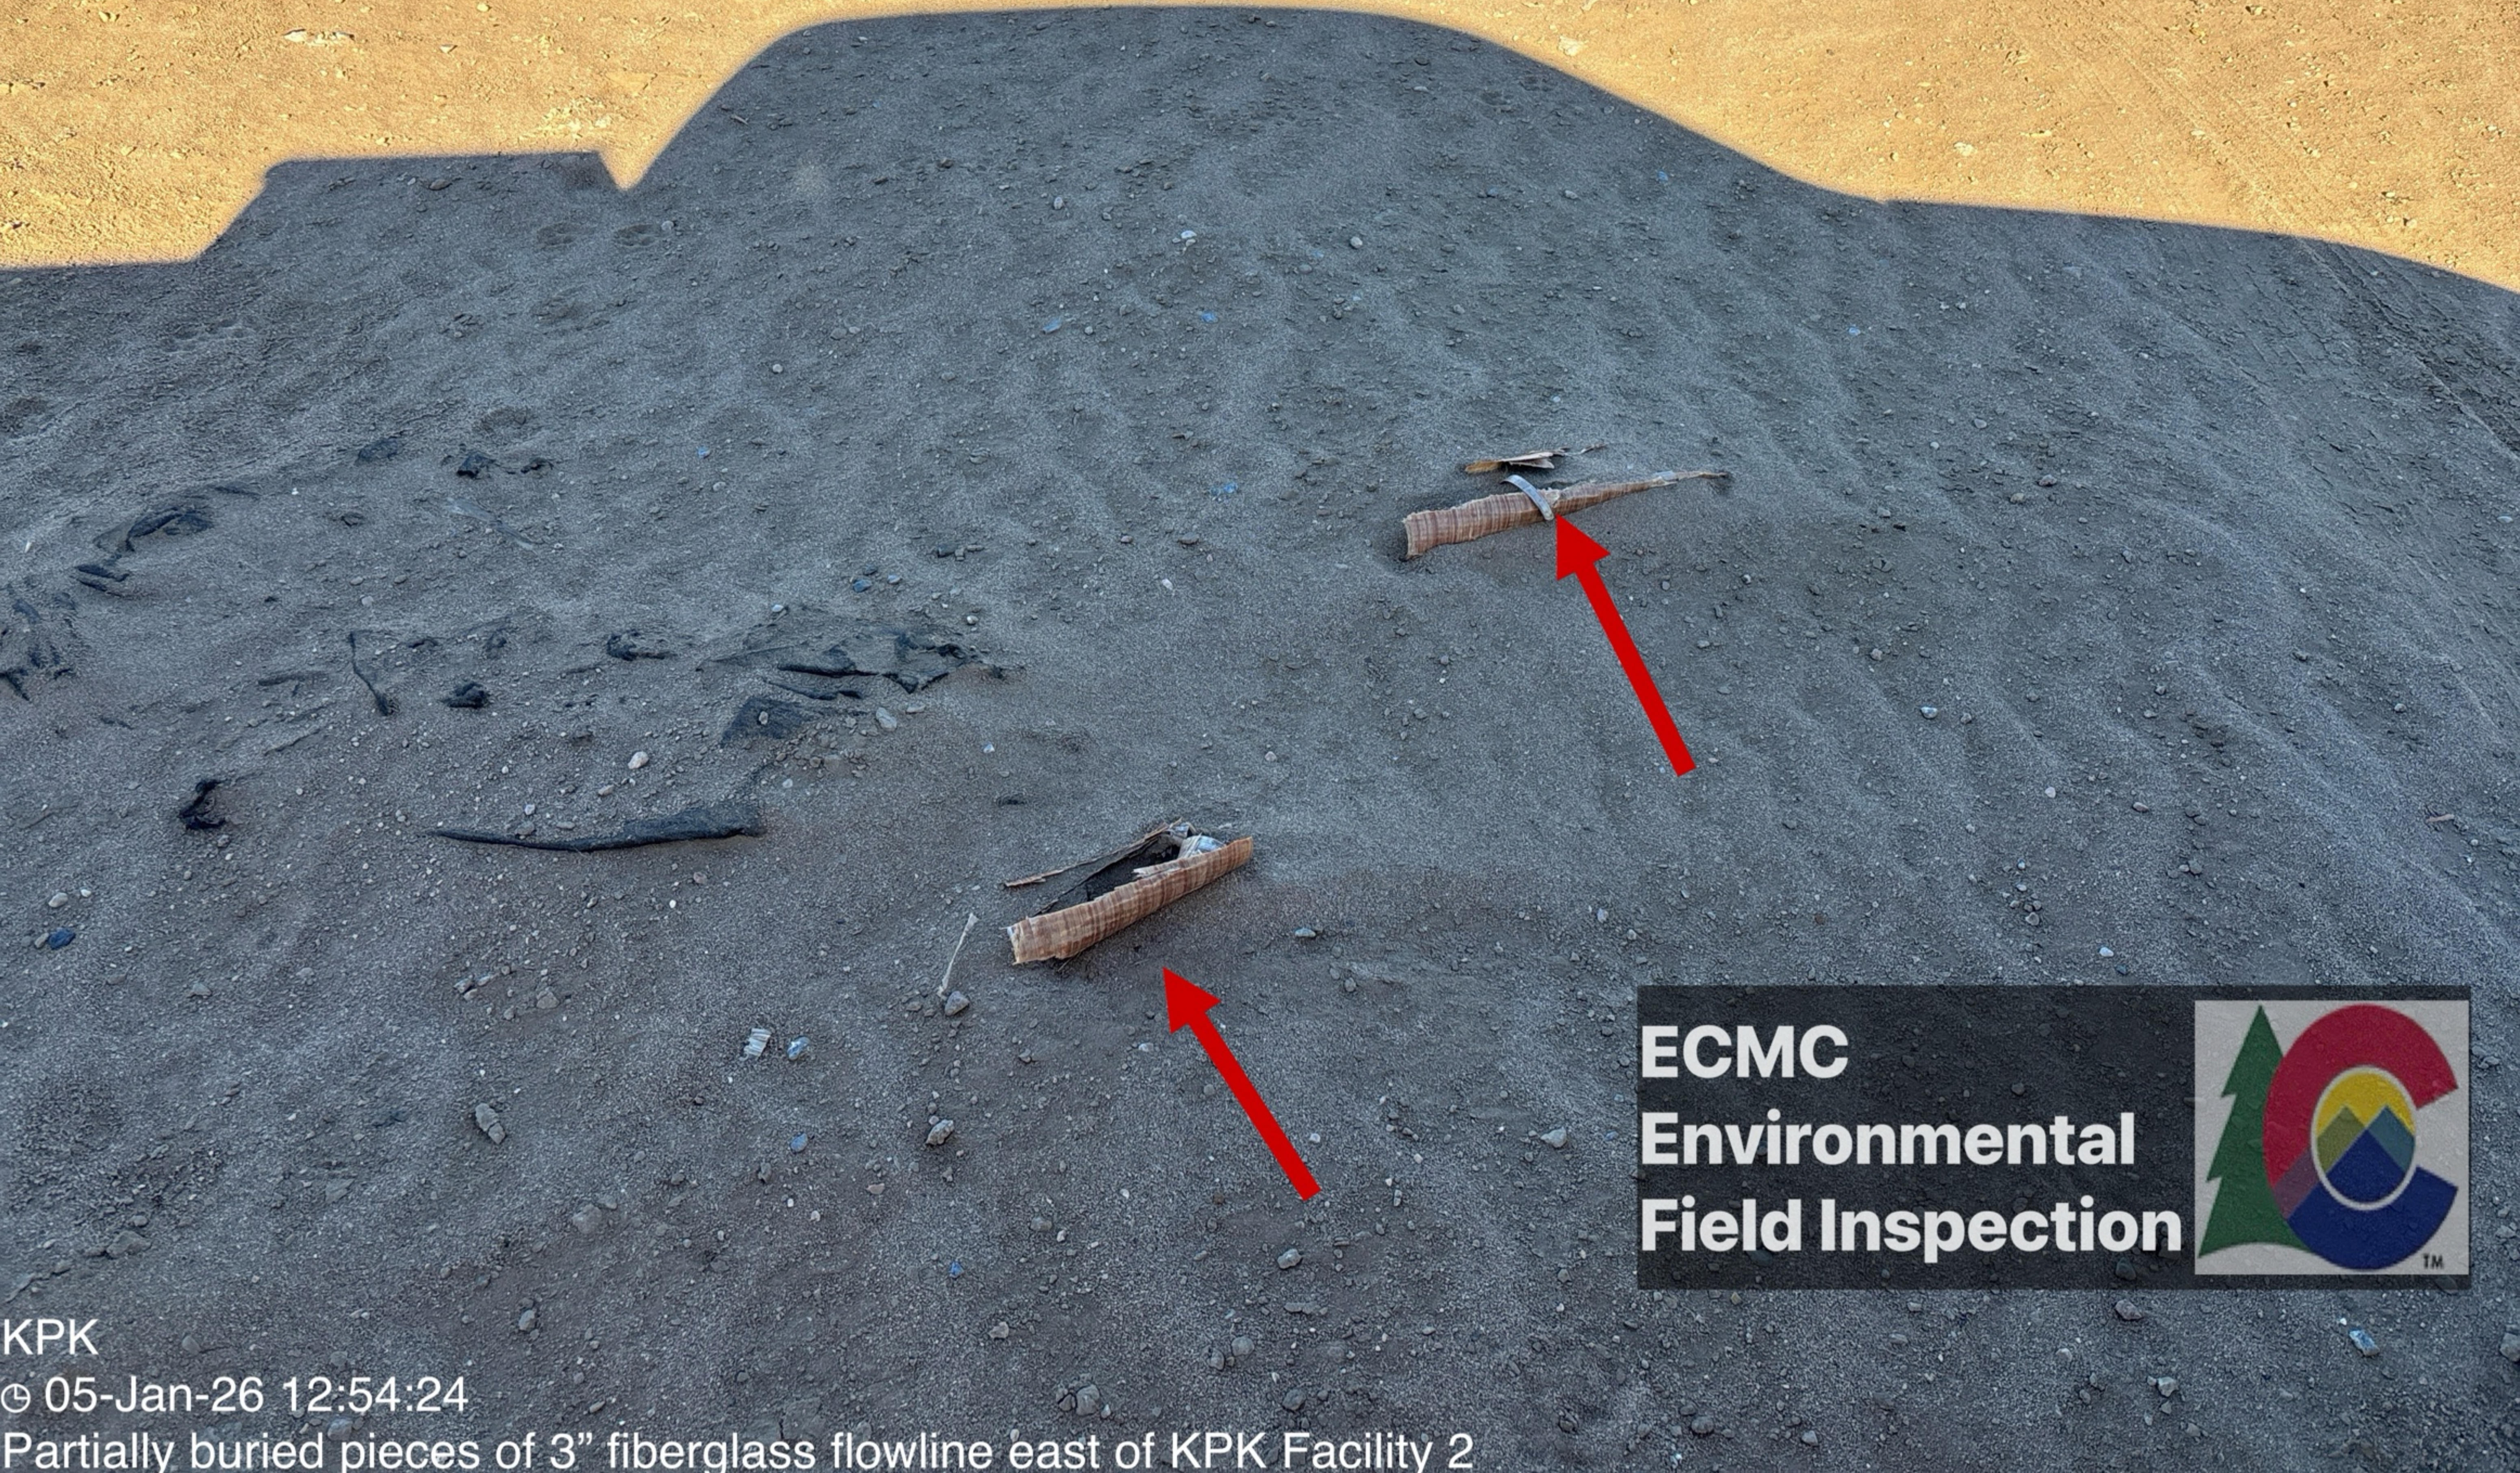
KPK
© 05-Jan-26 12:54:24
Partially buried pieces of 3" fiberglass flowline east of KPK Facility 2
