ECMC
Environmental
Field Inspection

© 05-Jan-26 12:57:29
Piece of 3" fiberglass flowline east of KPK Facility 2

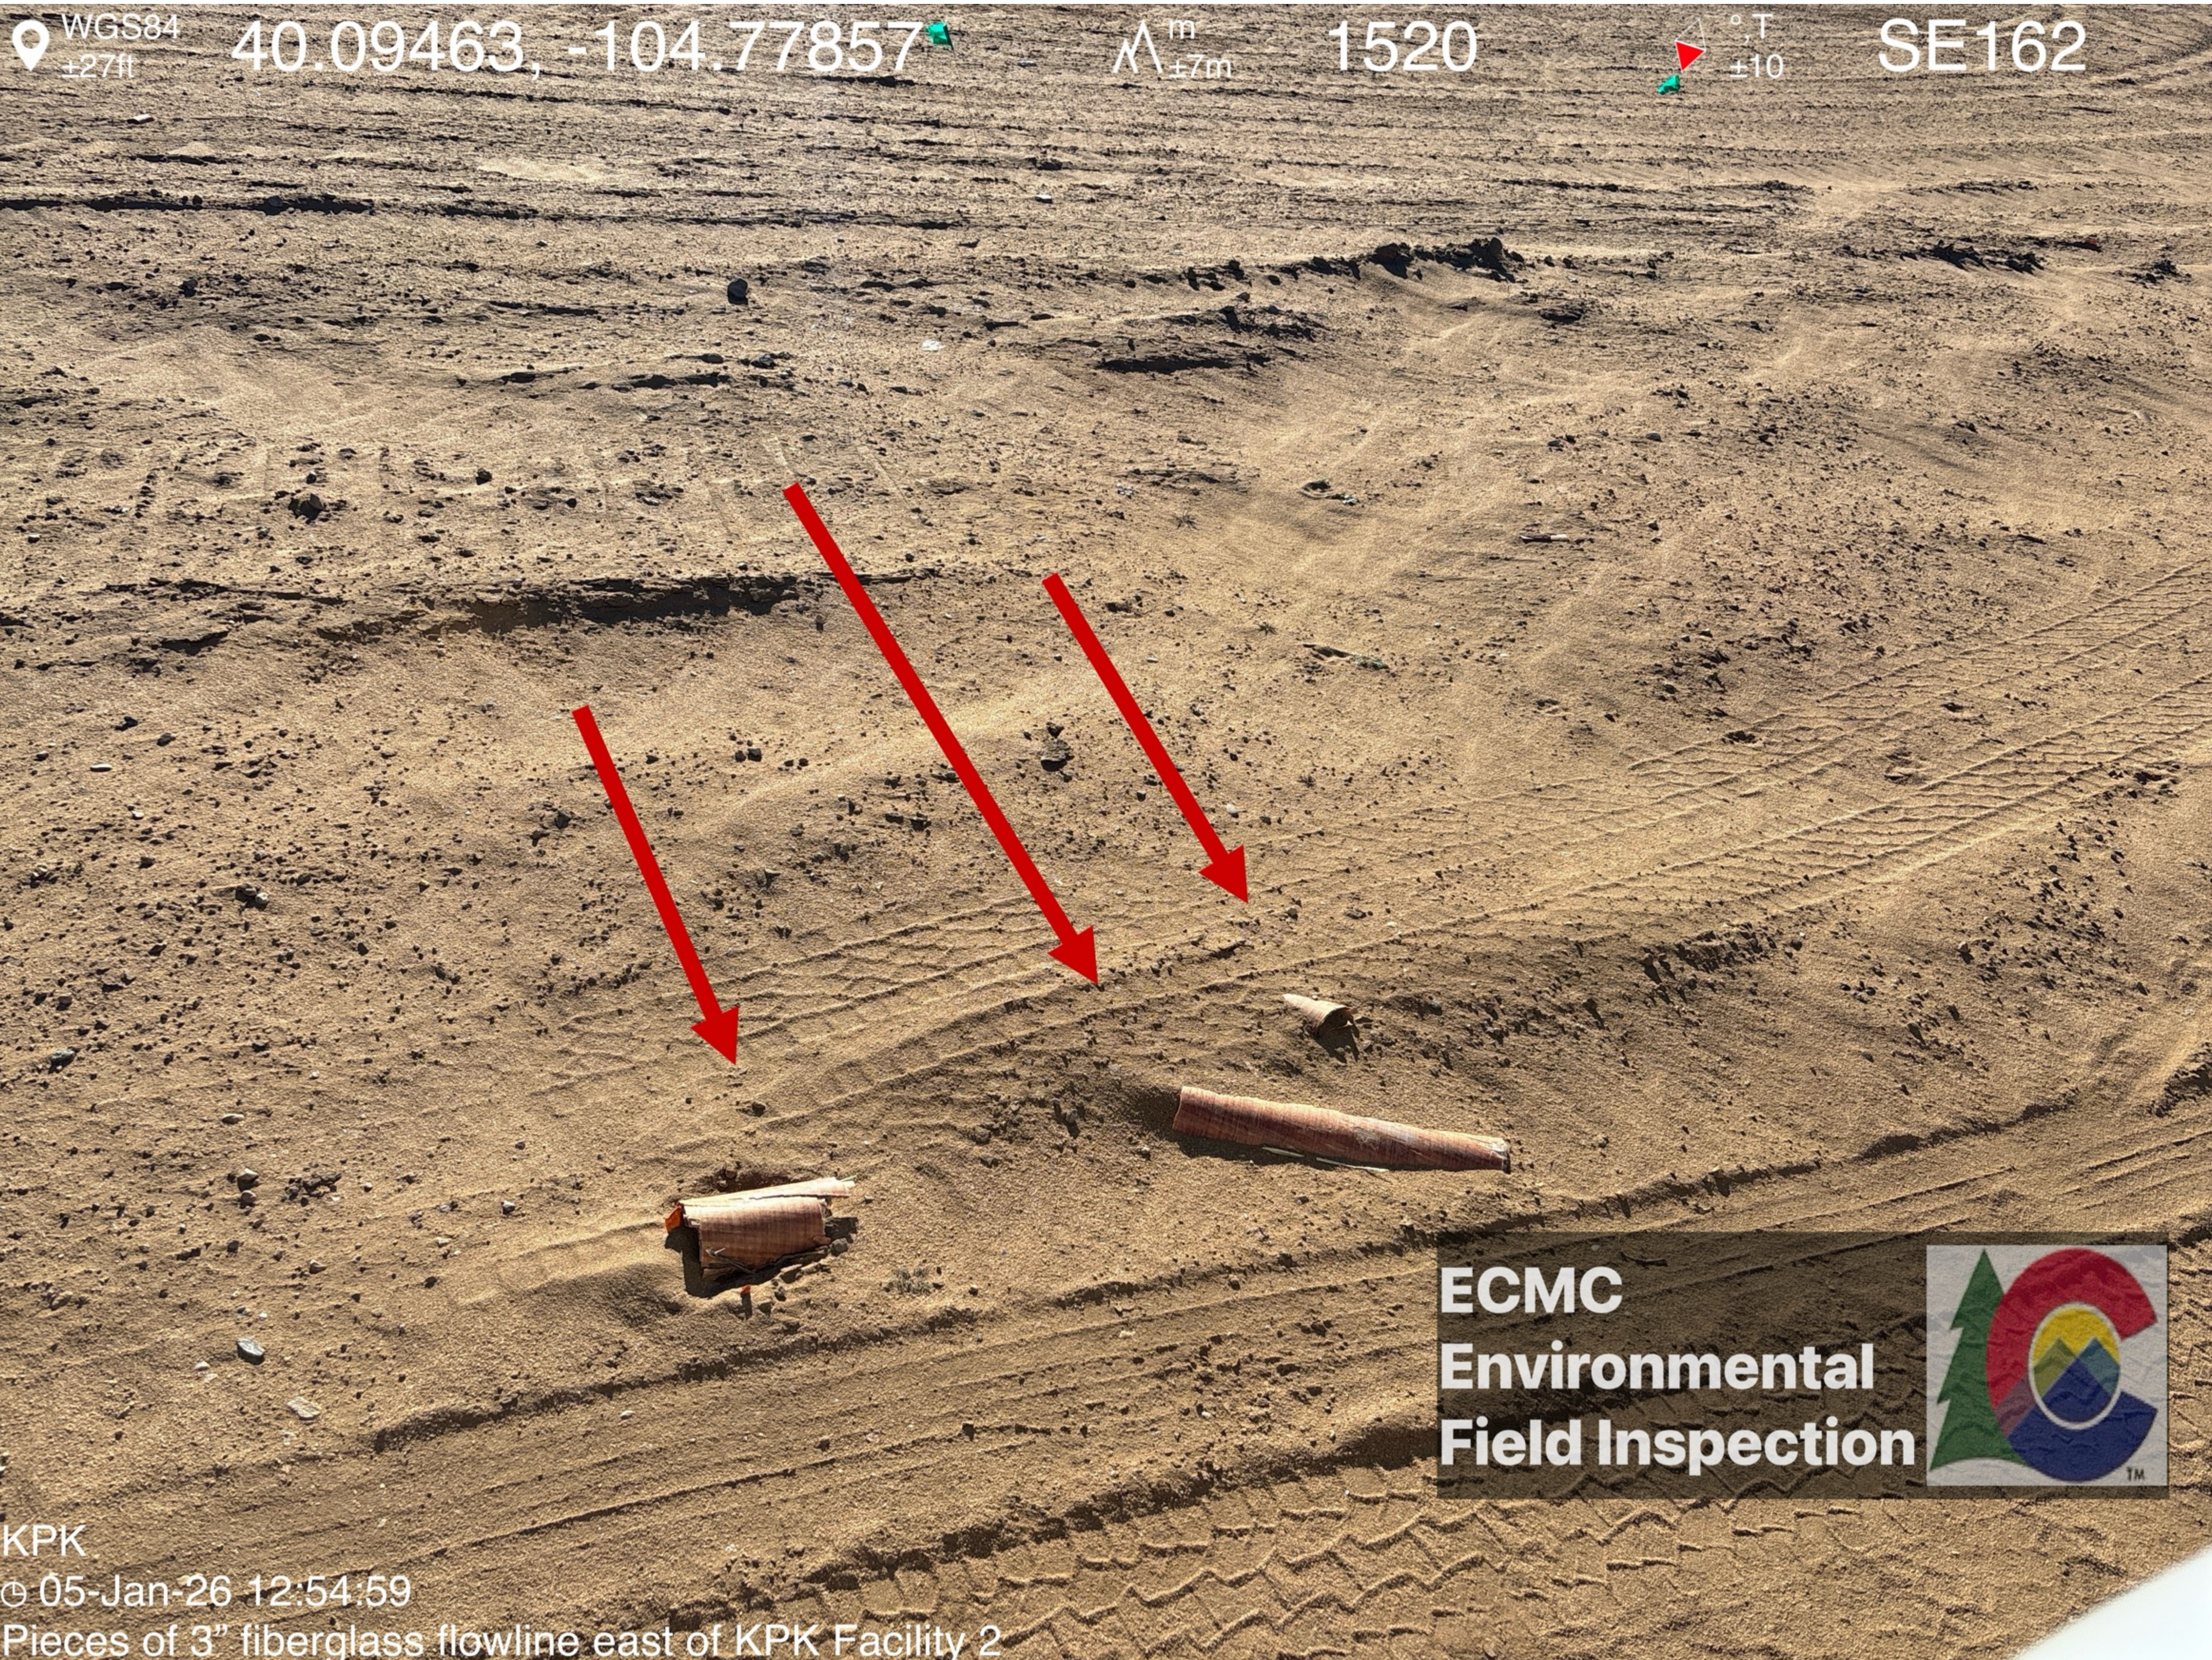
KPK
05-Jan-26 12:54:59
Pieces of 3" fiberglass flowline east of KPK Facility 2

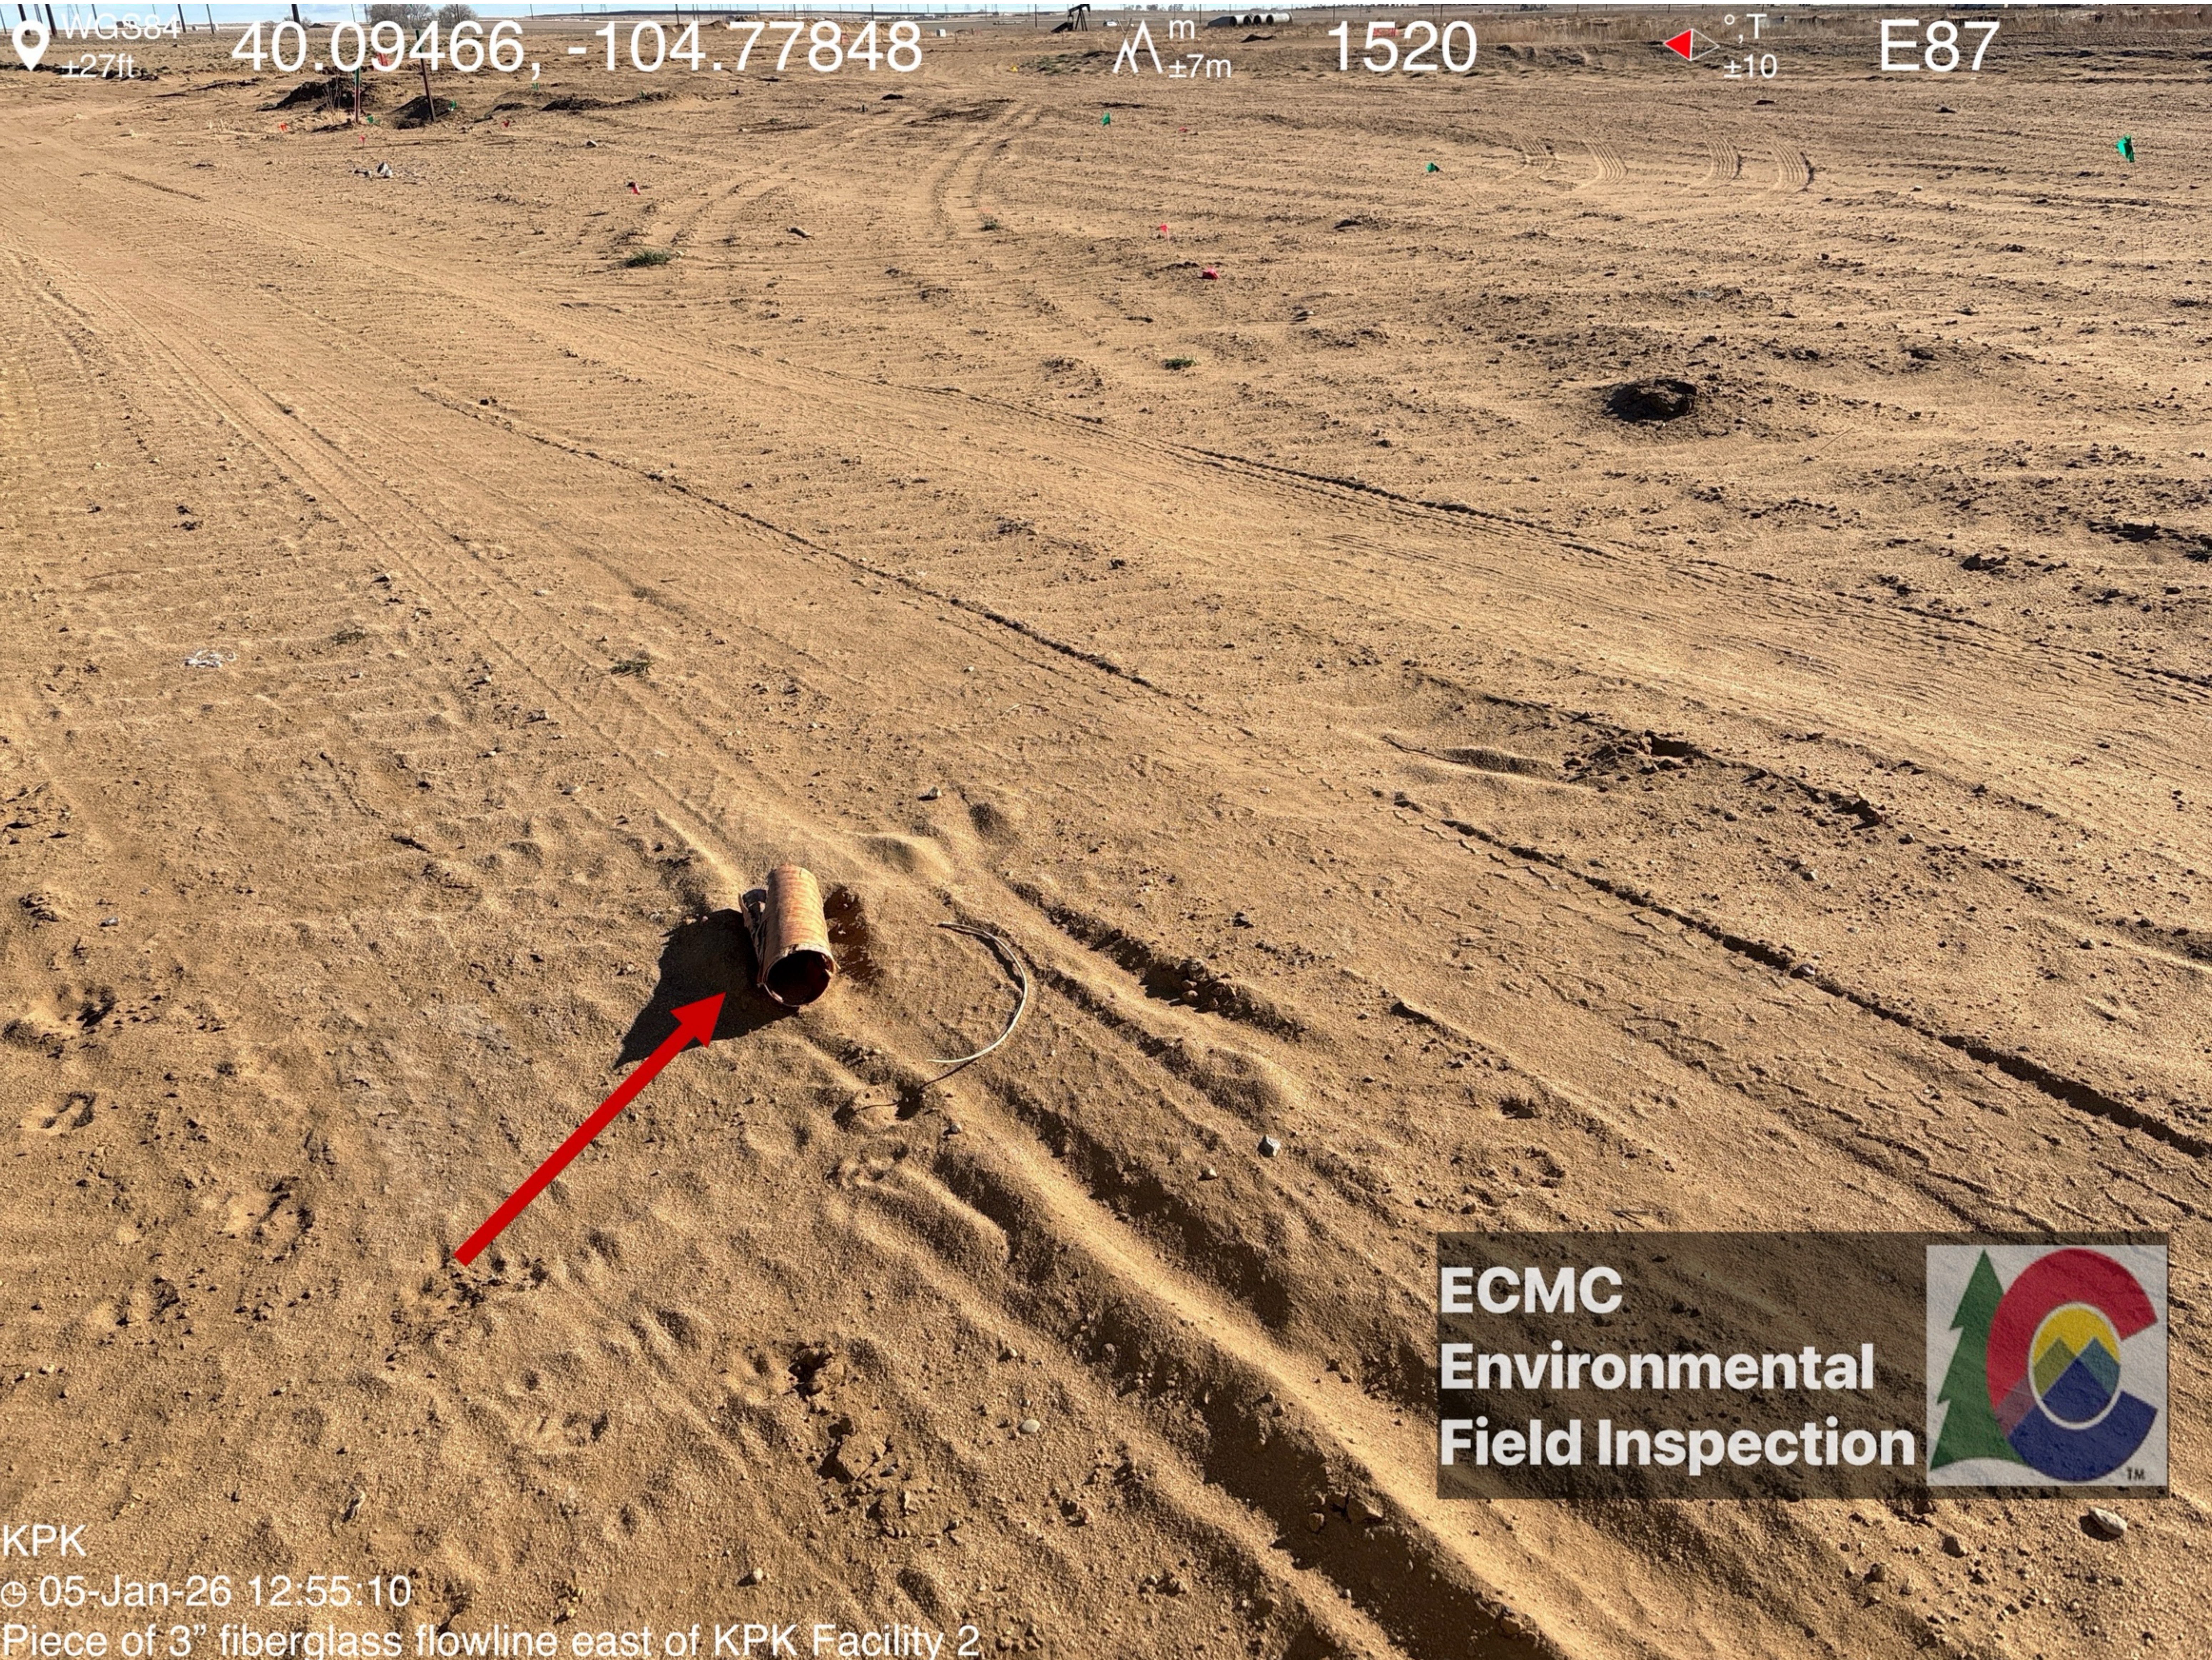
KPK
© 05-Jan-26 12:55:10
Piece of 3" fiberglass flowline east of KPK Facility 2

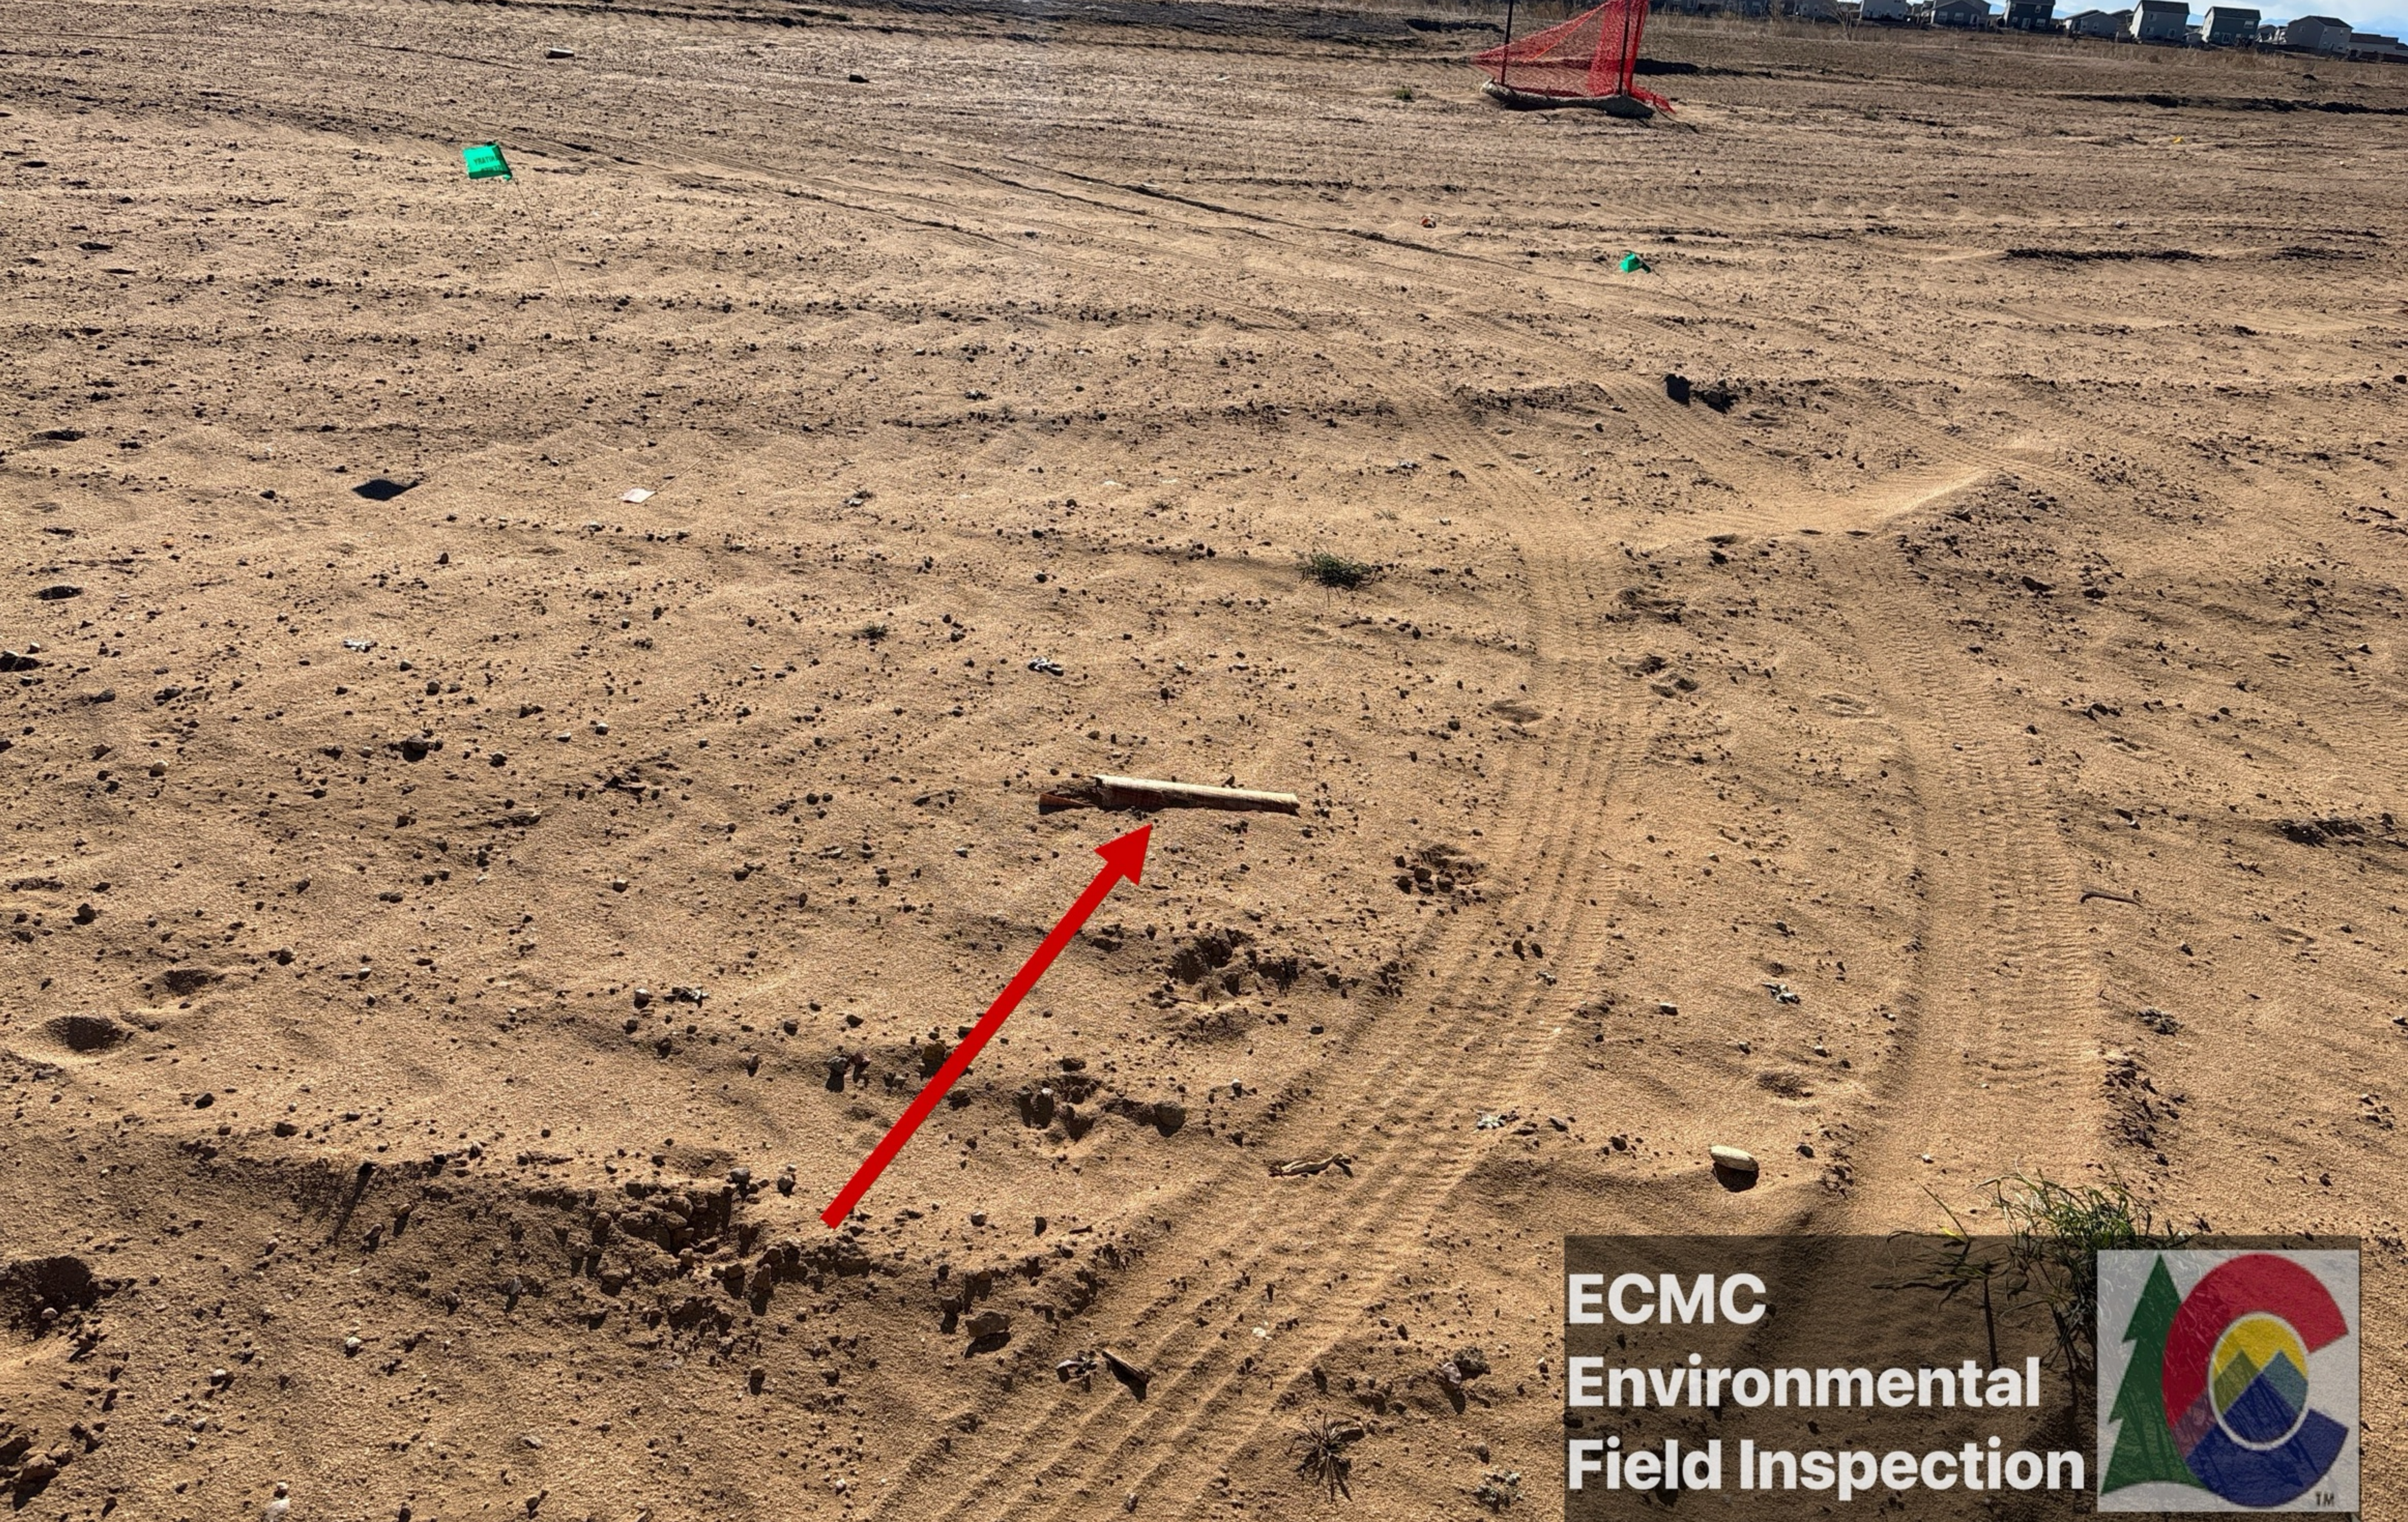
KPK
© 05-Jan-26 12:55:23
Piece of 3" fiberglass flowline east of KPK Facility 2
