<b>Date of Inspection</b>	12/30/2025
<b>Inspector Name</b>	Tyson Dilka, Stelbar
<b>Location Name</b>	Young 2-35
<b>API</b>	05-121-10079
<b>COGCC Loc ID</b>	317263
<b>County</b>	Washington
<b>Location Directions</b>	CR 19 & RR, E into
<b>Lat/Long</b>	39.839069, -102.951219
<b>TB Inspected</b>	Former wellsite only
<b>Equipment on Site</b>	No
<b>Livestock Grazing</b>	Yes
<b>Fences</b>	No – removed 12/30/2025
<b>Weeds or Debris</b>	No
<b>Visual of Vegetative Cover</b>	Location is visually observed at 80% overall, small percentage of common weed litter; access road has vehicle tracks in established tall grass, but no rutting
<b>Stormwater</b>	No stormwater issues observed, cattle and burrowing animals have created minor disturbance
<b>Recommendations</b>	Final Reclamation Release
<b>Photos</b>	See below 1-5
<b>Response to Inspection</b>	Photo 6 in document 708201890 states the access road was not re-graded with ruts evident. When driven on, tall established perennial vegetation creates a 2-track in the sandy texture soil. The road in fact does not require additional grading and meets Rule 1004 reclamation requirements. Please reference photo 1 below, without vehicle traffic.

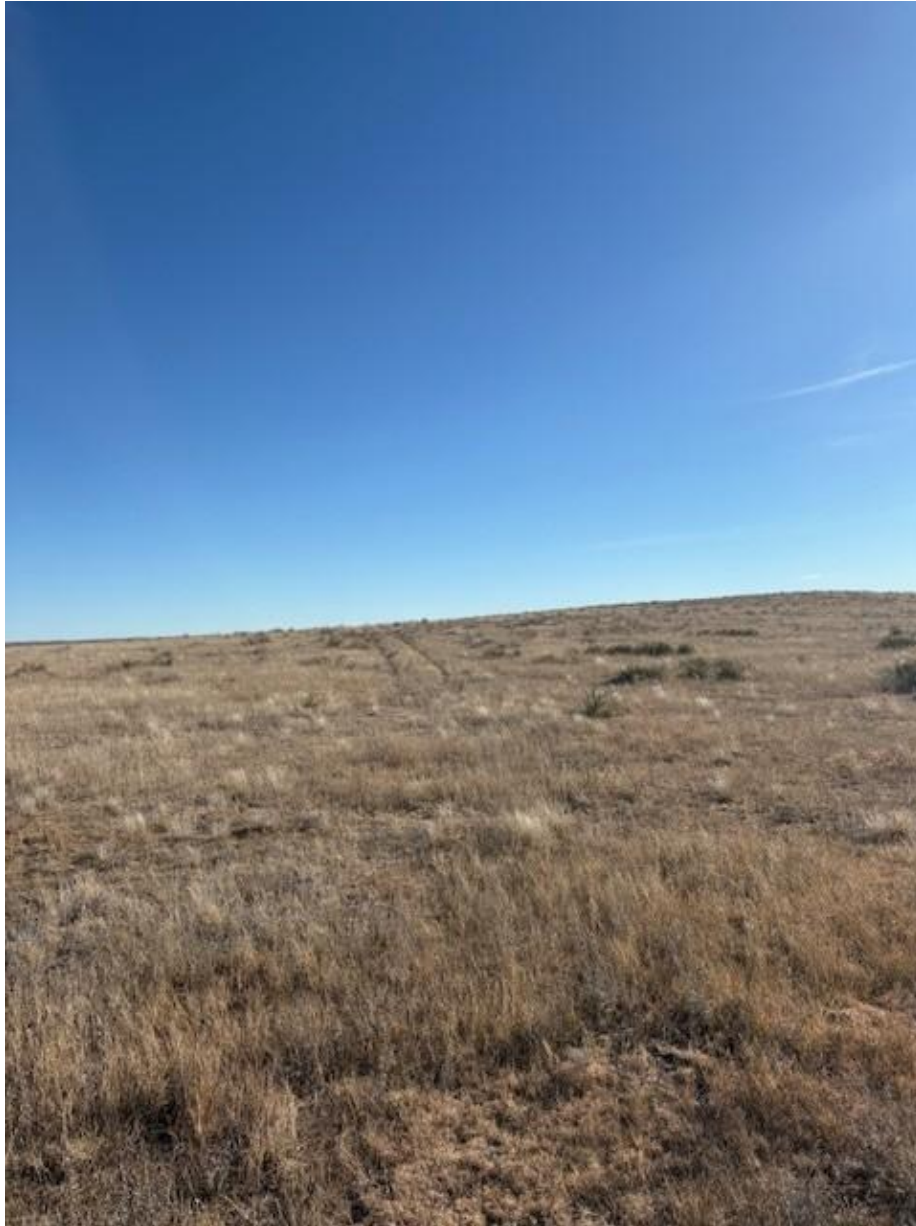
**Photo 1.** Photo facing east showing established vegetation on access road and reference areas.
