Looking at the spill location. Orange construction fencing has been installed around the open excavations, but has fallen.

Lat 40.123529, Long -105.013656  
01/13/2026 14:08 GMT-07:00  
ECMC : Environmental Inspection

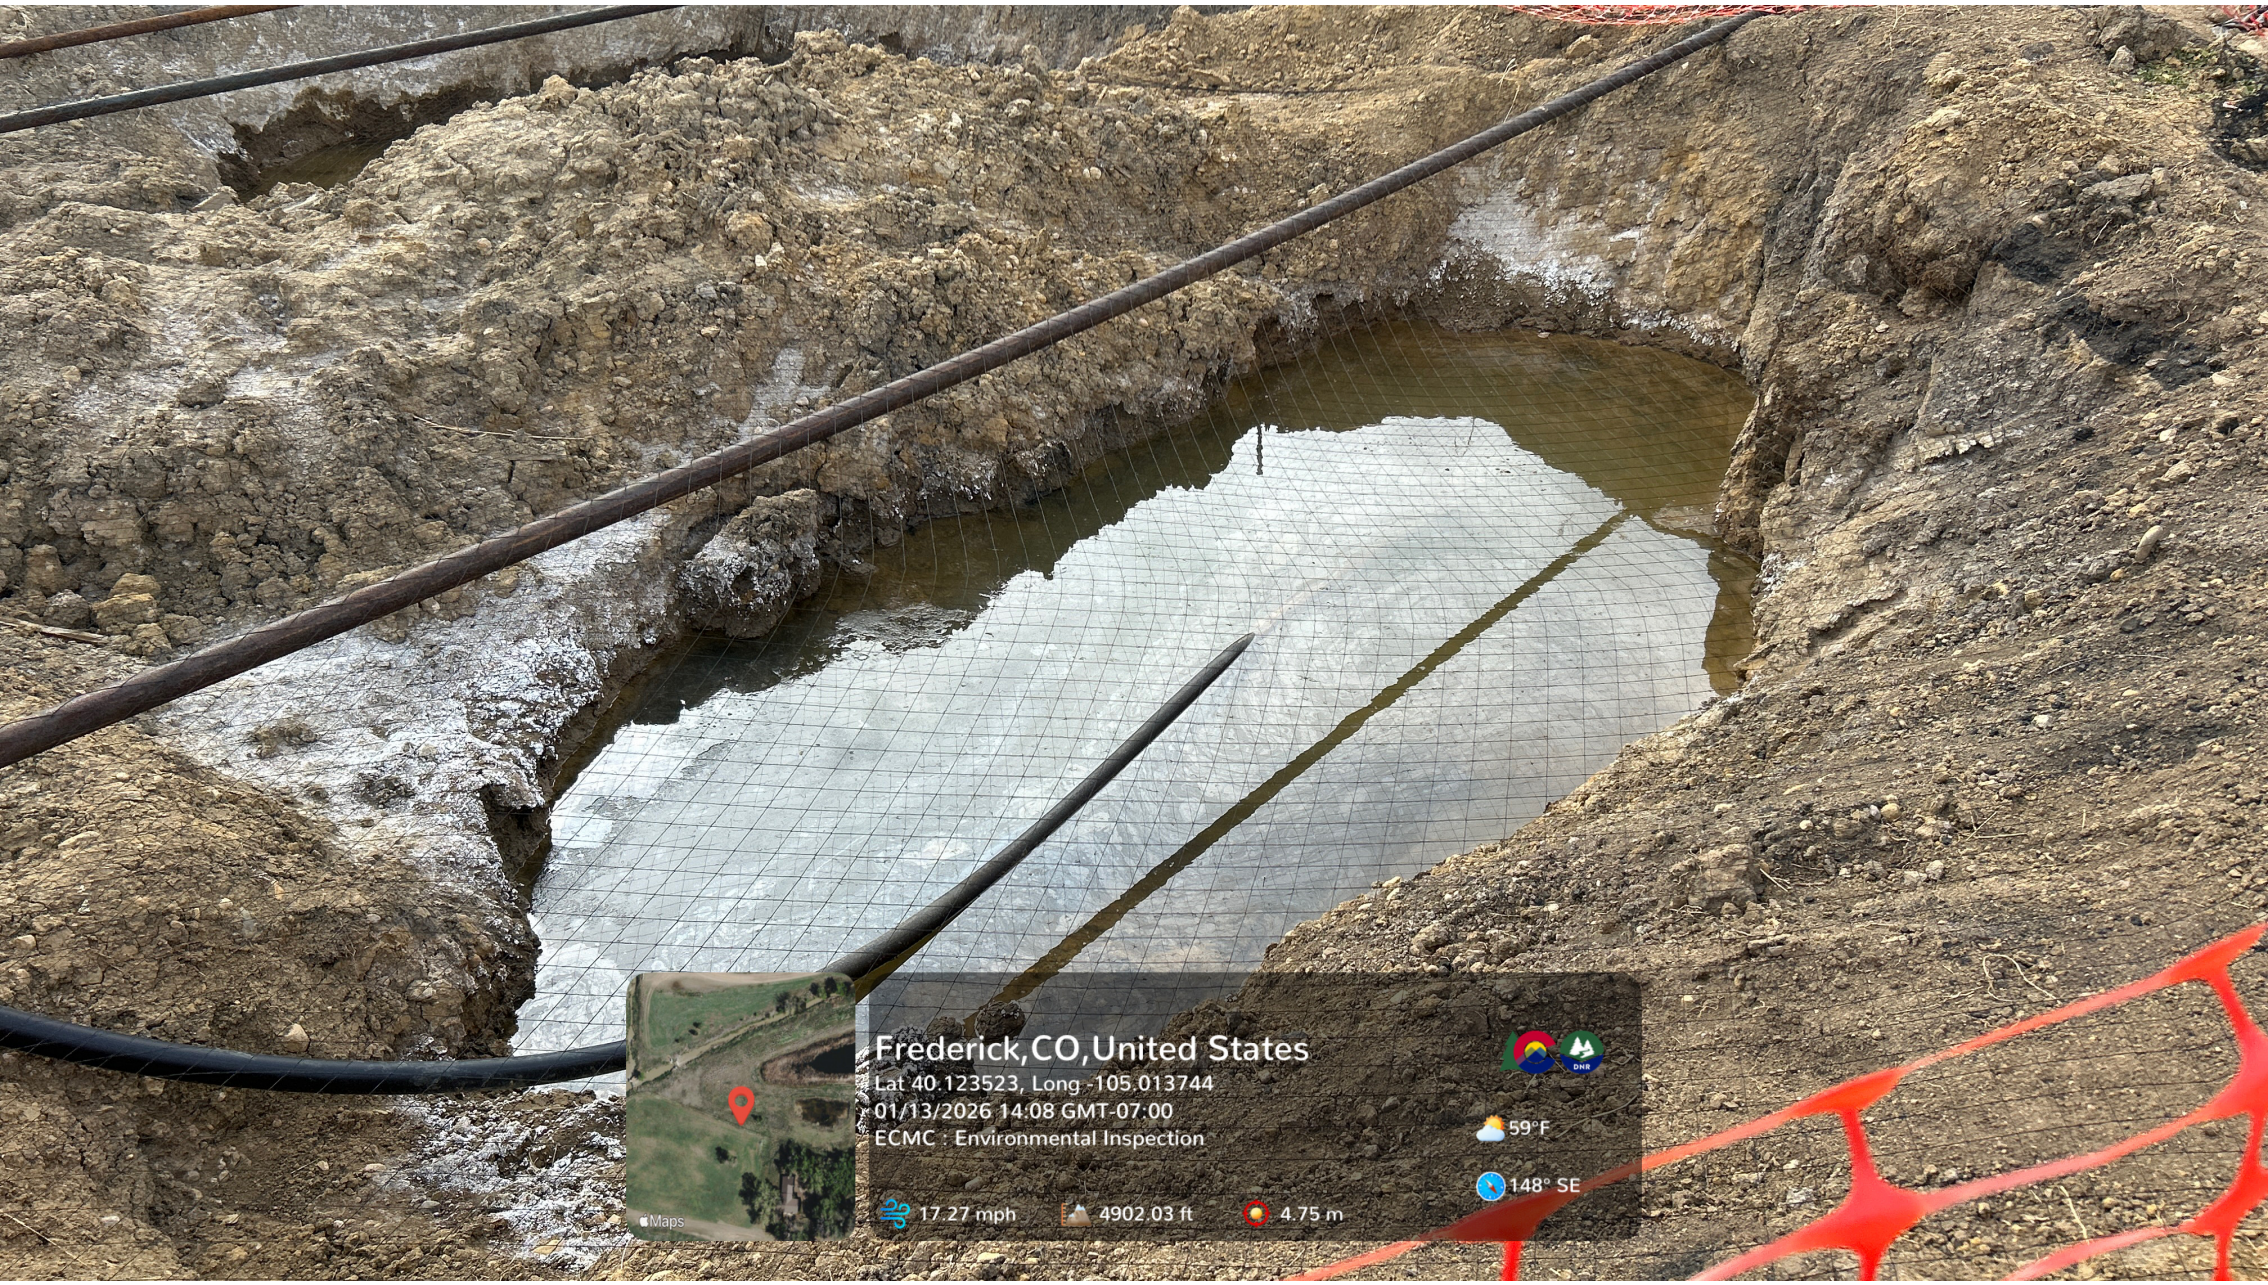
Looking at the northern excavation open at the spill location. Stained soil and salt crusting are visible on the excavation sidewalls. A sheen is visible on groundwater at the base of the excavation. Bird netting has been installed over the open excavations. A segment of flowline is visible protruding from the excavation.

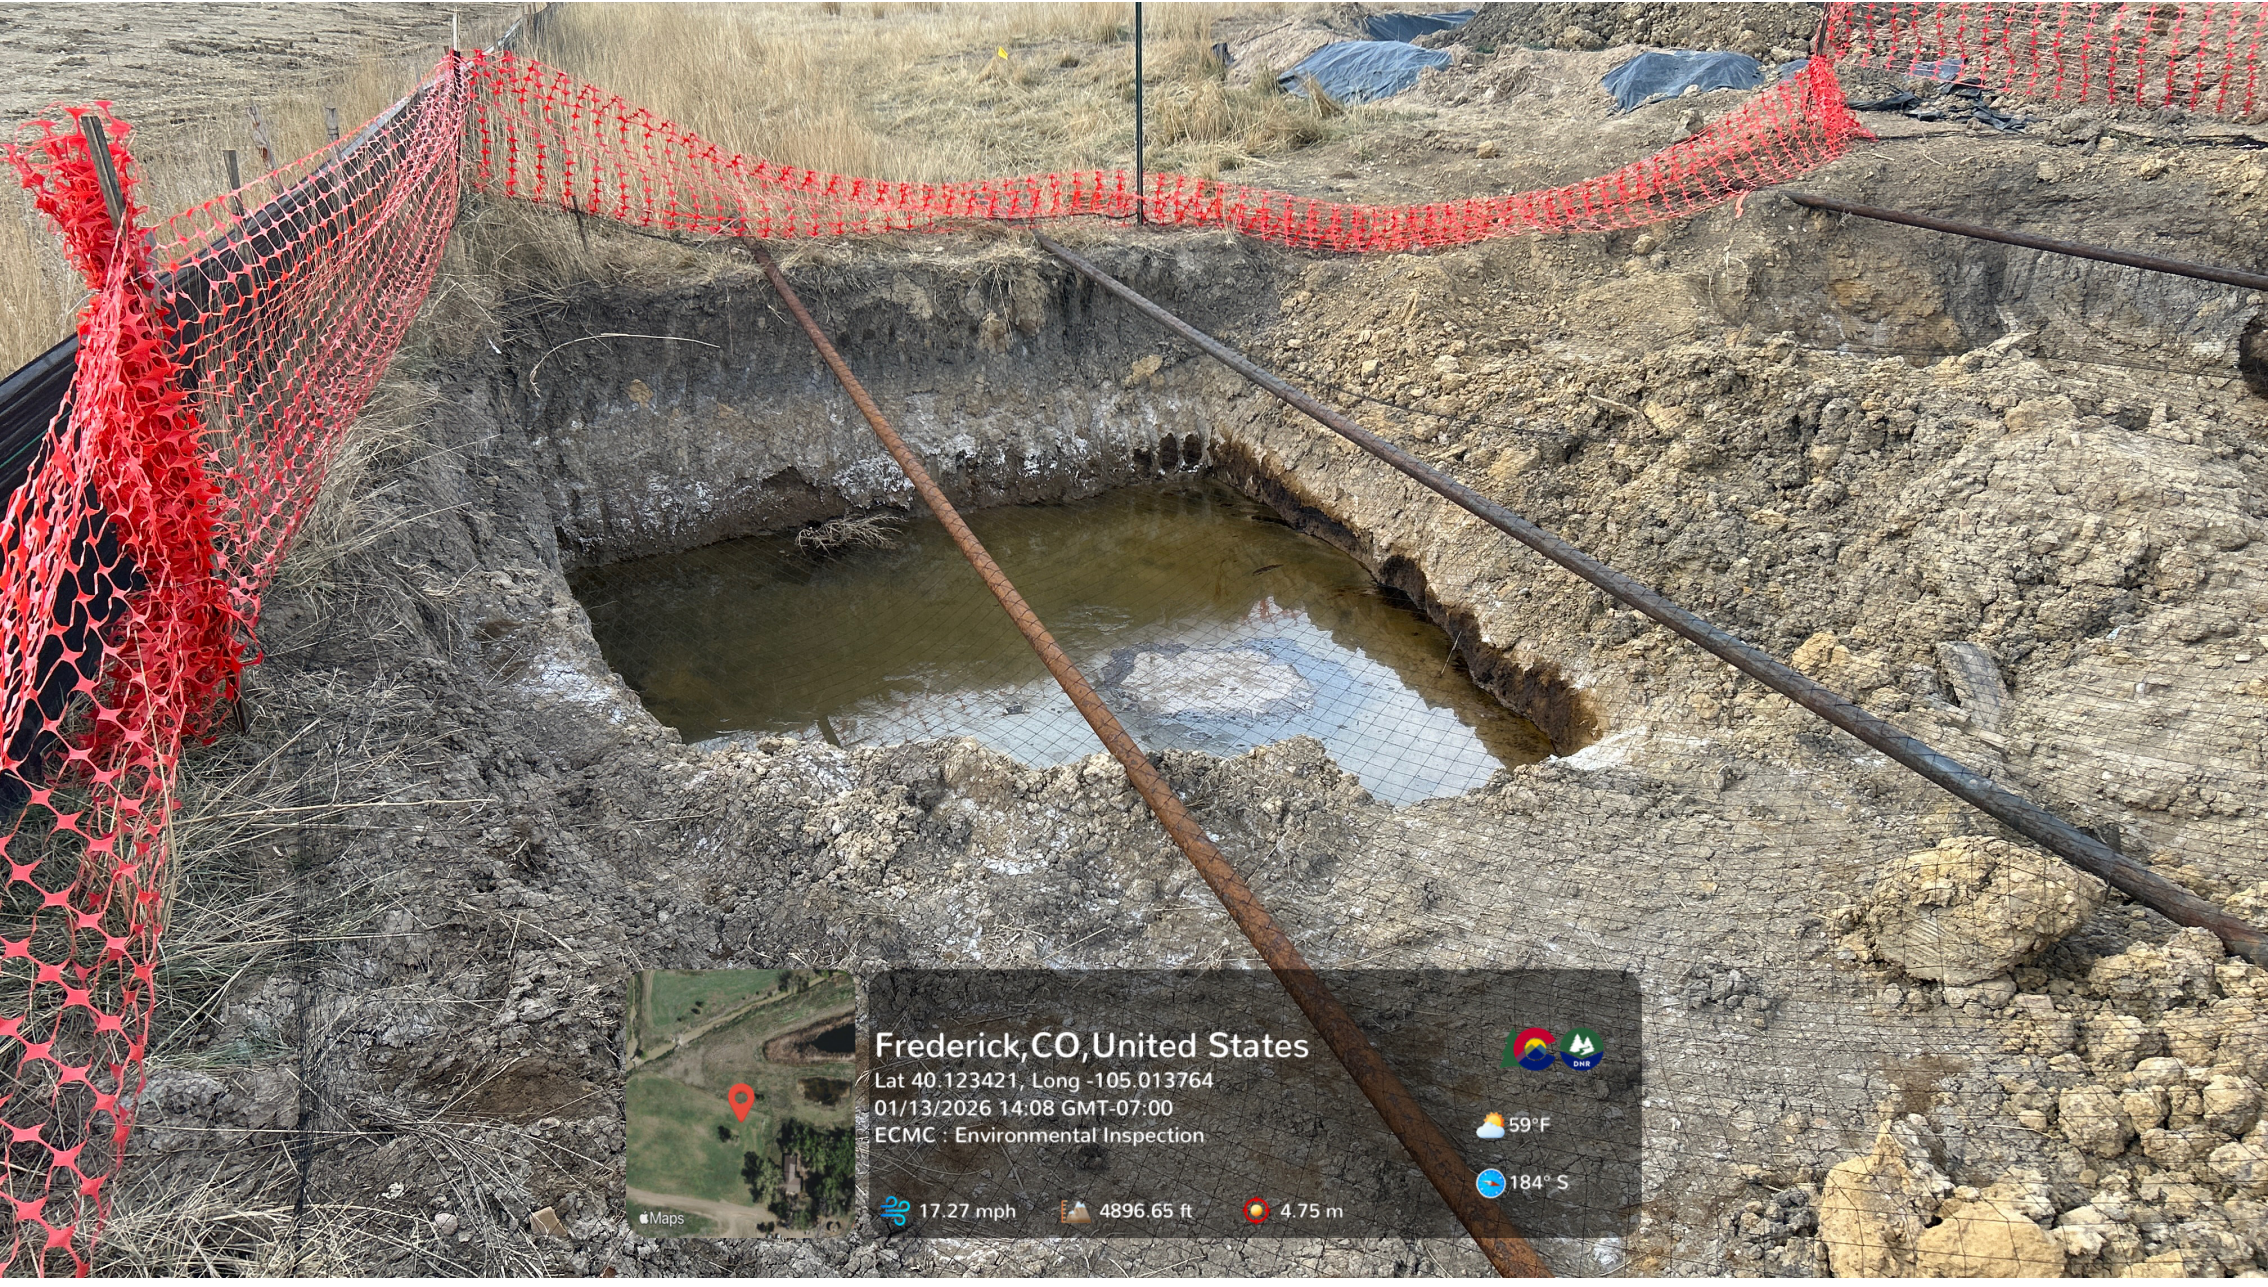
Looking at the southern excavation open at the spill location. Petroleum hydrocarbon saturated soil and salt crusting are visible on the excavation sidewalls. Free product is visible on groundwater at the base of the excavation. Bird netting has been installed over the open excavations.

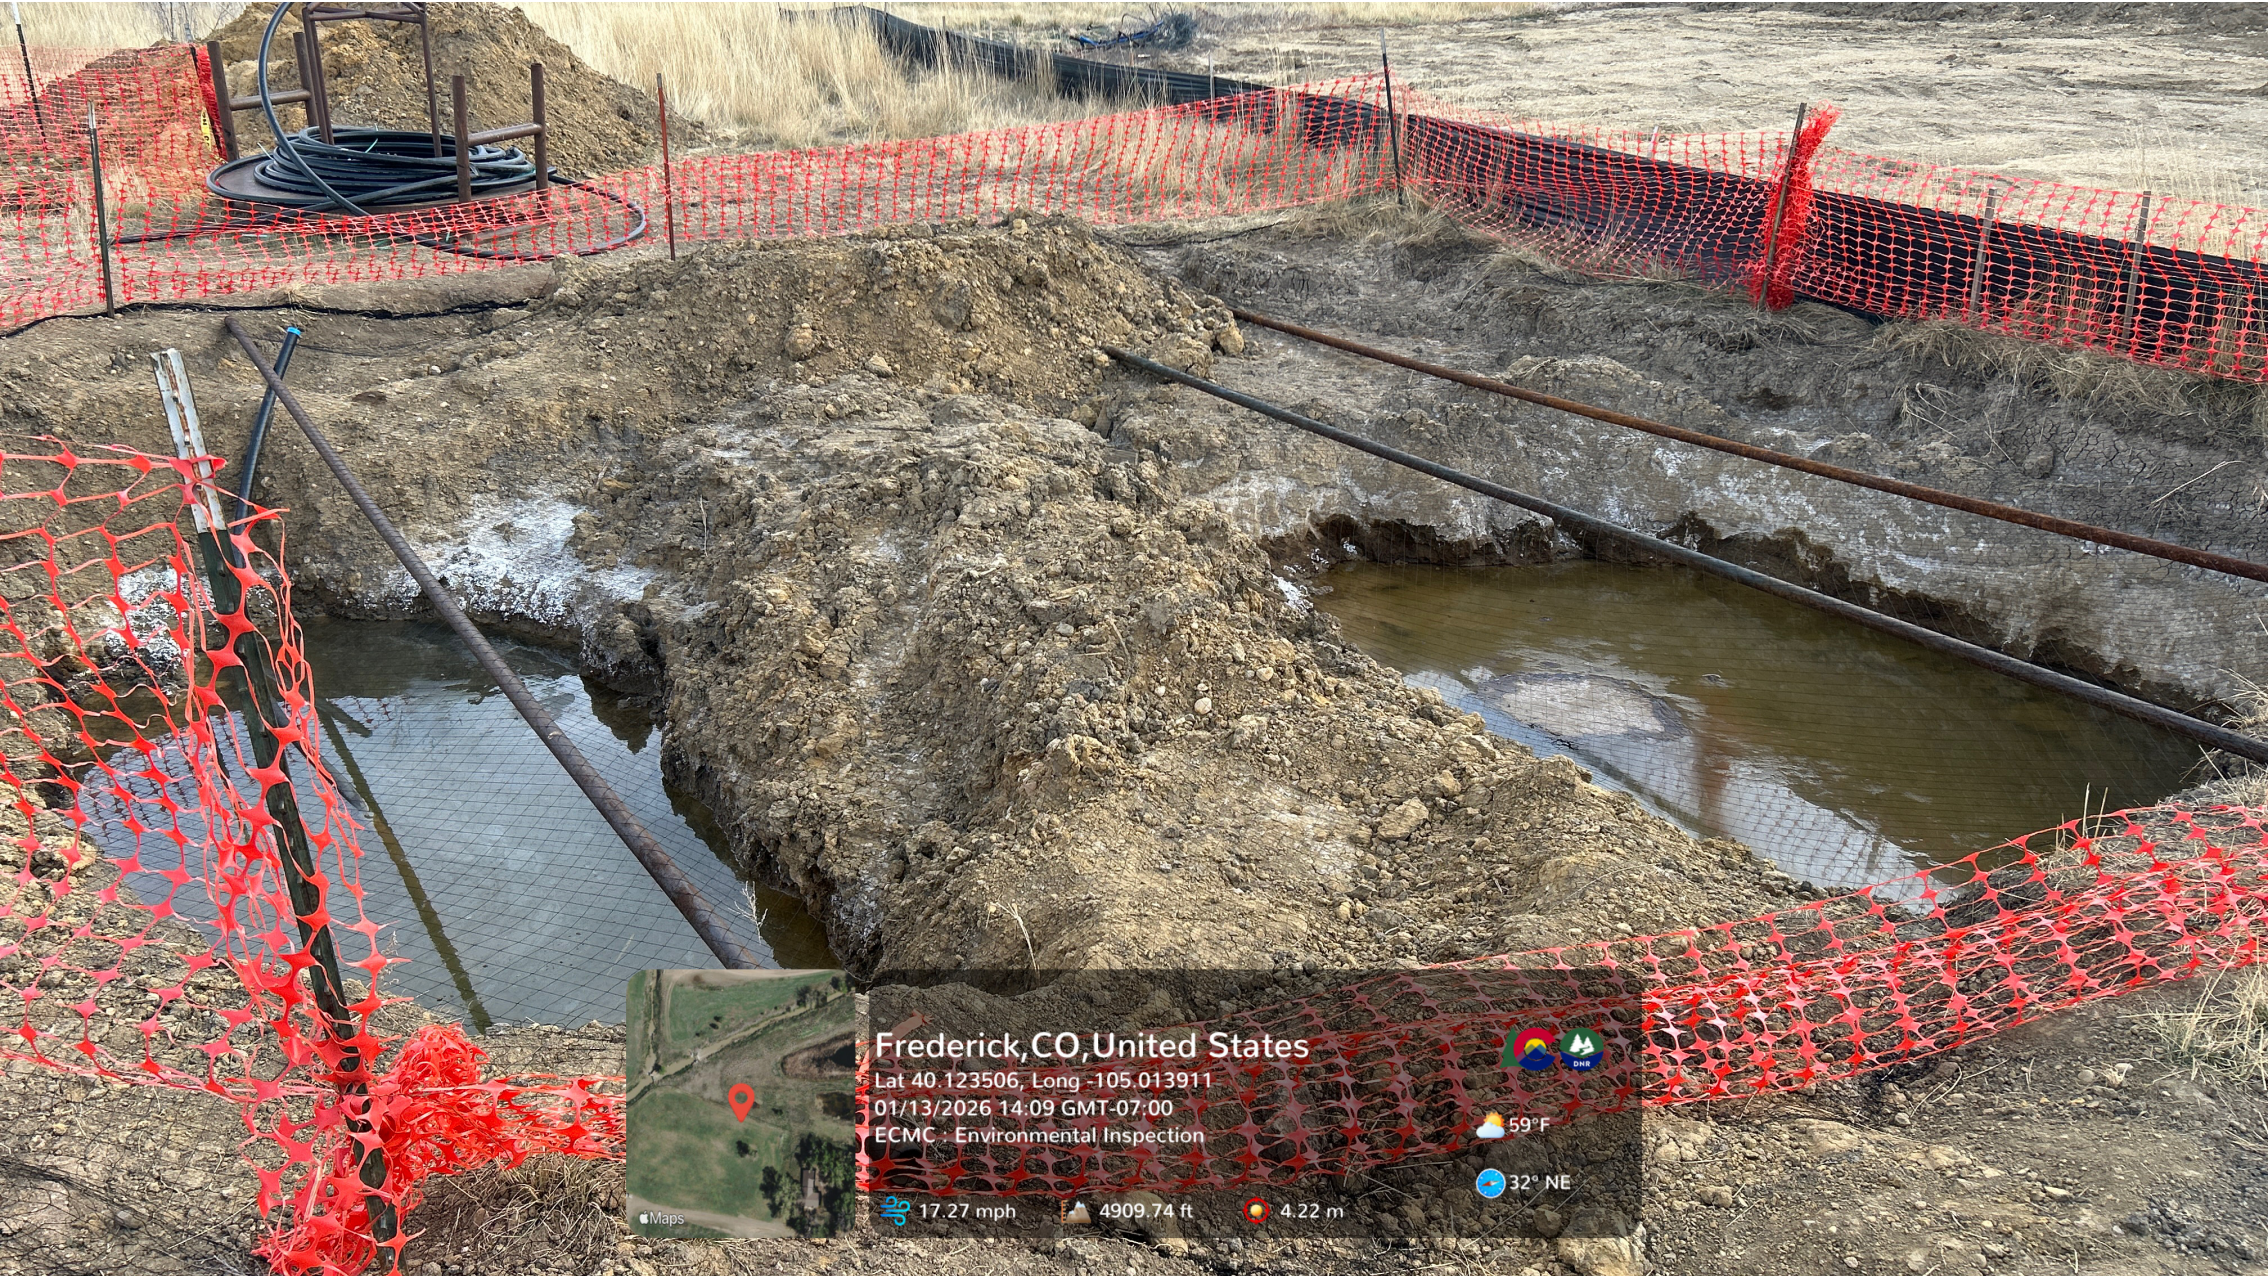
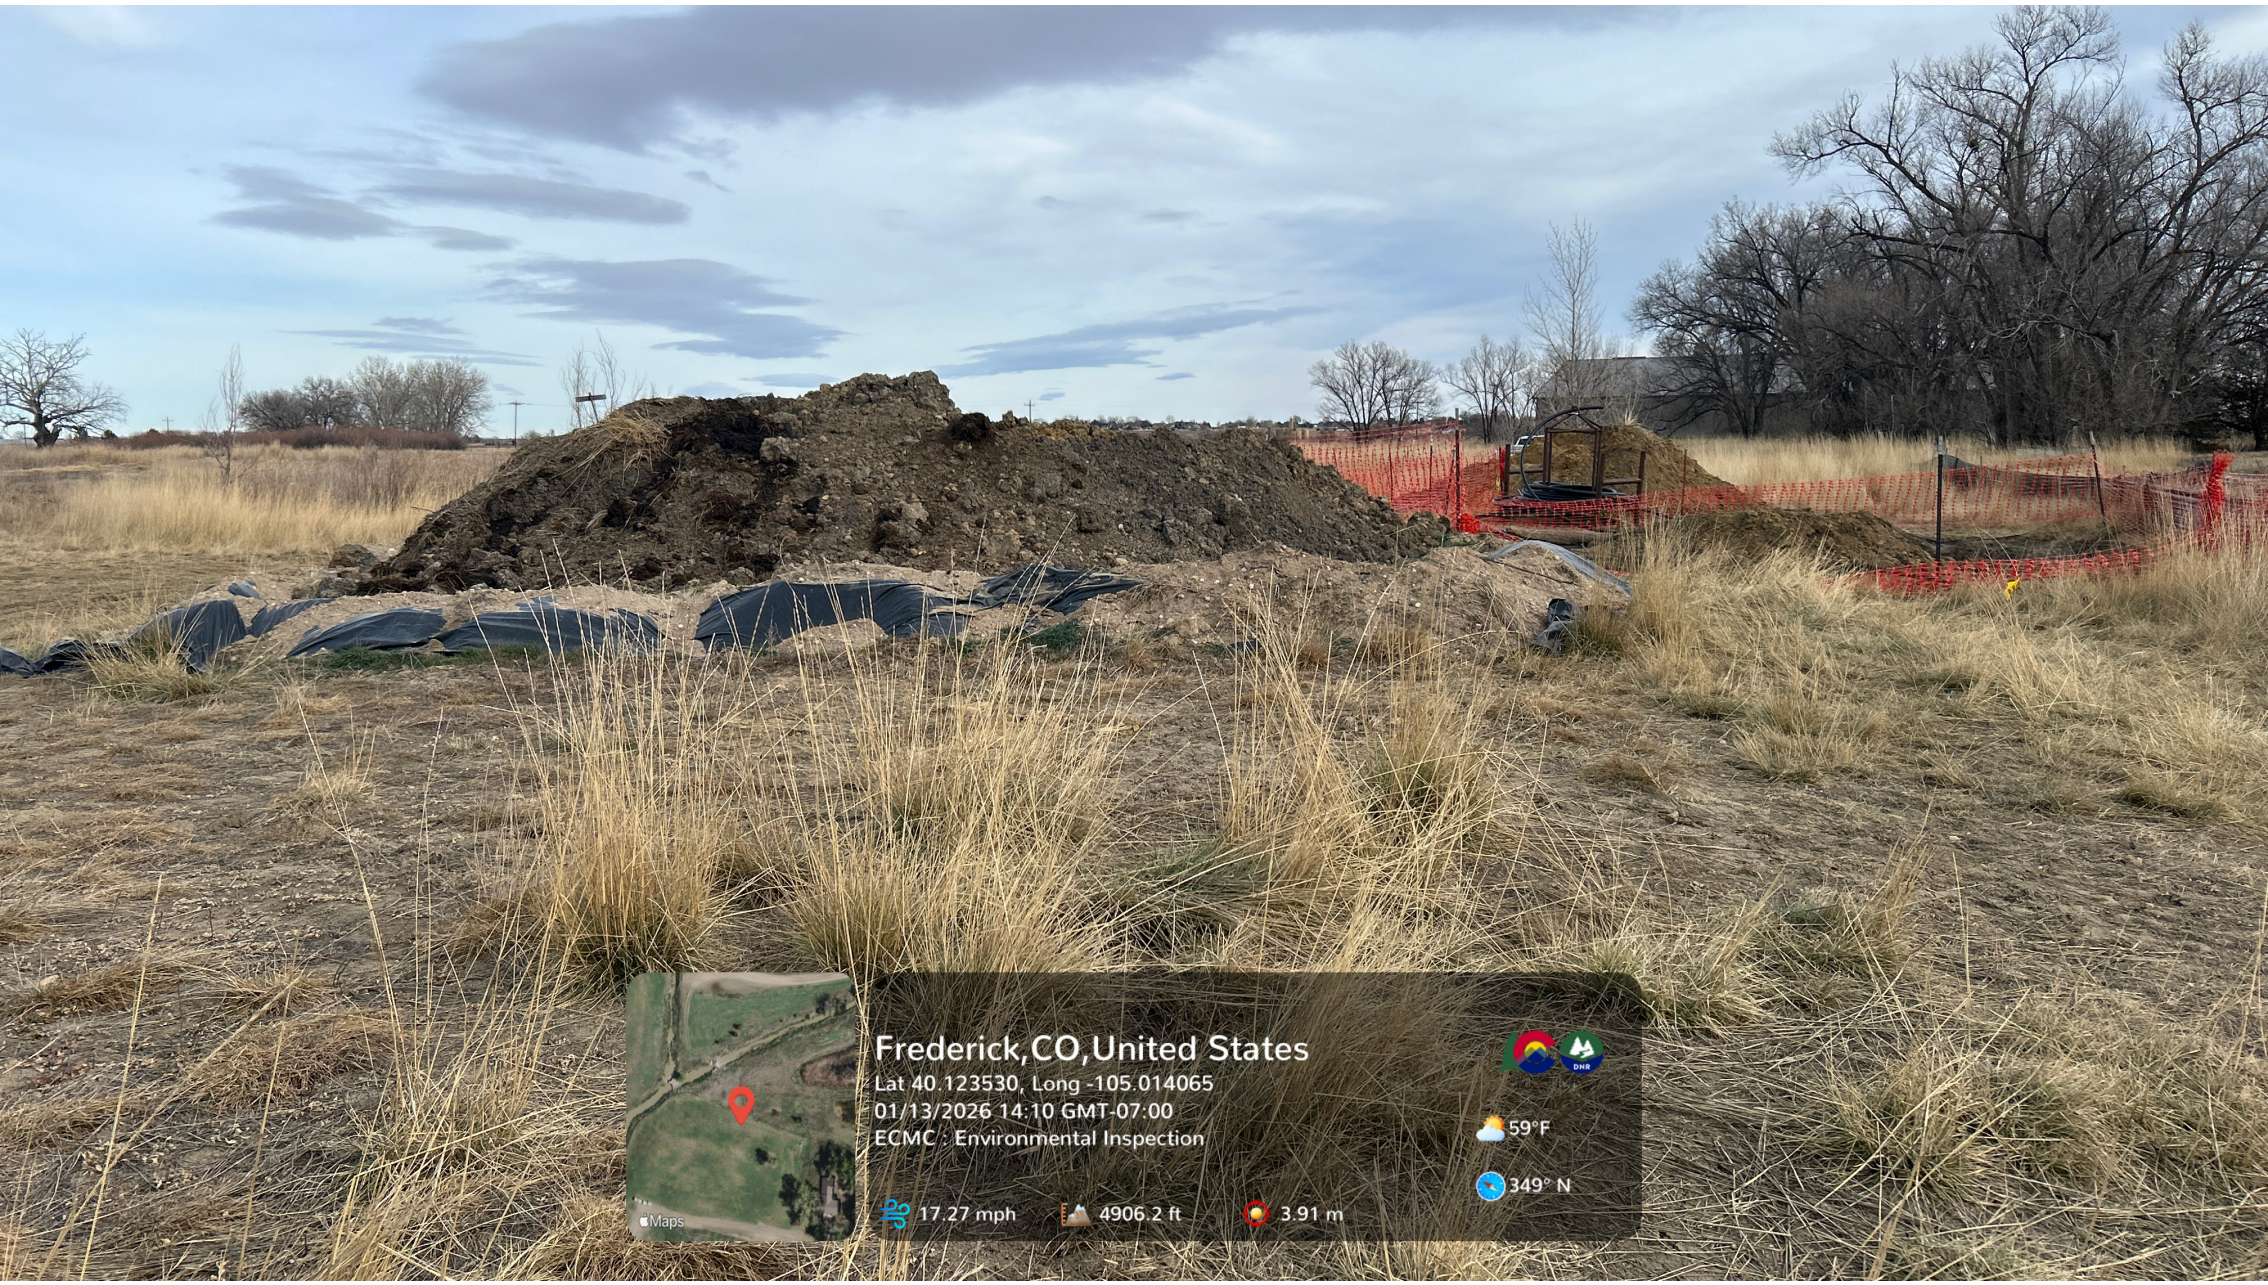
Looking at the northern and southern excavations open at the spill location. Petroleum hydrocarbon saturated soil, stained soil, and salt crusting are visible on the excavation sidewalls. A sheen and free product are visible on groundwater at the base of the excavations. Bird netting has been installed over the open excavations.

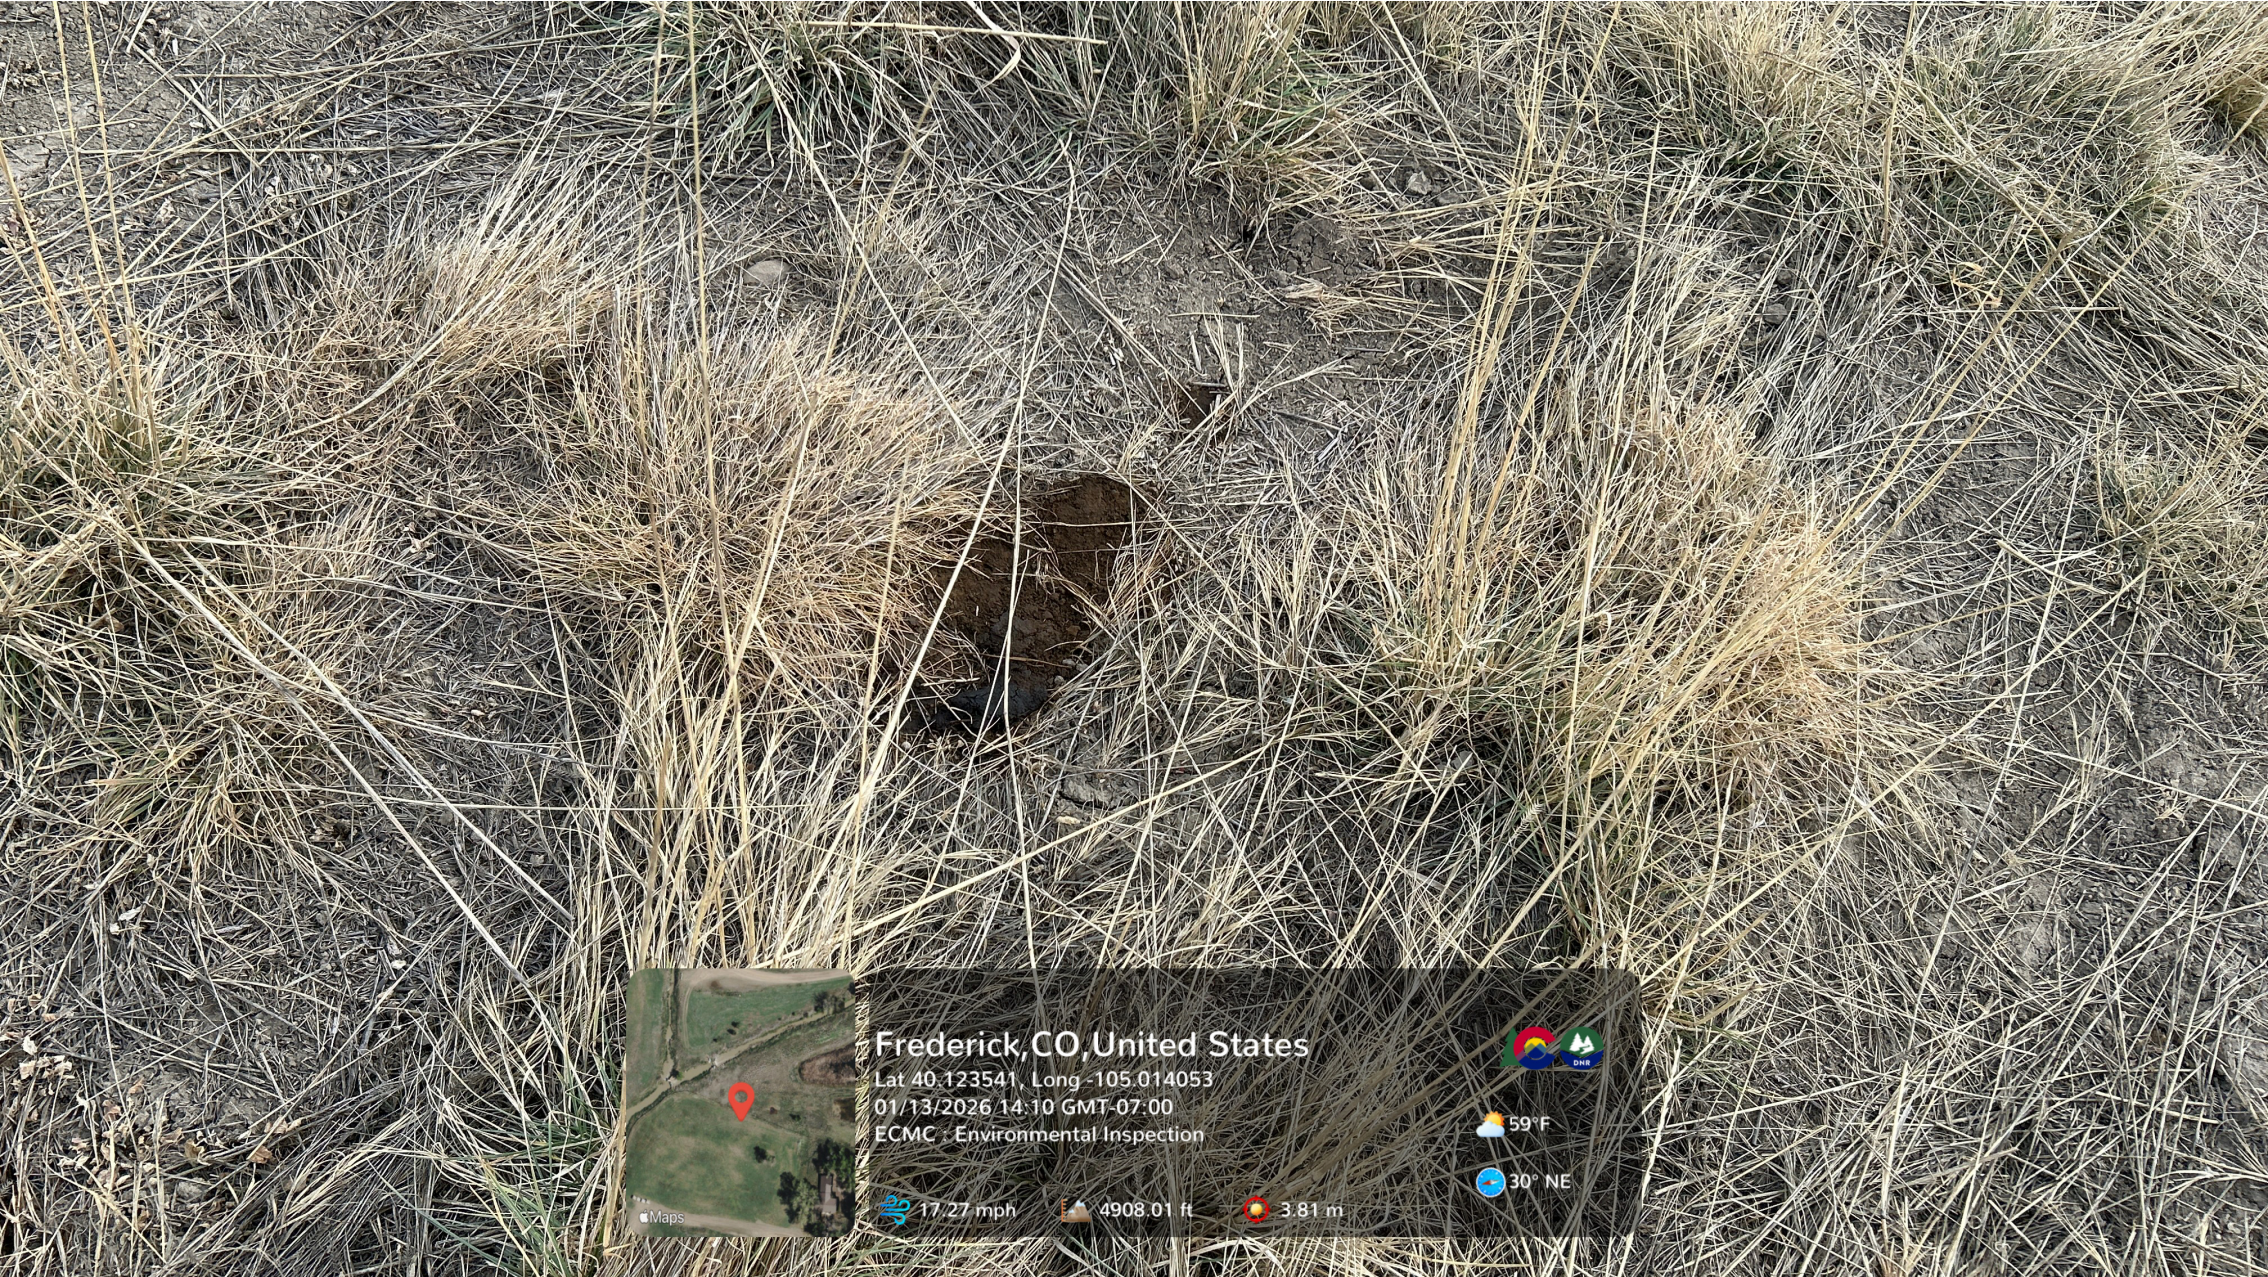
Stained soil is visible outside of the current spill response footprint.

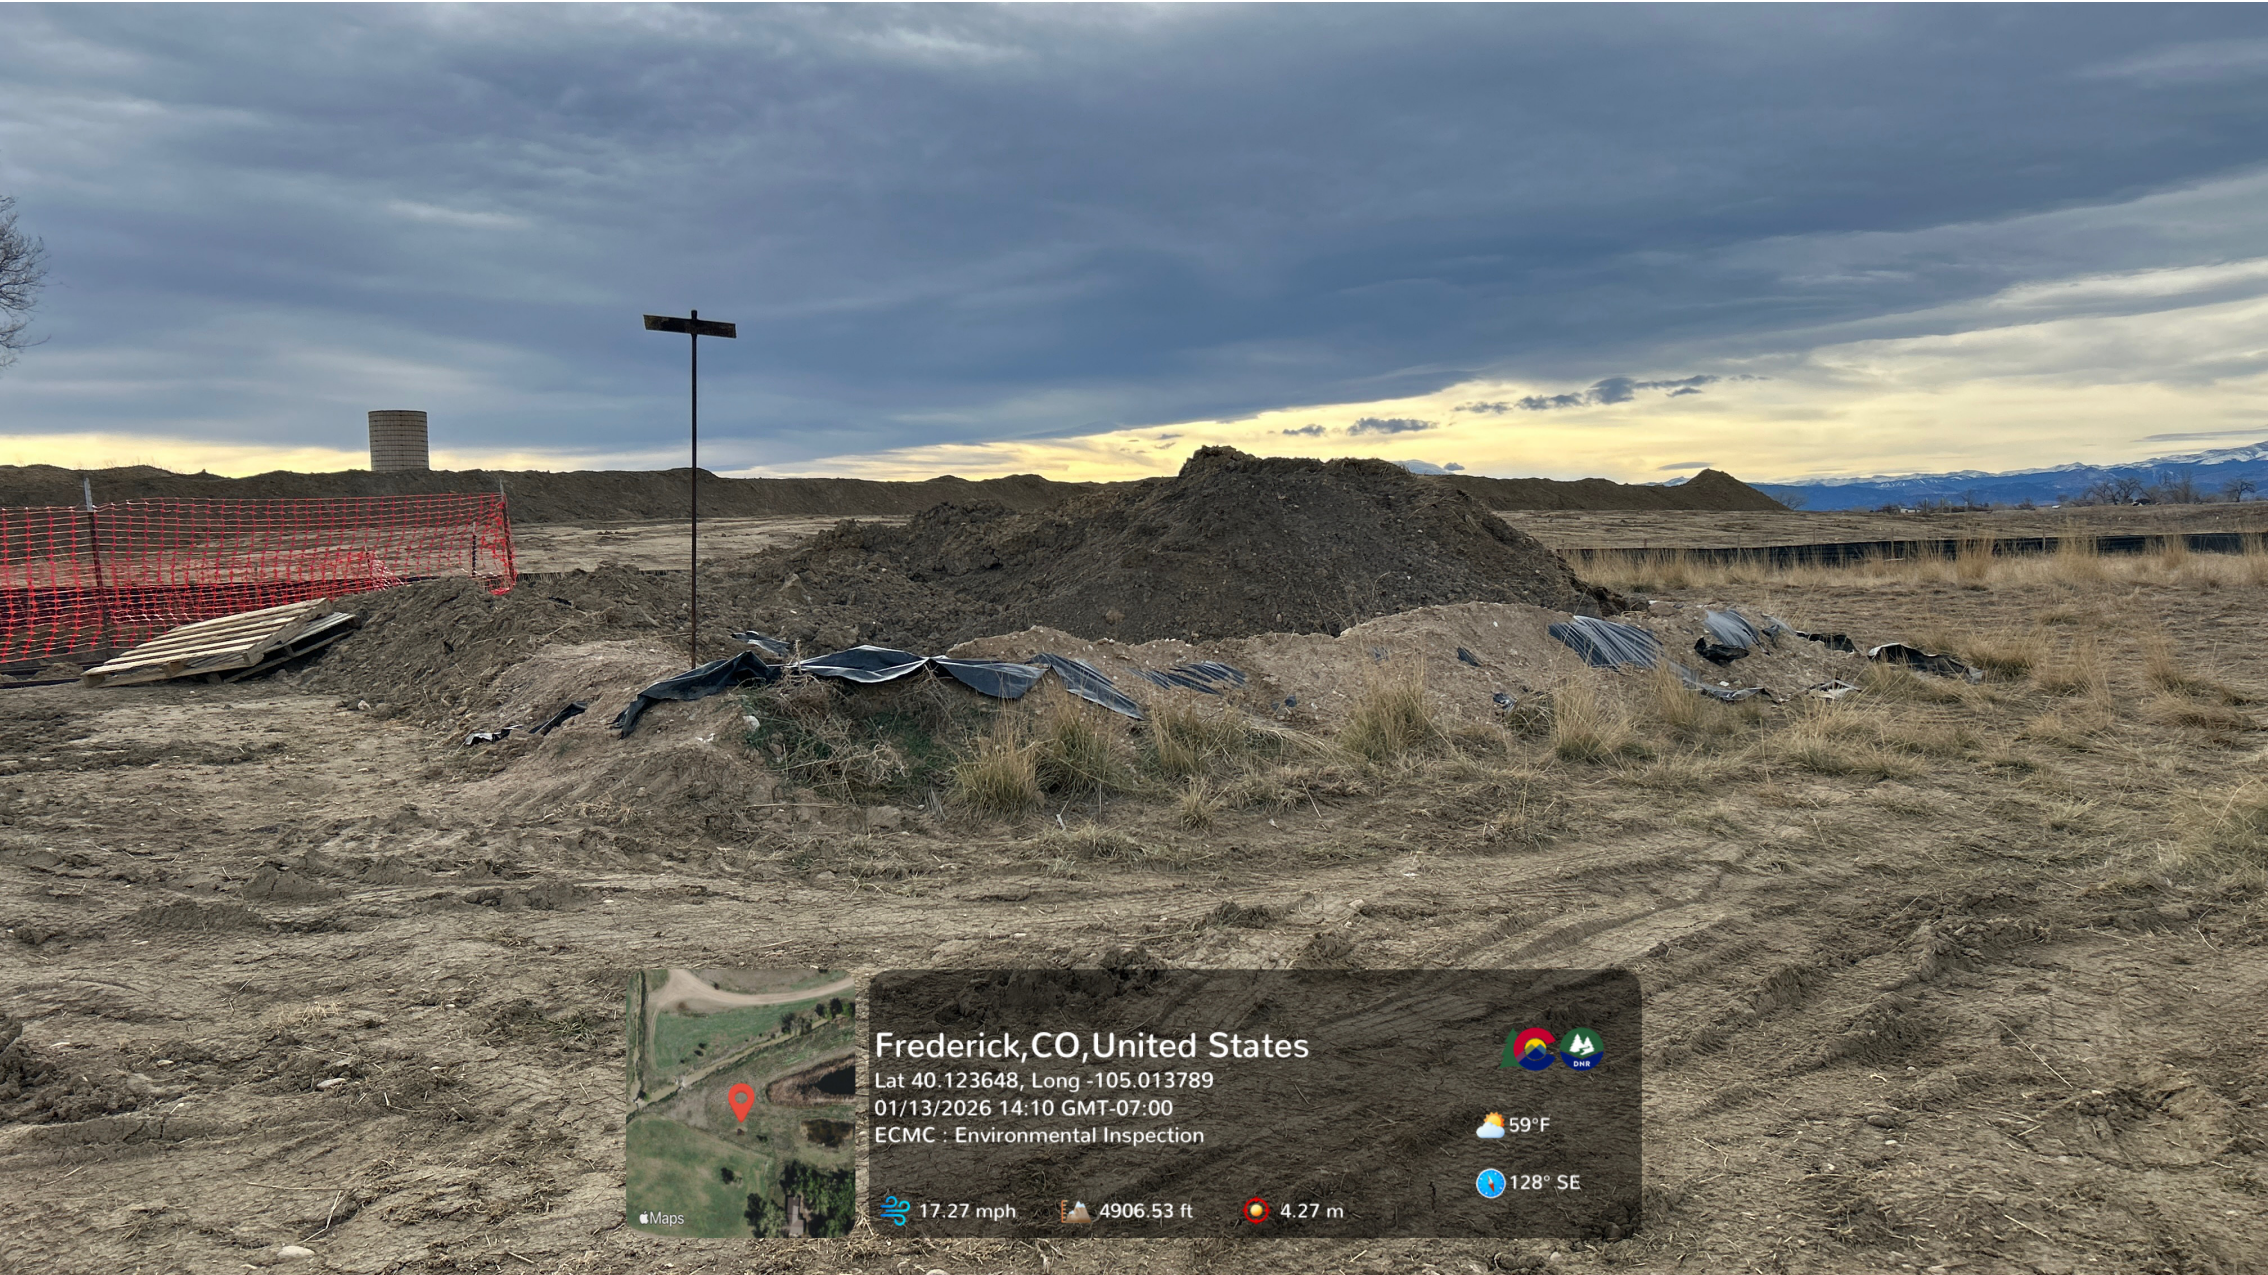
Looking at a stockpile marked "contaminated" which remains on location. Impacted soil was observed within the stockpile. A liner is visible but has been compromised by holes/tears; soil has spilled outside of containment.

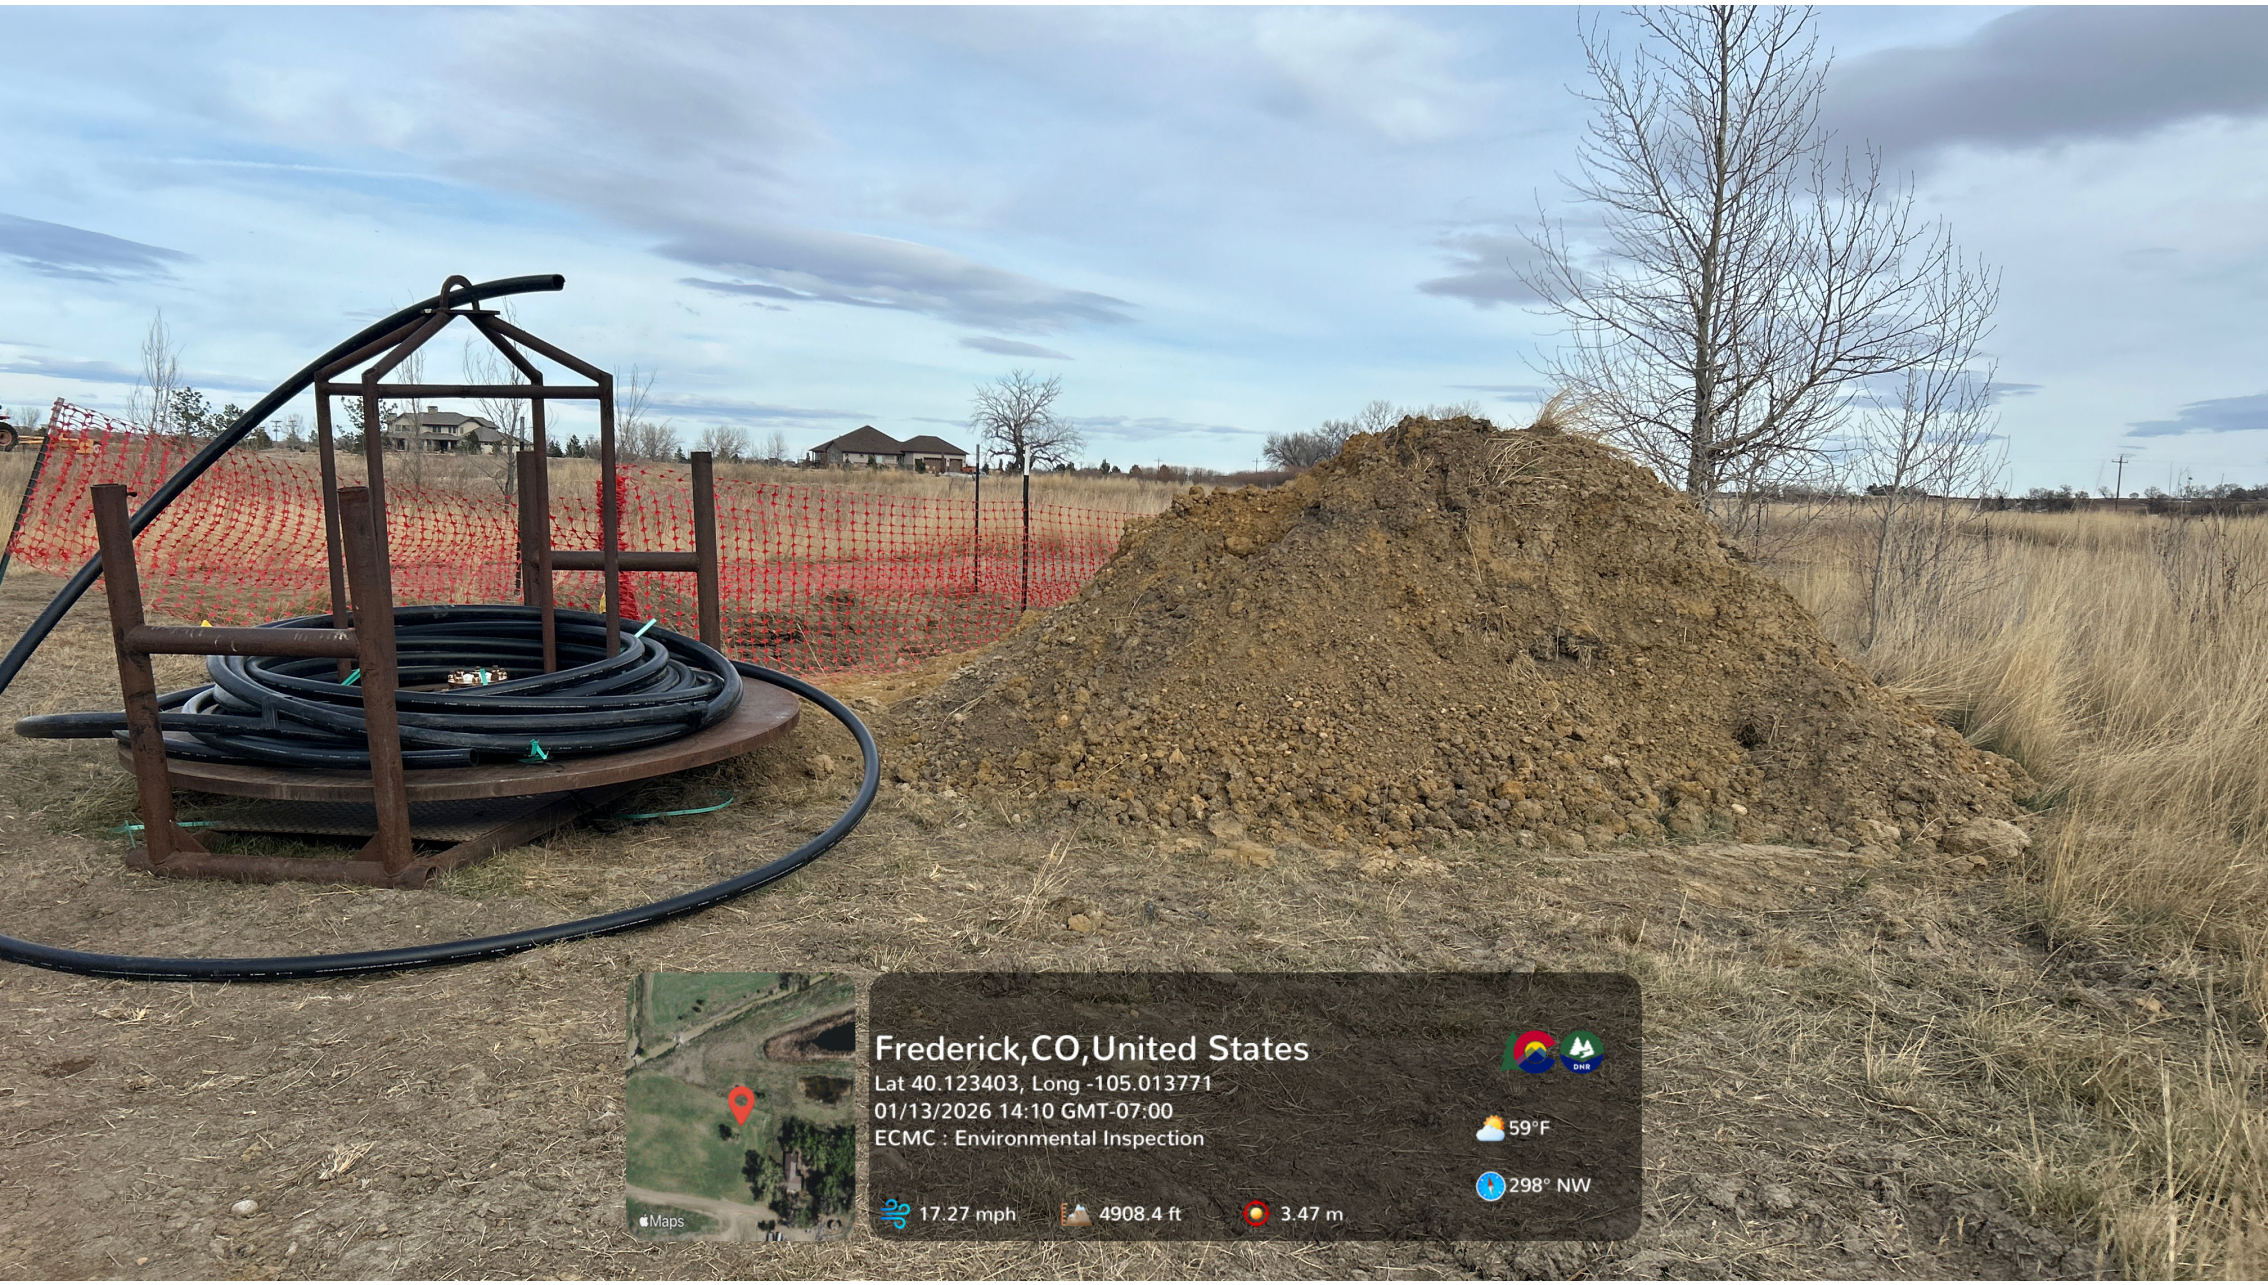
Looking at an unmarked, unlined soil stockpile with no stormwater BMPs which remains on location. Areas of gray staining are visible within the stockpile.
