Looking at the spill location. Orange construction fencing has been installed around the open excavations, but has fallen.

Lat 40.123529, Long -105.013656  
01/13/2026 14:08 GMT-07:00  
ECMC : Environmental Inspection

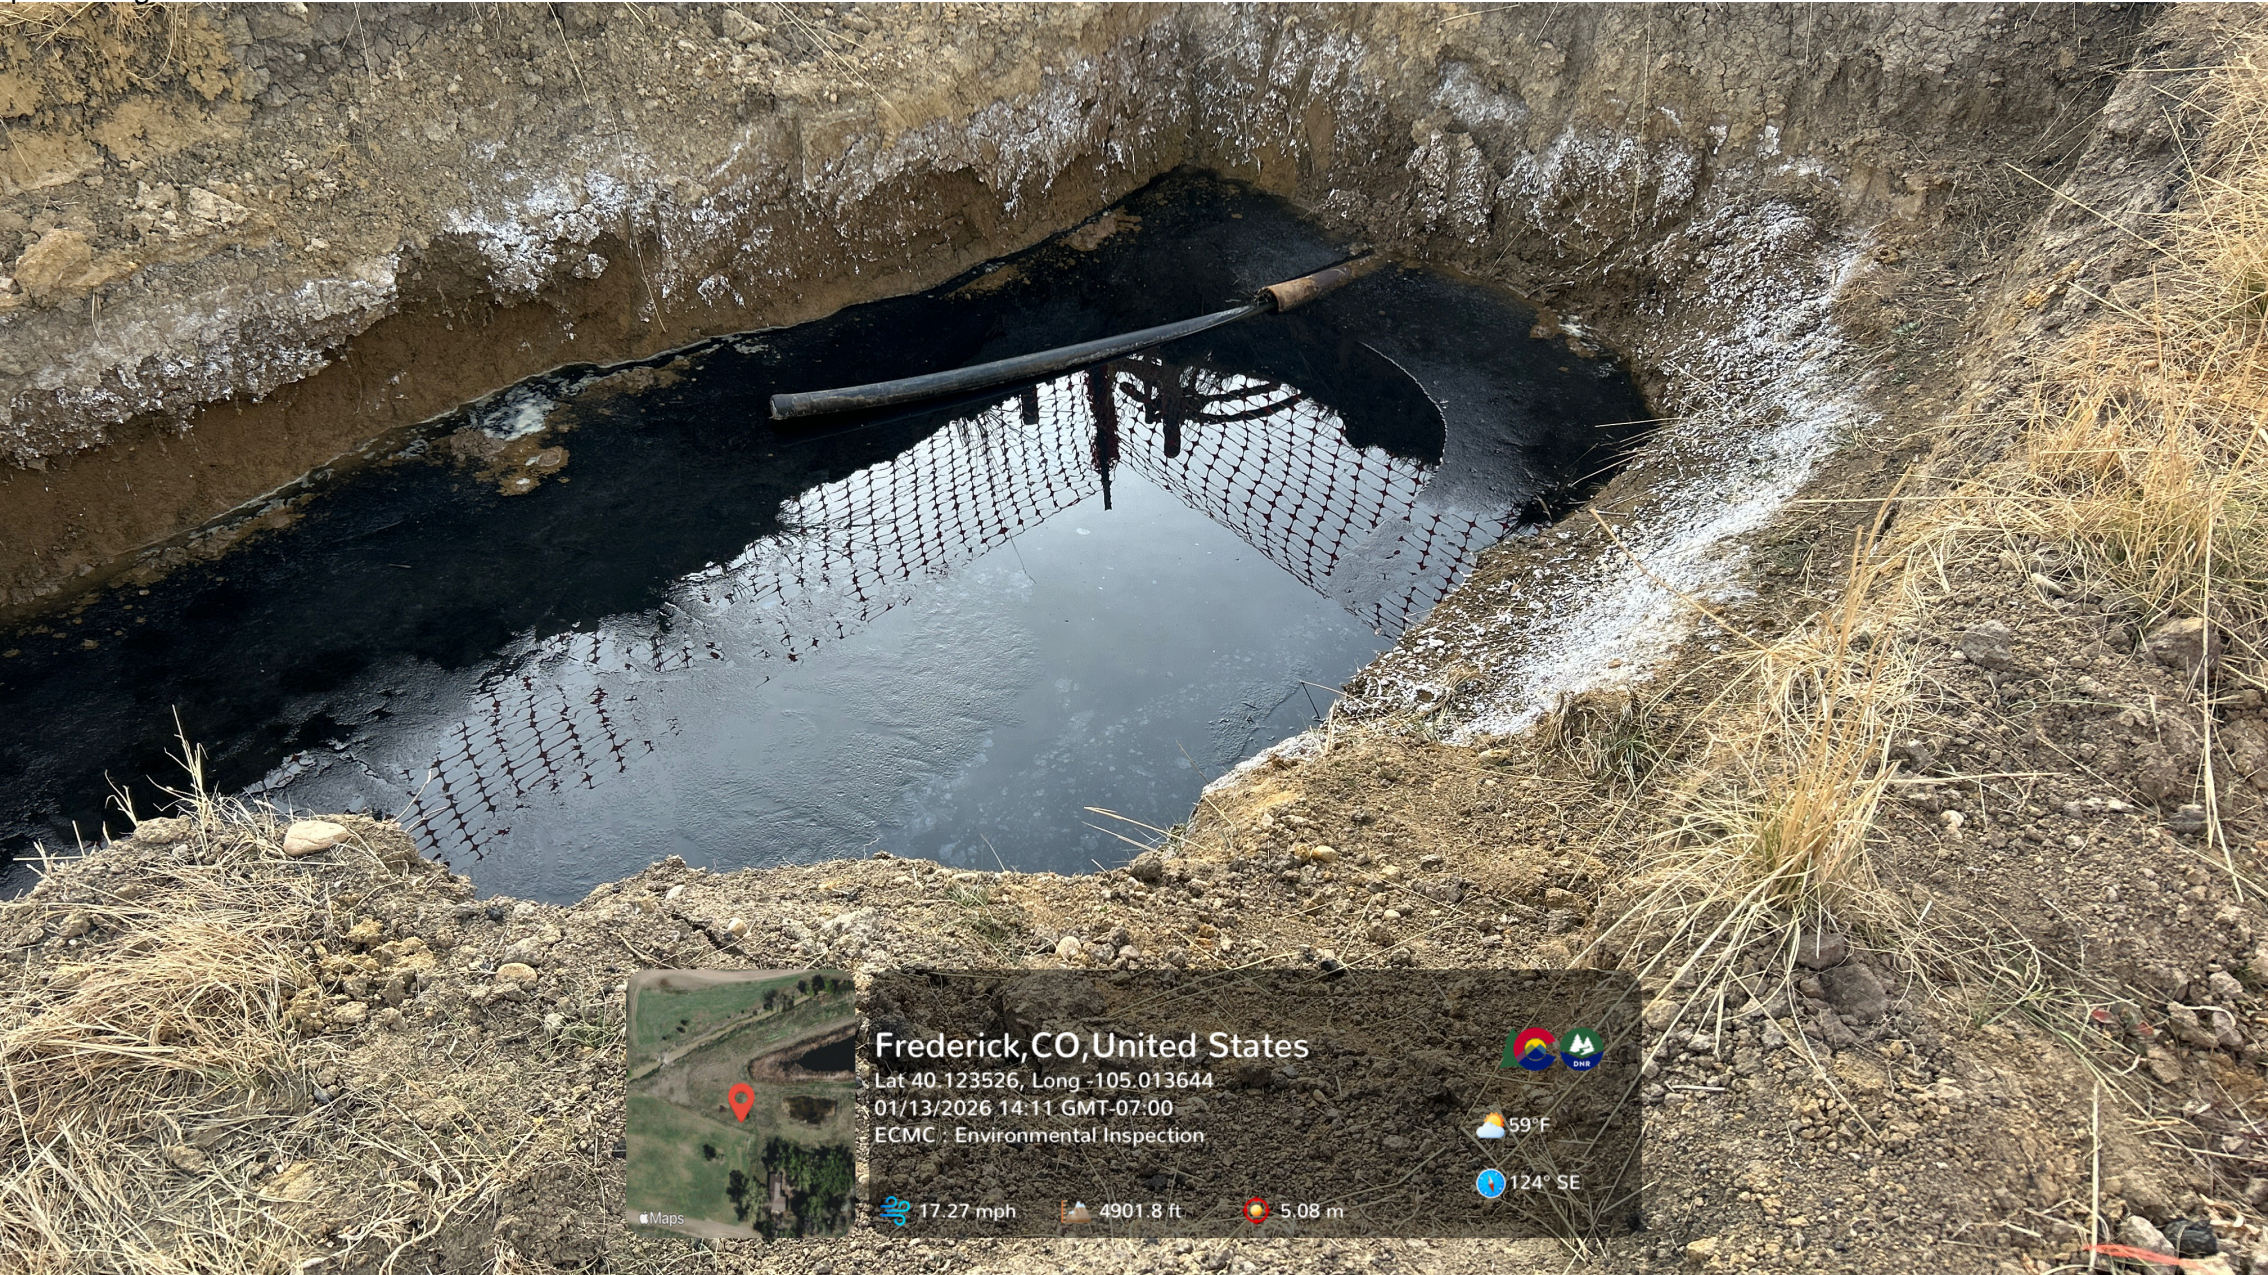
Looking at a third open excavation, located immediately east of the initial spill/release point. Stained soil and salt crusting are visible on the excavation sidewalls. A sheen is visible on groundwater at the base of the excavation. No wildlife protection equipment has been installed over the open excavation. A segment of flowline is visible protruding from the excavation.

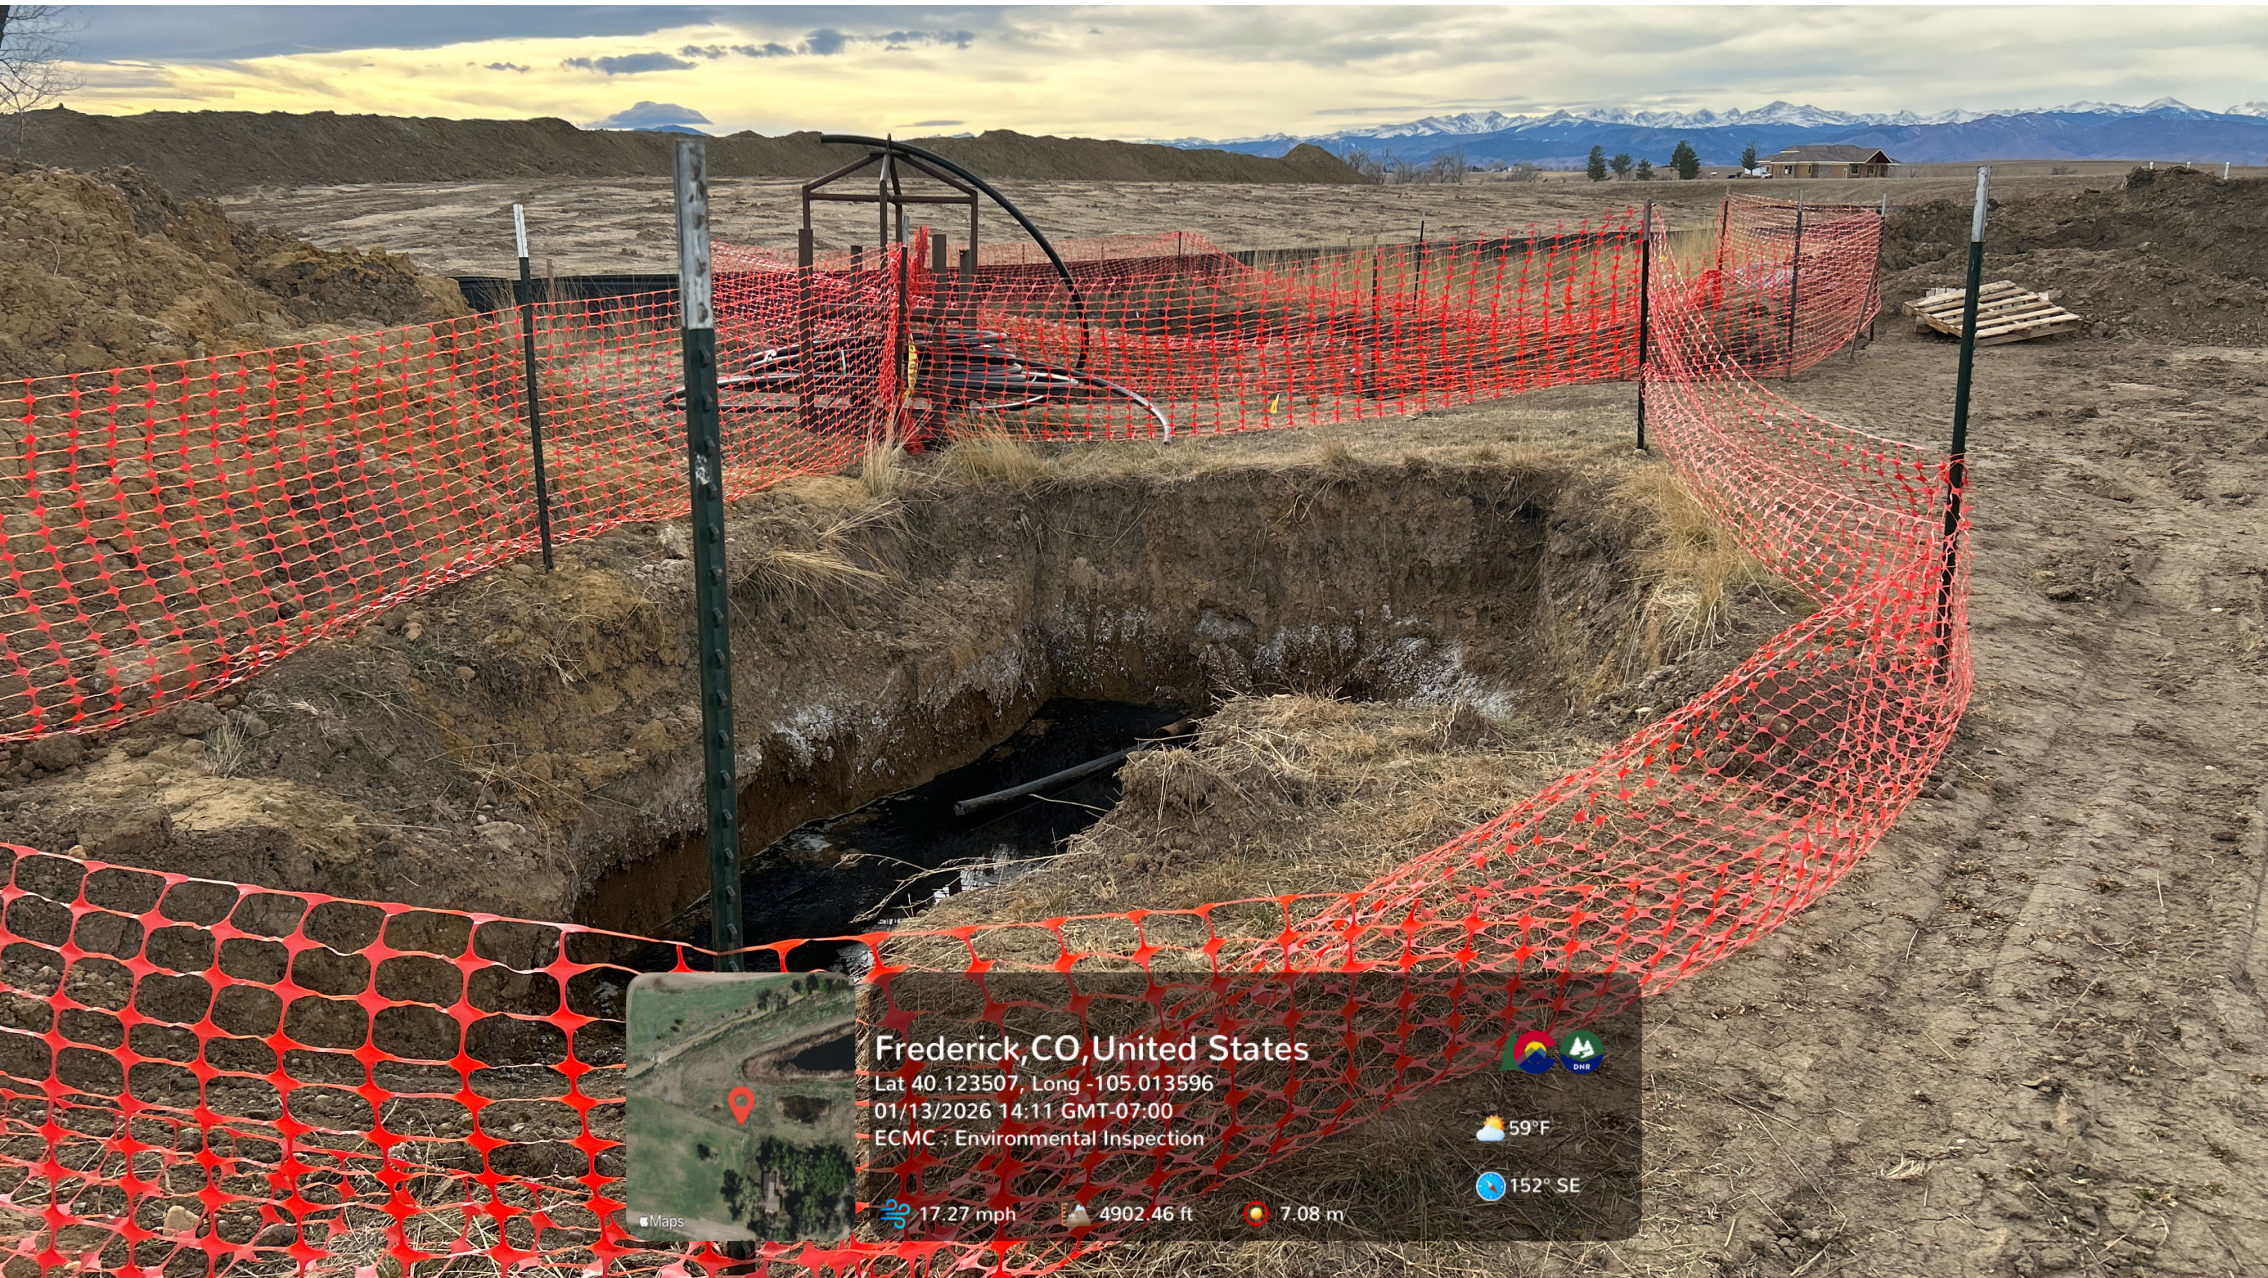
Looking at both excavations at the spill location. Orange construction fencing surrounds the eastern excavation but is beginning to fall.
