Looking at an open excavation at the location of Spill/Release Point ID 482194. Barbed wire fencing surrounds the excavation.

ECMC : Environmental Inspection

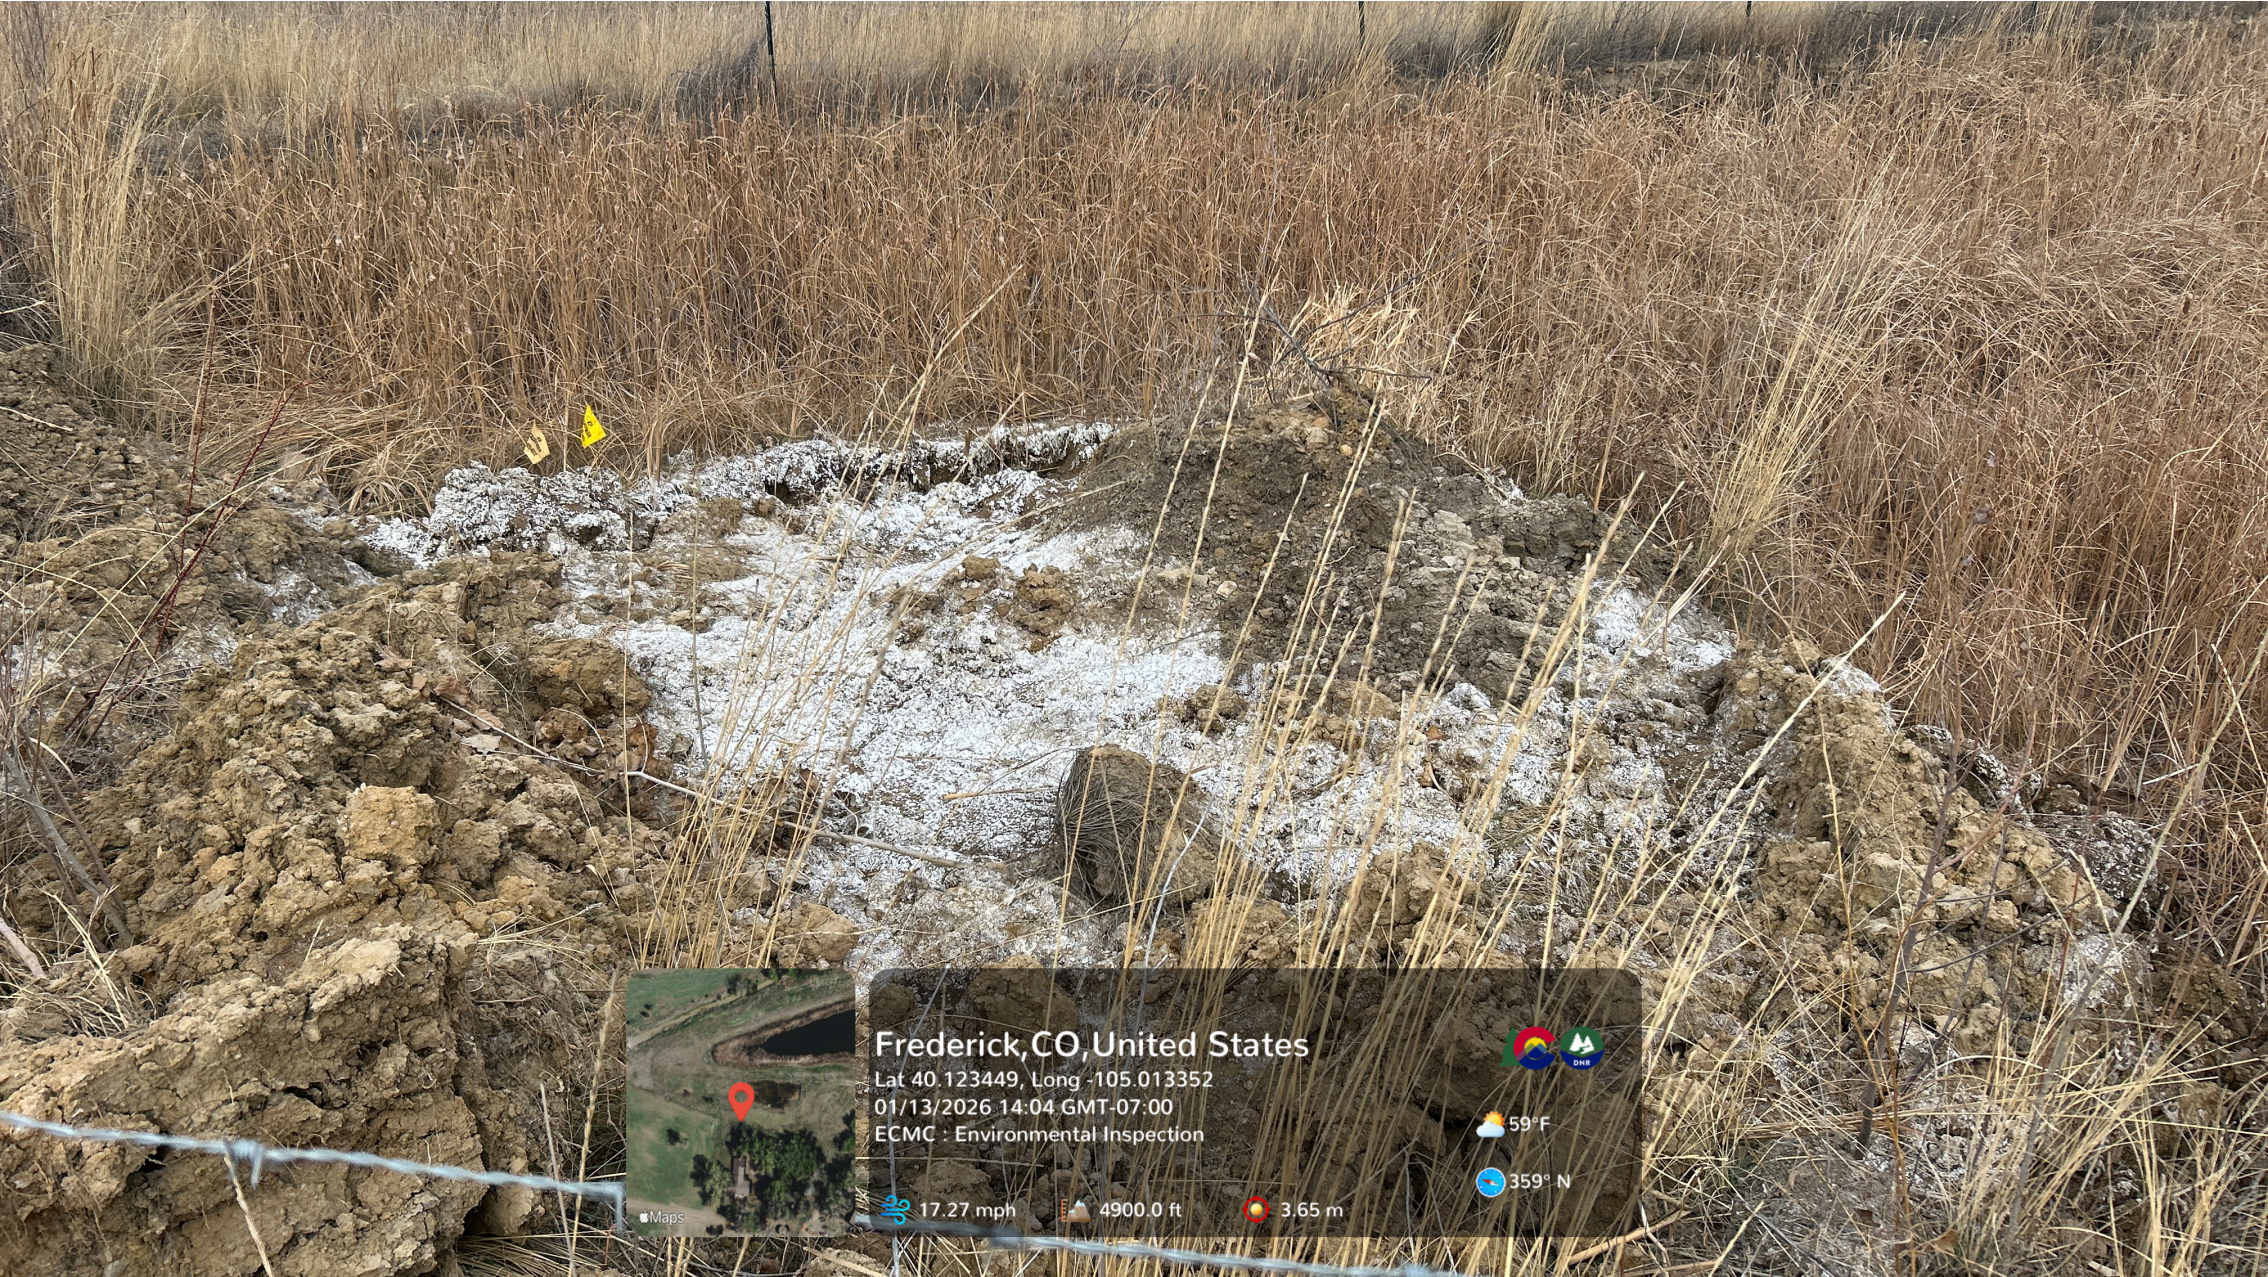
Salt crusting is visible within the excavation.

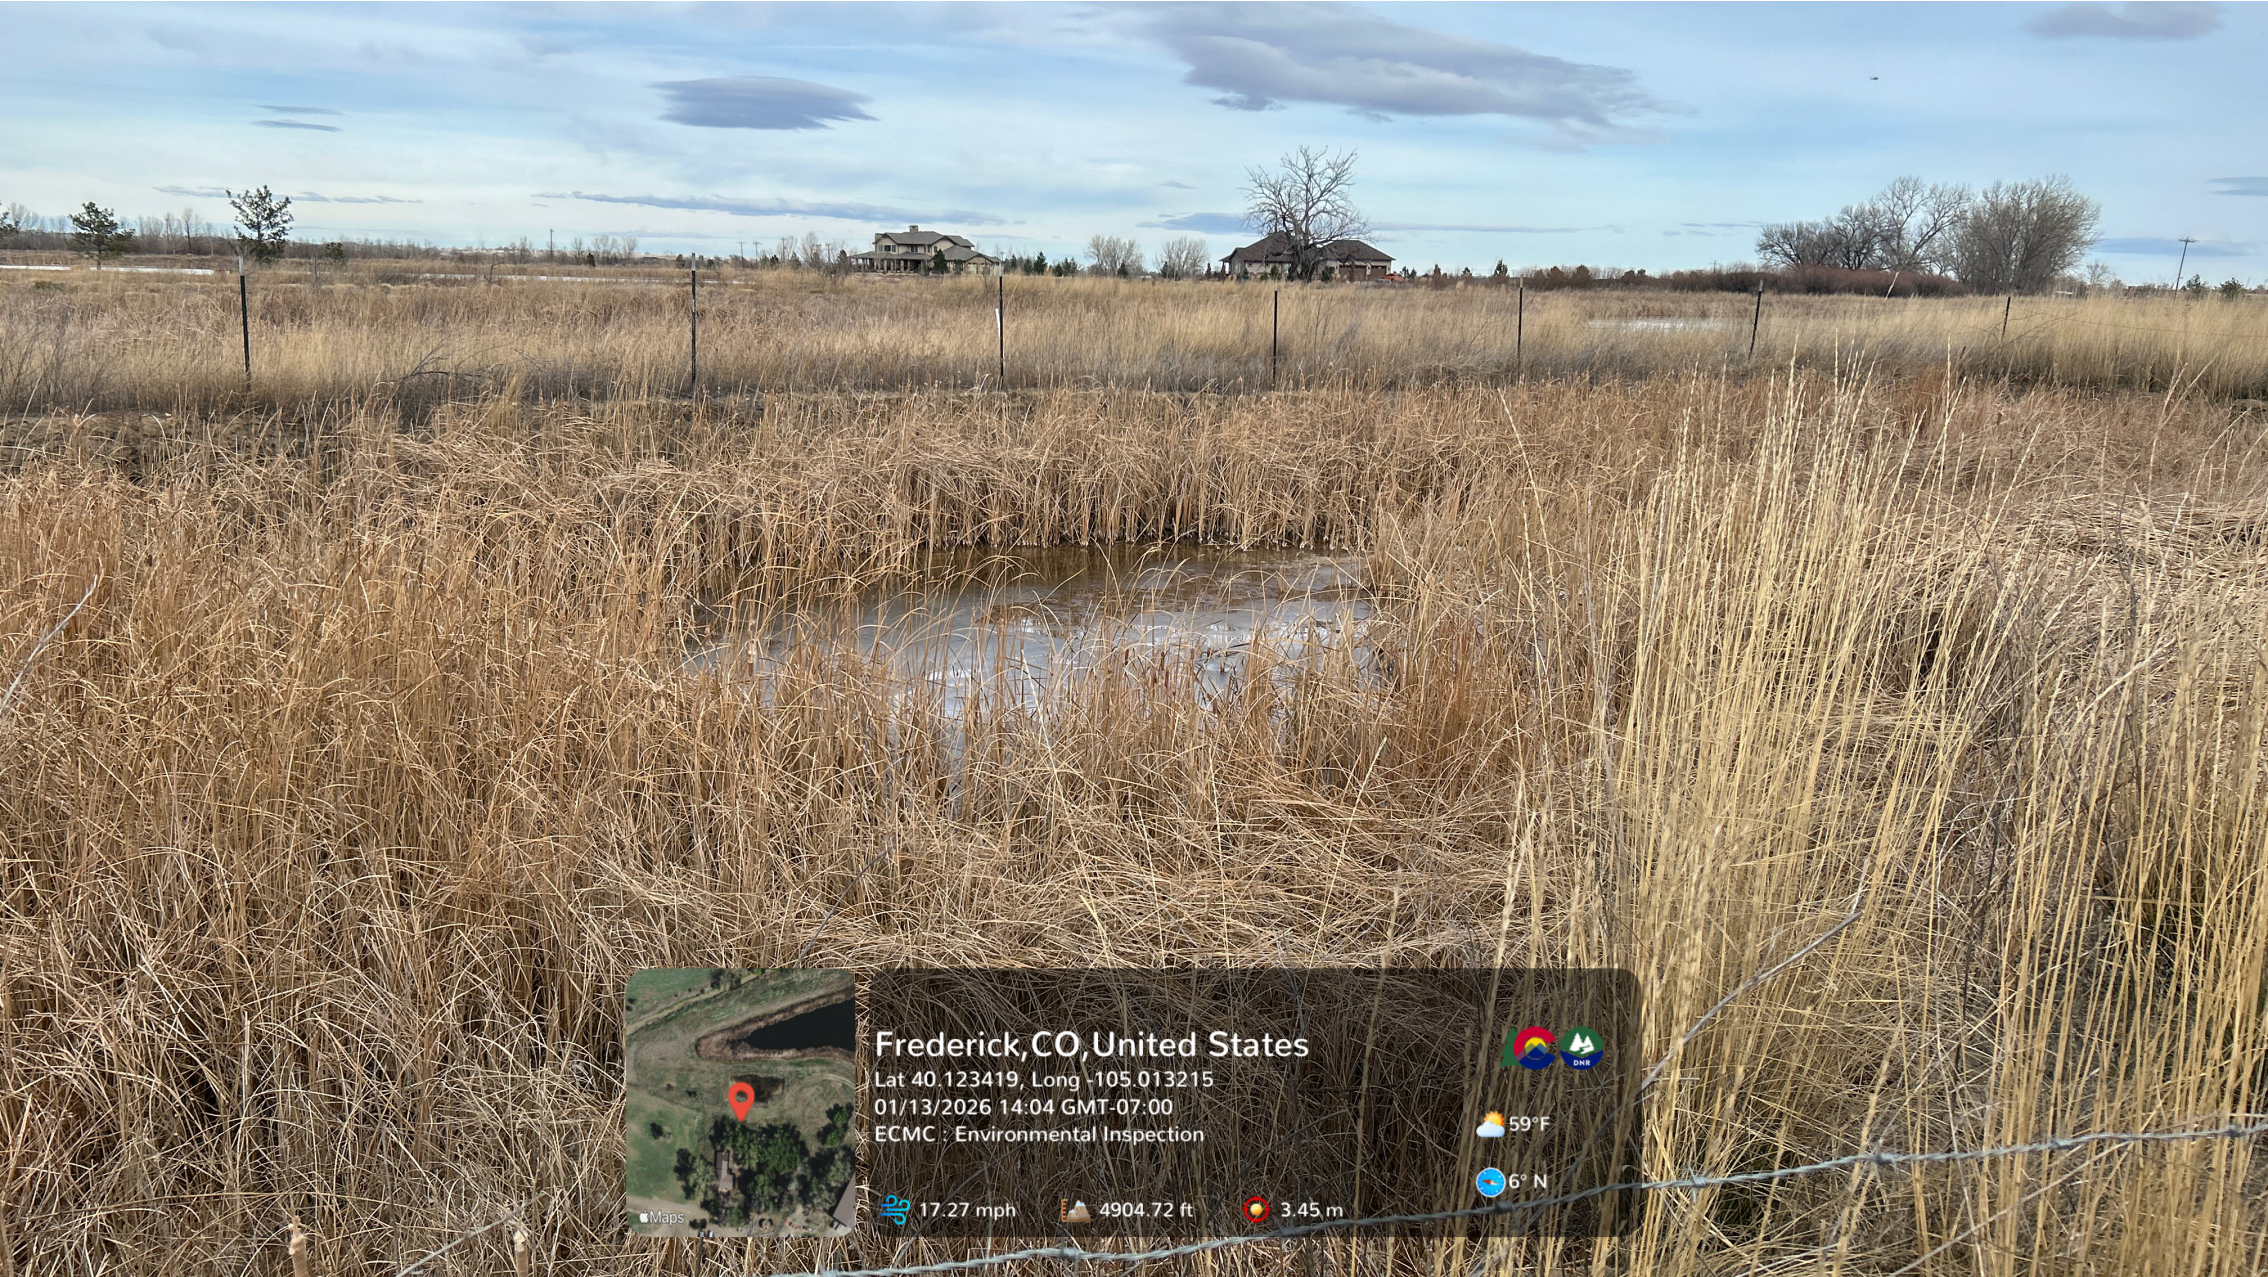
Weeds obscure visibility of the majority of the excavation base and sidewalls; groundwater is visible at the base of the excavation.

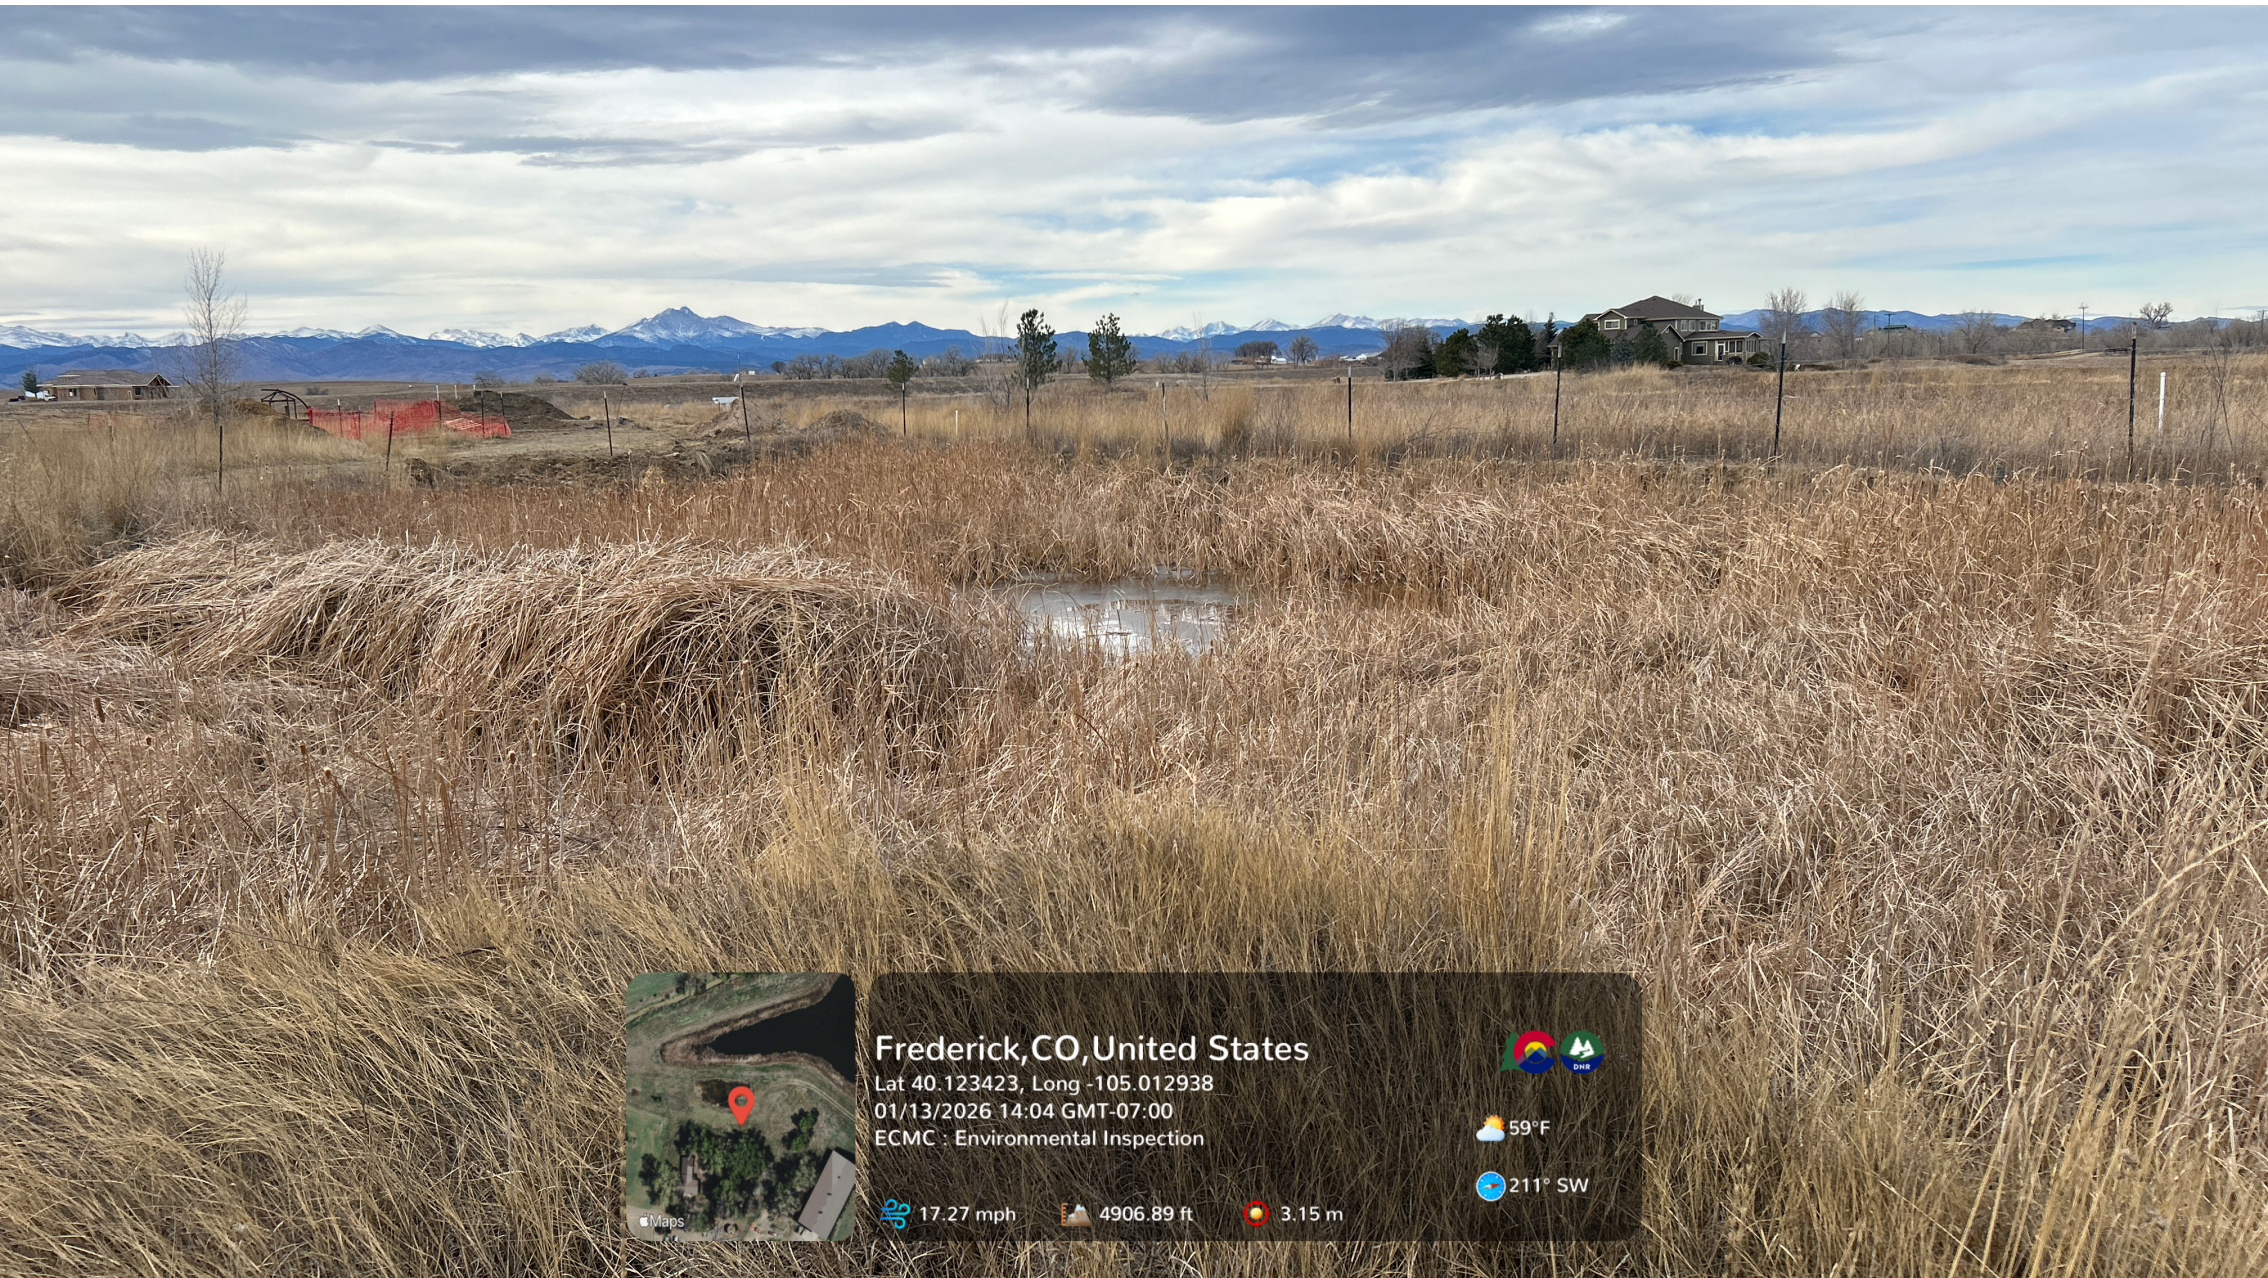
Monitoring wells completed as PVC stickups are visible outside of the excavation. Fencing and stockpiles associated with Spill/Release Point ID 491349 are visible in the background and will be addressed in a separate Field Inspection Report.

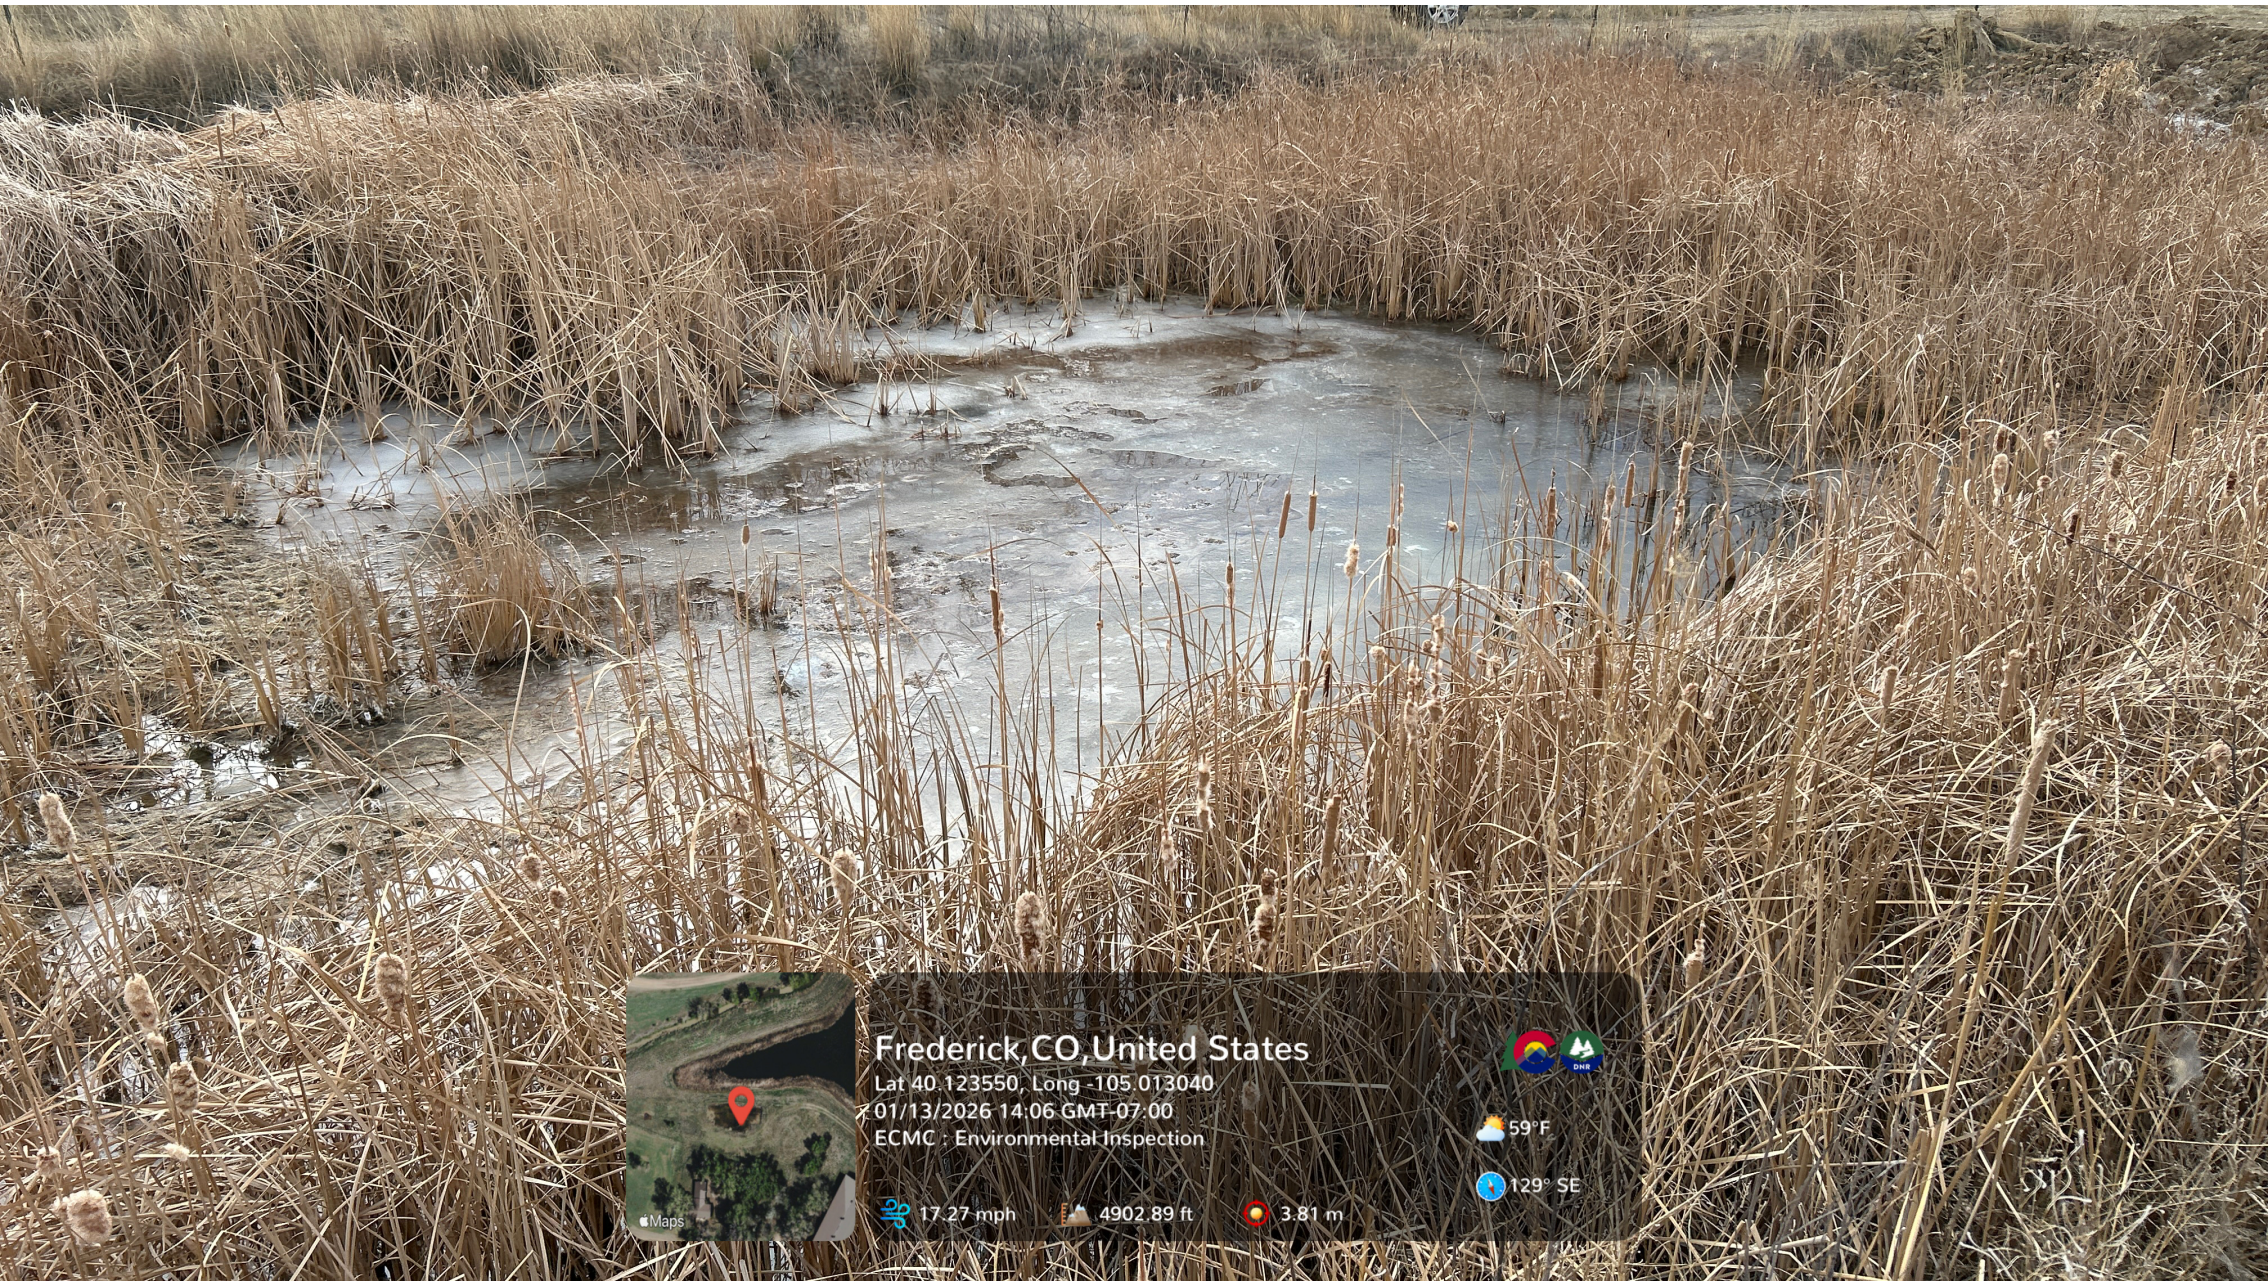
Looking at groundwater at the base of the excavation.

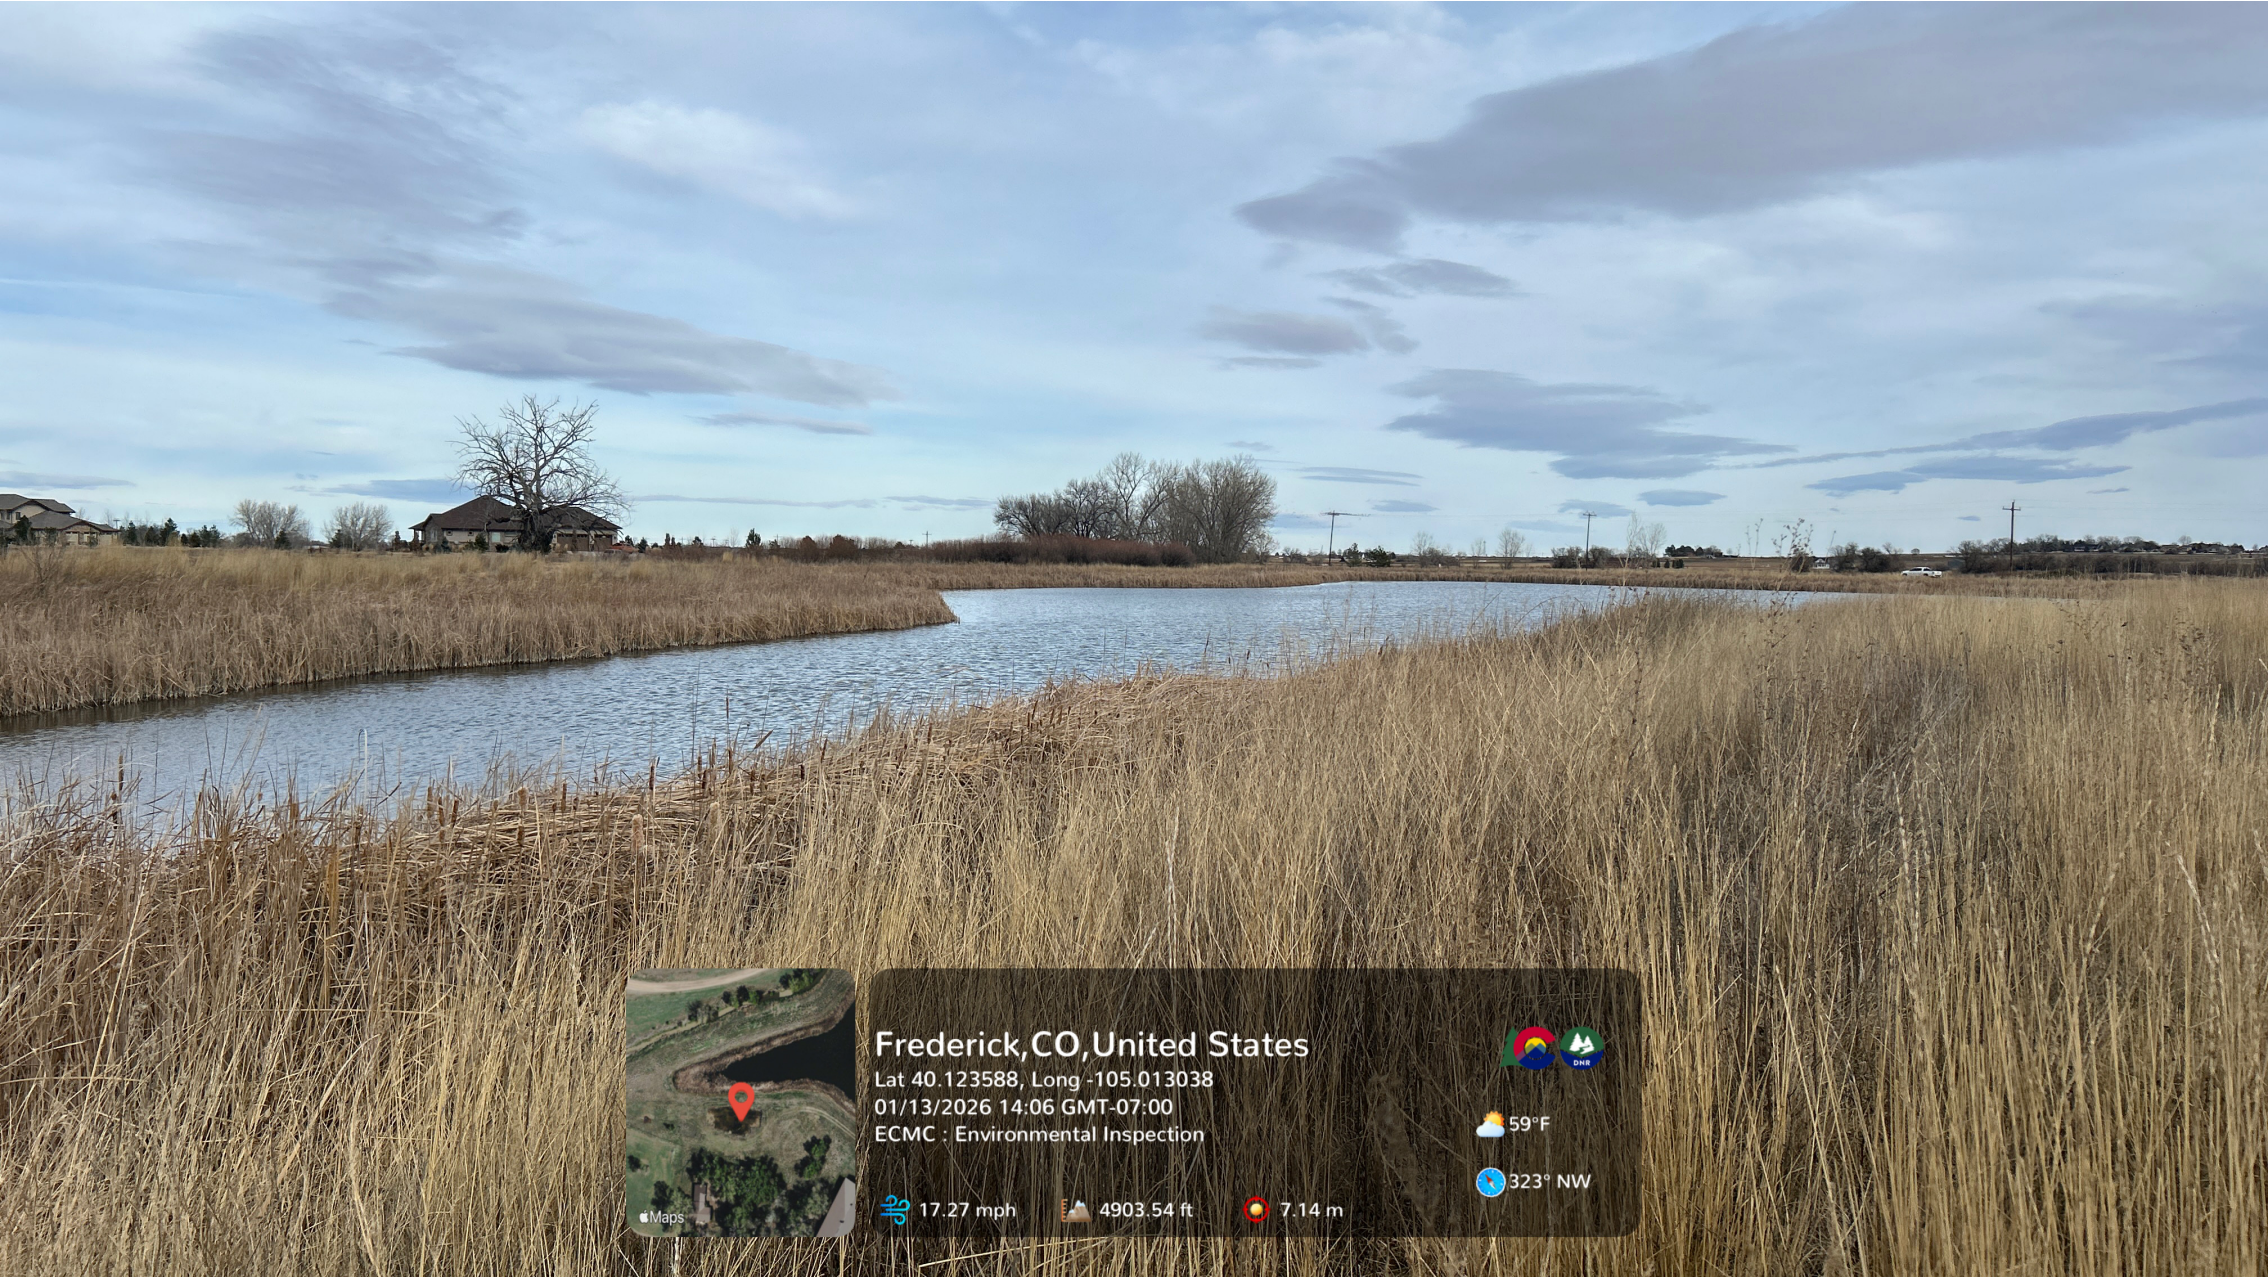
Looking at the pond adjacent to the location.
