# Inspection Photos

Location Name: LARAMIE ENERGY LLC Cascade Creek CC 0697-15-08 Pad  
Location # 481743

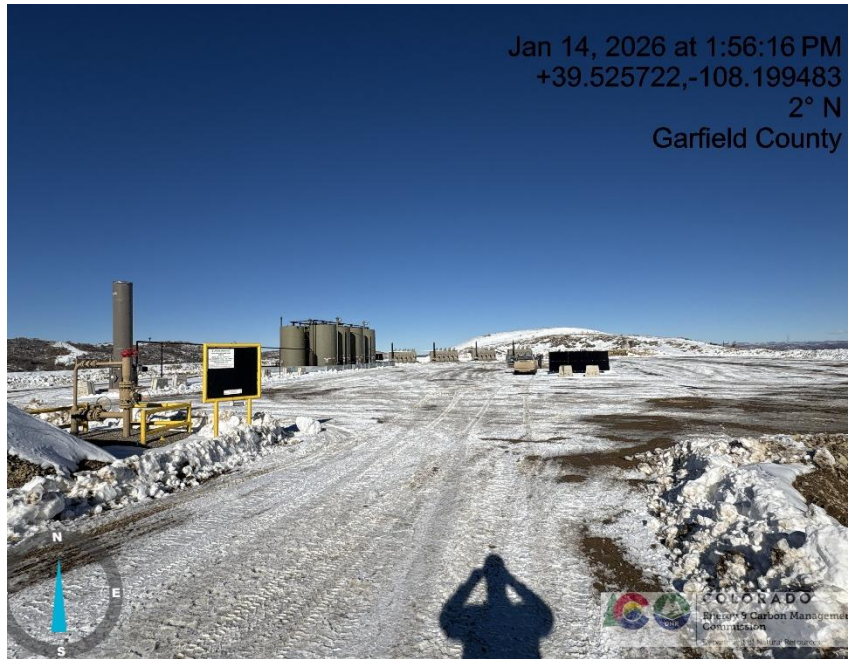
Photo # 1267 From entrance to location

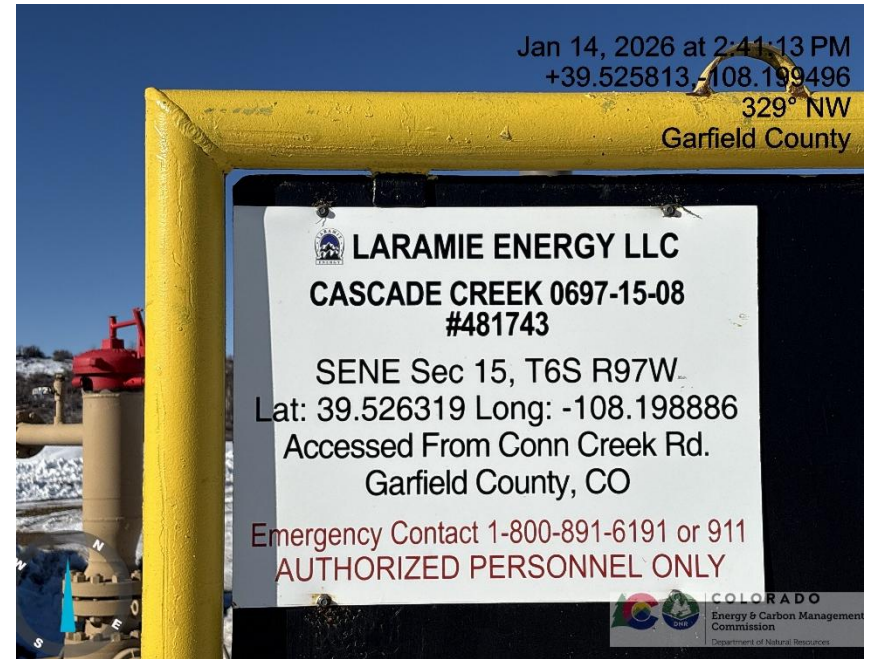
Photo # 1268 Sign at entrance to location

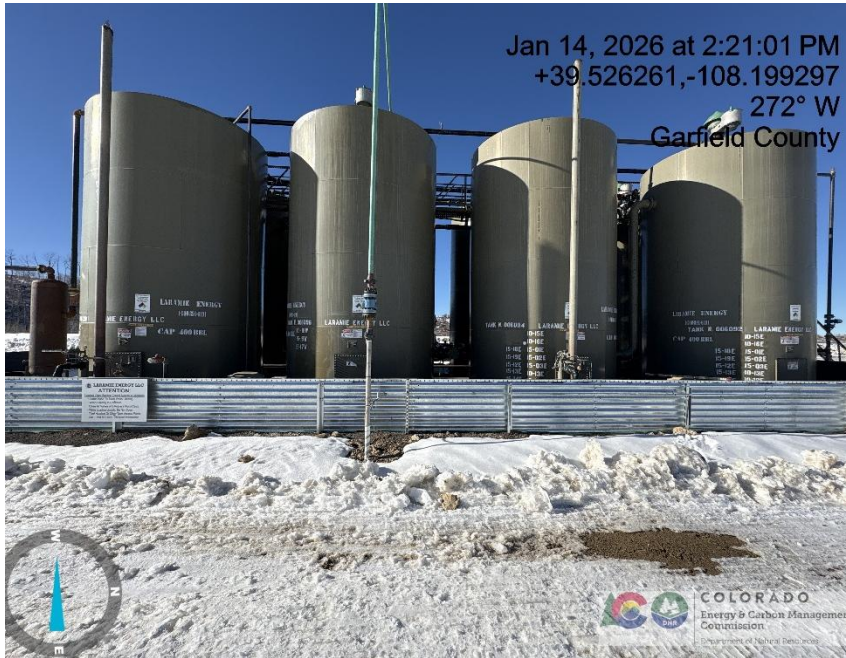
Photo # 1281 Tank battery lacks required signage

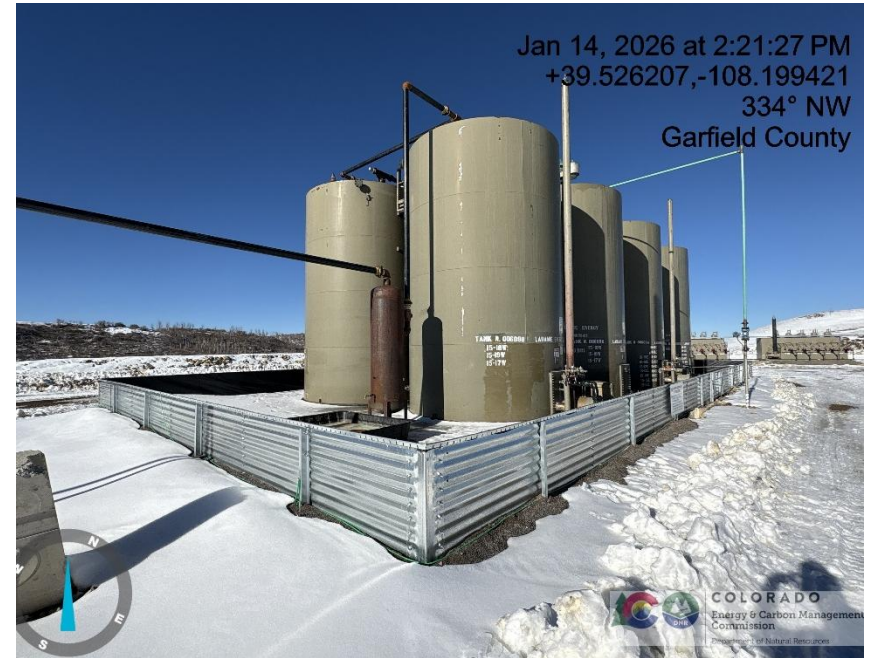
Photo # 1282 Tank battery lacks required signage

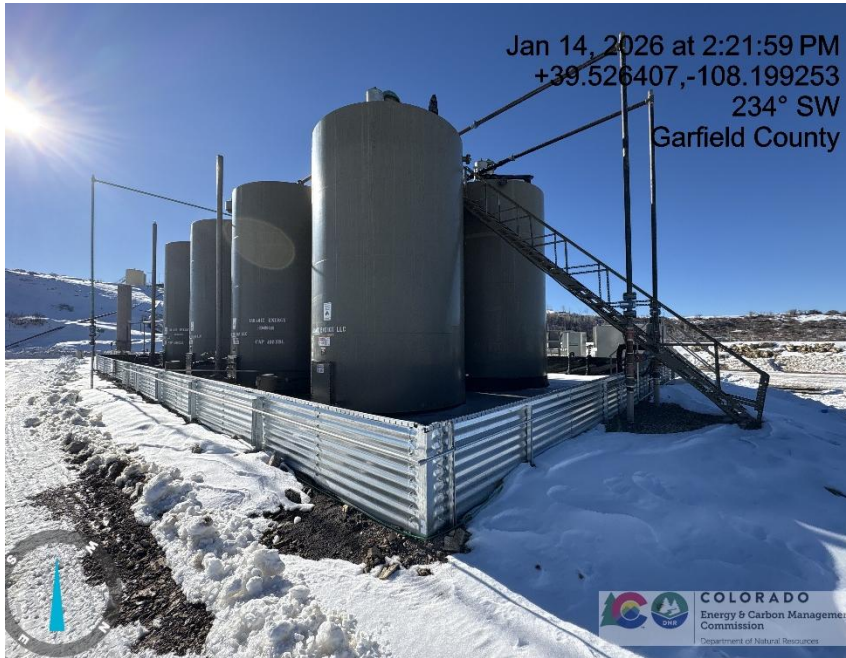
Photo # 1283 Tank battery lacks required signage

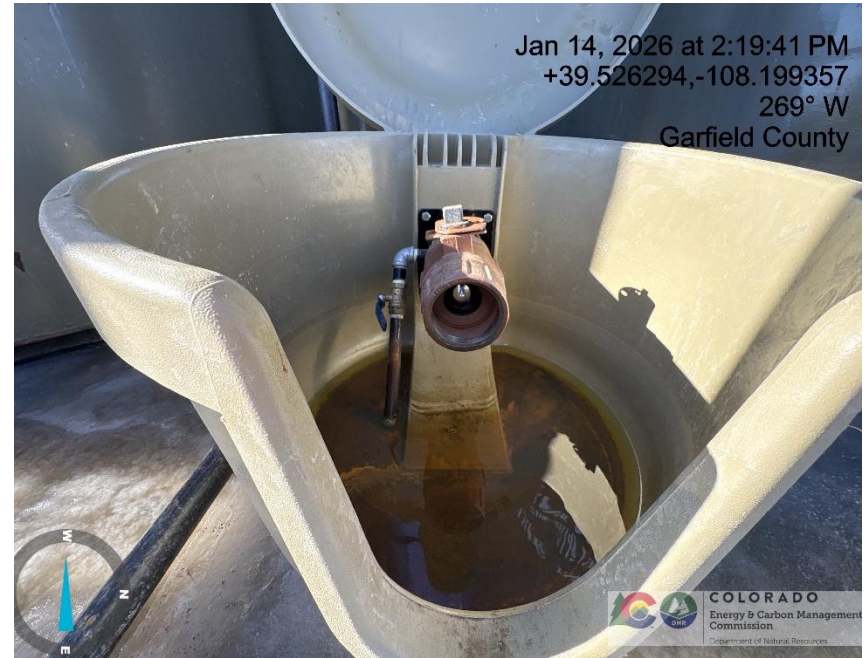
Photo # 1284 Open ended load line

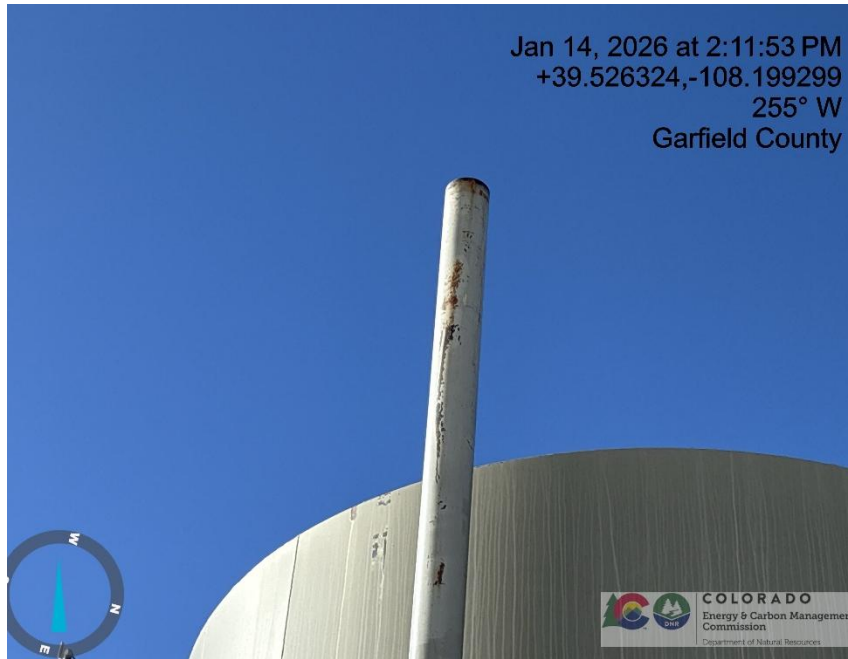
**Photo # 1285 Burner exhaust stack on heated 400 bbl condensate tank lacks bird protection/wildlife hazard**

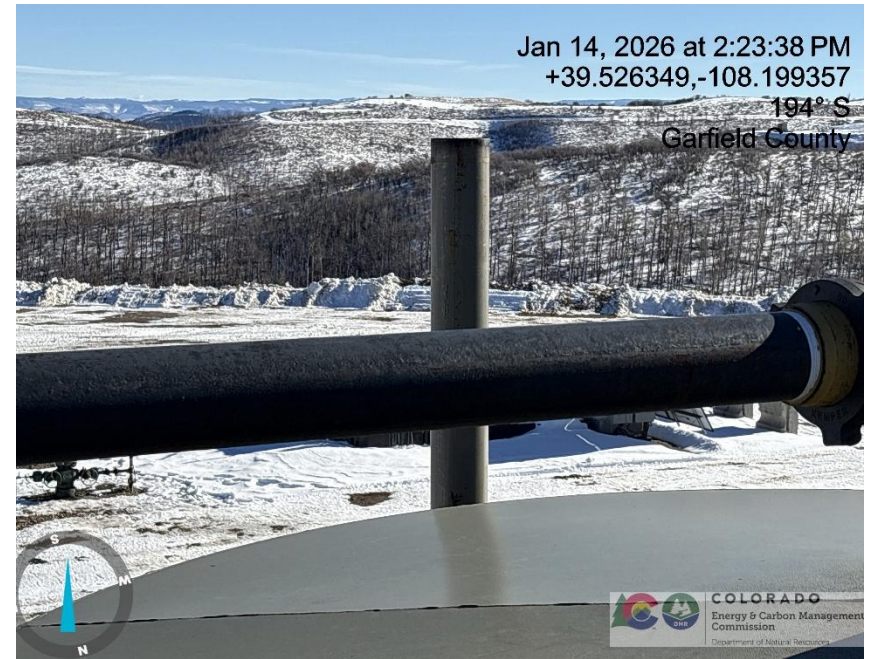
**Photo # 1286 Burner exhaust stack on heated 400 bbl condensate tank lacks bird protection/wildlife hazard**

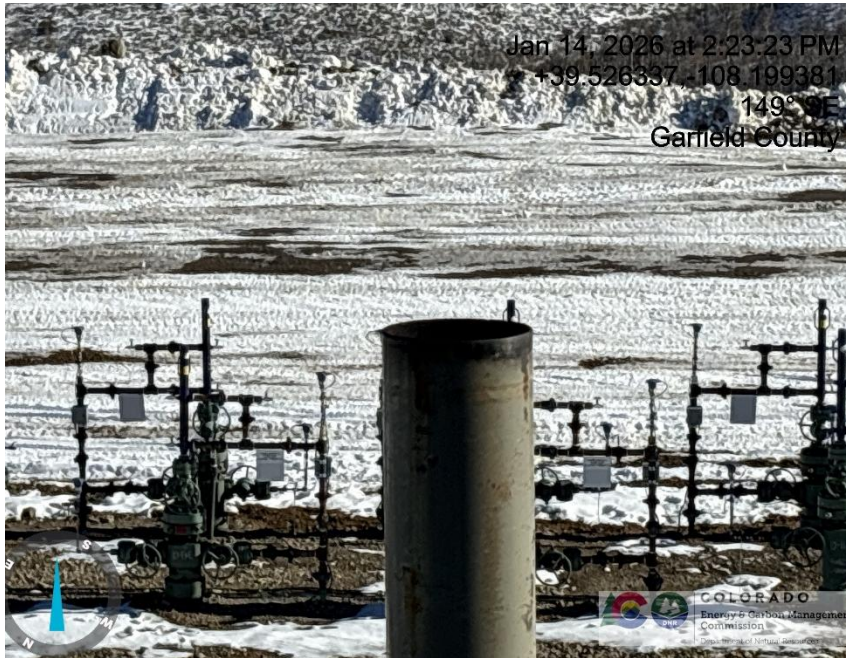
**Photo # 1287 Burner exhaust stack on heated 400 bbl condensate tank lacks bird protection/wildlife hazard**

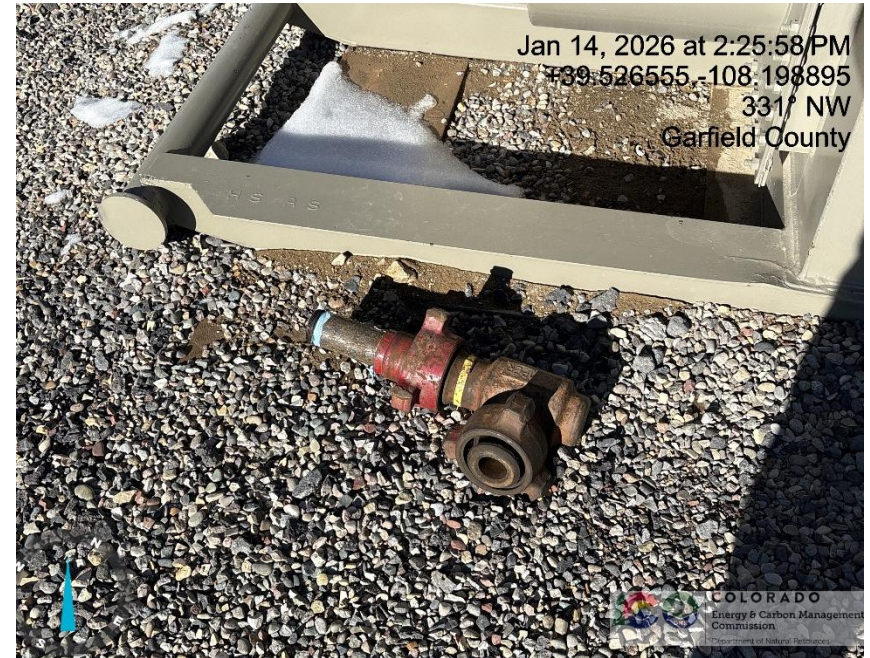
**Photo # 1288 Debris**

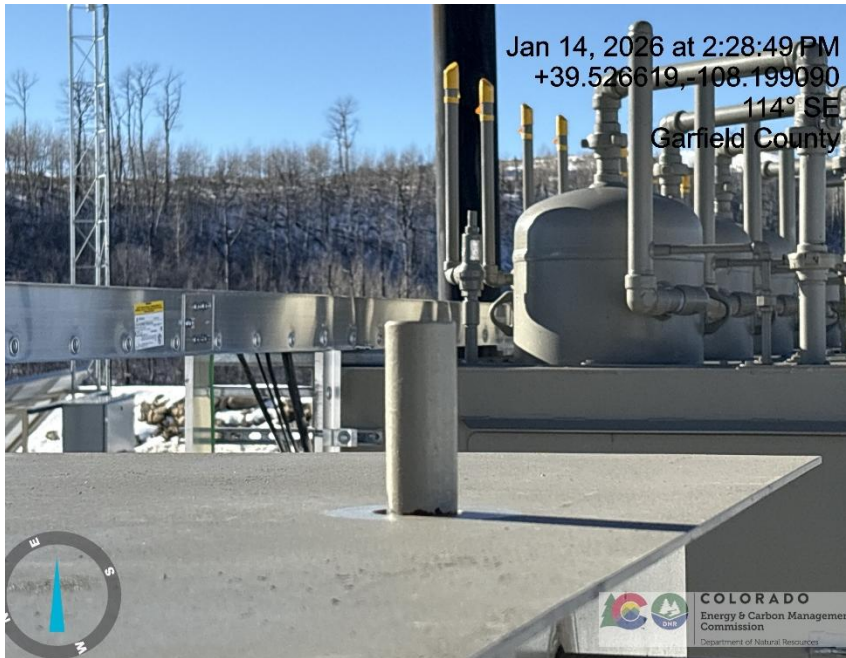
**Photo # 1289 PRV vent line does not comply with CECMC pressure safety device rules (fuel gas supply pot on separator unit)**

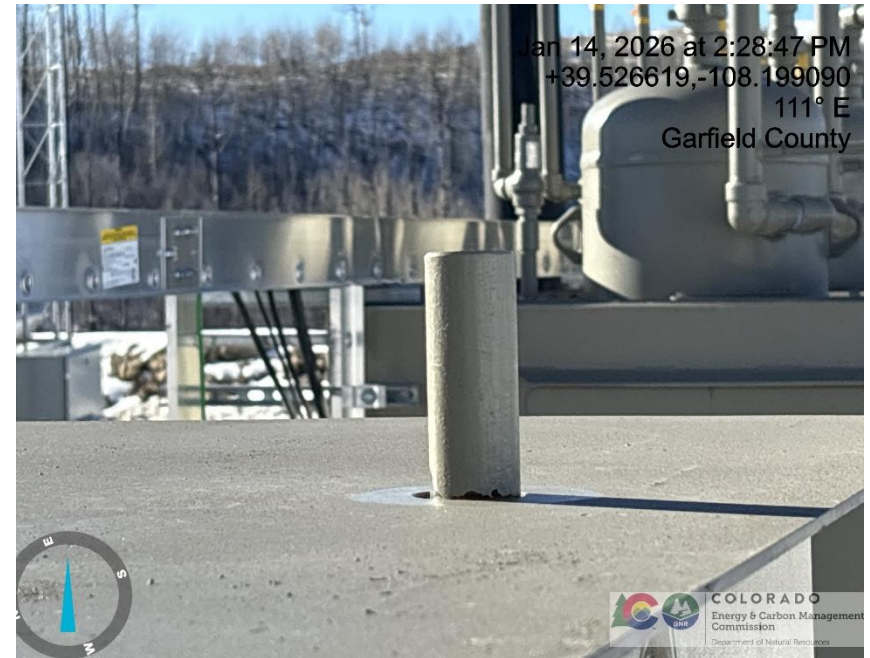
**Photo # 1290 PRV vent line does not comply with CECMC pressure safety device rules (fuel gas supply pot on separator unit)**

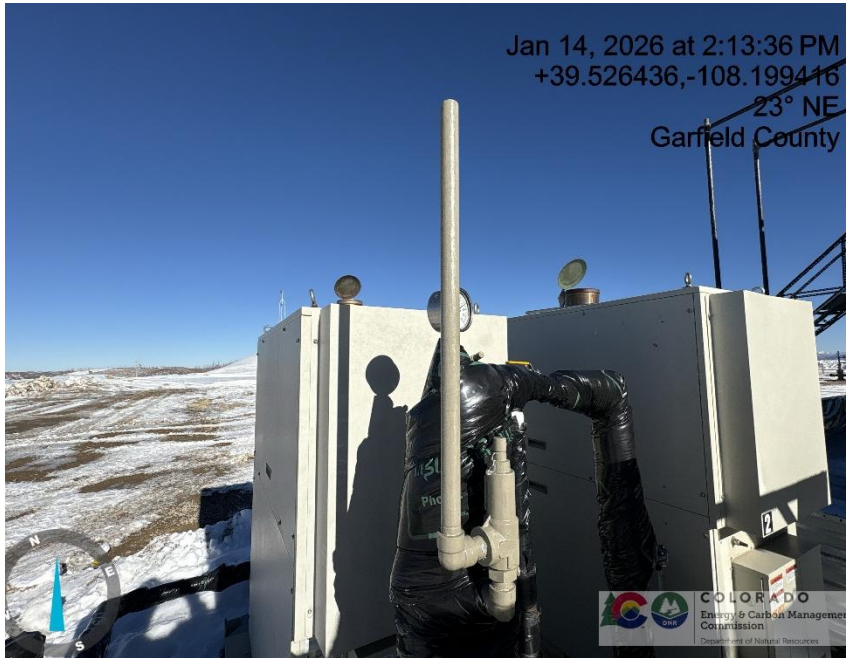
**Photo # 1291 PRV vent line does not comply with CECMC pressure safety device rules**

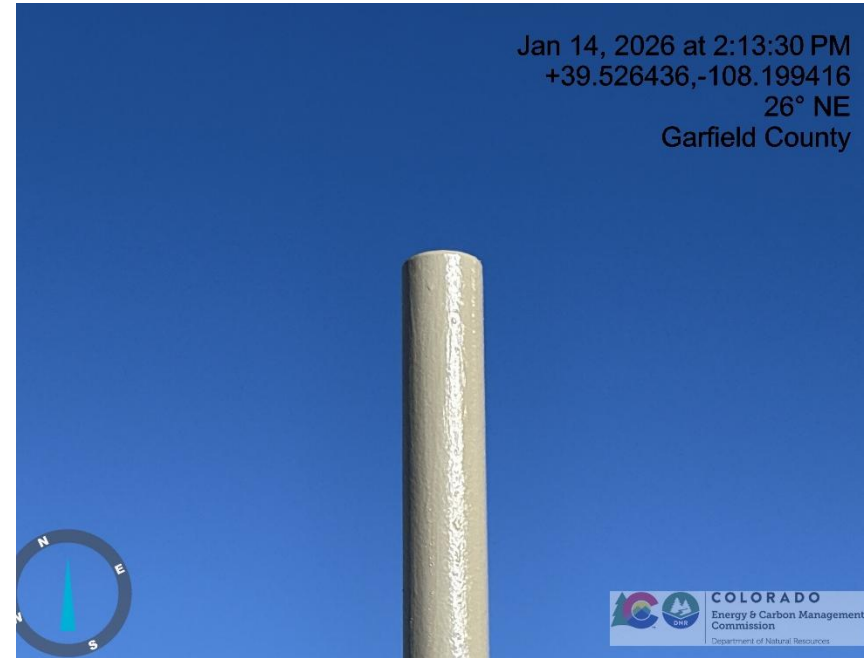
**Photo # 1292 PRV vent line does not comply with CECMC pressure safety device rules**

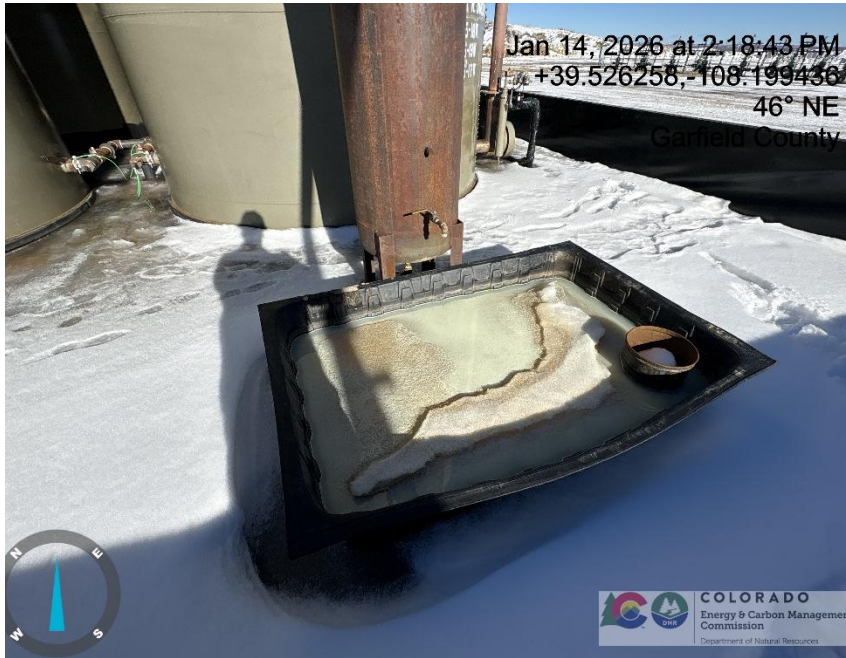
**Photo # 1293 Plastic containment containing unknown fluid lacks wildlife protection/wildlife hazard**

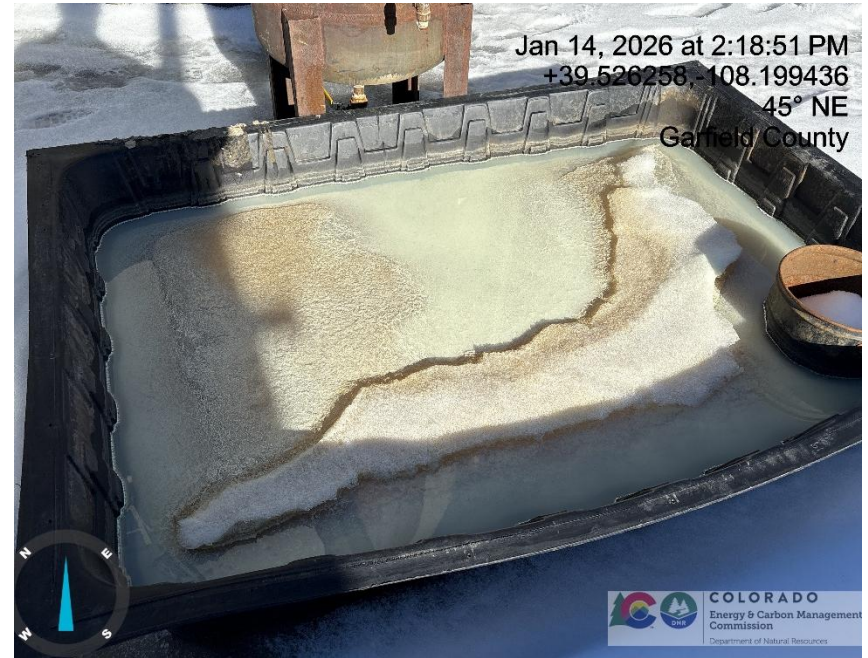
**Photo # 1294 Plastic containment containing unknown fluid lacks wildlife protection/wildlife hazard**
