ECMC Inspection Photos - KP Kauffman
Location: Facility #2 Consolidation (1/4/26) Spill ID #492701
Inspection date 01/6/2026 & 1/9/2026

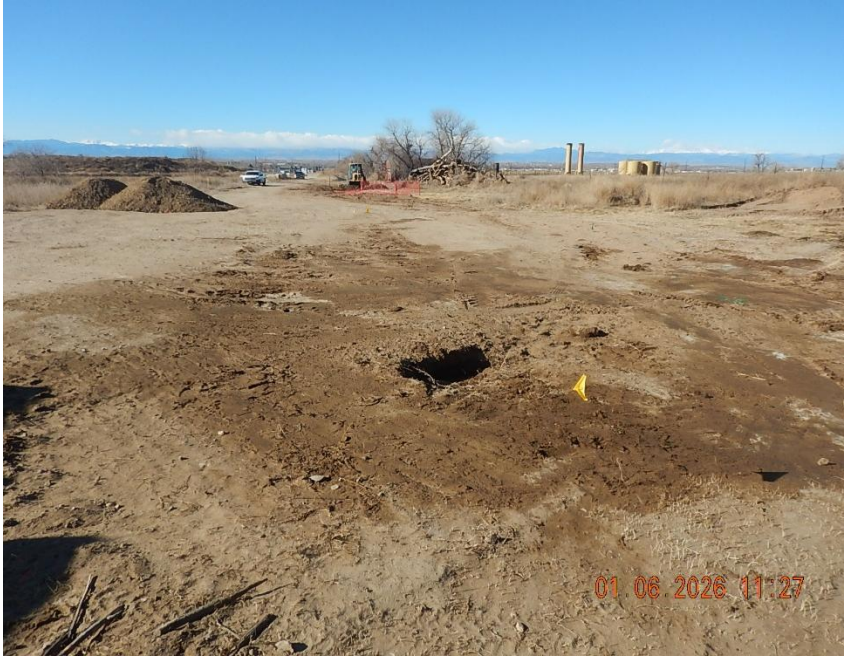
Facility #2 Consolidation 1/4/26 release point; surface expression @ 40.094593, -104.779910 (view looking west)
Inspection date 1/6/26

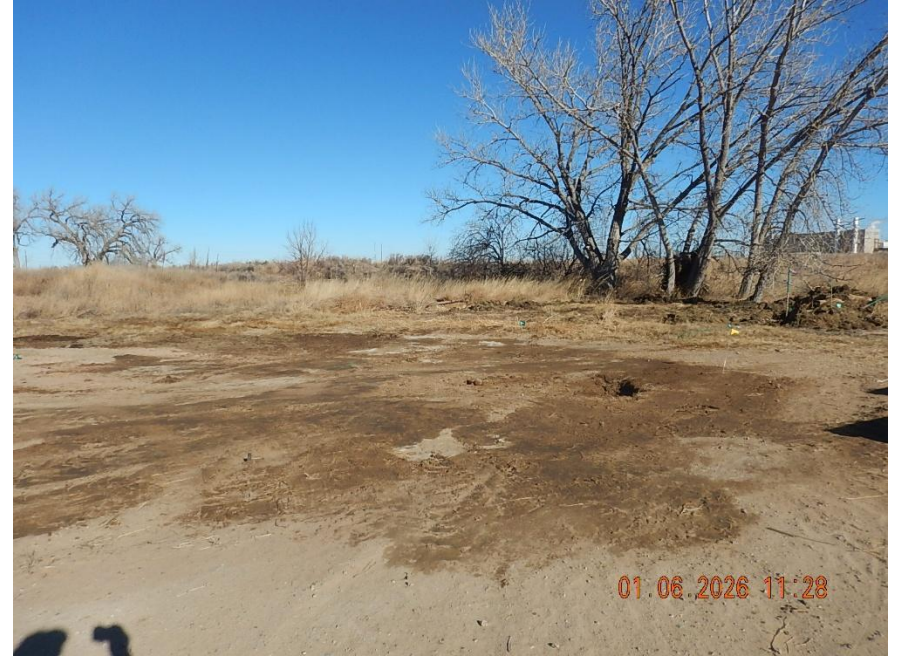
Facility #2 Consolidation 1/4/26 release point; surface expression @ 40.094593, -104.779910 (view looking east)
Inspection date 1/6/26

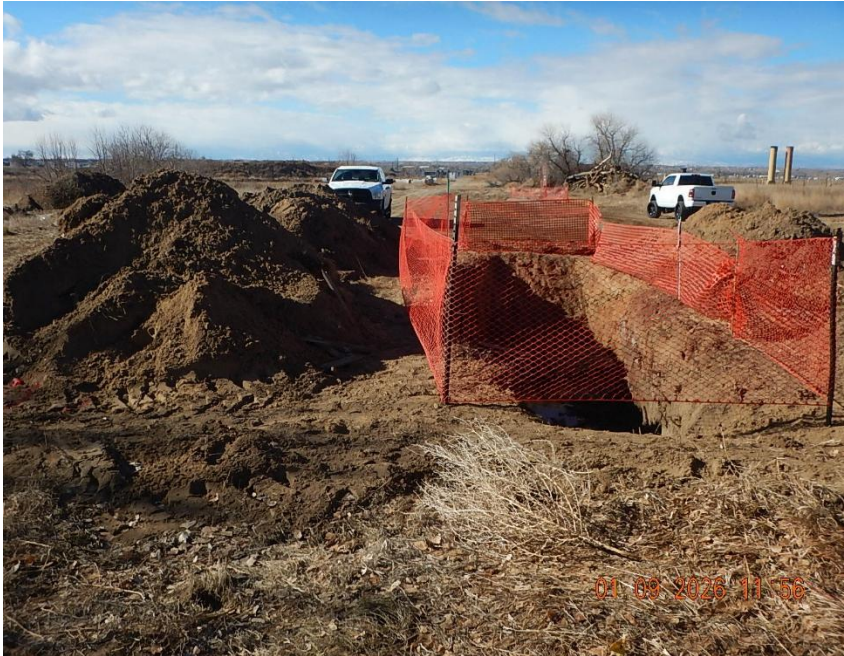
Fenced excavation exposing facility #2 consolidation line at area of failure. Inspection date 1/9/26 (view looking west)

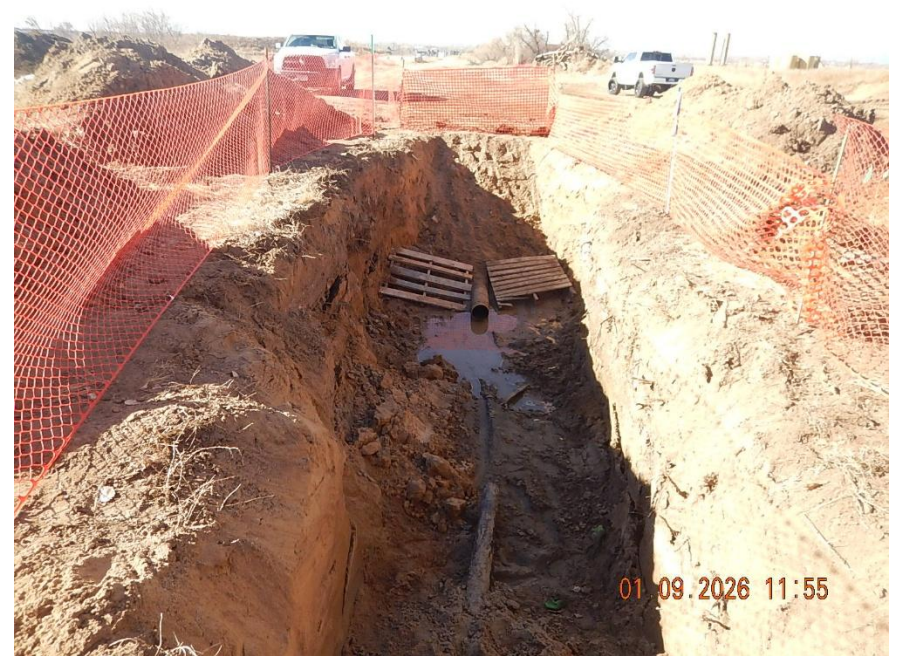
KPK Facility #2 consolidation off location flowline exposed in excavation. (1) 8 " CS and (1) 4" HDPE pipe/ material were observed in the excavation. The flowline transitions from 8" CS (to west) to 4" HDPE (to east) in the excavation.

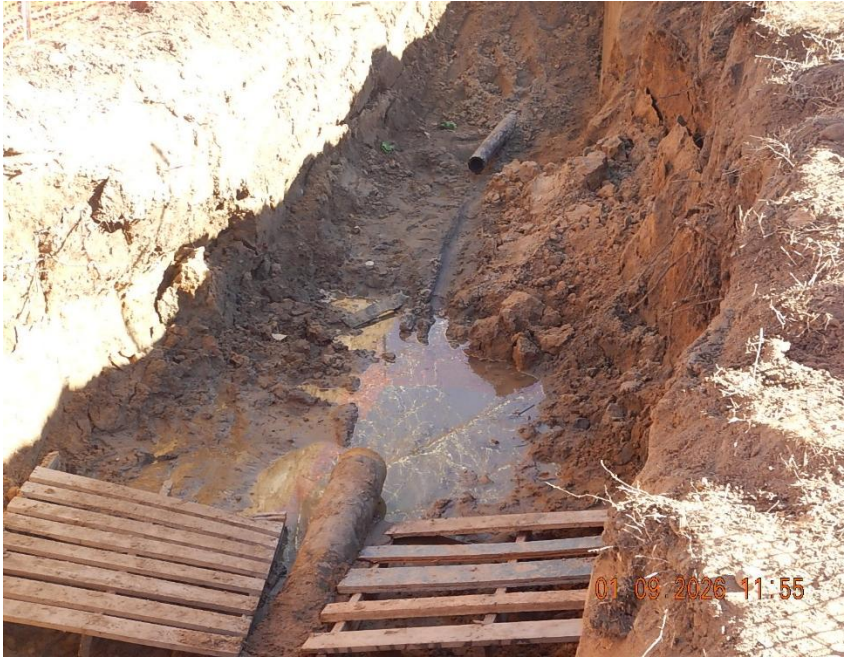
KPK Facility #2 consolidation off location flowline exposed in excavation. (1) 8 " CS and (1) 4" HDPE pipe/ material were observed in the excavation. The flowline transition area has been cut out in preparation for repair (view looking east)

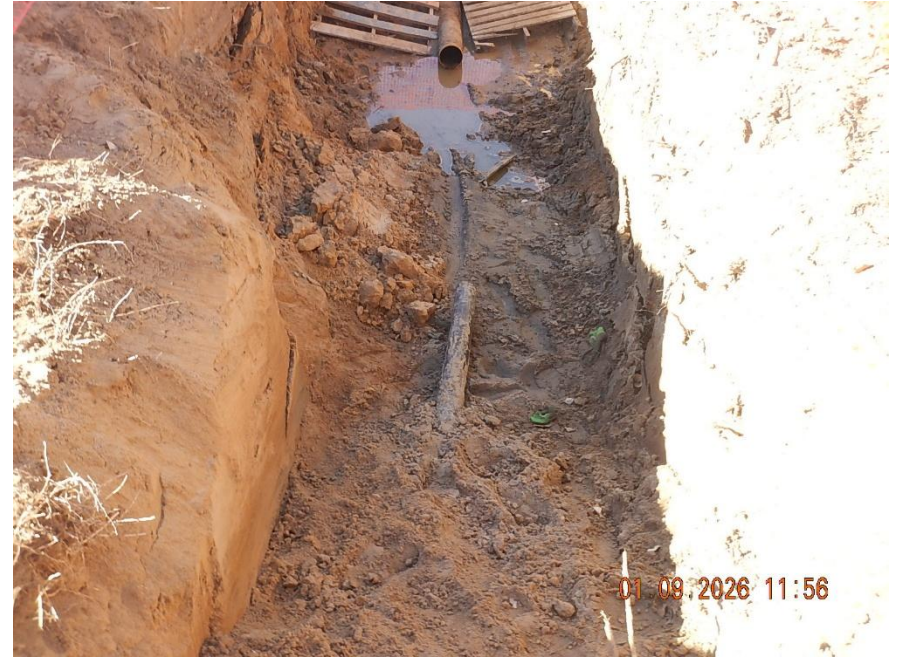
KPK Facility #2 consolidation off location flowline exposed in excavation. (1) 8 " CS and (1) 4" HDPE pipe/ material were observed in the excavation. The flowline transition area has been cut out in preparation for repair (view looking west)
