Inspection Photos
Location: Rainbow 23-20
Location ID: 322234
API # 05-043-06150

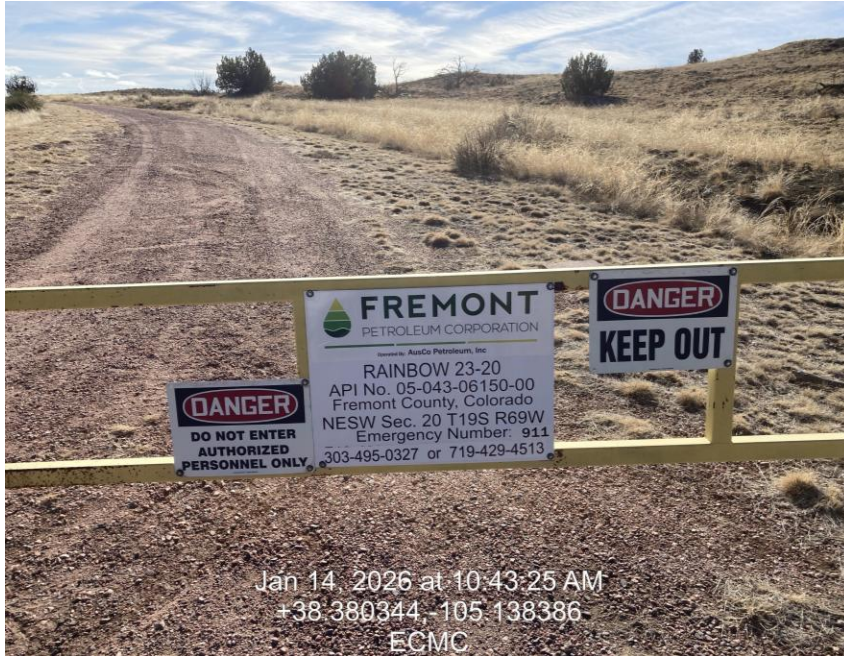
Photo 1 – Well Placard

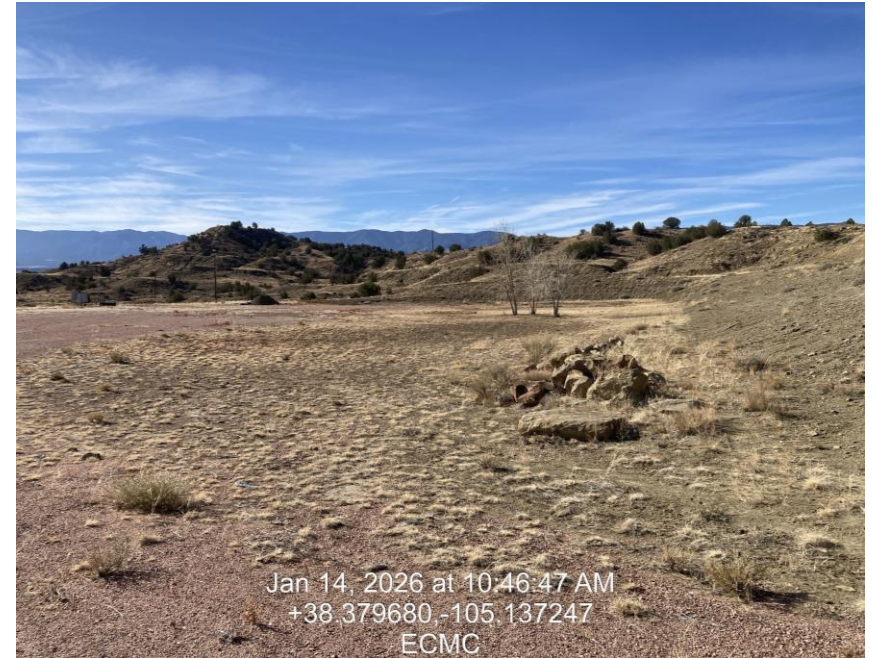
Photo 2 – Location Overview

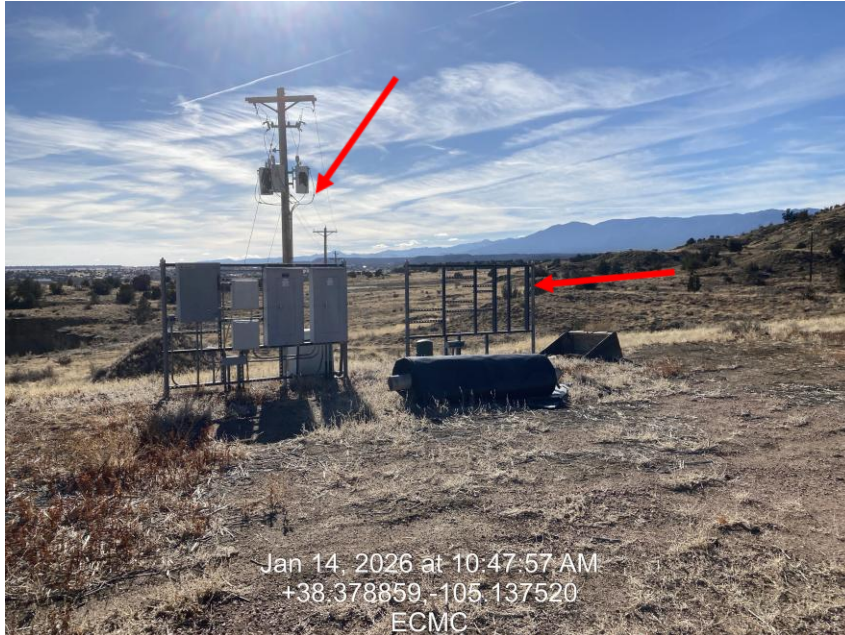
Photo 3 – Electrical Equipment

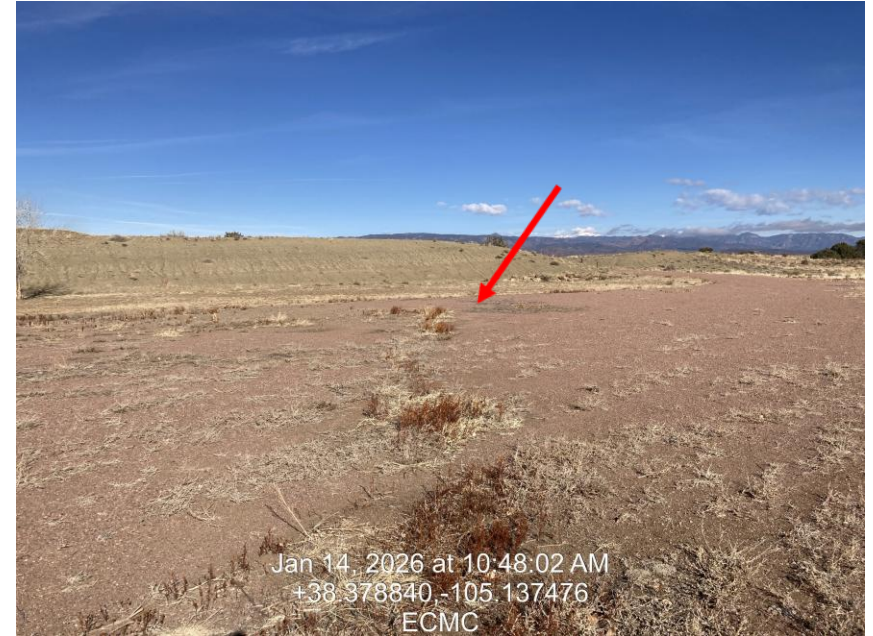
Photo 4 – Electrical Line corridor

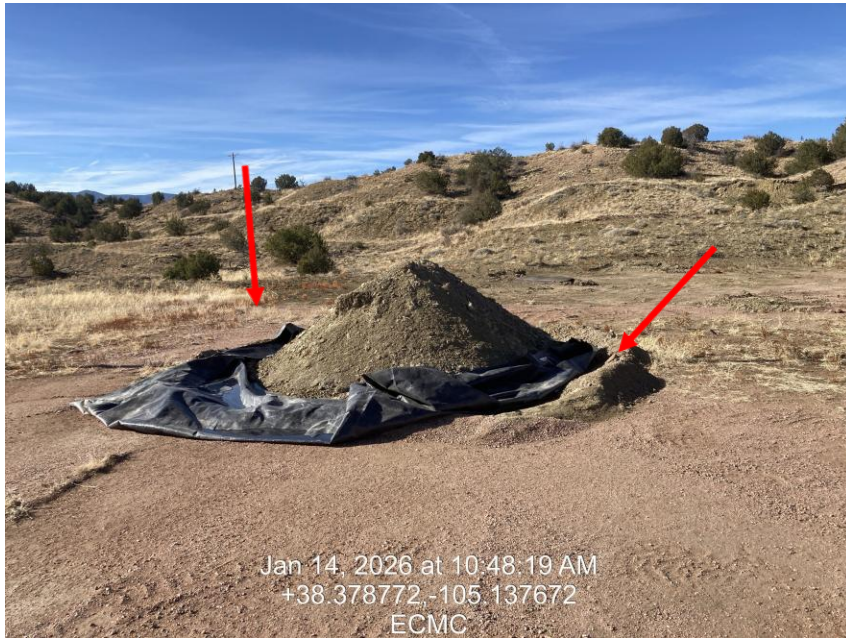
Photo 5 – Impacted spoil pile in containment

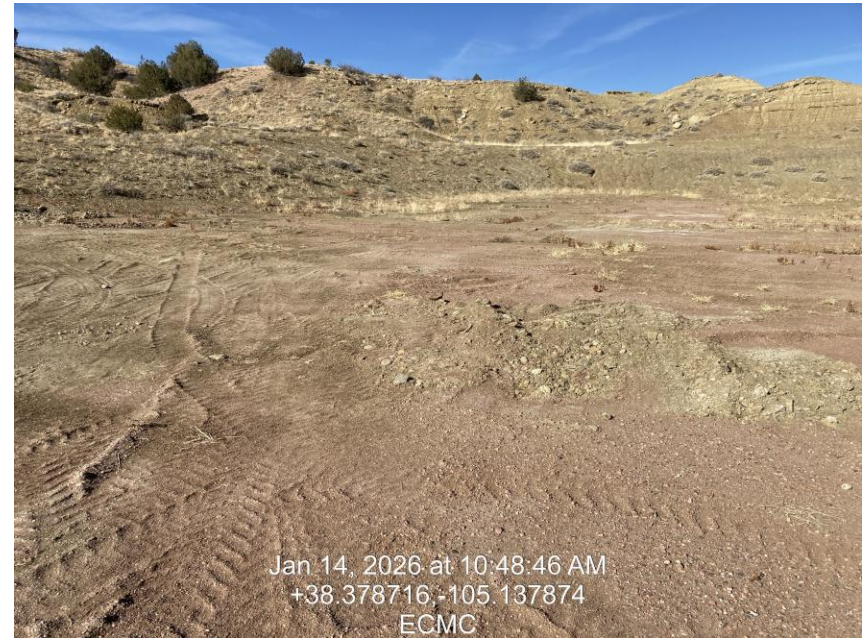
Photo 6 – Former Tank Battery/area with impacts to soils

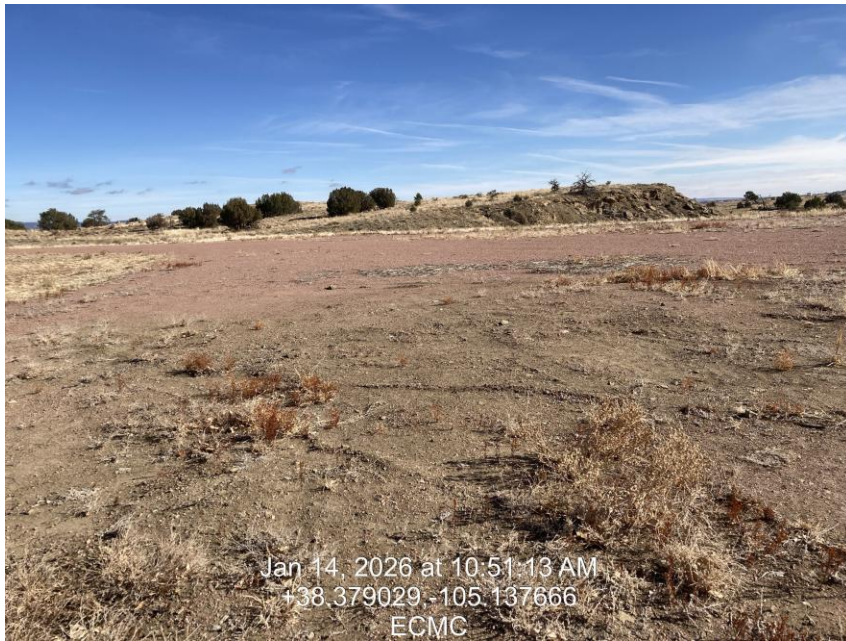
Photo 7 – Former Wellhead location

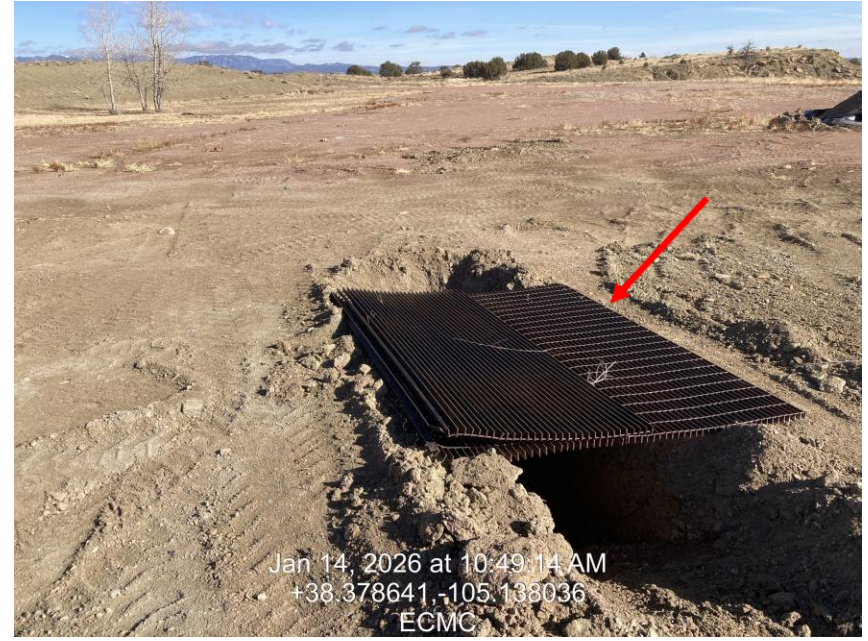
Photo 8 – Open Excavation

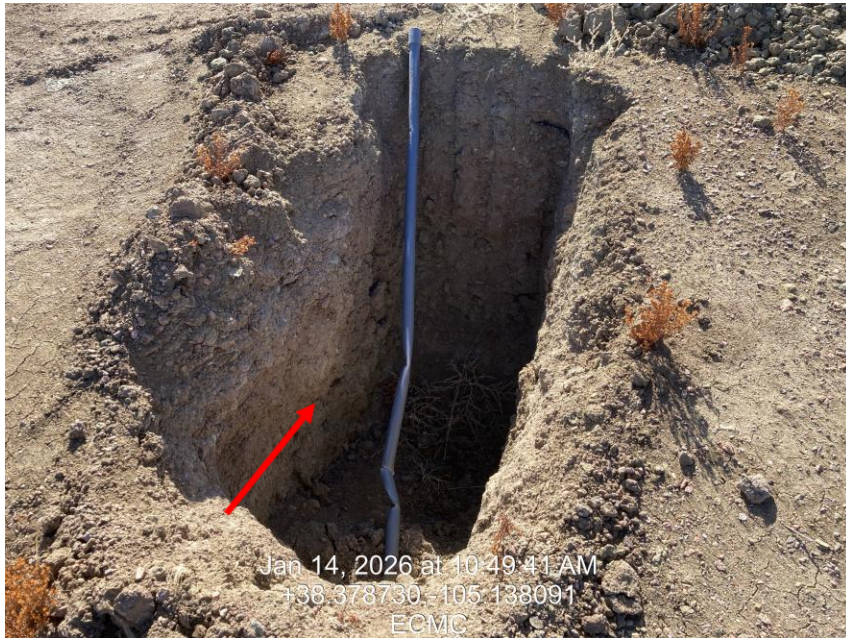
Photo 9 – Open Excavation

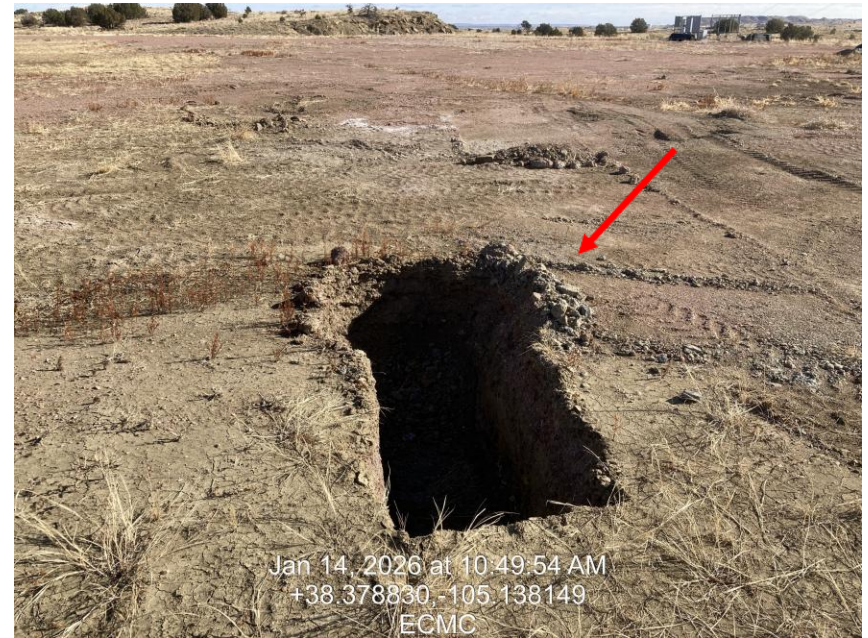
Photo 10 – Open Excavation

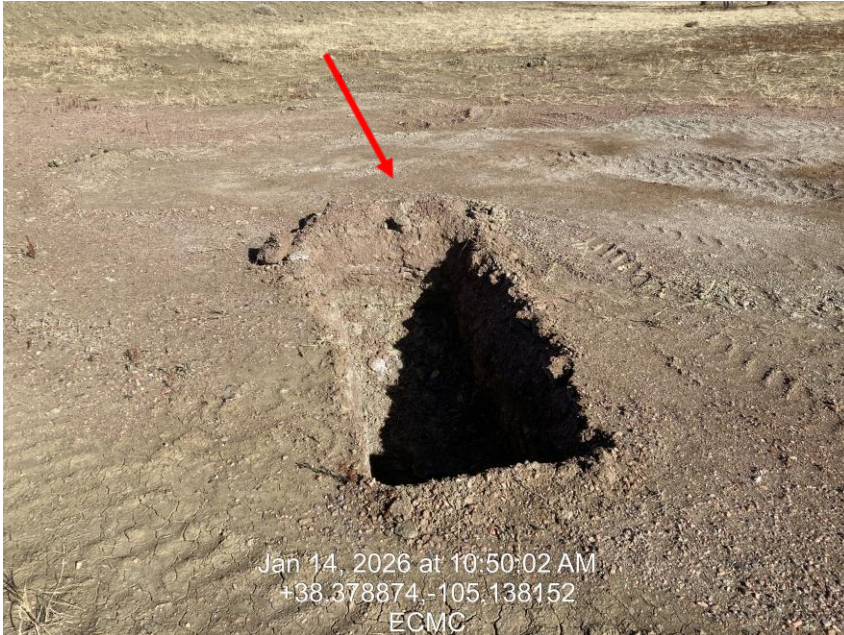
Photo 11 – Open Excavation

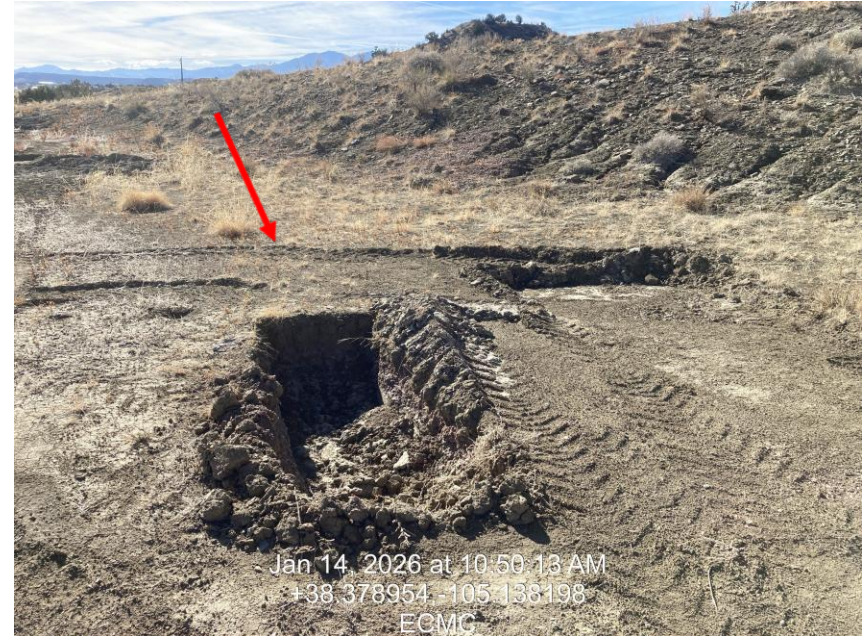
Photo 12 – Open Excavation

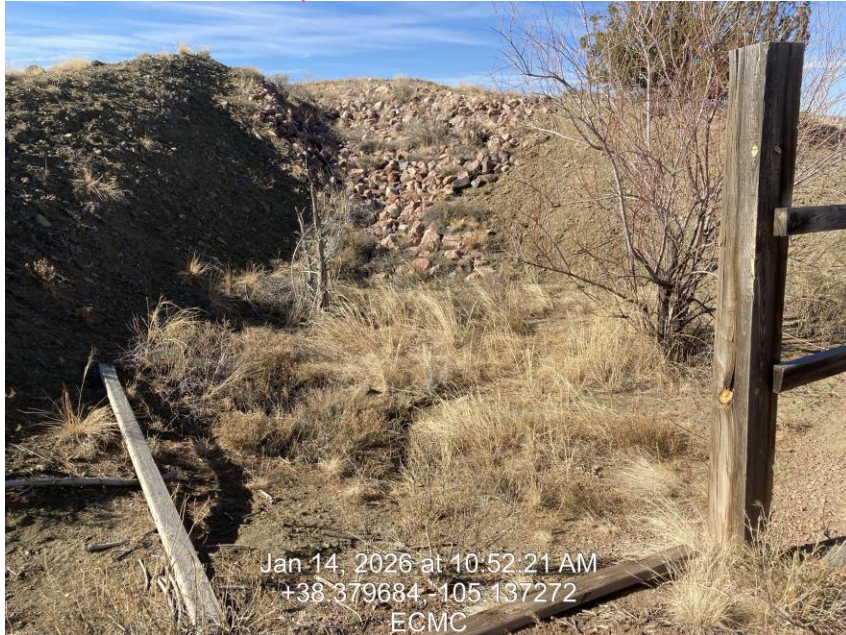
Photo 13 – Stormwater BMP adjacent to access road

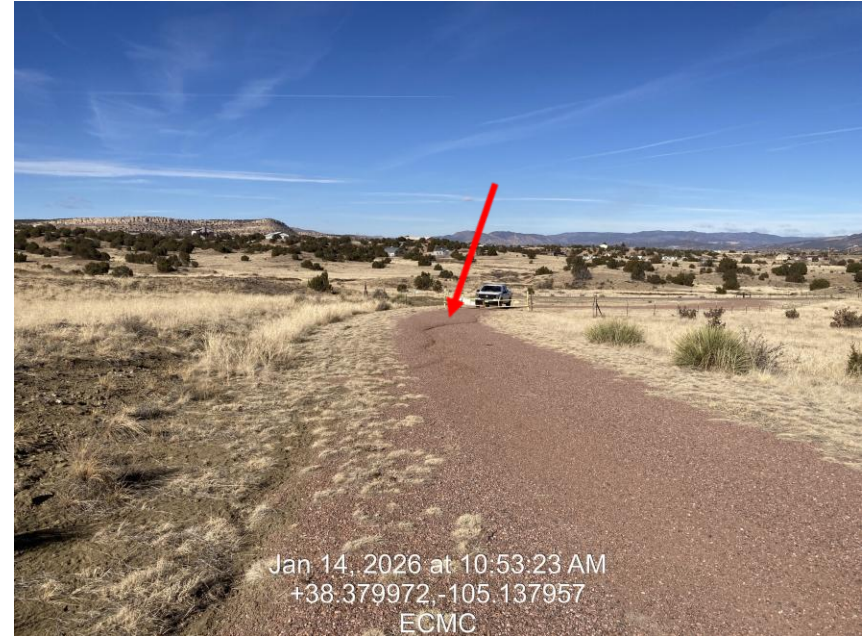
Photo 14 – Erosion Along access road
