Final Reclamation Inspection

Operator: Kerr McGee Oil & Gas Onshore - 47120

Location ID: 318186

Location Name: UPRR 42 Pan Am AD 1

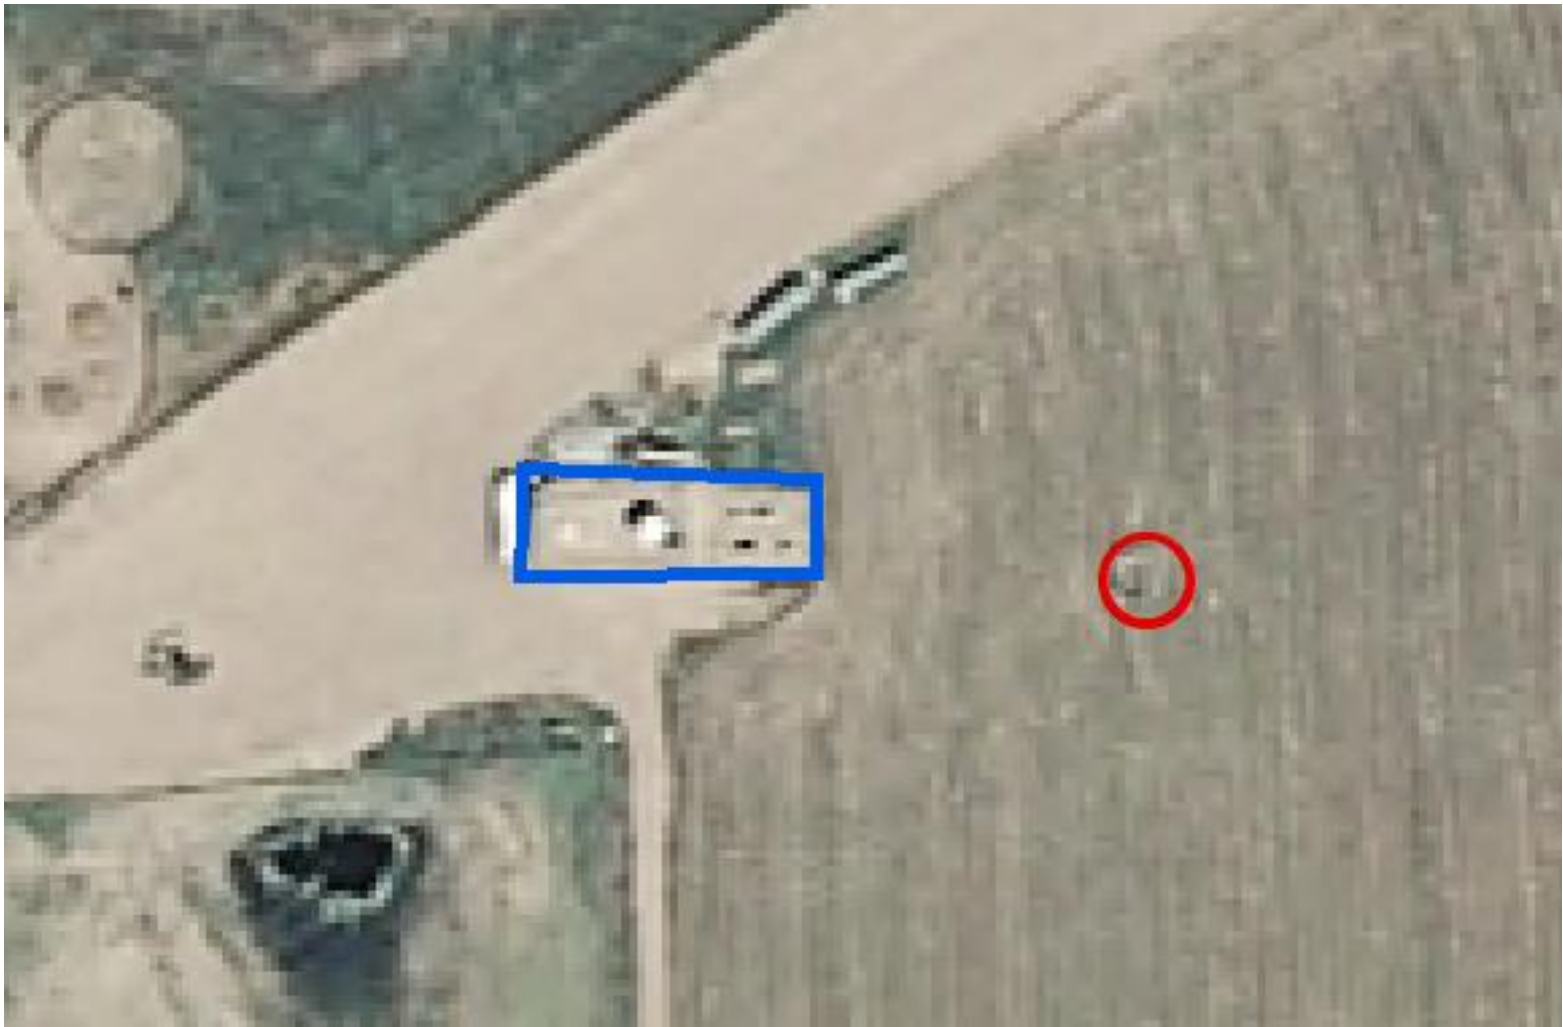
Photo 1. NAIP aerial imagery (2009) illustrating the well location (red circle) and associated tank battery location (blue polygon). Note: no obvious existing road in historic imagery.

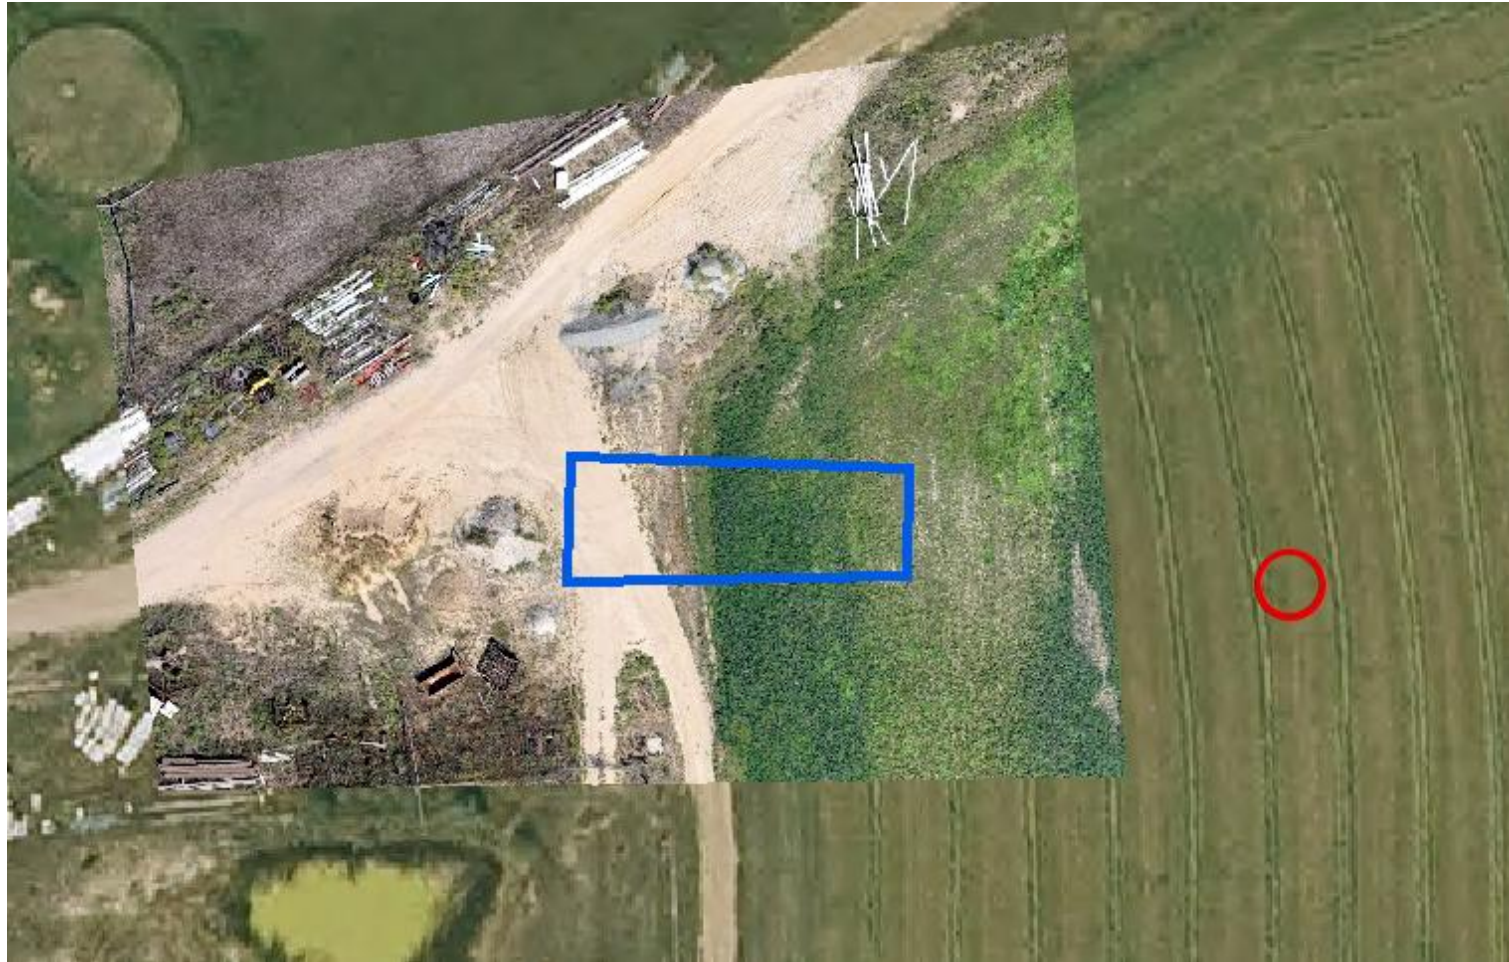
Photo 2. NAIP imagery (2023) illustrating the well location (red circle) and associated tank battery (blue polygon).

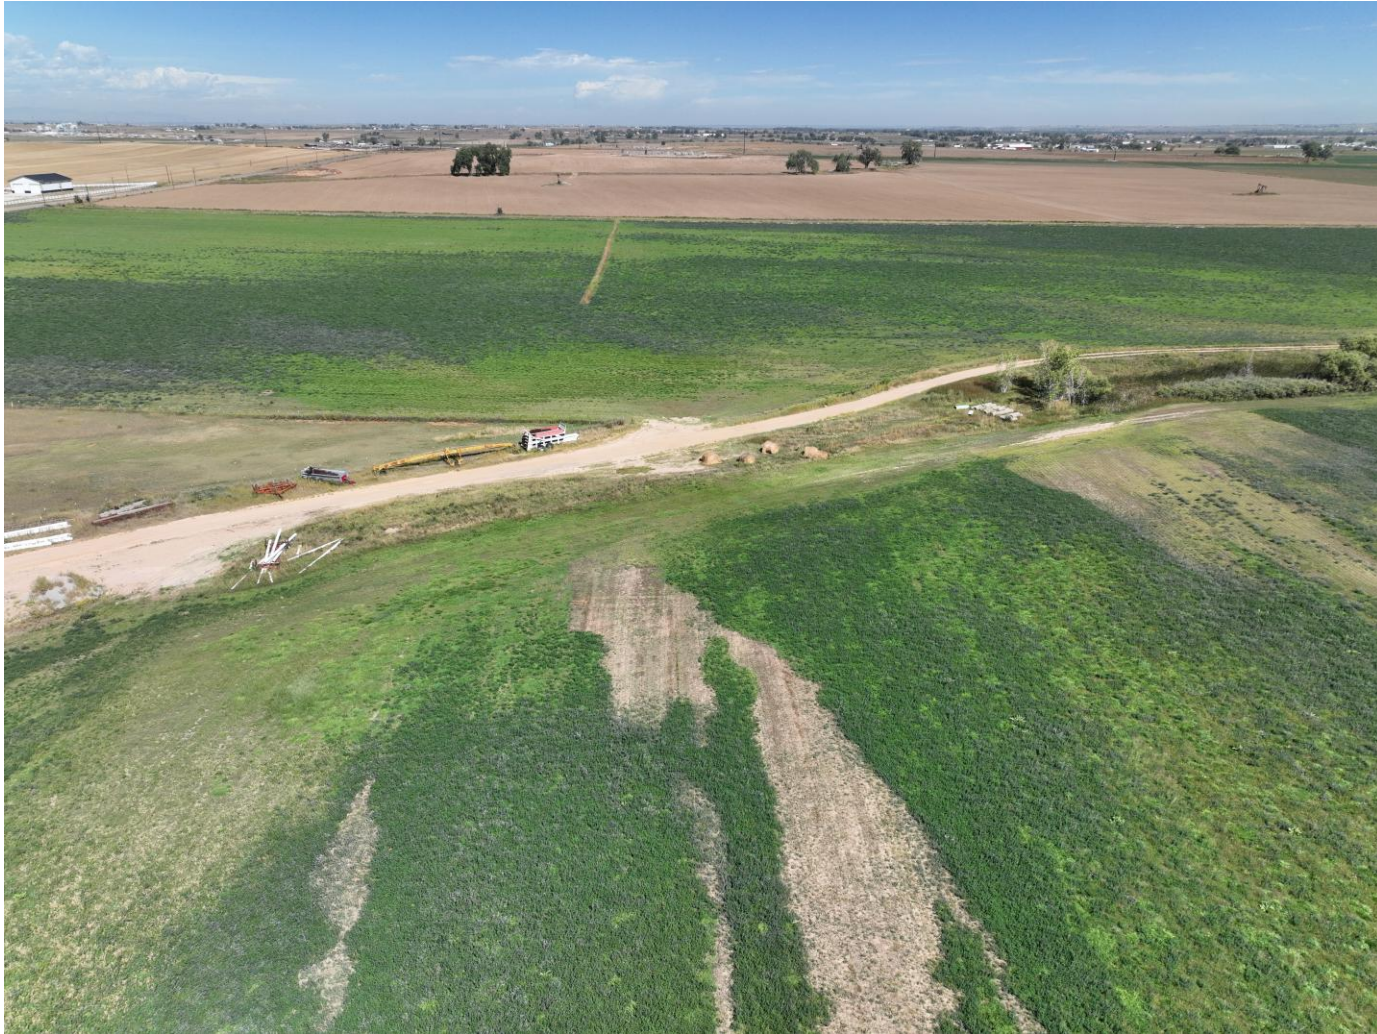
Photo 3. Drone aerial imagery taken south of well location, facing north (displaying the well).

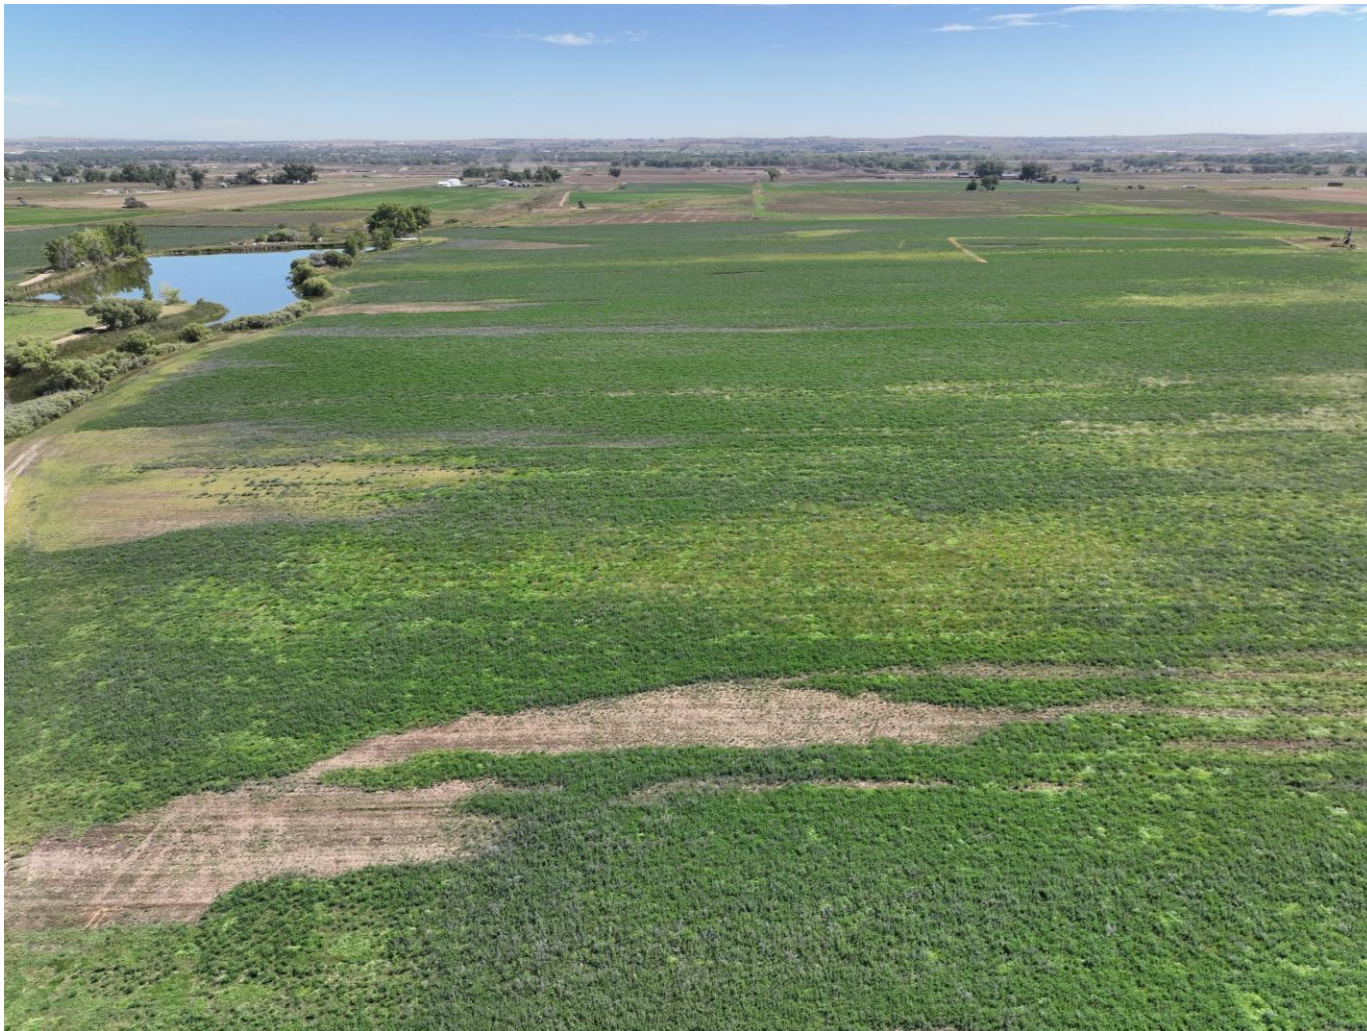
Photo 4. Drone aerial imagery taken west of well location, facing east (displaying the well).

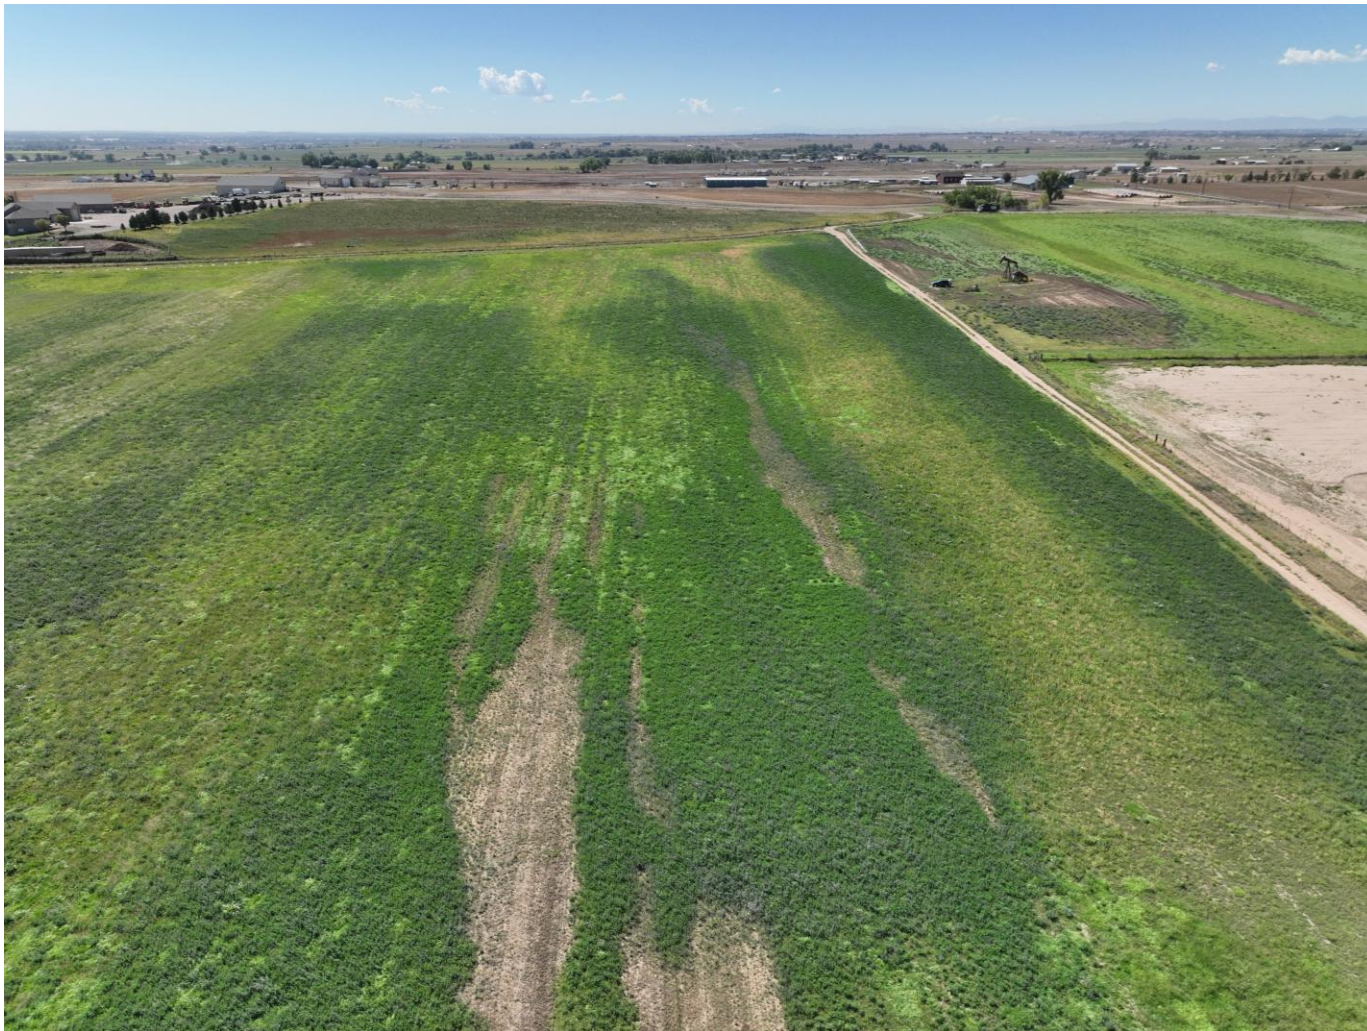
Photo 5. Drone aerial imagery taken north of well location, facing south (displaying the well).

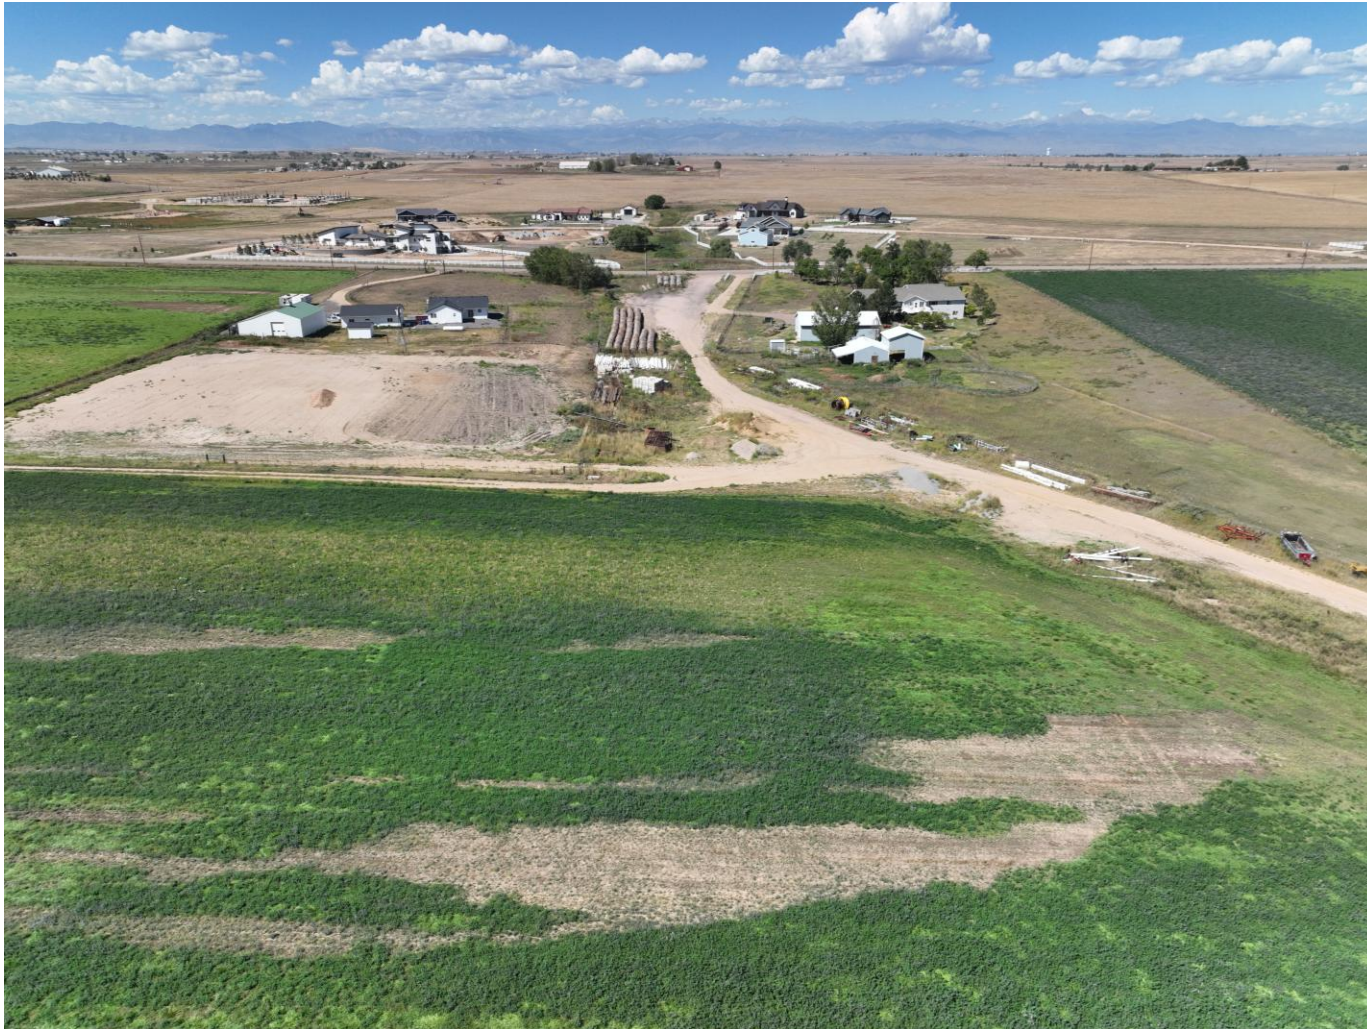
Photo 6. Drone aerial imagery taken east of well location, facing west (displaying the well, presumed flowline, and TB).

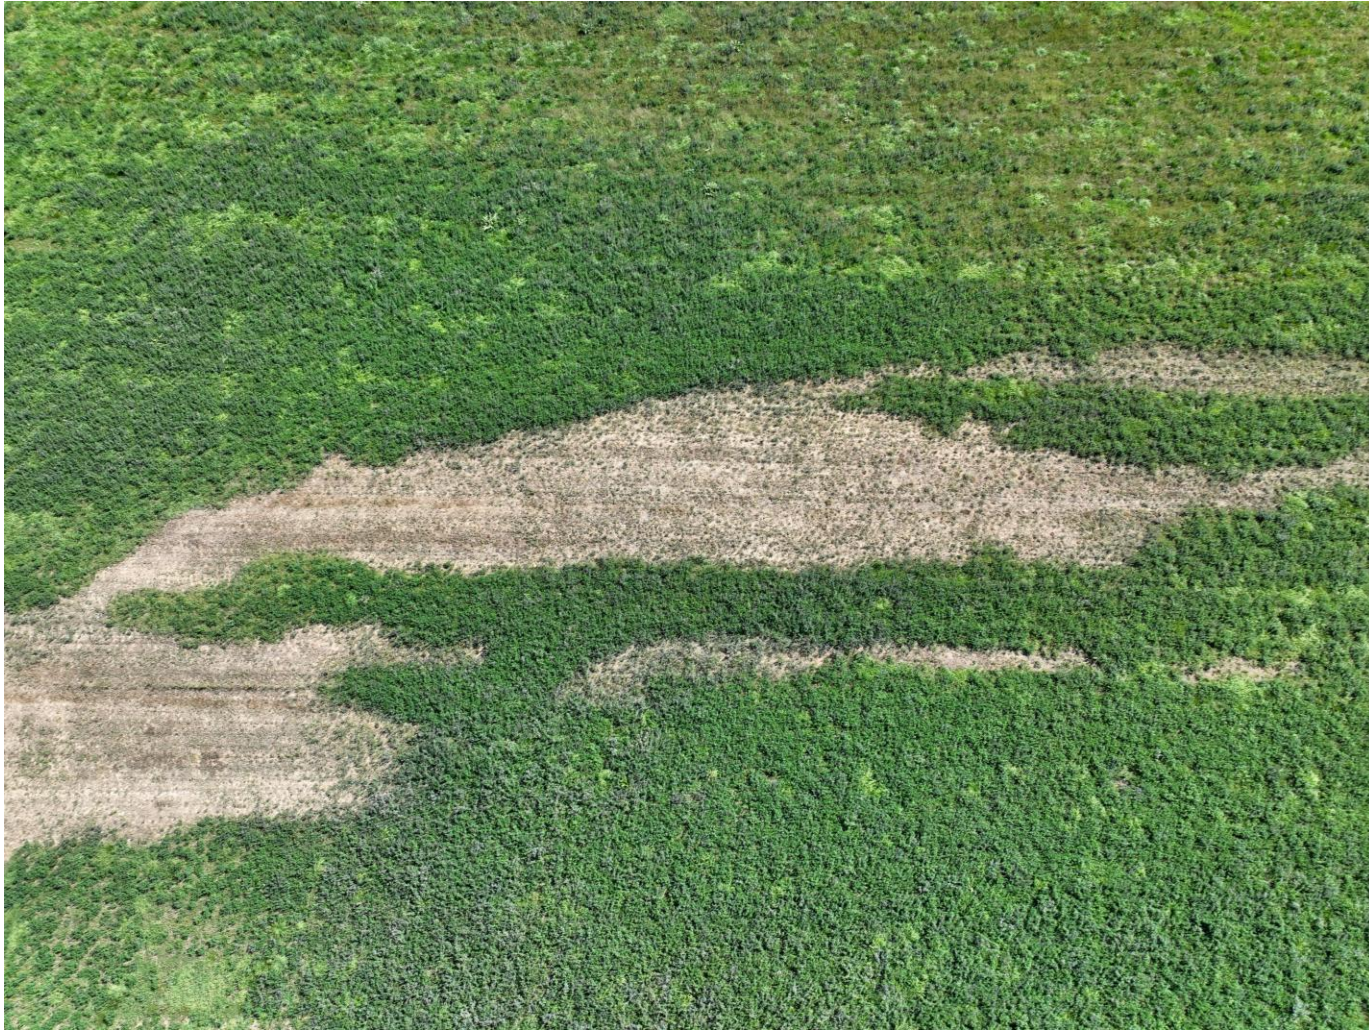
Photo 7. Drone aerial imagery looking downward at the well (displaying the well).

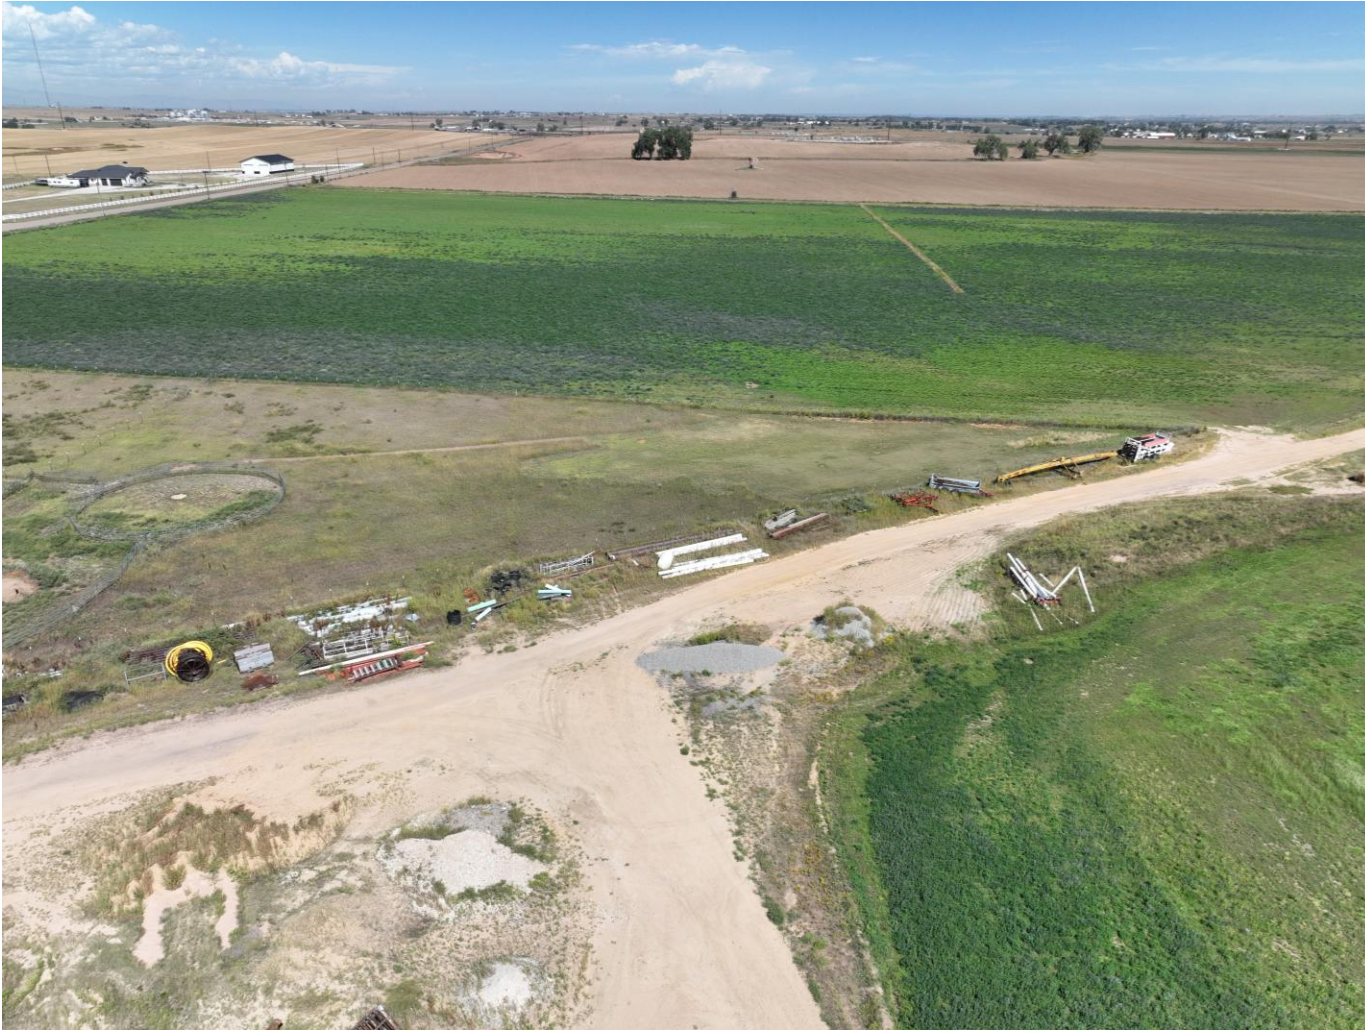
Photo 8. Drone aerial imagery taken south of the tank battery location, facing north (displaying the TB).

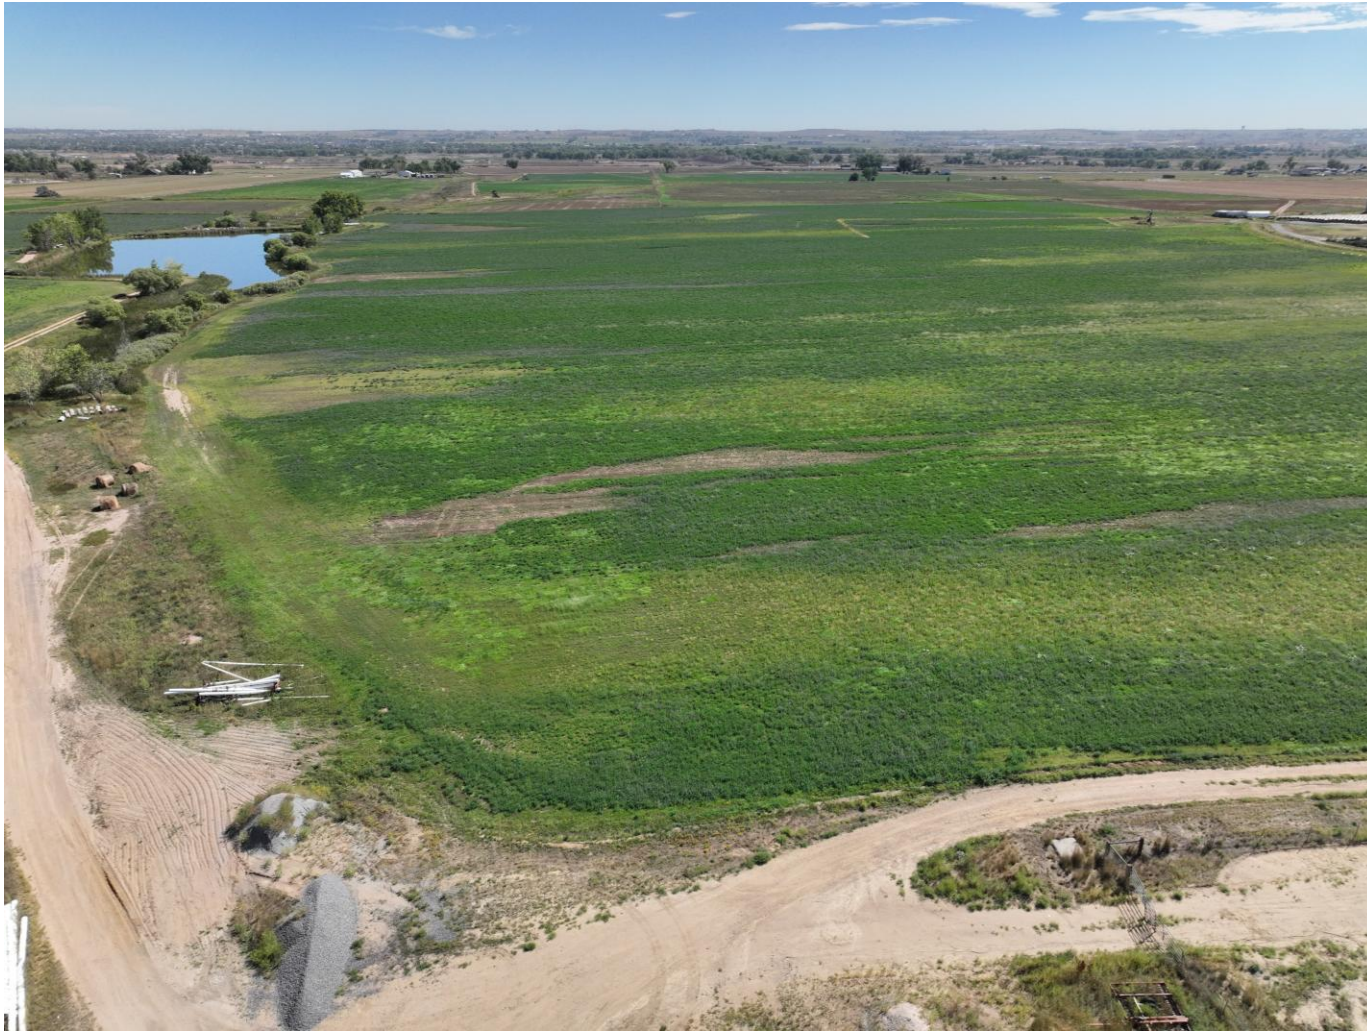
Photo 9. Drone aerial imagery taken west of the tank battery location, facing east (displaying the TB, presumed flowline, and well).

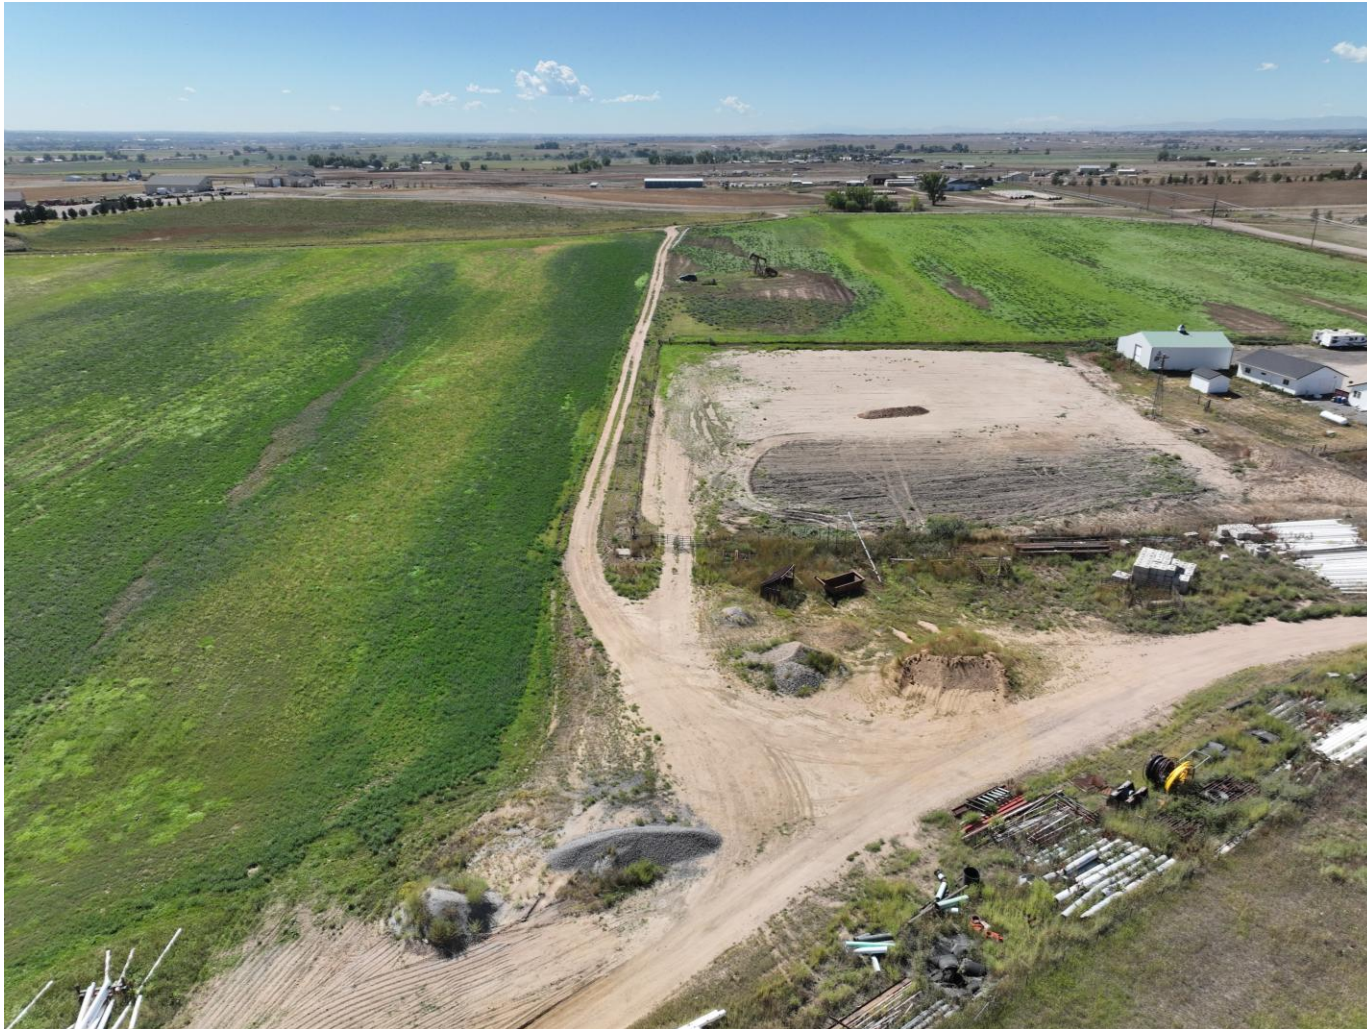
Photo 10. Drone aerial imagery taken north of the tank battery location, facing south (displaying the TB).

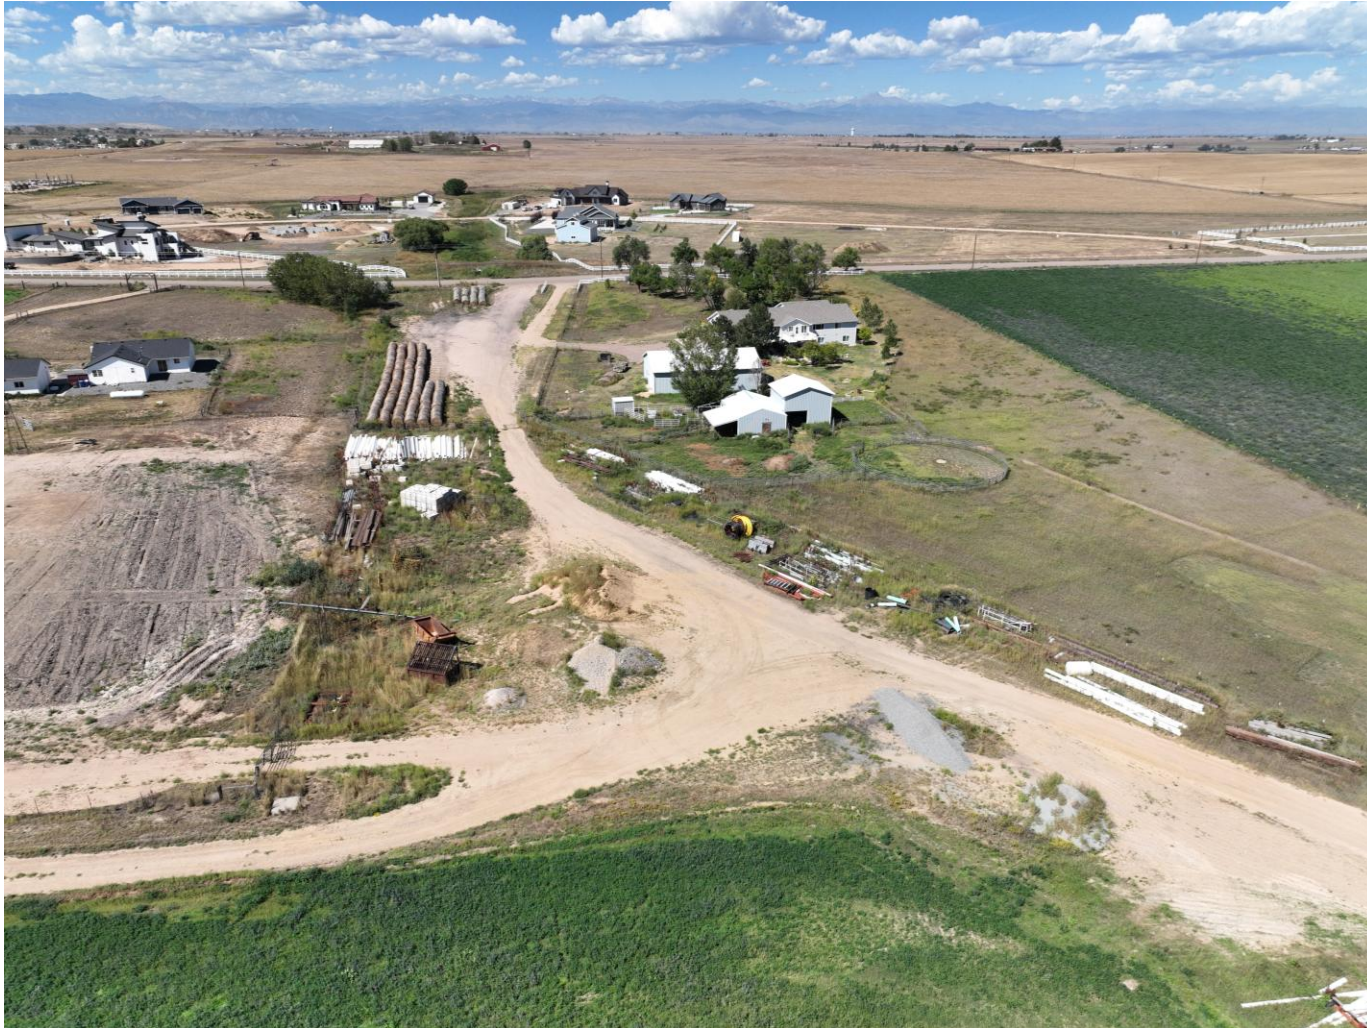
Photo 11. Drone aerial imagery taken east of the tank battery location, facing west (displaying the TB).

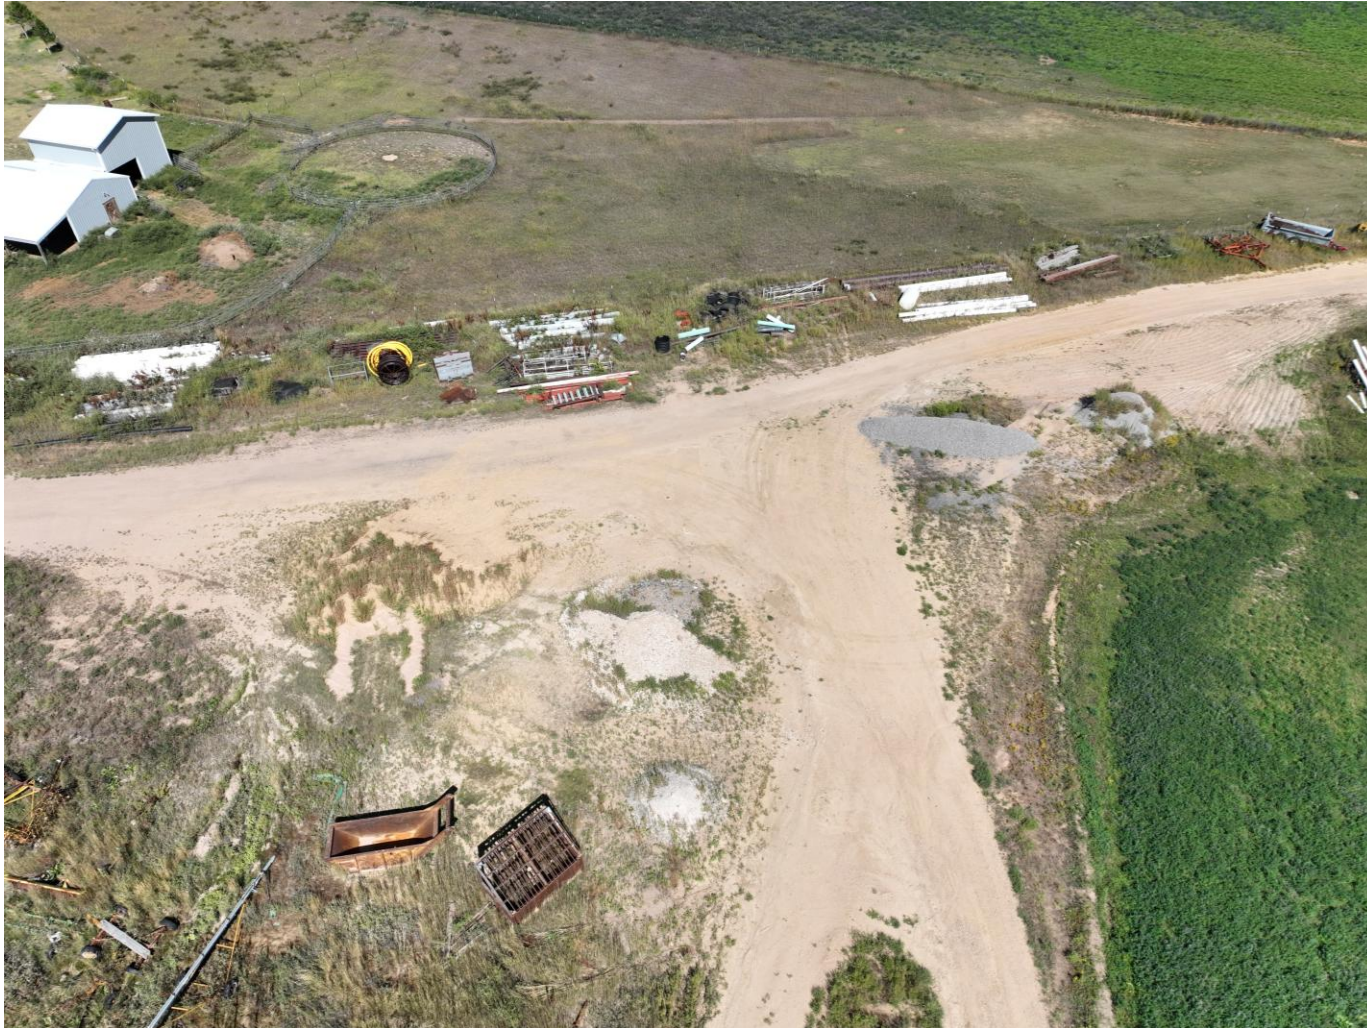
Photo 12. Drone aerial imagery looking downward at the TB (displaying part of the TB).

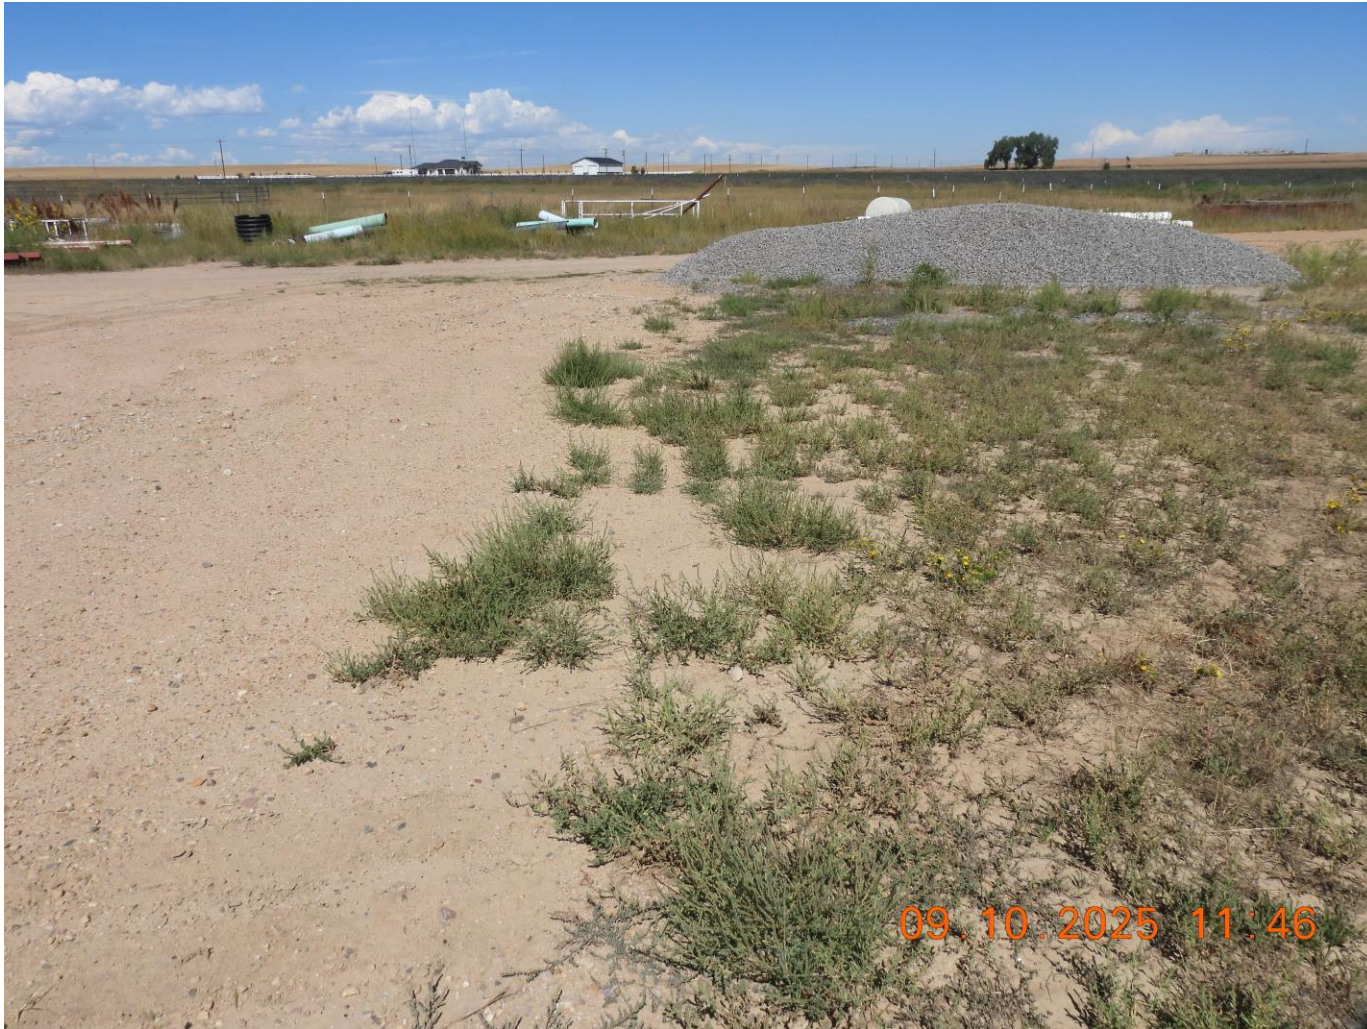
Photo 13. Ground imagery taken from the center of the tank battery location, facing north (displaying the TB).

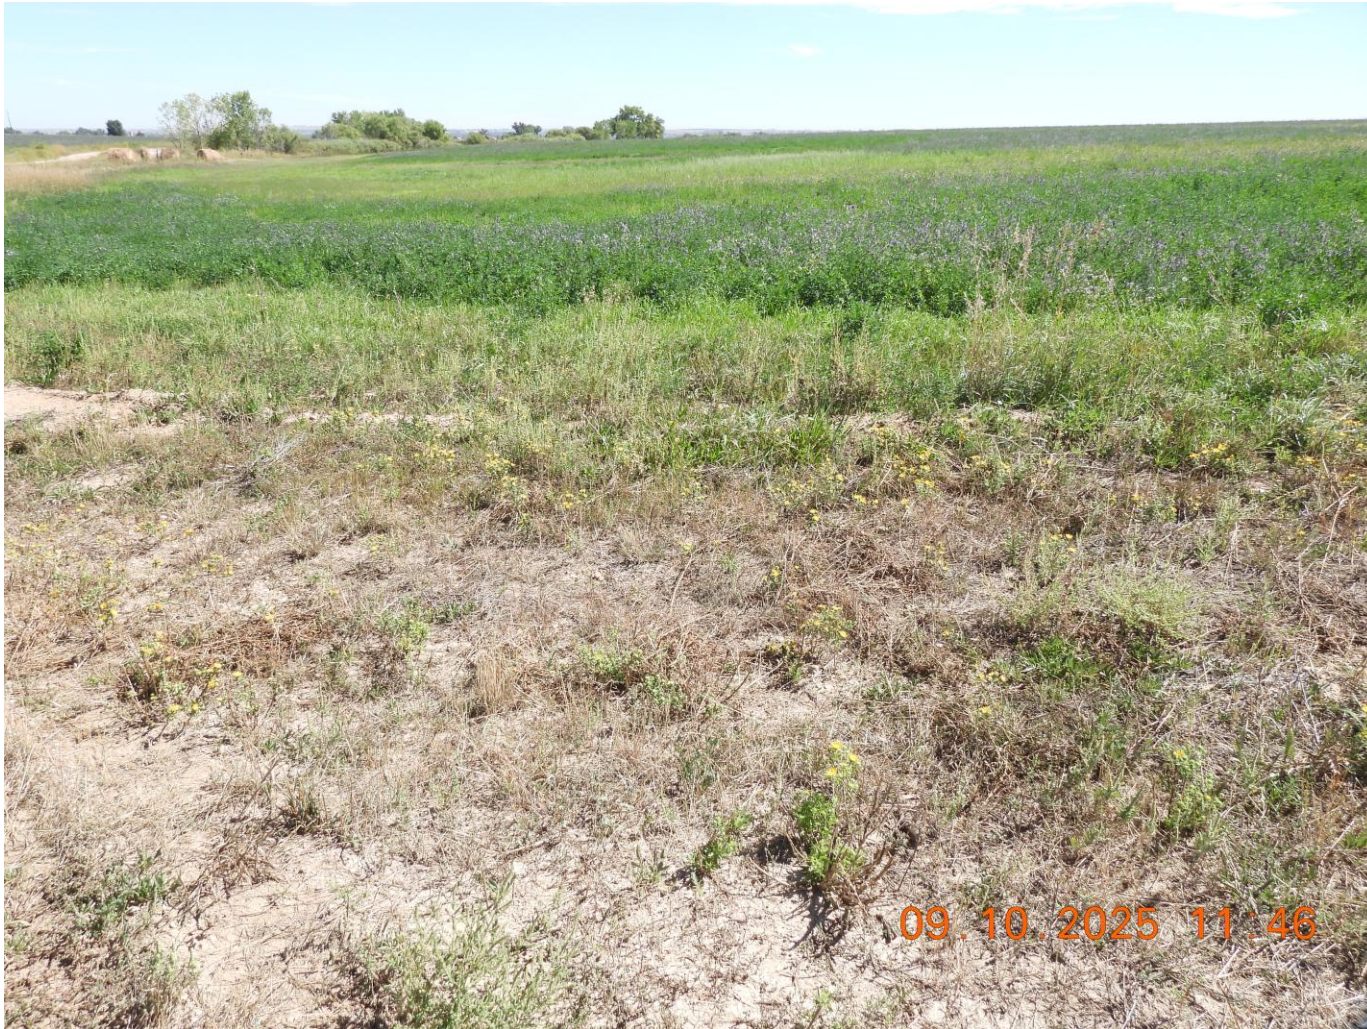
Photo 14. Ground imagery taken from the center of the tank battery location, facing east (displaying the TB).

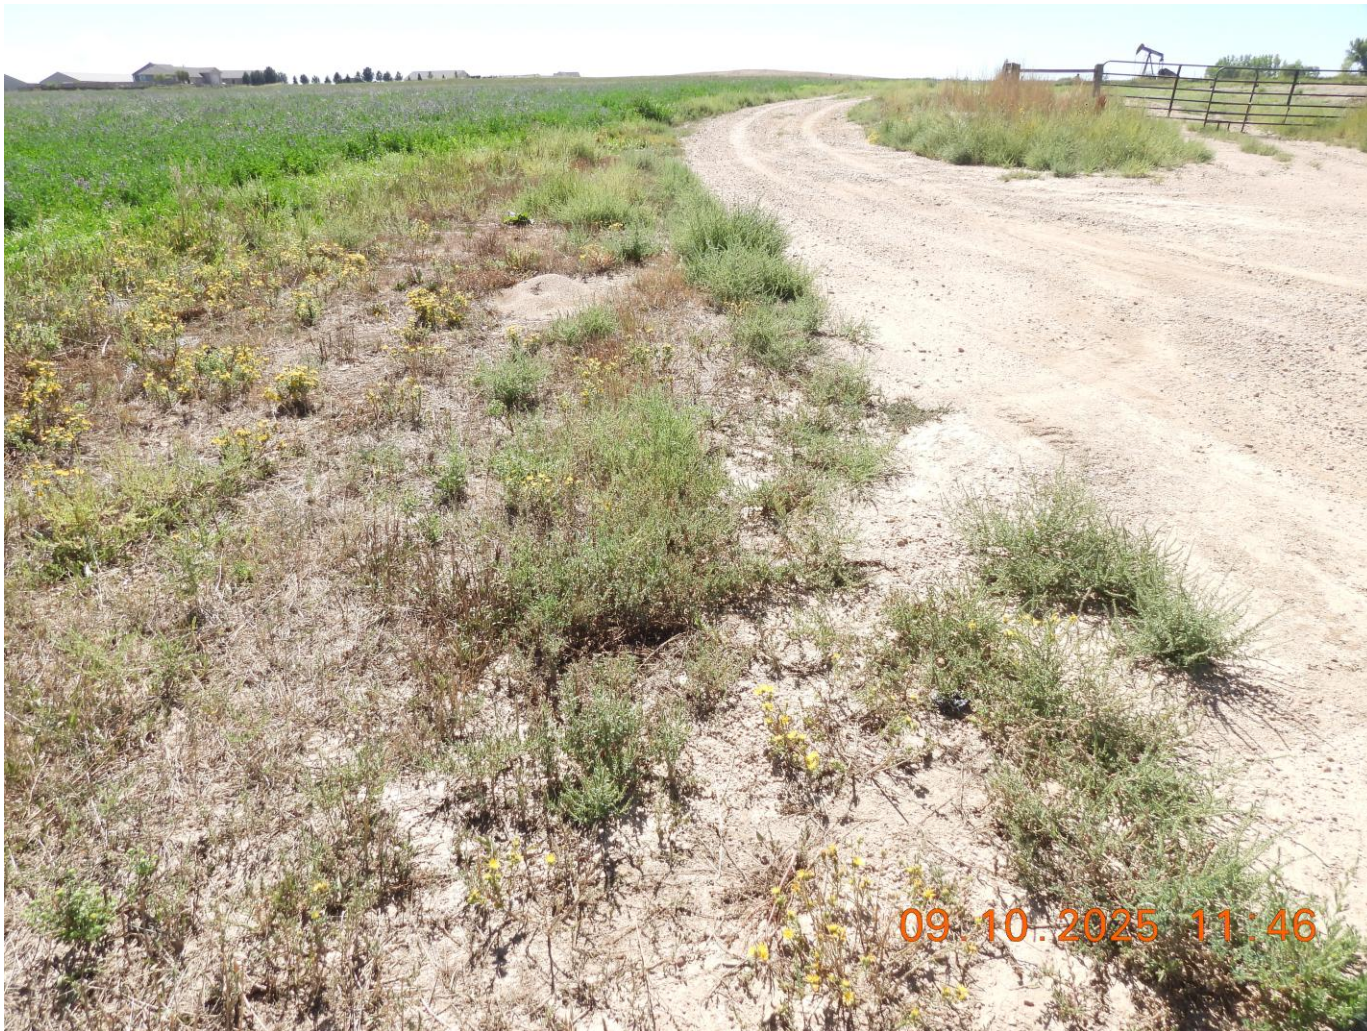
Photo 15. Ground imagery taken from the center of the tank battery location, facing south (displaying the TB).

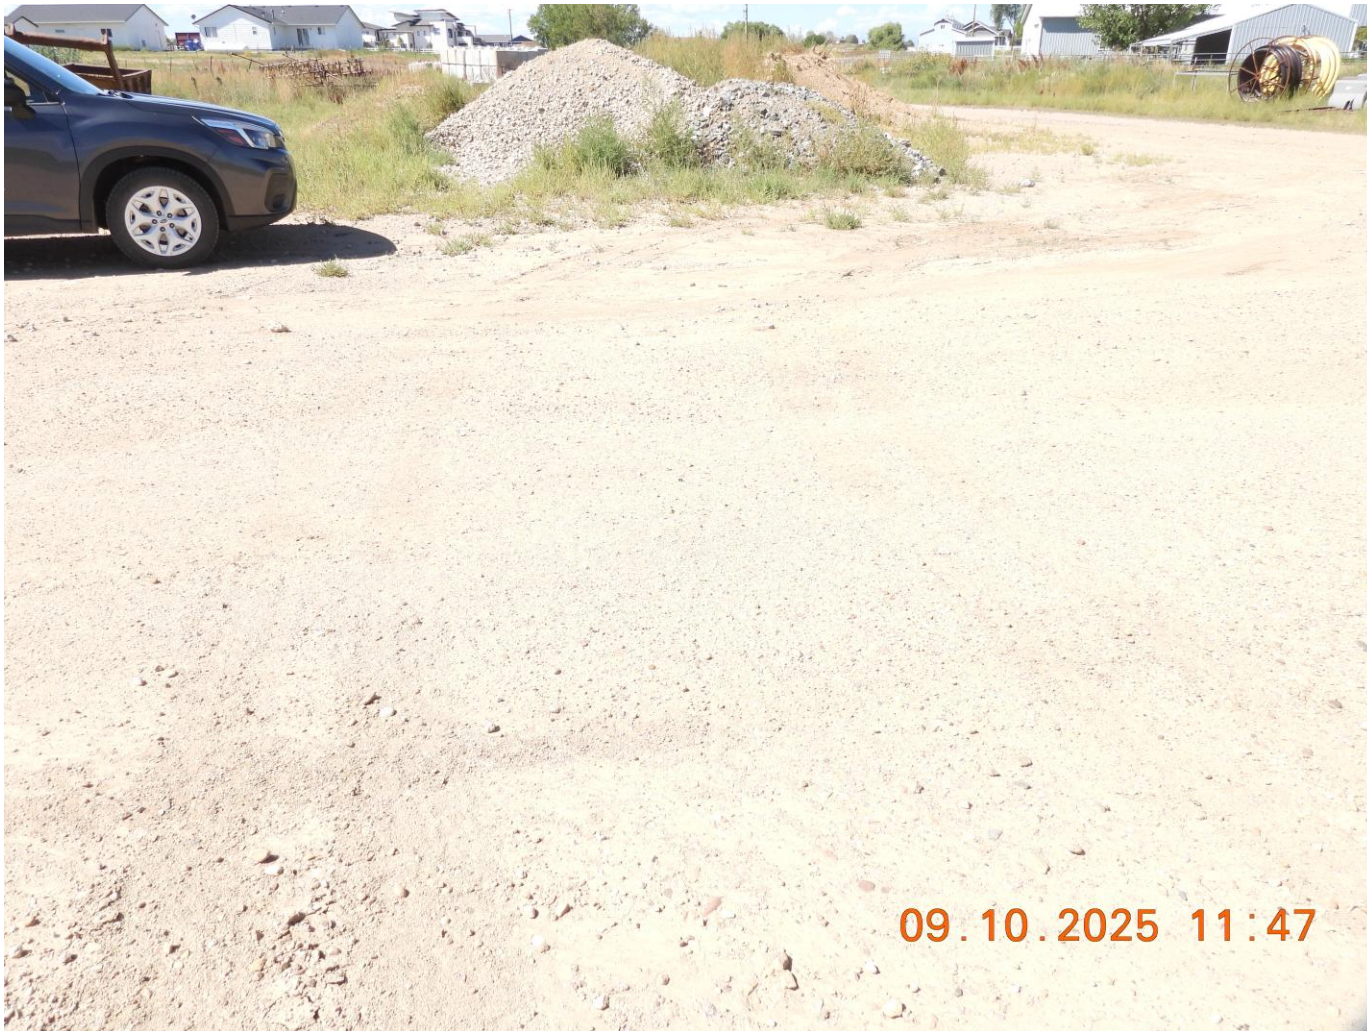
Photo 16. Ground imagery taken from the center of the tank battery location, facing west (displaying the TB).
