Final Reclamation Inspection

Operator: Kerr McGee Oil & Gas Onshore - 47120

Location ID: 318186

Location Name: UPRR 42 Pan Am AD 1

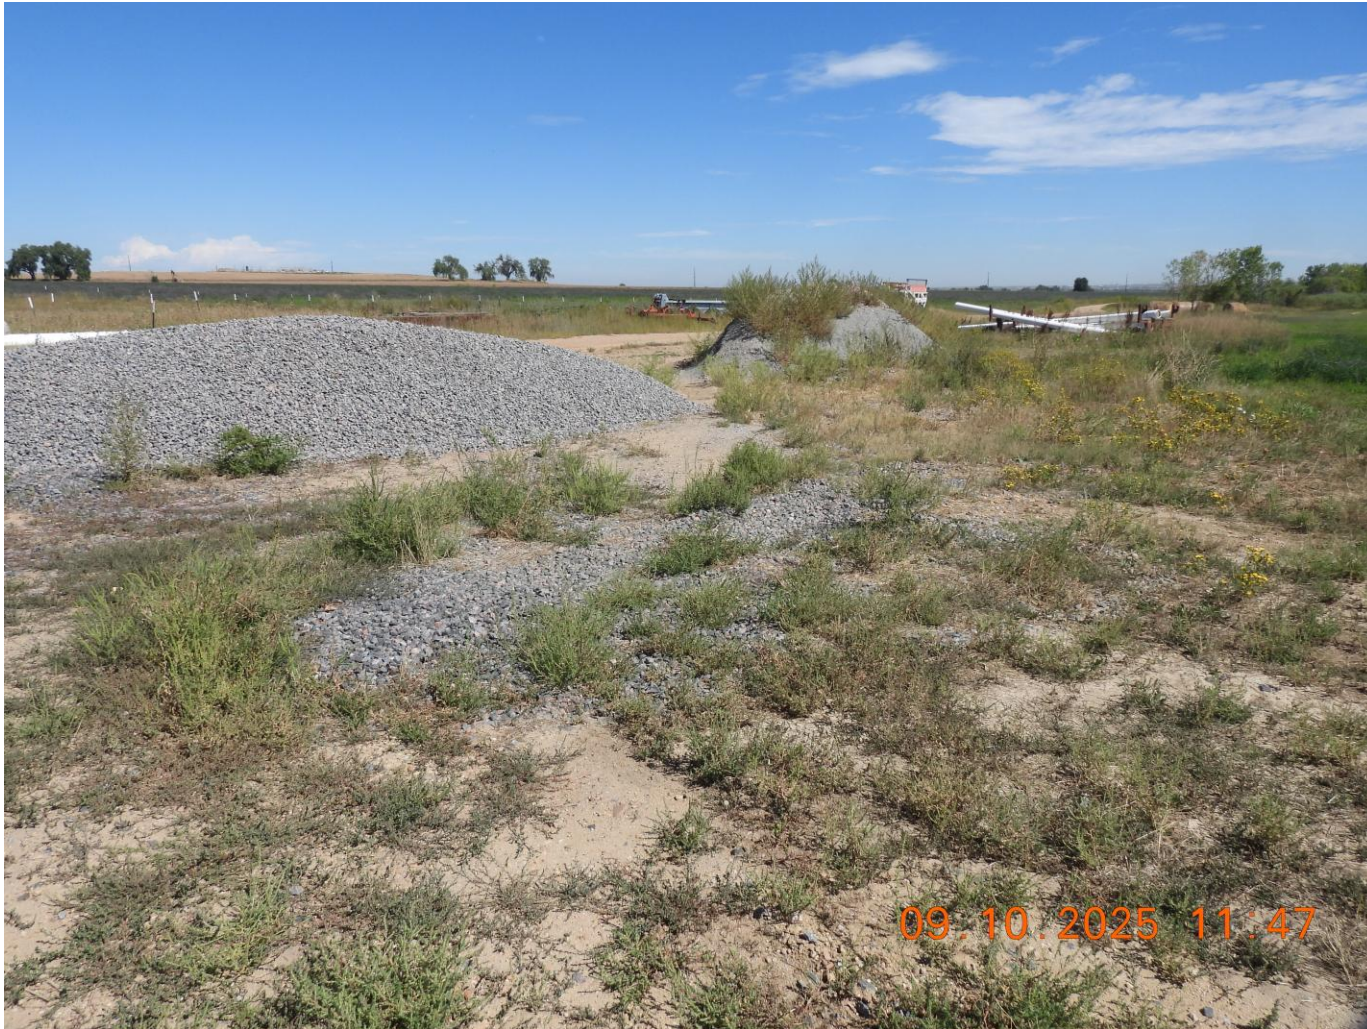
Photo 17. Ground imagery taken from the tank battery location (displaying the gravel pile).

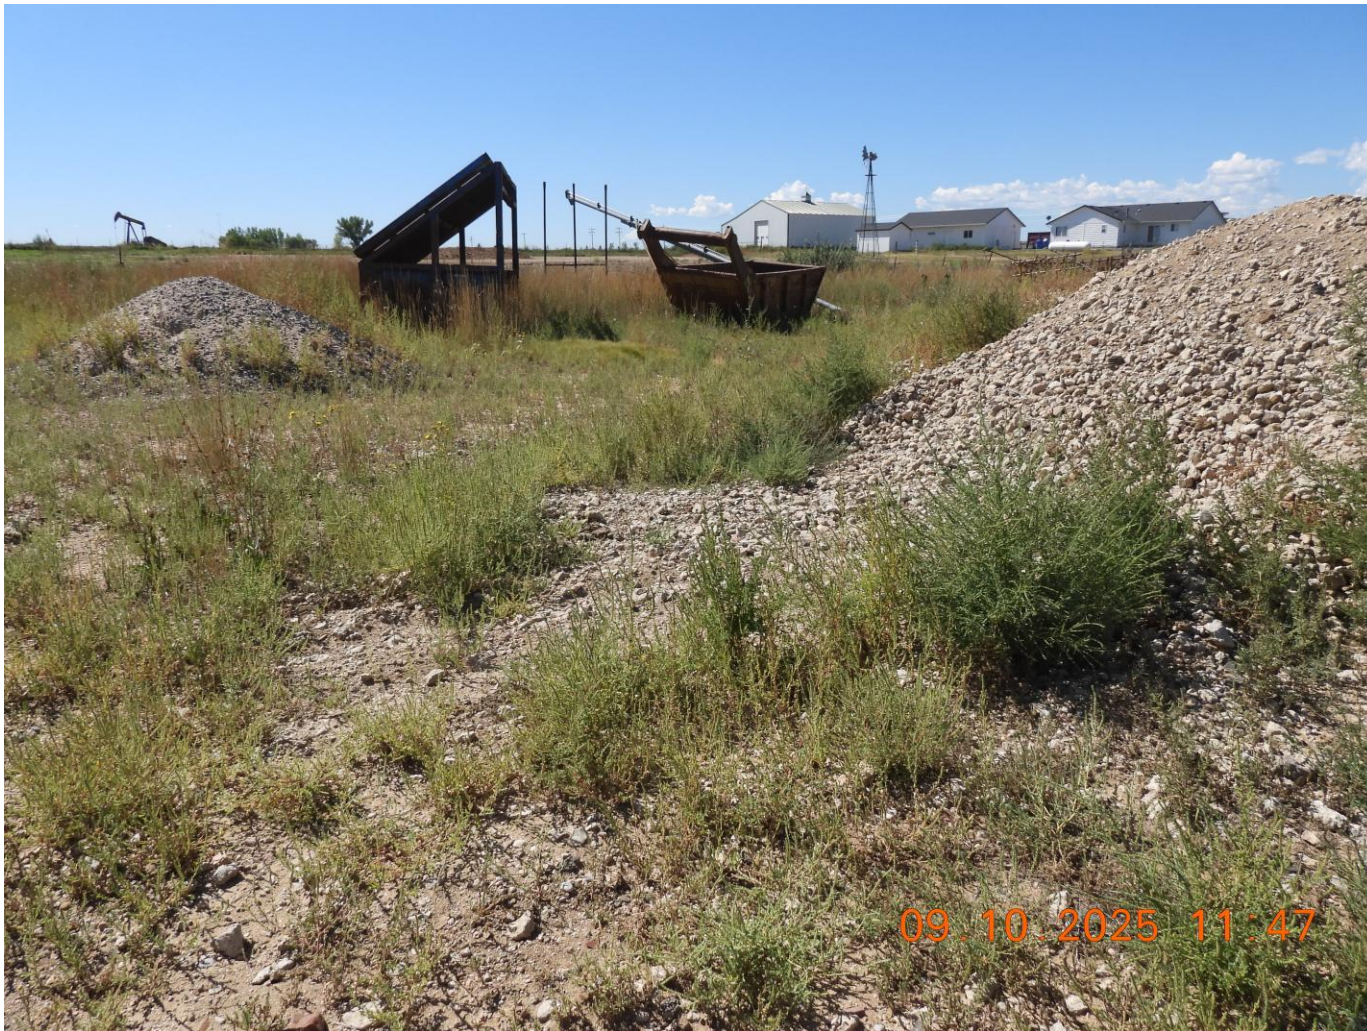
Photo 18. Ground imagery taken west of the tank battery location (displaying the farm equipment).
