# Inspection/Audit Photos

Location Name: QB ENERGY OPERATING LLC Chevron F06 696 Pad

Location #: 335887

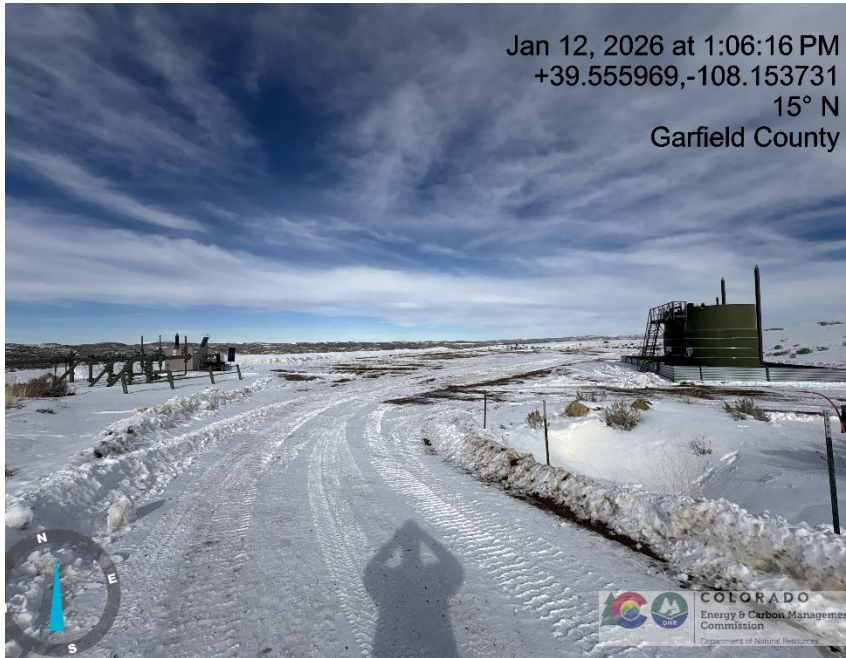
Photo # 87 From entrance to location

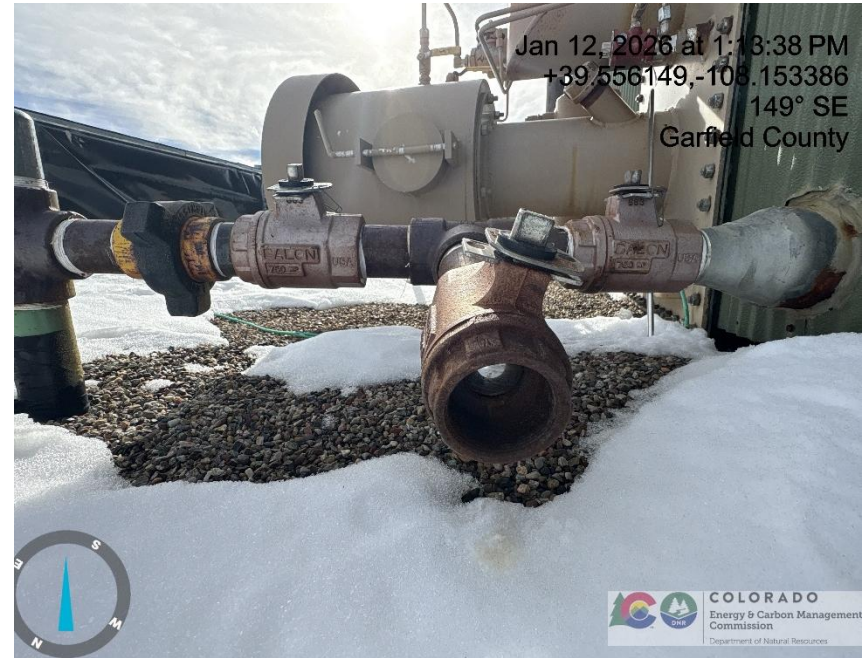
Photo # 94 Open ended load line

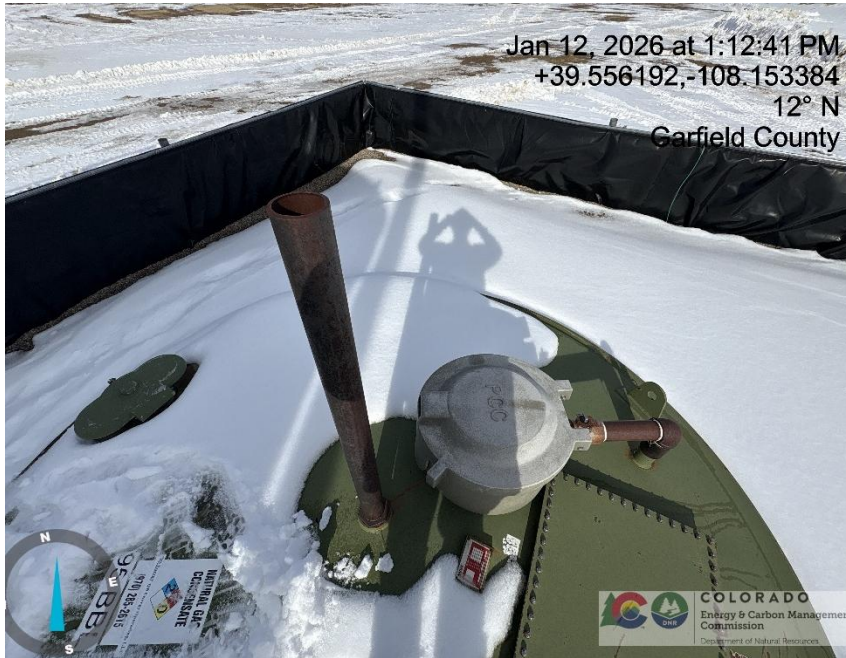
**Photo # 95 Partially buried condensate tank not properly sealed & open to atmosphere (Additionally the open ended piping is also a wildlife hazard)**

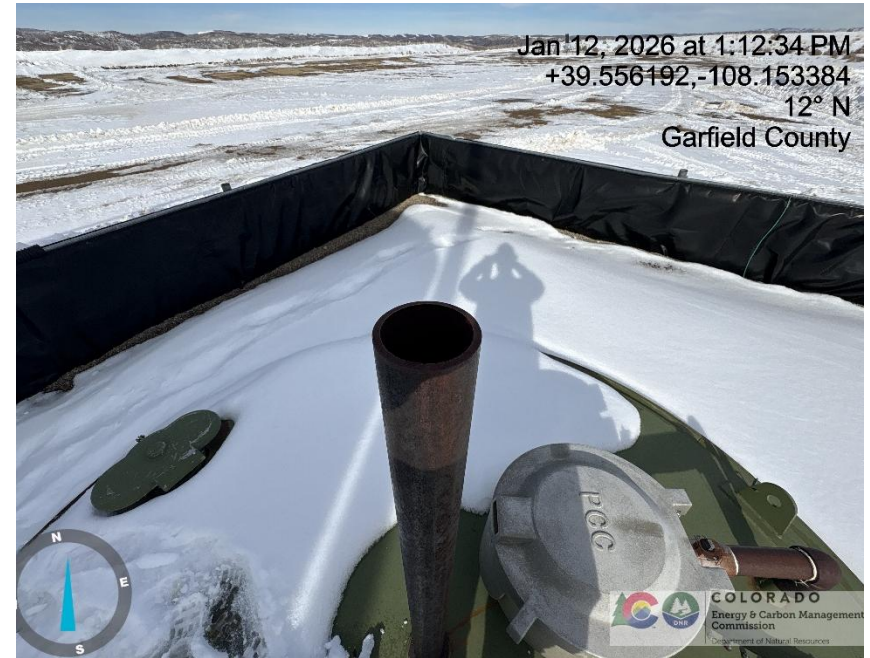
**Photo # 96 Partially buried condensate tank not properly sealed & open to atmosphere (Additionally the open ended piping is also a wildlife hazard)**

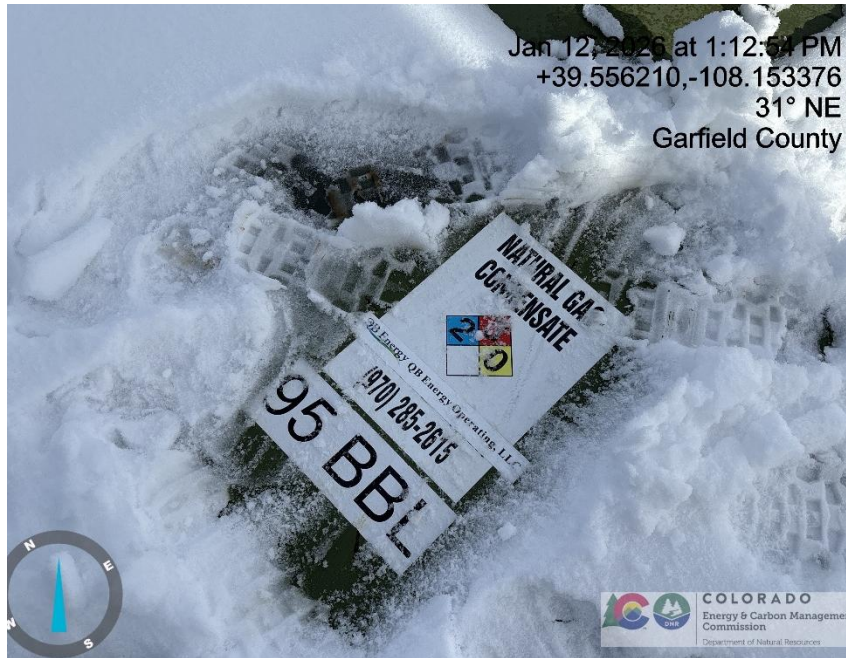
Photo # 97 Labeling on partially buried tank

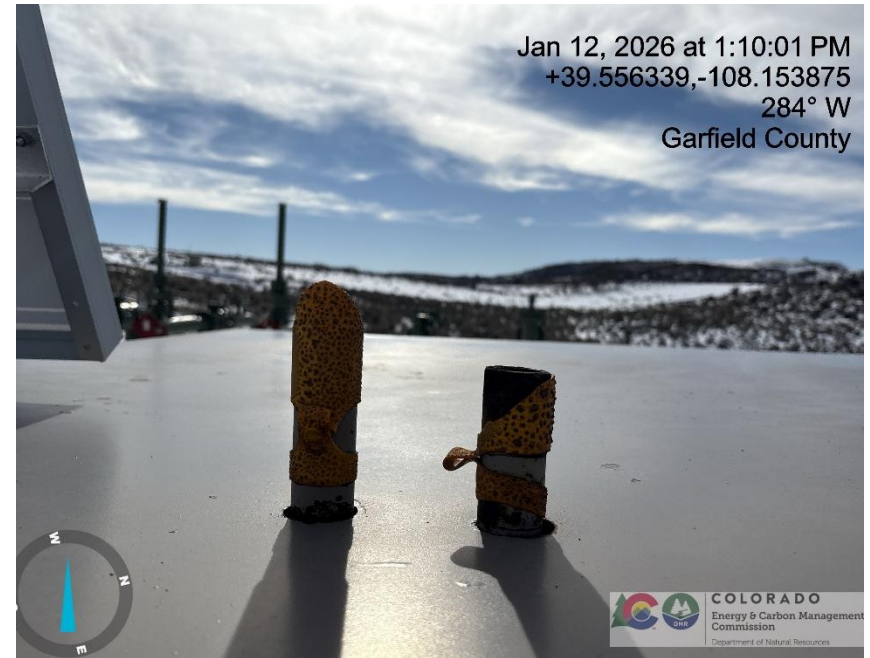
Photo # 98 PRV vent line does not comply with CECMC pressure safety device rules

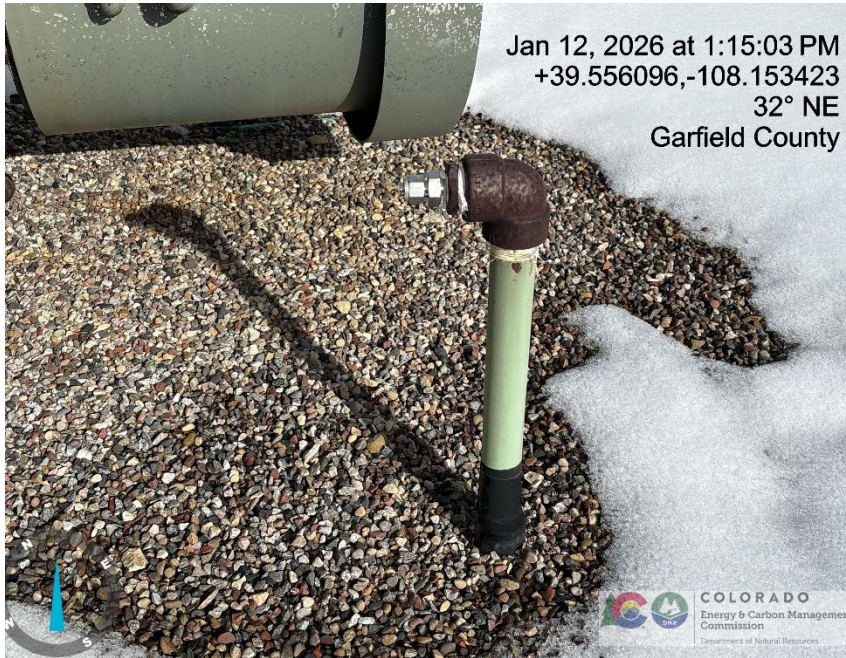
**Photo # 99 Unused flowline lacks lockout tagout (OOSLAT)  
Line is located in secondary containment near tank heater**

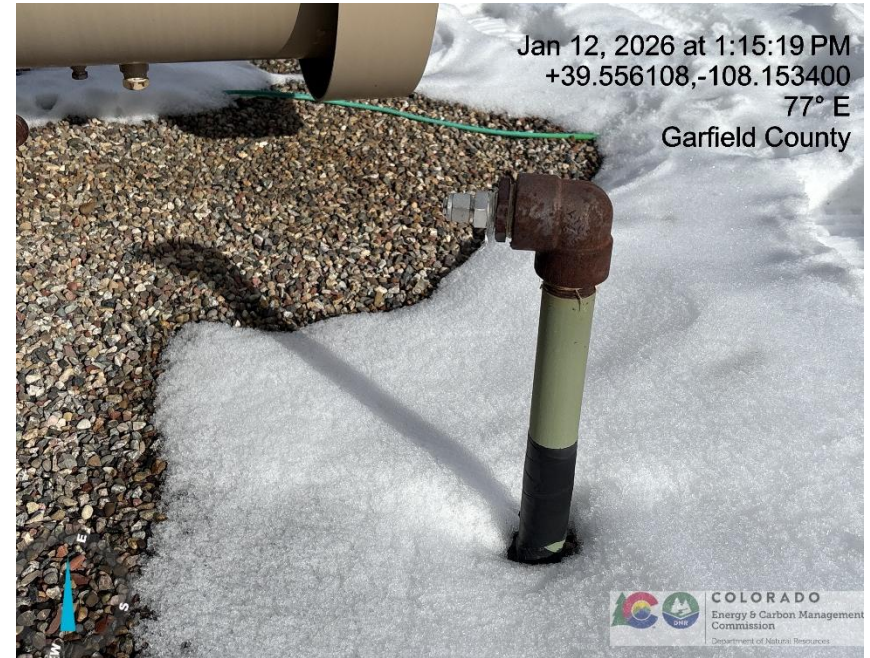
**Photo # 100 Unused flowline lacks lockout tagout (OOSLAT)  
Line is located in secondary containment near tank heater**

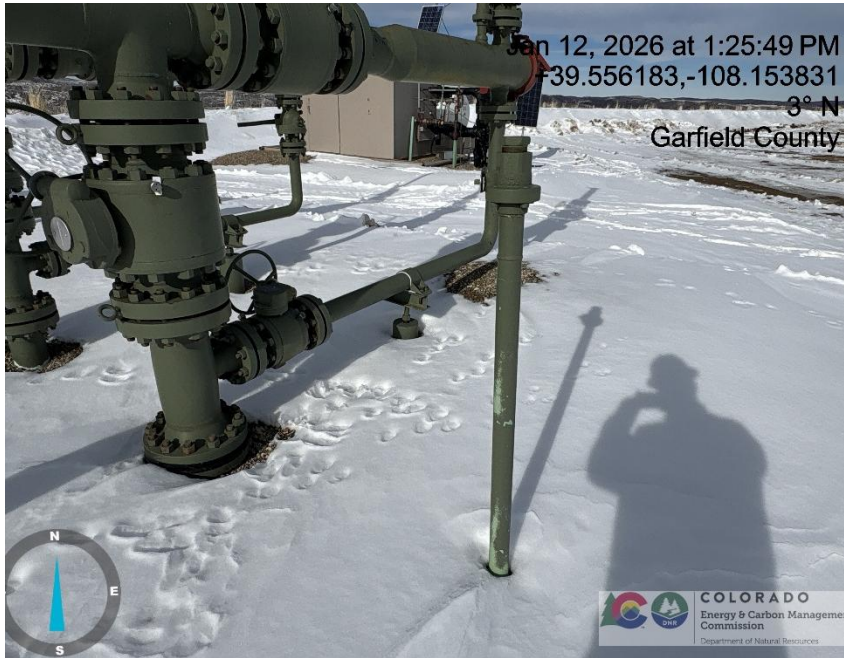
Photo # 101 Unused flowline lacks lockout tagout (OOSLAT)

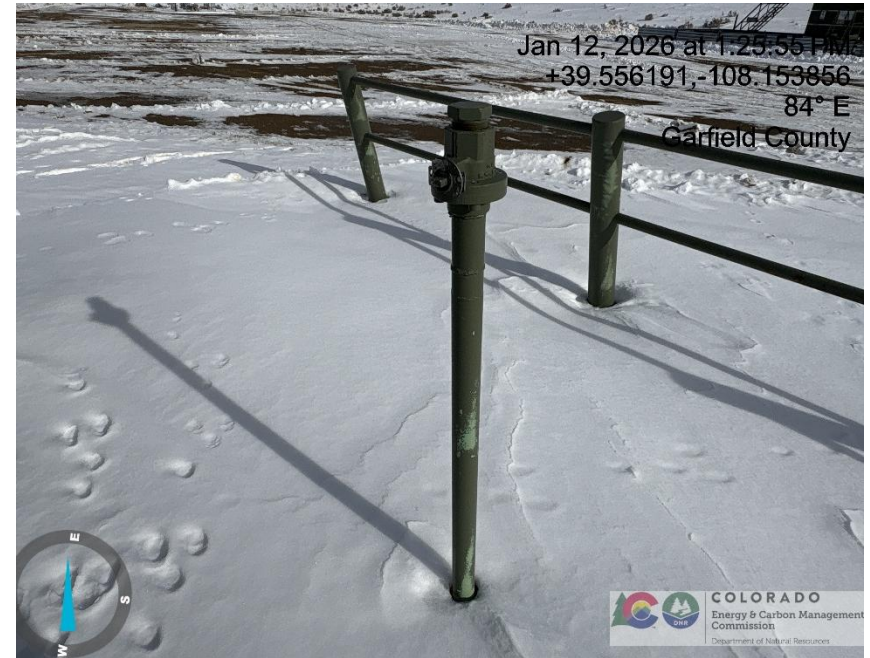
Photo # 102 Unused flowline lacks lockout tagout (OOSLAT)  
Line is located near pig station
