# Inspection Photos

API: 073-06735

Operator: MURFIN DRILLING COMPANY

Inspection Date: 1/14/2026

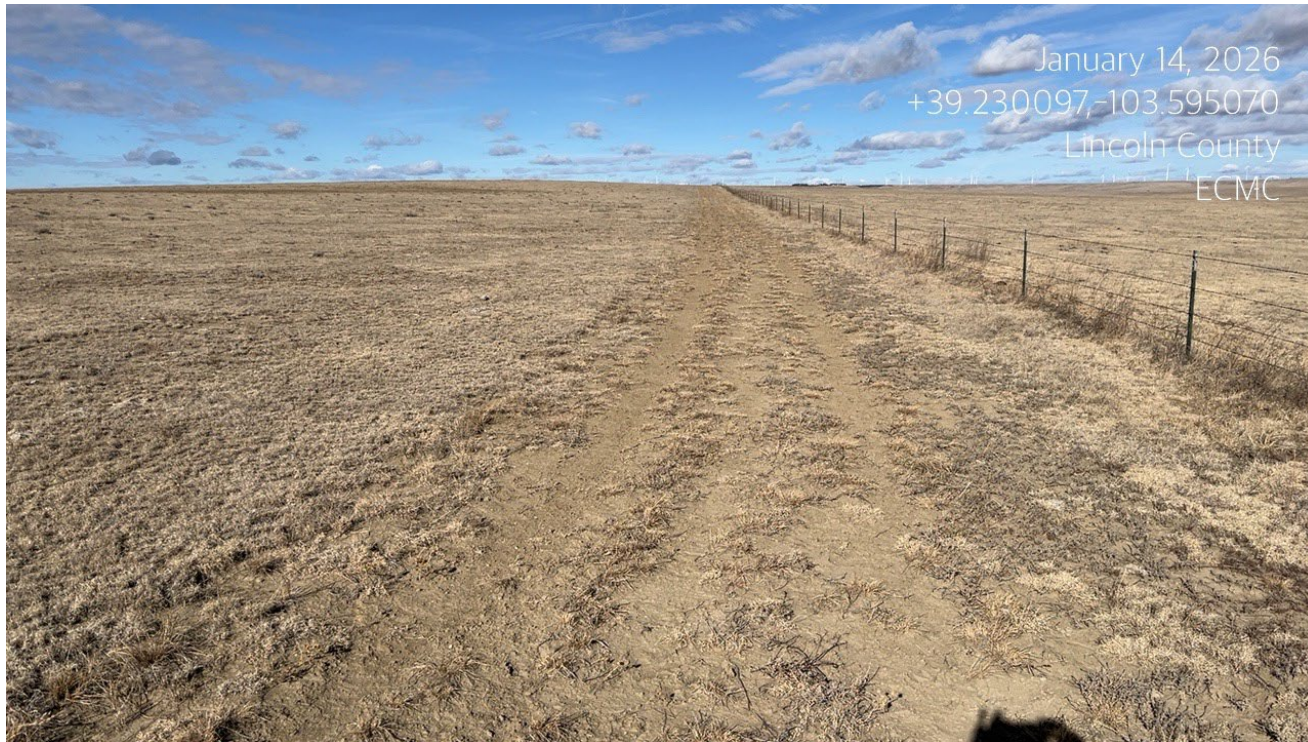
**Photo 1.** Facing north along the former access road. A two track road is still visible.

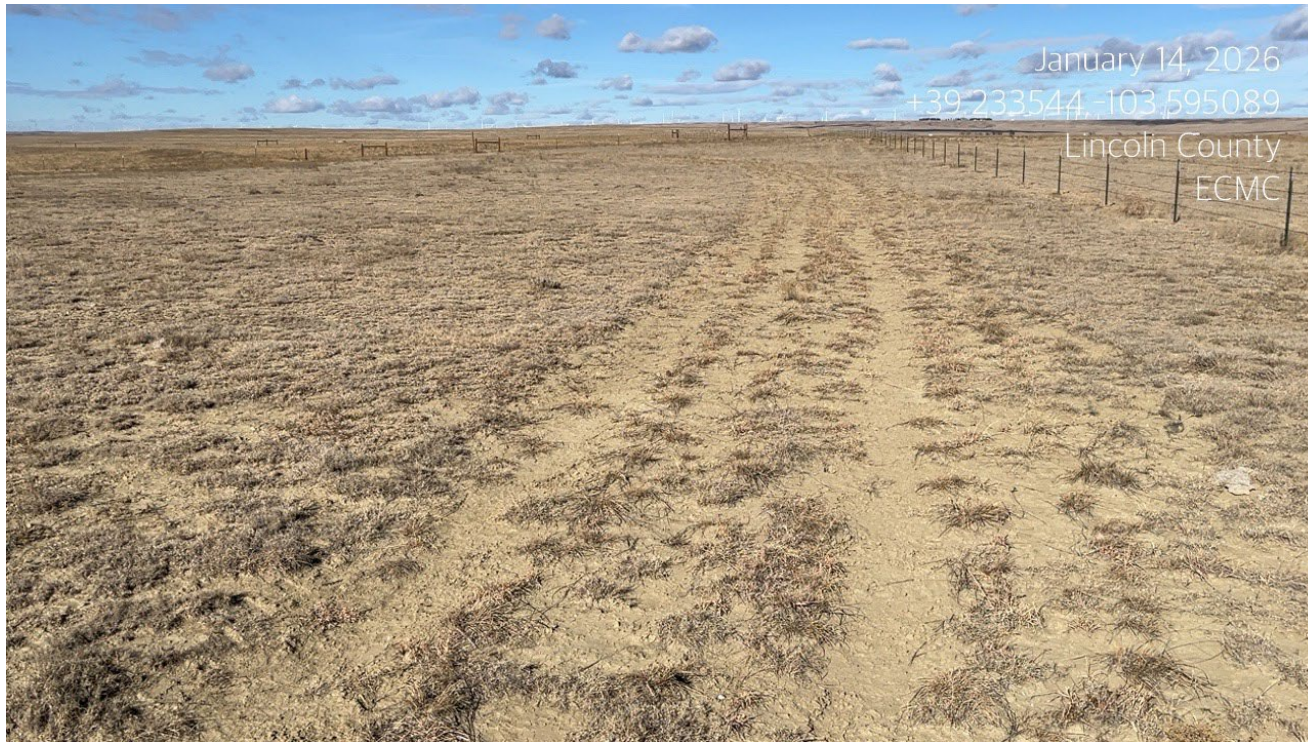
**Photo 2.** Facing north along the former access road. A two track road is still visible.

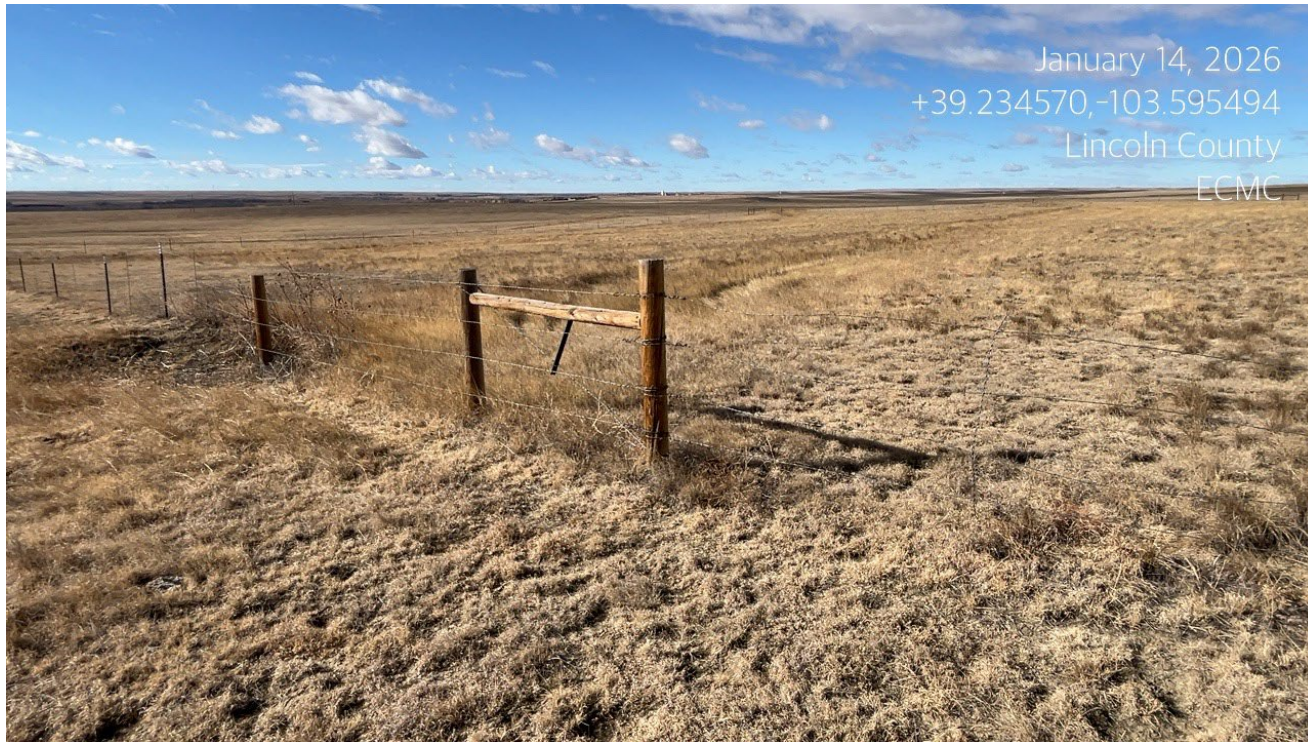
**Photo 3.** Facing northwest along the access road. The fence remains around the location.

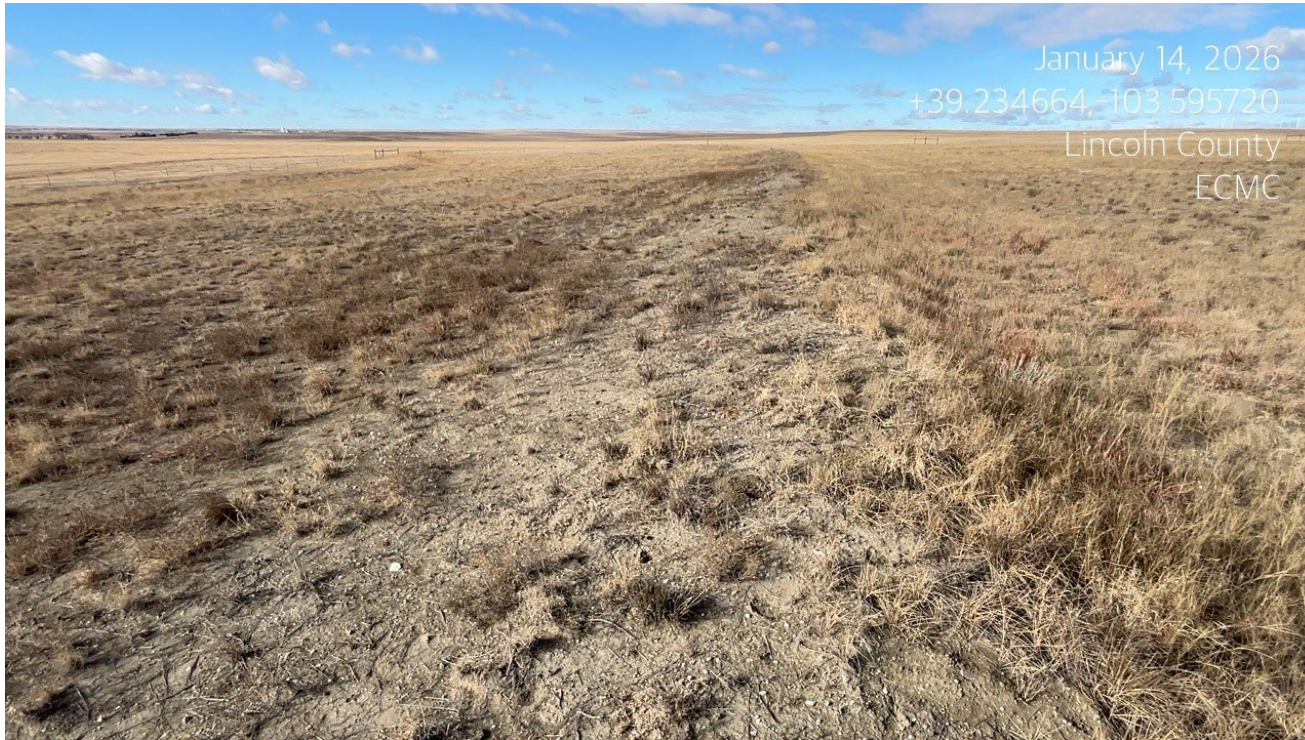
**Photo 4.** Facing northwest at the location. This area along the berm has not revegetated.

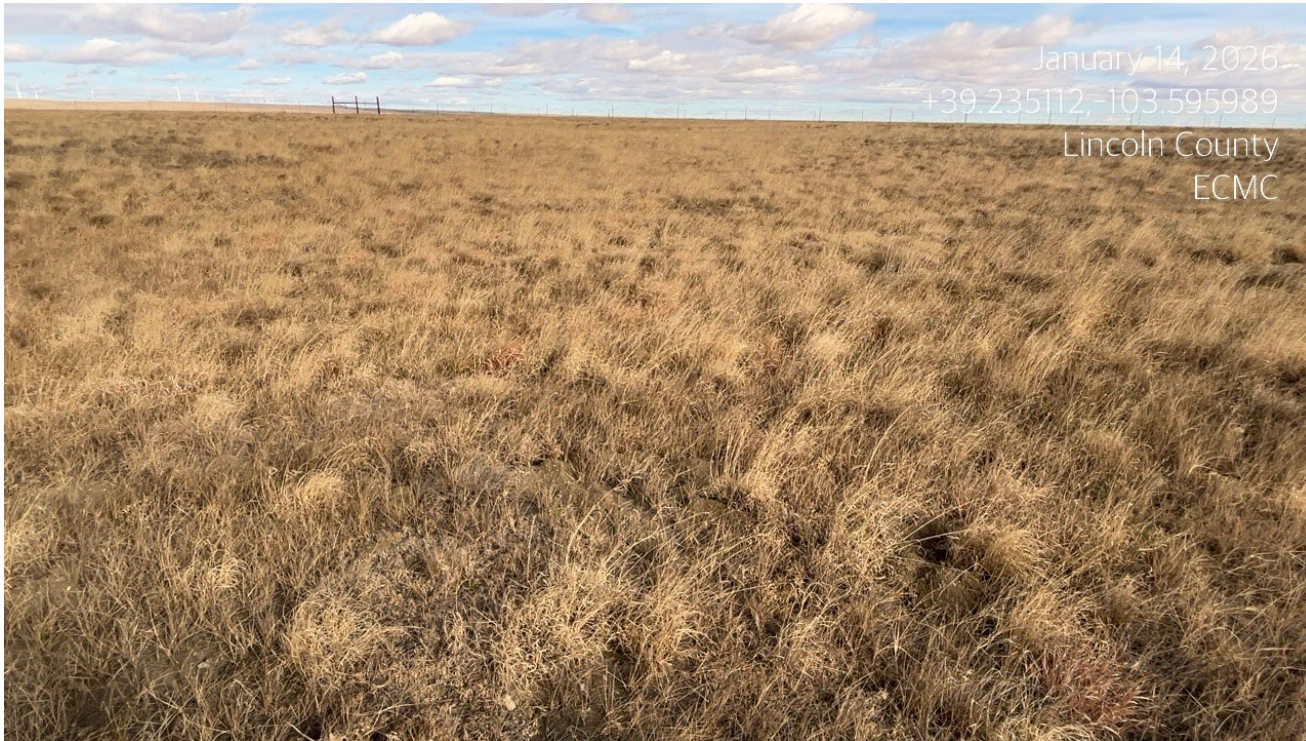
**Photo 5.** Facing east at the location. The perennial vegetation along the eastern side appears to be well established.

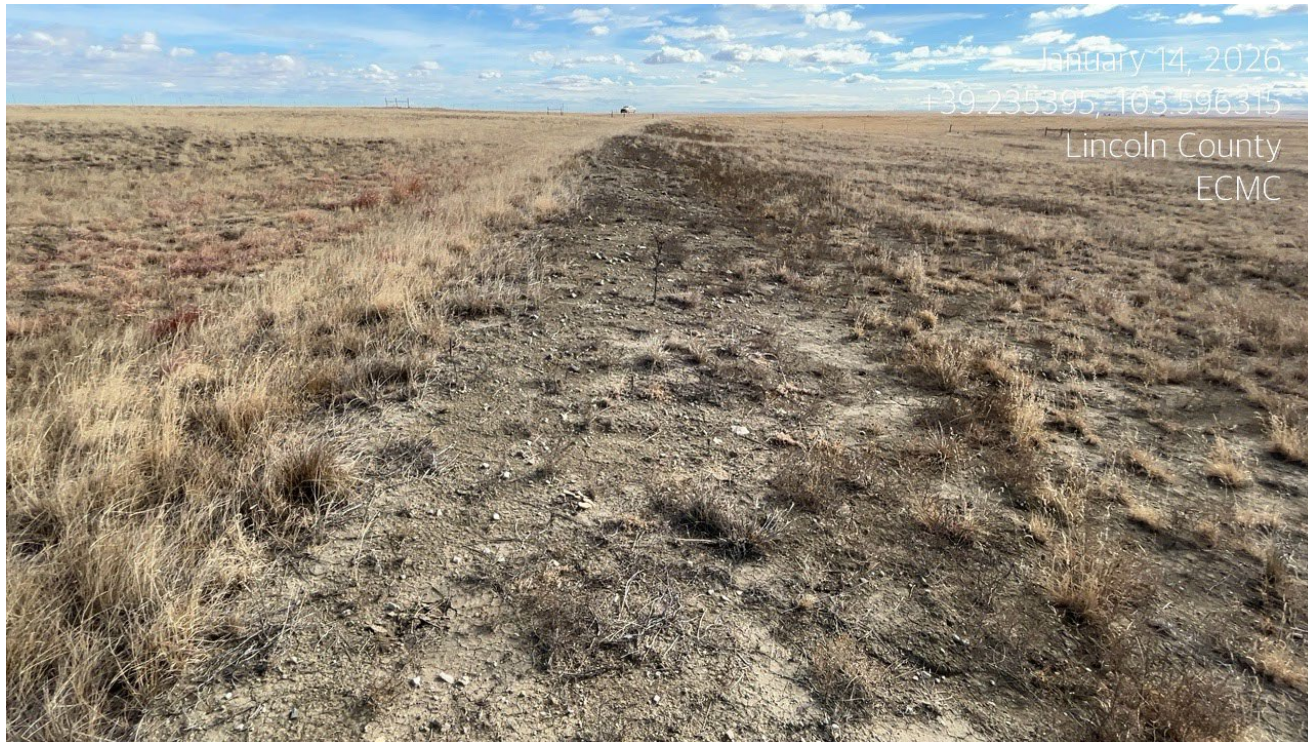
**Photo 6.** Facing southeast at the location. The area along the berm has not revegetated.

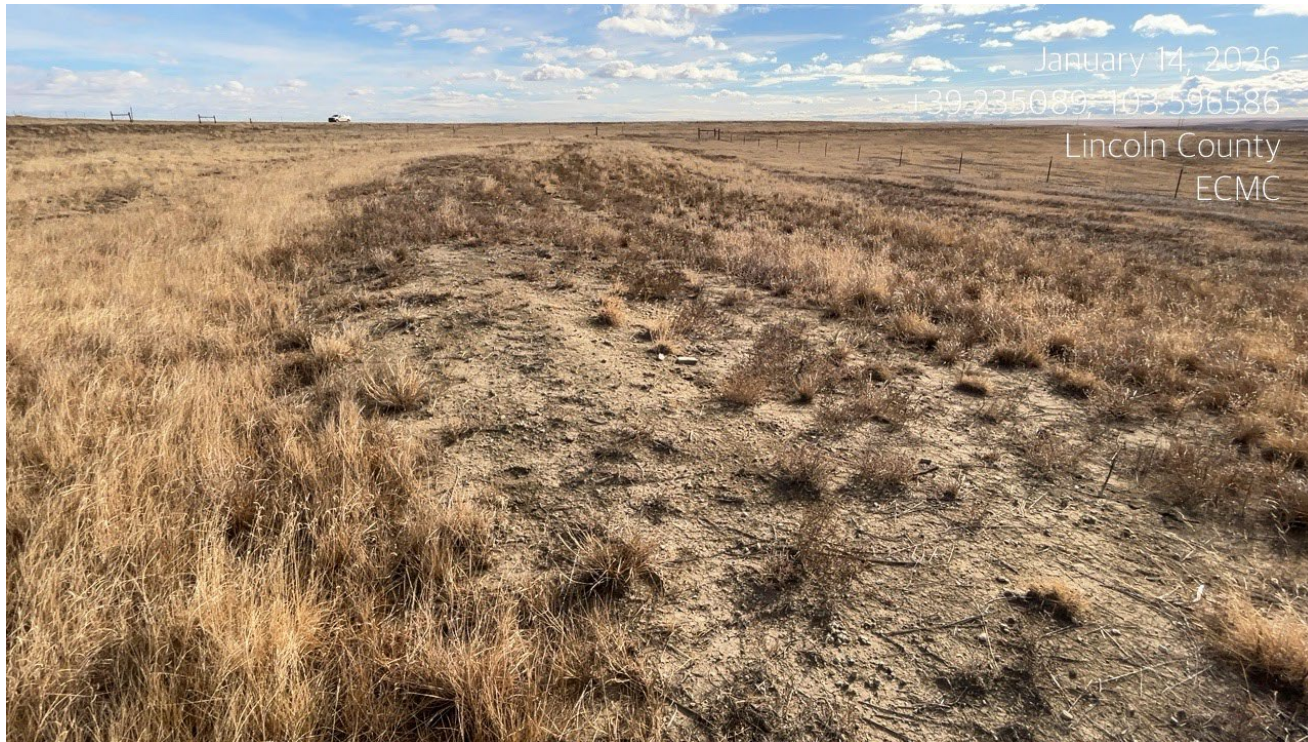
**Photo 7.** Facing southeast at the west side of the location. This area along the berm has not revegetated.

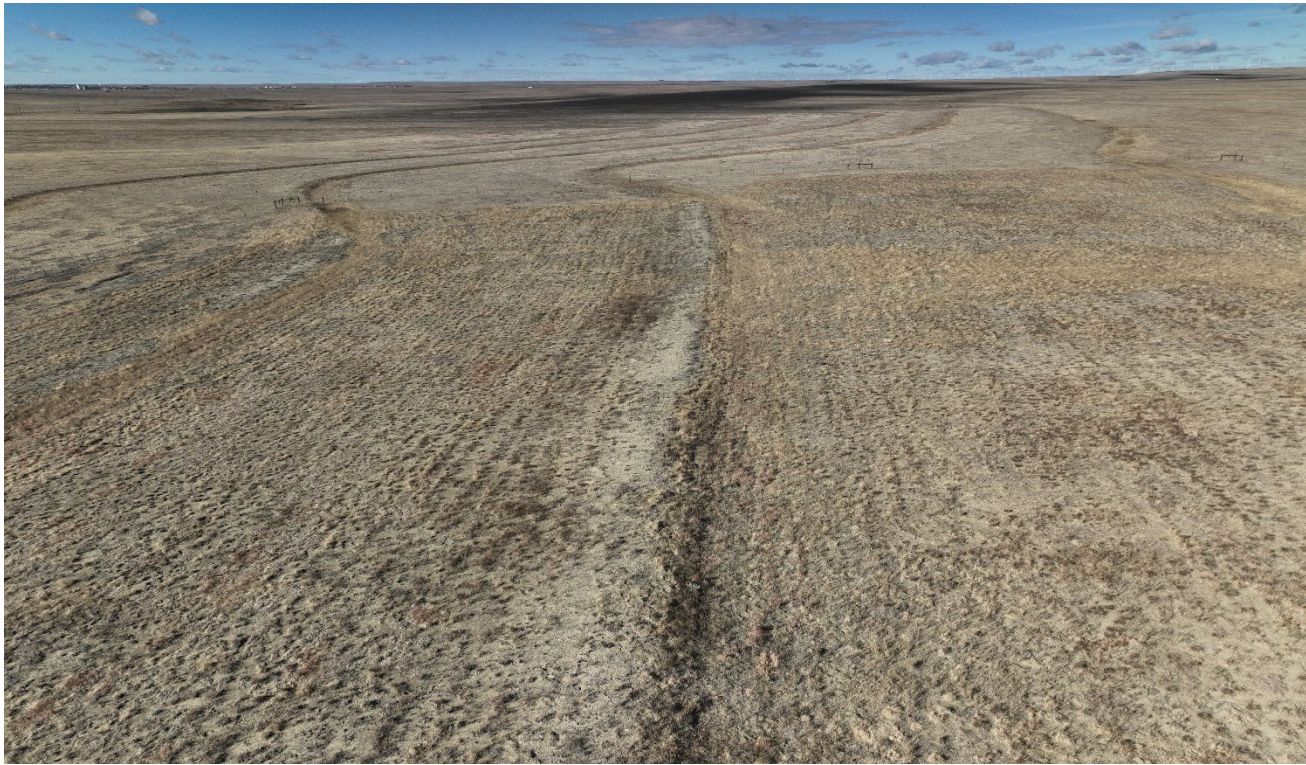
**Photo 8.** Drone aerial photo facing northwest overlooking the location.

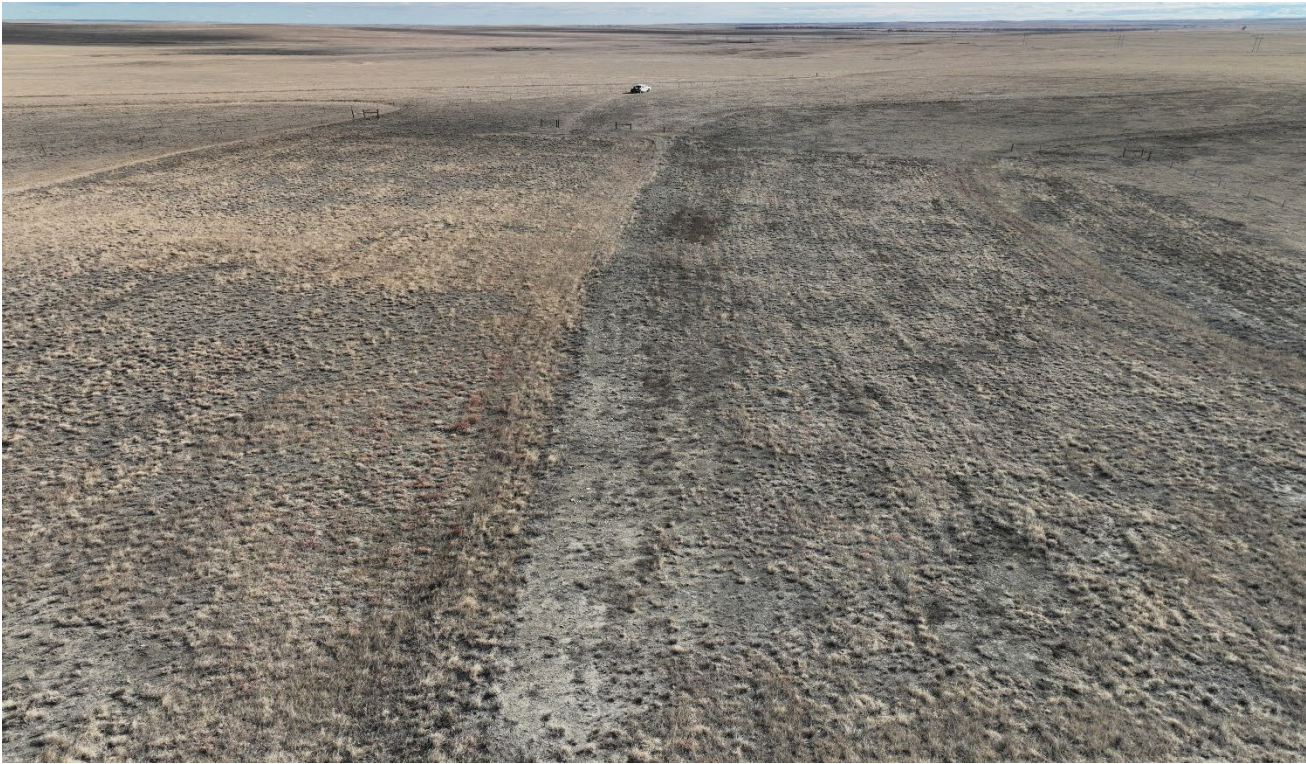
**Photo 9.** Drone aerial photo facing southwest overlooking the location.

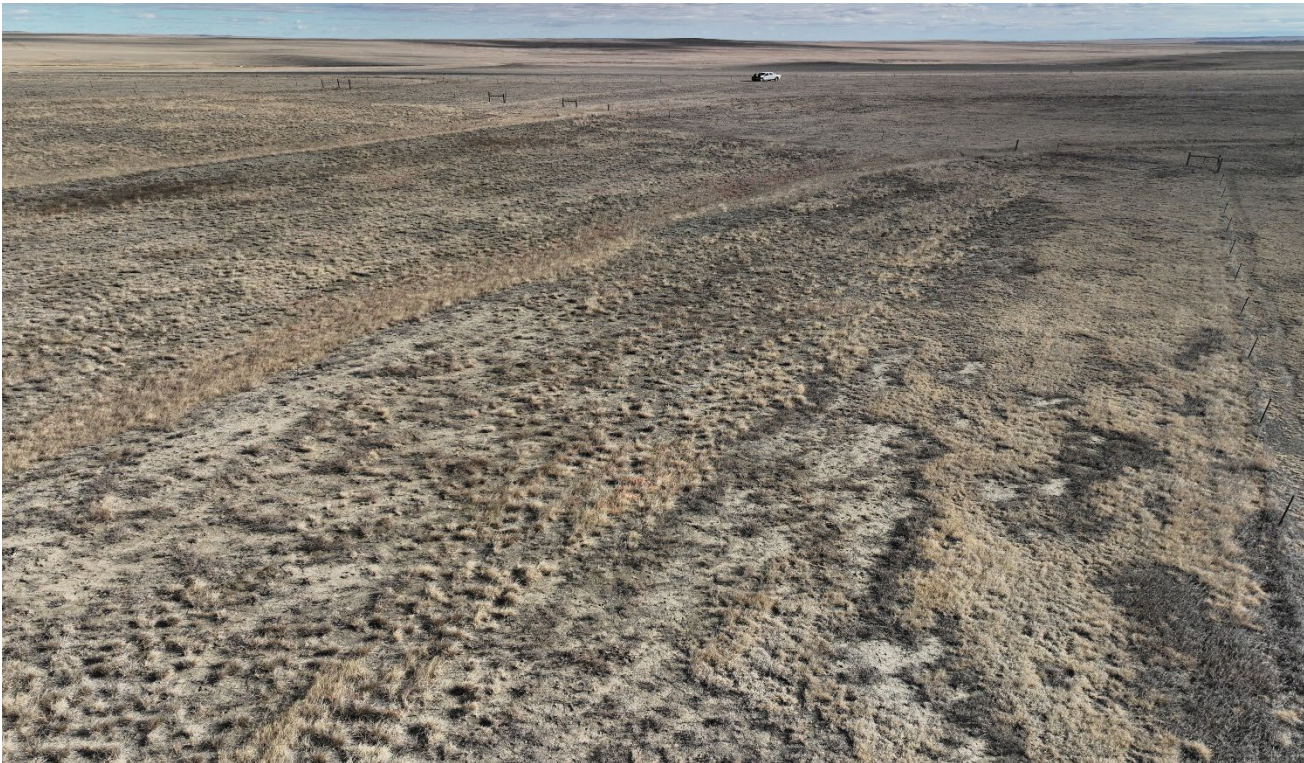
**Photo 10.** West side of the location facing southeast. There are areas along the western side that have not revegetated to reference area levels.

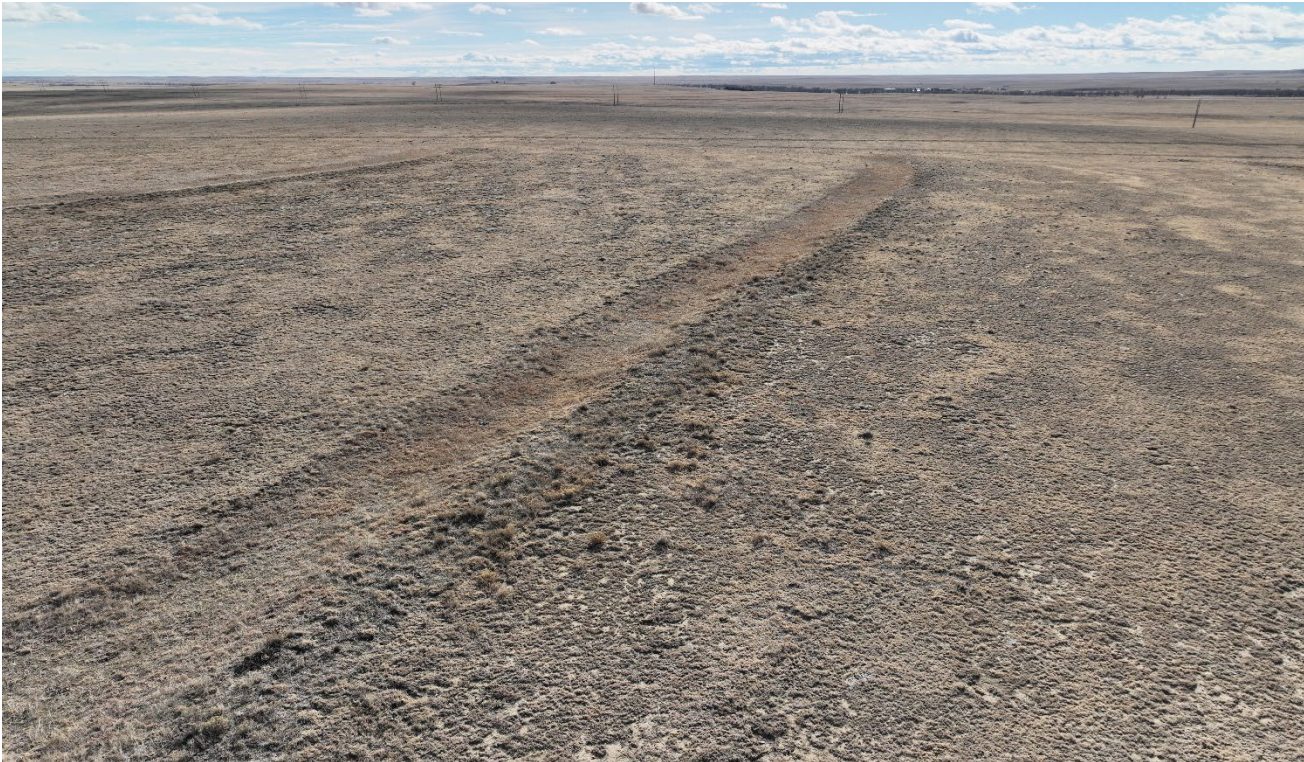
**Photo 11.** Drone aerial photo facing northwest toward the surrounding reference area.
