# Site Specific Final Reclamation Completion Notice – Cropland Drone Imagery

## Permit Closure Report – Cropland

**Location Name:** OLSON-64N67W/29SESW

11/5/2025

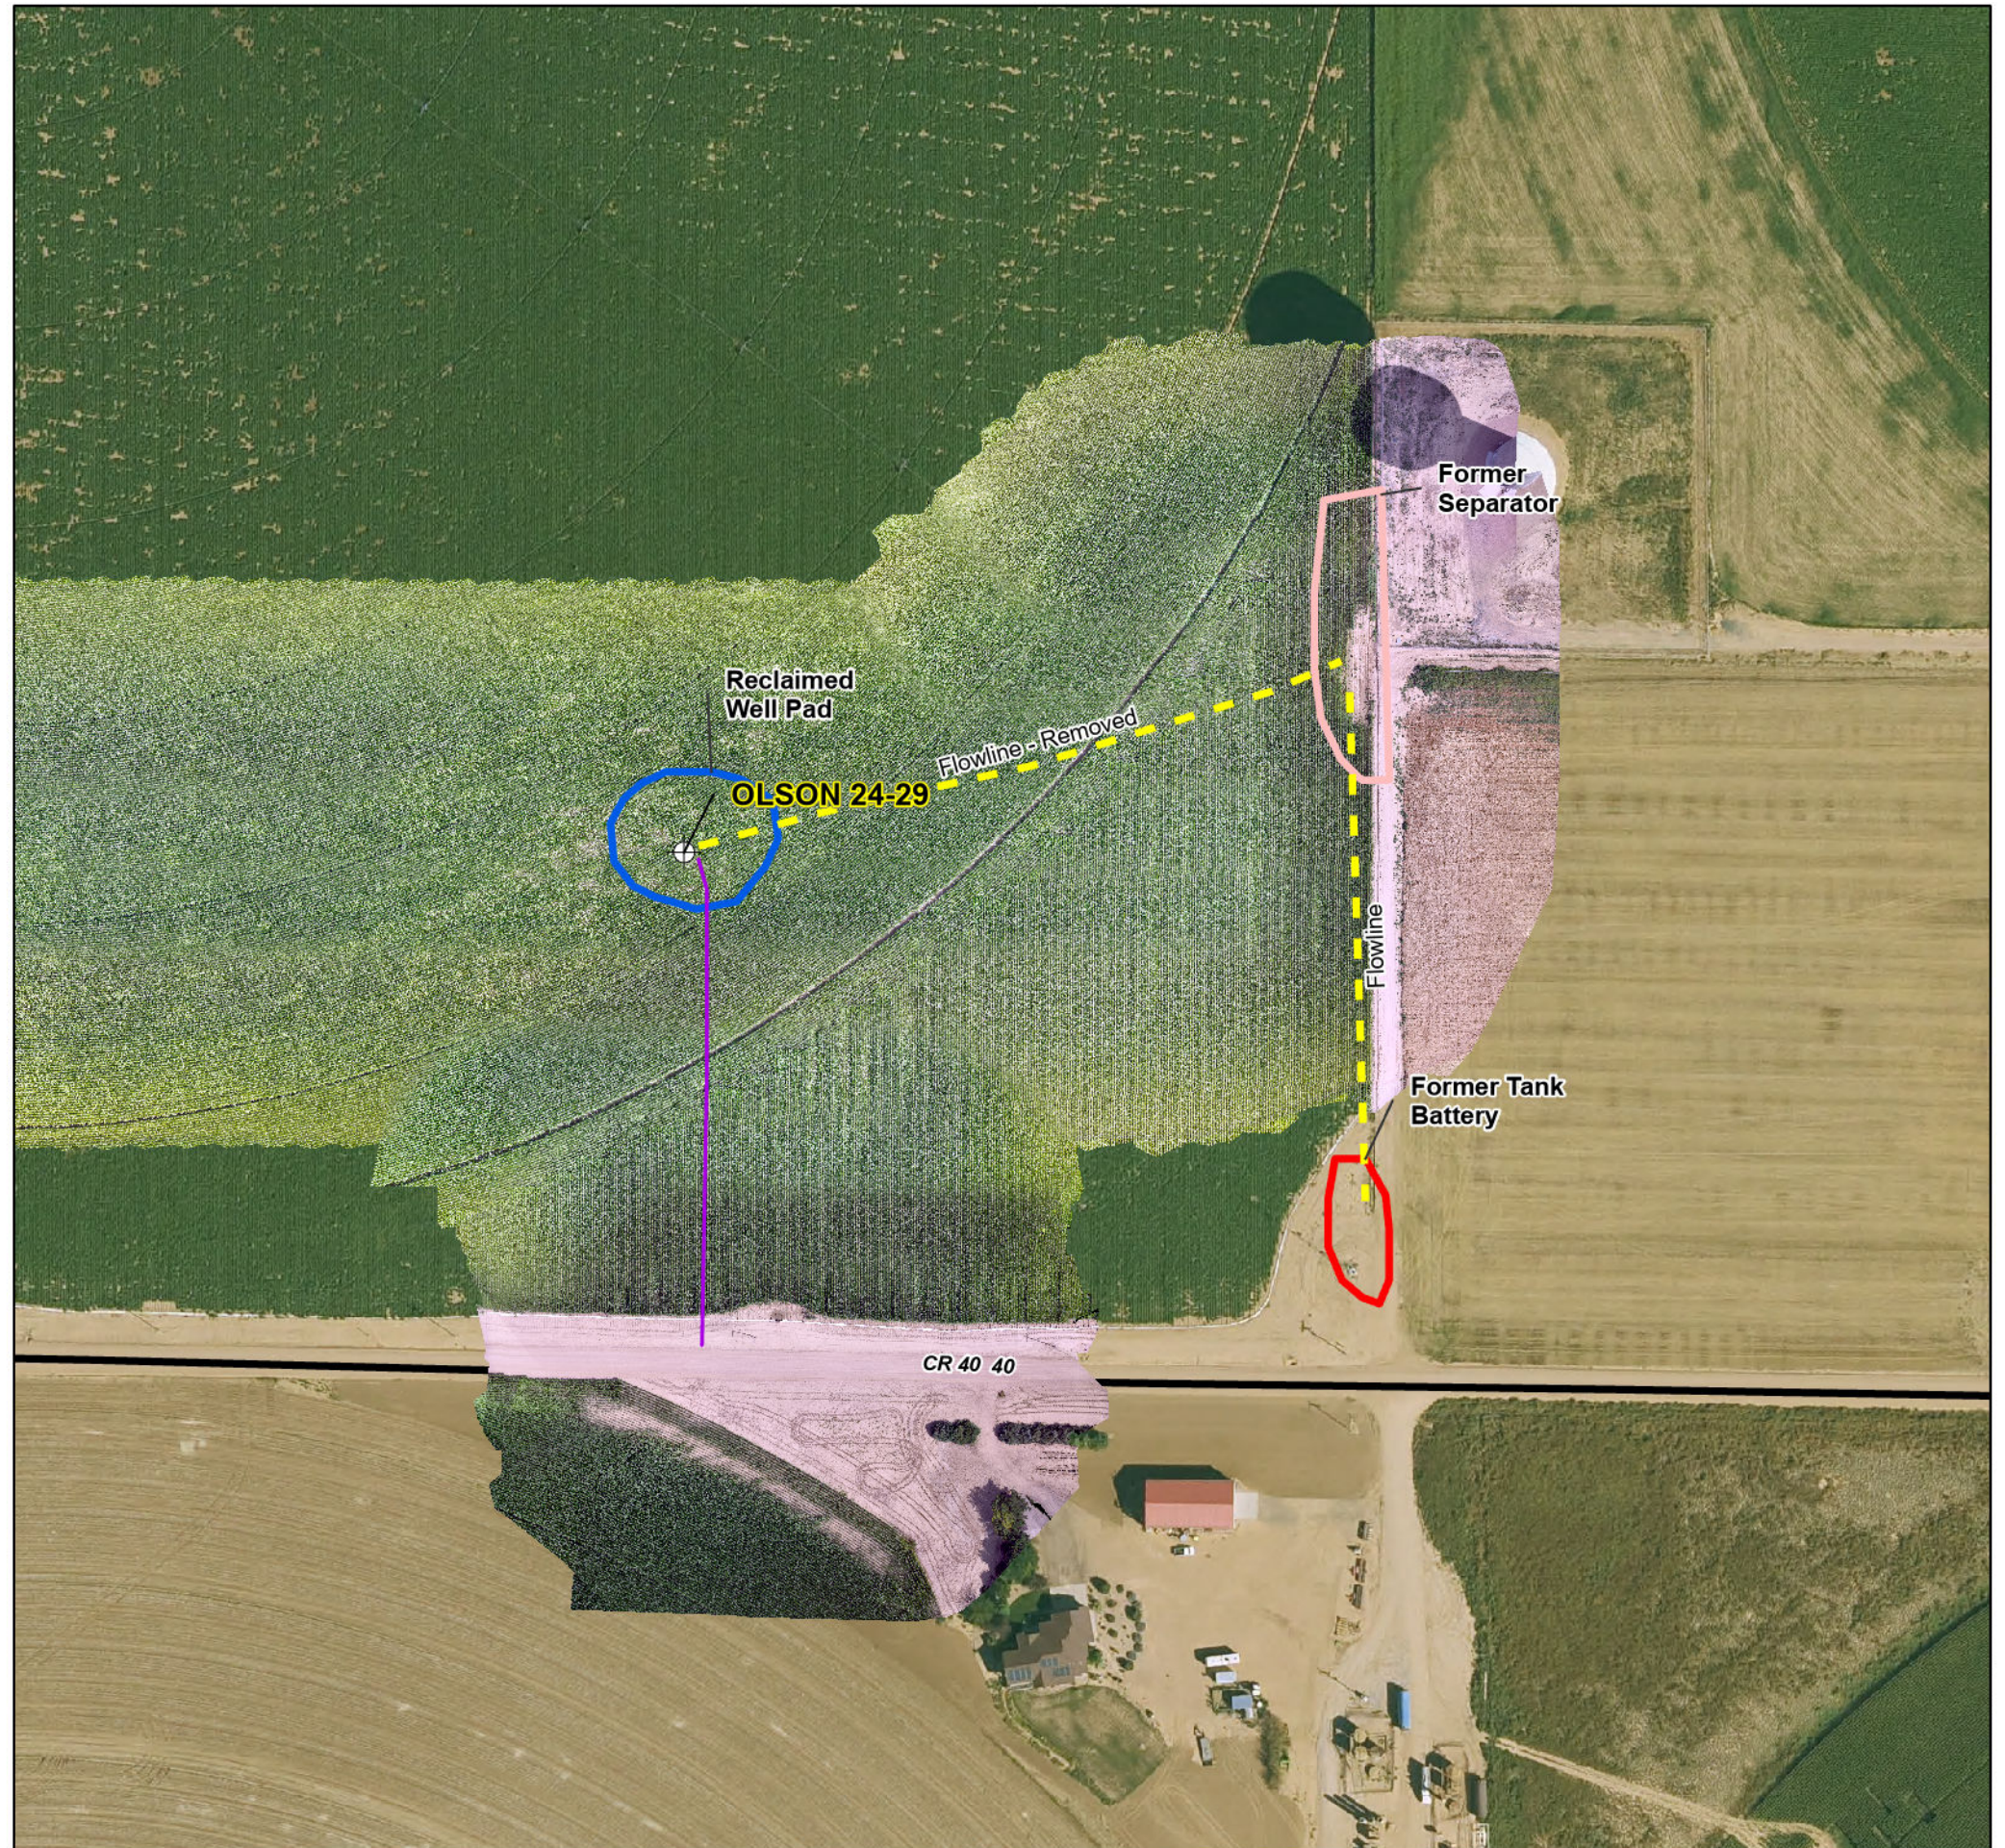
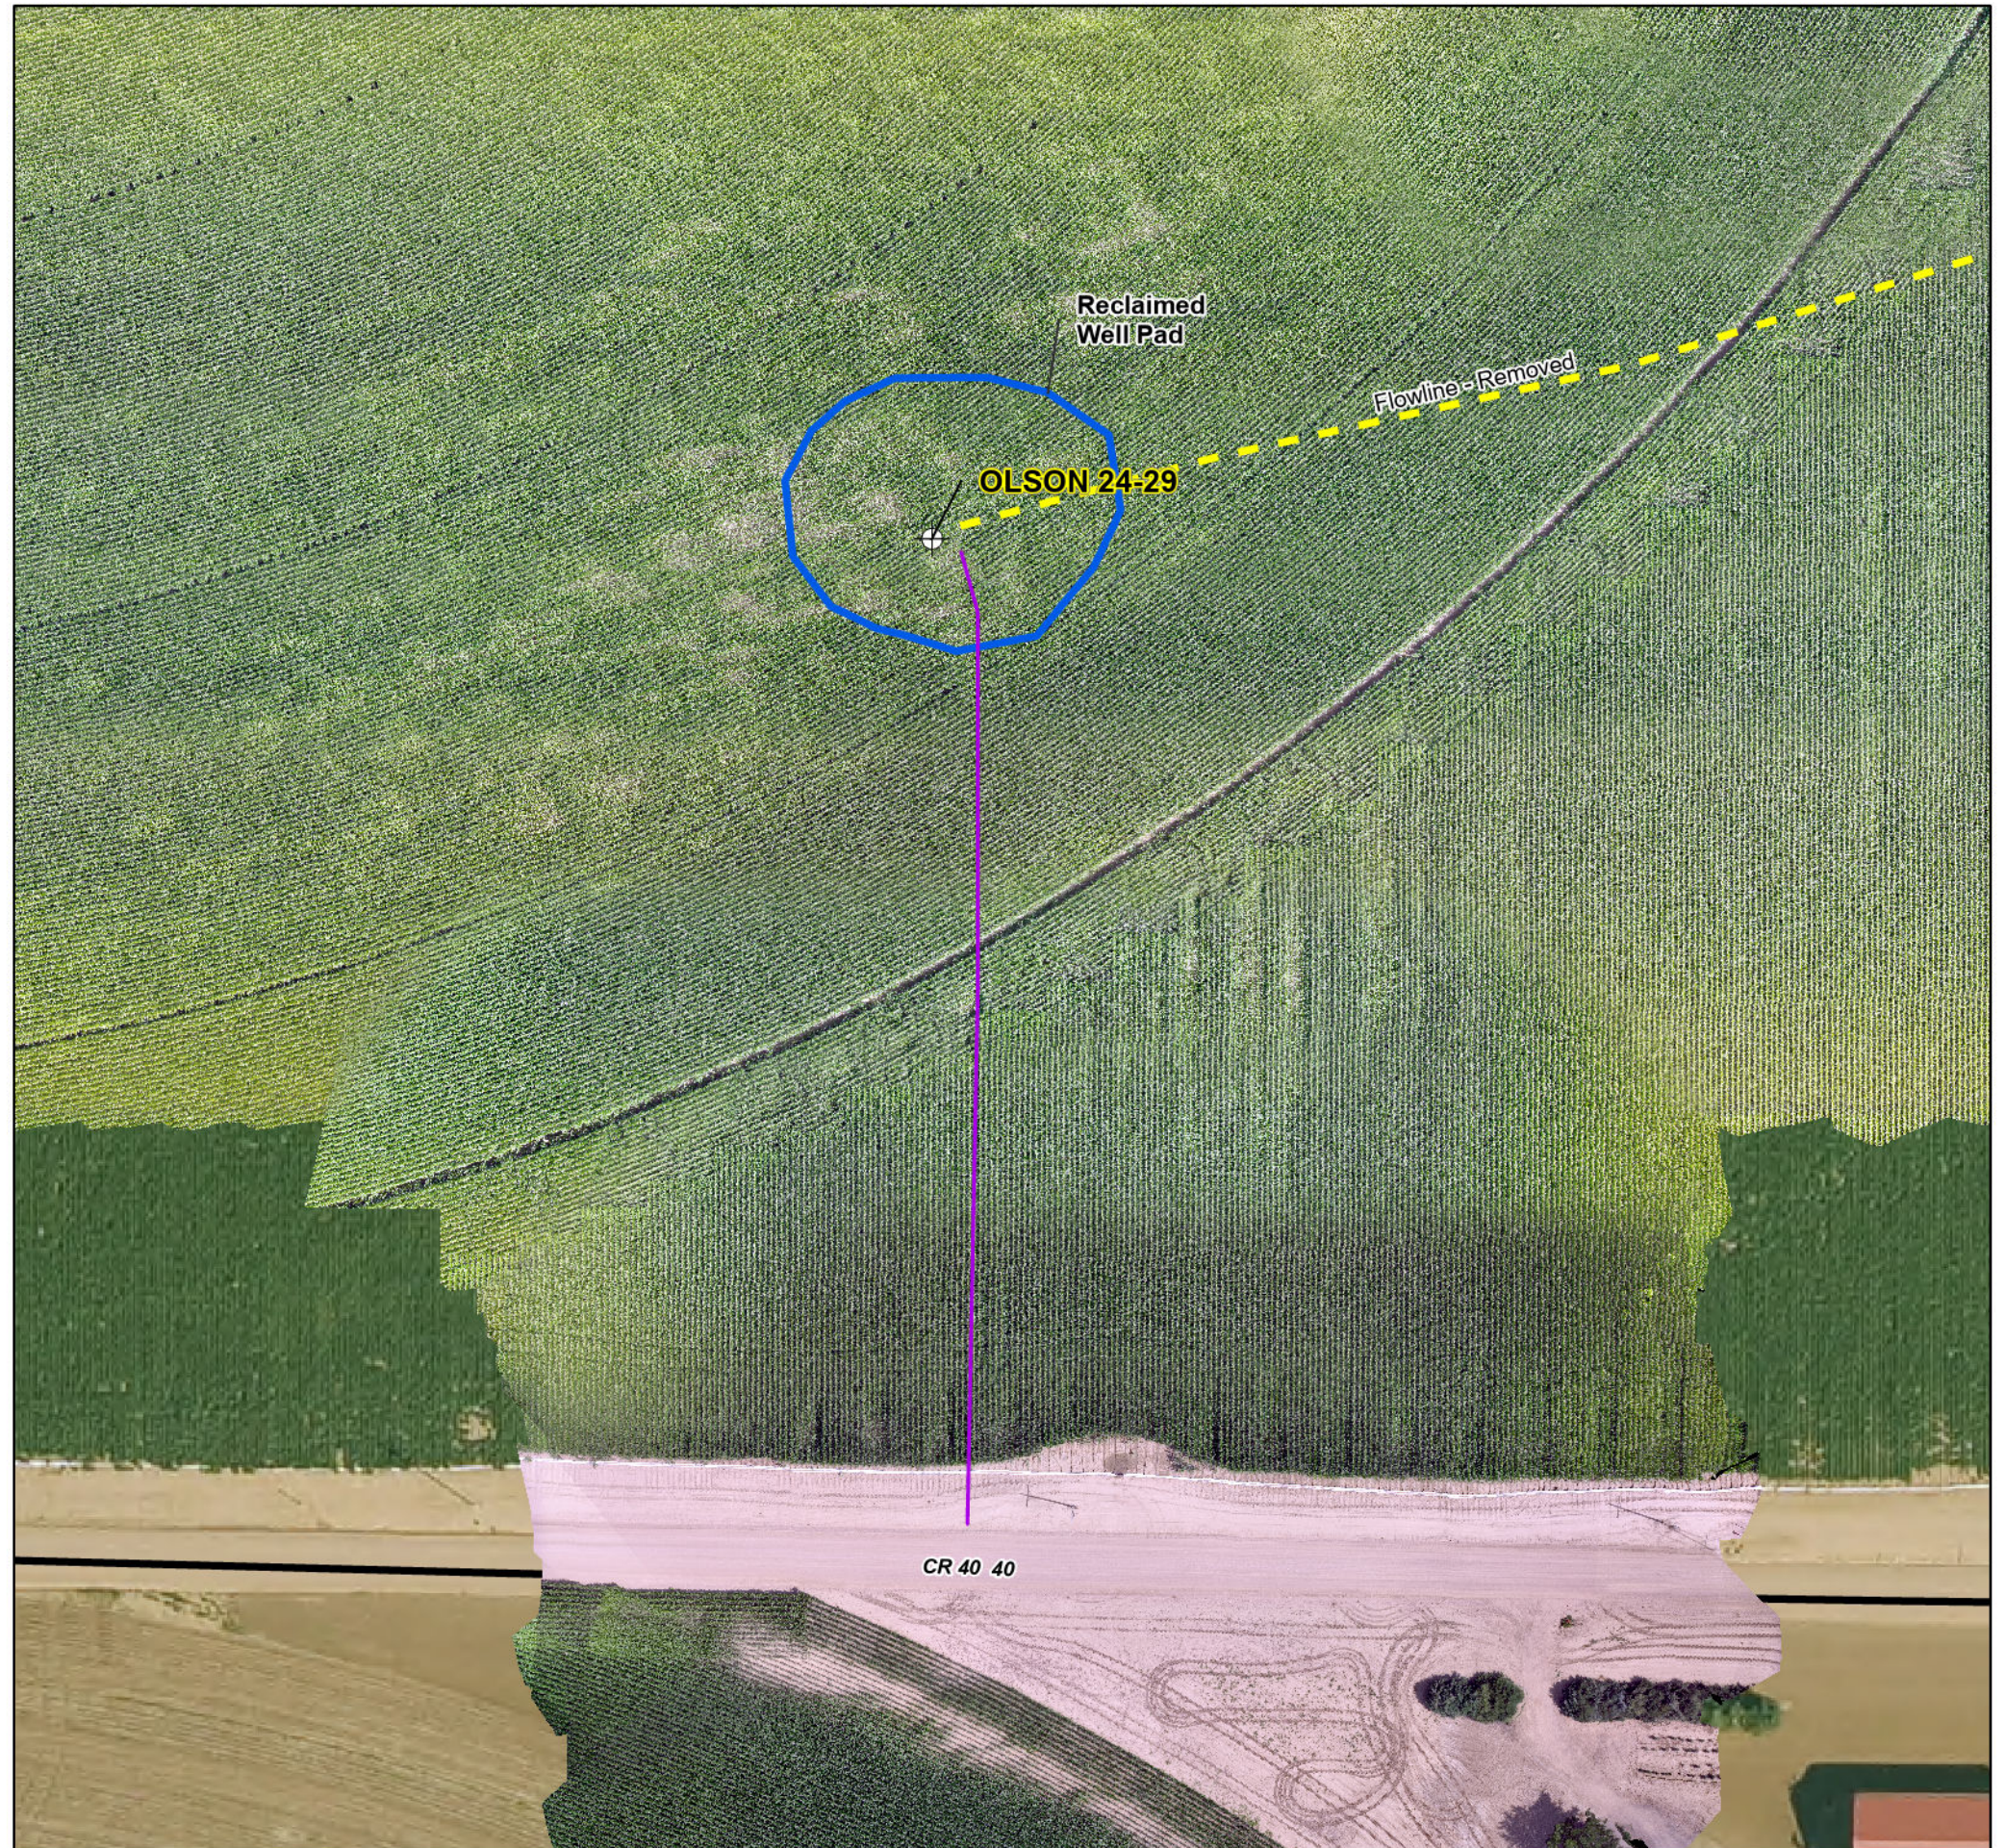
Drone imagery confirms that no equipment was left on site at this location after reclamation activities occurred.

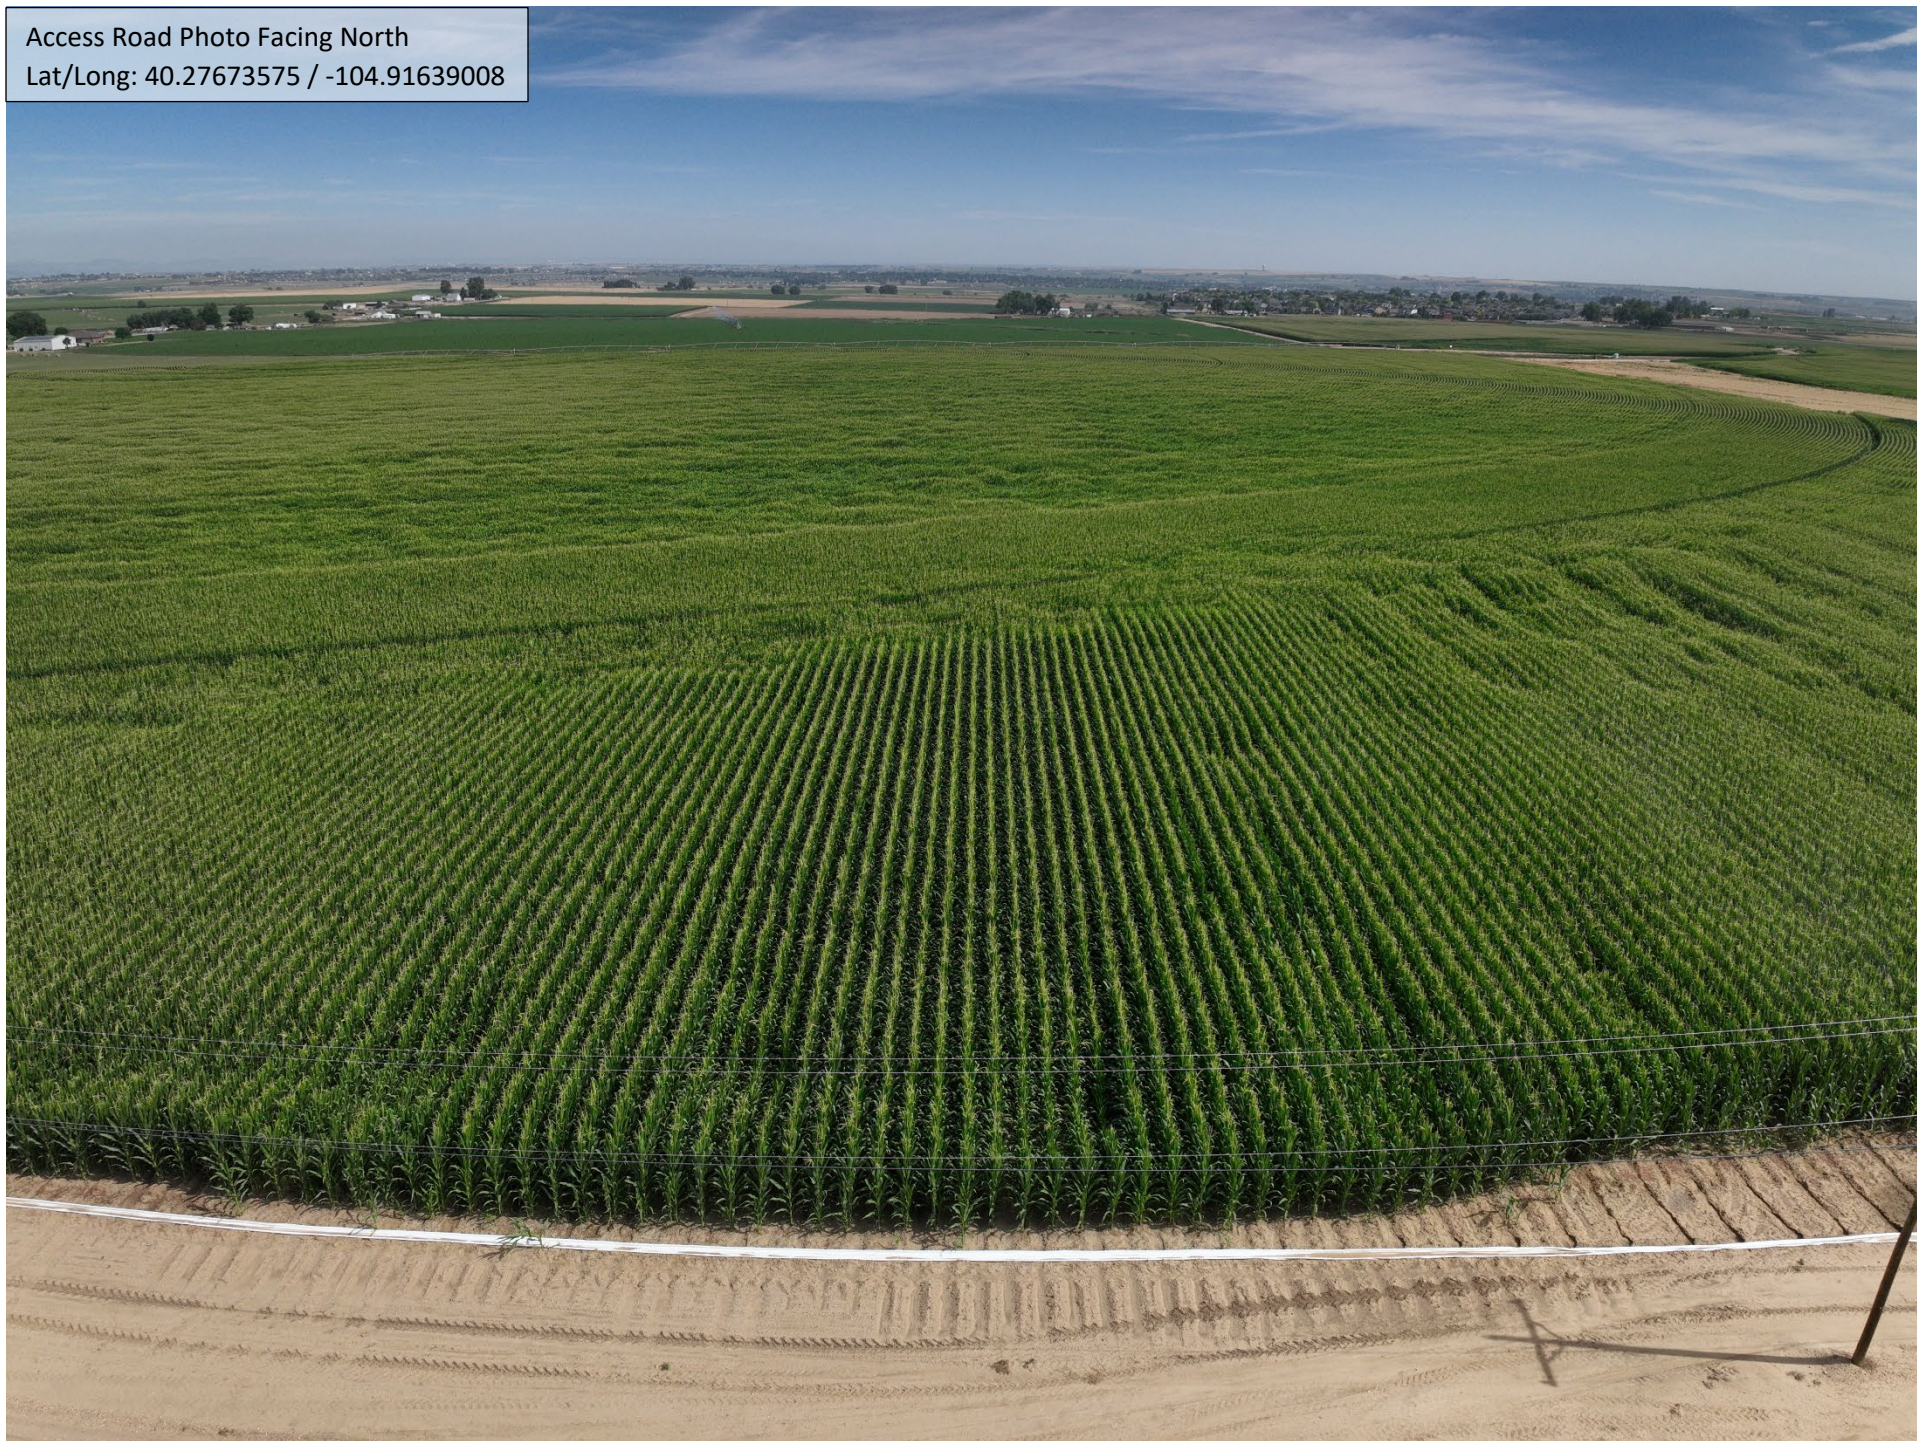
Access Road Photo Facing North  
Lat/Long: 40.27673575 / -104.91639008

OLSON #24-29 was reclaimed and returned to the landowner for agricultural use in 2021. The wellhead was accessed from an unpaved access road that originated off of County Road 40. The access road was reclaimed and returned to agriculture in conjunction with the reclamation of the well location.
