# Final Reclamation and Stormwater Inspection

December 31, 2025

Well Name: DOUBLE BAR O #1

Inspection Document #: 718601280

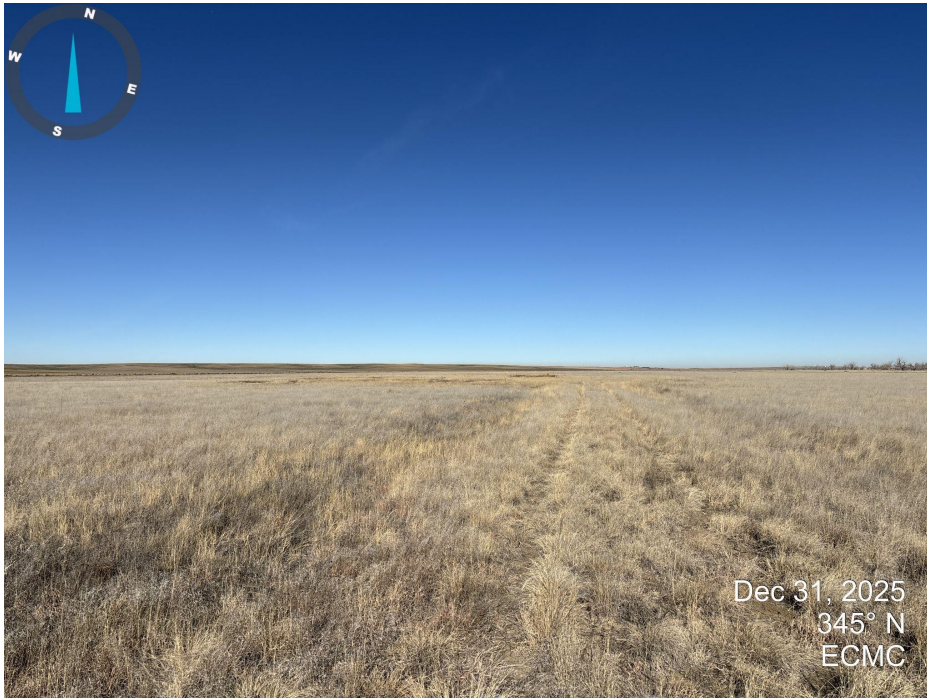
**Photo 1.** Looking north down the former access road. Original gate has been removed. Desirable perennial vegetation is present on the access road. List C noxious weed cheatgrass is also present on the access road.

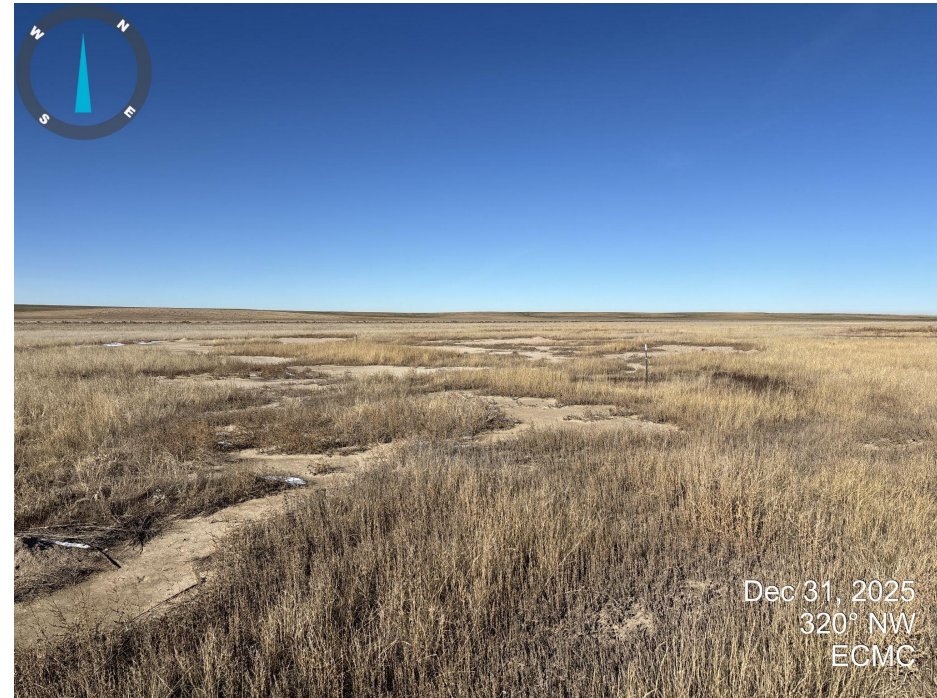
**Photo 2.** Looking northwest across the well turn around area.

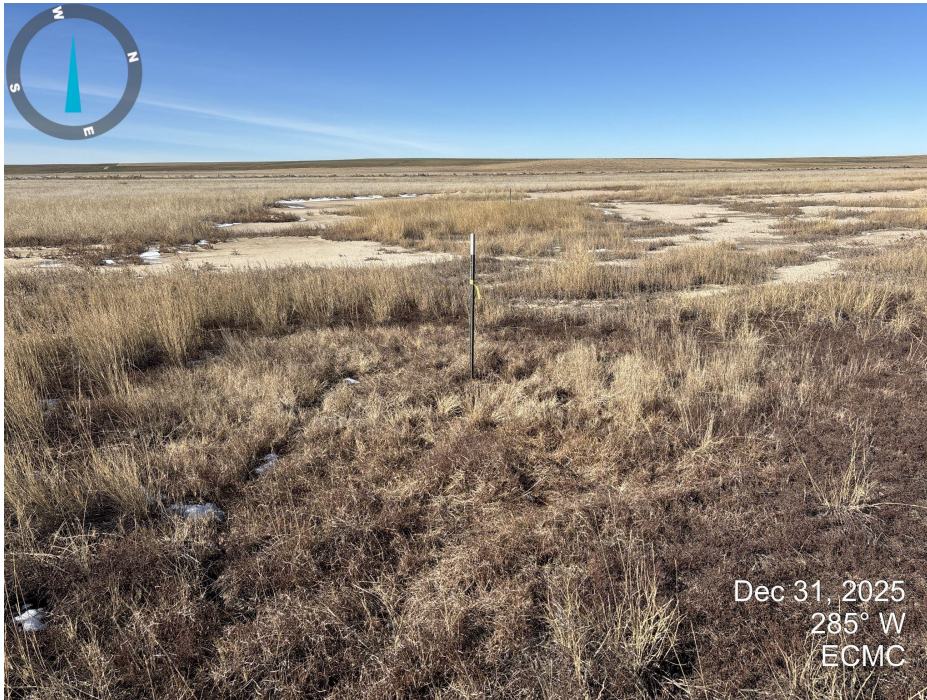
**Photo 3.** Picture taken looking west across the south side of the turnaround road. On the south side of the well turnaround area, two depressions are marked with t-posts

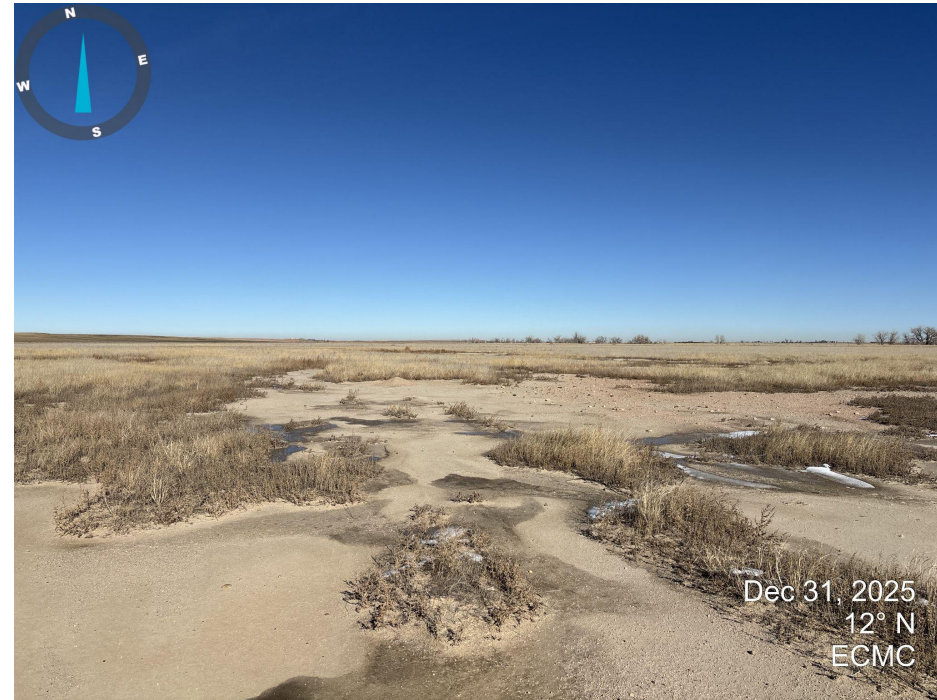
**Photo 4.** Picture taken at the center of the well turnaround area. Bare soil is present throughout the location. Undesirable weeds such as russian thistle and kochia are present on the location along with List C noxious weed cheatgrass. Desirable vegetation such as western wheatgrass, crested wheatgrass and blue gramma is also present in limited amounts on location.

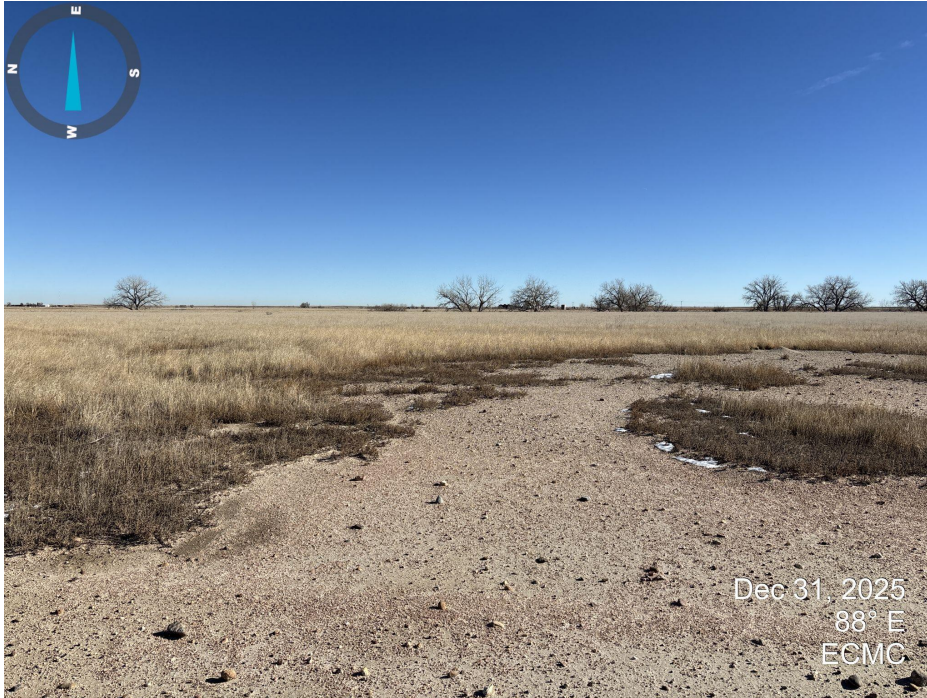
**Photo 5.** Looking east from the center of the well turnaround area. See photo 4 comments.

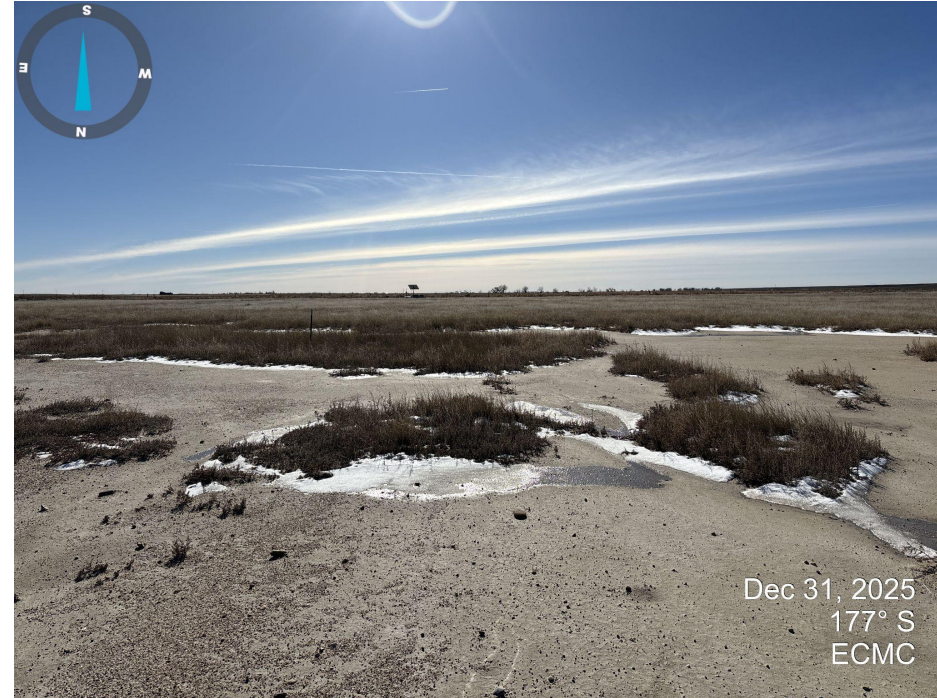
**Photo 6.** Looking south from the center of the well turnaround area. See photo 4 comments.

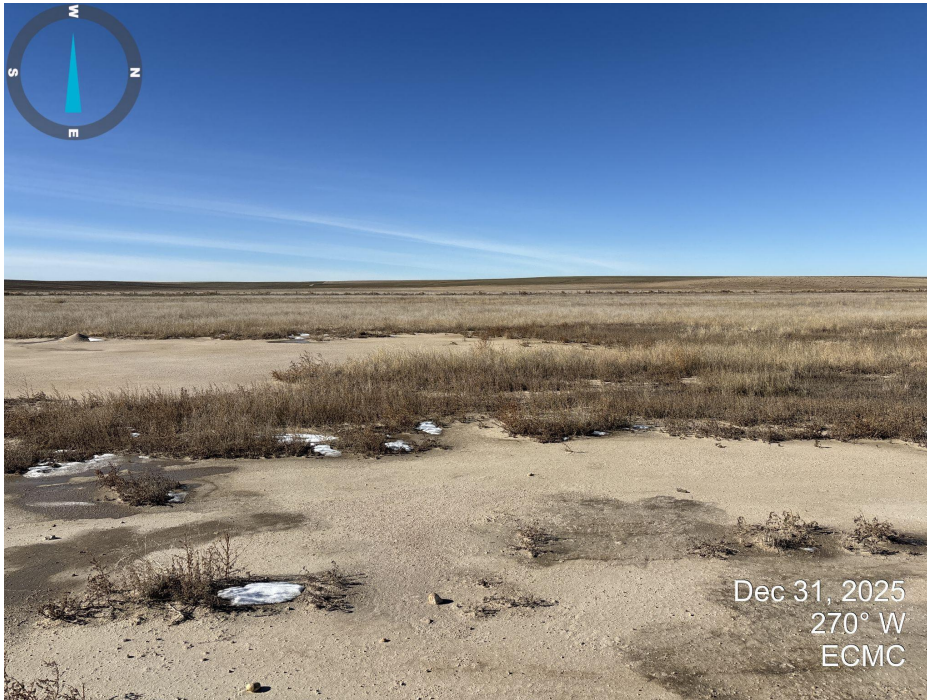
**Photo 7.** Looking west from the center of the well turnaround area. See photo 4 comments.

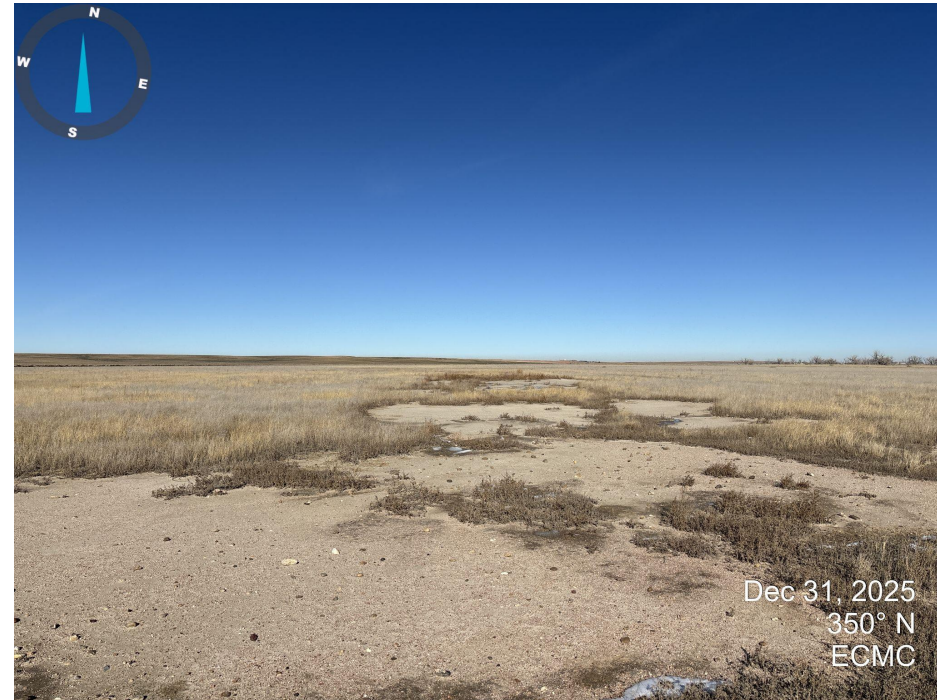
**Photo 8.** Looking north across the wellbore area. No equipment is present. Bare earth extends approximately 350 ft to the north of the well area. The former access road runs adjacent to the bare area to the east side of this photo.

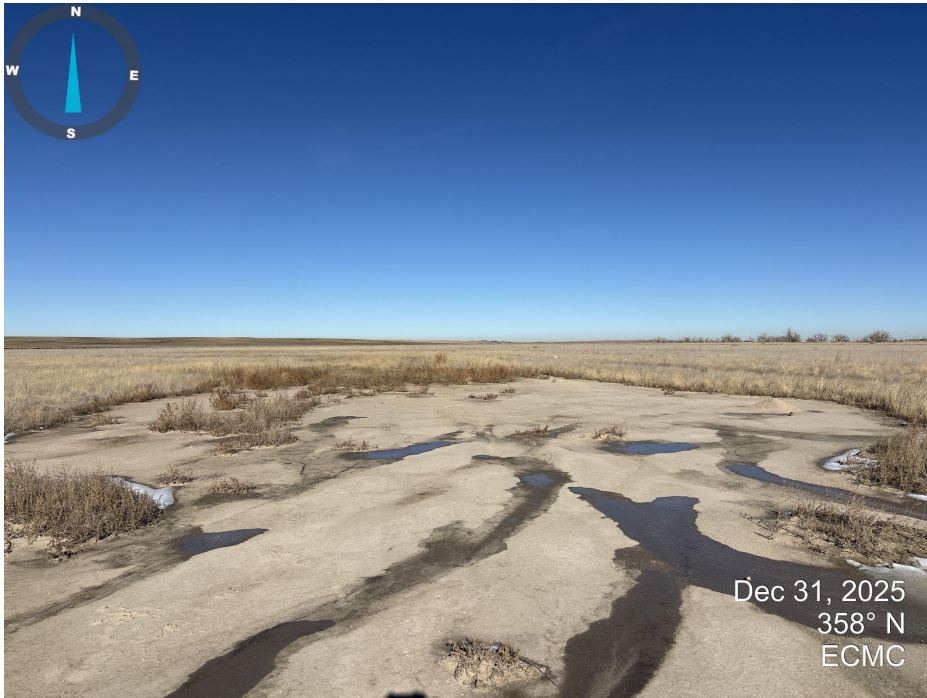
**Photo 9.** Picture taken south of the tank battery area looking north across the tank battery southern access road. Bare soil is present in this area.

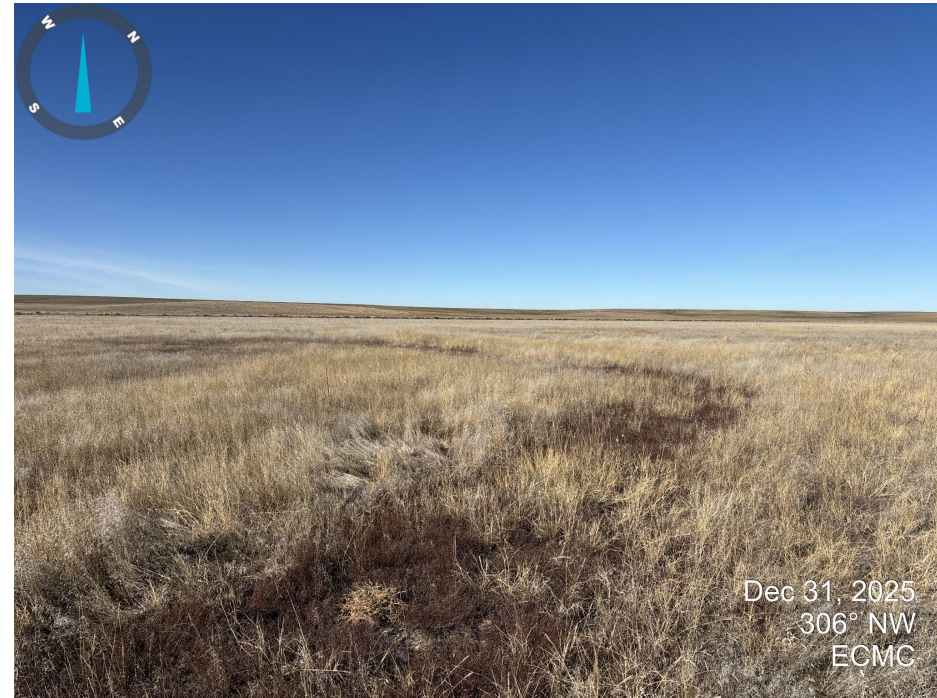
**Photo 10.** Looking west across the former tank battery area. The access road is visible due to a higher concentration of undesirable weeds. List C noxious weed cheatgrass is present throughout the tank battery location. There appears to be less desirable vegetation establishment on the tank battery location than the surrounding reference areas.

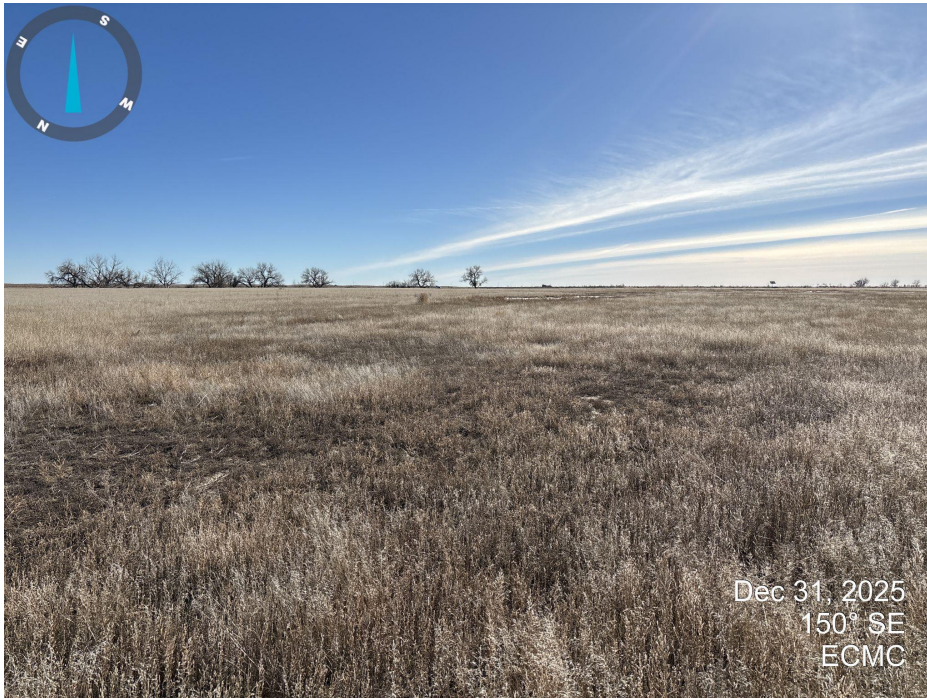
**Photo 11.** Looking south across the tank battery location and access road. There appears to be slight depressions/subsidence on the tank battery location.

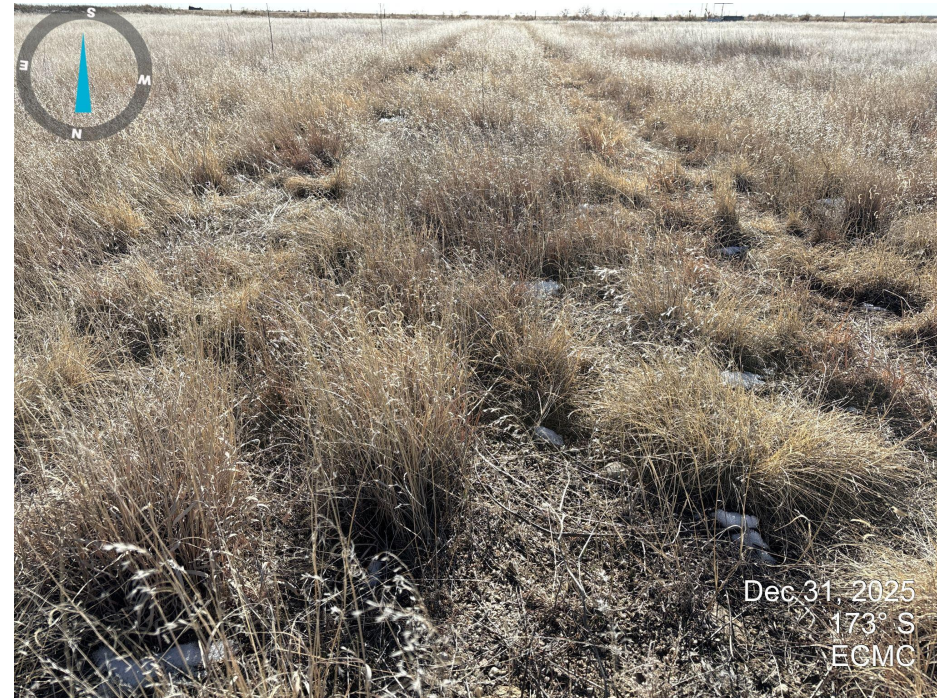
**Photo 12.** Photo taken on the access road near the entrance looking south. The road is slightly contoured and raised. Gravel remains on the access road. Desirable perennial vegetation is present on the access road. List C noxious weed cheatgrass is also present on the access road. Desirable vegetation coverage varies along the length of the access road.

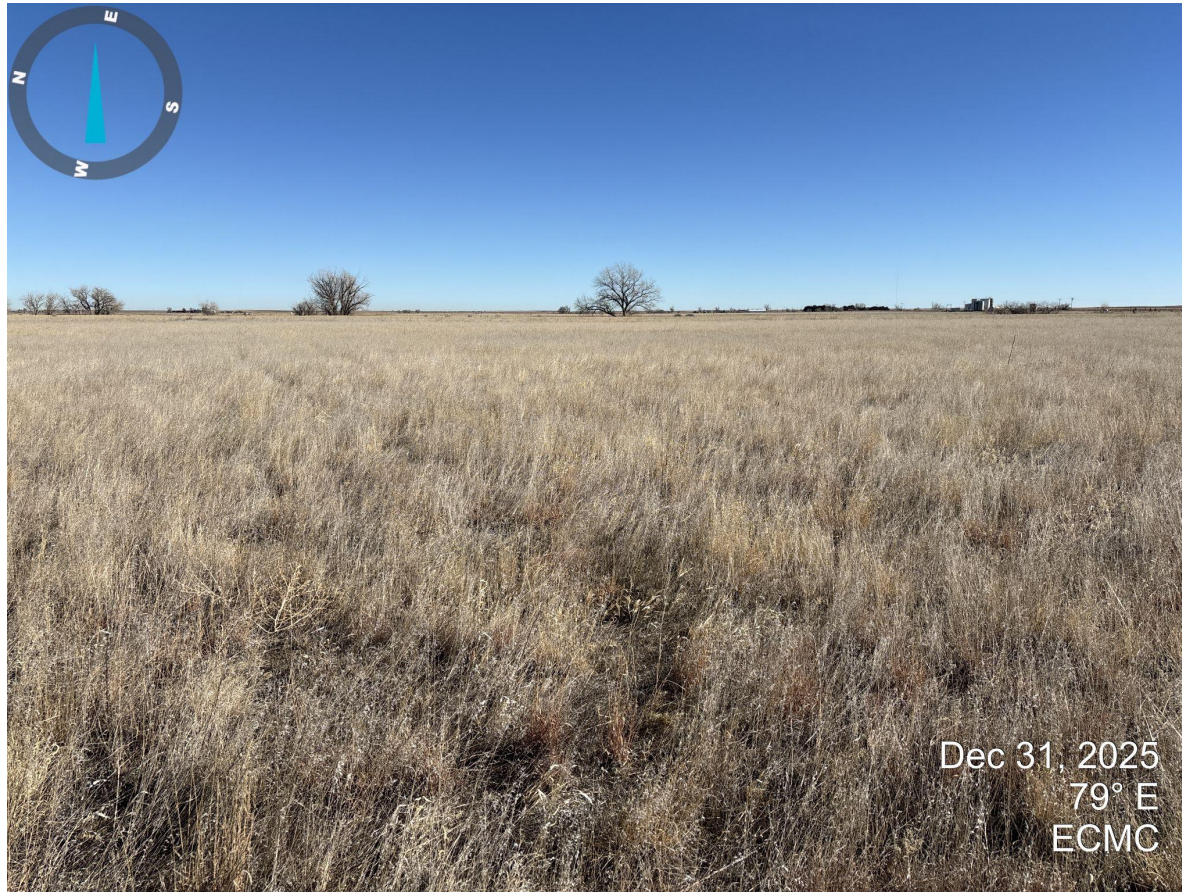
**Photo 13.** Reference vegetation to the east of the well location. List C noxious weed cheatgrass is present in the reference area. Desirable vegetation such as western wheatgrass, crested wheatgrass, blue gramma, and big bluestem are present throughout the reference area.
