Inspection Photos

Location Name: Cosslett 1,2 Historical
Spill ID: 491039

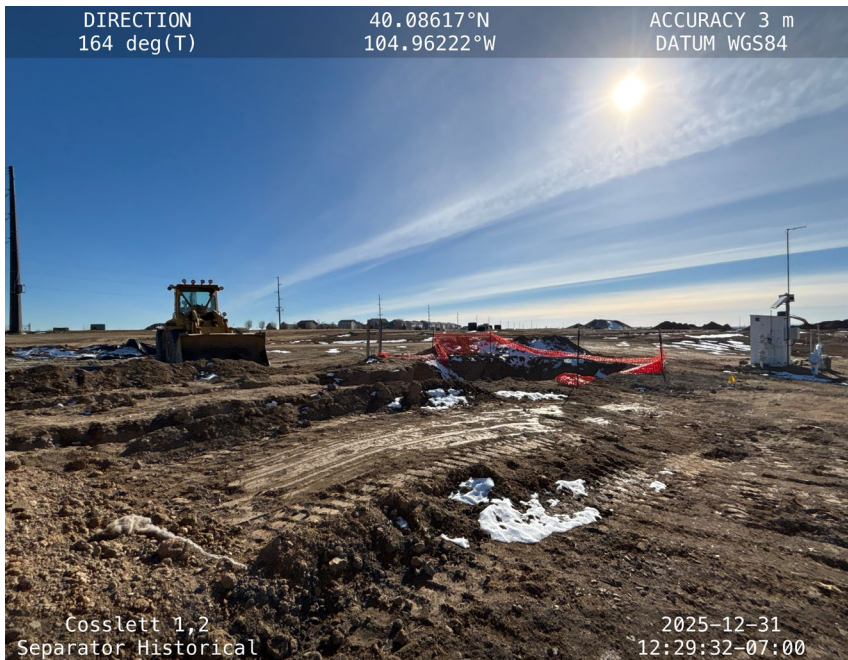
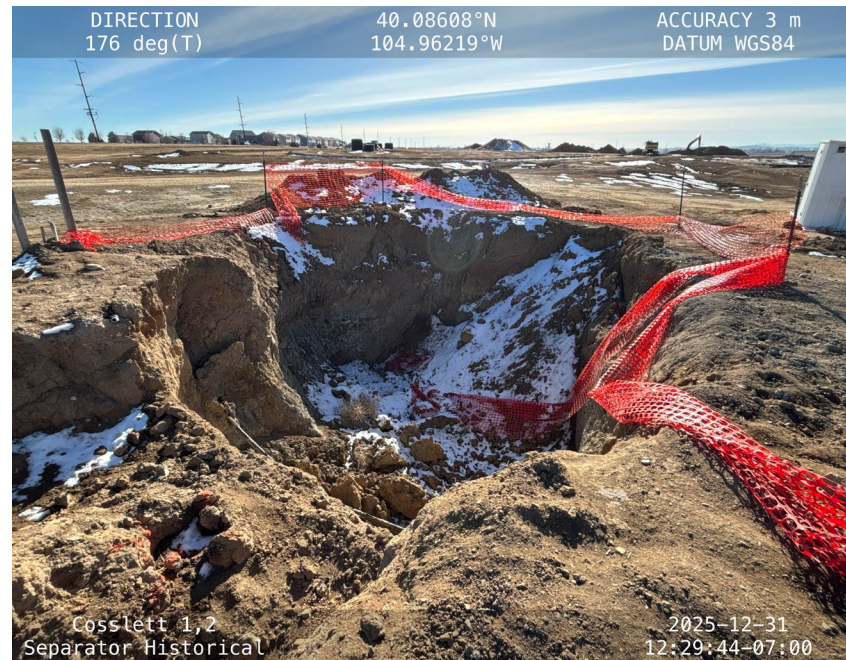
Excavation with inadequate fencing

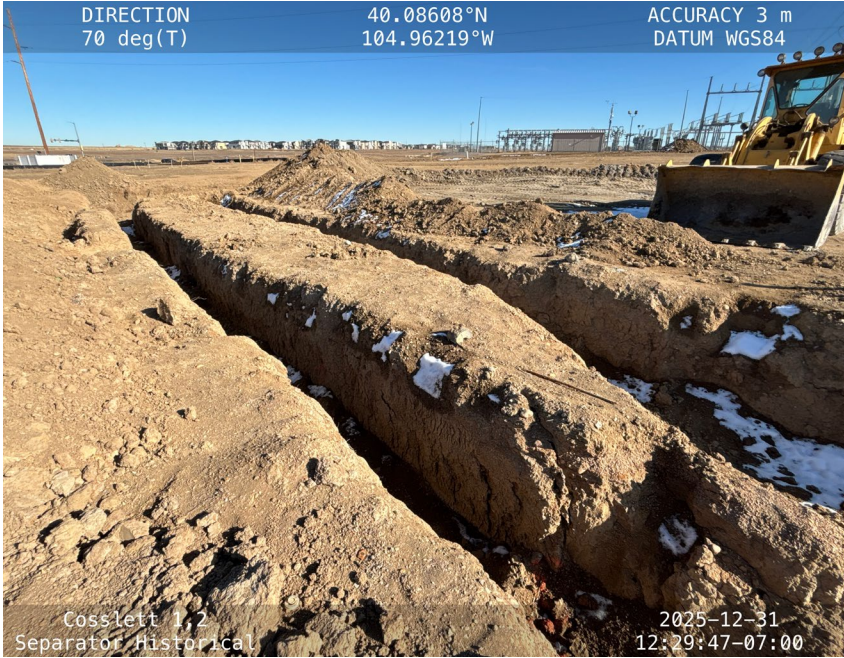
Excavation with inadequate fencing

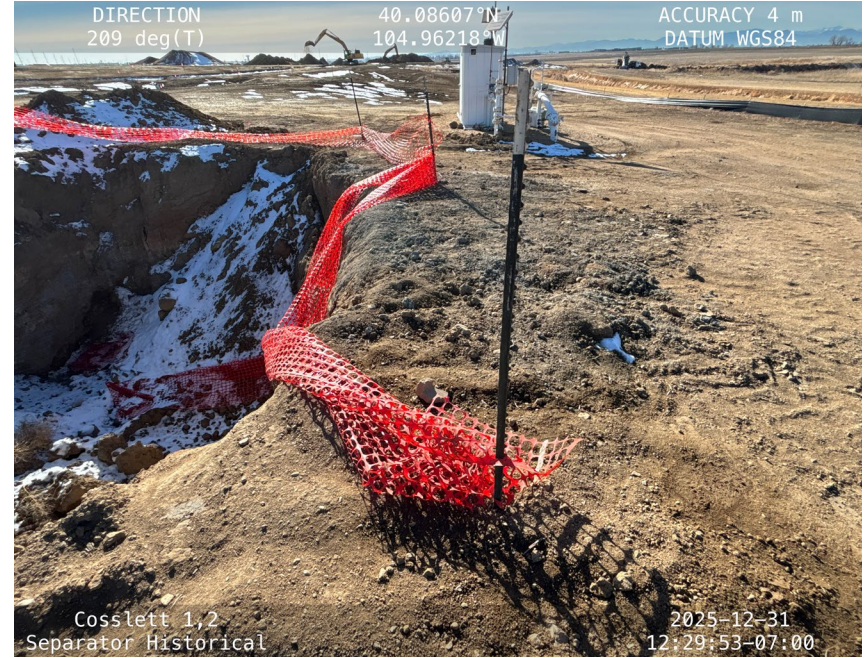
Excavation with inadequate fencing

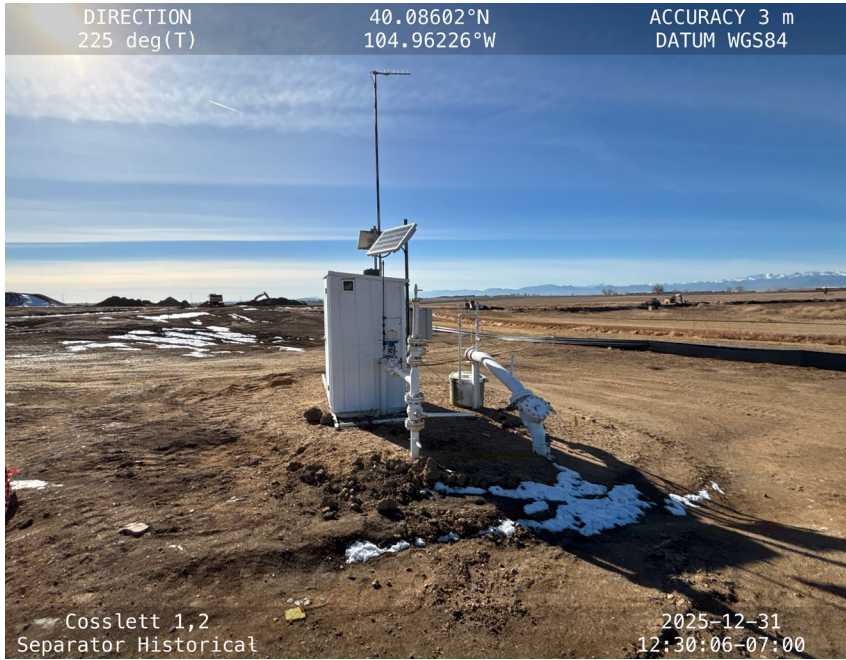
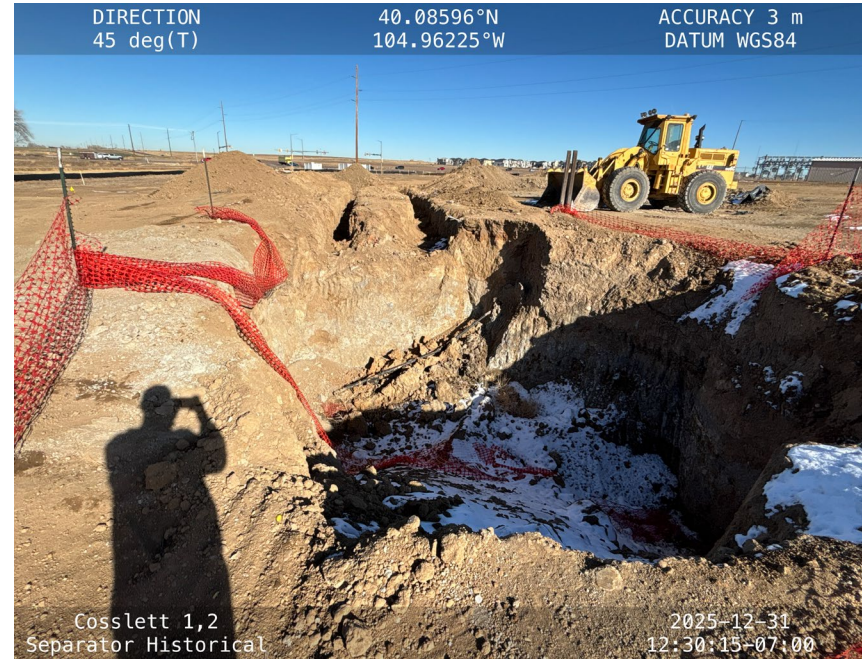
Excavation with inadequate fencing

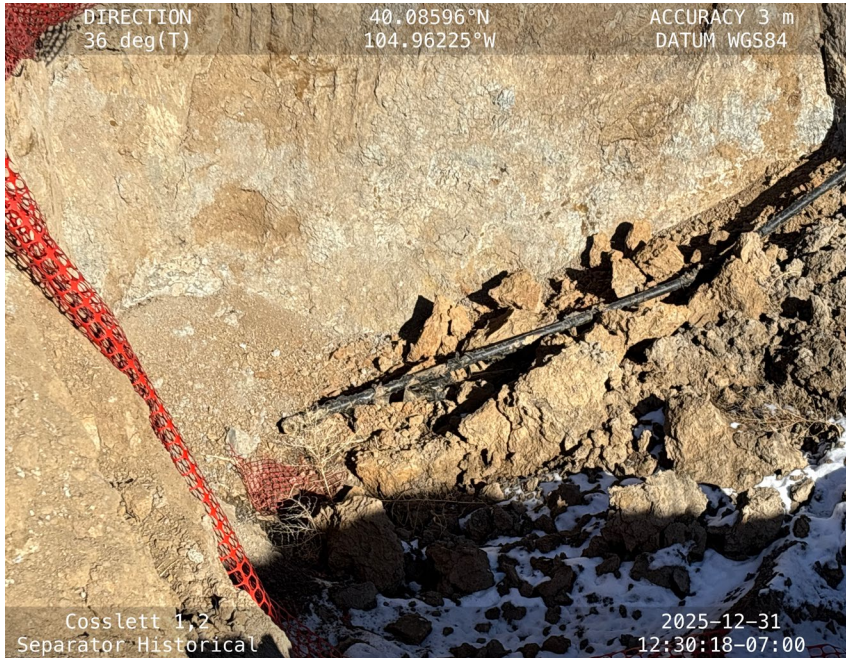
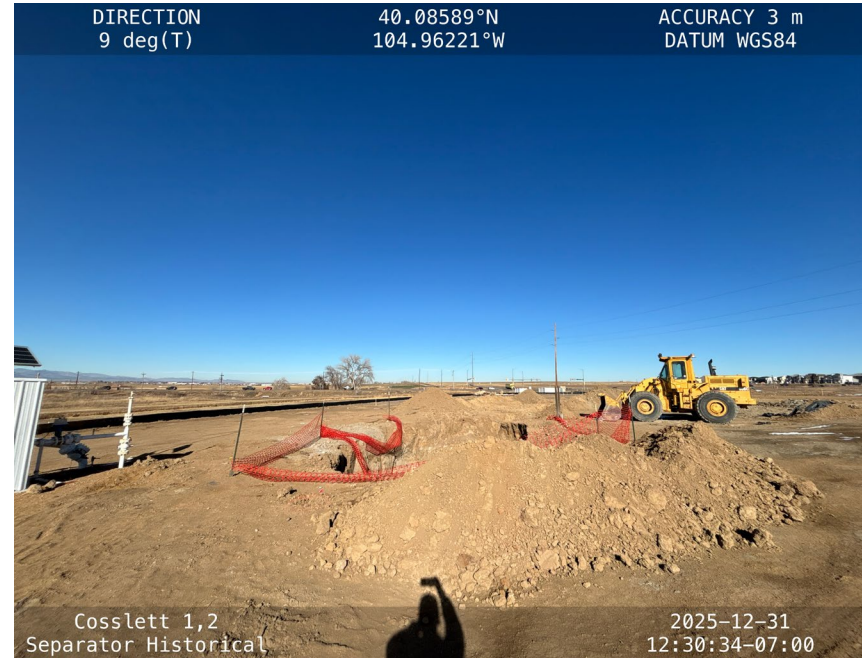
Stockpile with no BMPS

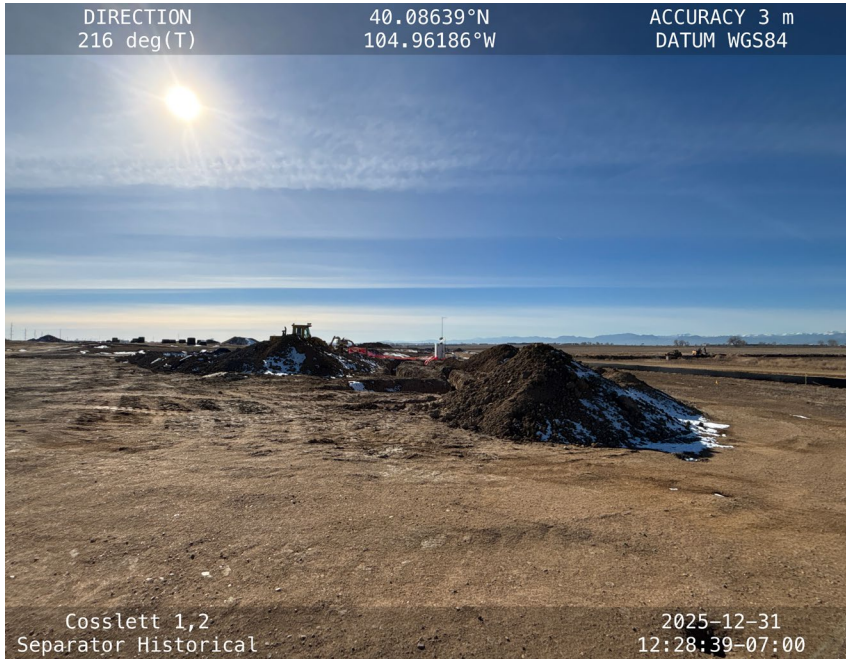
Stockpile with no BMPS

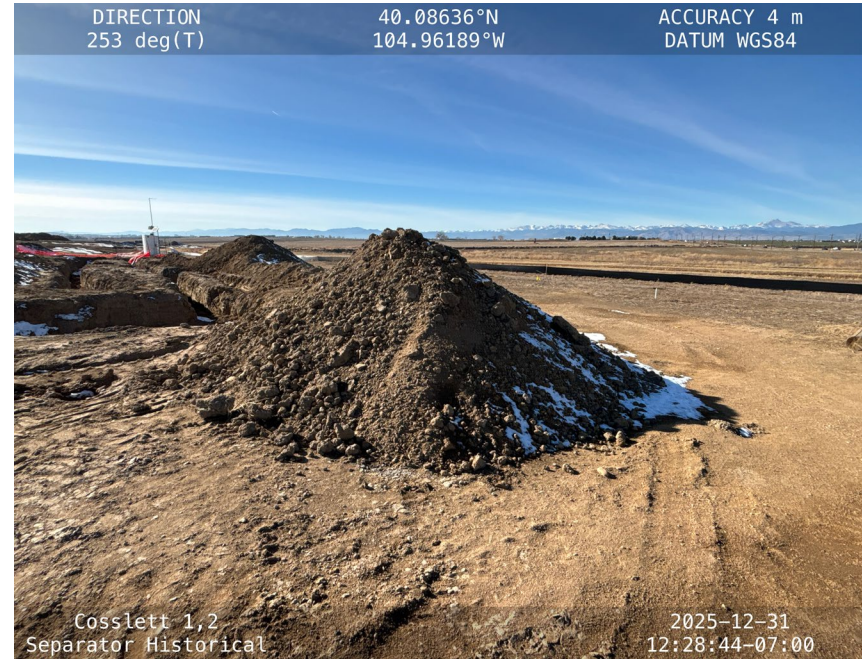
Stockpile with no BMPS

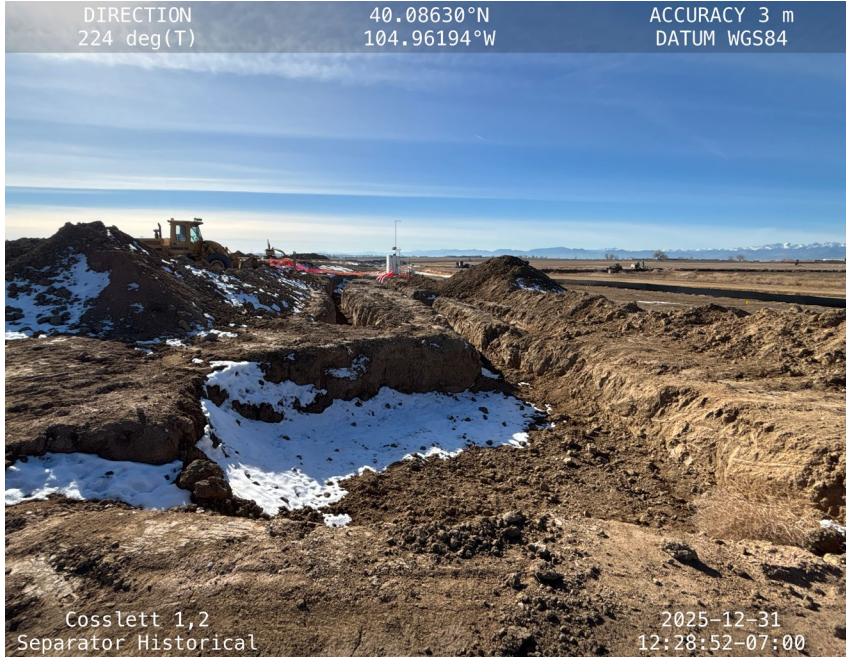
Excavation with inadequate fencing

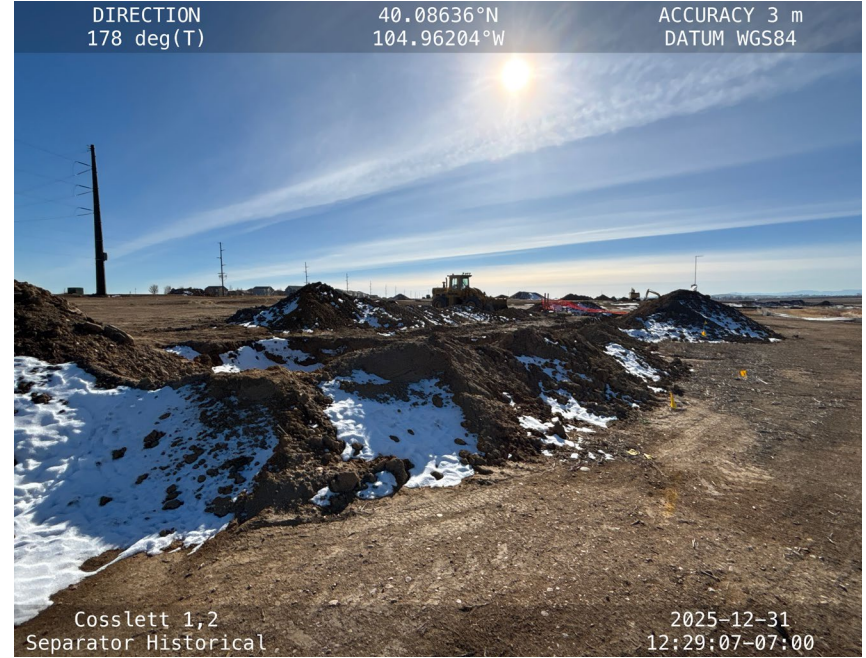
Stockpile with no BMPS

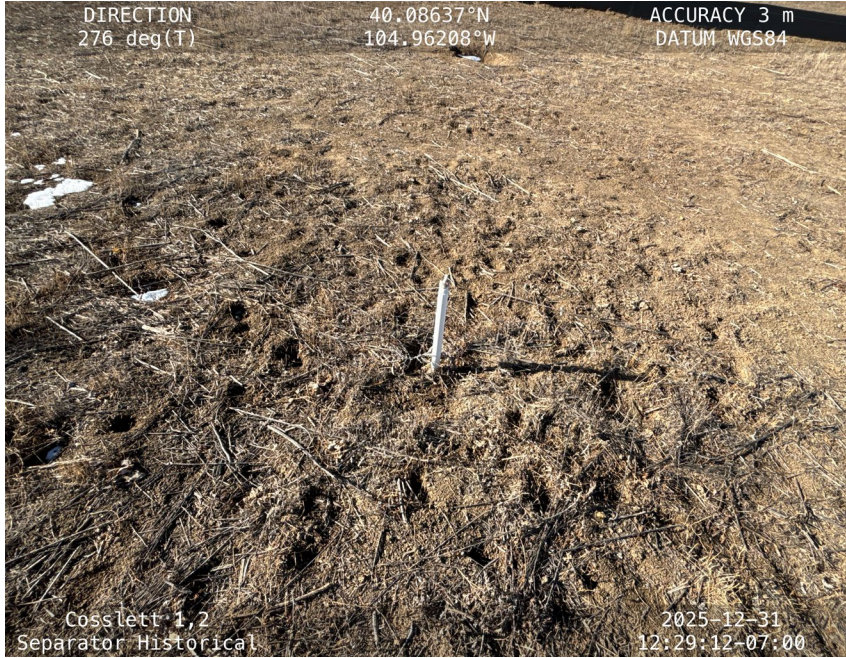
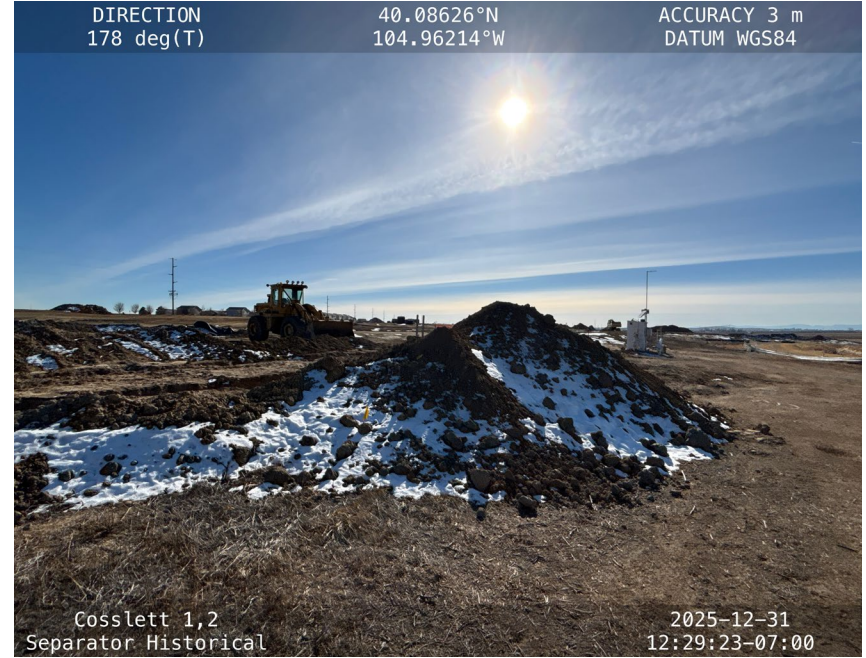
Stockpile with no BMPS

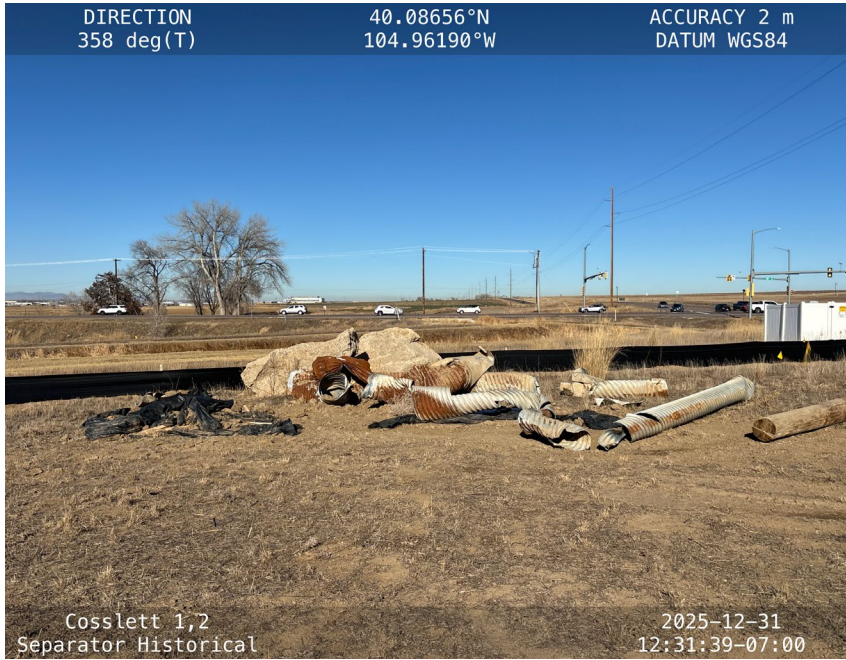
Trash

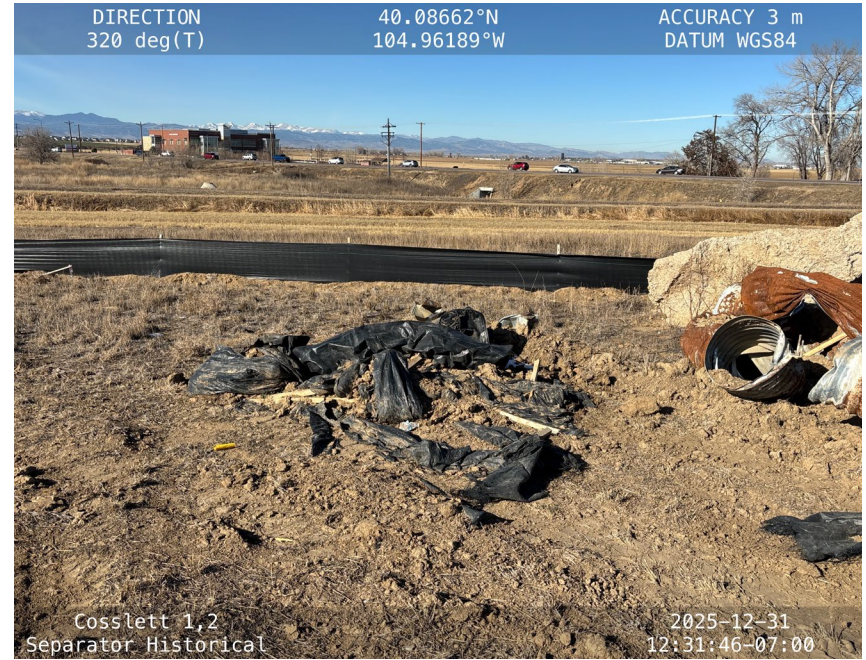
Trash
