Inspection Photos  
Well Name: HUBER-ARADO 1-13  
LOCATION ID:326308

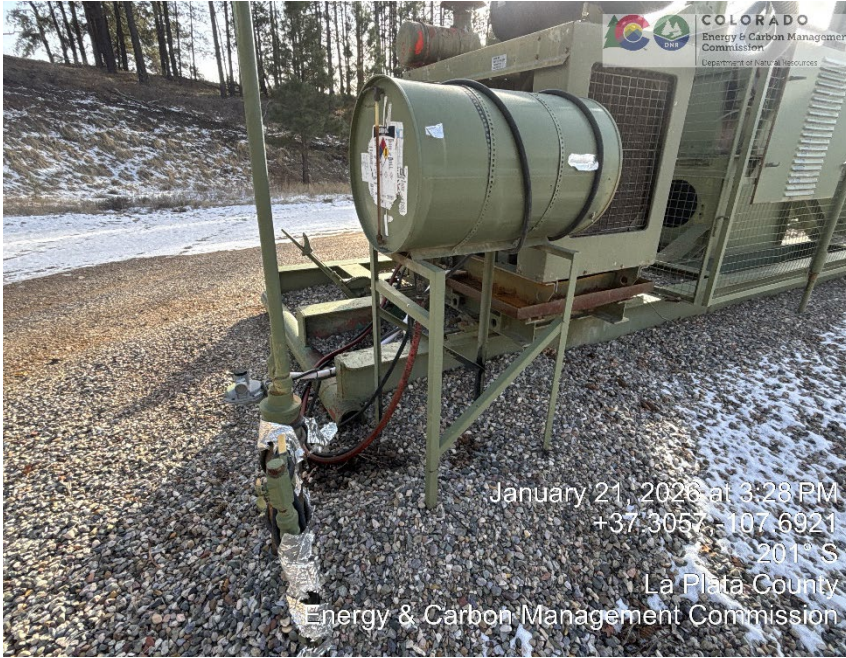
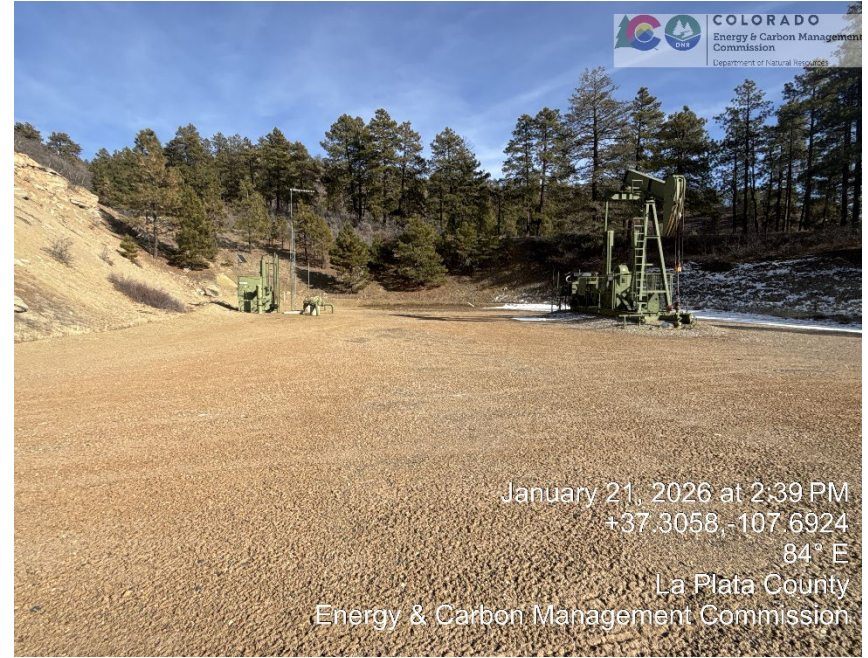
**NO SPILL PREVENTION**
