Inspection Photos
Location: Trade Winds 1-28
Location ID: 413318
API # 05-061-06838

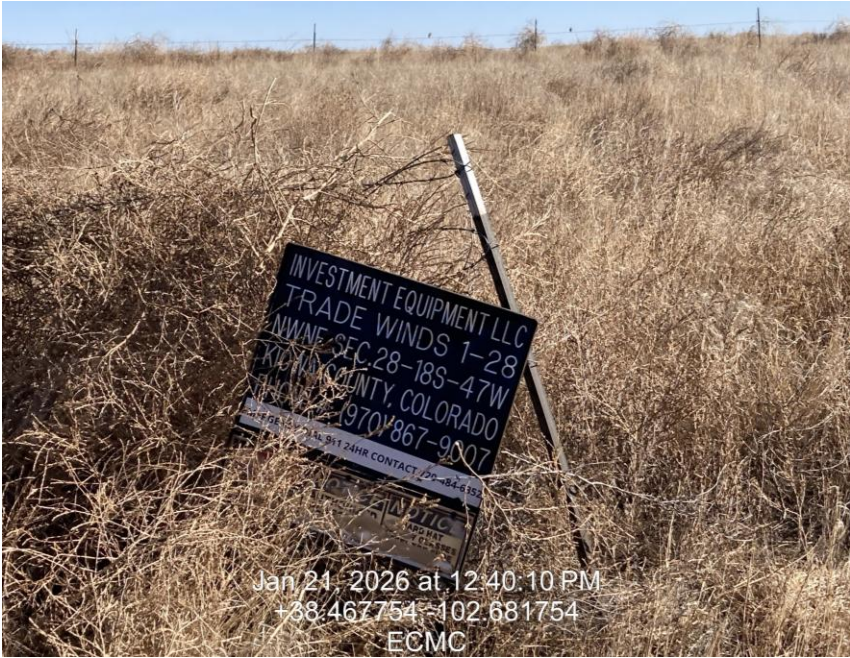
Photo 1 – Location Placard at entrance to location

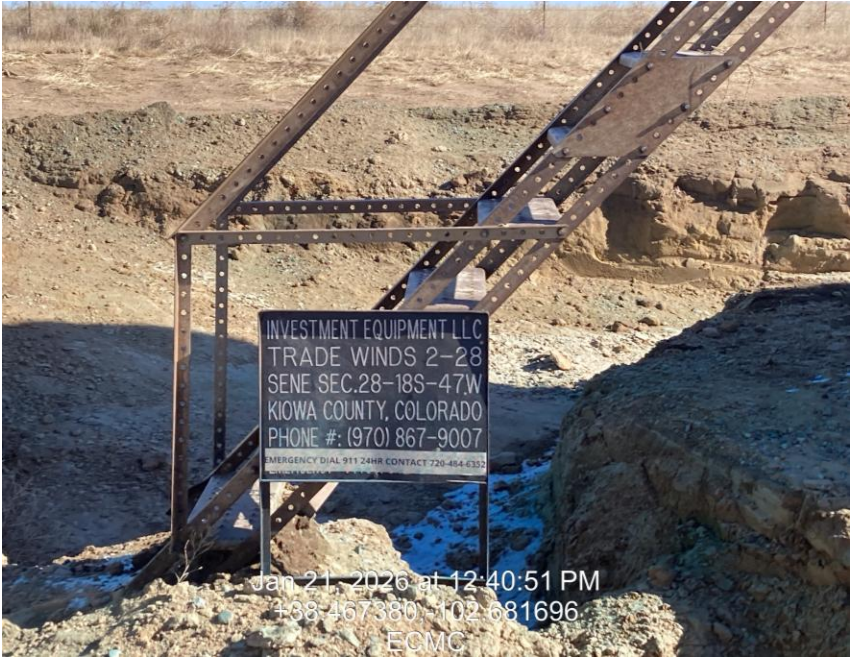
Photo 2 – Placard at Tank Battery

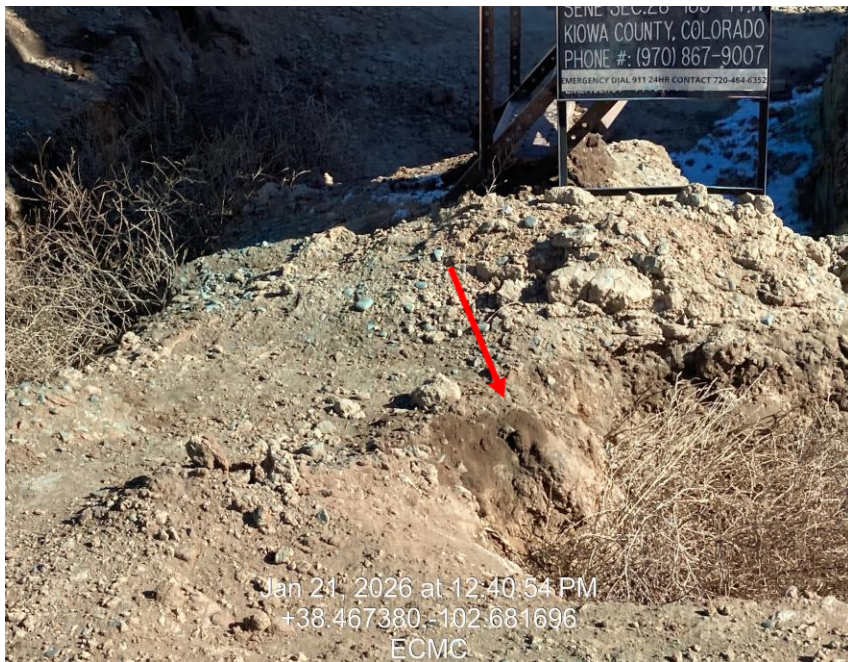
Photo 3 – Impacted soils

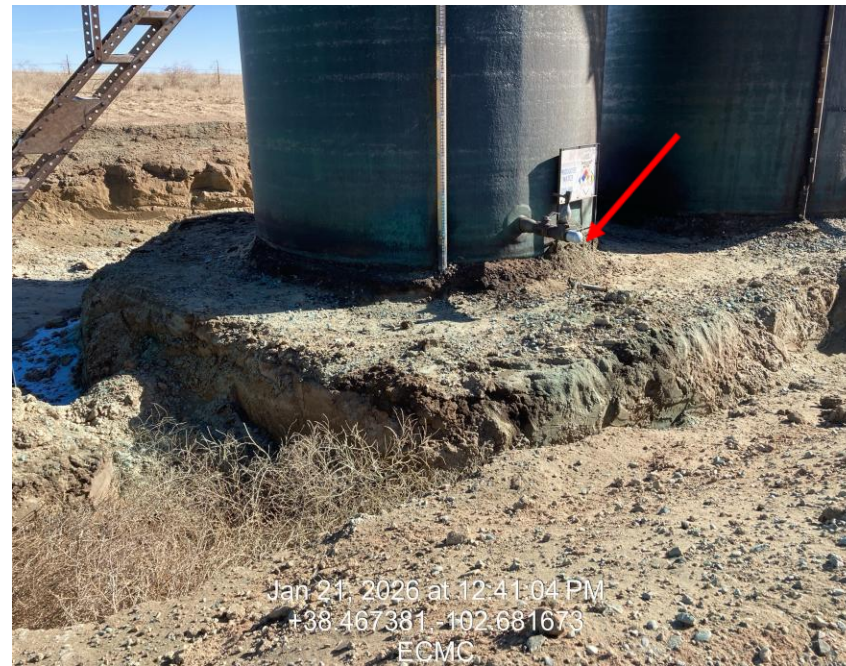
Photo 4 – Impacted soils under tanks

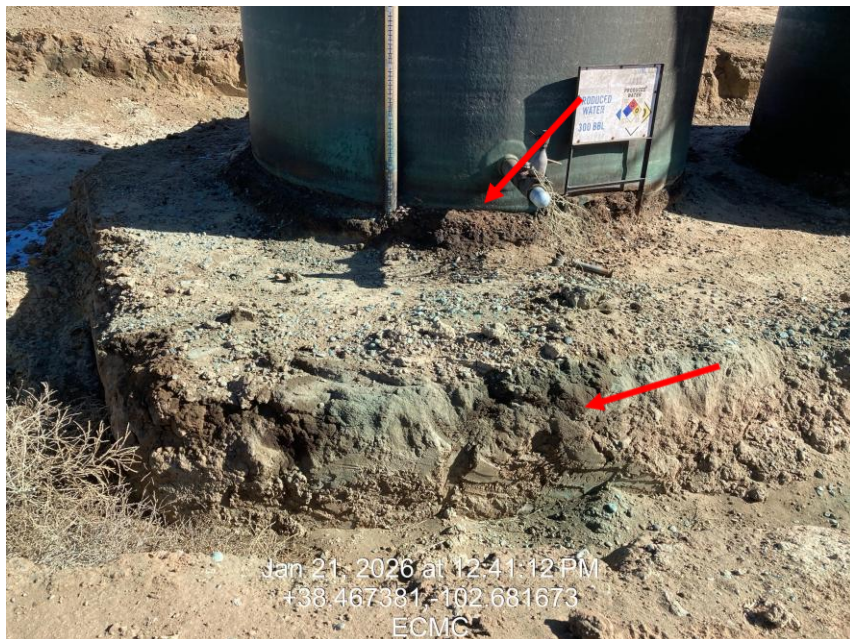
Photo 5 – impacted soils

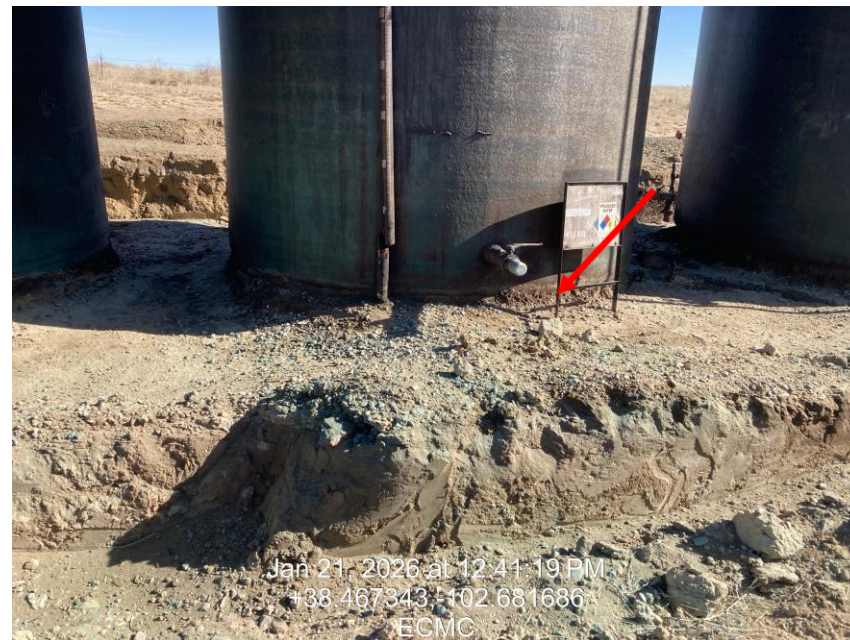
Photo 6 – impacted soils

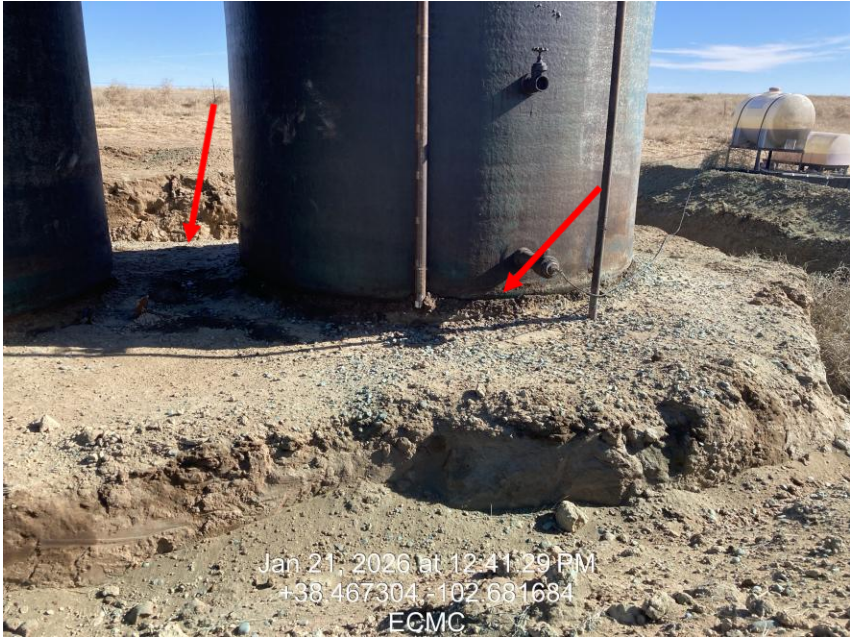
Photo 7 – Impacted soils

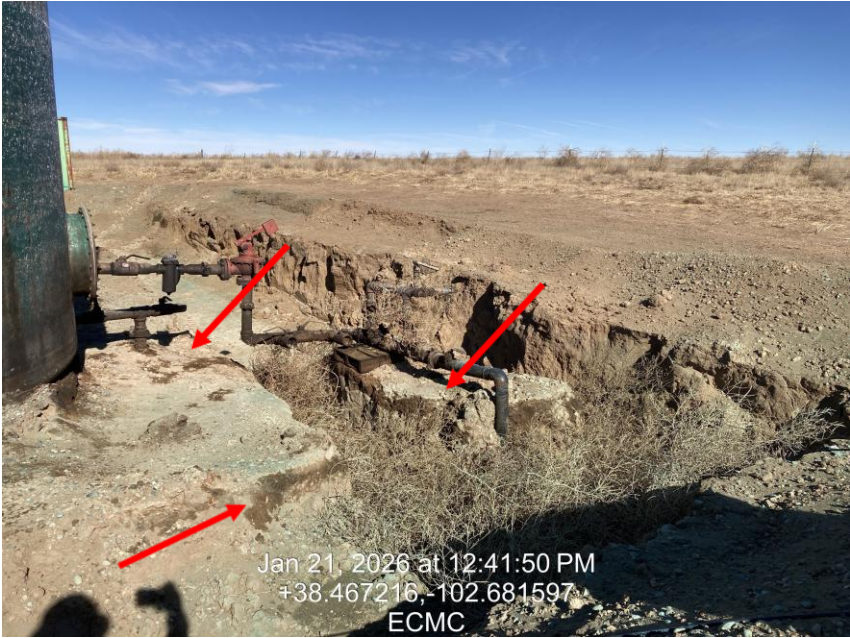
Photo 8 – Impacted Soils

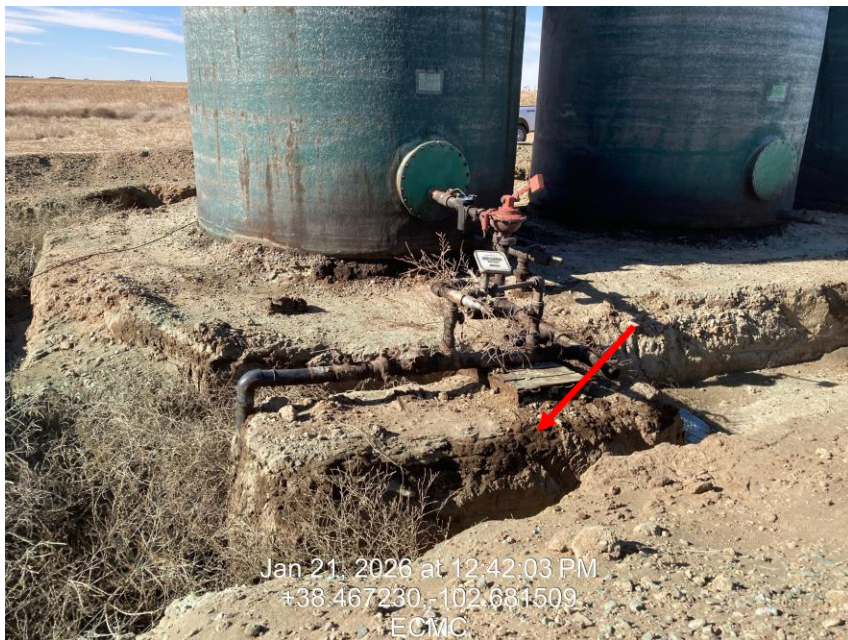
Photo 9 – Impacted soils east side of tanks.

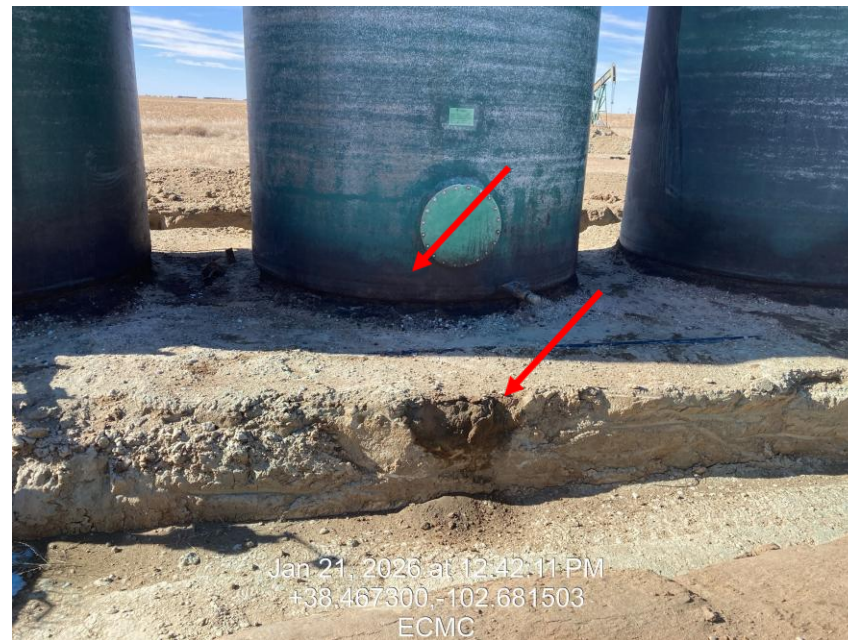
Photo 10 – Impacted soils east side of tanks.

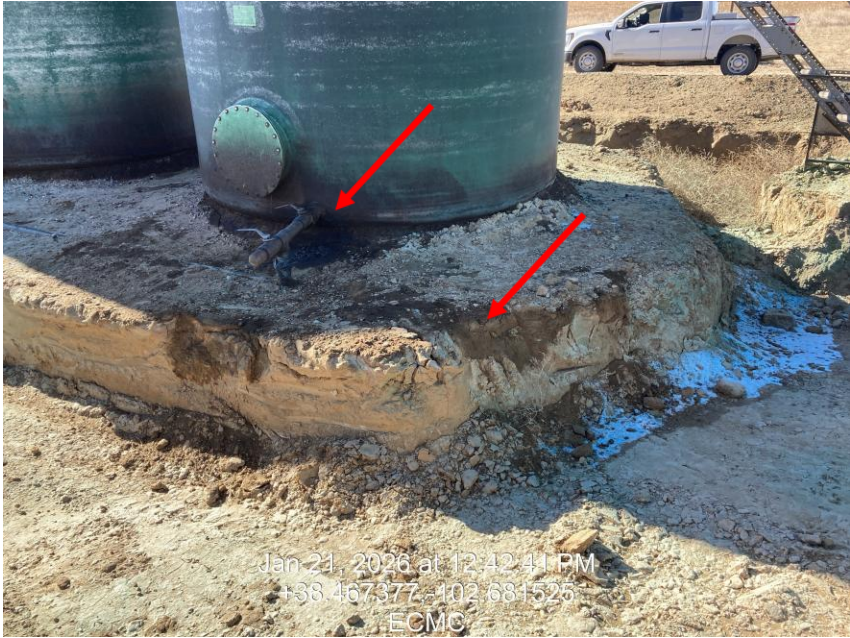
Photo 11 – Impacted soils east side of tanks.

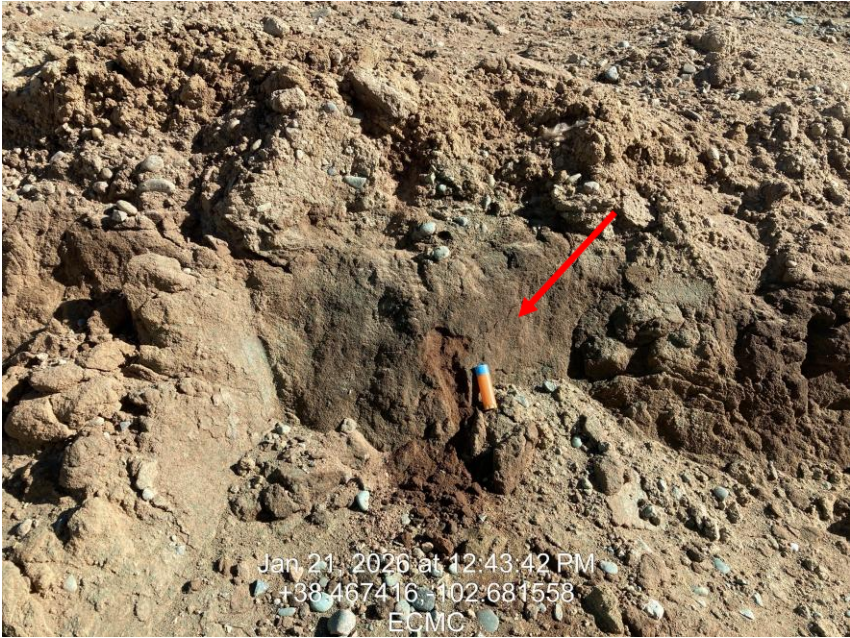
Photo 12 – Impacted soils east side wall of excavation

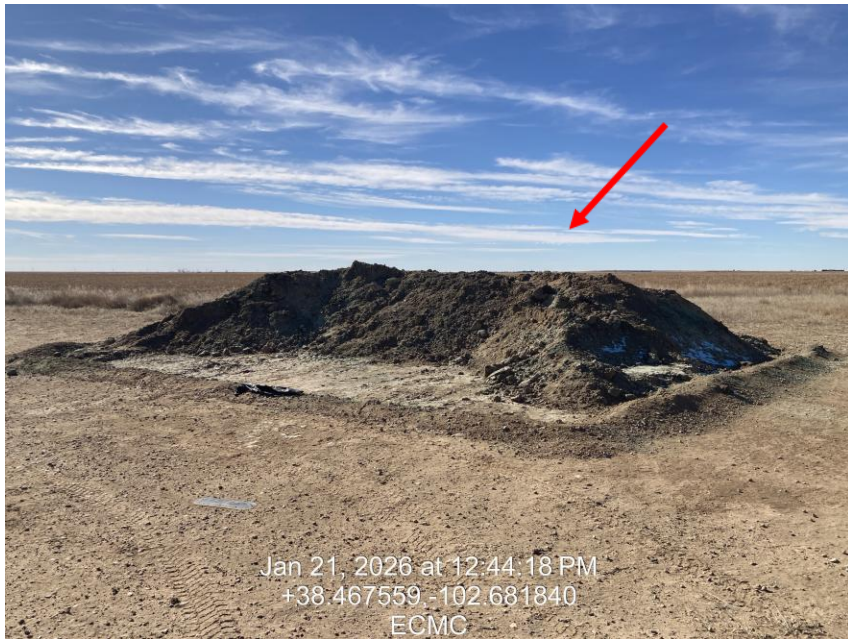
Photo 13 – Spoil Pile

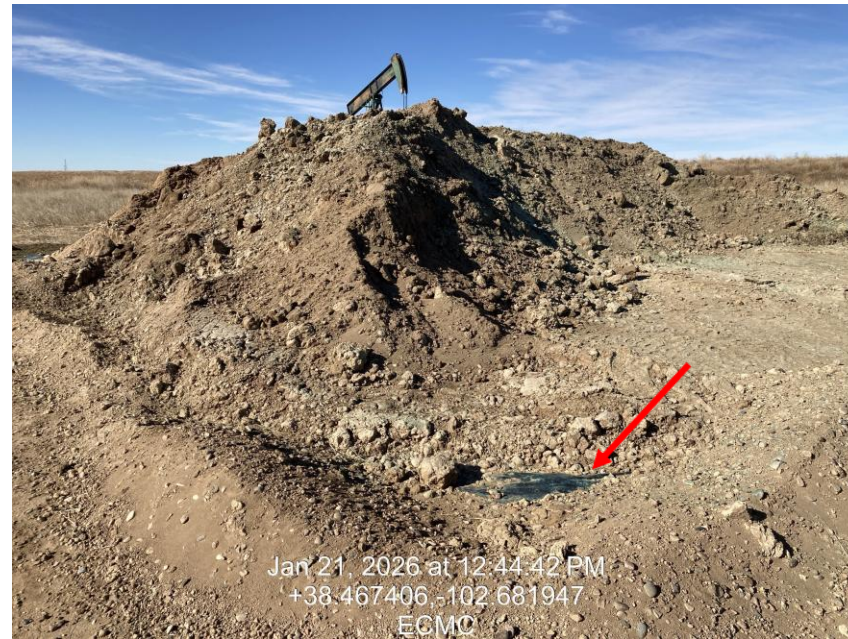
Photo 14 – Spoil pile on liner
