Inspection Photos  
Location Name: Carl Miller Consolidation  
Spill ID: 489817

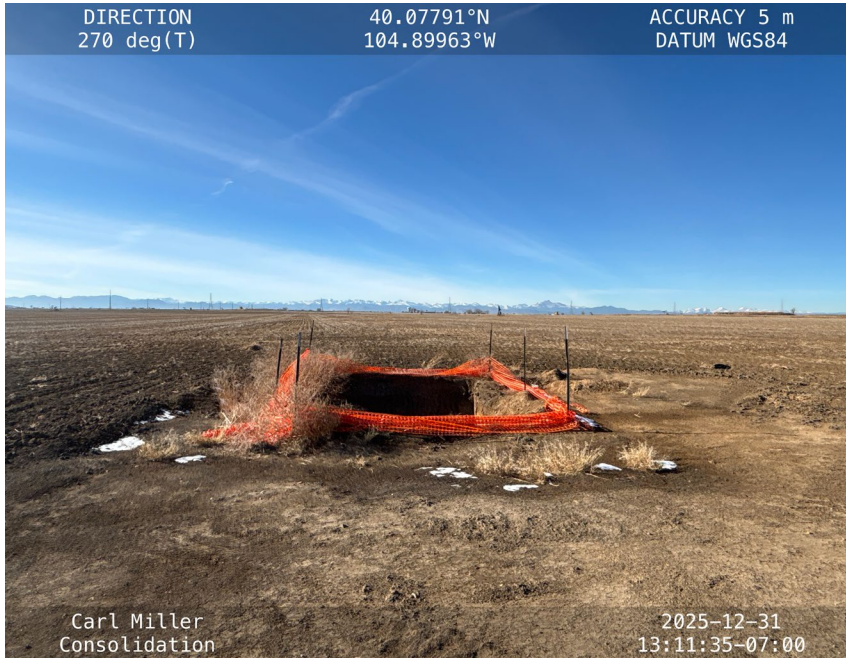
Excavation fencing has fallen. Weeds growing through it.

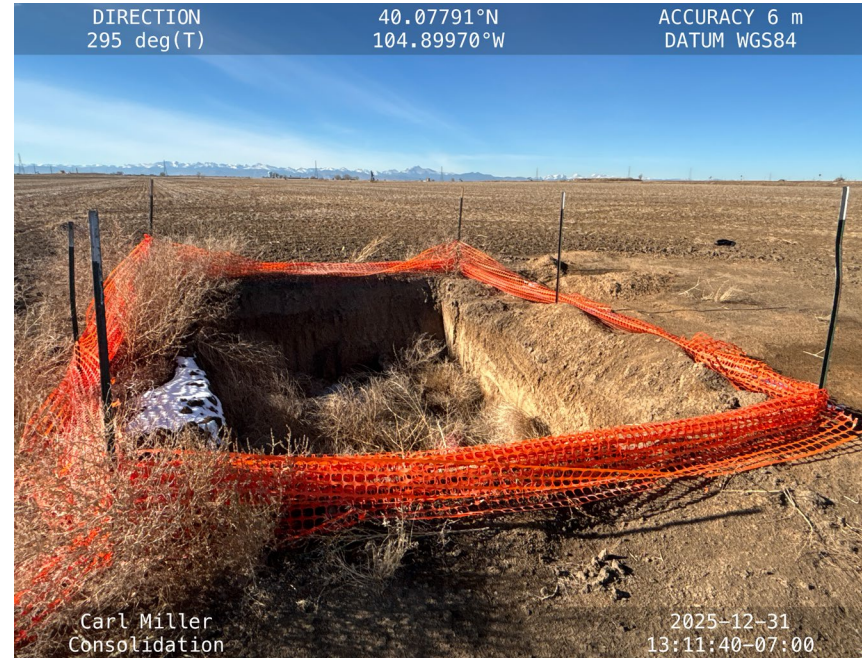
Excavation fencing has fallen. Weeds growing through it.

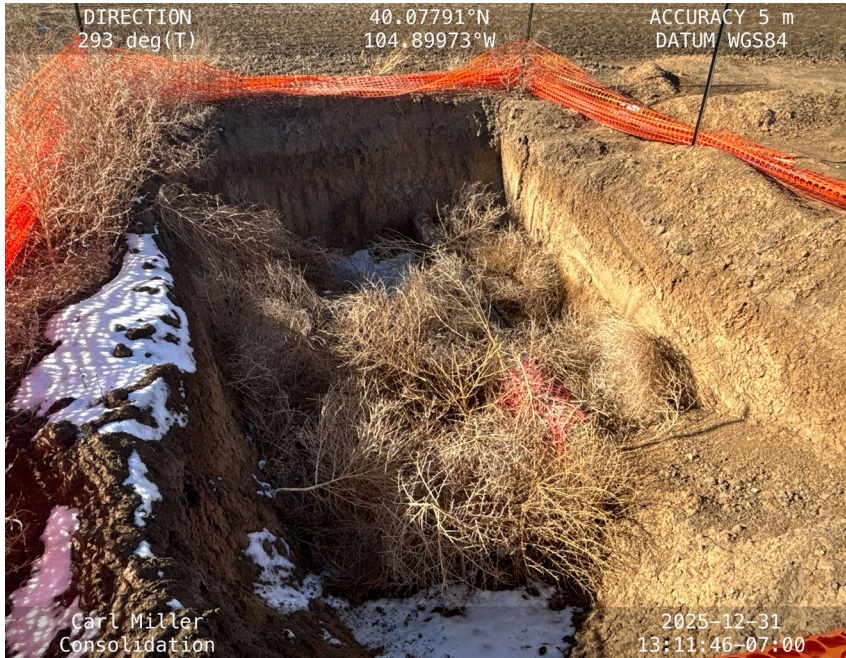
**Excavation fencing has fallen. Weeds growing through it.**

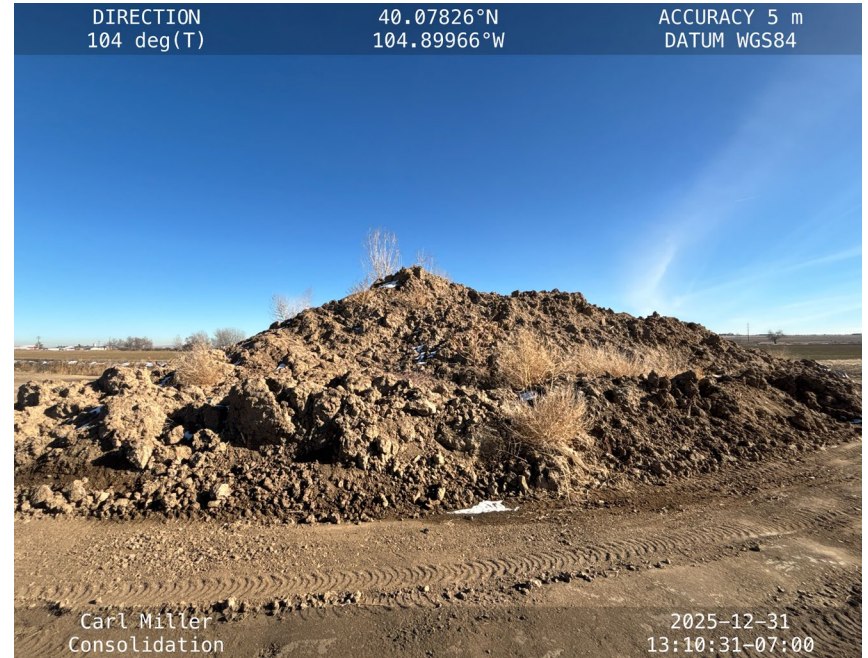
**Stockpile no liner of BMPs**

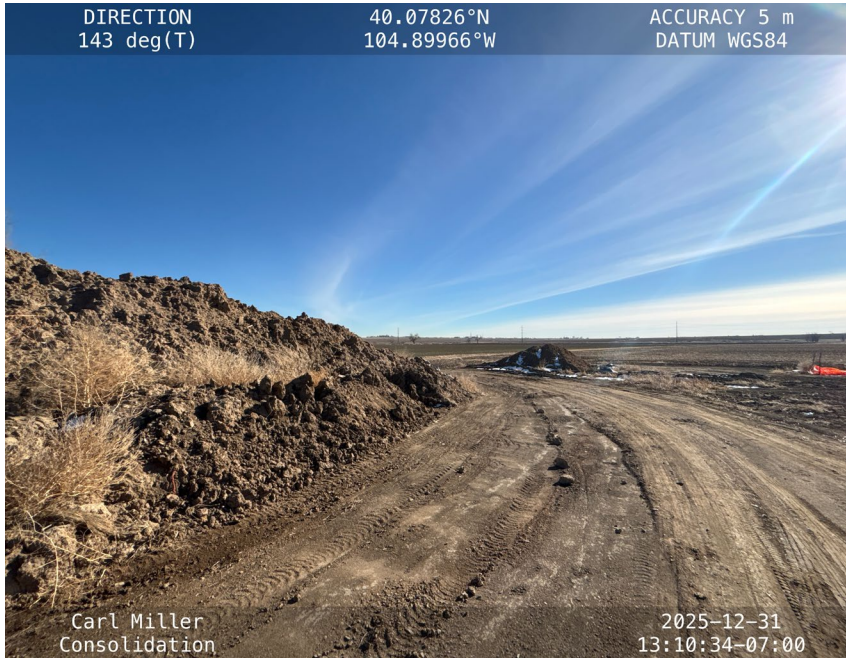
**Stockpile no liner of BMPs**

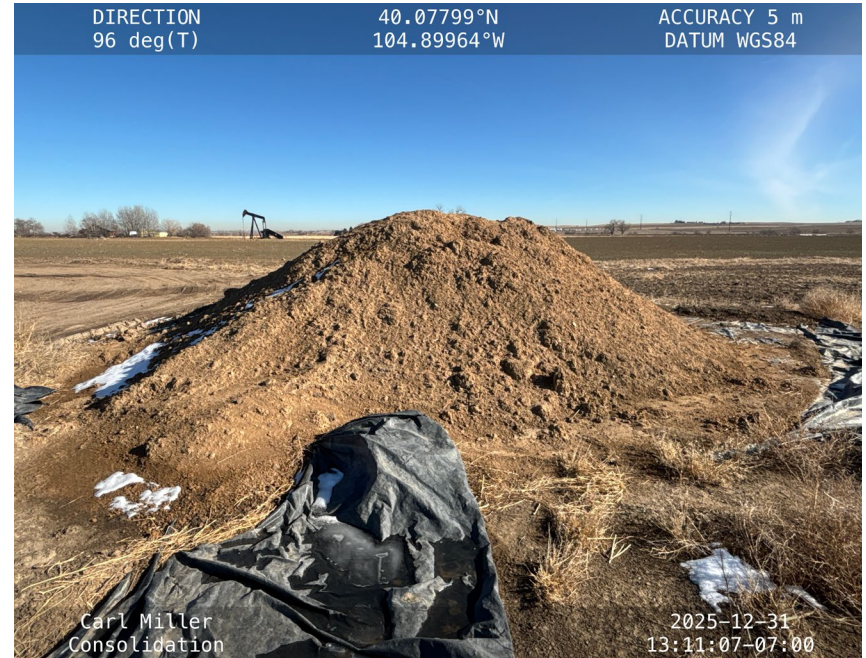
**Stockpile with liner torn**

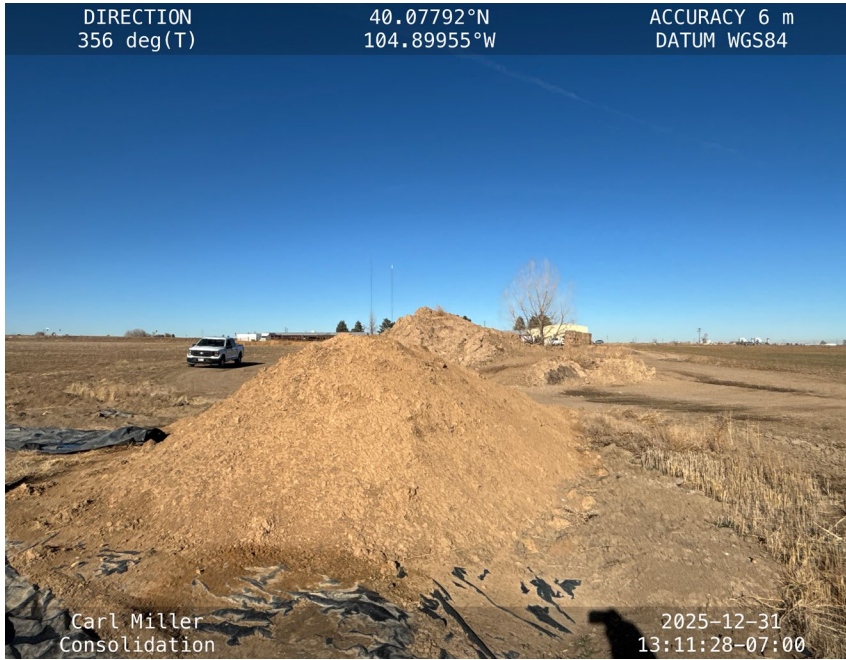
**Stockpile with liner torn**

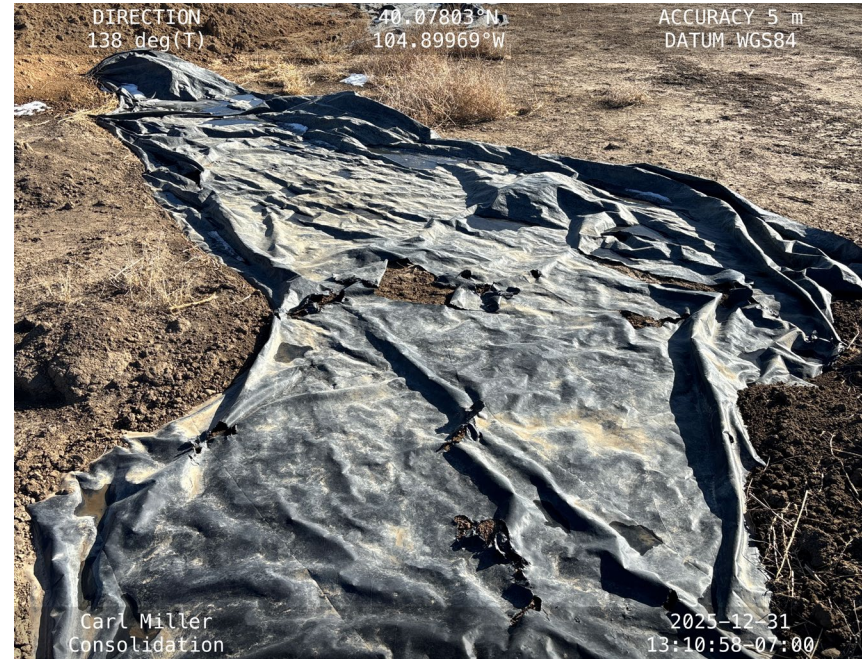
**Stockpile with liner torn**

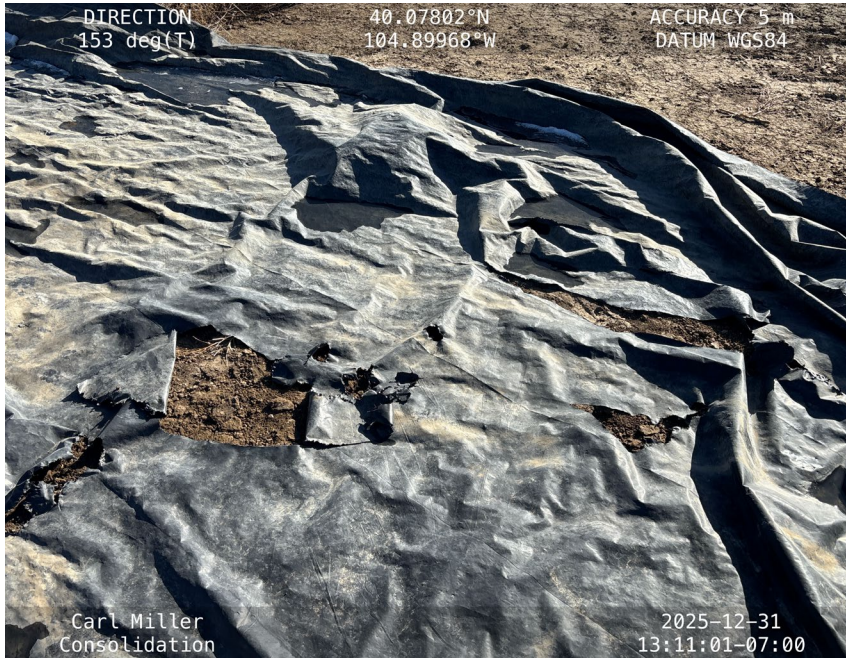
**Stockpile with liner torn**

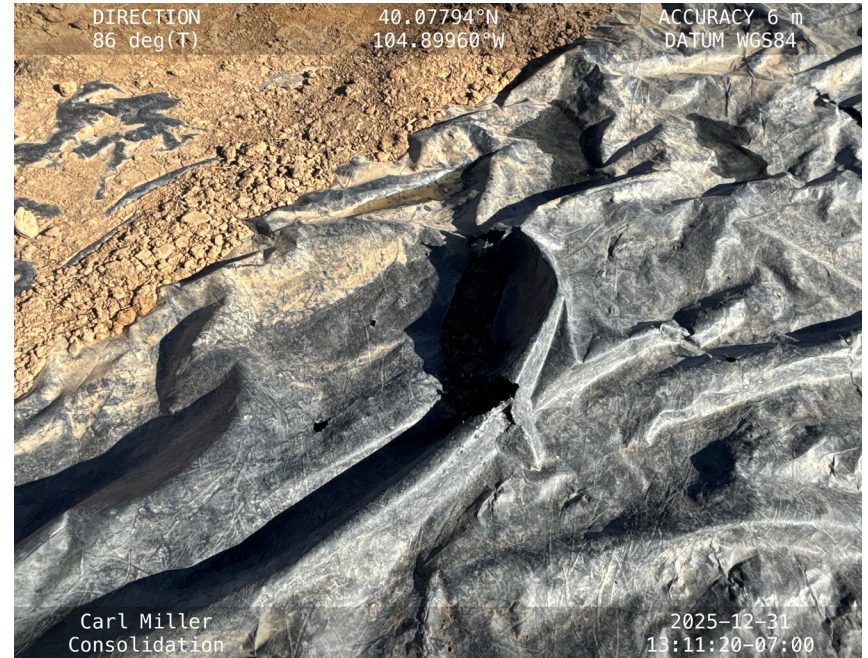
**Stockpile with liner torn**
