ECMC Inspection Photos - KP Kauffman
Location: Stonebraker 42-12 API 05-123-16056
Date 01/14/2026

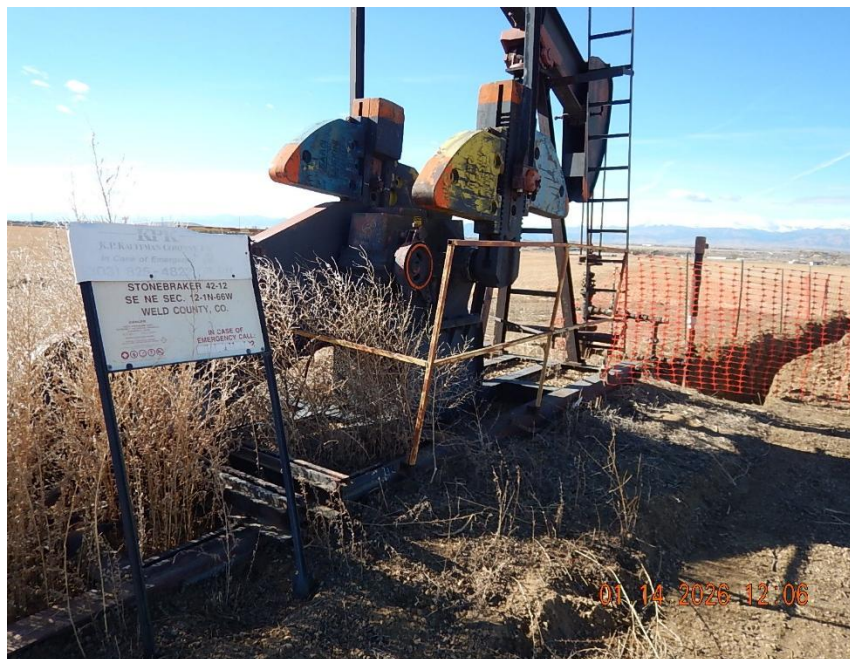
Stonebraker 42-12 well, pump jack and signage
@ 40.067981, -104.945214

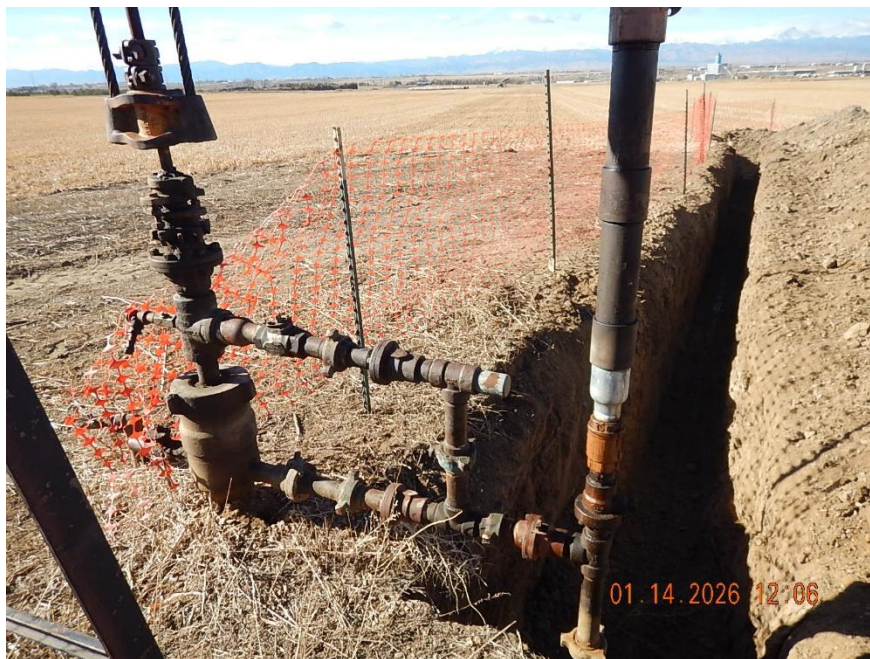
Wellhead and flowline manifold; valves are SI
No OOSLAT observed in place on flowline valves at wellhead
Flowline trench open from wellhead approx. 100' to west

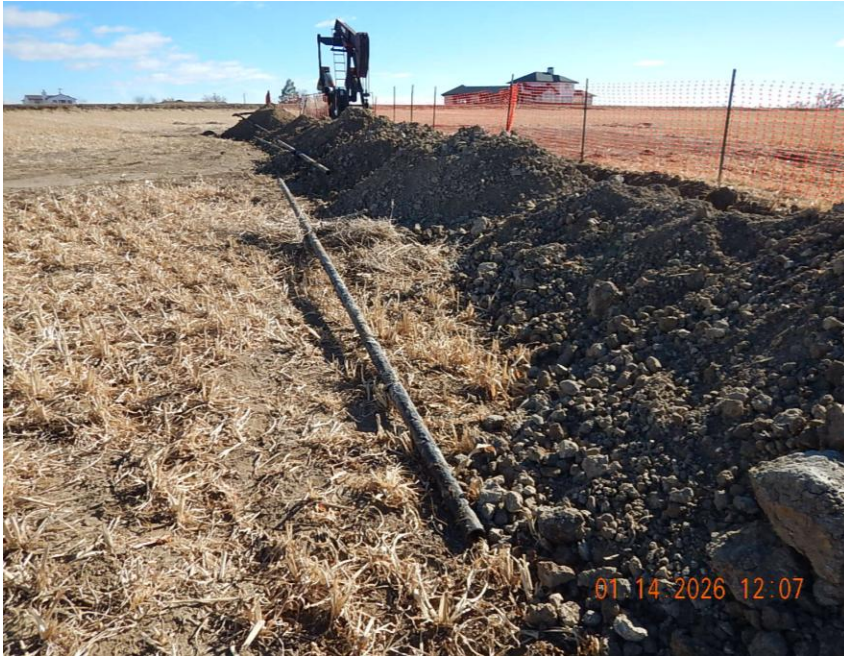
**Flowline pipe segment removed;
2" carbon steel off location multiphase flowline with
historical tape wrap external coating
View looking east**

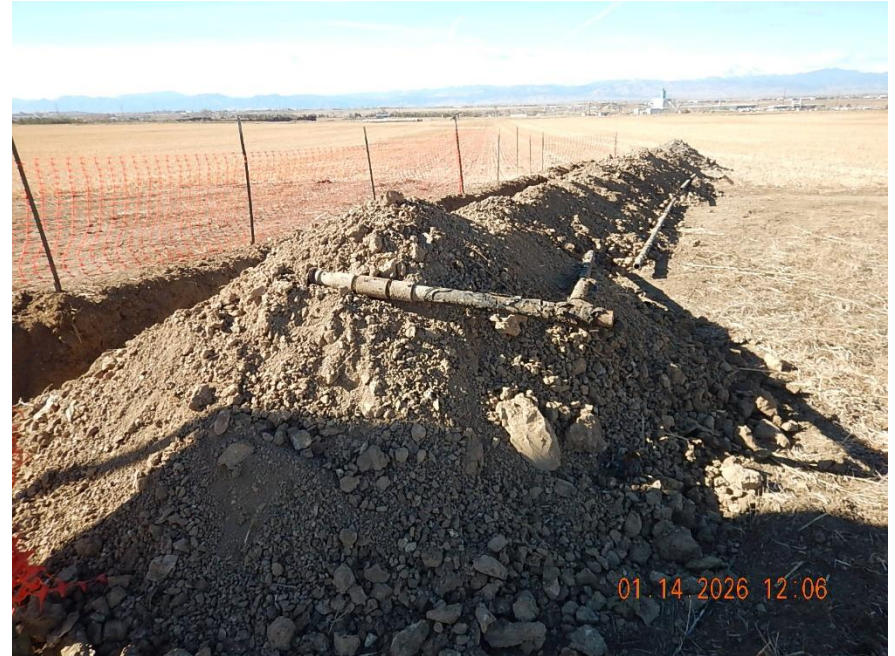
**Flowline pipe segment removed;
2" carbon steel off location multiphase flowline, 90 elbow
and flowline riser that previously tied into wellhead
manifold. View looking west**

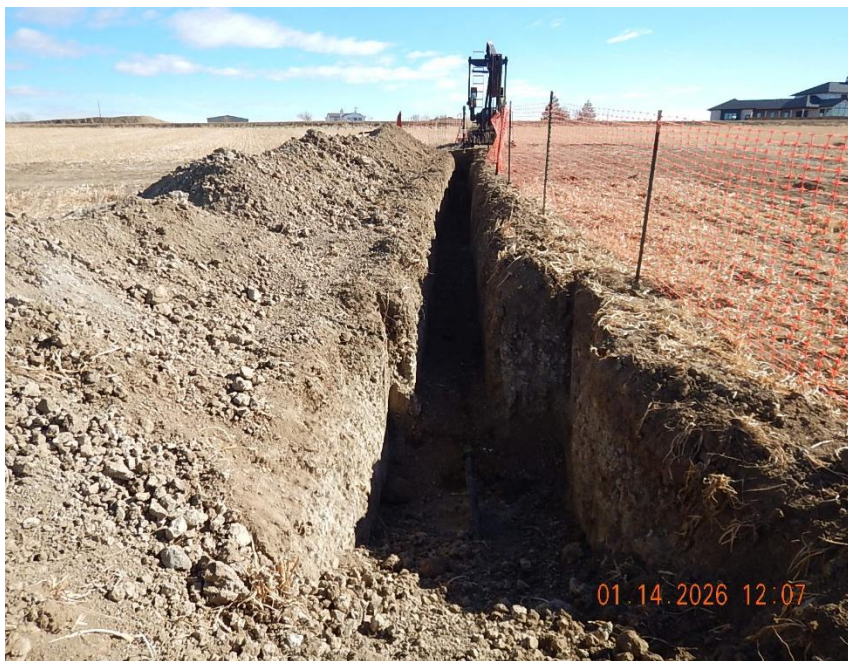
Flowline trench western endpoint @ 40.06798, -104.945571
View looking east

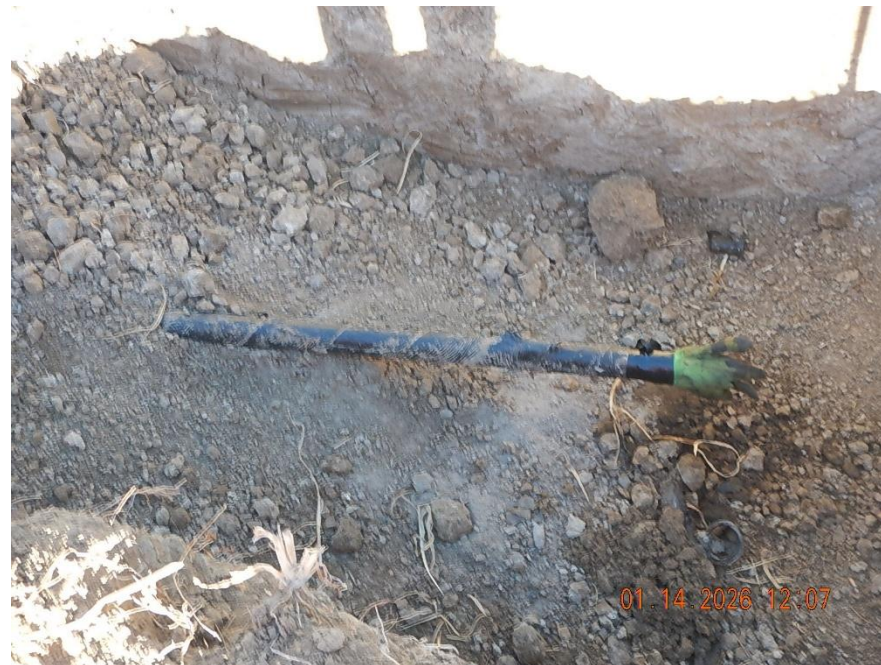
Cut end of Stonebraker 42-12 off location flowline at western endpoint. The cut end appears to be capped; work glove has been placed over the pipe cut end
Stained soils can be seen under cut end of pipe
