Inspection Photos

Location Name: TEP Rocky Mountain LLC MAHAFFEY PA 24-32 Pad

Location # 323949

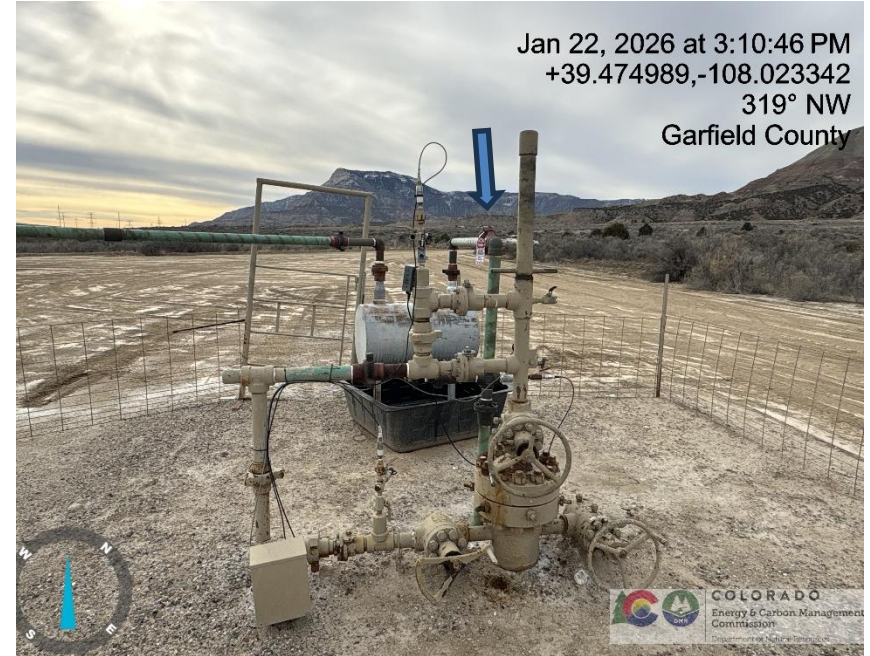
Photo # 4388 Observed valve on BH line going to ECD closed & tagged out

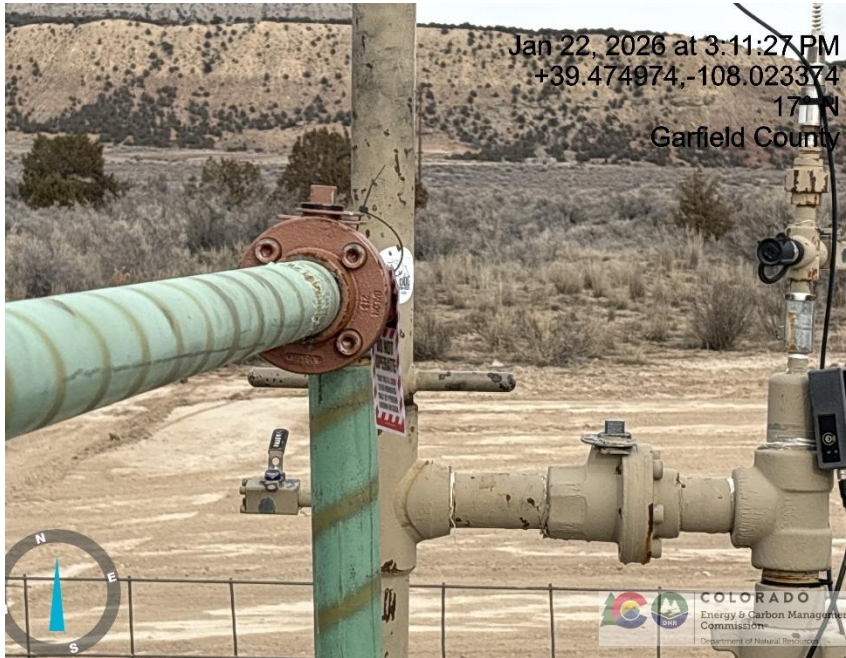
Photo # 4389 Observed valve on BH line going to ECD closed & tagged out

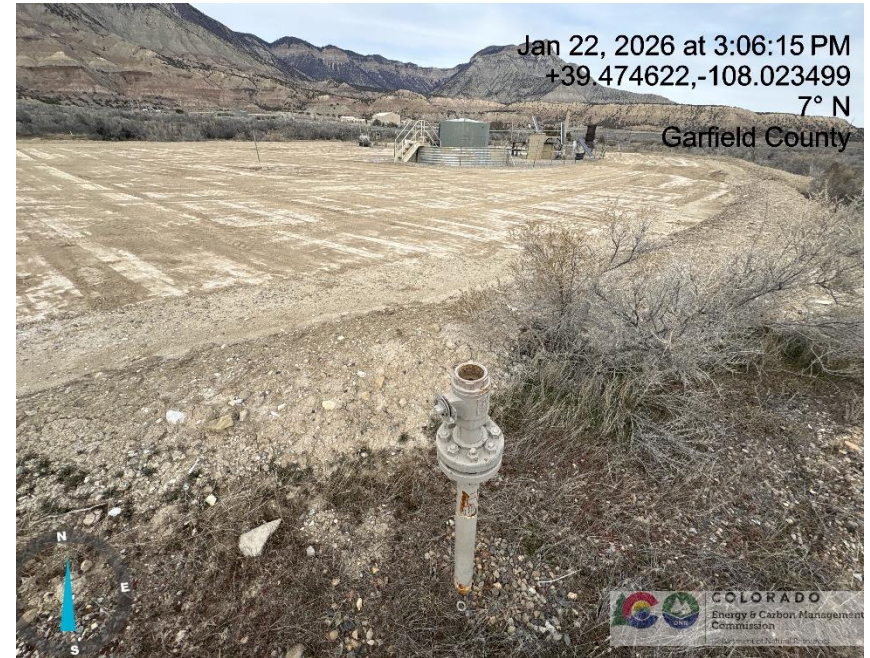
Photo # 4390 Unused flowline lacks lockout tagout (OOSLAT)

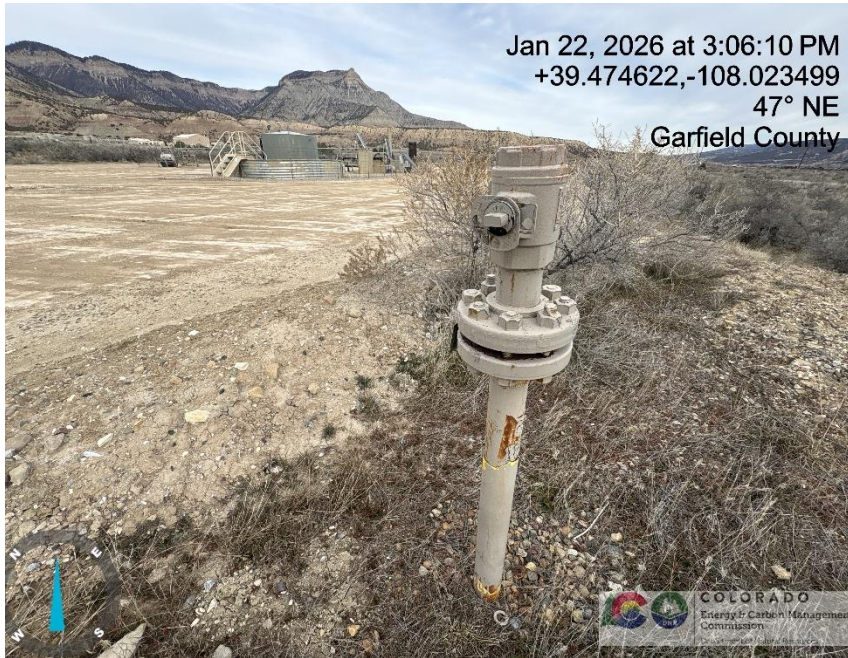
Photo # 4391 Unused flowline lacks lockout tagout (OOSLAT)
