Inspection Photos

Location Name: TEP ROCKY MOUNTAIN LLC CHEVRON GM 33-20 Pad

Location ID: 324126

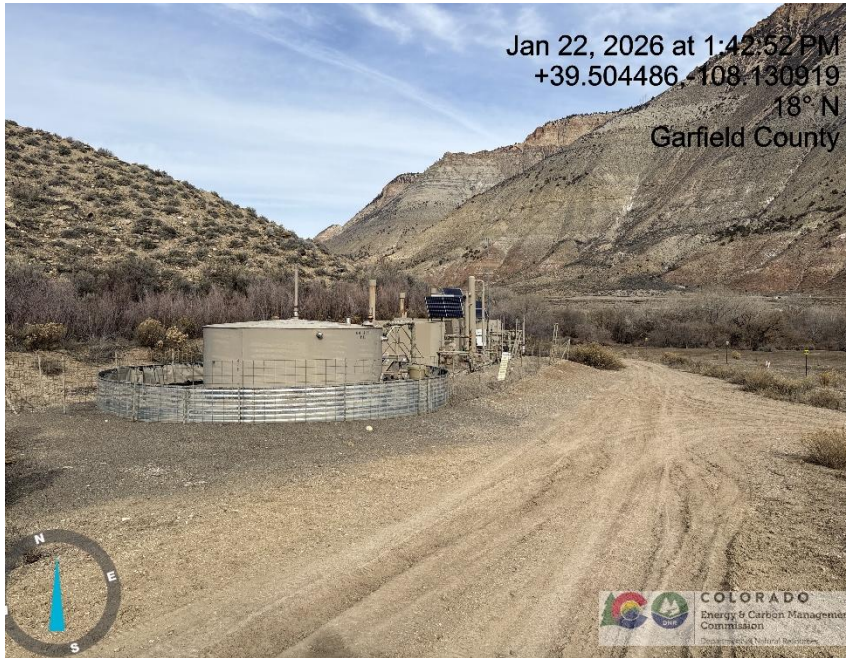
Photo # 4079 From entrance to location

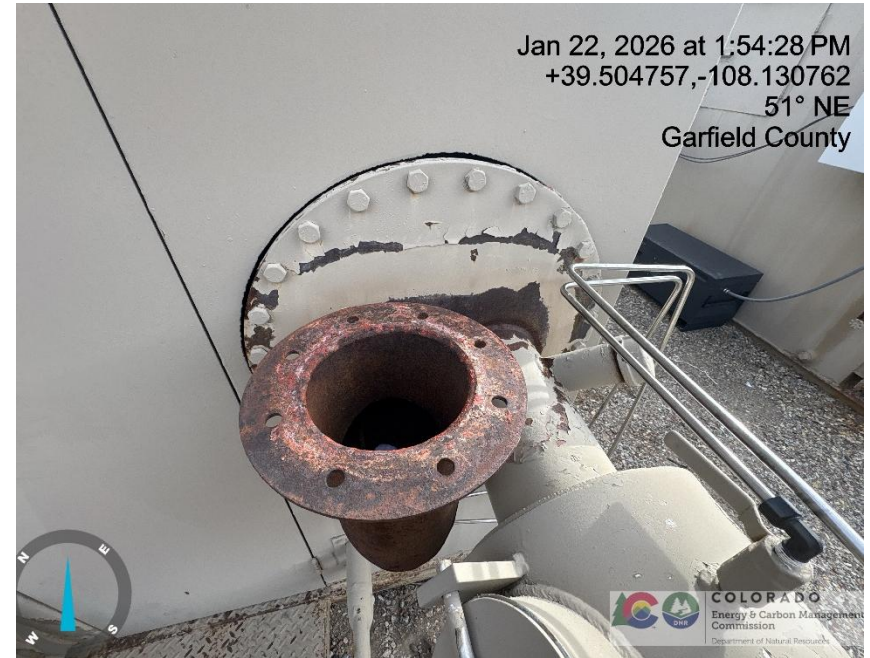
Photo # 4086 Burner exhaust open ended/wildlife hazard/available for entry by wildlife

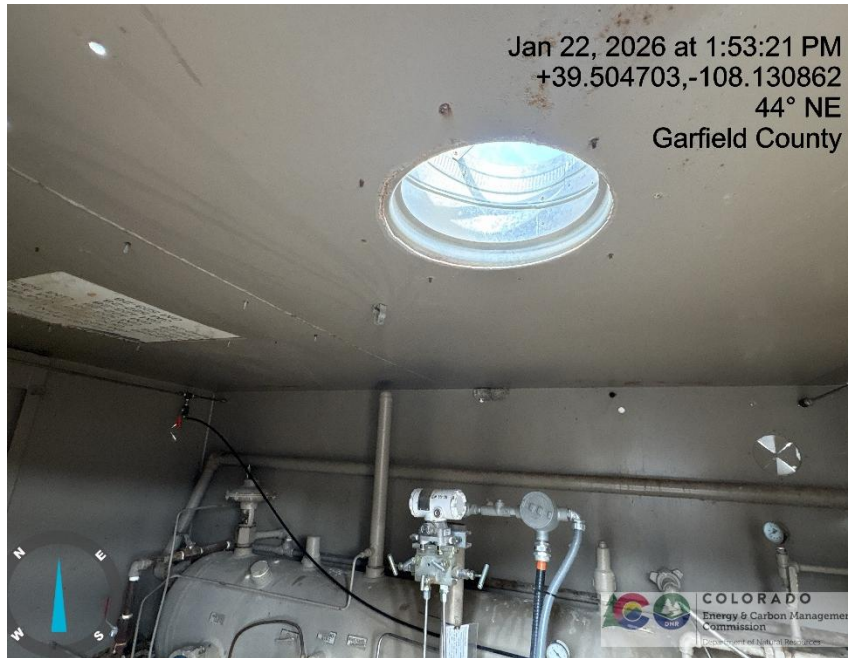
Photo # 4087 Hole in separator/wildlife hazard/available for entry by wildlife

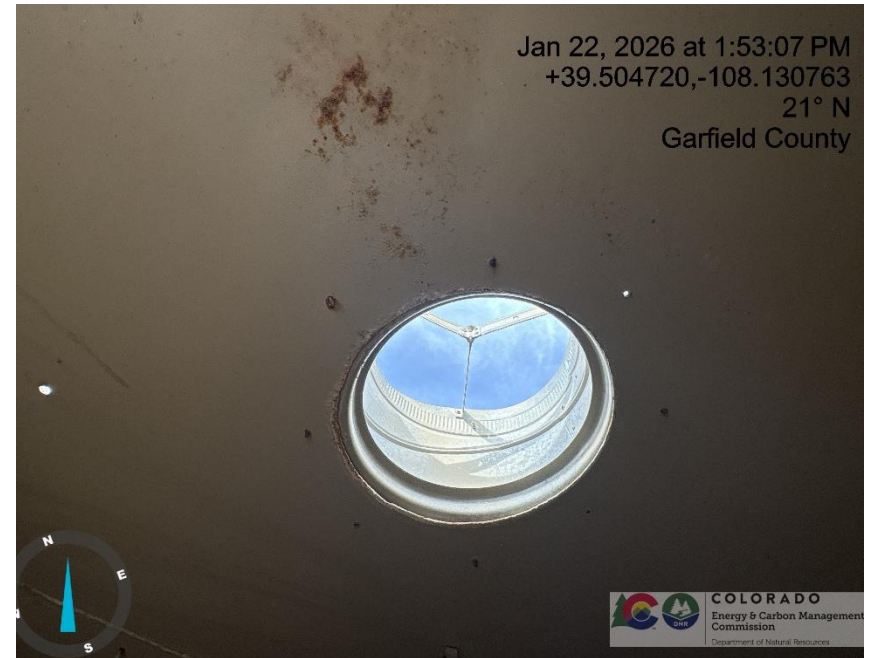
Photo # 4088 Hole in separator/wildlife hazard/available for entry by wildlife

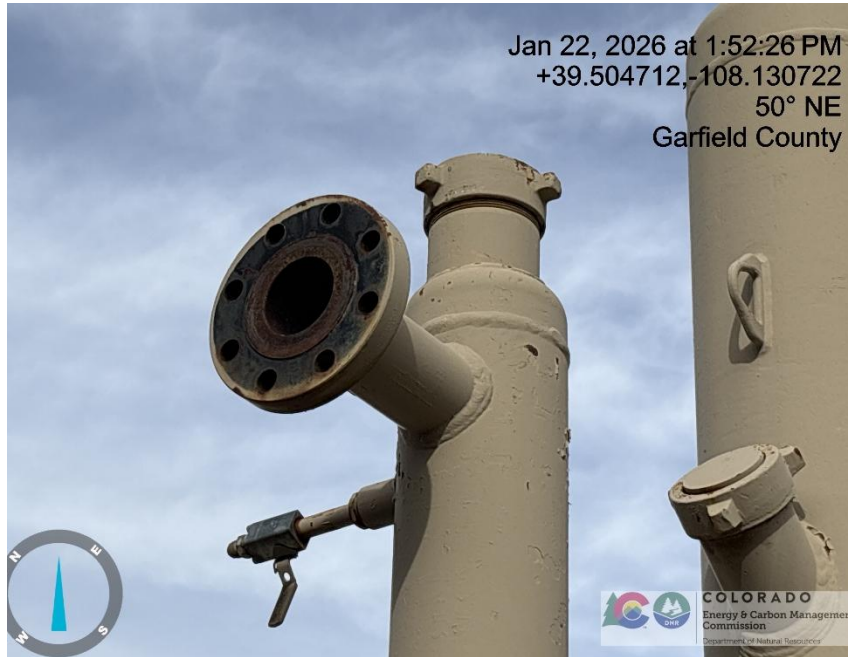
Jan 22, 2026 at 1:52:26 PM
+39.504712, -108.130722
50° NE
Garfield County

Photo # 4089 Flanged piping on separator unit open ended
/wildlife hazard/available for entry by wildlife

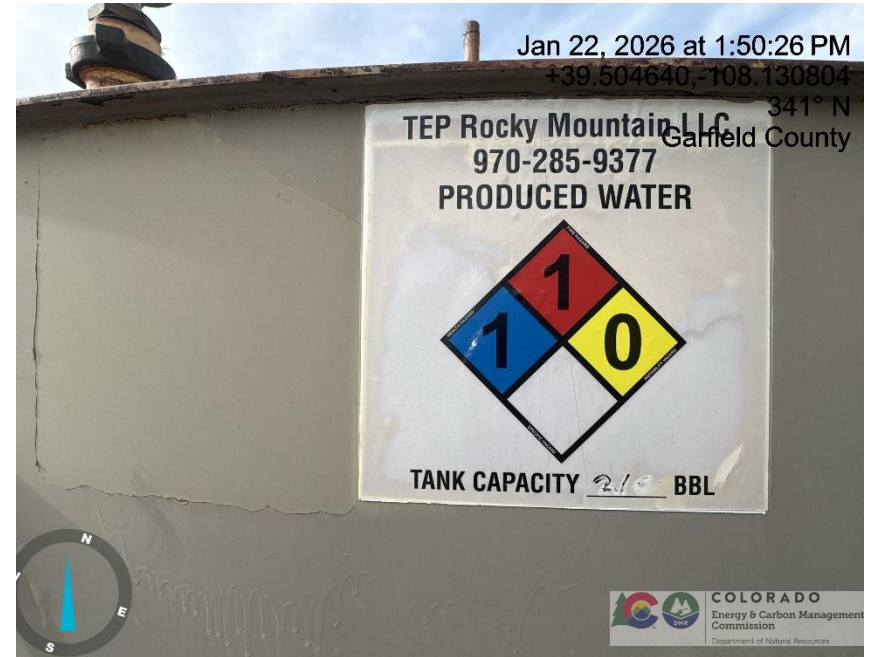
Jan 22, 2026 at 1:50:26 PM
+39.504640, -108.130804
341° N
Garfield County

Photo # 4090 Capacity on tank label faded & becoming
illegible
