Final Reclamation Inspection

Operator: PDC ENERGY INC - 69175

Location ID: 329406

Inspection Photos
Location Name: BECKER #5-11
Location ID: 329406

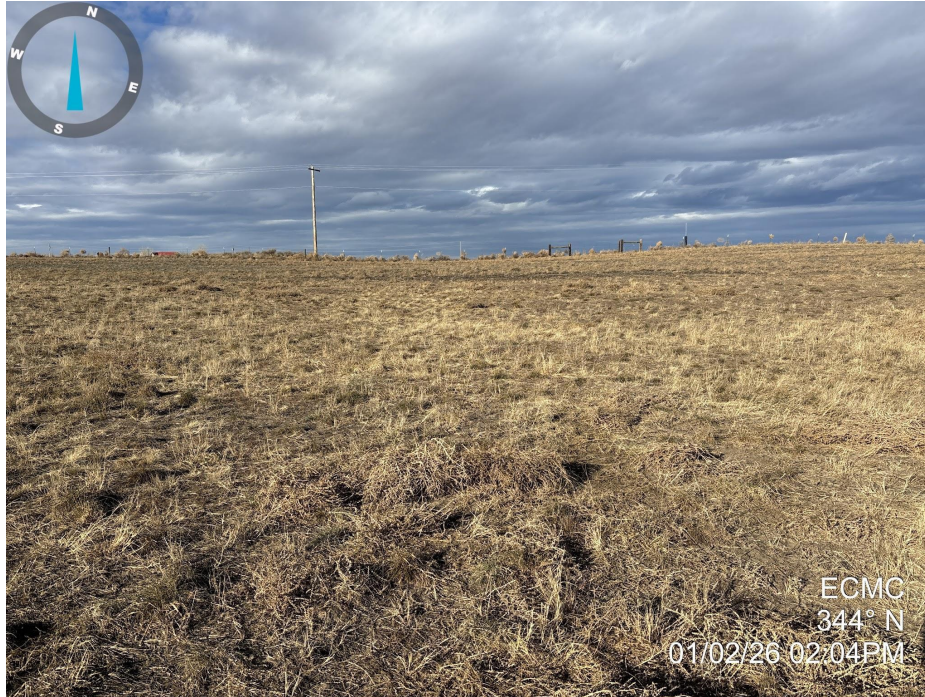
Photo 1. Photo taken of the well location, facing north. Photo illustrates that final reclamation activities appear to have taken place, with evidence of drill row seeding, but vegetation establishment does not meet Rule 1004 standards. Weedy annual vegetation including kochia (*Bassia scoparia*) was observed across the location.

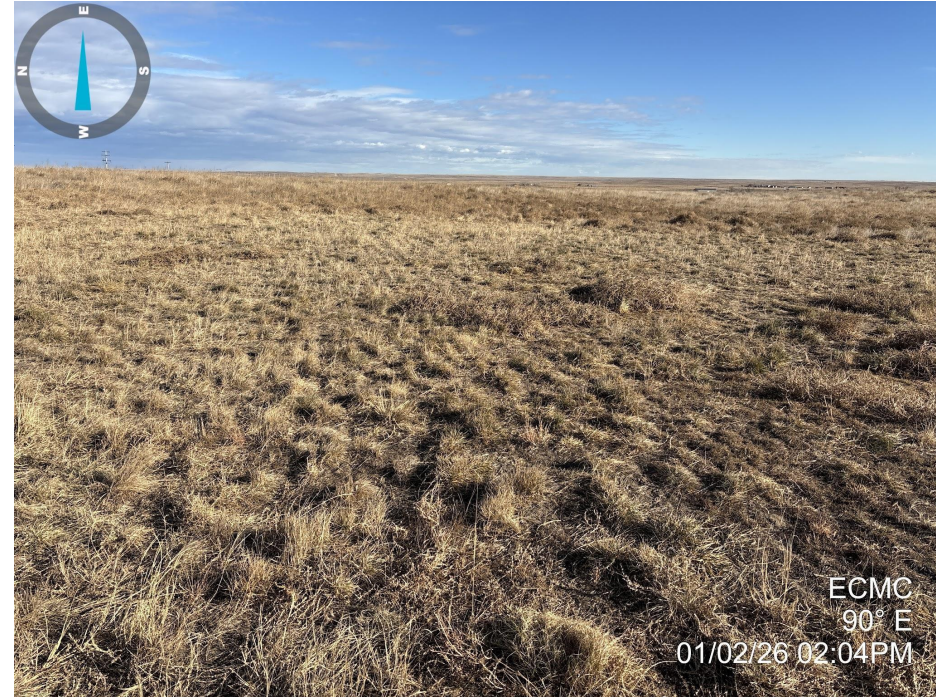
Photo 2. Photo taken of the well location, facing east. See comments under Photo 1.

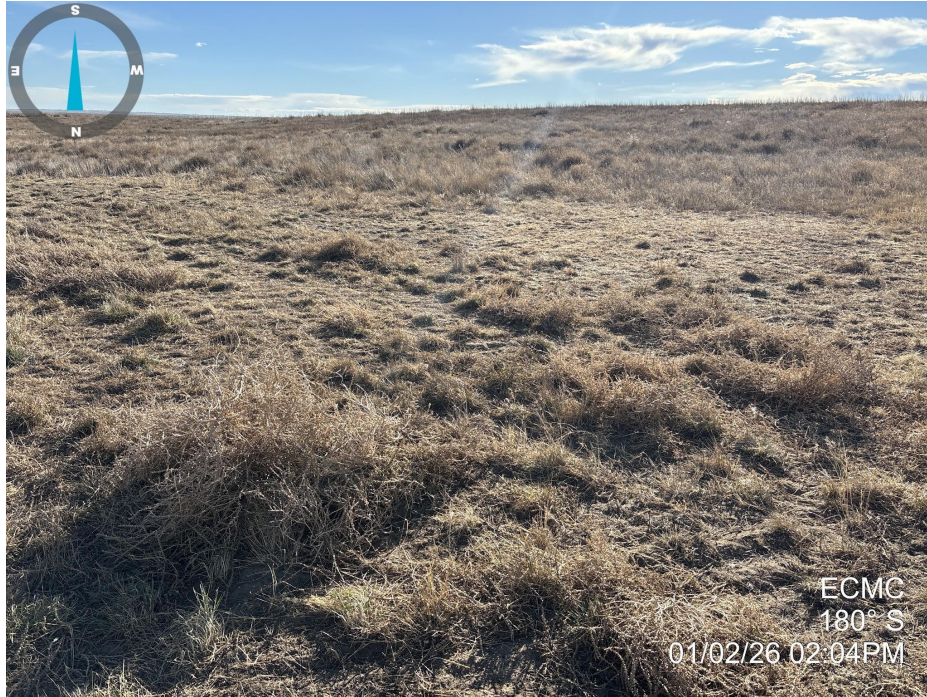
Photo 3. Photo taken of the well location, facing south. See comments under Photo 1.

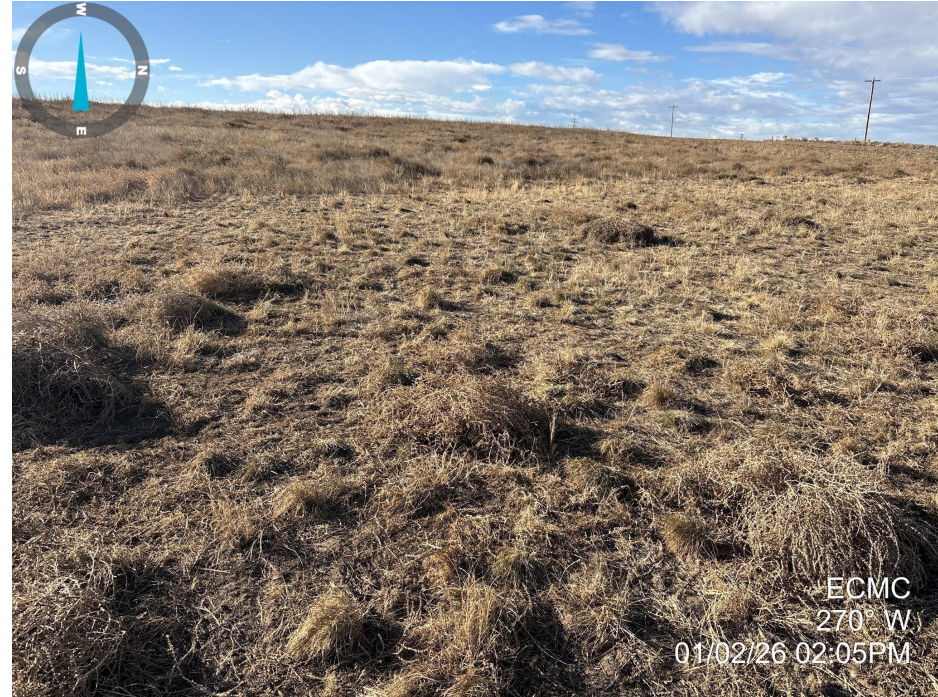
Photo 4. Photo taken of the well location, facing west. See comments under Photo 1.

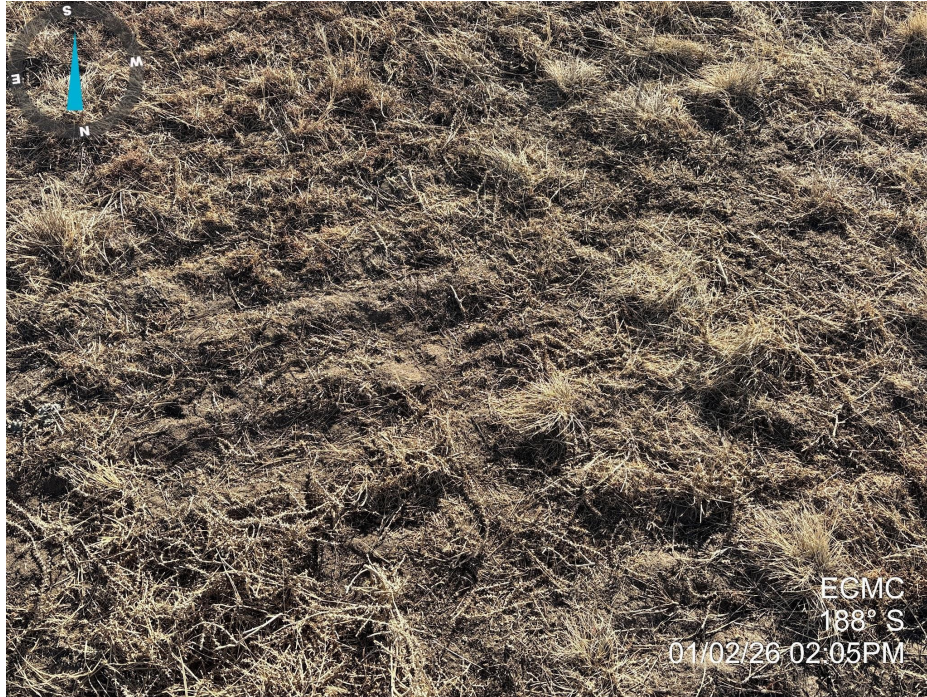
Photo 5. Photo taken of ground cover at the location. Photo illustrates perennial grass, bare ground, and drill rows from seeding.

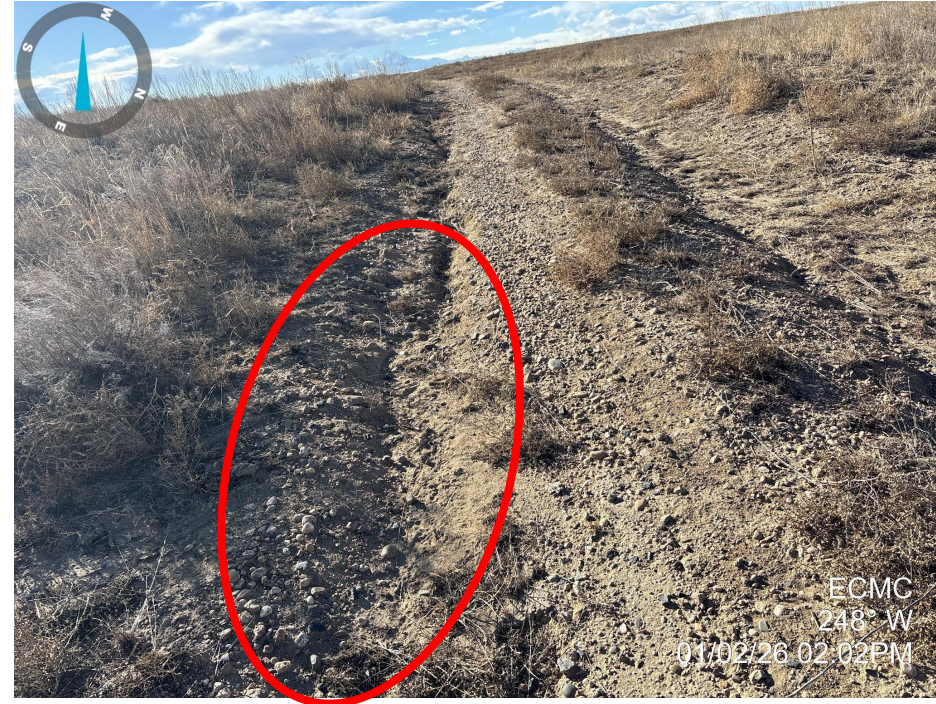
Photo 6. Photo taken of the access road to the location, facing west. Photo illustrates that this portion of the access road to the location remains unreclaimed. Stormwater erosion was observed along the road (circled in red).

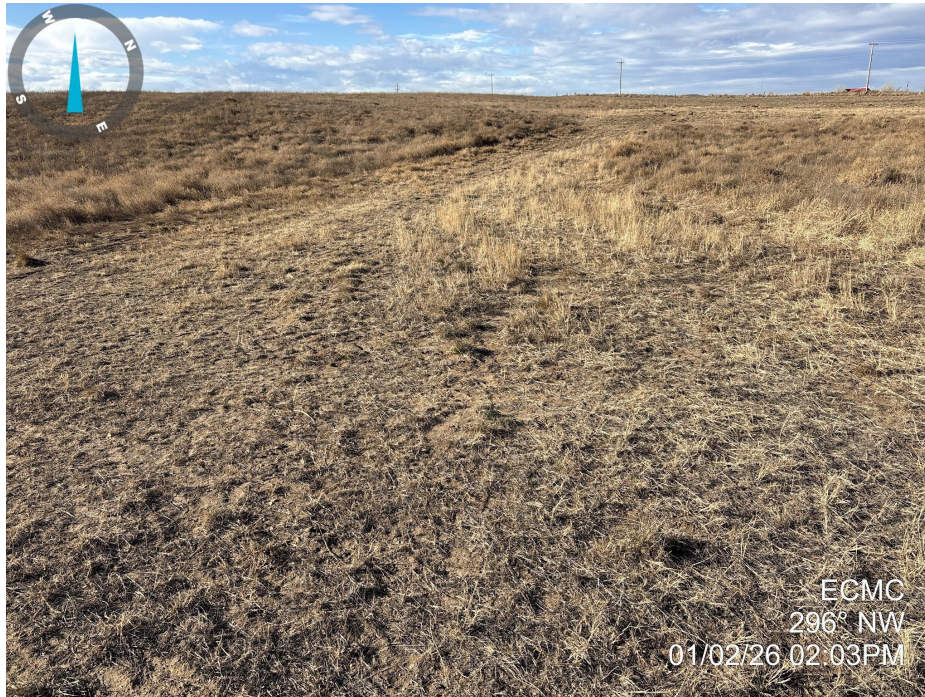
Photo 7. Photo taken of the access road to the location, from the location, facing northwest. Photo illustrates that this portion of the access road has been reclaimed, with evidence of drill row seeding. However, vegetation establishment does not meet Rule 1004 standards.

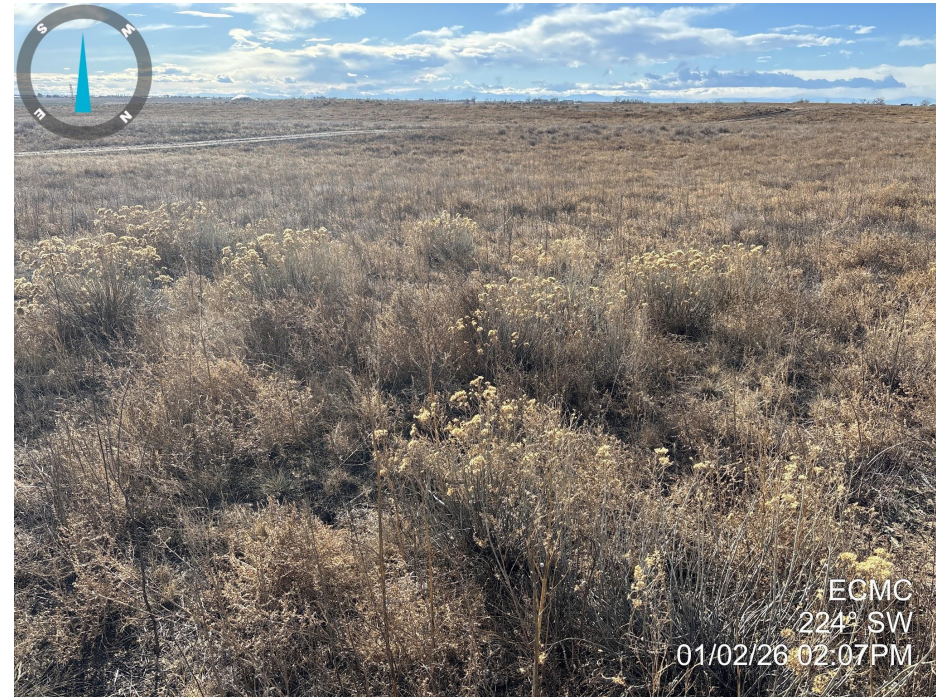
Photo 8. Photo taken of the reference area to the location, southwest of the location, facing southwest. Photo illustrates perennial grass and weedy annual vegetation.
