# Final Reclamation and Stormwater Inspection

Operator: WESTERN INTERIOR ENERGY INC - 95750

Location ID: 319953

Well Name: HILTON #1

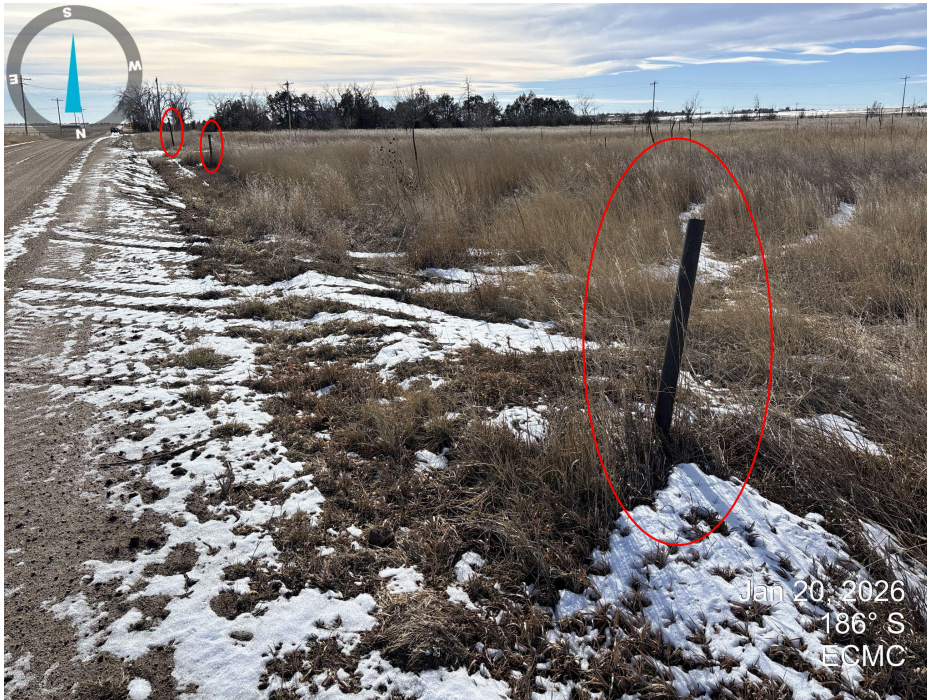
**Photo 1.** Picture taken on wolf creek rd looking south. Three oilfield pipes are present near the entrances to the tank battery (red circles).

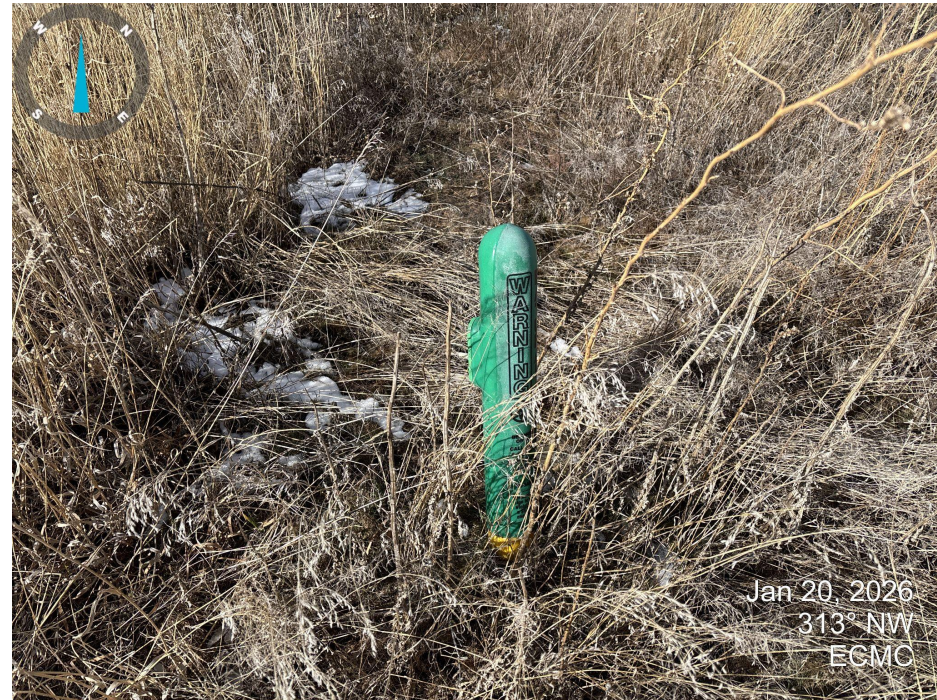
**Photo 2.** An underground gas line ground test station is present on location. A previous FIRR indicated this may be a permanent piece of equipment. The L shaped vent pipe was not observed on the location.

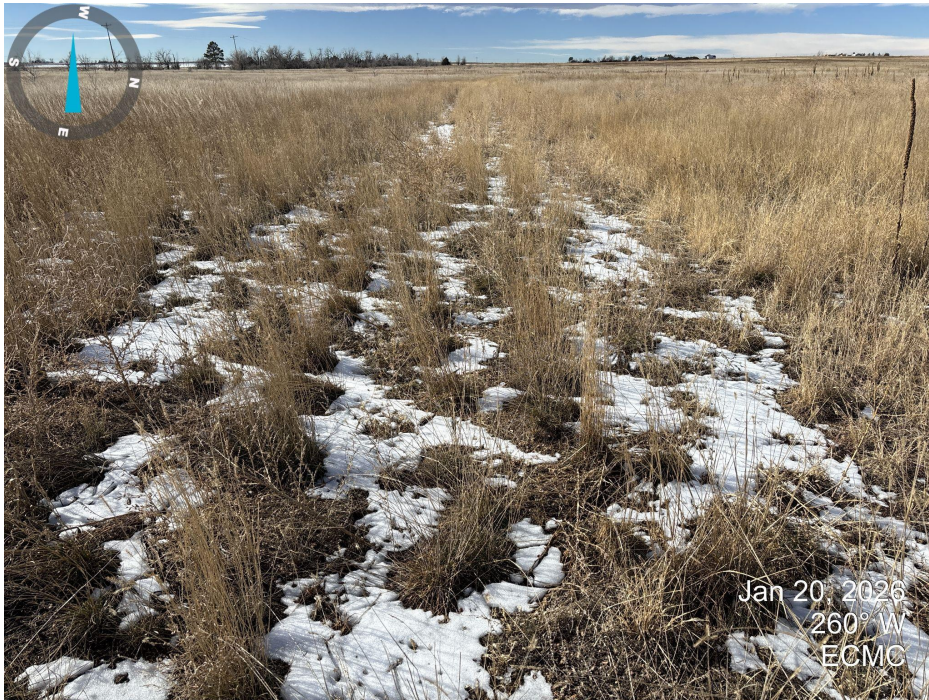
**Photo 3.** Looking west down the former access road. Desirable vegetation appears to have established on the access road and is progressing towards 80% coverage of the reference area.

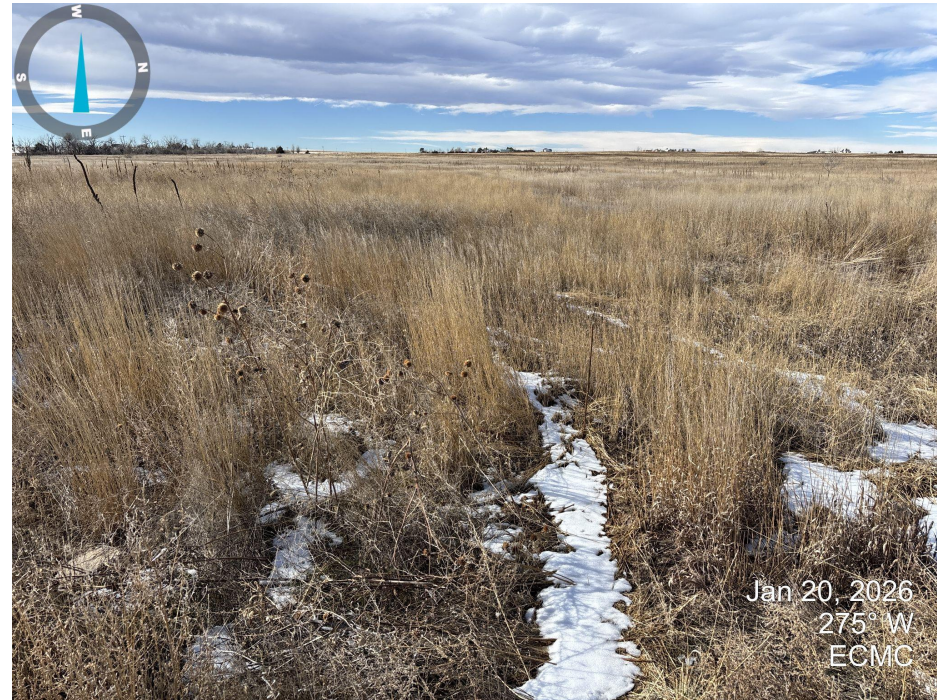
**Photo 4.** Looking west across the tank battery location from the east side. Desirable vegetation is present on the location and appears to be progressing towards 80% coverage of the reference area. Undesirable vegetation such as kochia and list C noxious weed cheatgrass is present on the location.

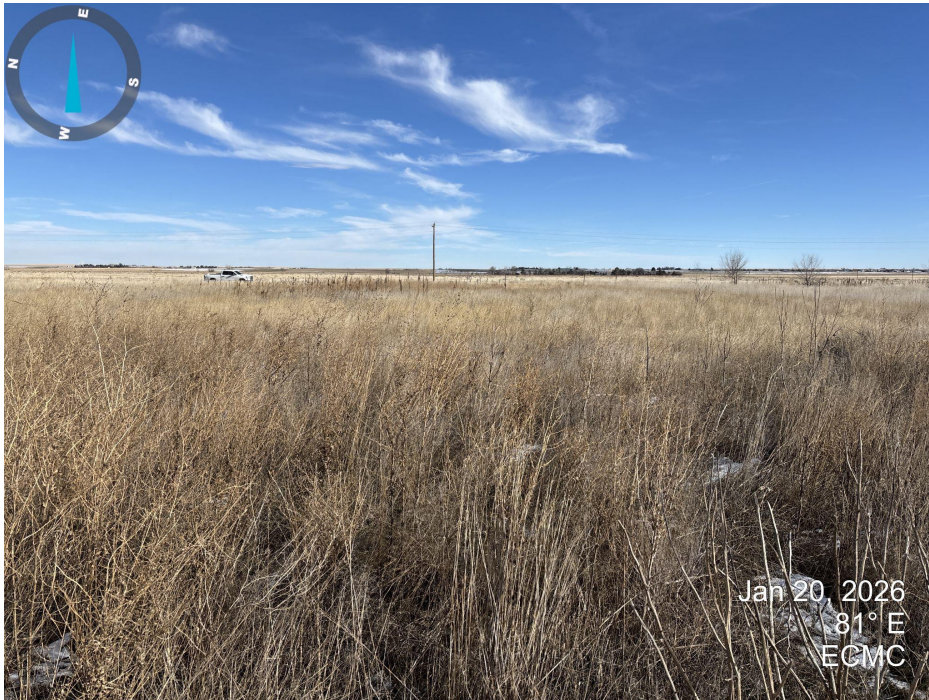
**Photo 5.** Looking east across the tank battery location from the west side of the tank battery. See photo 4 comments.

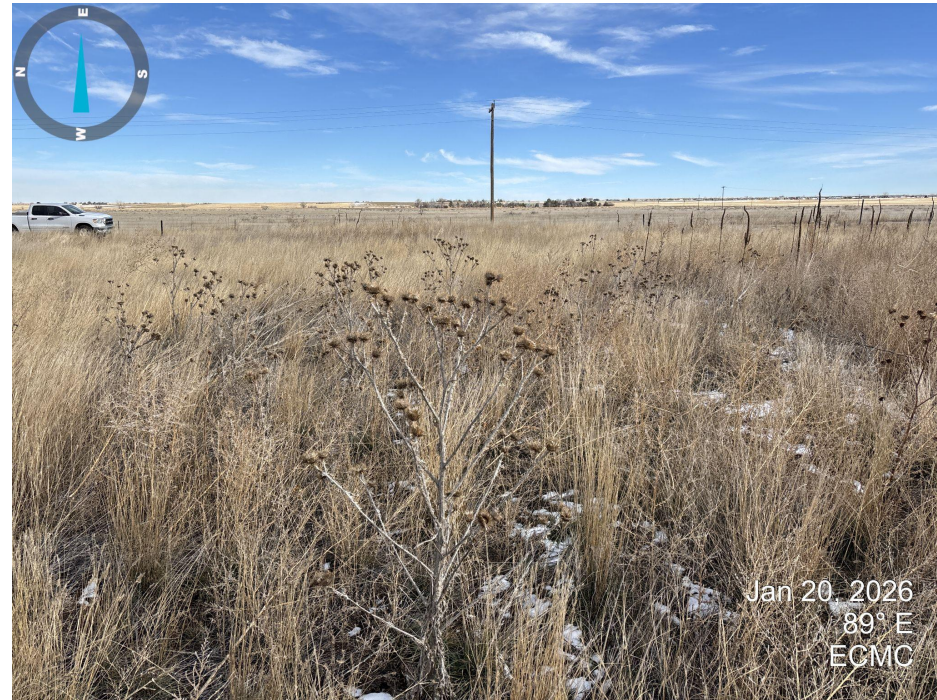
**Photo 6.** Photo taken near the center of the tank battery looking east. List B noxious weed scotch thistle was observed on the location.

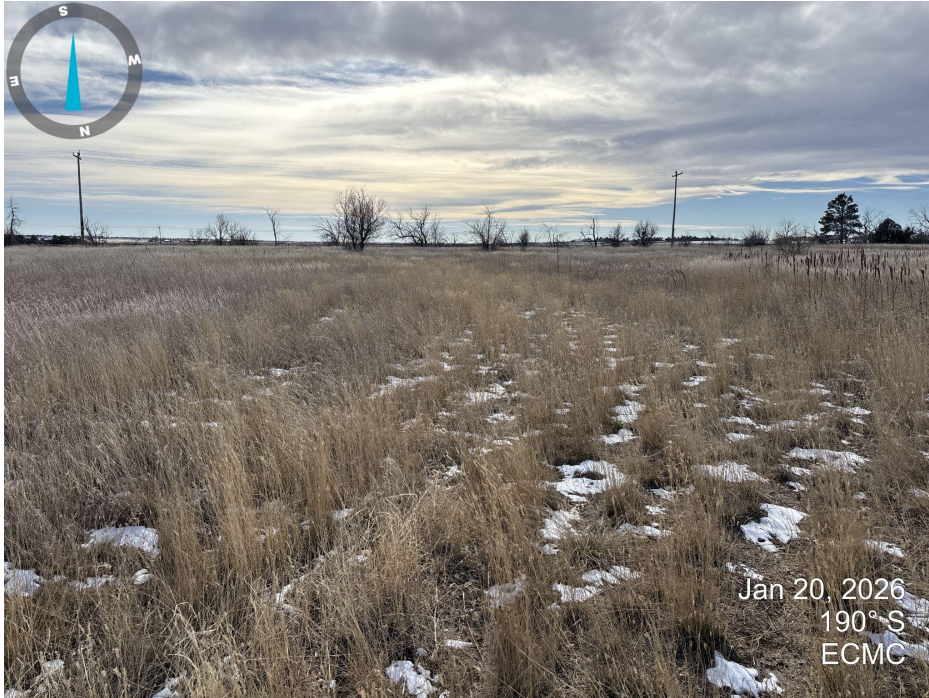
**Photo 7.** Looking south down the access road towards the well location. Desirable vegetation has established on the access road.

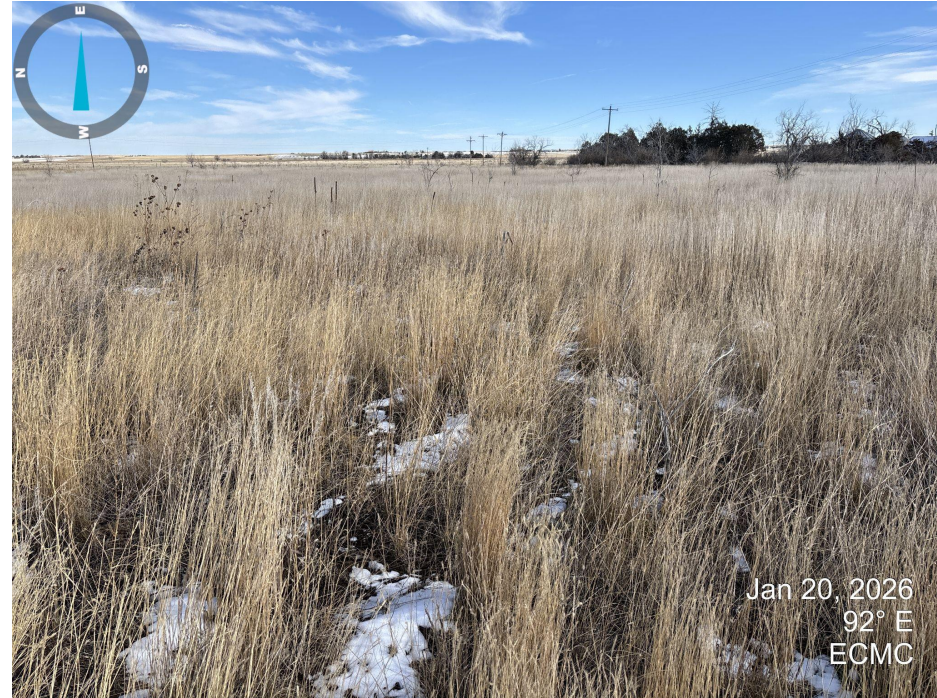
**Photo 8.** Looking east across the well location. Desirable vegetation has established on the well location.

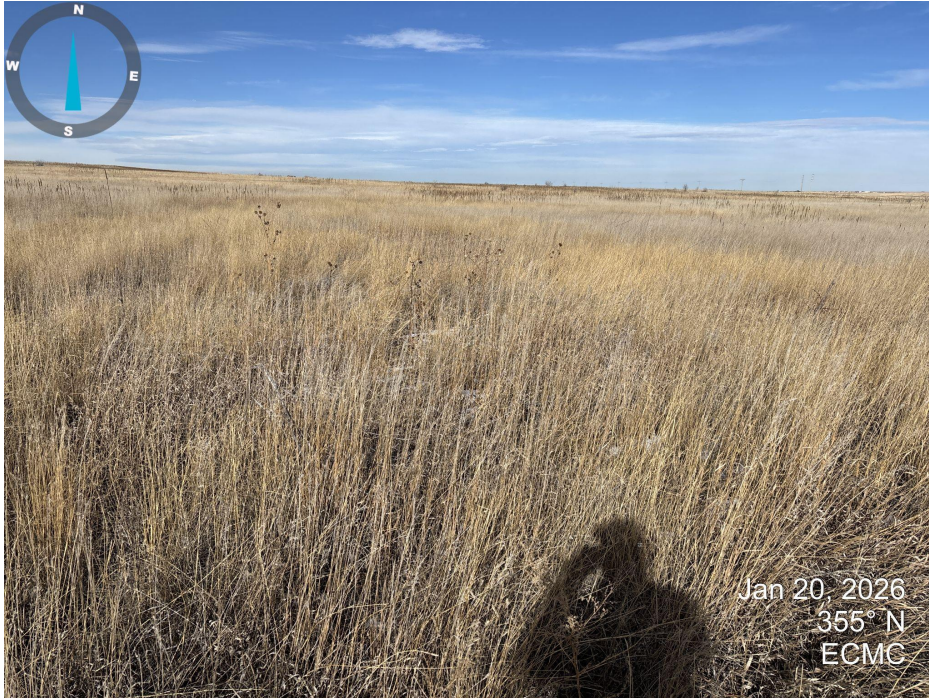
**Photo 9.** Looking north from the wellbore area. See photo 8 comments.

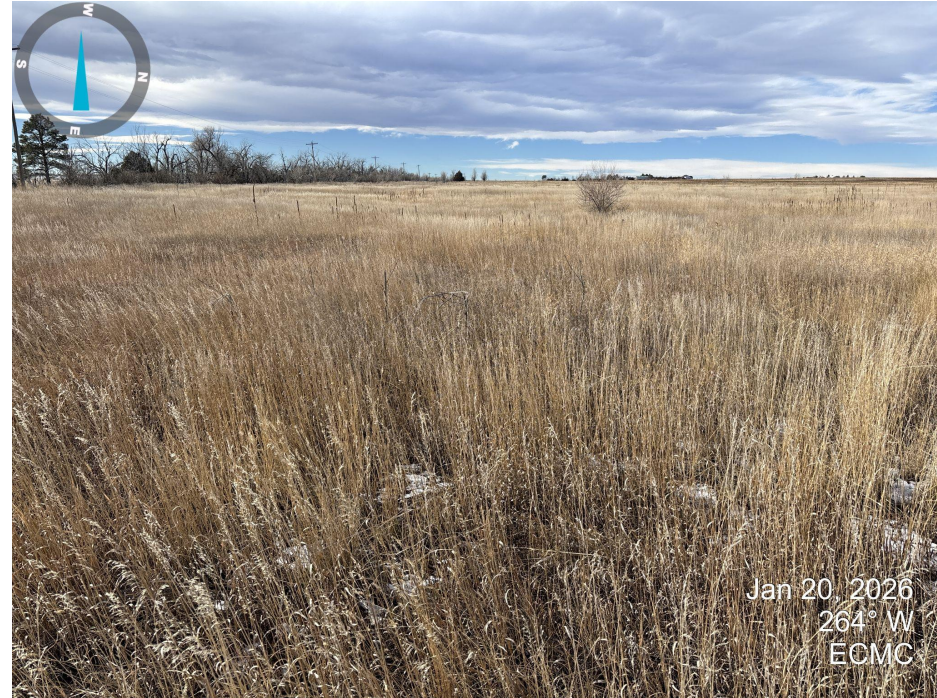
**Photo 10.** Looking west from the wellbore area. See photo 8 comments.

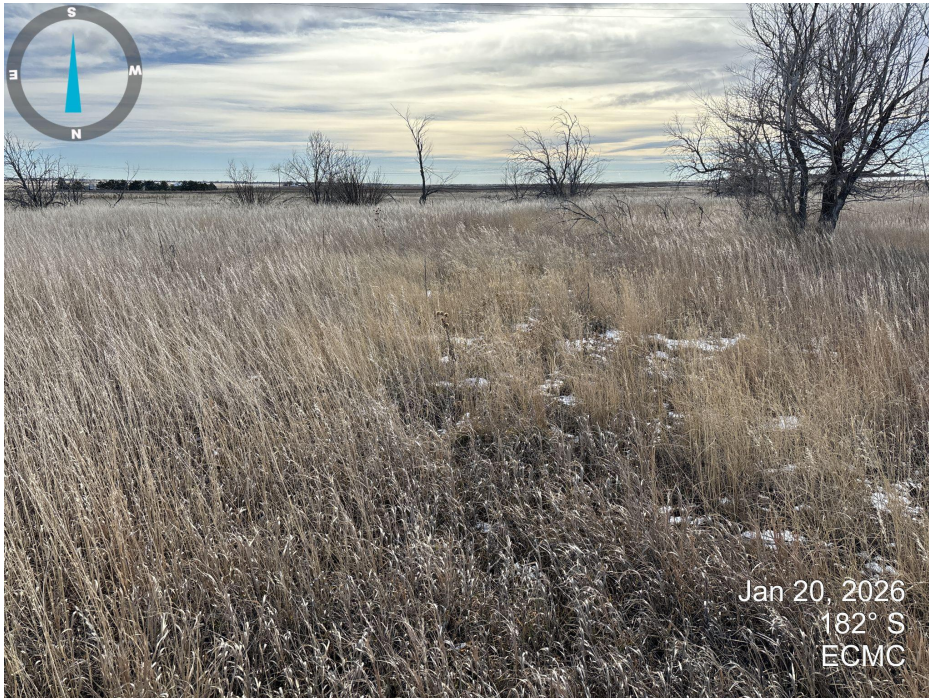
**Photo 11.** Looking south from the wellbore area. See photo 8 comments.

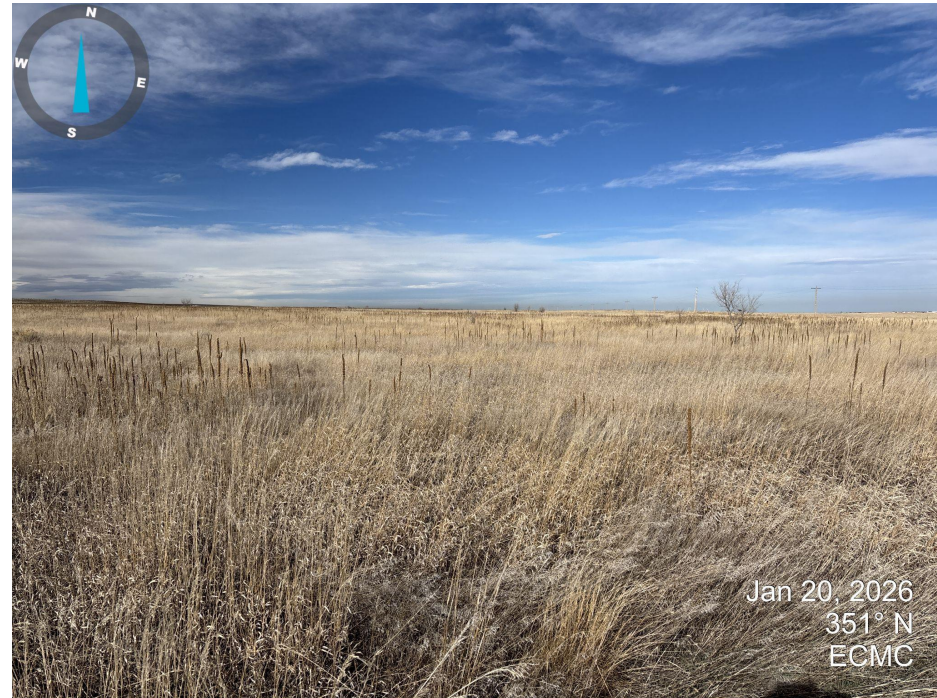
**Photo 12.** Reference vegetation to the north of the tank battery location.

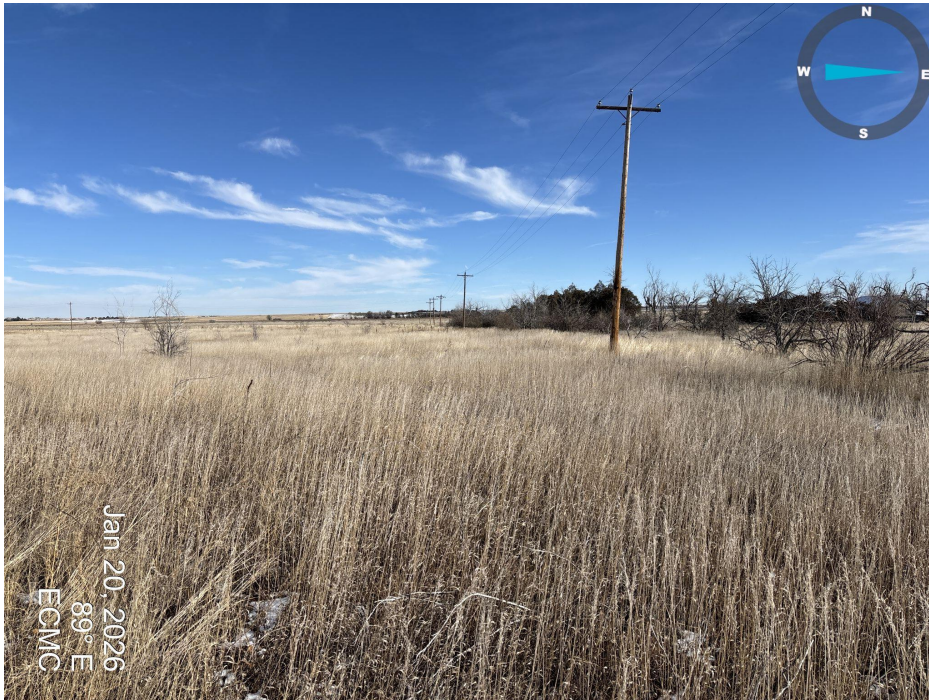
**Photo 13.** Picture taken near the wellbore location looking east. Powerline remains.

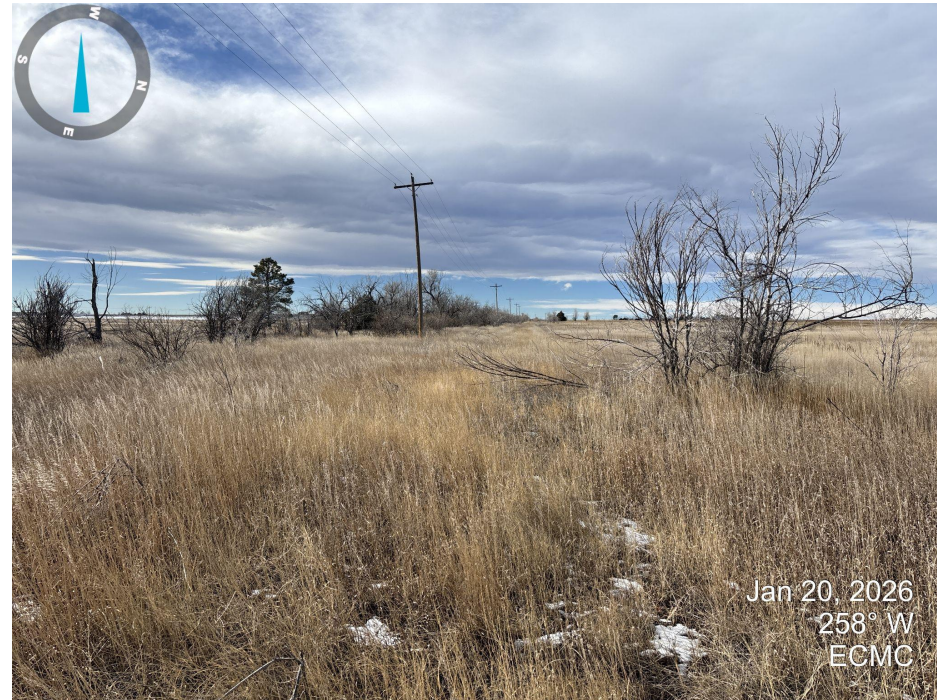
**Photo 14.** Looking west near the wellbore location. Powerline continues onward to well api 001-07435.

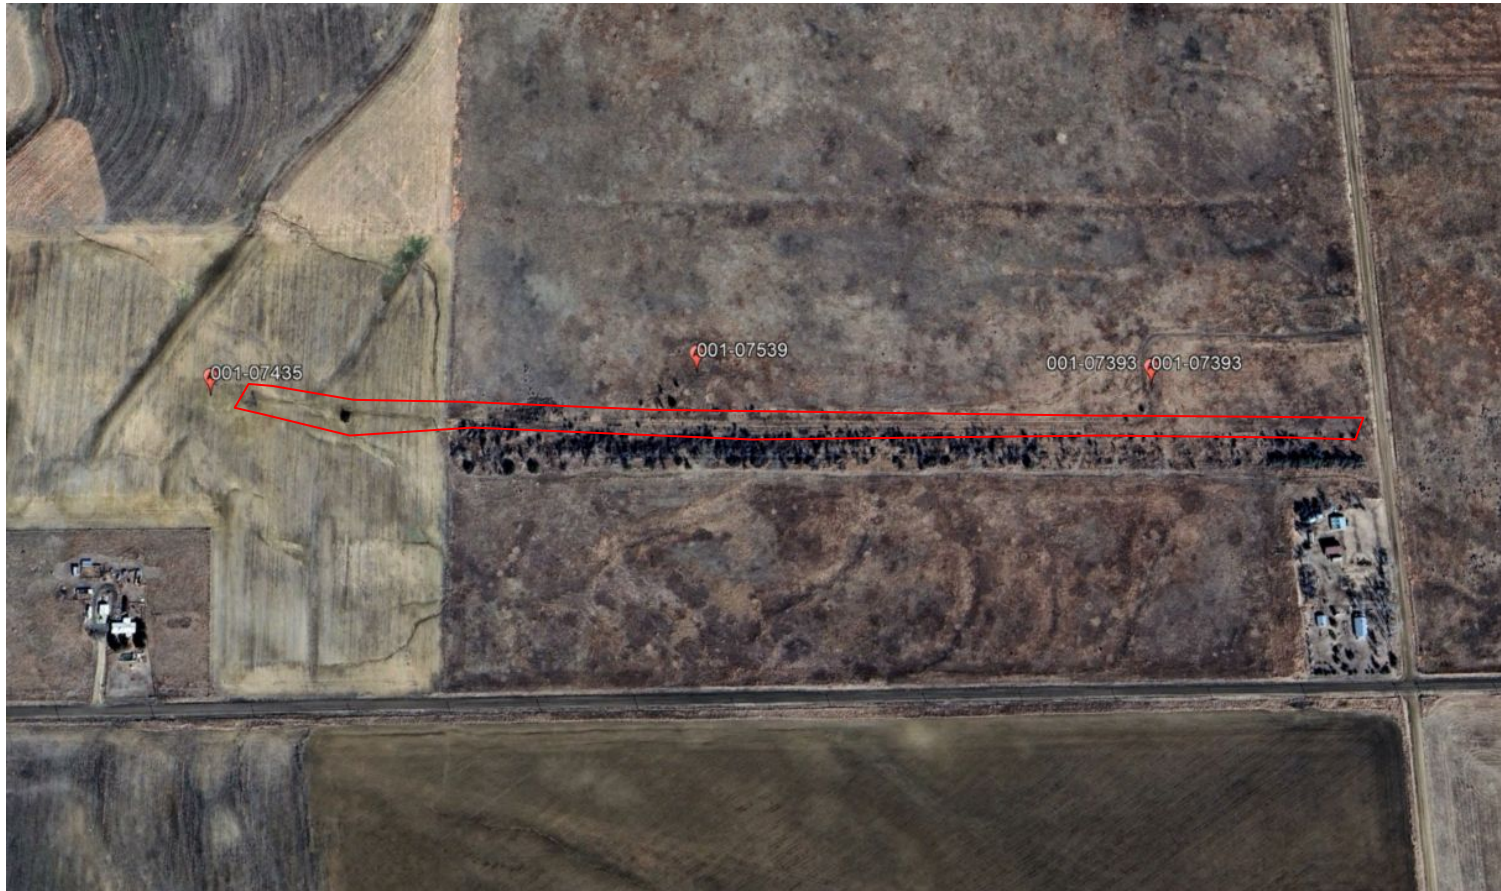
**Photo 15.** This section of power line appears to have been installed for oil and gas and does not extend past well 001-07435.
