Final Reclamation and Stormwater Inspection

Operator: WESTERN INTERIOR ENERGY INC - 95750

Location ID: 319966

Well Name: LUNDGREN #1

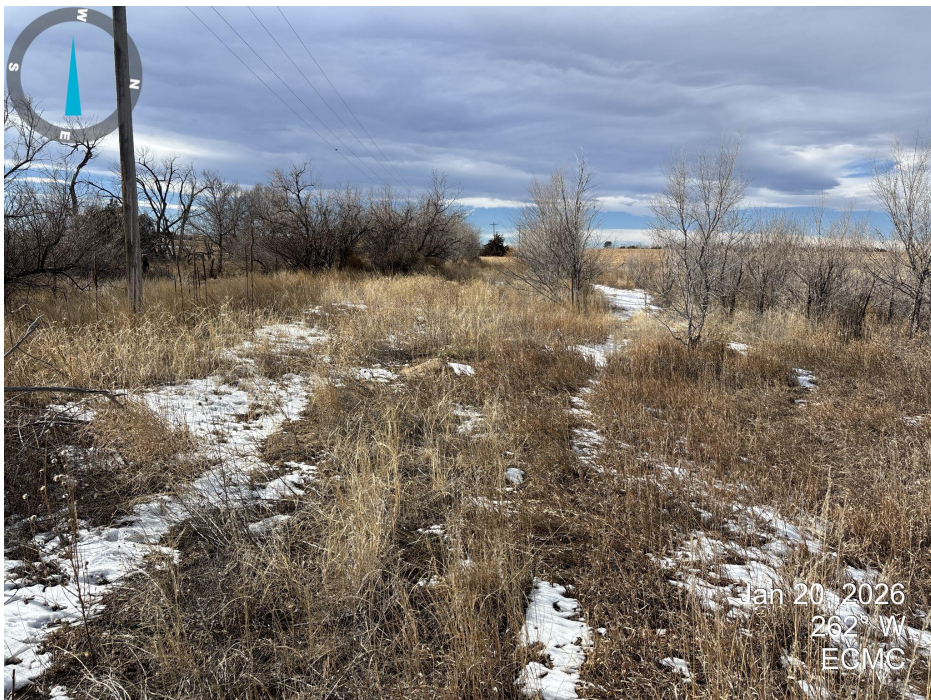
Photo 1. Picture taken looking down the access road from well API 001-07539 towards the well location. Desirable vegetation appears to have established on the access road. The powerline that served this well remains in place along the access road.

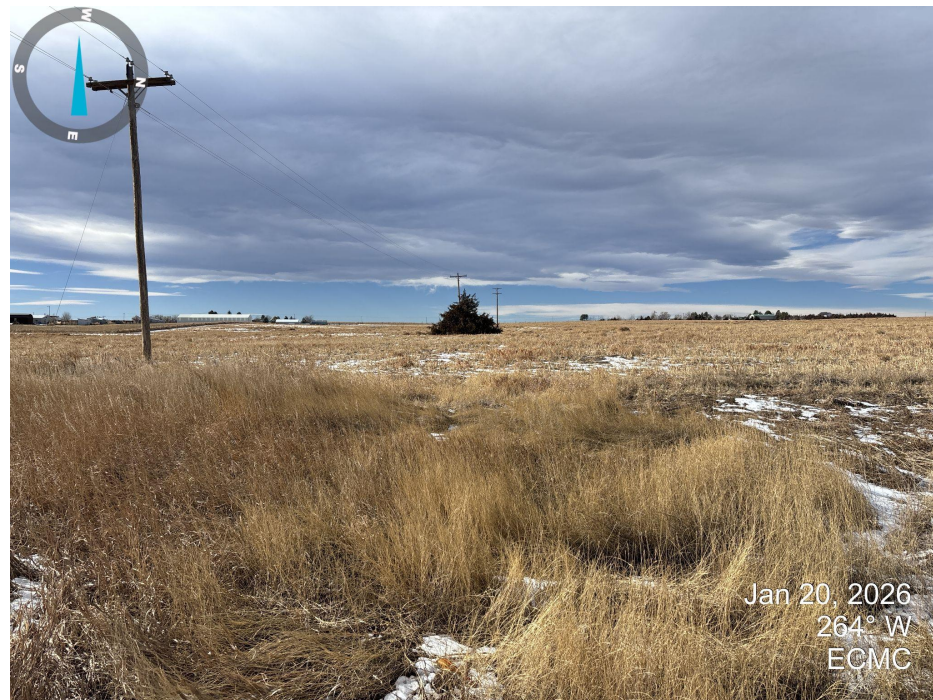
Photo 2. Looking west down the access road towards the well location. The land transitions from non-cropland to cropland. The field is out of growing season at the time of inspection.

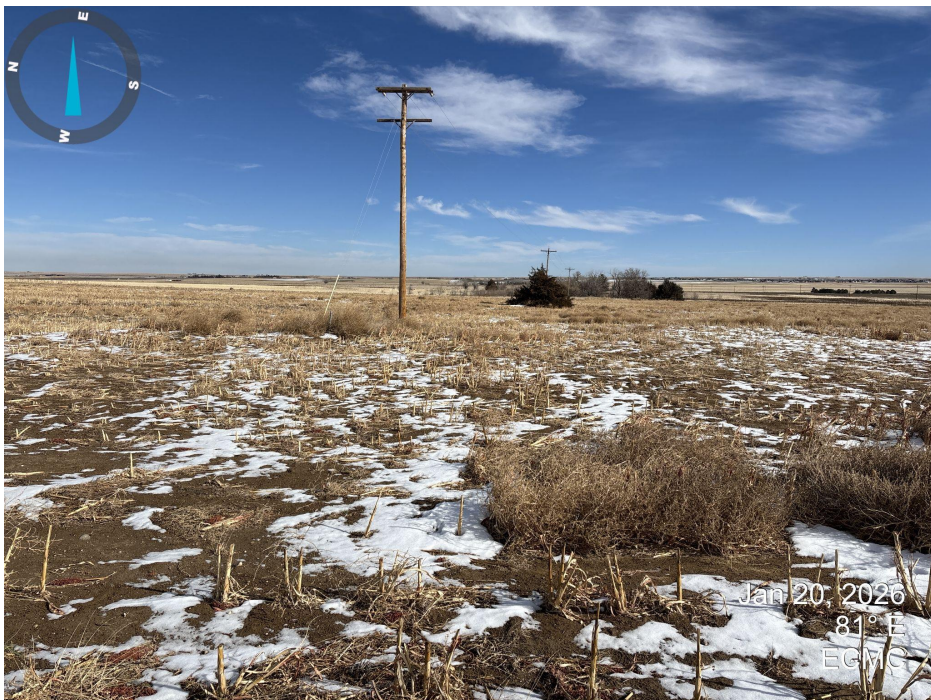
Photo 3. Looking east from the well area across the location. The electrical service terminates at this location and appears to be unused. The location is in cropland, fallow at the time of inspection.

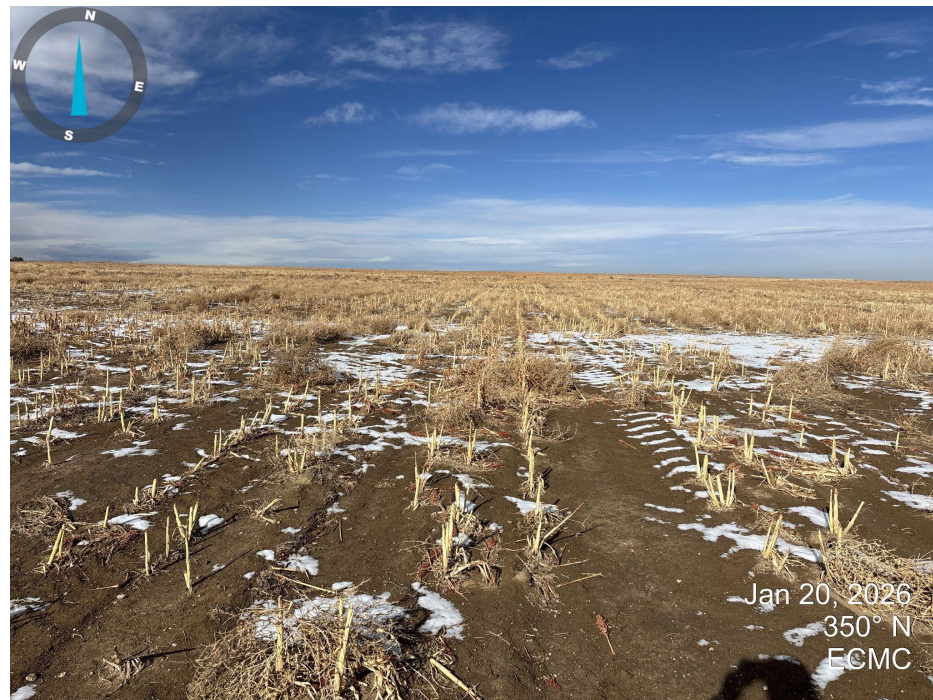
Photo 4. Looking north from the wellbore. See photo 3 comments.

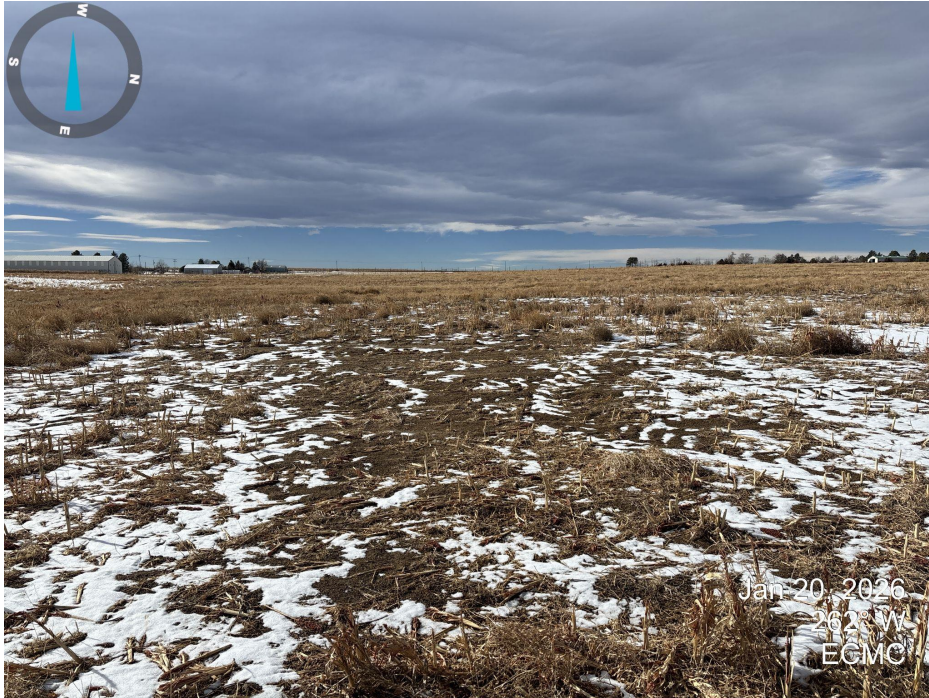
Photo 5. Looking west from the wellbore. See photo 3 comments.

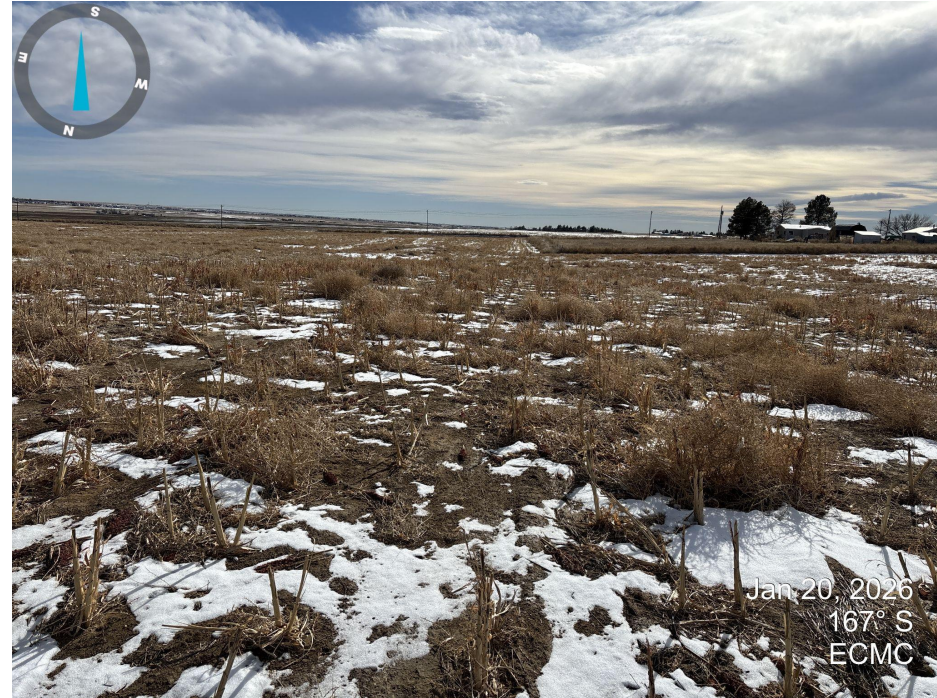
Photo 6. Looking south from the wellbore. See photo 3 comments.

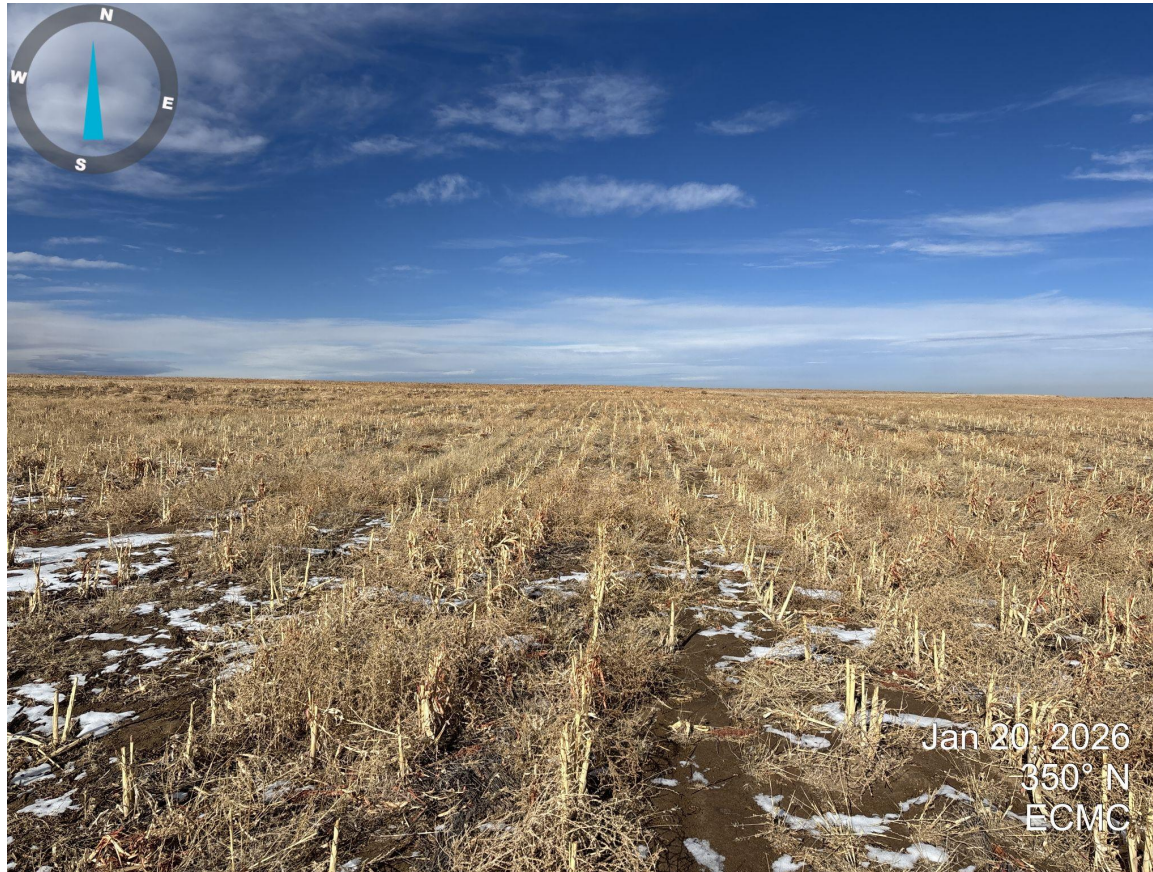
Photo 7. Reference area to the north of the well location.

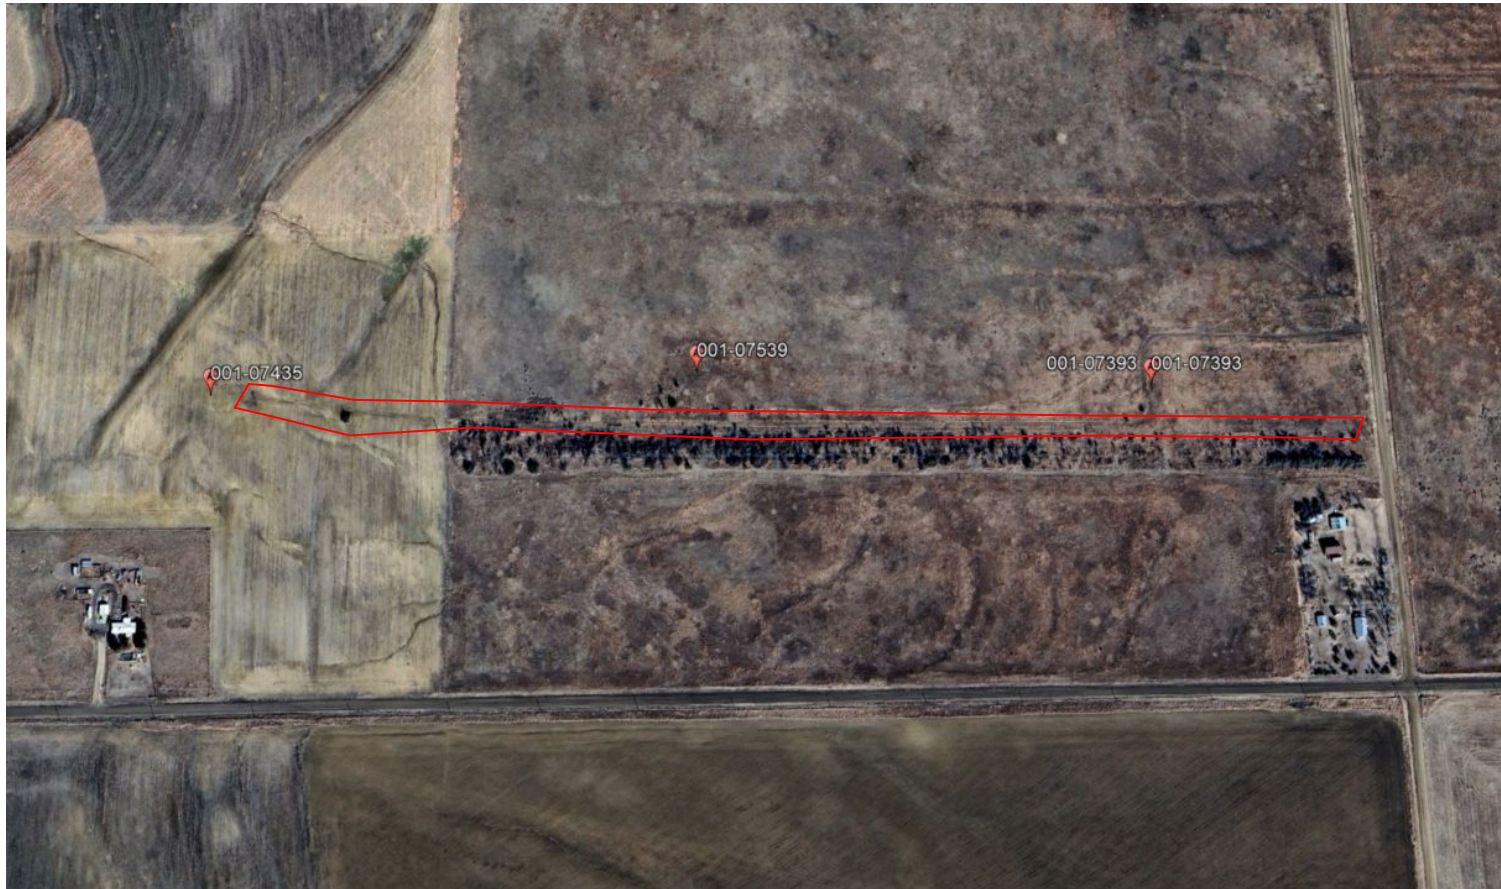
Photo 8. This section of power line appears to have been installed for oil and gas and does not extend past well 001-07435.
