Inspection/Audit Photos

Location: KT RESOURCES LLC WRD UNIT #20-33 PAD

Location ID: 316158

Date: 01/6/2026

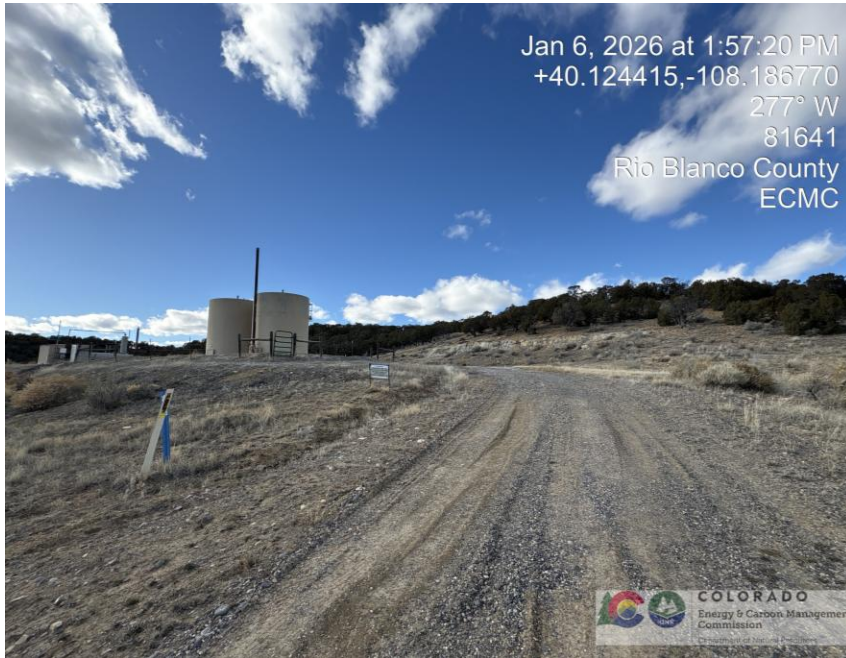
Photo # 0693 Entrance to location

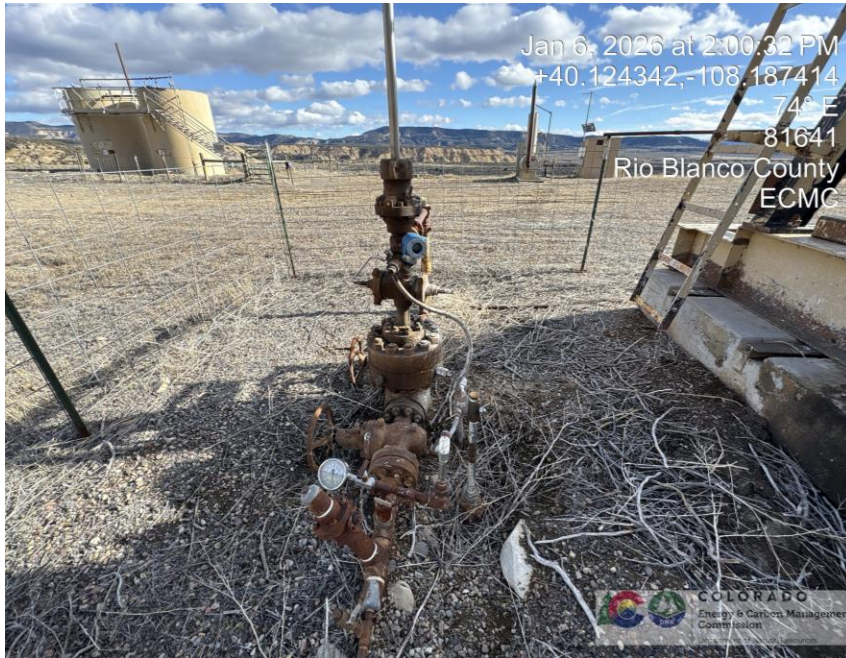
Photo # 0699 Weeds & weed debris near wellhead and pump jack presents a potential fire hazard

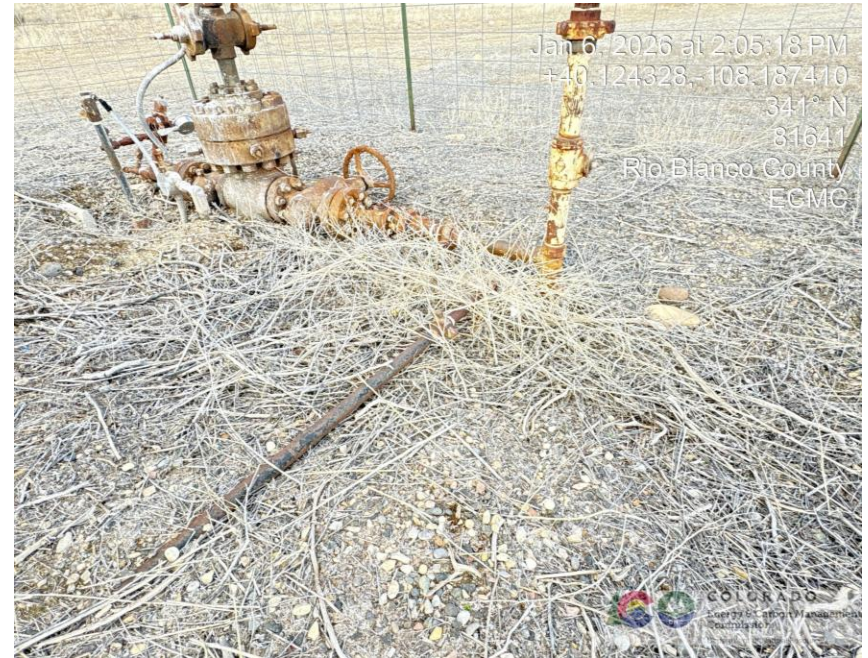
Photo # 0709 Weeds & weed debris near wellhead and pump jack presents a potential fire hazard

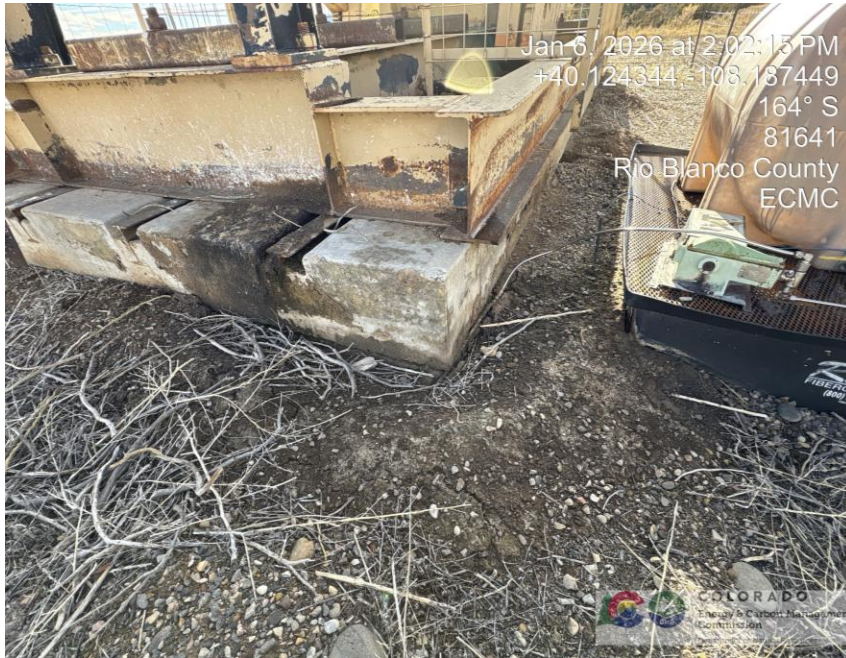
Photo # 0704 Staining on location around Pump Jack

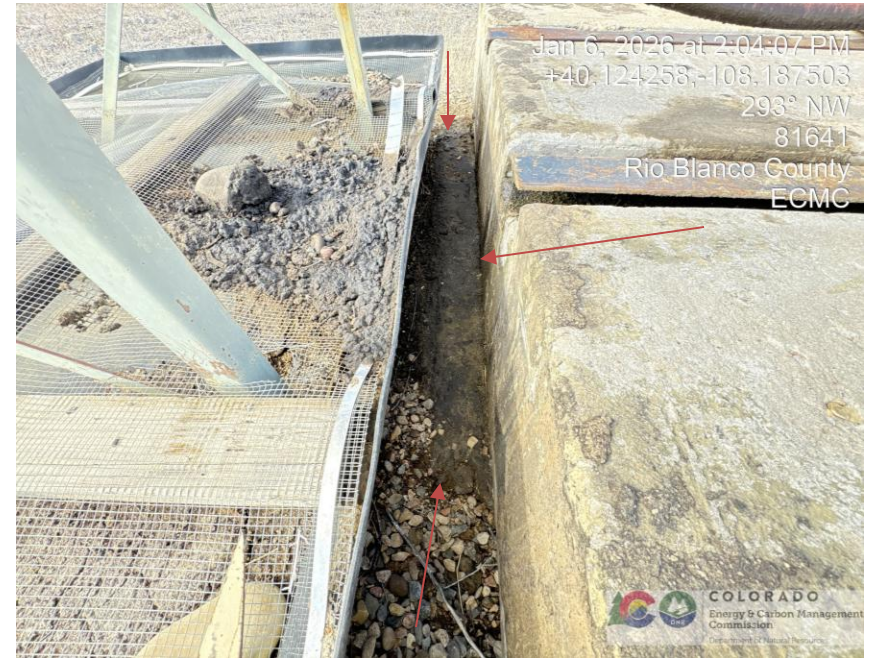
Photo # 0706 Staining on location around Pump Jack

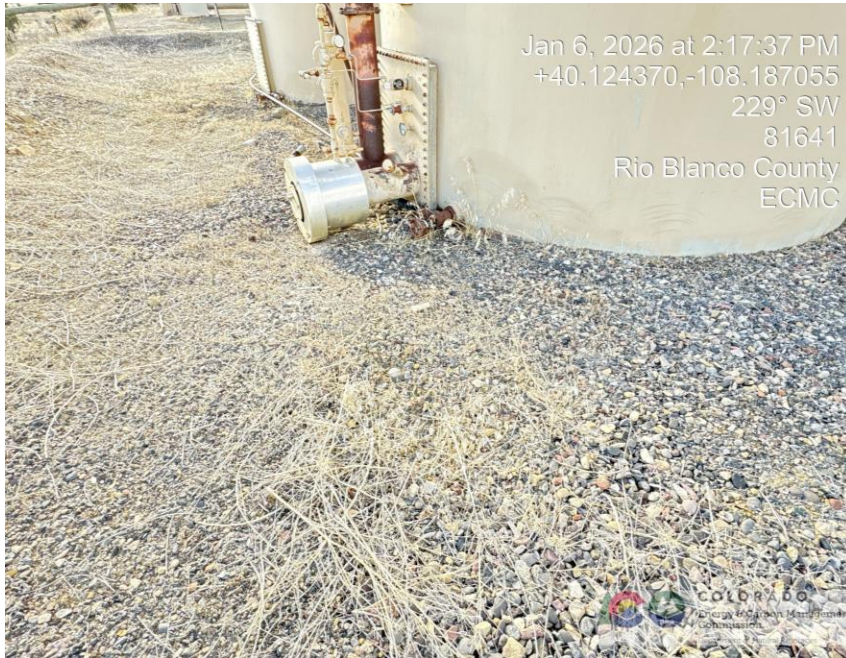
Photo # 0732 Weeds & weed debris in secondary containment presents a potential fire hazard

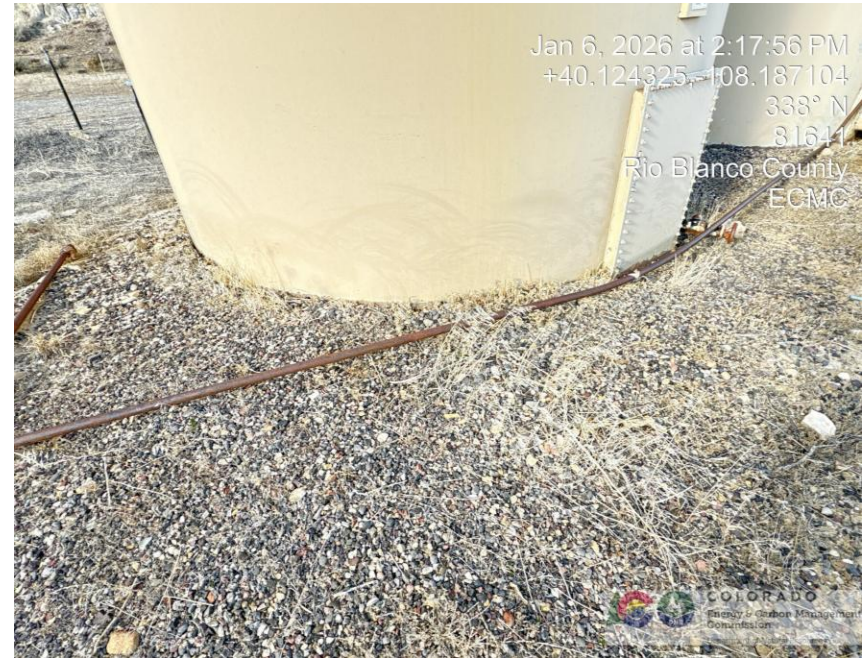
Photo # 0733 Weeds & weed debris in secondary containment presents a potential fire hazard
