Inspection Photos

API: 071-06297

Operator: EVERGREEN NATURAL
RESOURCES LLC

Inspection Date: 1/29/2026

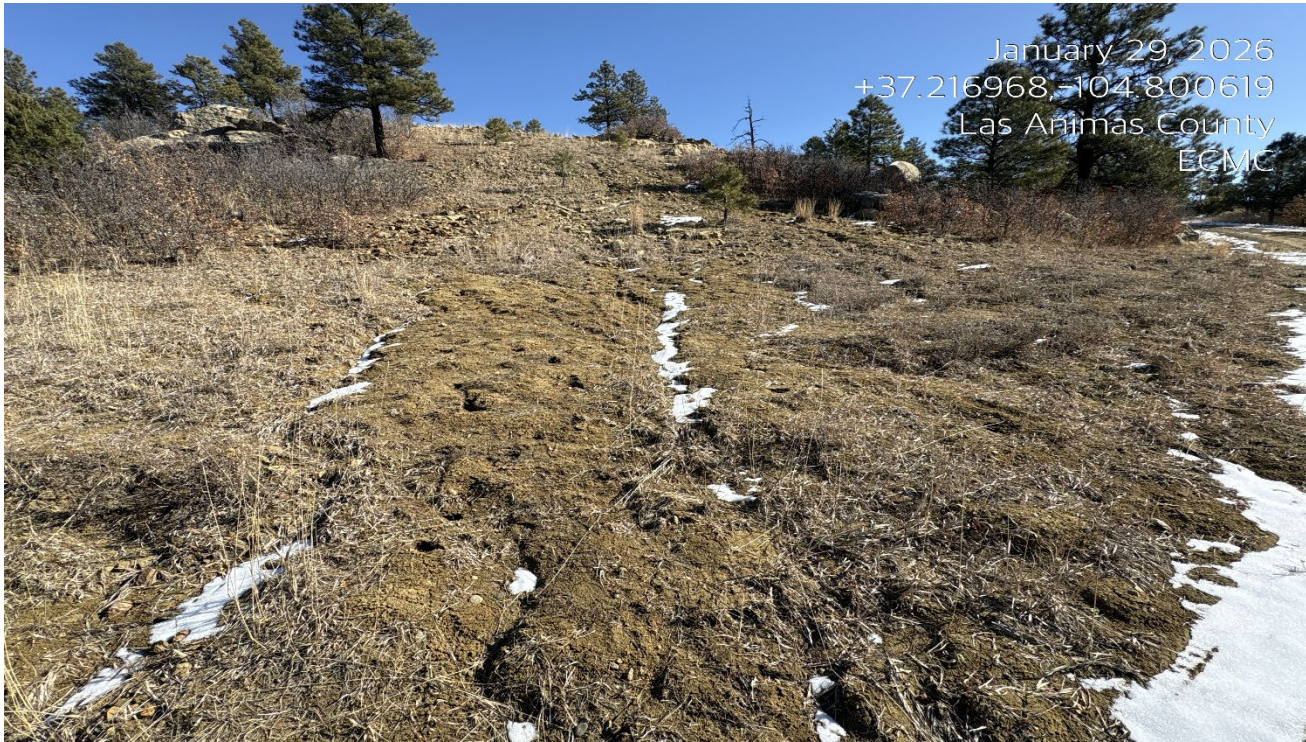
Photo 1. Standing at the access road facing northeast toward the reclaimed flowline ROW. There is erosion along this area that will need to be repaired, reseeded, and stabilized.

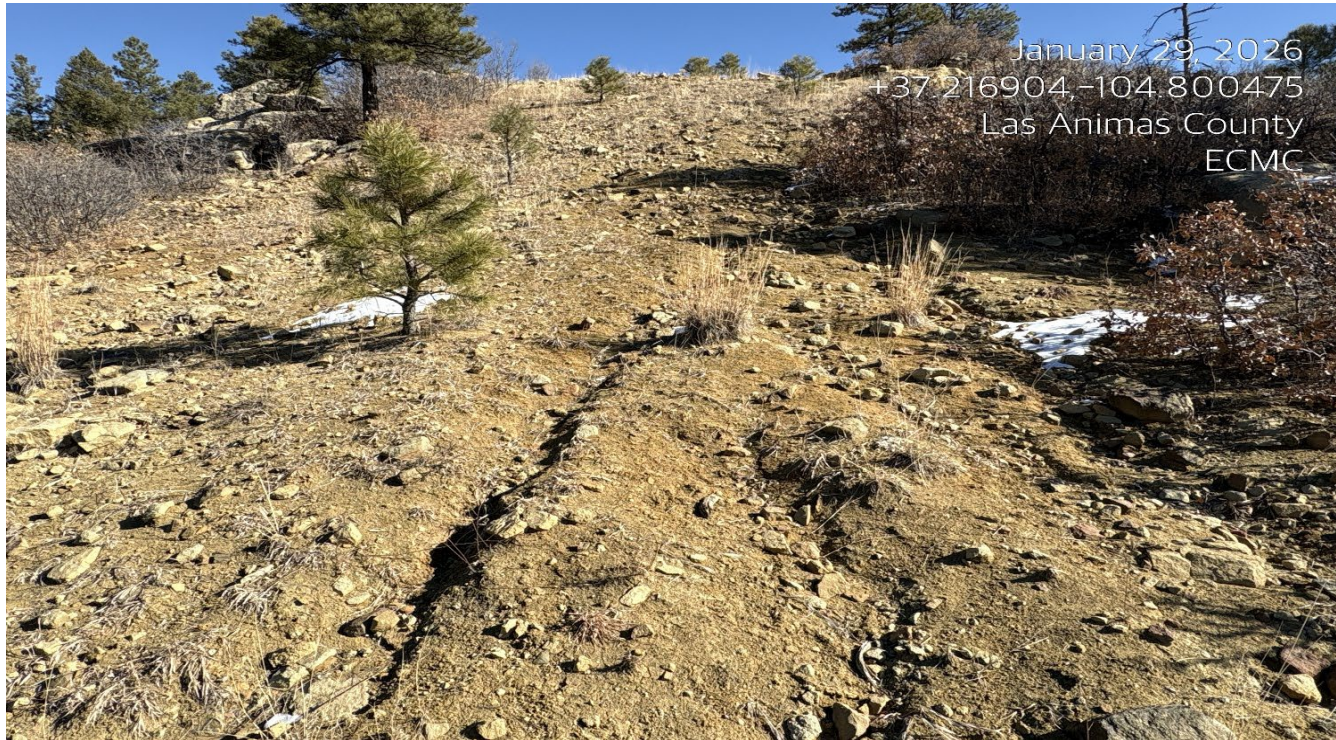
Photo 2. Facing toward the flowline area where erosion has occurred. This area will need to be repaired, reseeded, and stabilized.

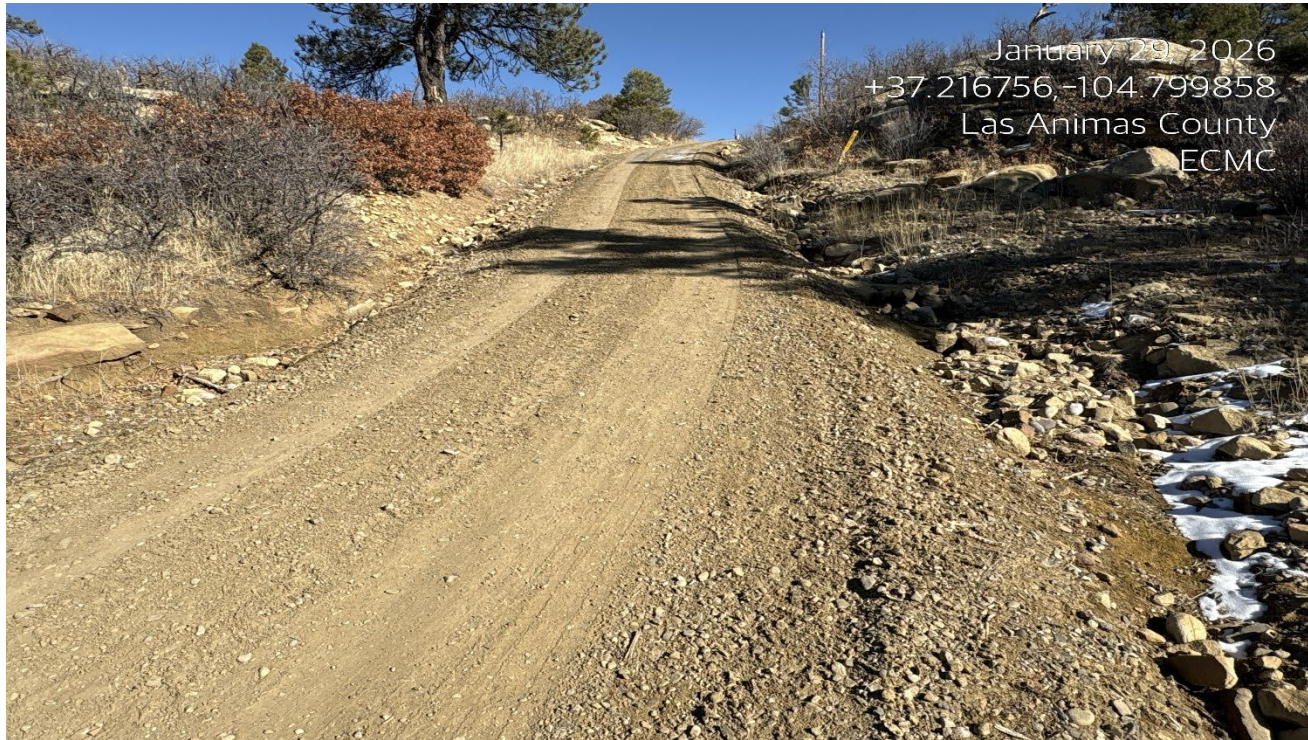
Photo 3. Facing northeast along the access road. There is erosion along both sides of the road that will need to be repaired with BMP's.

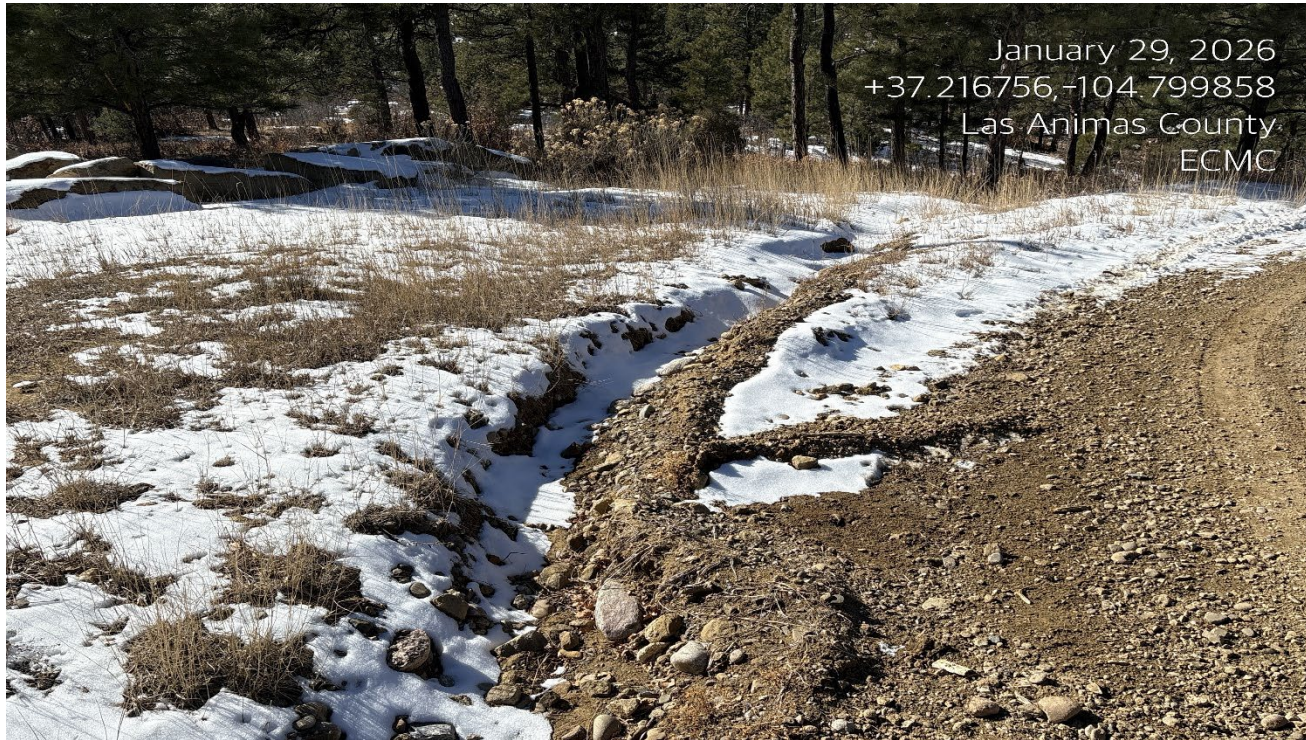
Photo 4. There is a stormwater diversion at the switchback of the road that should have BMP's to prevent erosion such as rip/rap, checkdams. ect.

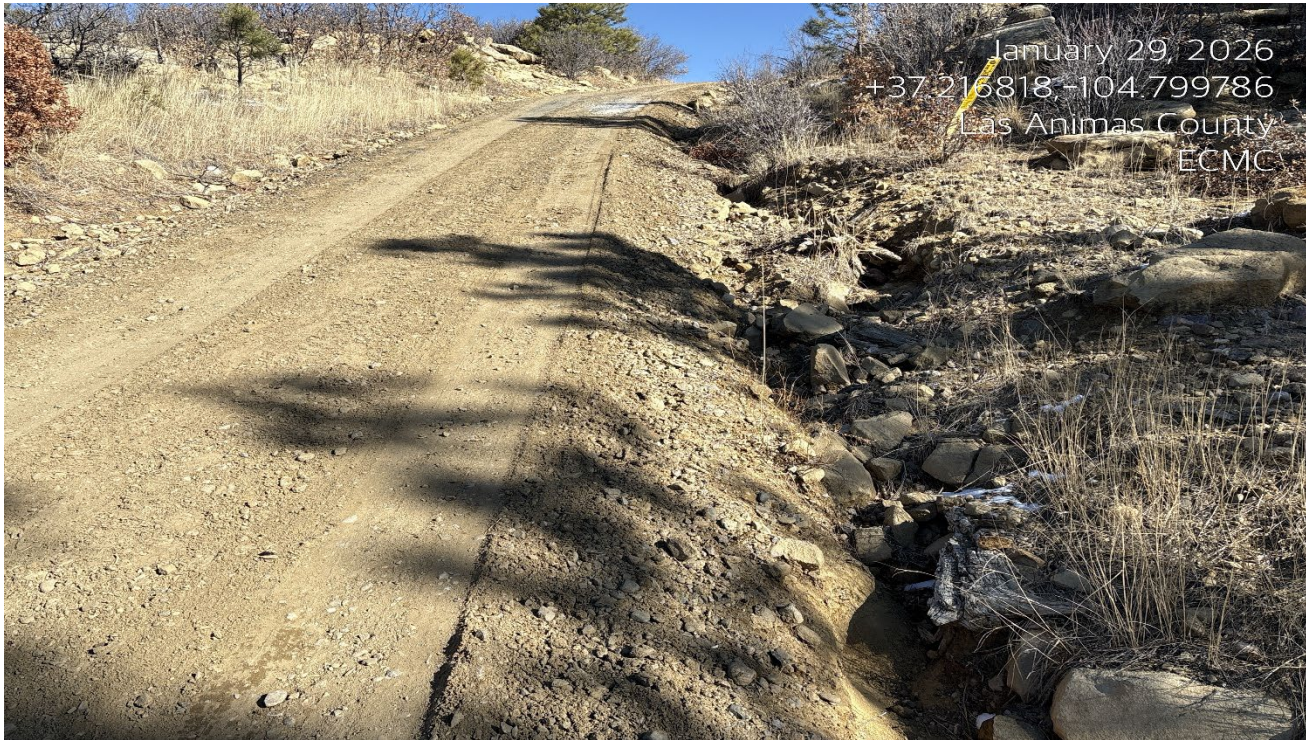
Photo 5. Facing northeast along the access road. BMP's along the roadside will need to be installed. The road has narrowed due to erosion of the roadbase along the road sides.

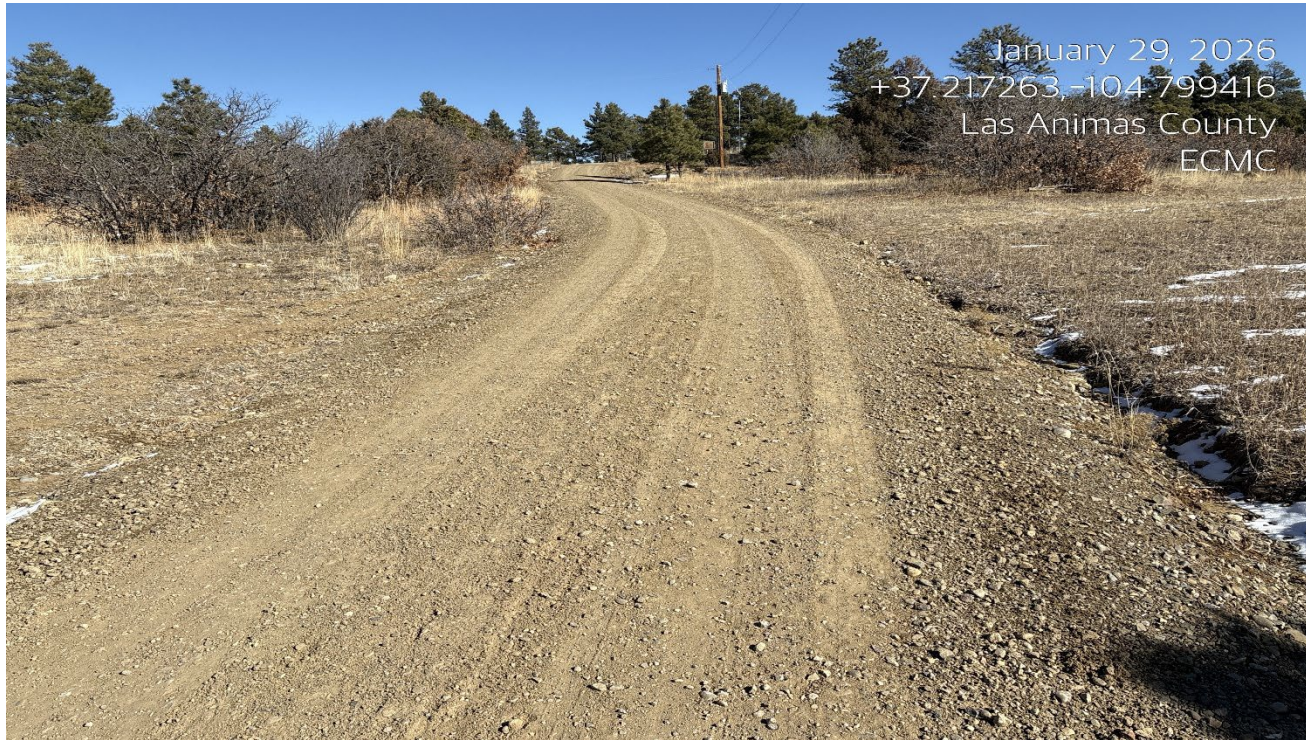
Photo 6. Further up the road the roadsides are stabilized with vegetation and gravel. Stormwater from this area of the road is directed down the road contributing to erosion shown in previous photos.

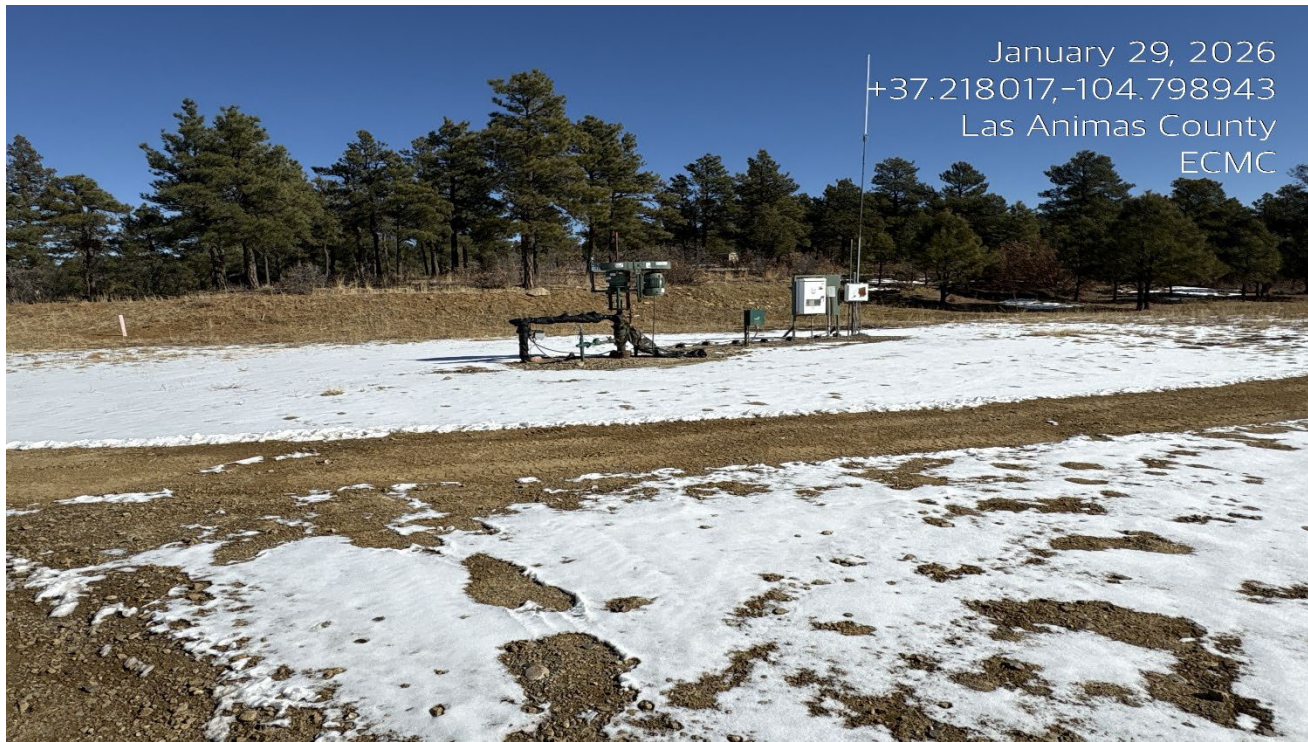
Photo 7. Facing northeast toward the wellsite.

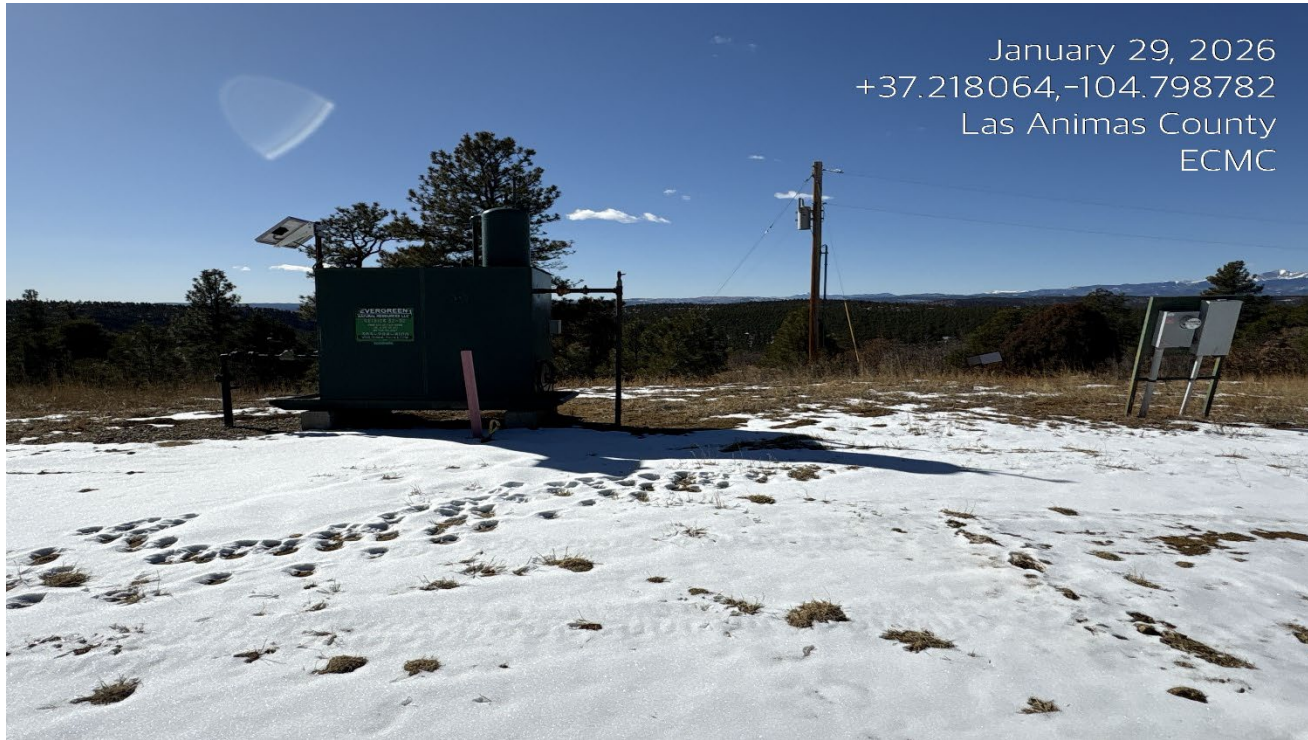
Photo 8. Facing southwest toward the meter shed where the well sign is installed. The wellsite utilizes the electric power line shown in the photo.

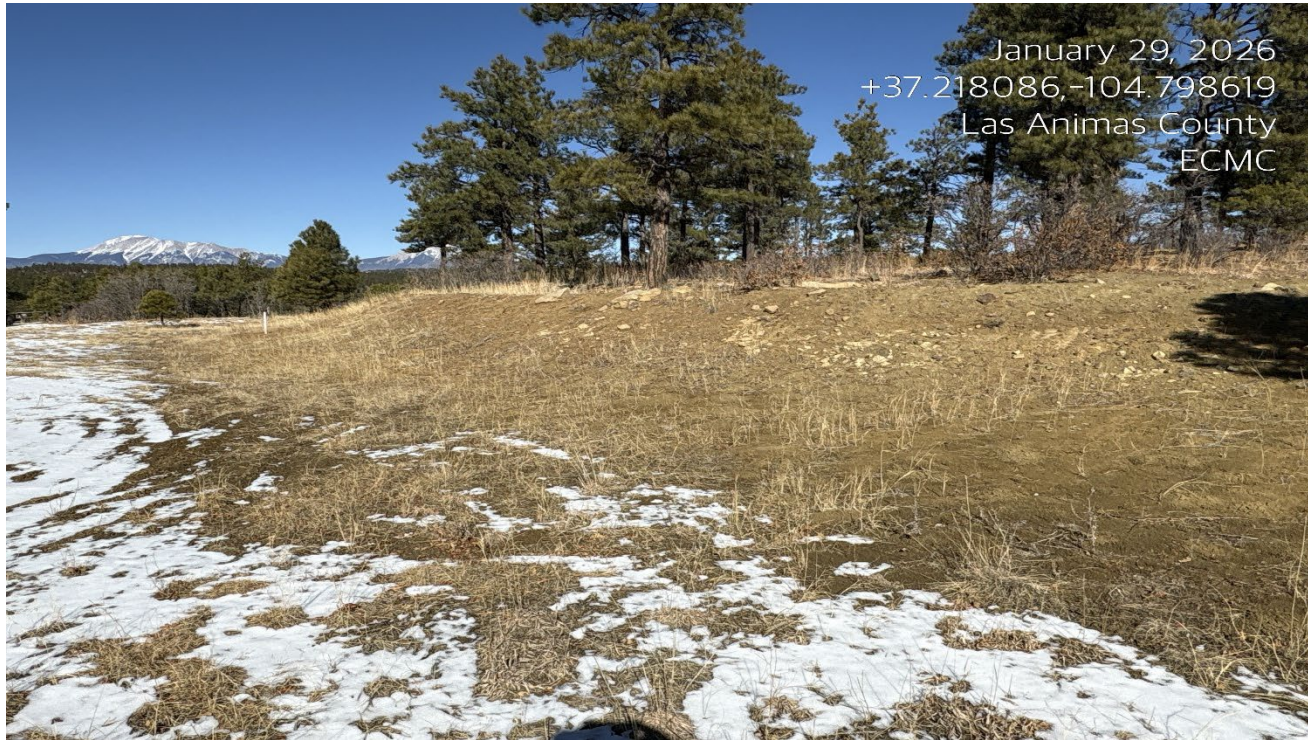
Photo 9. Facing north toward the cut slope. There are some bare areas that could benefit from hand seeding to establish more vegetation.
