Inspection Photos

Location Name: Huber-Nelson 36-2

API # 05-067-07789

Inspector Name: James Blair Inspection Date: 01/27/2026

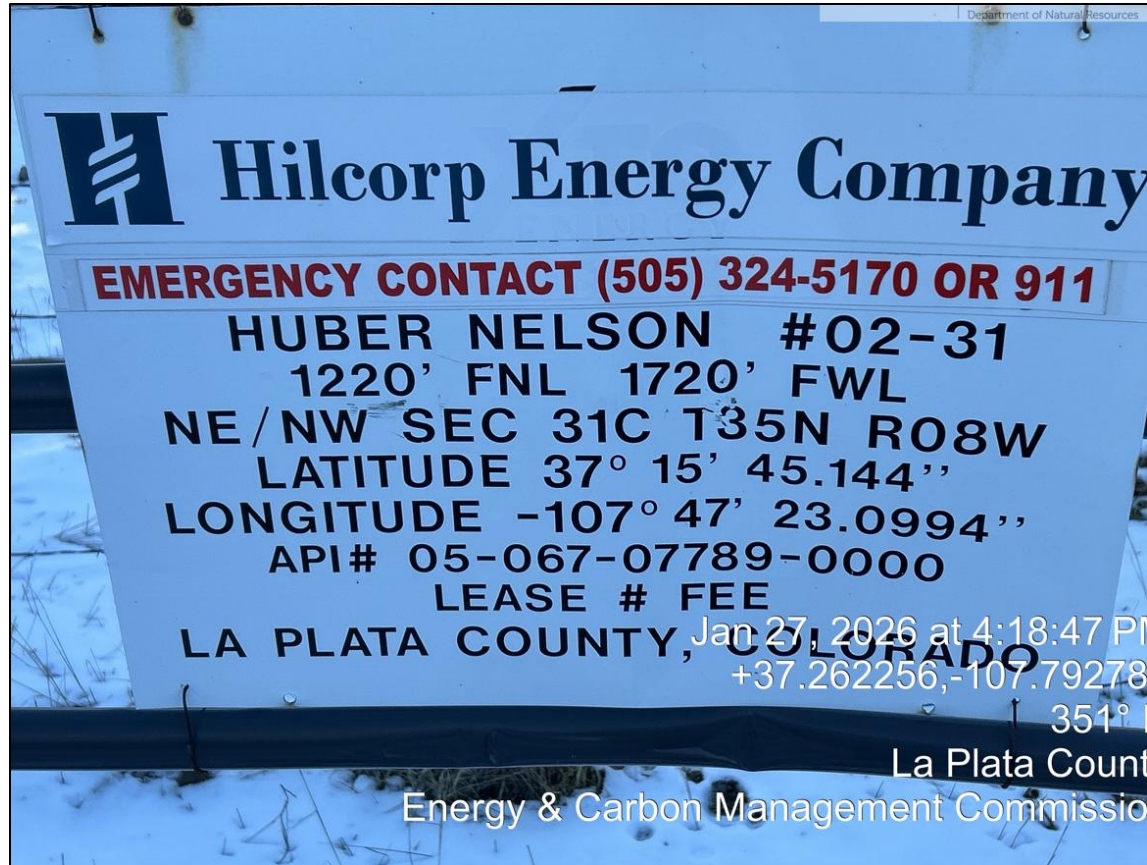
01: Well location sign located at first gate next to house along access road. No lock on gate.

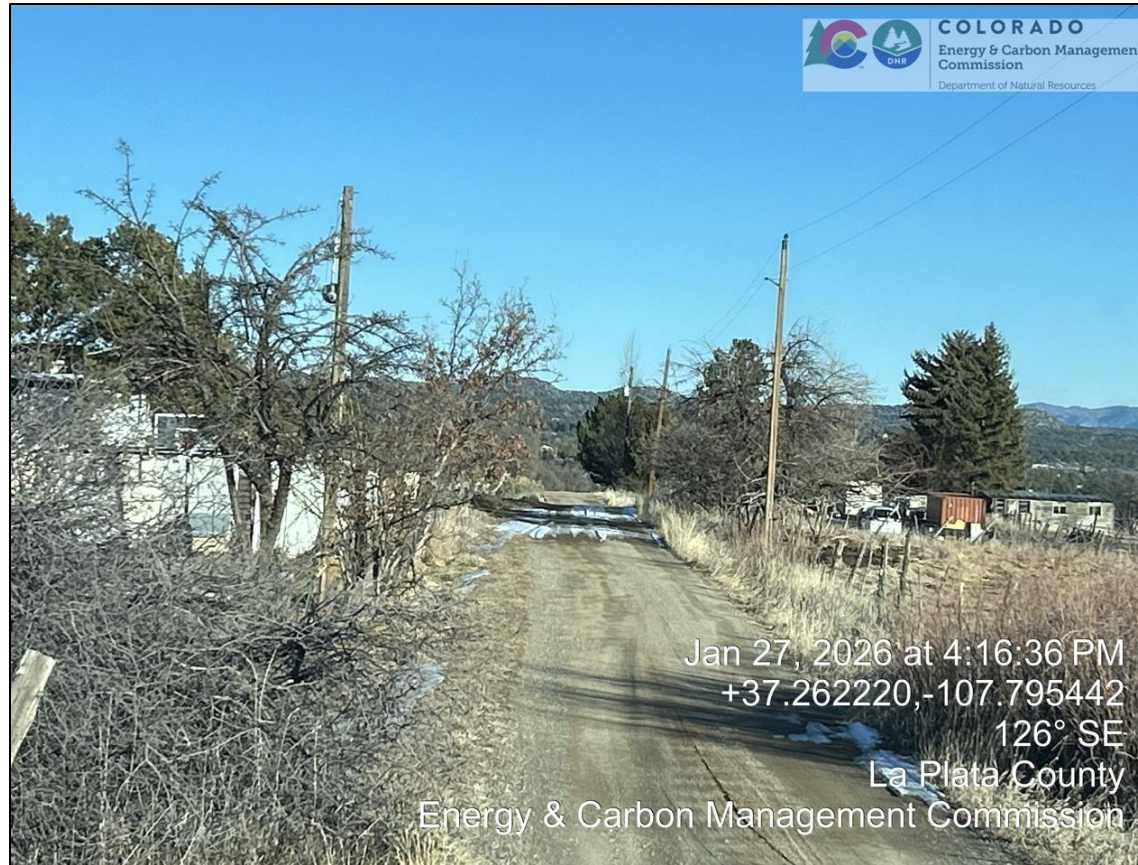
02: Access road near intersection with paved county road looking east towards well.

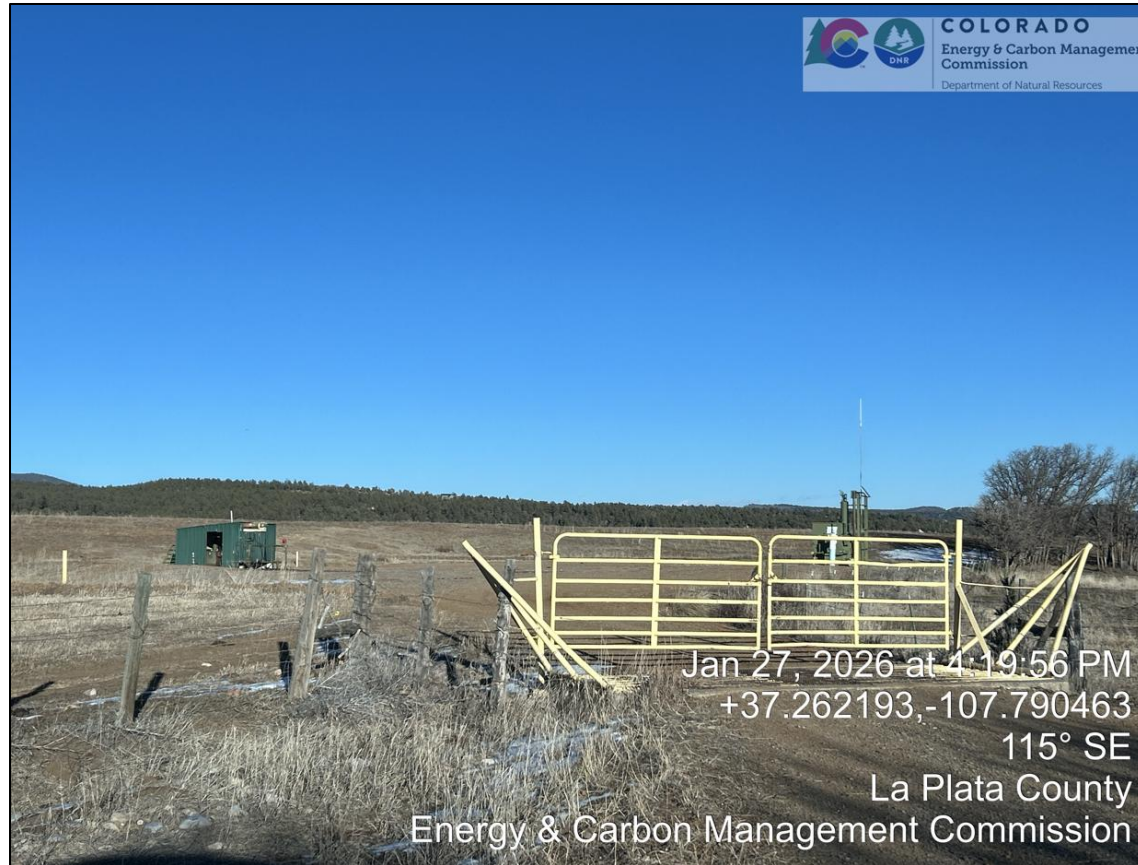
03: Access gate at edge of well pad. No lock.

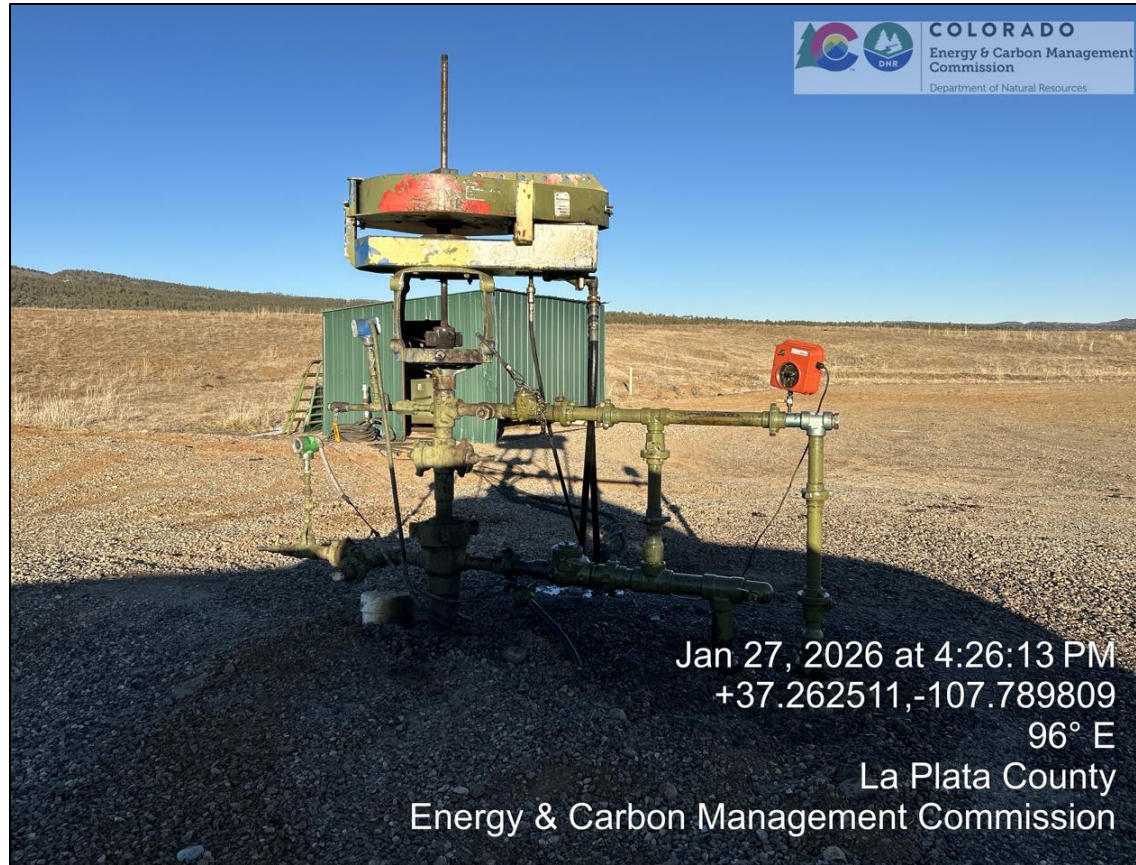
04: Well head with hydrostatic drive linear rod pump. The bradenhead is located in the white PVC tube. They hydraulic lines lead from the well head to the shelter in the background, which houses the gas powered hydraulic drive pump.

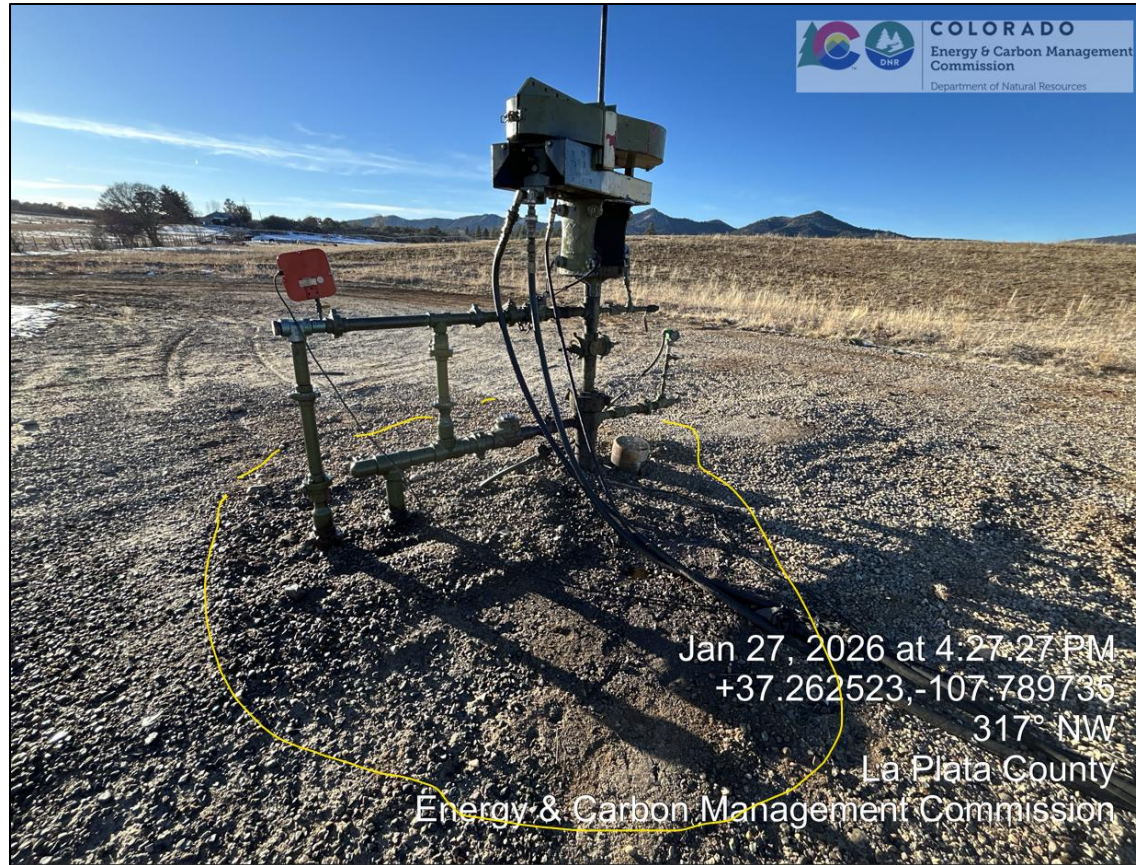
05: Northwest view of wellhead with hydrostatic drive linear rod pump. The gravel surrounding the wellhead is stained with hydraulic oil, with the ground being saturated with free hydraulic fluid accumulating in small puddles (see next photo). Yellow line indicates surface approximate staining extent.

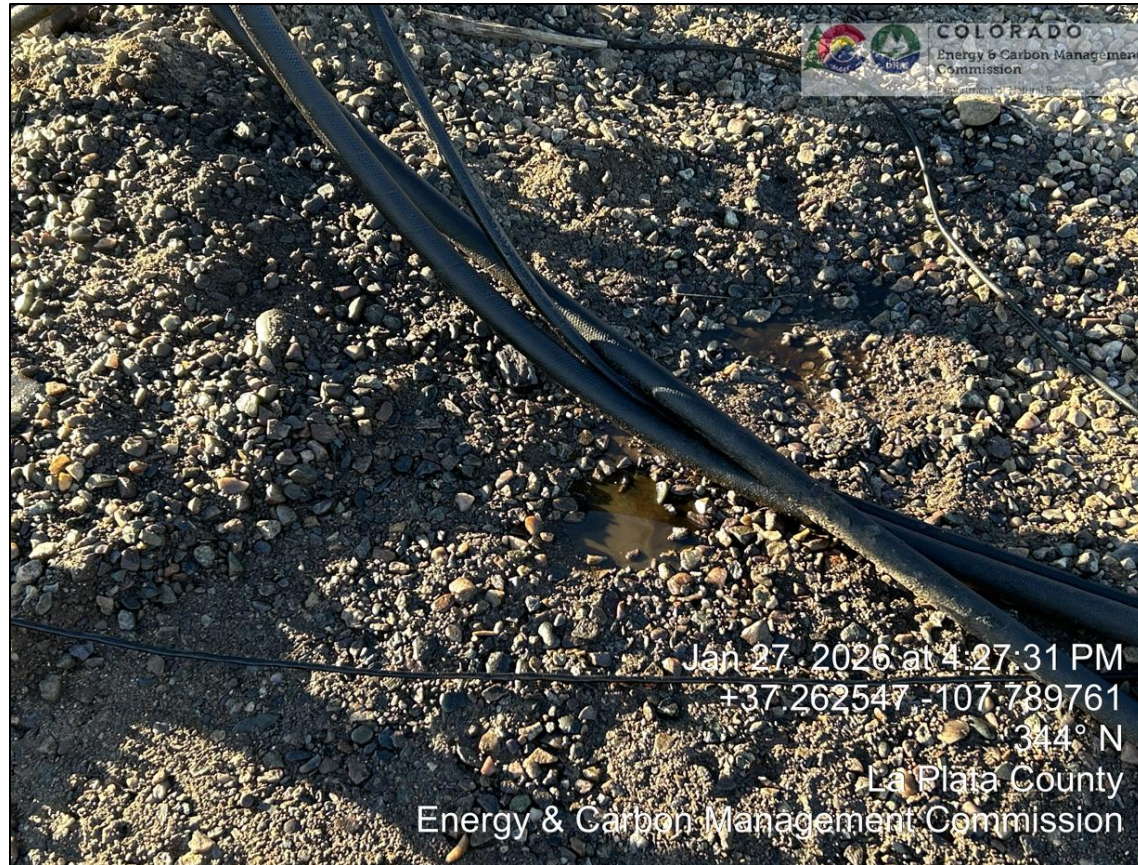
06. Puddle of free-standing hydraulic fluid by wellhead indicating ground saturation. Hoses are for the hydraulic drive unit.

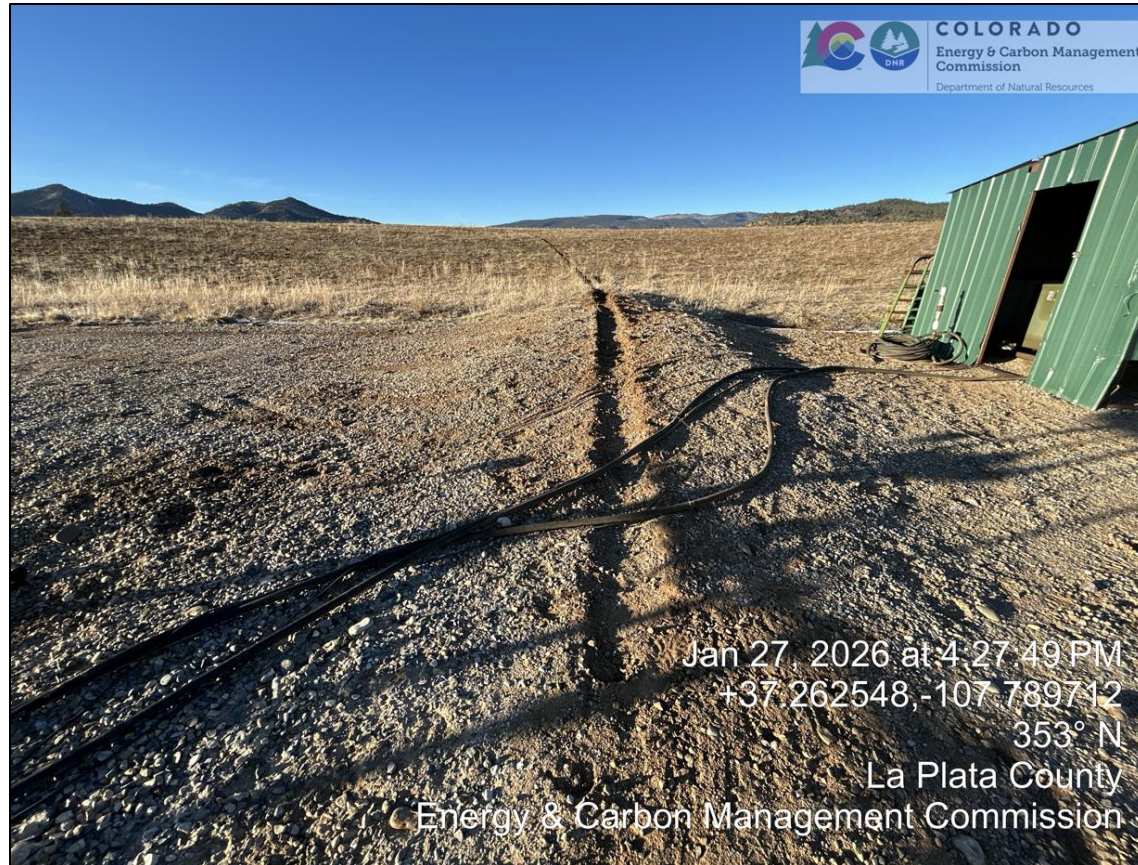
07: Hydraulic hoses run across wheel ruts from irrigation center pivot. There is no mechanism prevent damage to the hoses if the pivot runs over the hoses or to prevent other vehicles from driving over it.

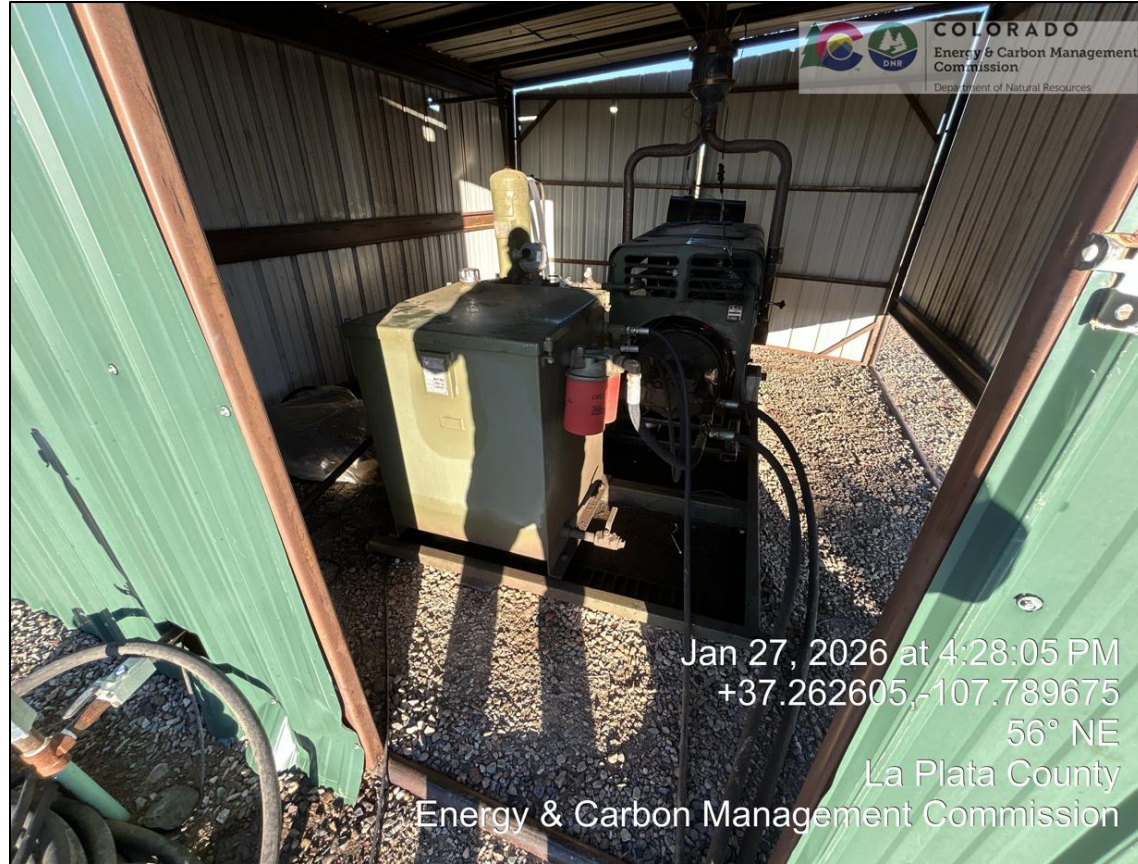
08. View inside shelter housing the hydraulic pump and motor. There was no door on the hinge at the time of the inspection. Note unused hoses in lower left.

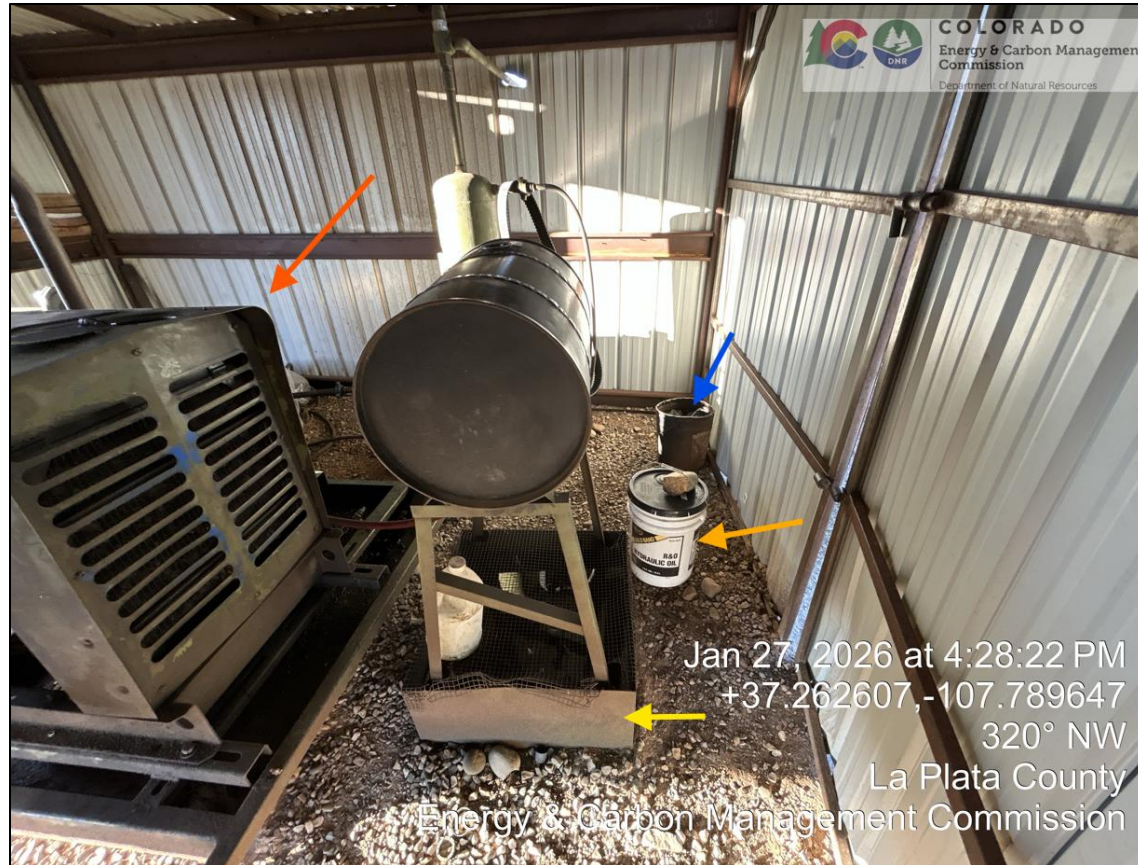
09. View inside hydrostatic drive pump shed. There is lube or secondary hydraulic oil reservoir atop a secondary containment structure that is $\frac{3}{4}$ full (yellow arrow indicates level), a bucket of hydraulic oil (orange arrow), an open-topped bucket with oily rags (blue arrow), and various unused hoses, pipe fittings and other equipment behind the motor (red arrow). There gravel on the ground has oil stains. There is also an unlabelled jug and oil stains on the gravel in various place.

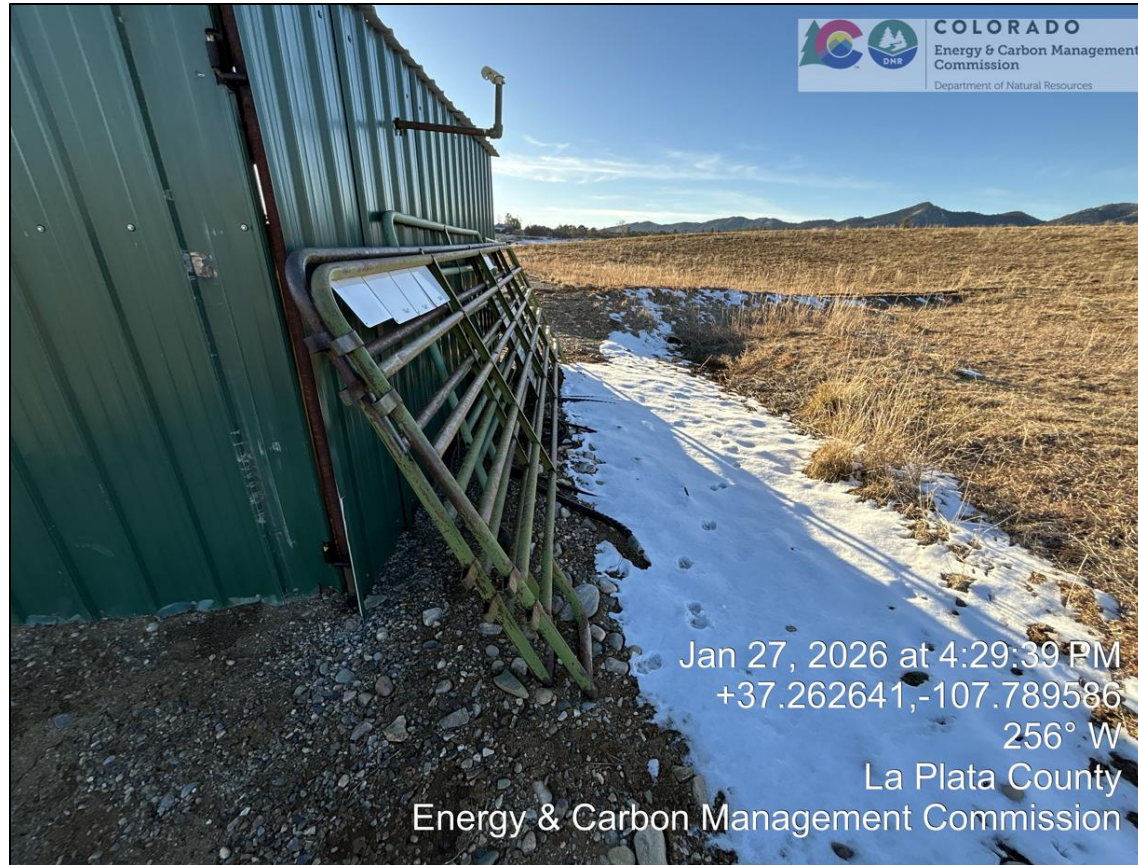
10. Unused hydraulic hose on ground beneath cattle panel fence segments on north side of shed.

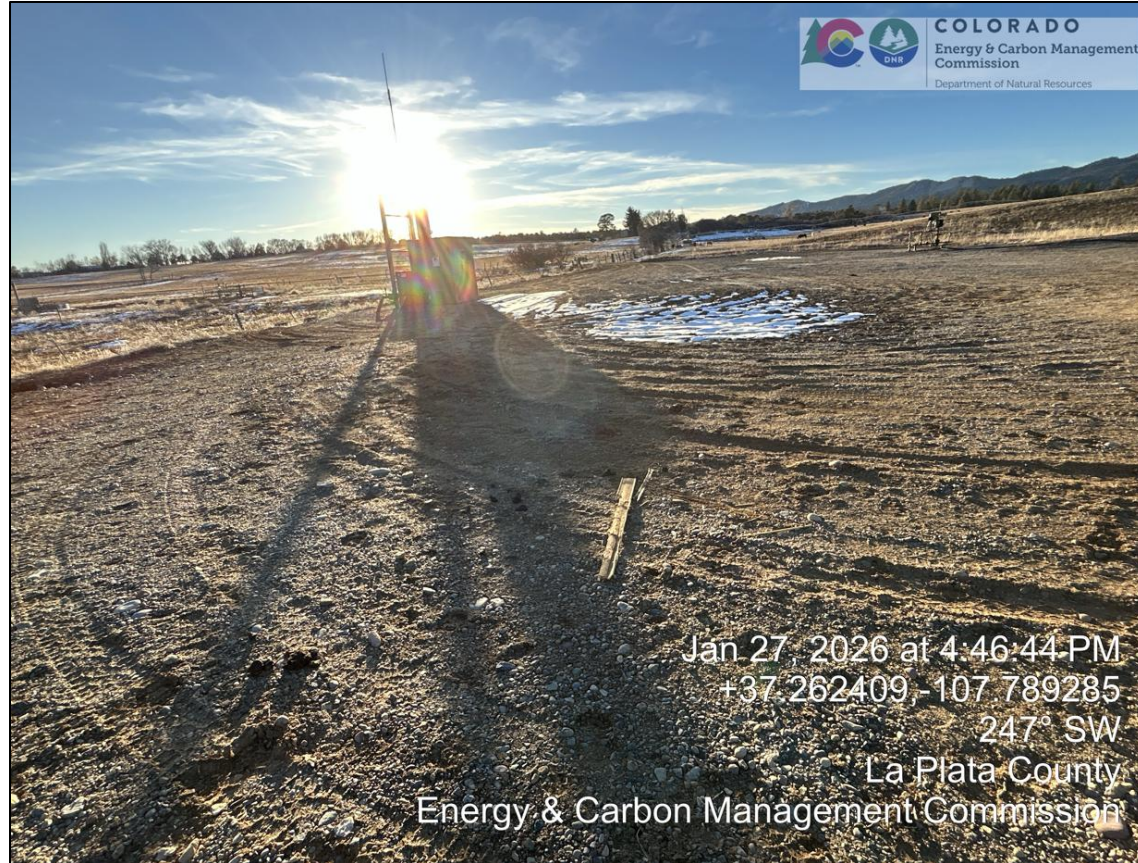
11. Combined vertical heated separator and meter run enclosure. There is a bird protector on top of the heater stack. The broken yellow fiberglass sign is presumably a rig anchor marker. No rig anchor was found to go with it. 3 other rig anchors were present and properly marked.

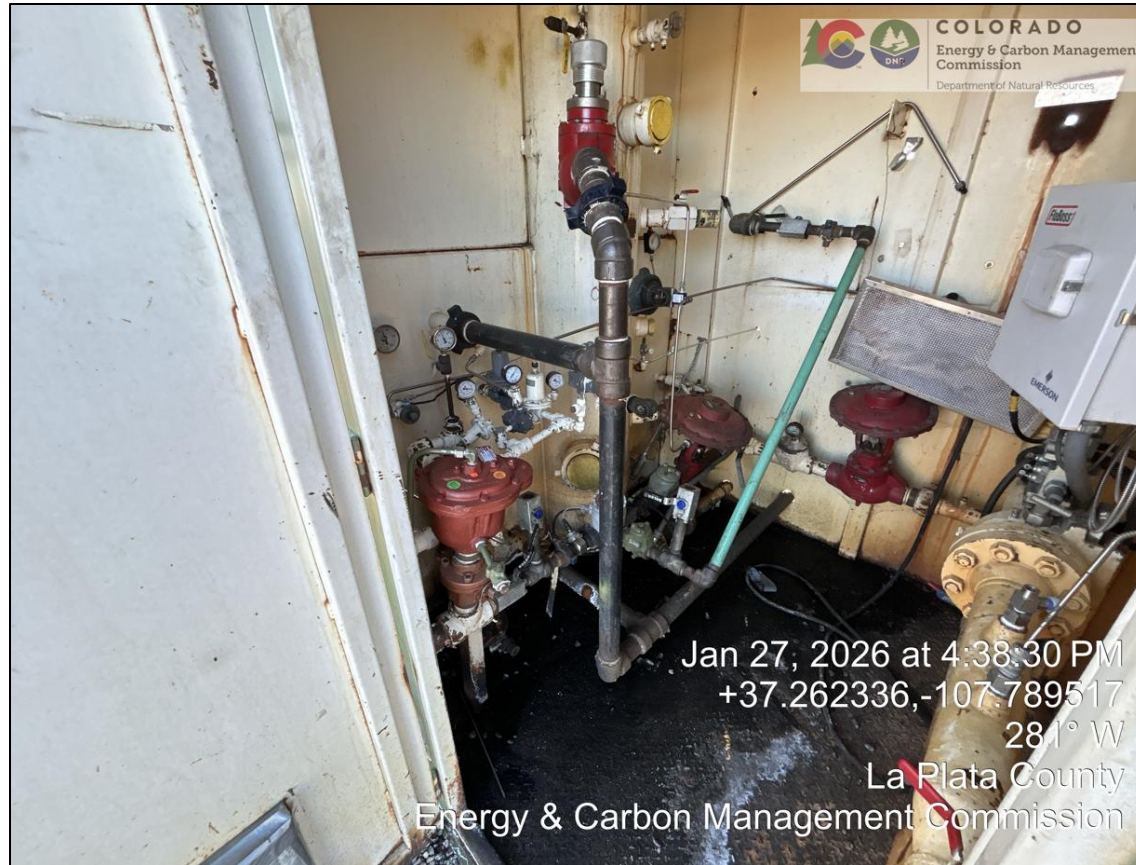
12. View inside meter run shelter. Mineral precipitate on ground is consistent with produced water leakage. Last meter calibration date: 09/25/2025.

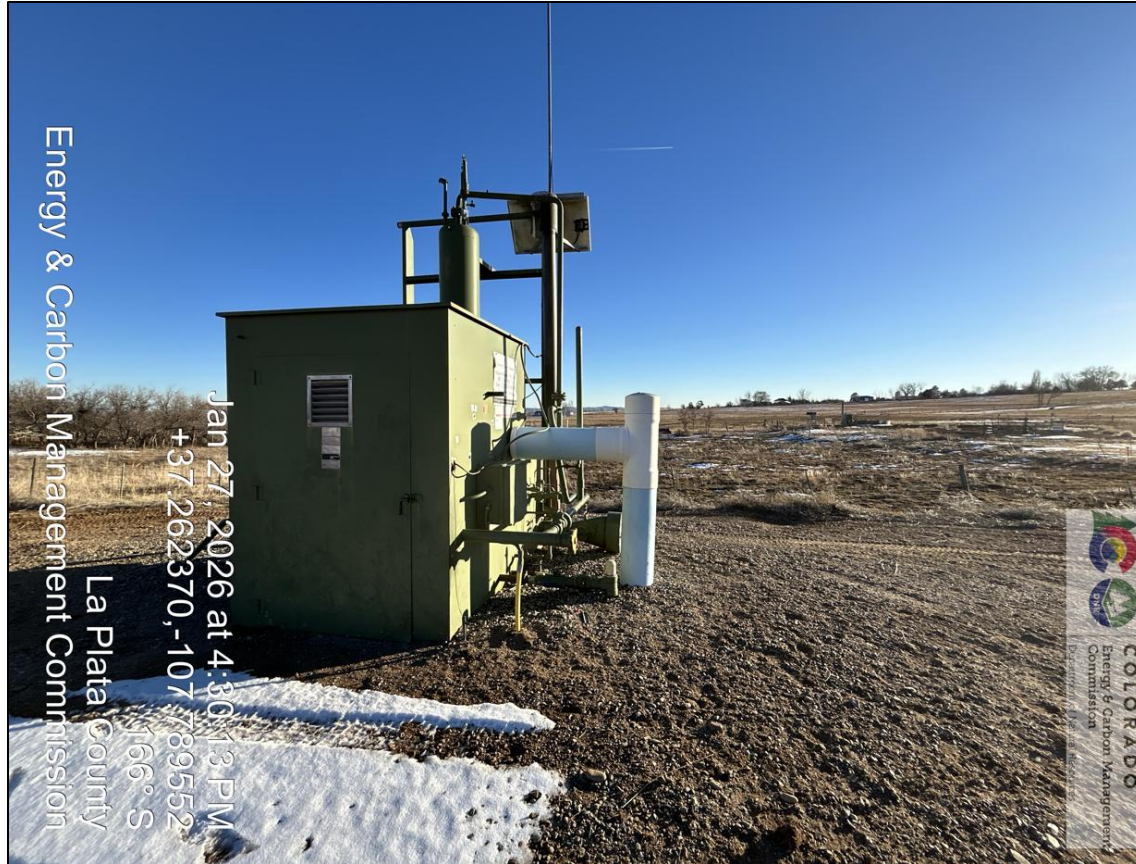
13. Meter run and vertical heated separator. Bird protector on heater exhaust stack.

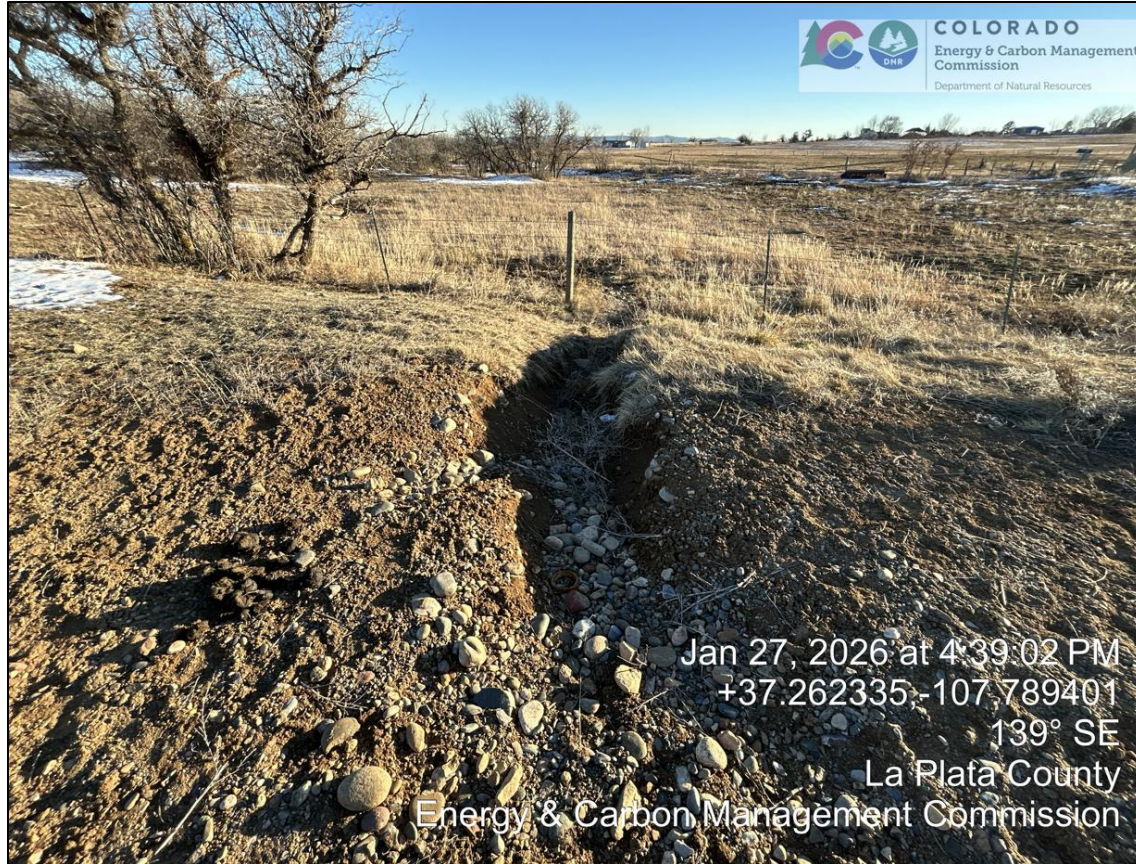
14. Drainage channel where stormwater exits pad.
