Inspection Photos

Location Name: TEP ROCKY MOUNTAIN LLC OXY USA INC MV 32-4 Pad

Location ID: 334843

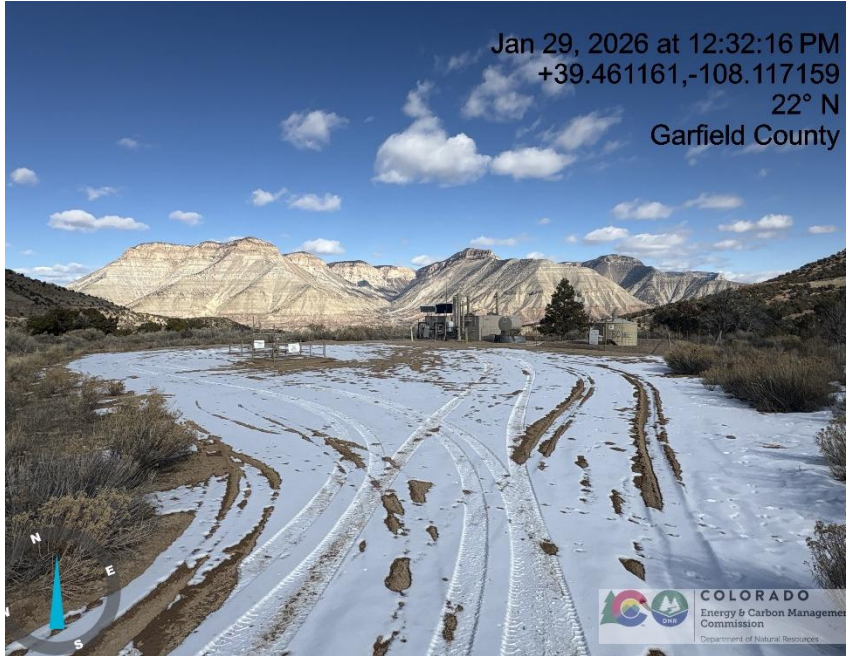
Photo # 7269 From entrance to location

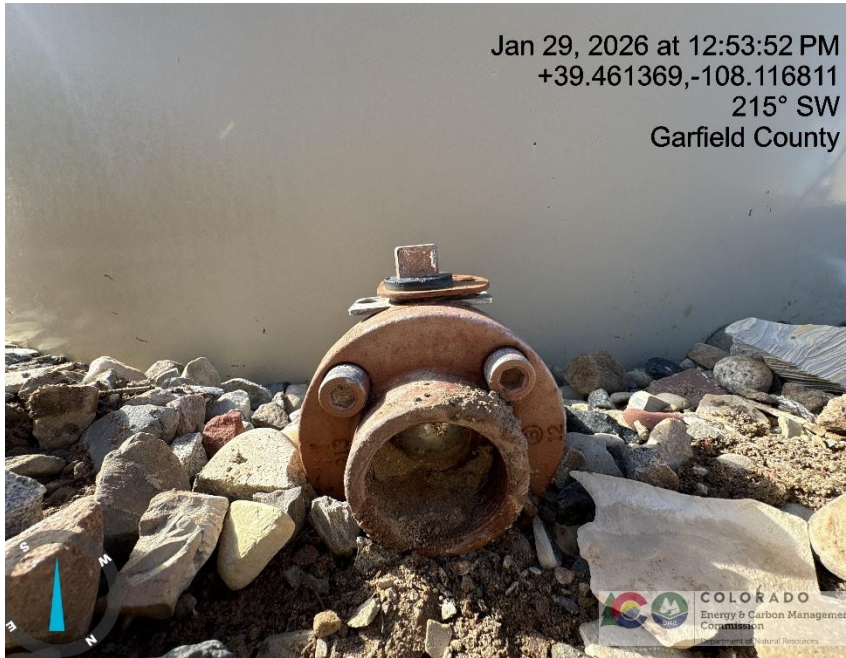
Photo # 7275 Open ended load line

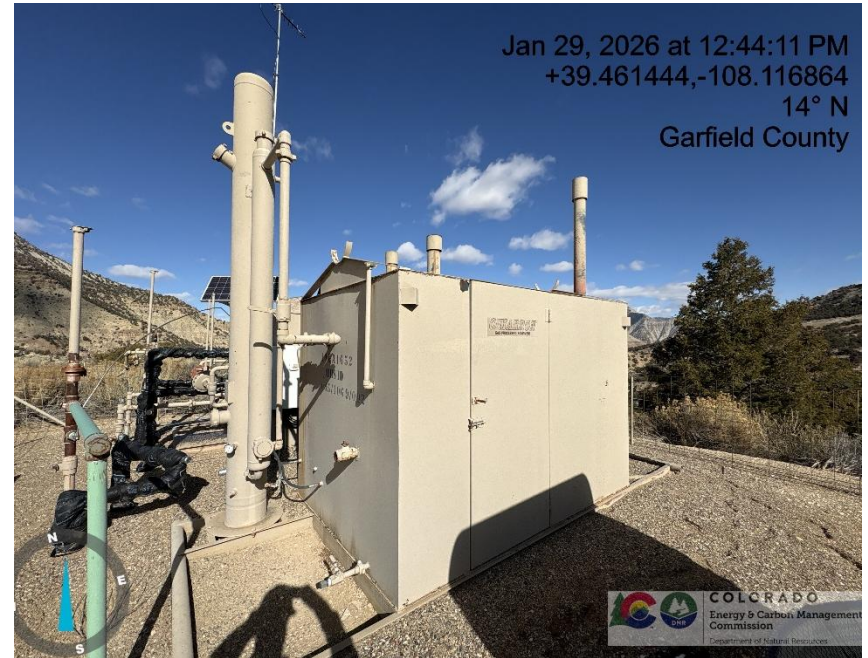
Photo # 7276 Dehy disconnected & not in use/unused equipment

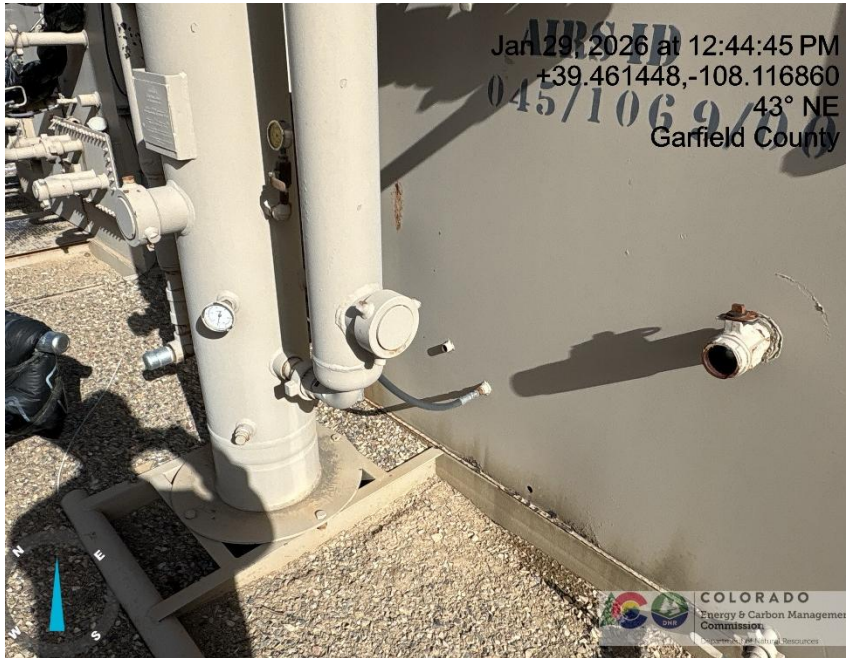
Photo # 7277 Piping on dehy disconnected/dehy not in use/unused equipment

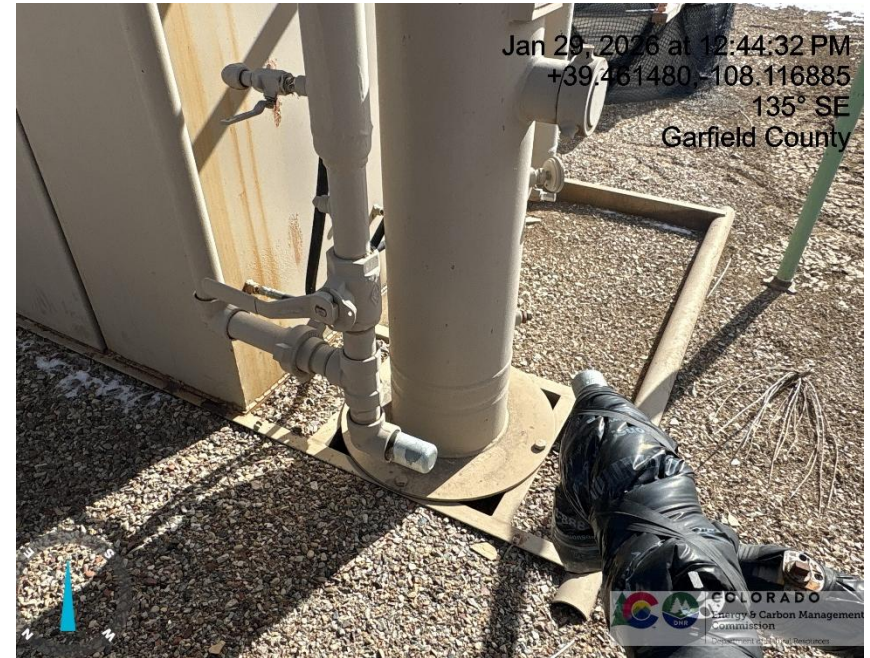
Photo # 7278 Piping on dehy disconnected/dehy not in use/unused equipment

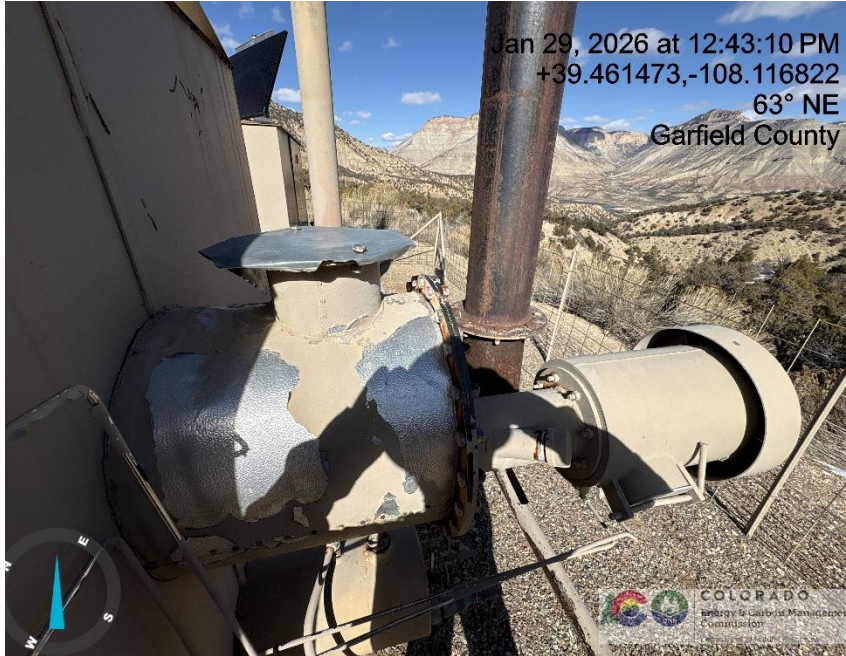
Photo # 7279 Still column has been removed from dehy /dehy inoperable & not in use/unused equipment

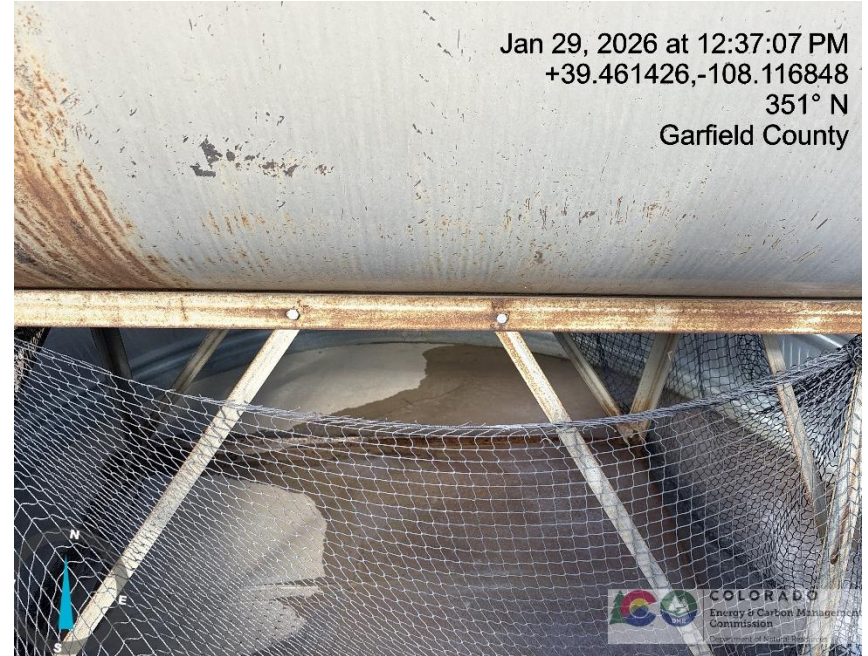
Photo # 7280 Netting for methanol tank containment needs maintenance/wildlife hazard

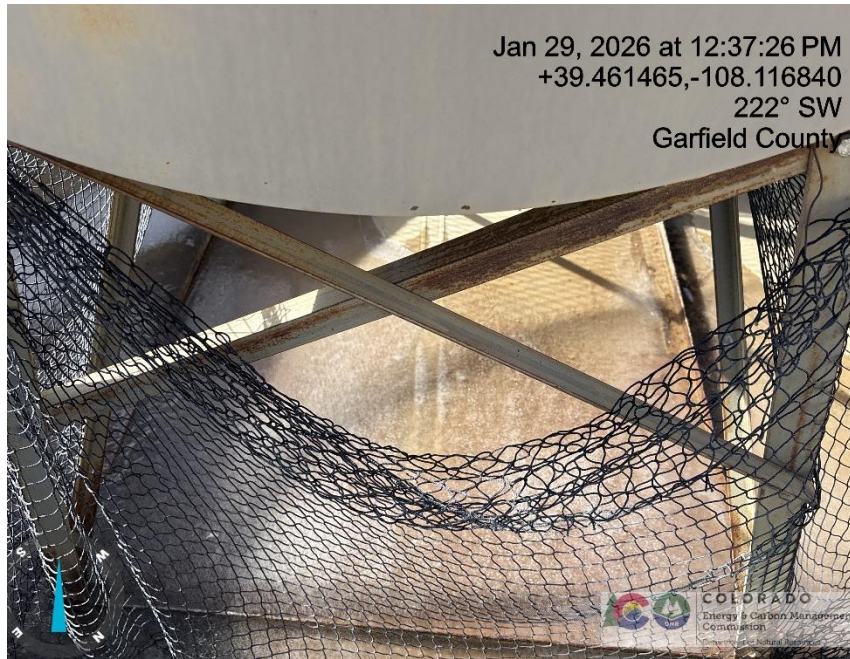
Photo # 7281 Netting for methanol tank containment needs maintenance/wildlife hazard

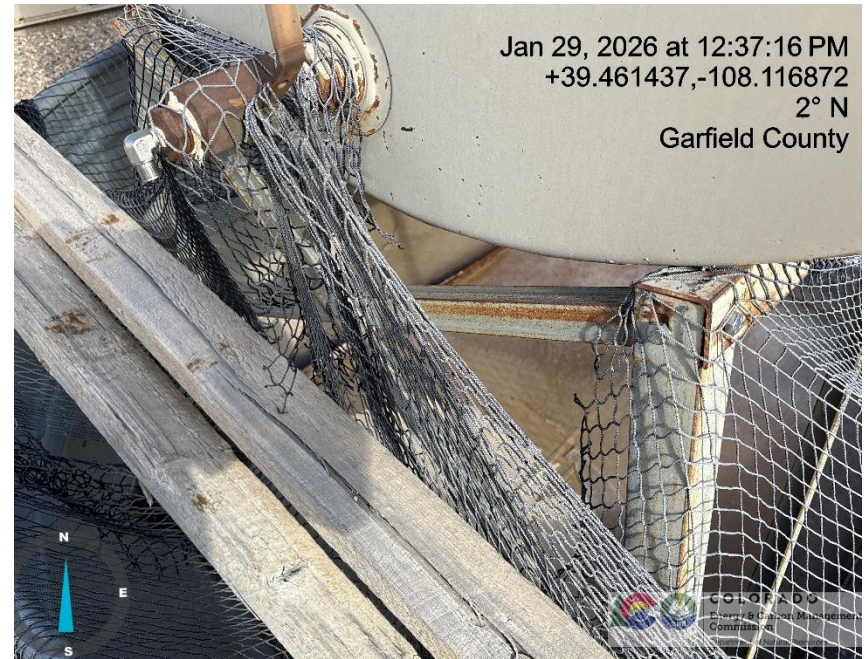
Photo # 7282 Netting for methanol tank containment needs maintenance/wildlife hazard
