Inspection/Audit Photos

Location: UTAH GAS OP LTD DBA UTAH GAS CORP DOUGLAS CREEK UNIT #7 PAD

Location ID: 314651

Date: 01/14/2026

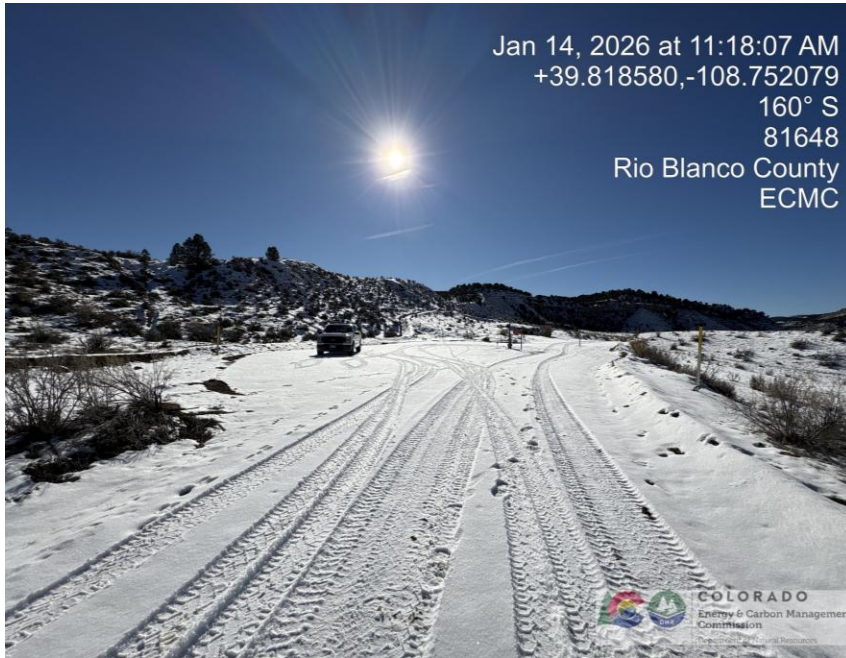
Photo # 0990 Entrance to location

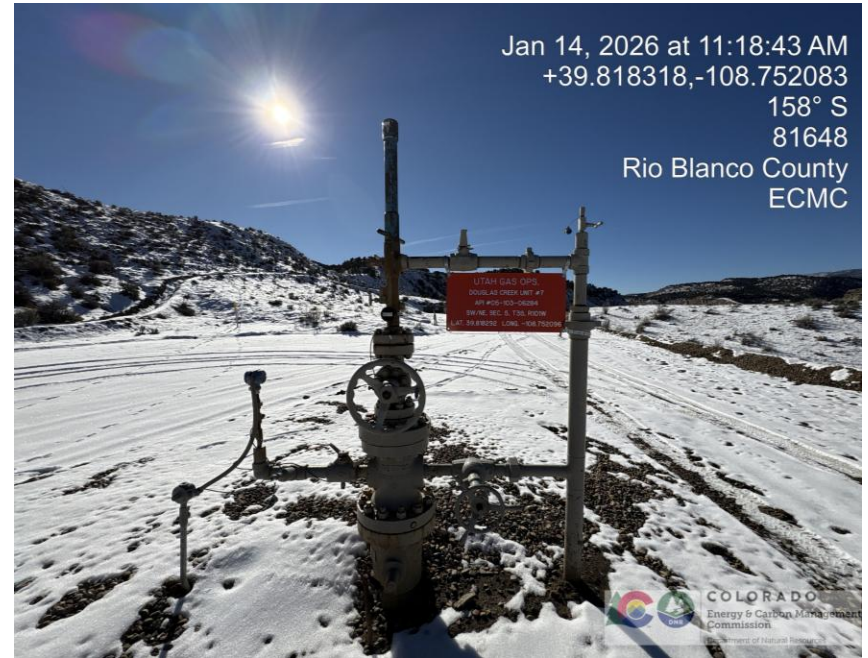
Photo # 0991 Location

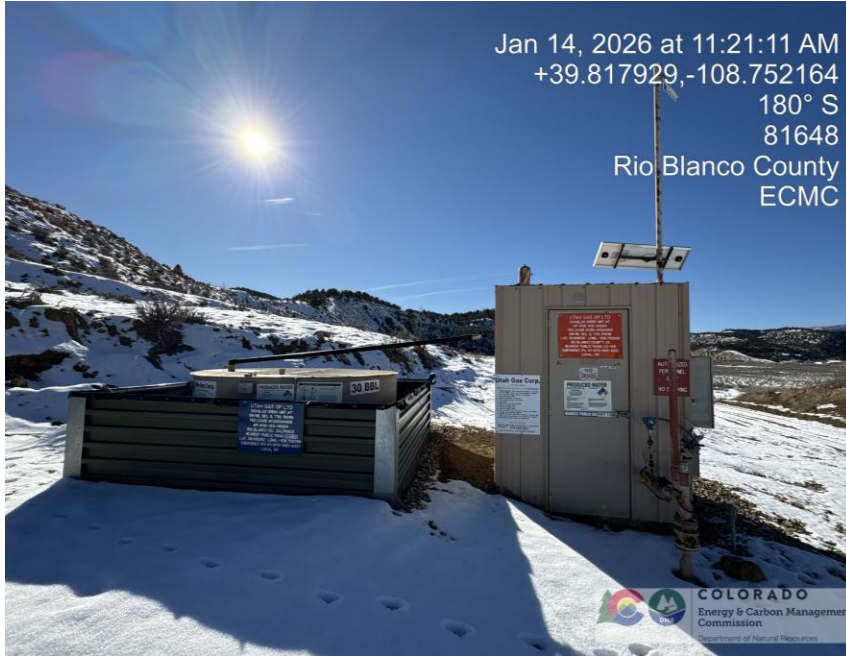
Photo # 0996 Location

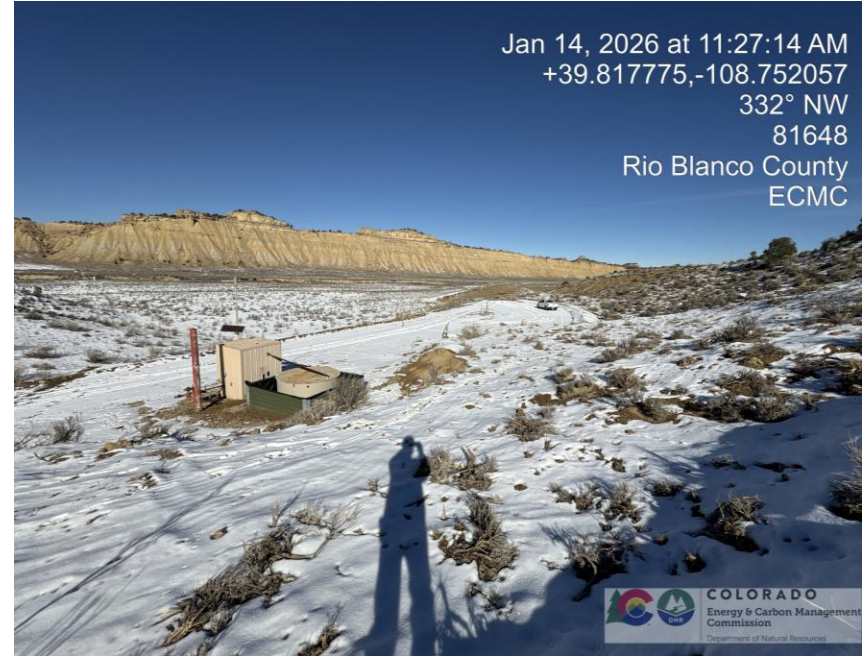
Photo # 1014 SE corner of location

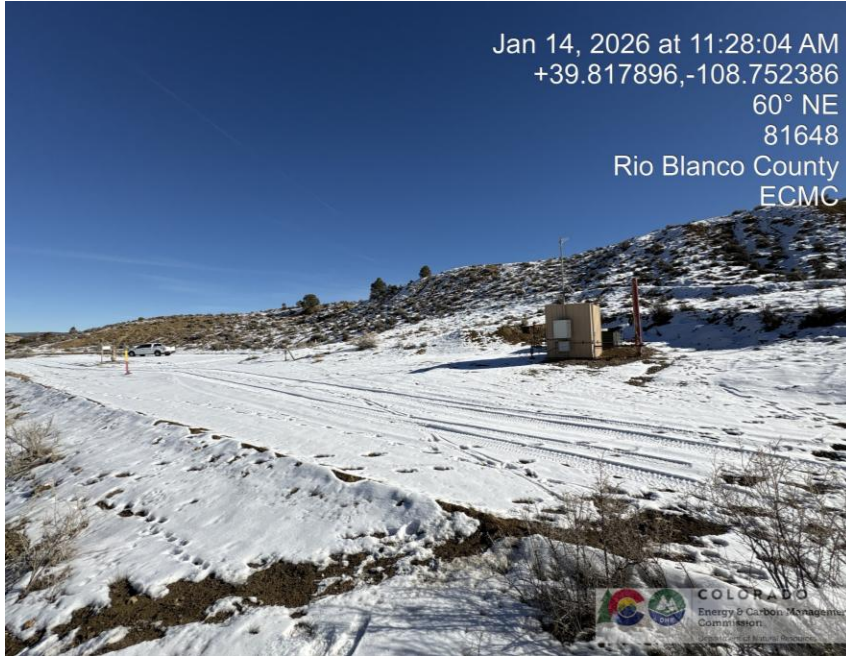
Photo # 1015 SW corner of location

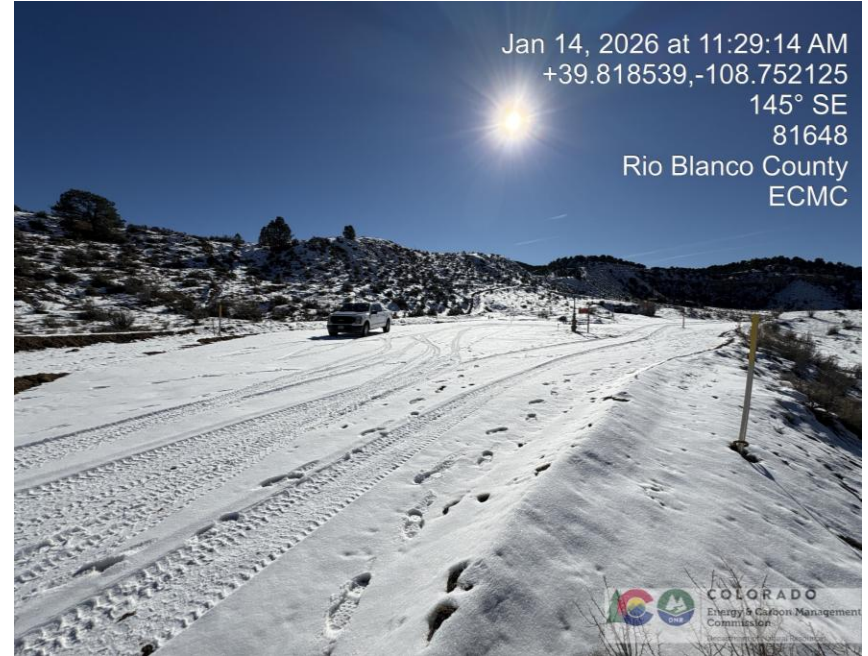
Photo # 1016 NW corner of location

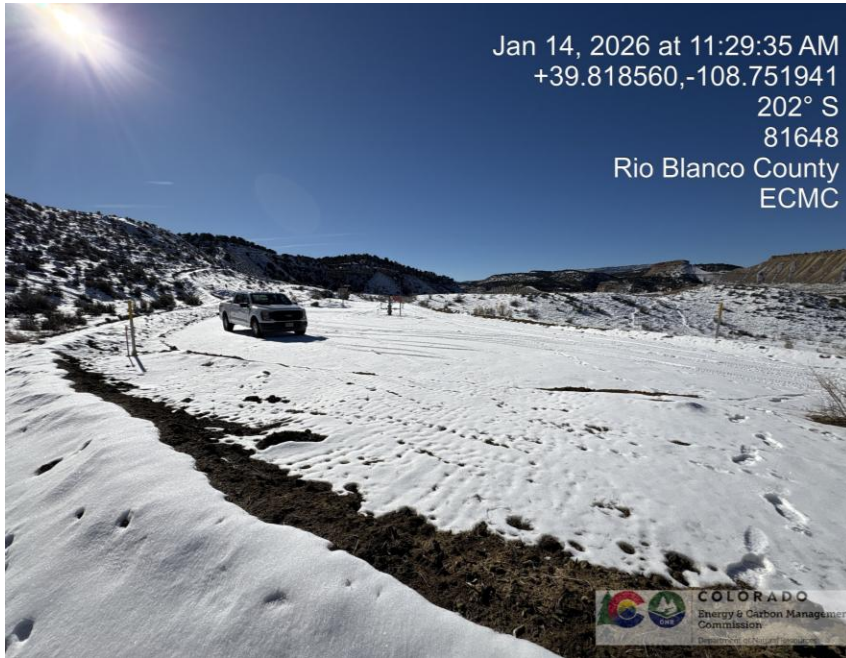
Photo # 1017 NE corner of location

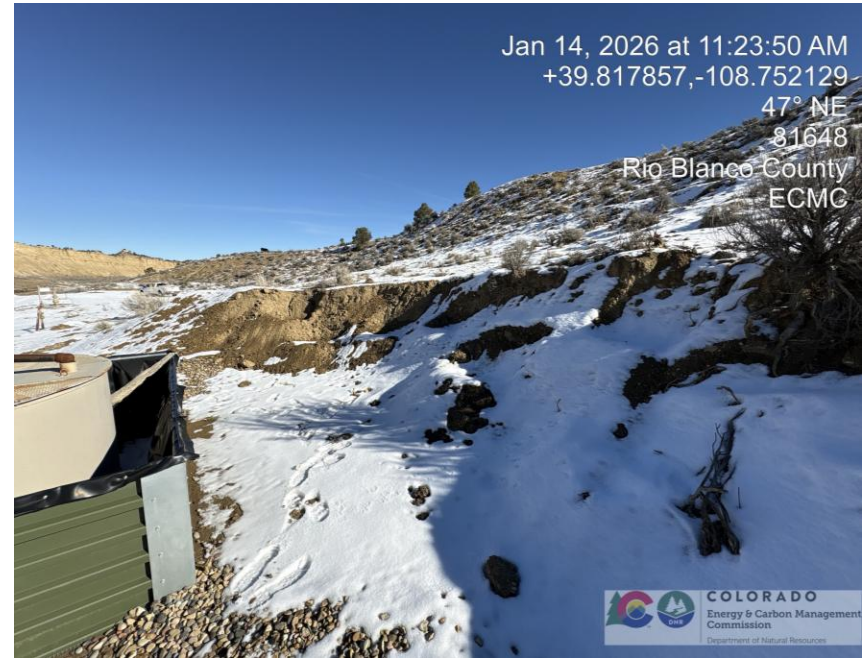
Photo # 1006 Erosion & transport of sediment on cut slope, sediment is migrating onto location near tank battery, the cut slope has experienced progressive erosion and is now actively sloughing, resulting in slope instability.

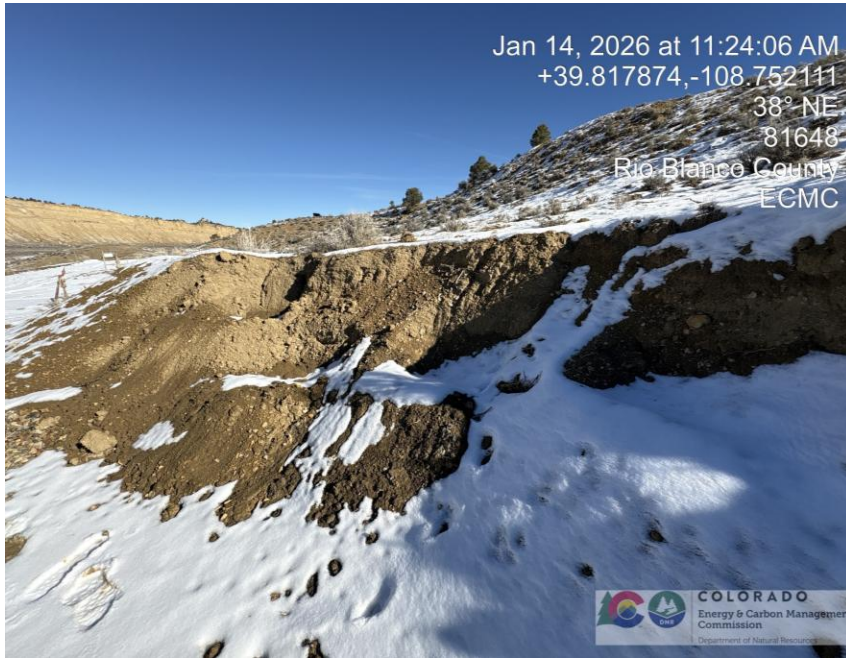
Photo # 1008 Erosion & transport of sediment on cut slope, sediment is migrating onto location near tank battery, the cut slope has experienced progressive erosion and is now actively sloughing, resulting in slope instability.

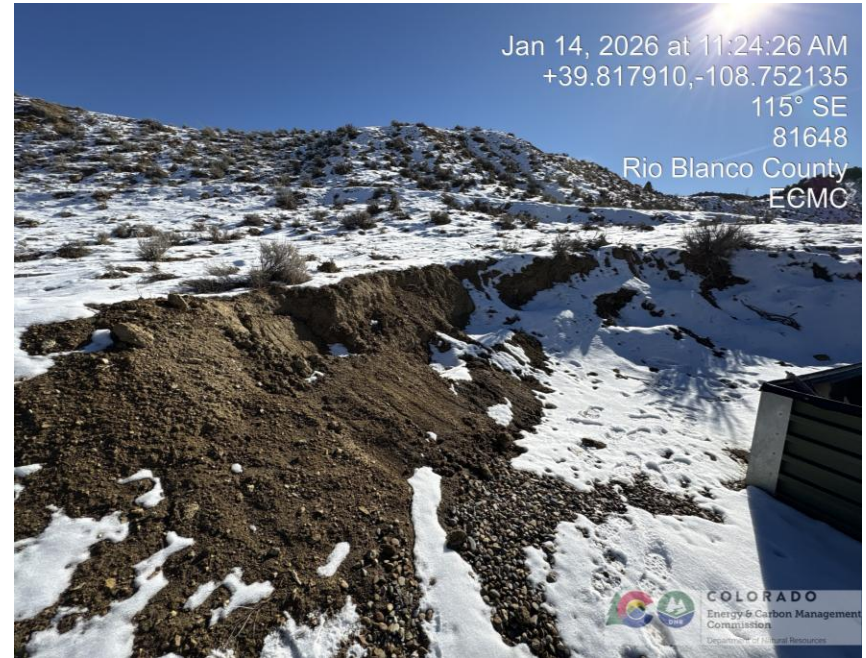
Photo # 1009 Erosion & transport of sediment on cut slope, sediment is migrating onto location near tank battery, the cut slope has experienced progressive erosion and is now actively sloughing, resulting in slope instability.

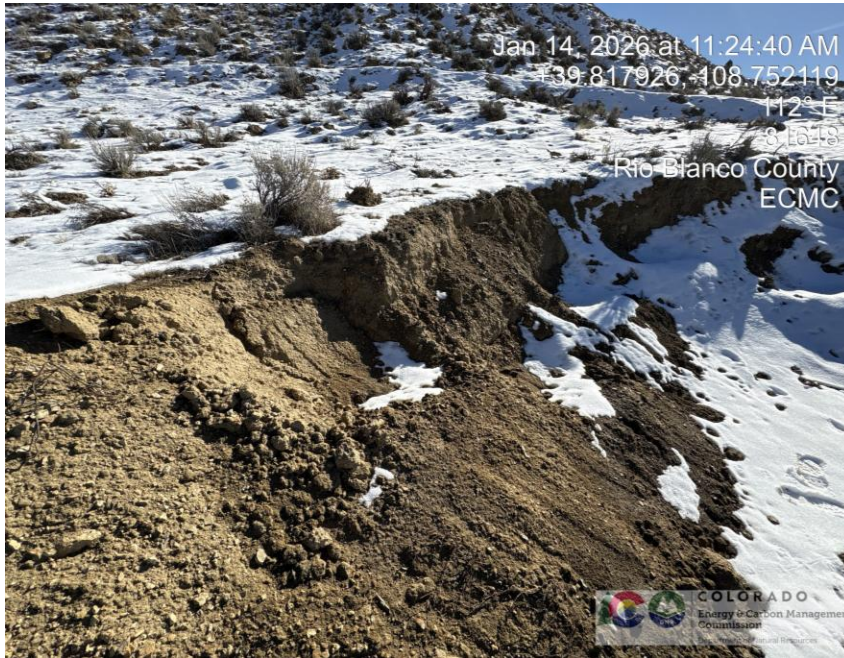
Photo # 1010 Erosion & transport of sediment on cut slope, sediment is migrating onto location near tank battery, the cut slope has experienced progressive erosion and is now actively sloughing, resulting in slope instability.

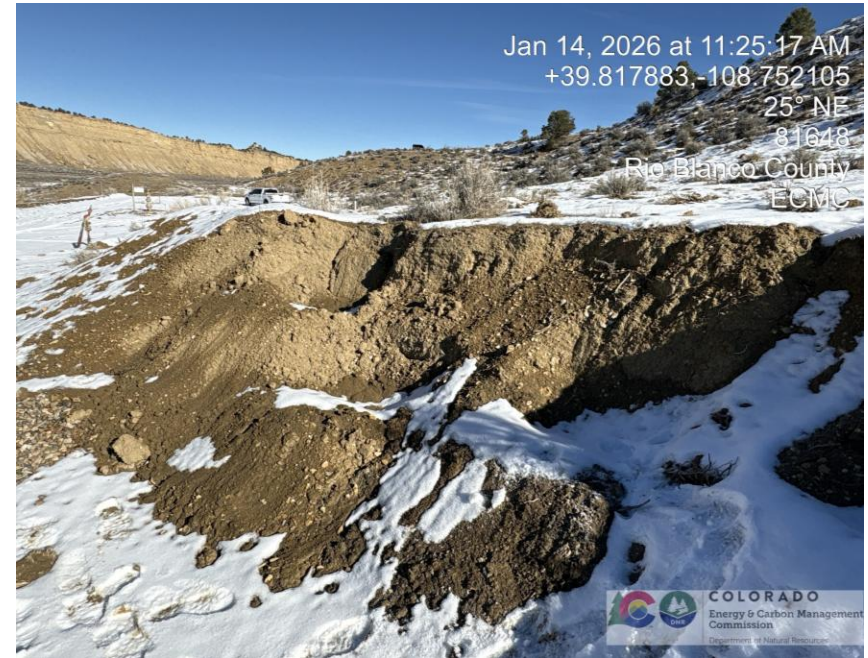
Photo # 1011 Erosion & transport of sediment on cut slope, sediment is migrating onto location near tank battery, the cut slope has experienced progressive erosion and is now actively sloughing, resulting in slope instability.

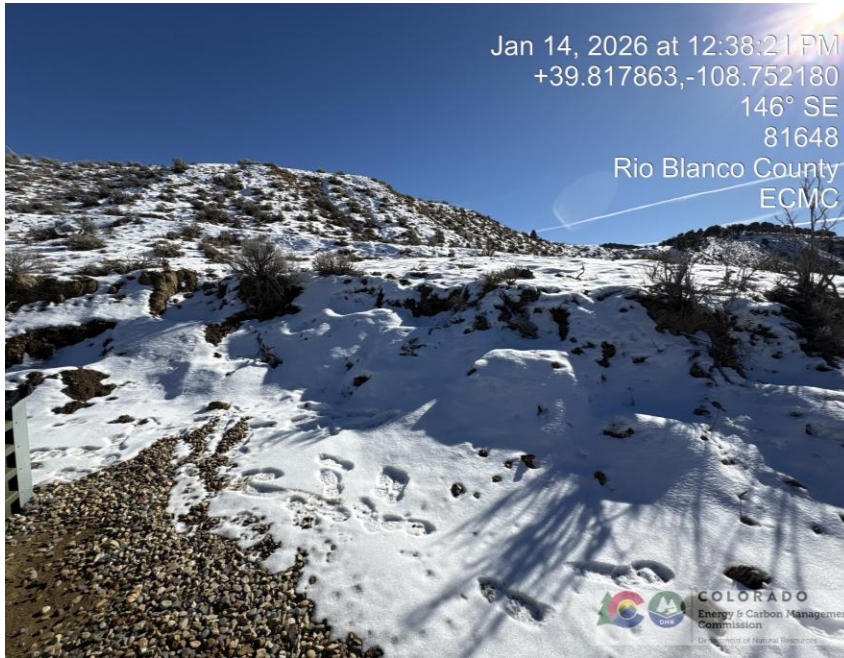
Photo # 1052 Erosion & transport of sediment on cut slope, sediment is migrating onto location near tank battery, the cut slope has experienced progressive erosion and is now actively sloughing, resulting in slope instability.

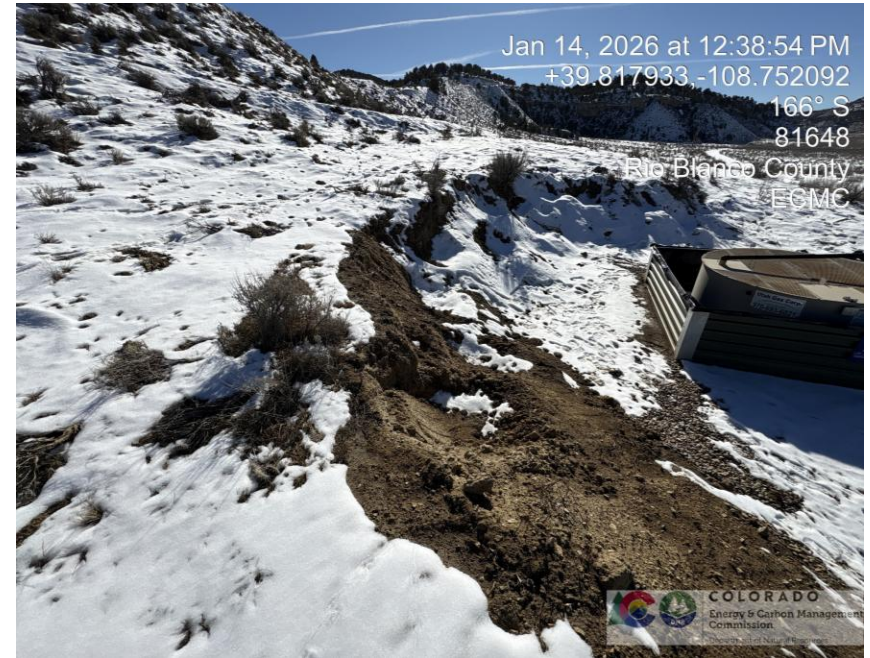
Photo # 1054 Erosion & transport of sediment on cut slope, sediment is migrating onto location near tank battery, the cut slope has experienced progressive erosion and is now actively sloughing, resulting in slope instability.

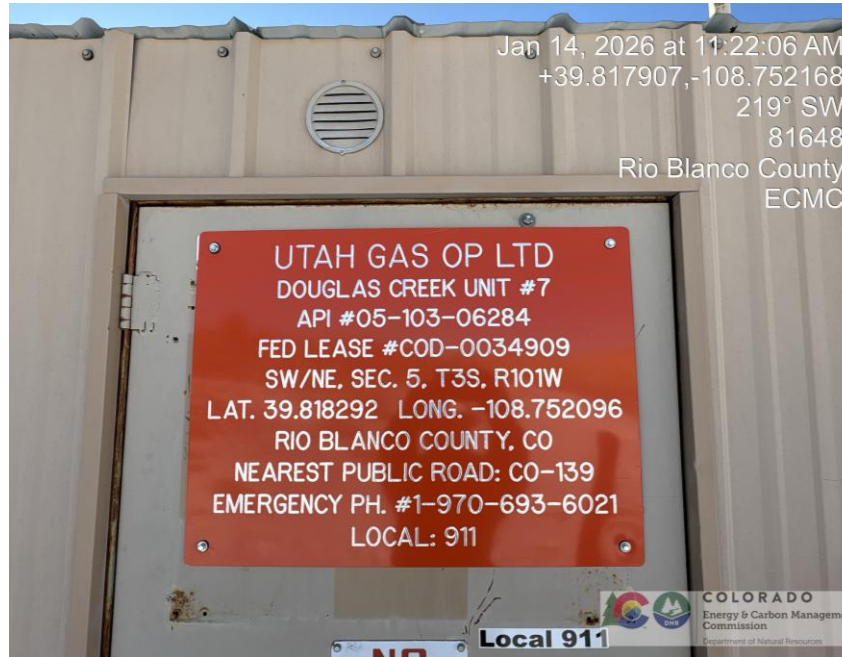
Photo # 1000 Location – Signage addressed
