Inspection Photos
Location Name: Facility 5 Gas Line
Spill ID: 492917

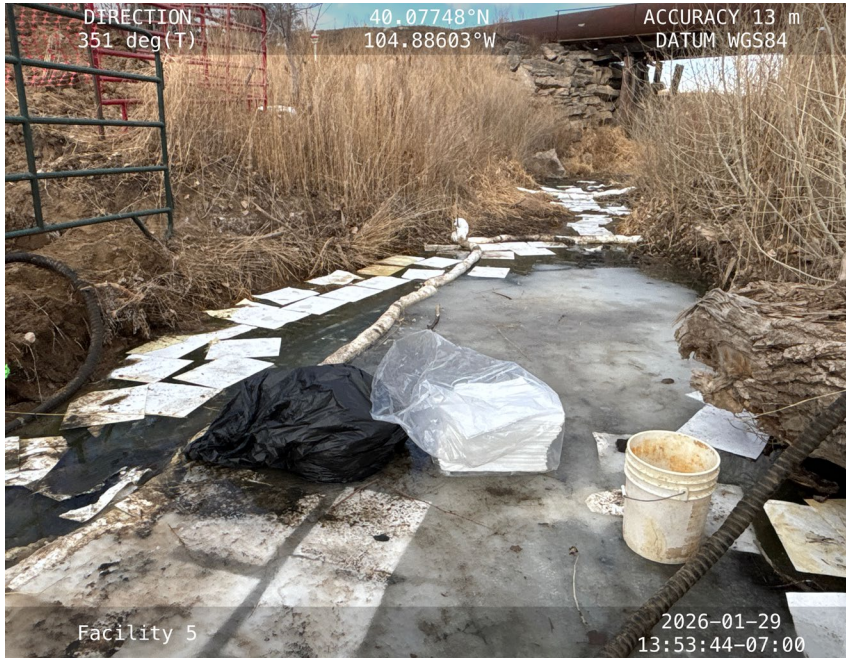
Impacted waters and inadequate storage of supplies

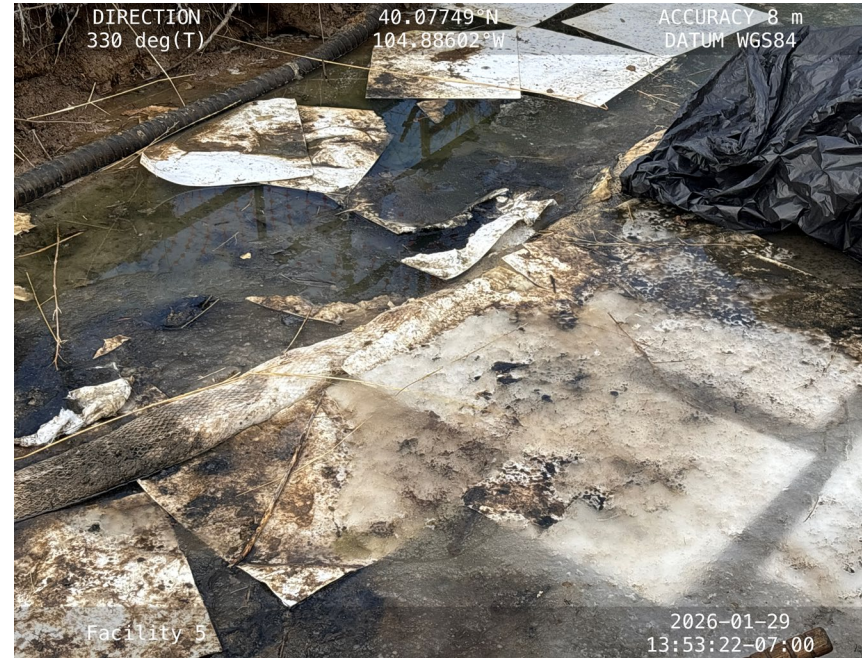
Impacted waters and inadequate storage of supplies

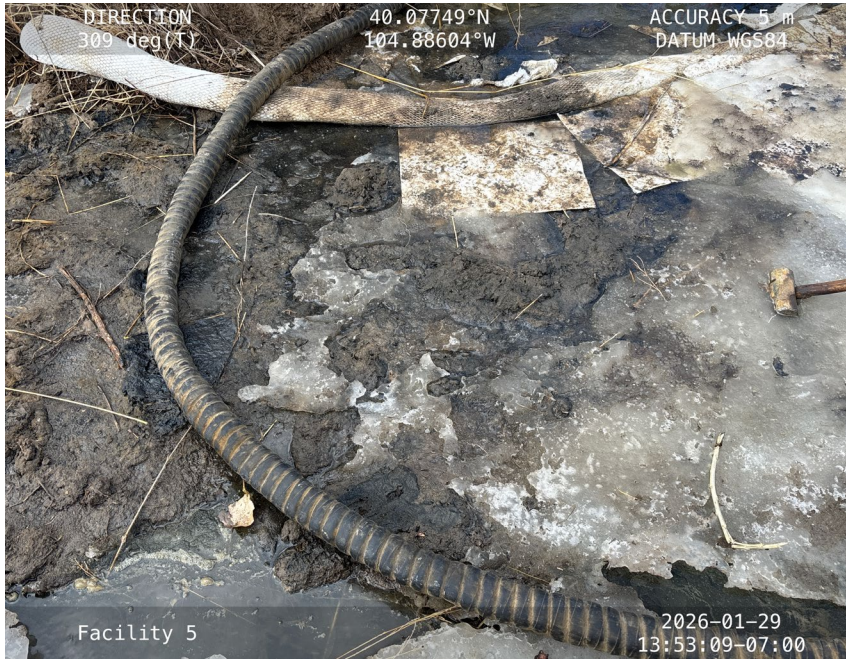
Impacted waters and inadequate storage of supplies

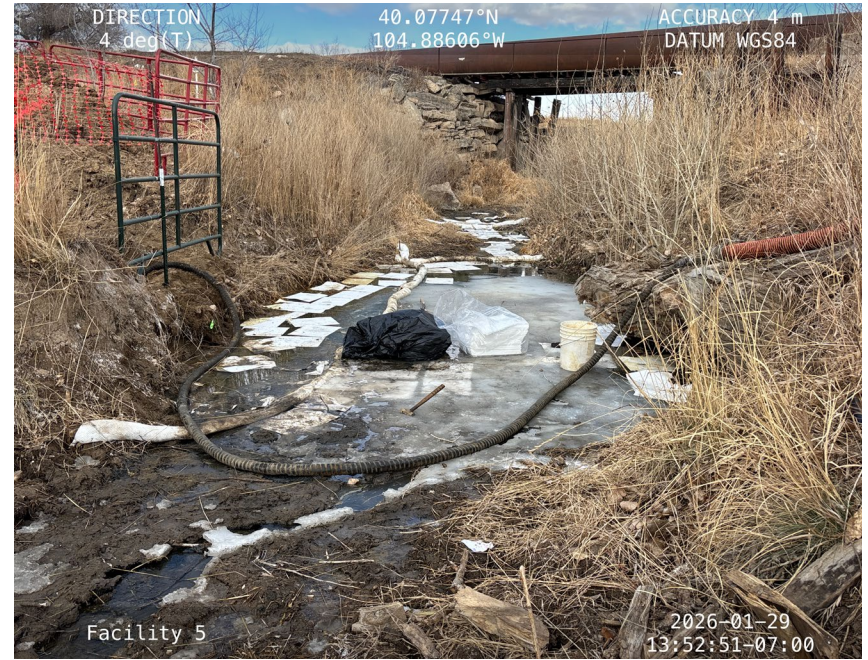
Impacted waters and inadequate storage of supplies

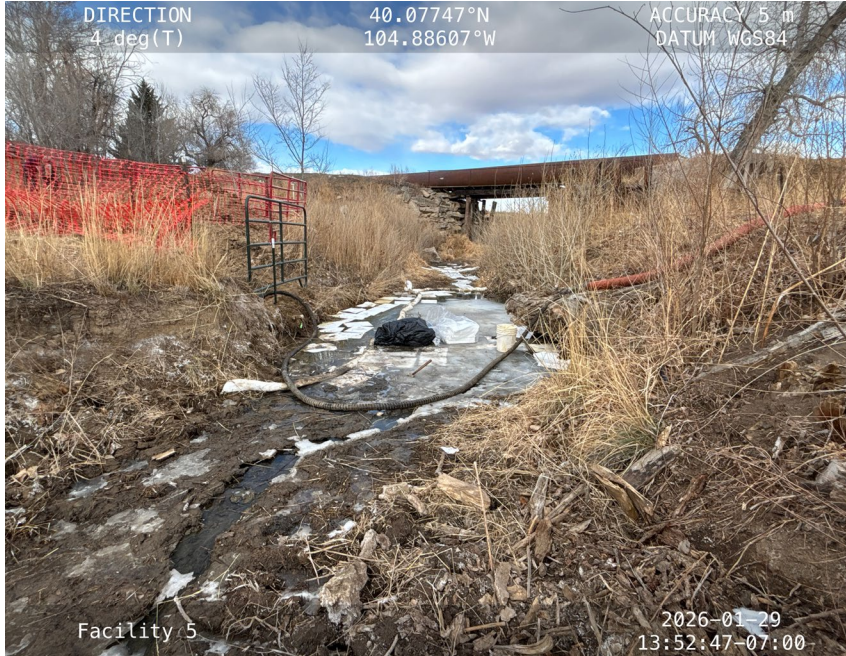
Impacted waters and inadequate storage of supplies

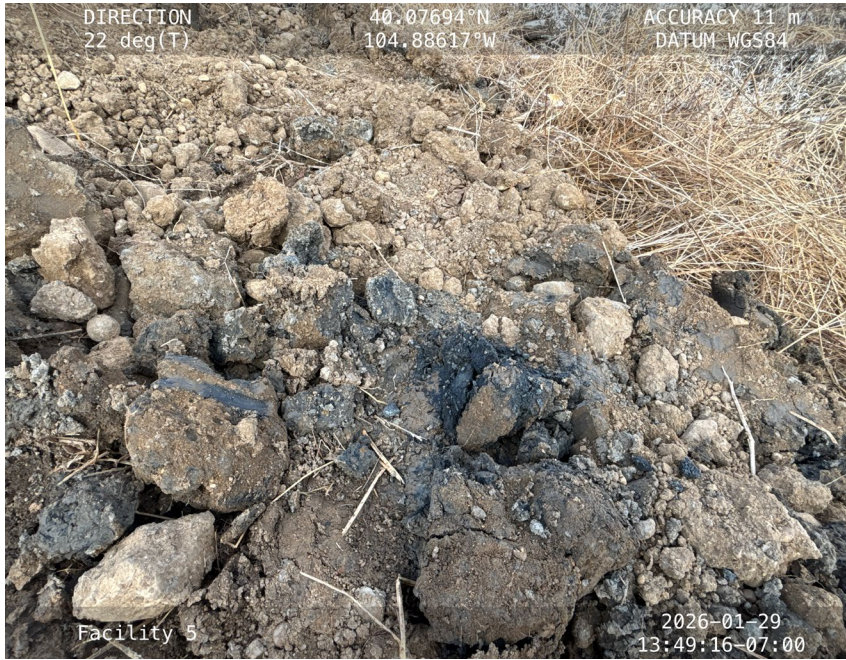
Stained soil observed upstream

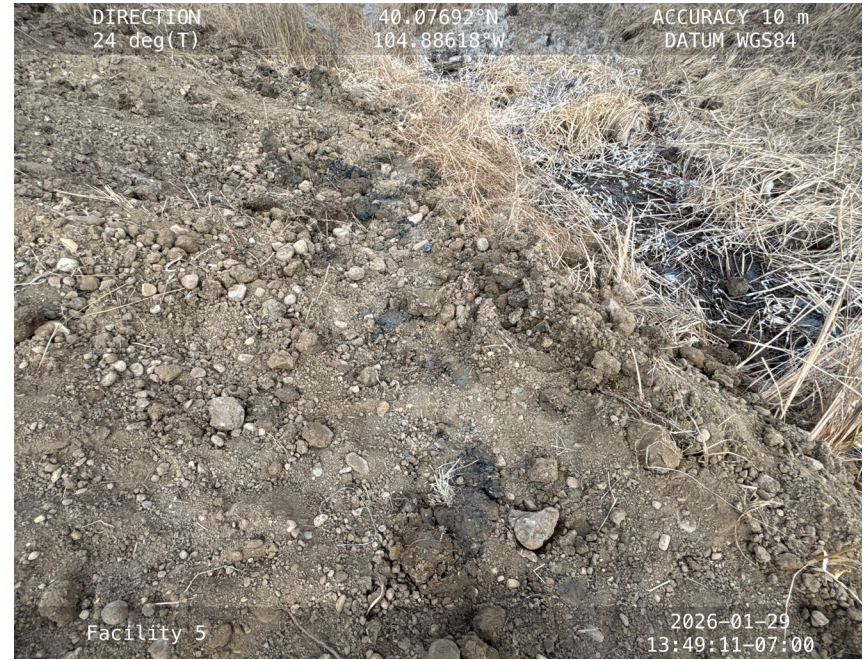
Stained soil observed upstream

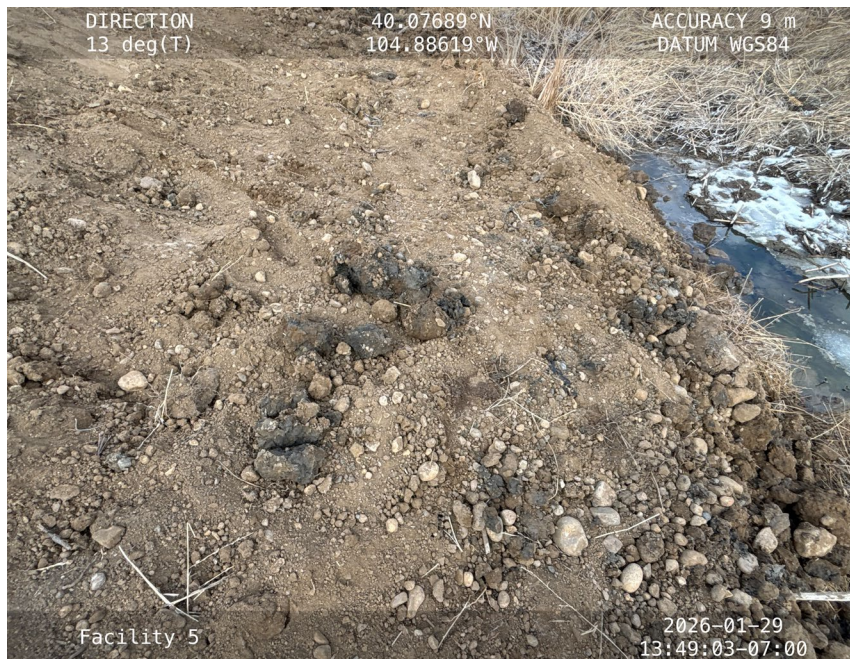
Stained soil observed upstream

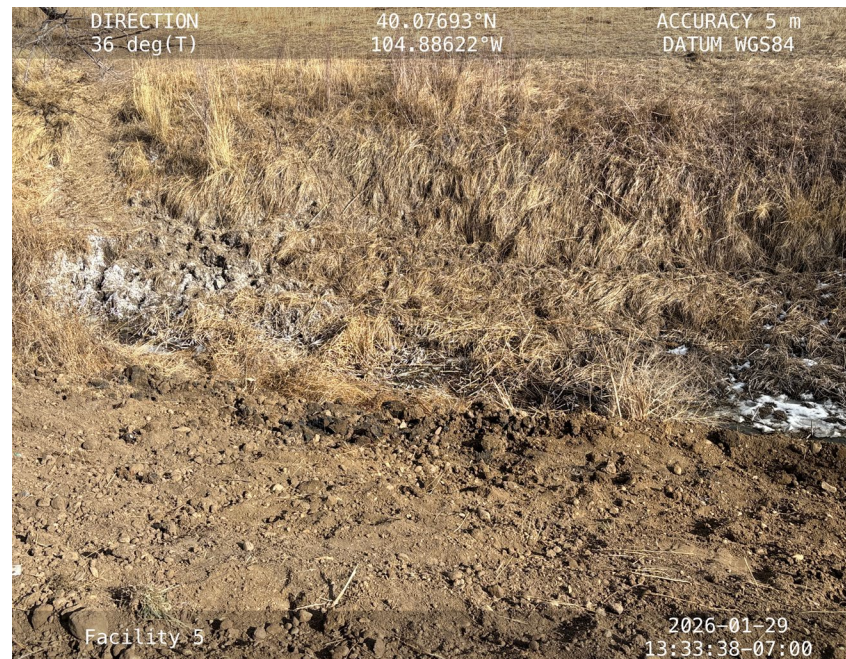
Stained soil observed upstream

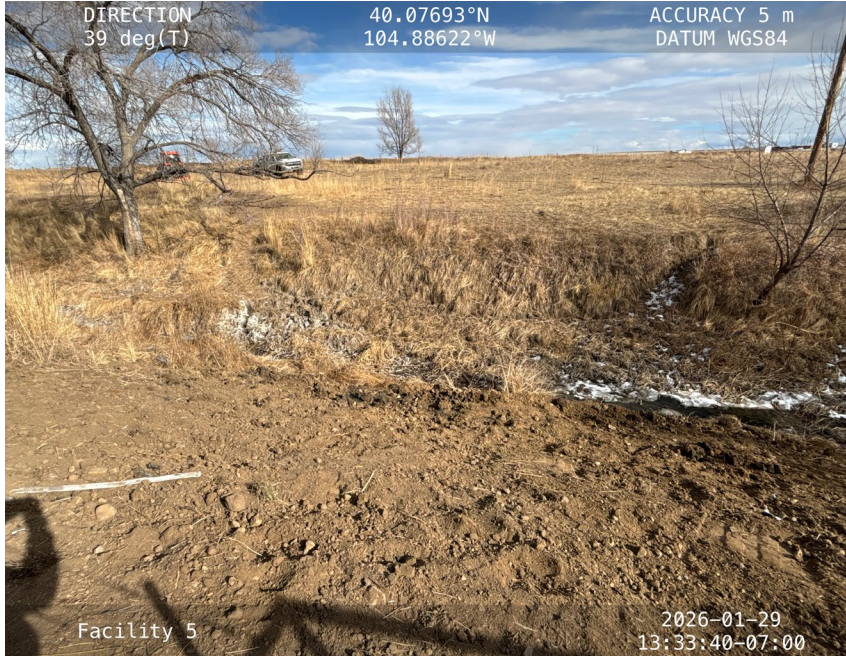
Stained soil observed upstream

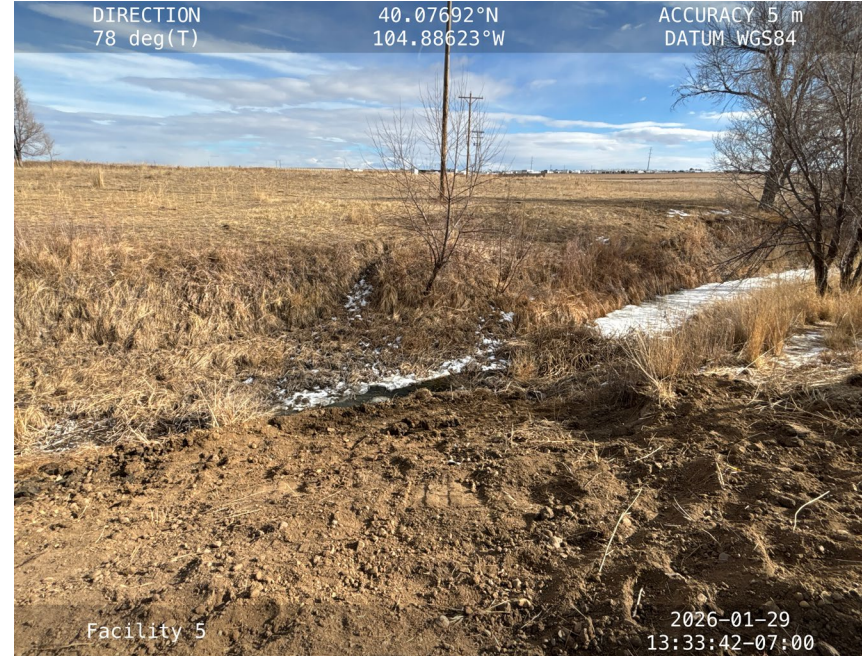
Stained soil observed upstream

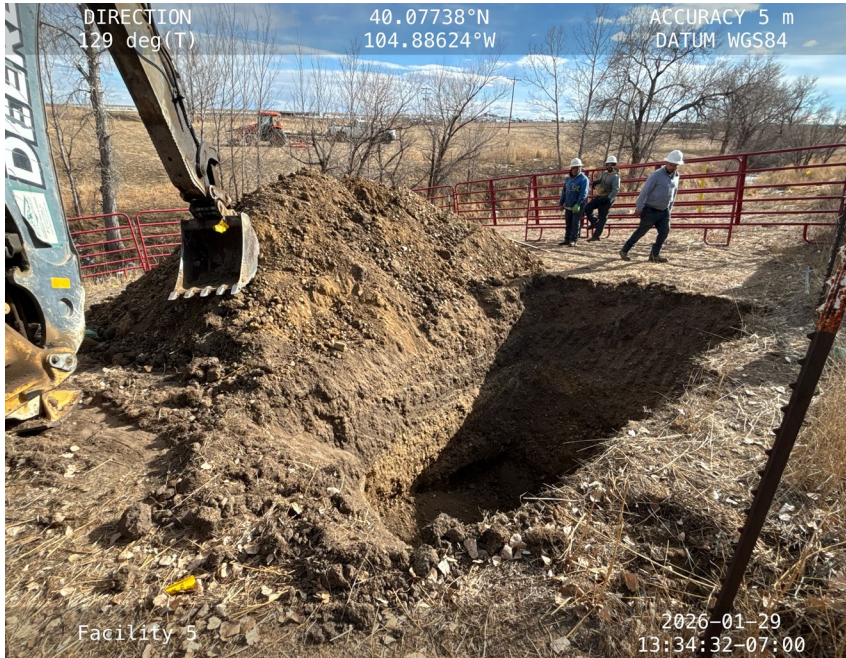
Presumed release point location excavation

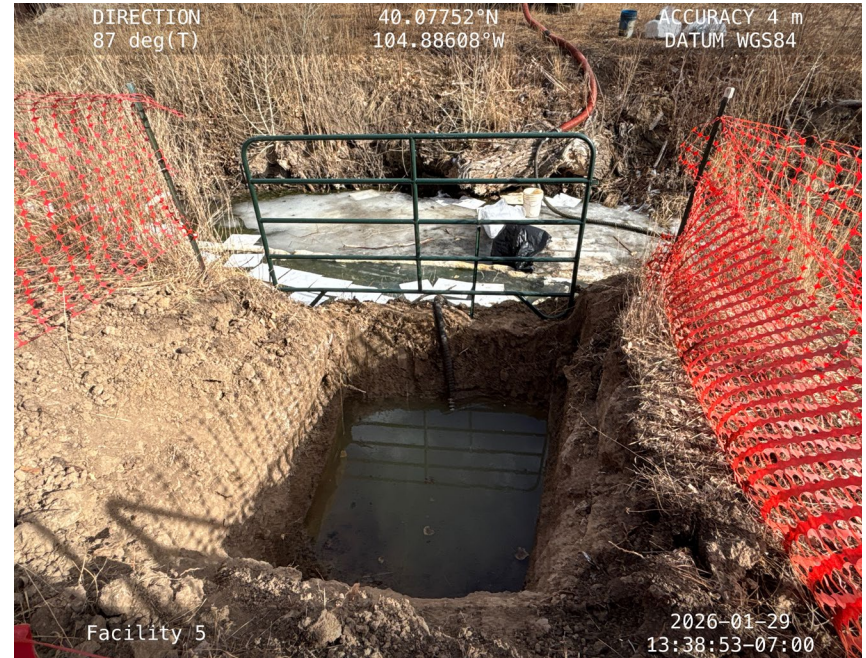
Presumed release point location excavation. Oily sheen observed on water within excavation.

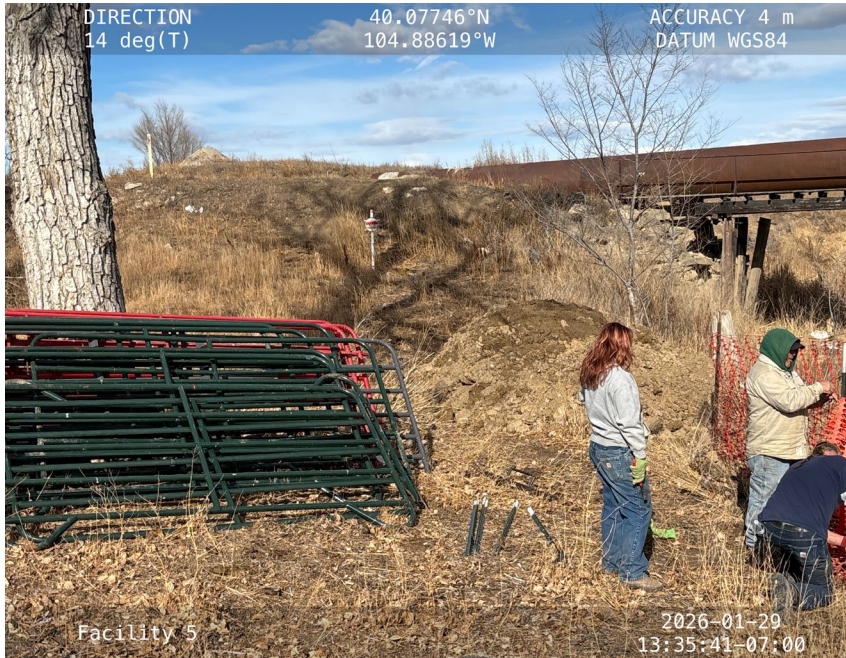
Waste stockpile. Inadequate stockpile management

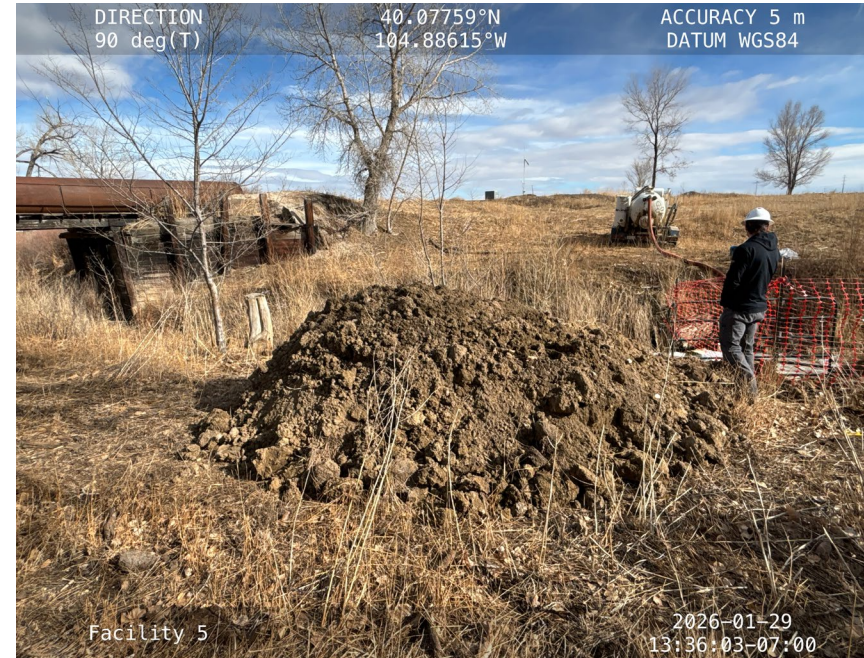
Waste stockpile. Inadequate stockpile management

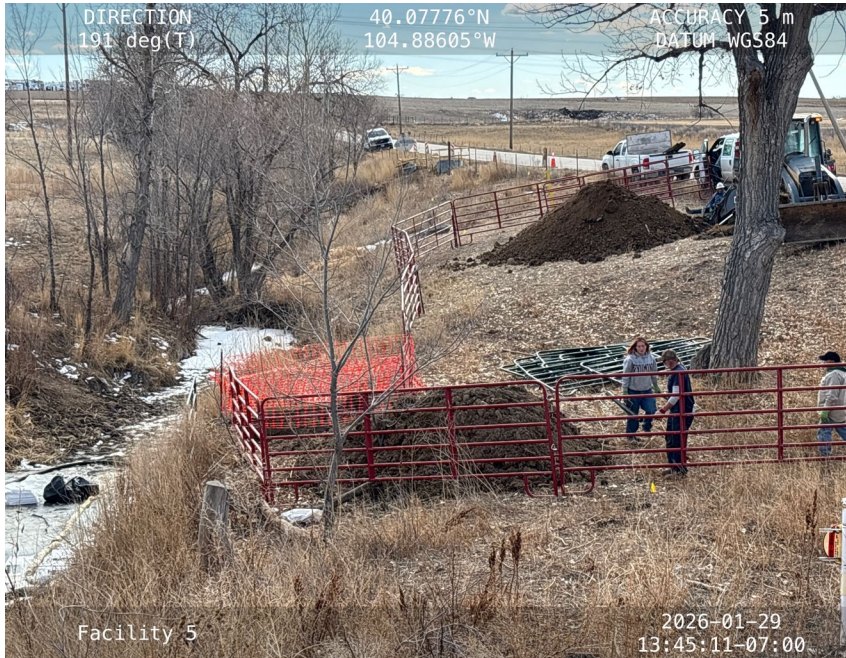
Inadequate stockpile management

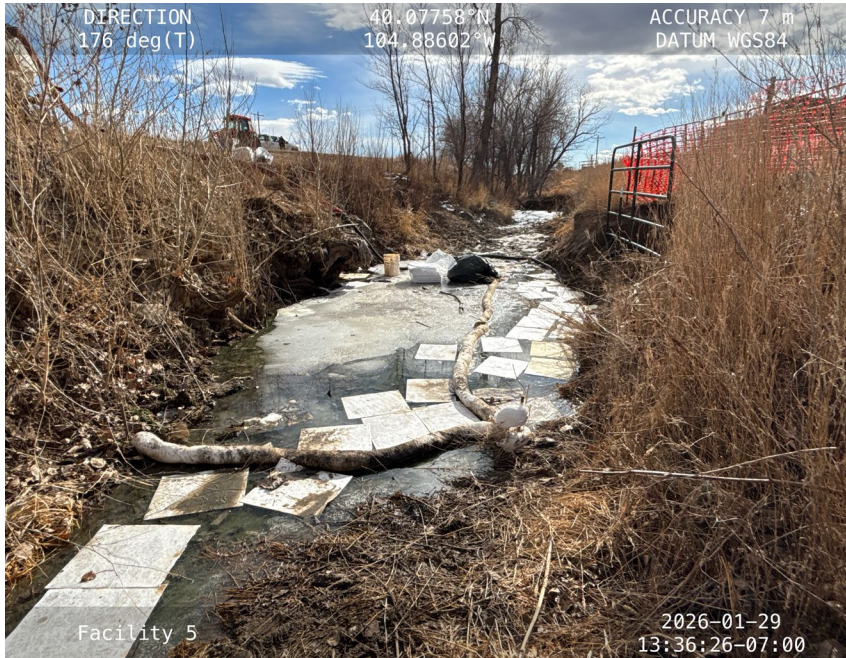
Inadequate absorbent mats

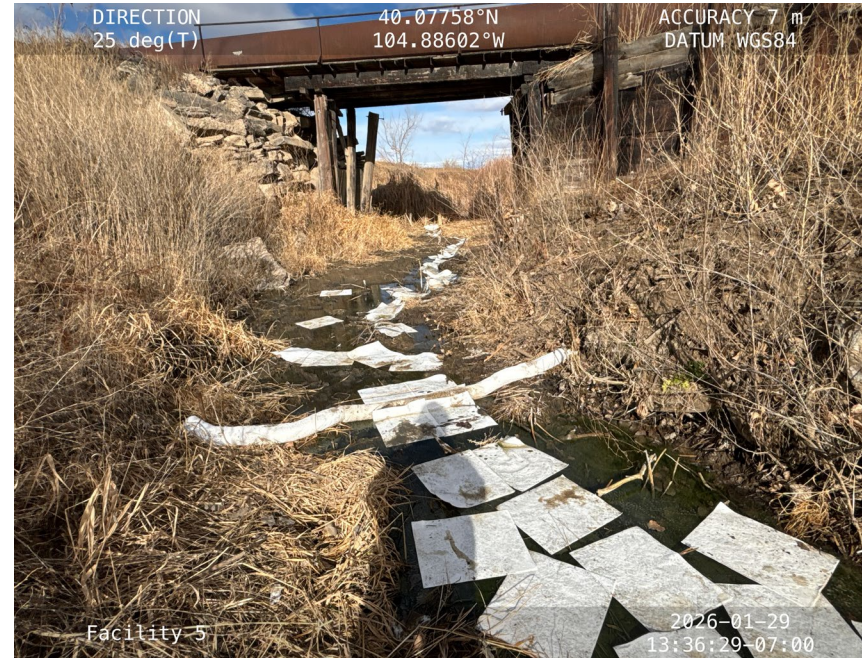
Inadequate absorbent mats

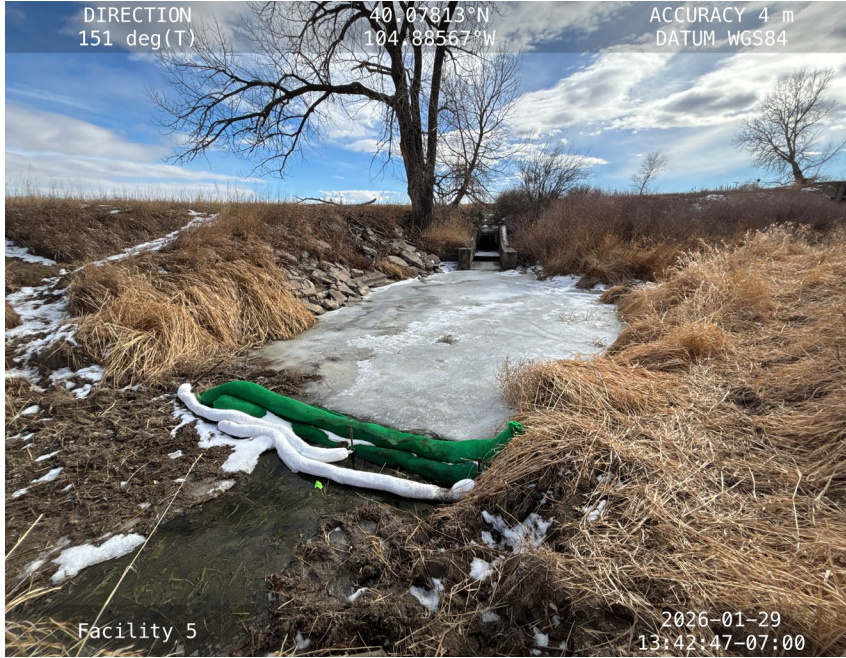
Inadequate booms

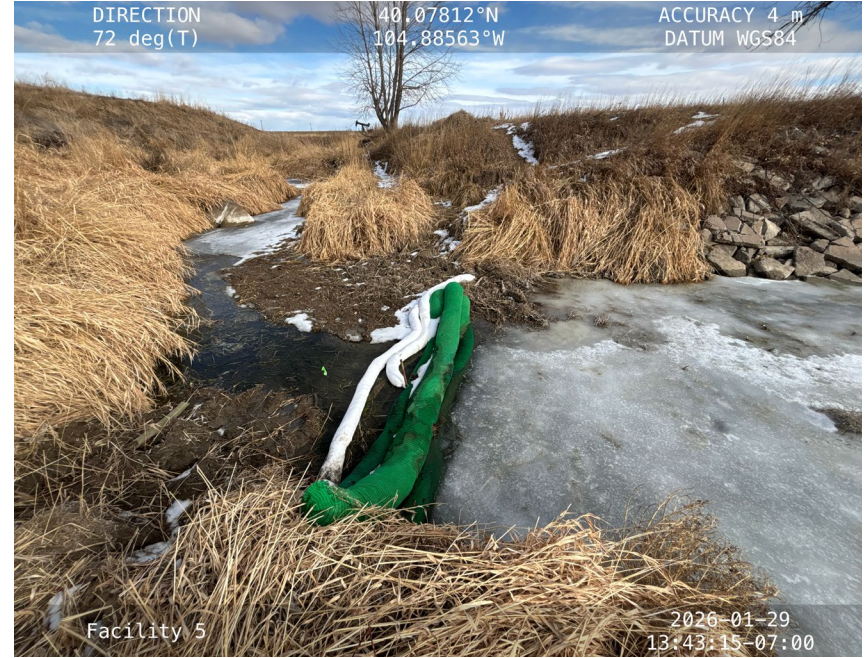
Inadequate booms
