Inspection Photos

Location Name: Logos Operating LLC. – Northwest Cedar Hill 32-10API # 05-067-05010

Inspector Name: Jamie Blair. Inspection Date: 02/02/2026

Inspection Doc #: 721100095

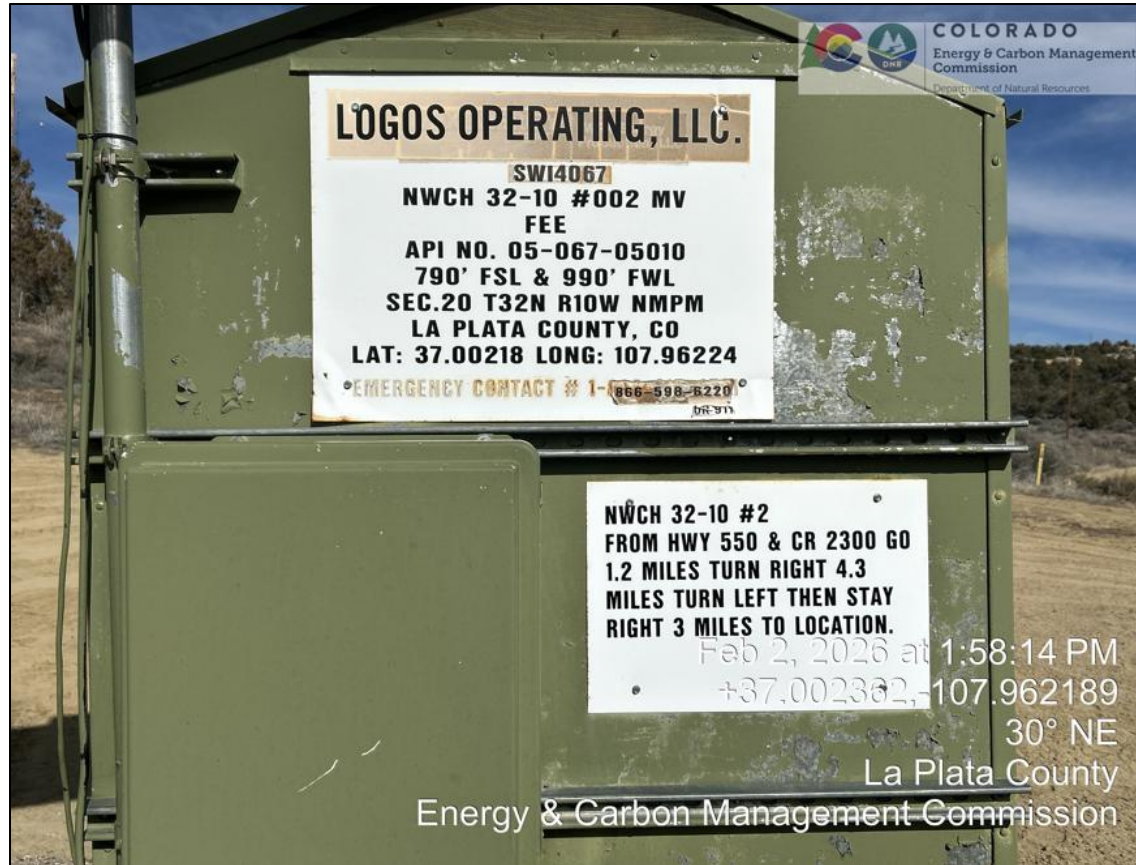
01 – Well Sign posted on side of meter run shed. Note that 24 hour and emergency contact numbers are getting very difficult to read.

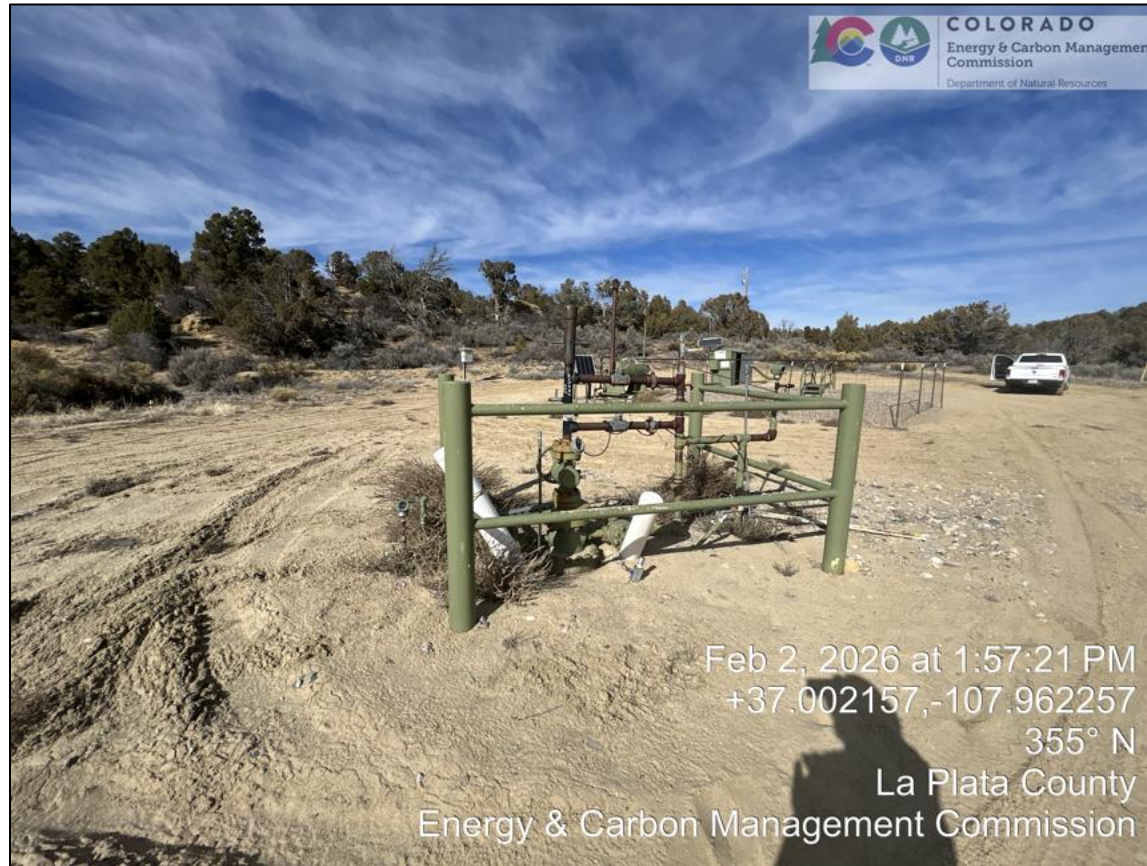
**02. Well head and well pad area. Note that dead vegetative material from last season is accumulated. The well production area and lease road appear to be composed of native sand and not gravel, which is mostly buried or washed away.**

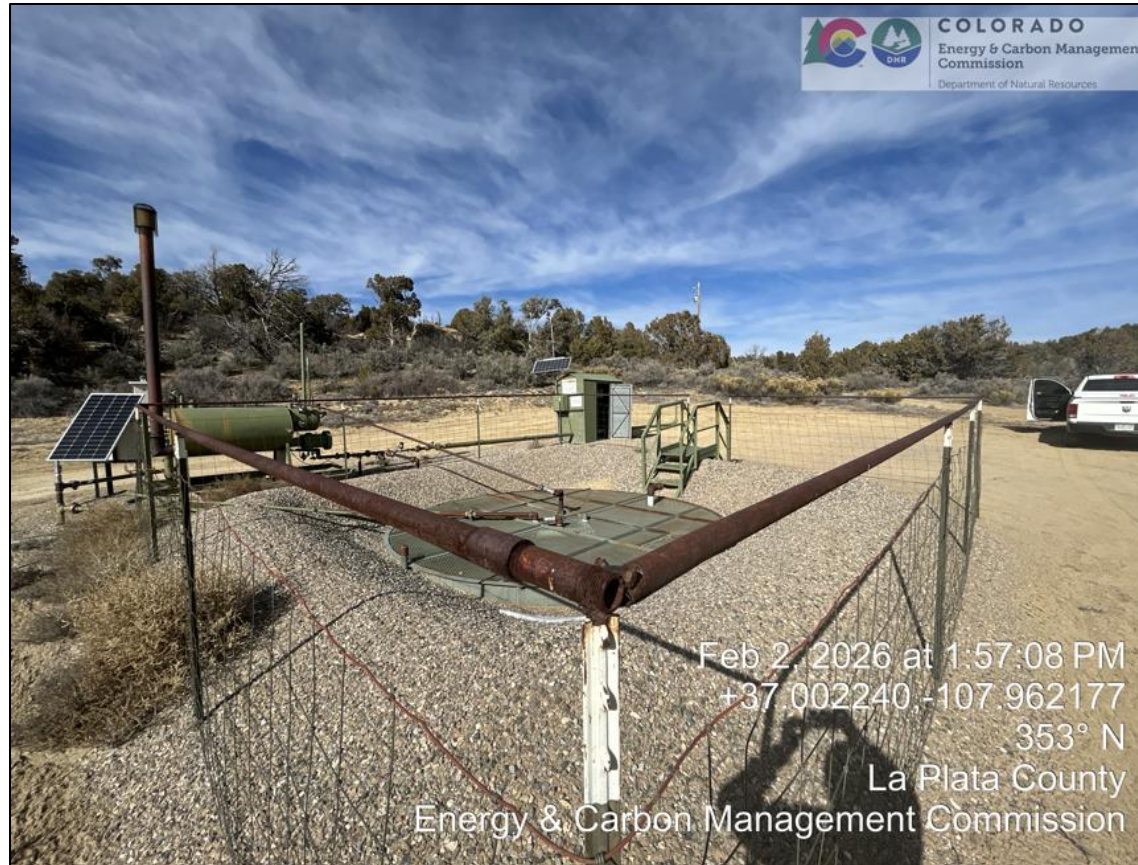
**4: Steel PBV Tank. The tank has an expanded metal top. It appears to contain produced water, but there is no sign to indicate contents or volume.**

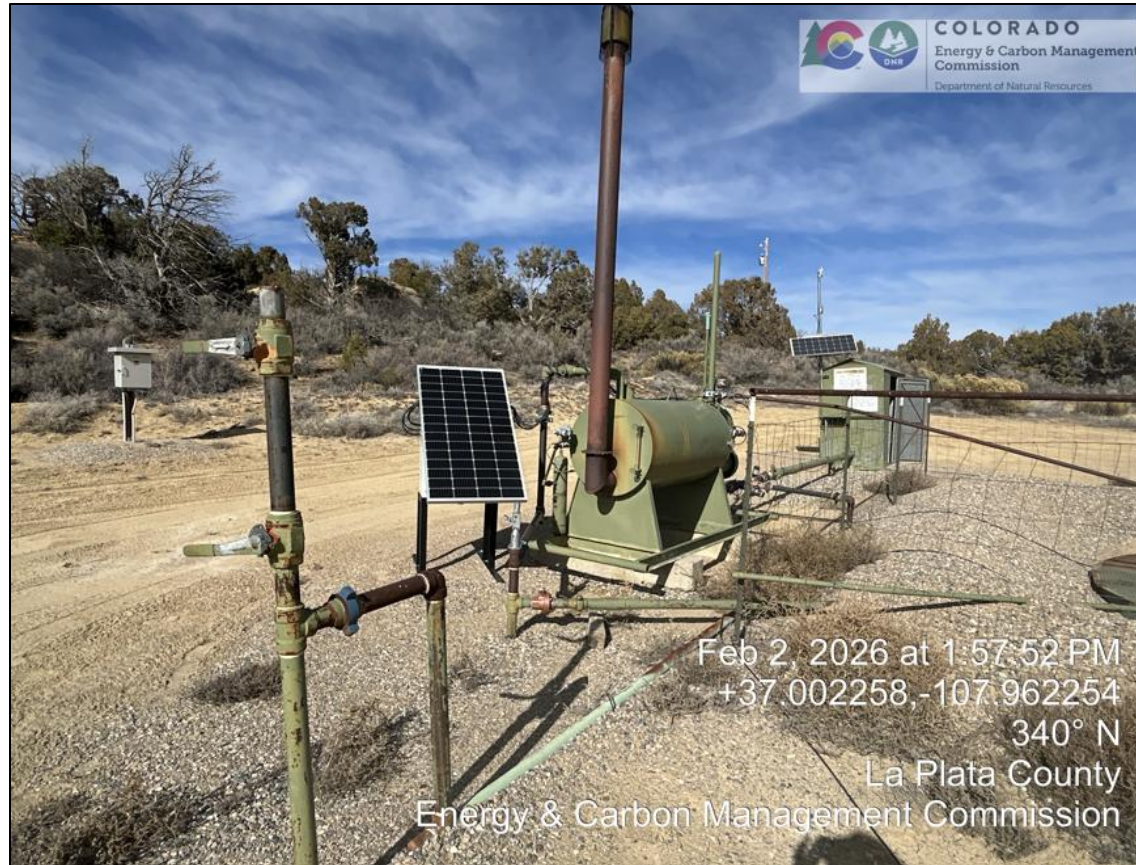
**5. Heated horizontal separator. Note that there is dead vegetative debris accumulating near the separator.**

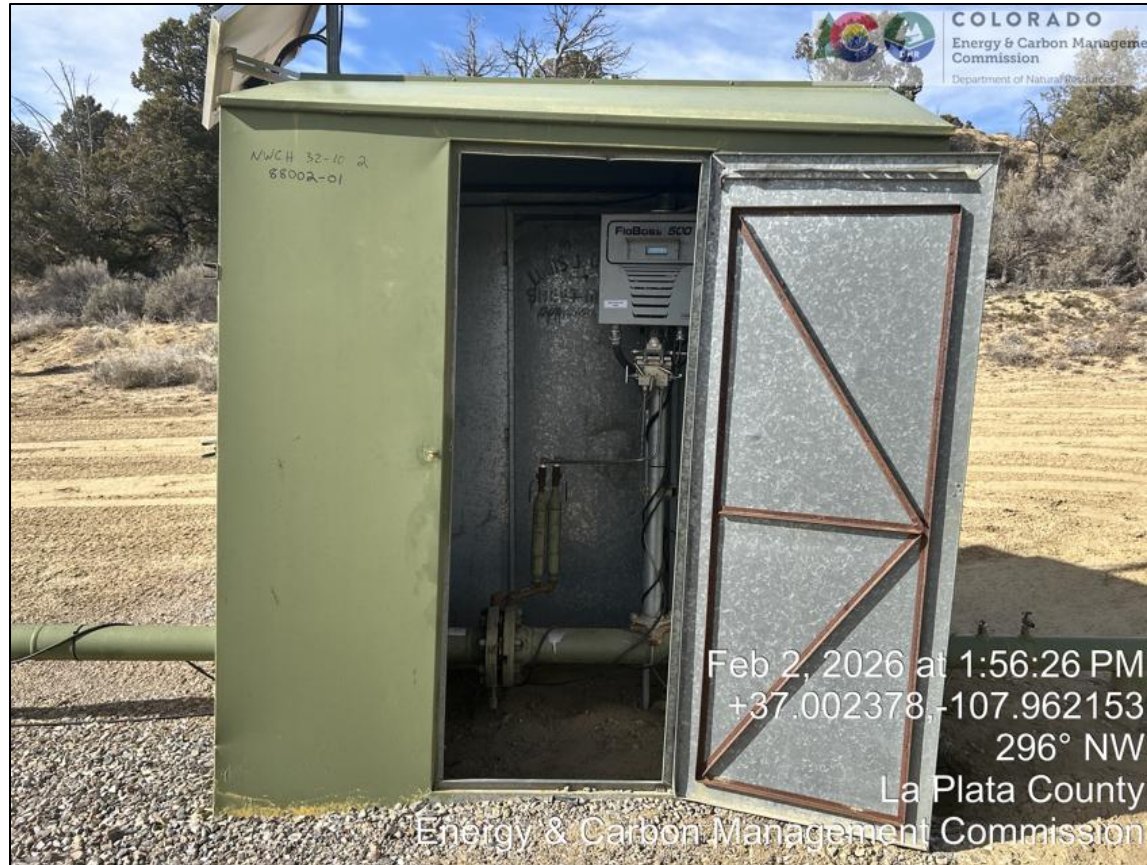
6. Meter run shed. The calibration card was present inside the structure. Dated 1/20/2026. There is no latch on the door, which swings freely in the wind.
