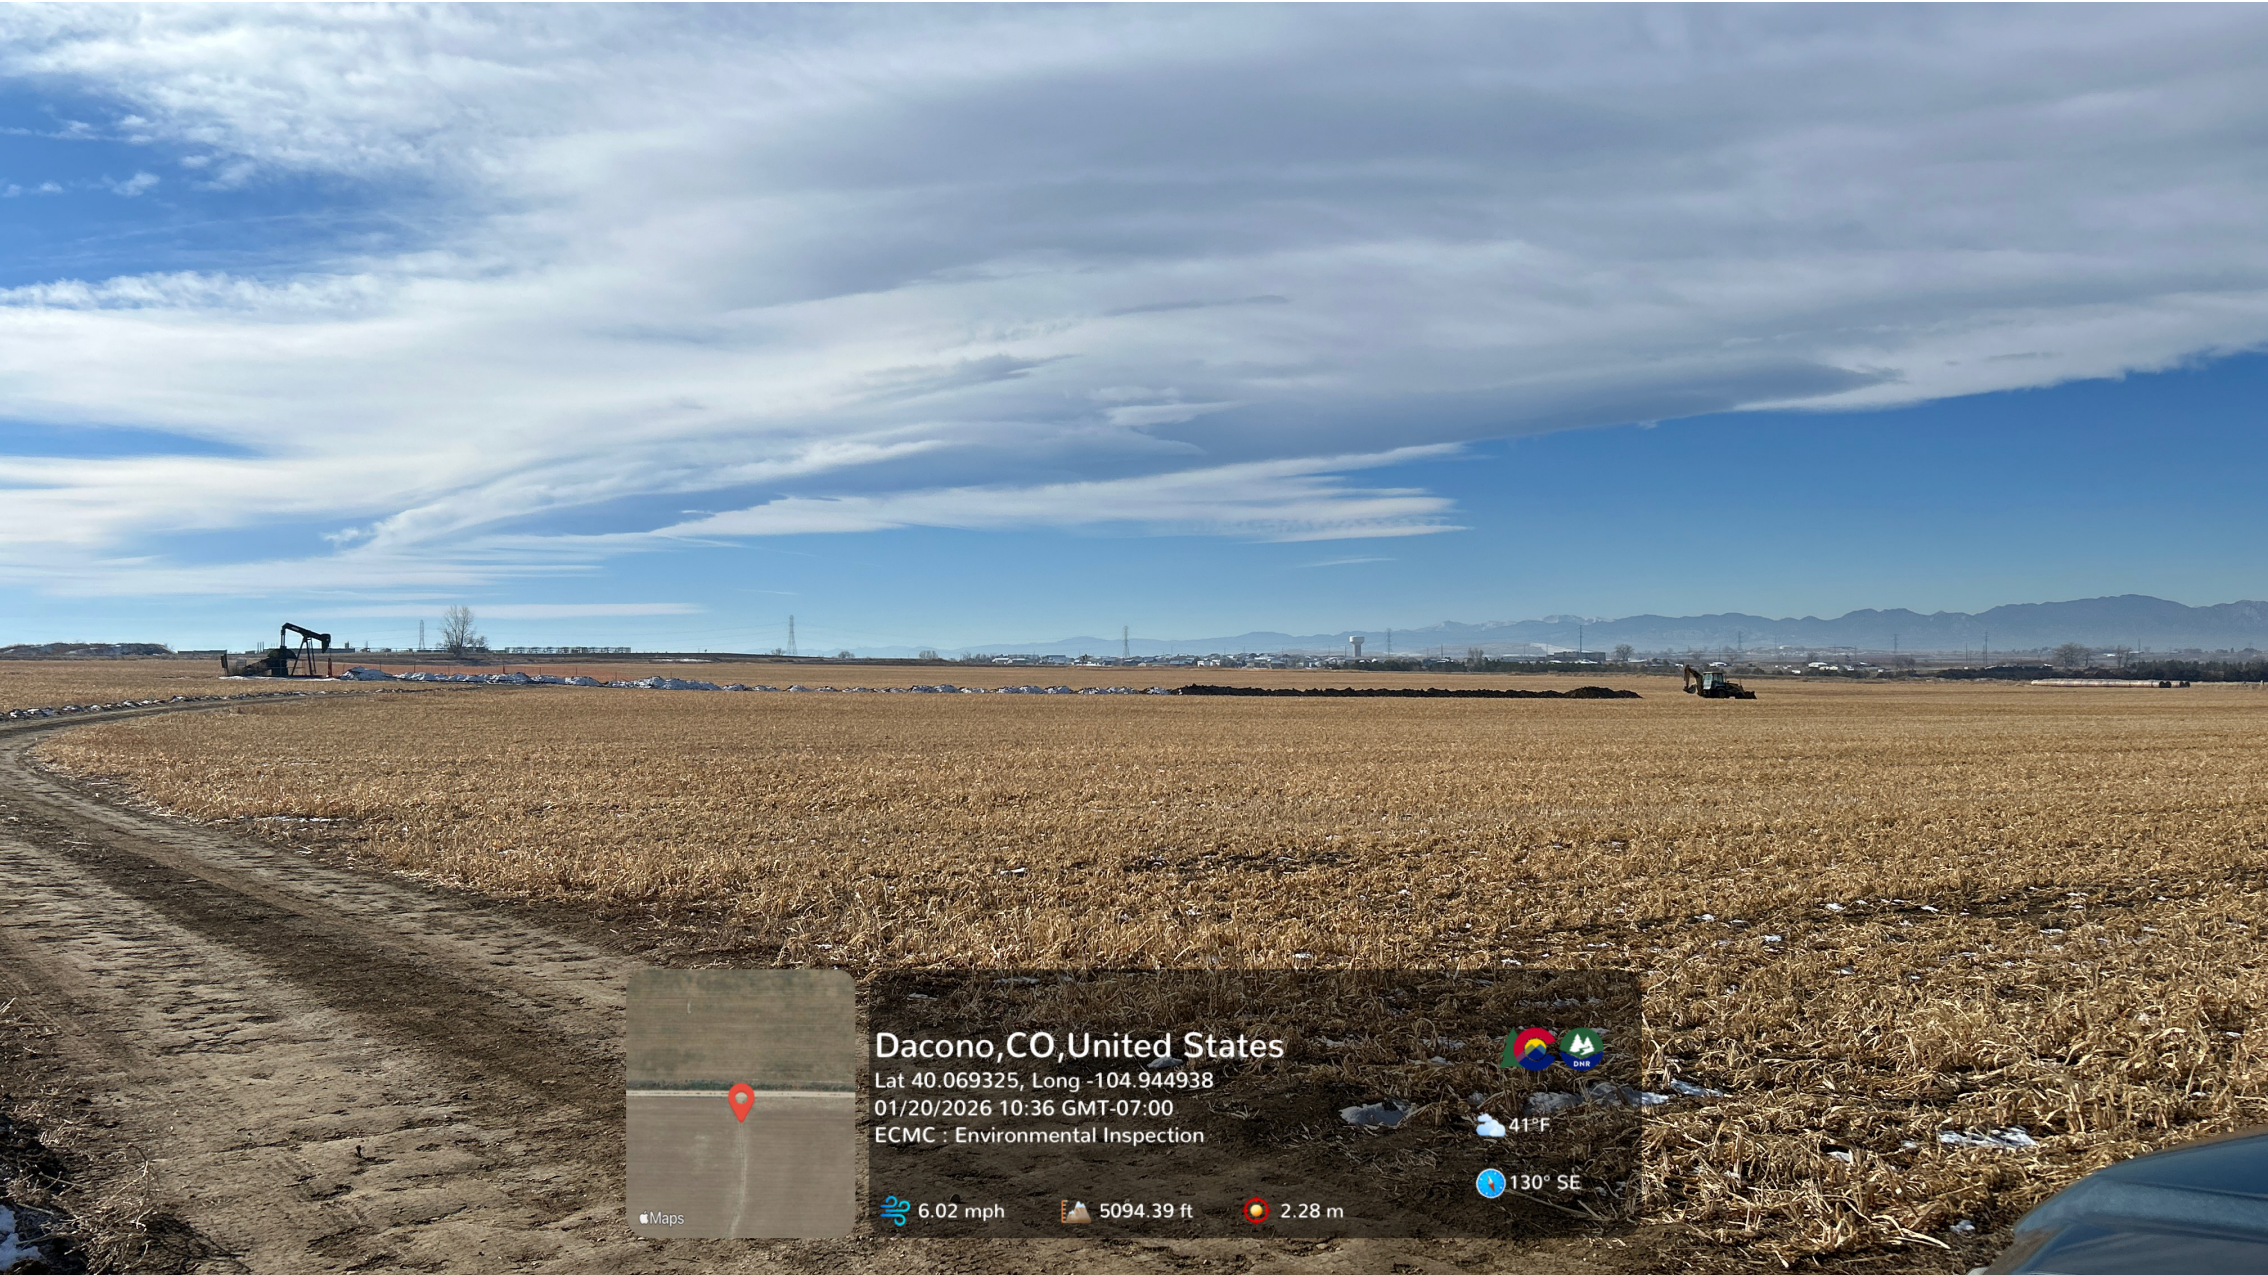
Looking towards STONEBRAKER 42-12 pumping unit and flowline trench from access road. Stockpiled soil is visible adjacent to the trench. Operator equipment (backhoe) was on location; however, no Operator personnel were on location at the time of inspection.

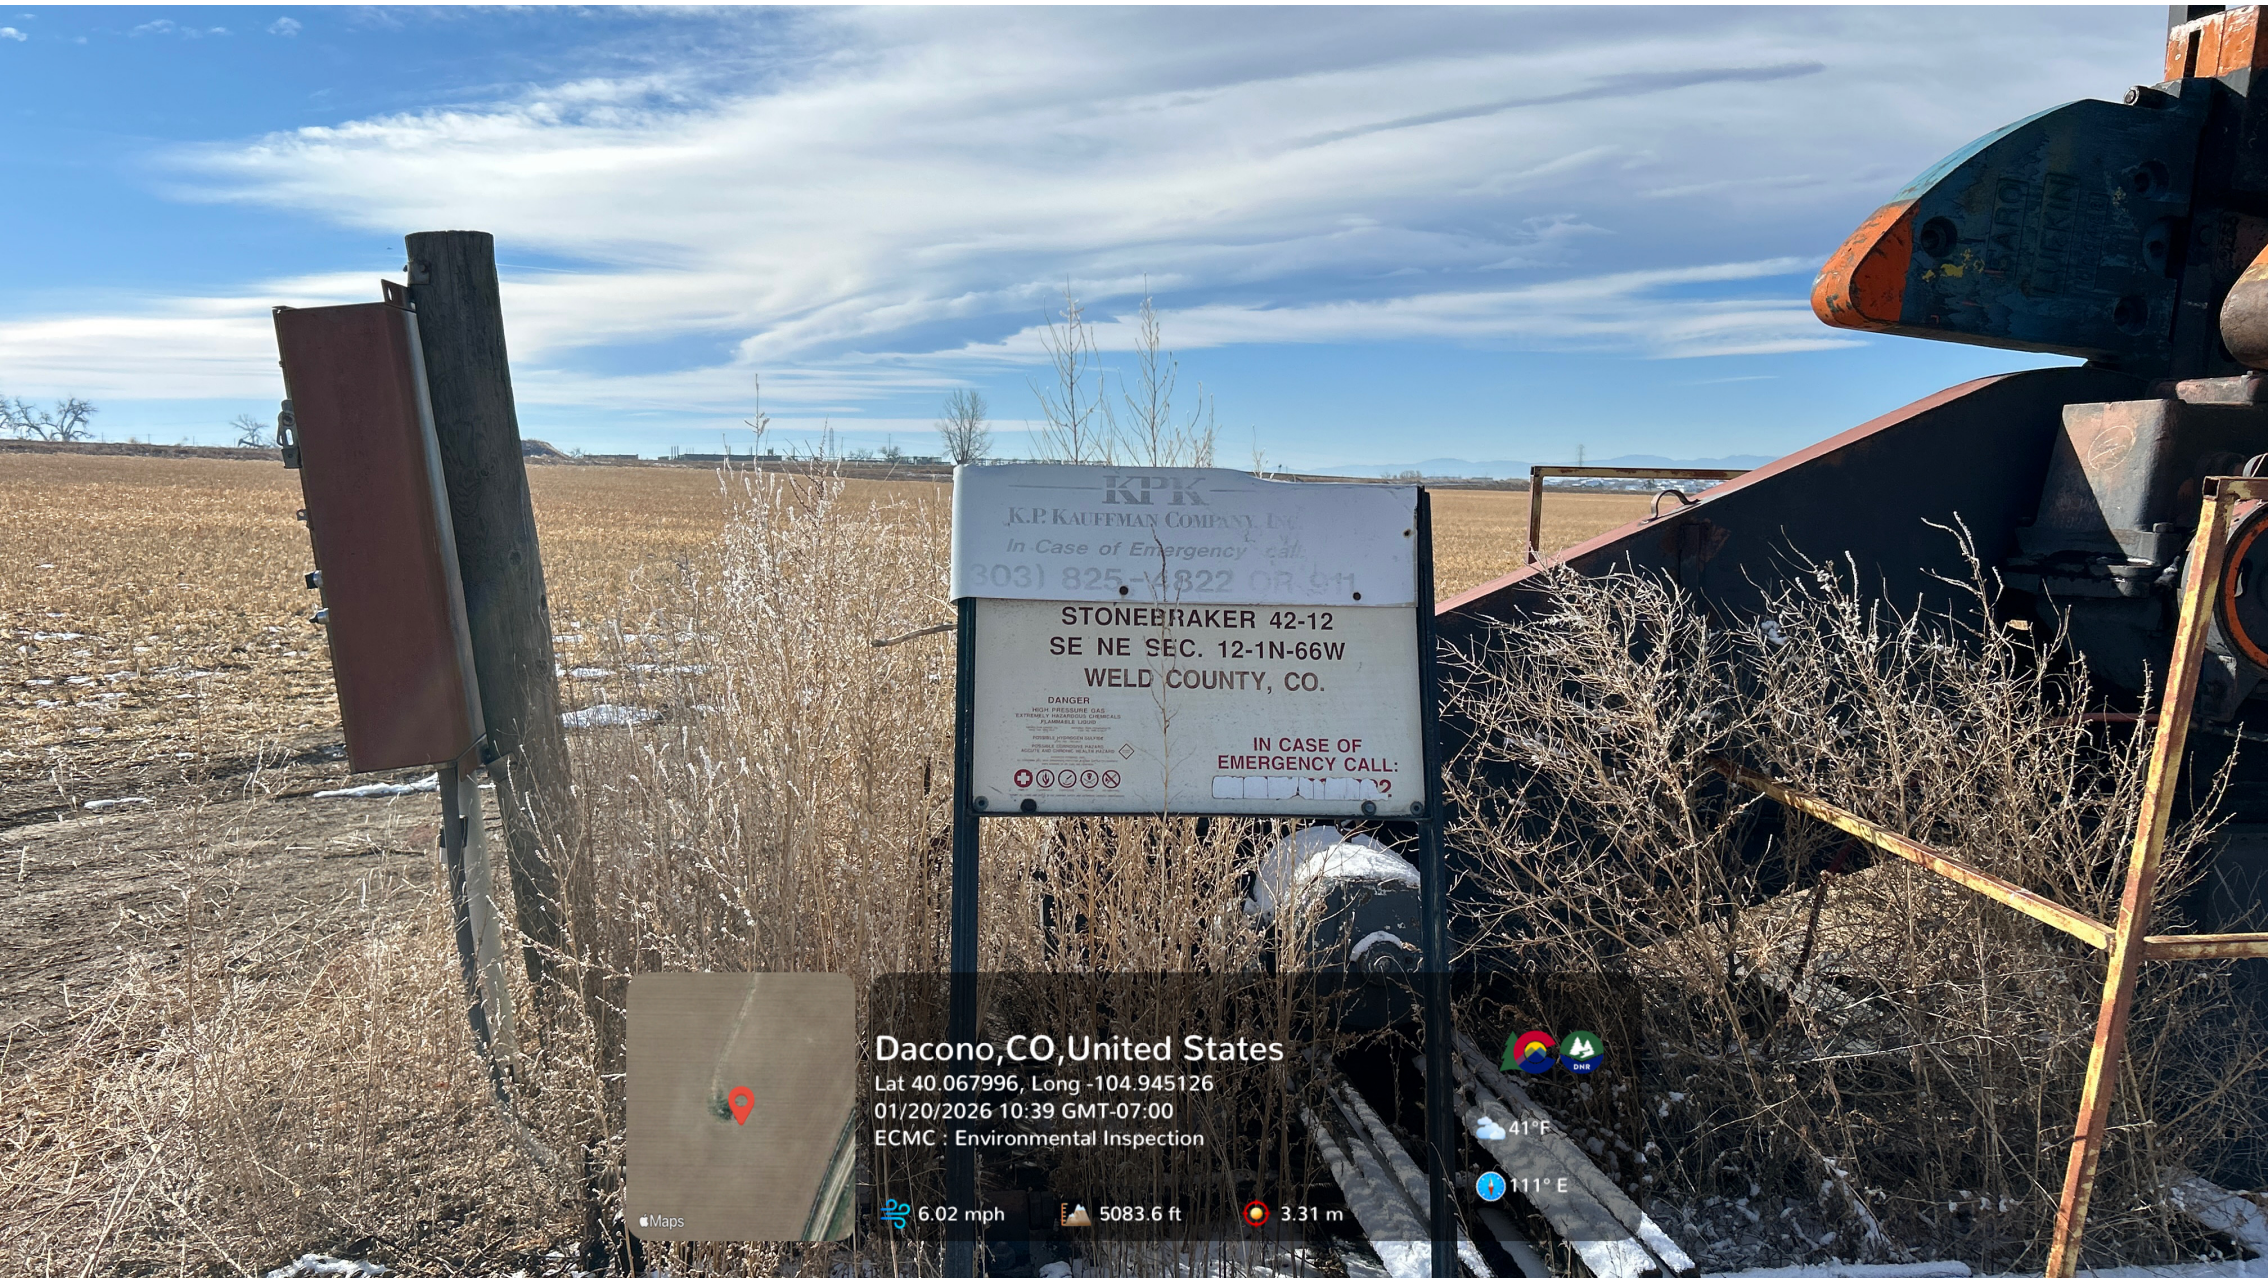
Signage with emergency contact number has faded and is becoming illegible. Dead weeds are visible adjacent to the pumping unit.

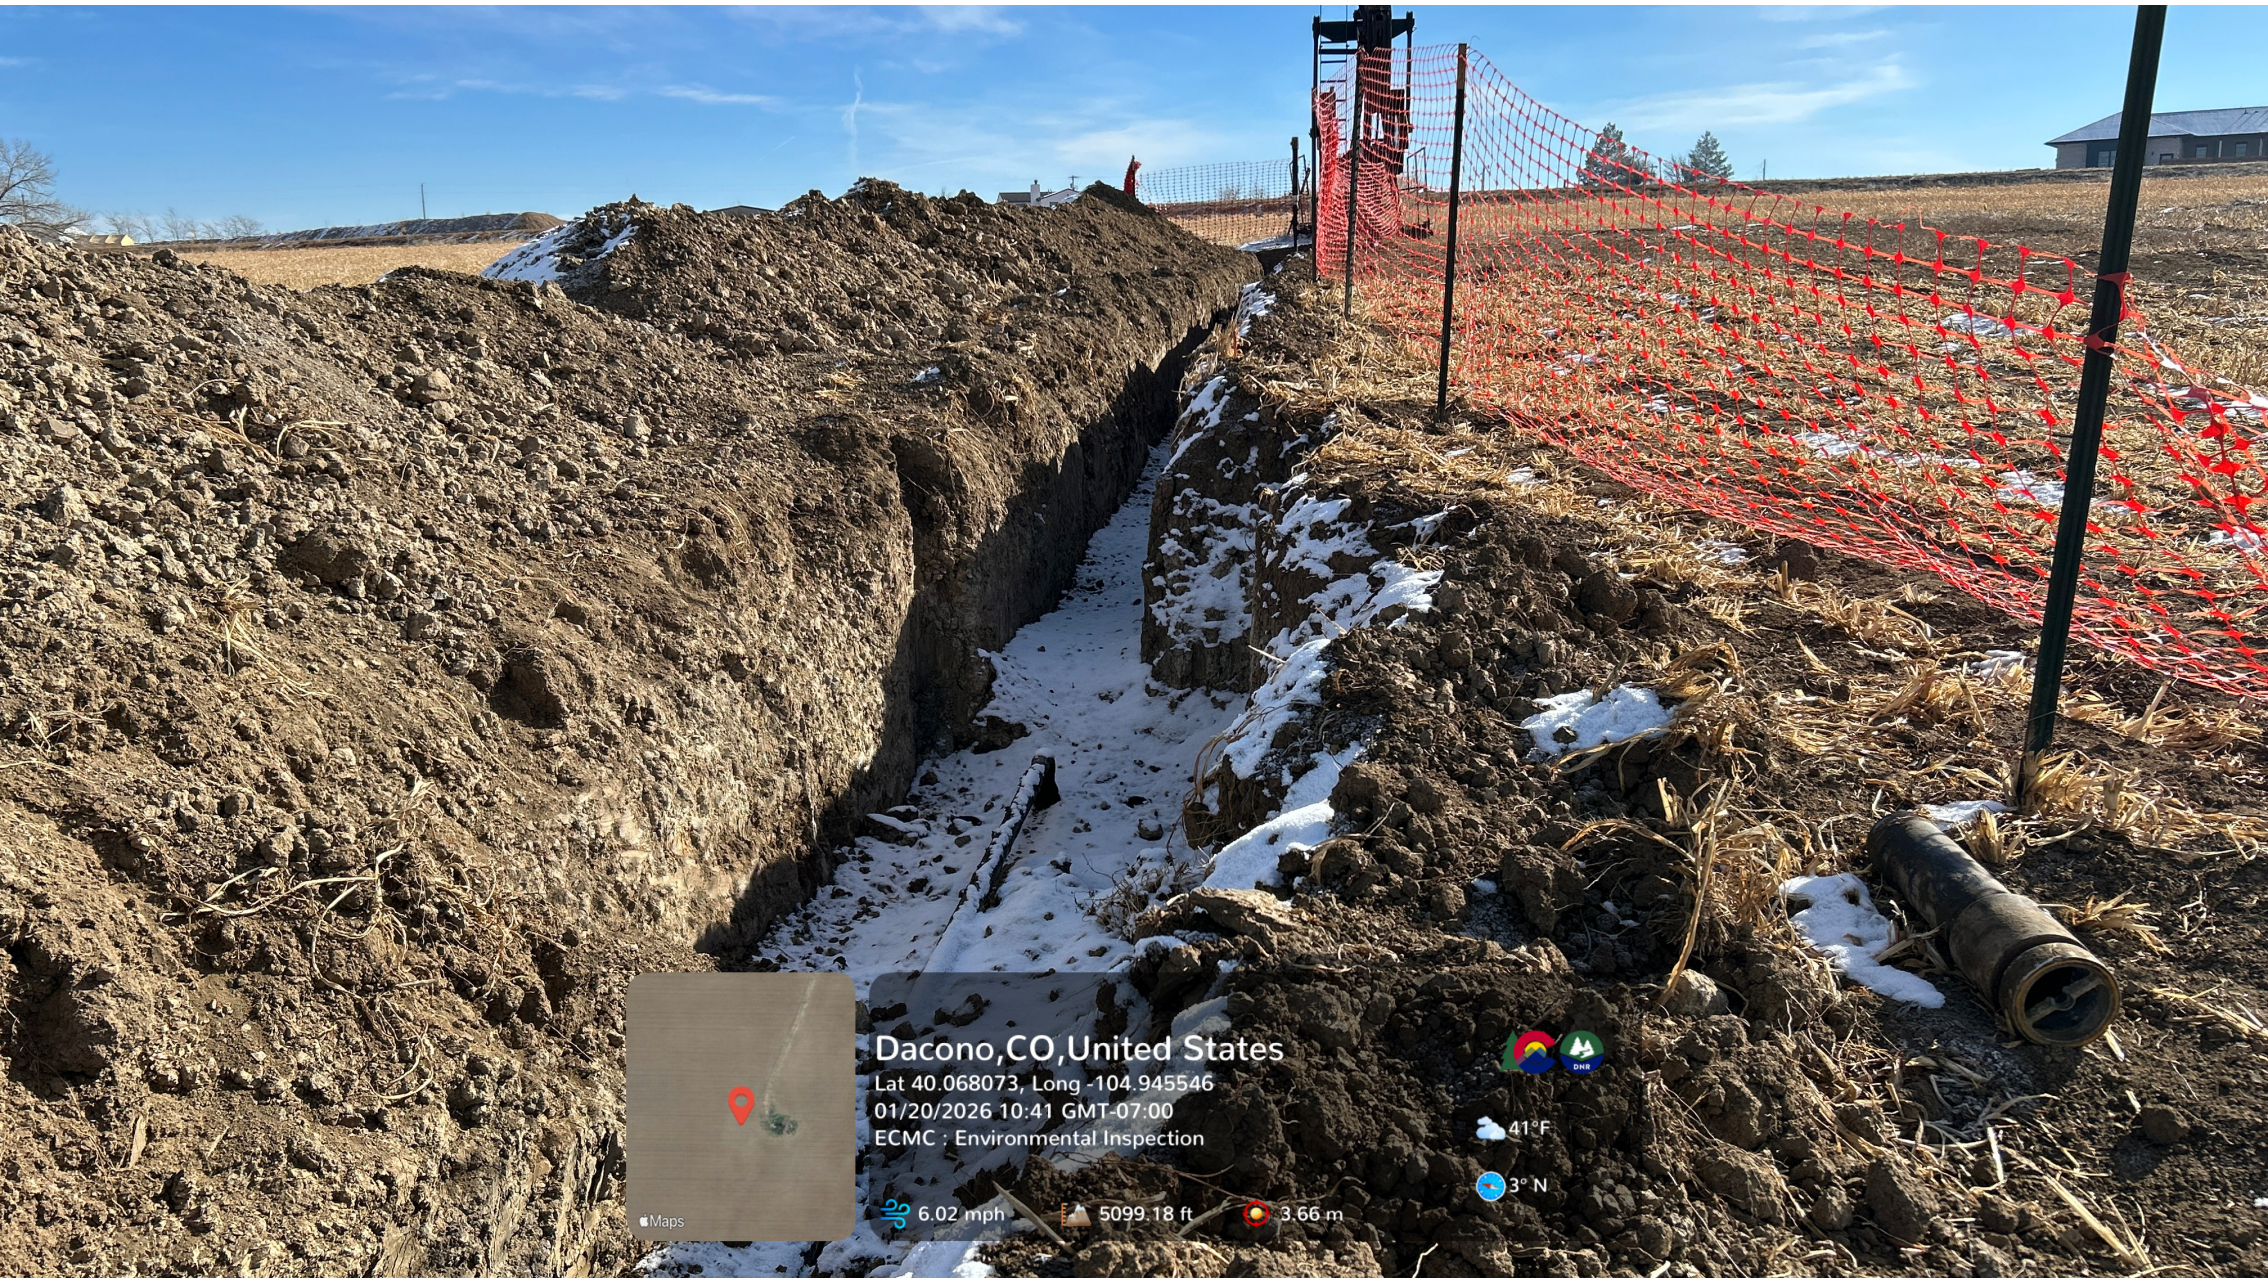
Looking at the area at which stained soil was previously documented in Field Inspection Report (FIR) Document # 717300689. Snow covers the stained soil. Orange construction fencing has been installed along a portion of the southern edge of the trench, but does not encompass the perimeter of the trench.

Glove on flowline documented in photo log attached to FIR Document # 717300689

Area of stained soil documented in photo log attached to FIR Document # 717300689

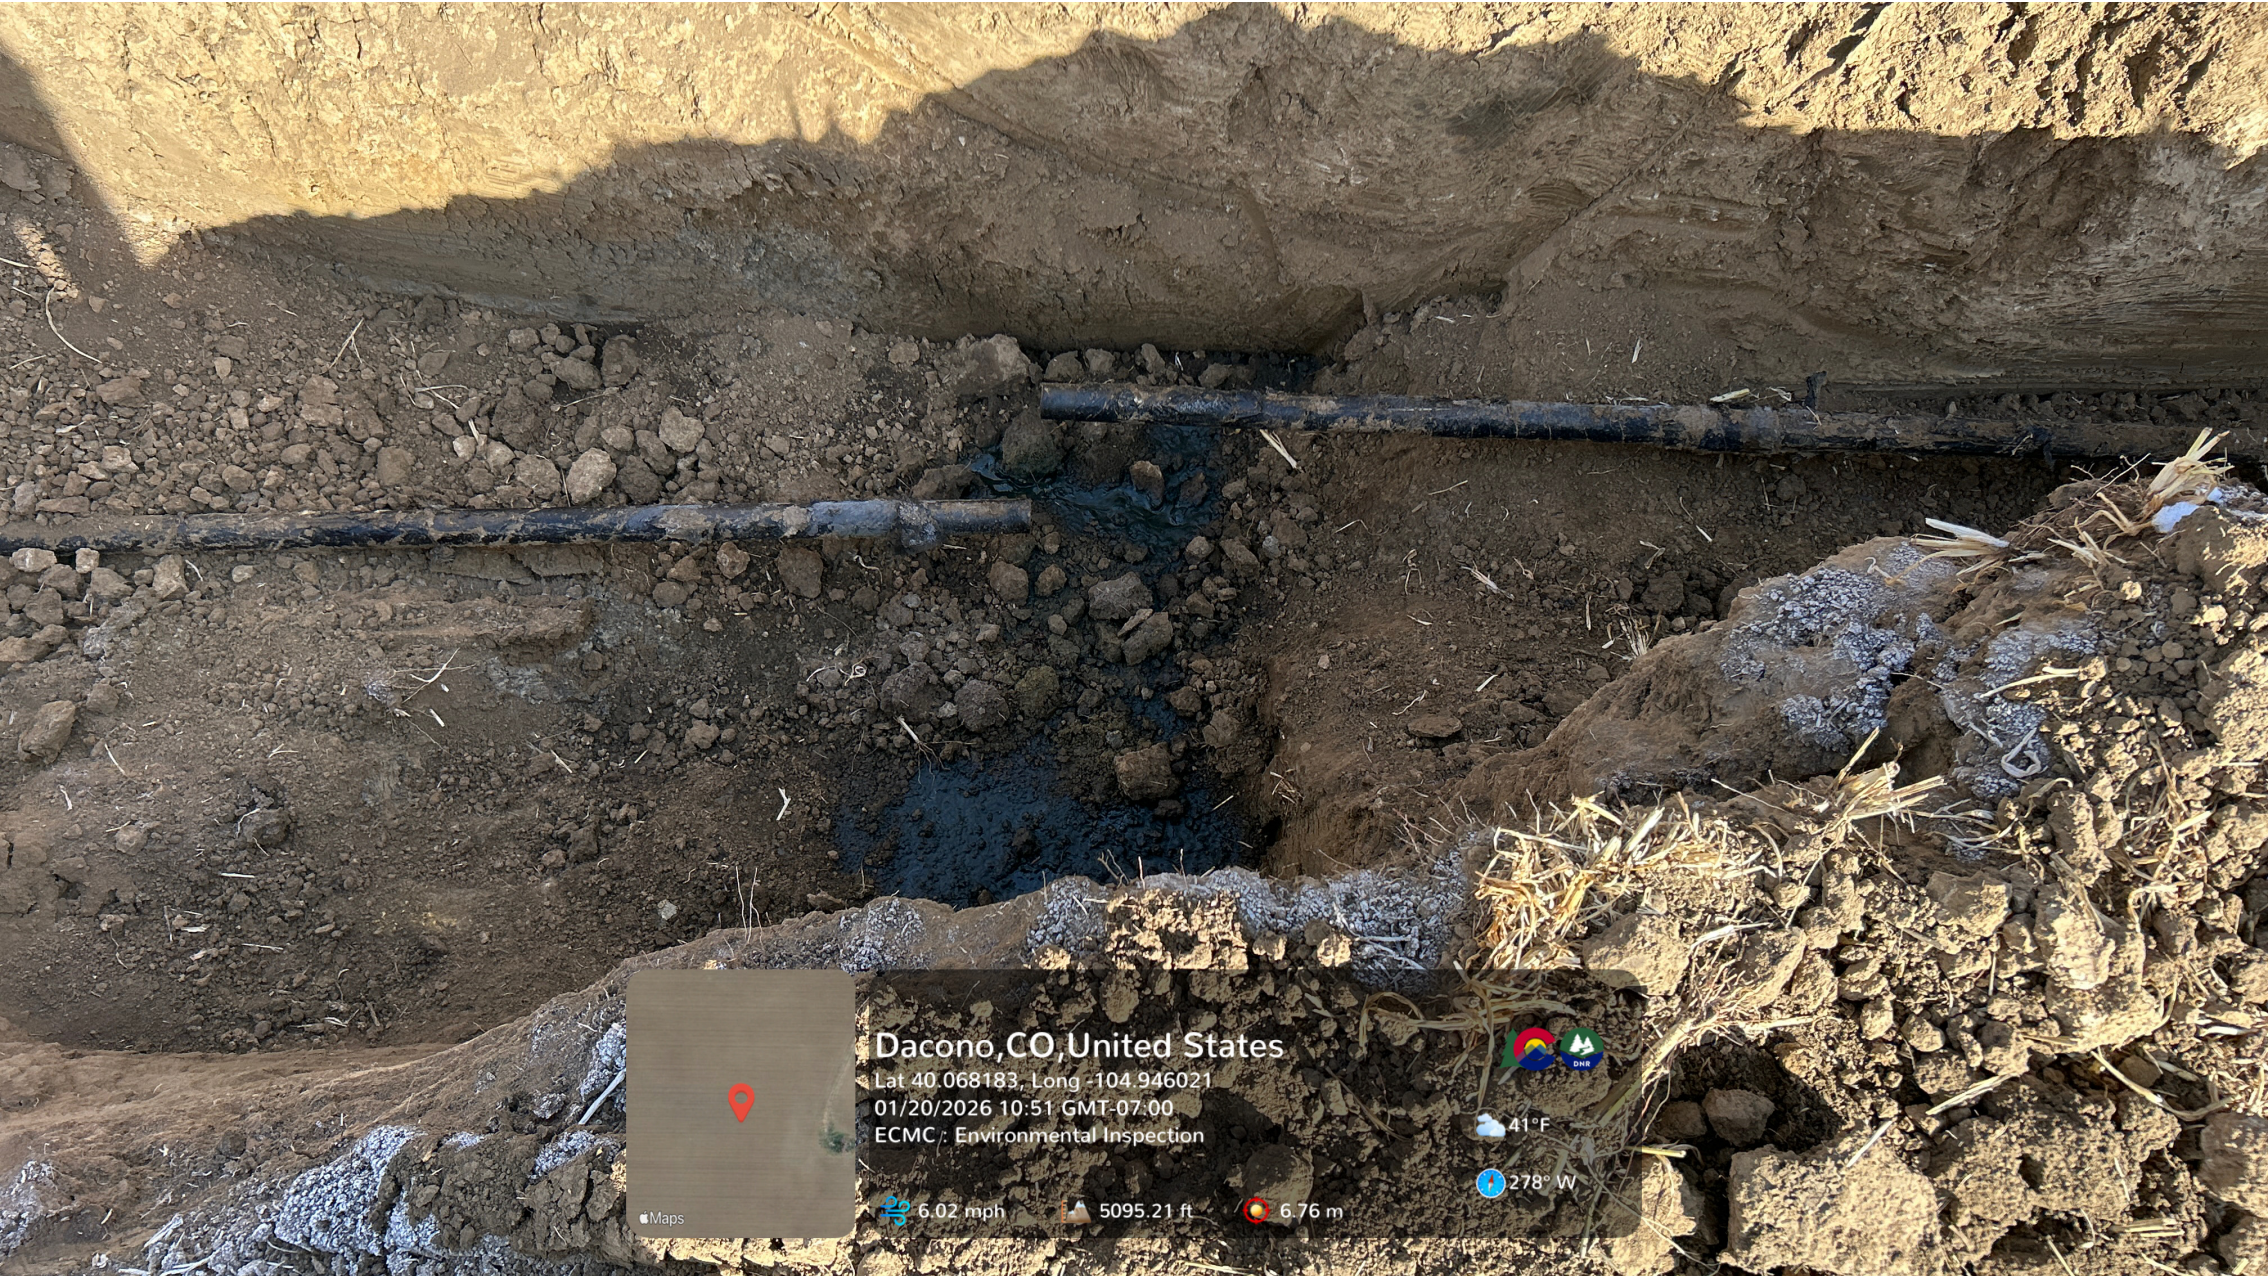
Looking at a second area of impacts to soil. Pooled petroleum hydrocarbon fluid is visible under a cut segment of flowline.

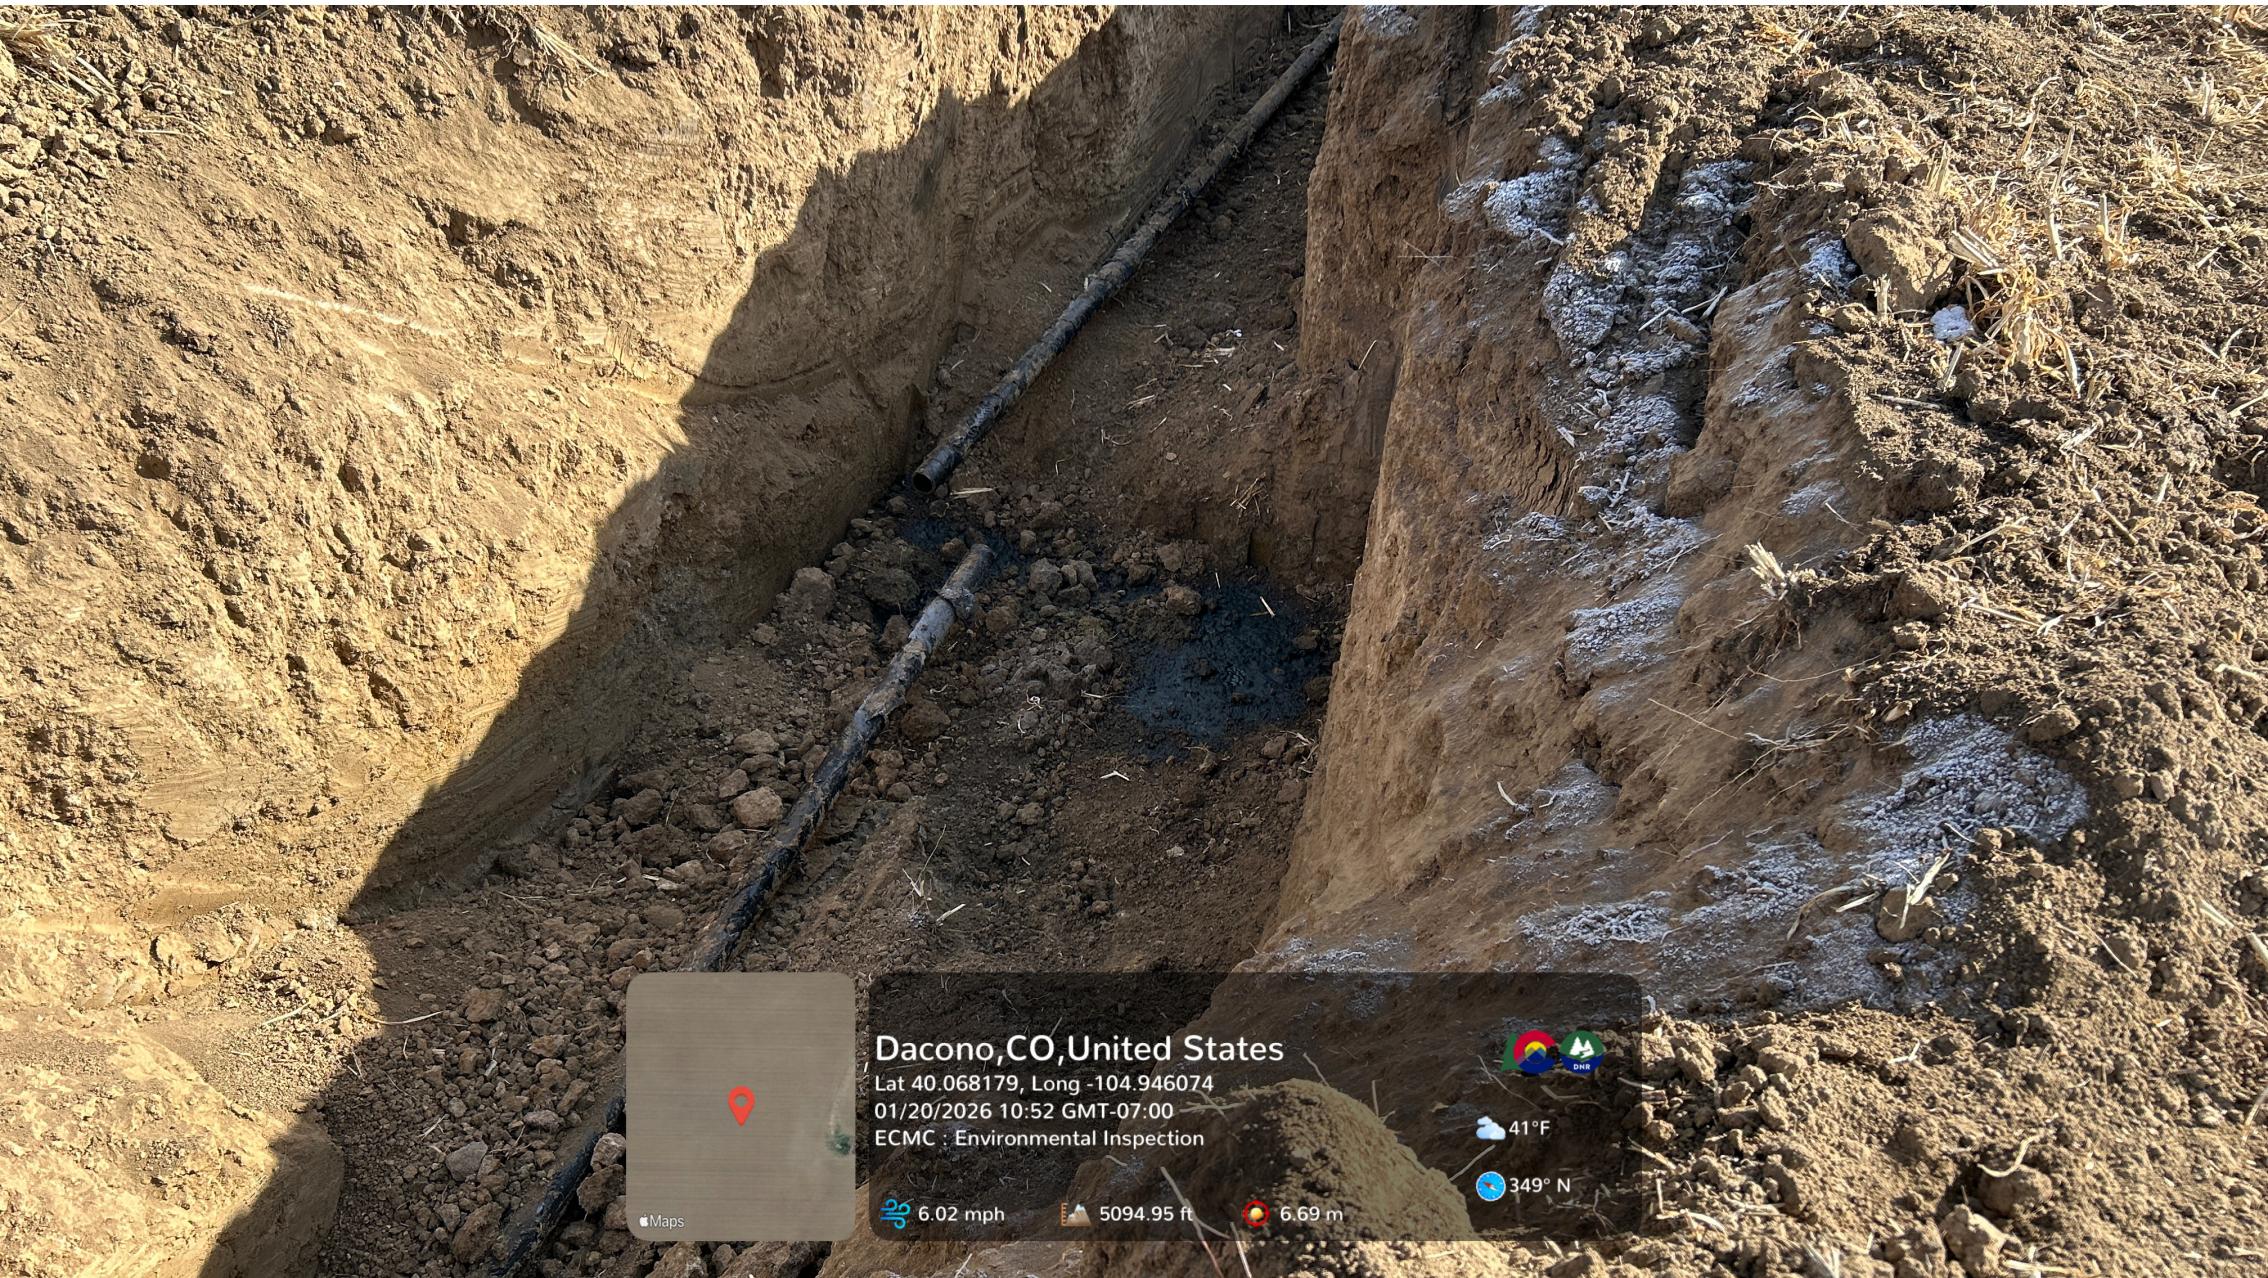
Looking at the second area of impacts to soil. Pooled petroleum hydrocarbon fluid is visible under a cut segment of flowline.

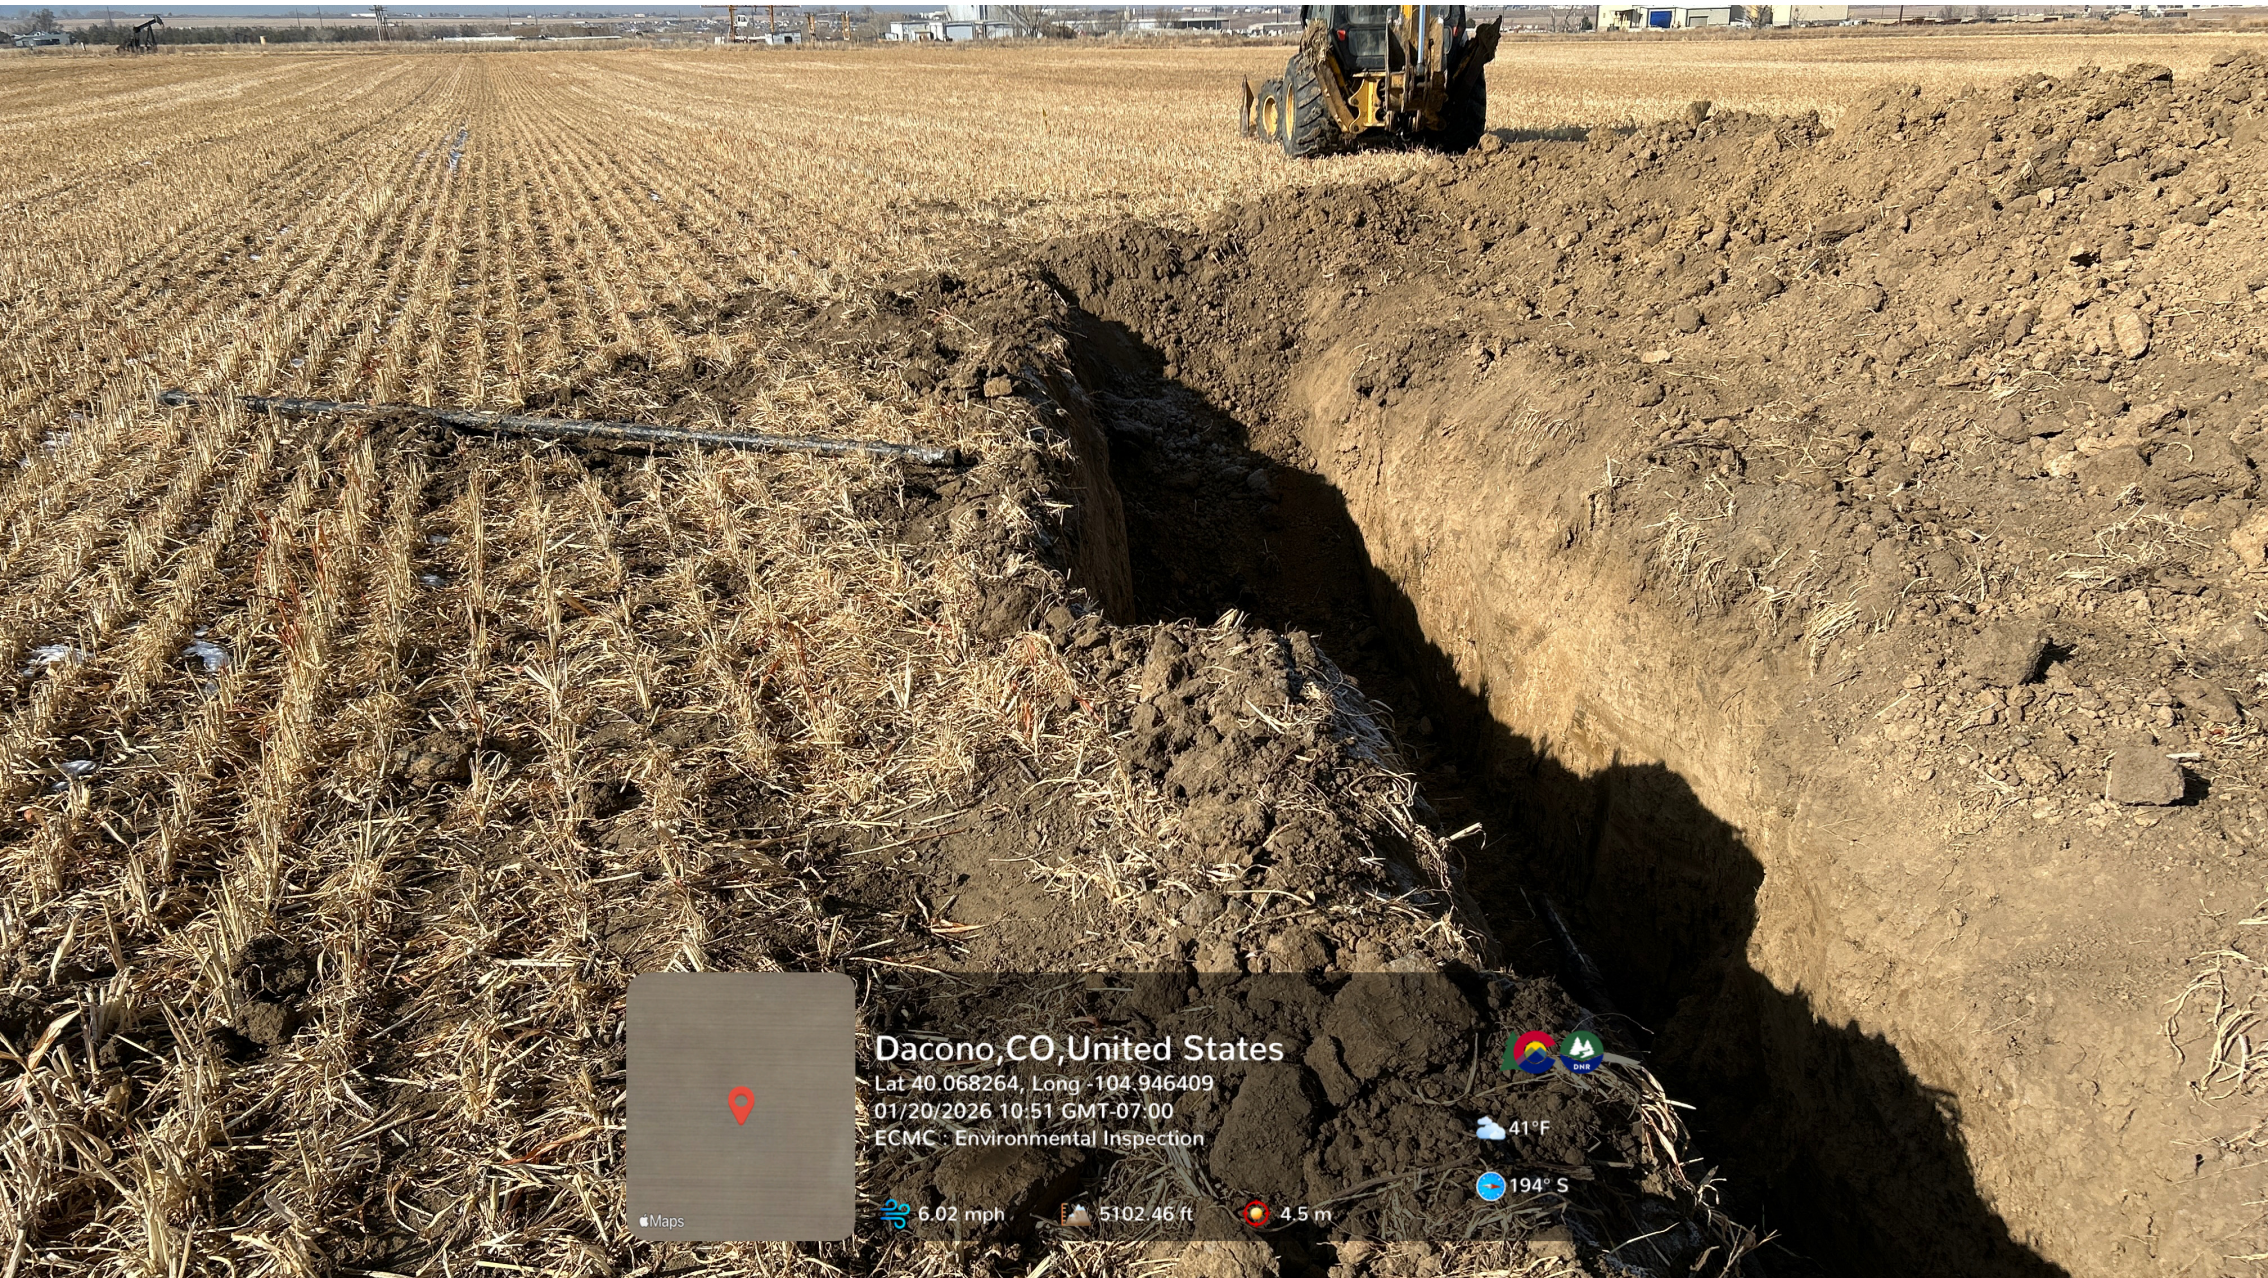
Looking at the western endpoint of the trench. A segment of flowline has been removed and placed on the ground surface adjacent to the trench. (Zoomed in on next photo).

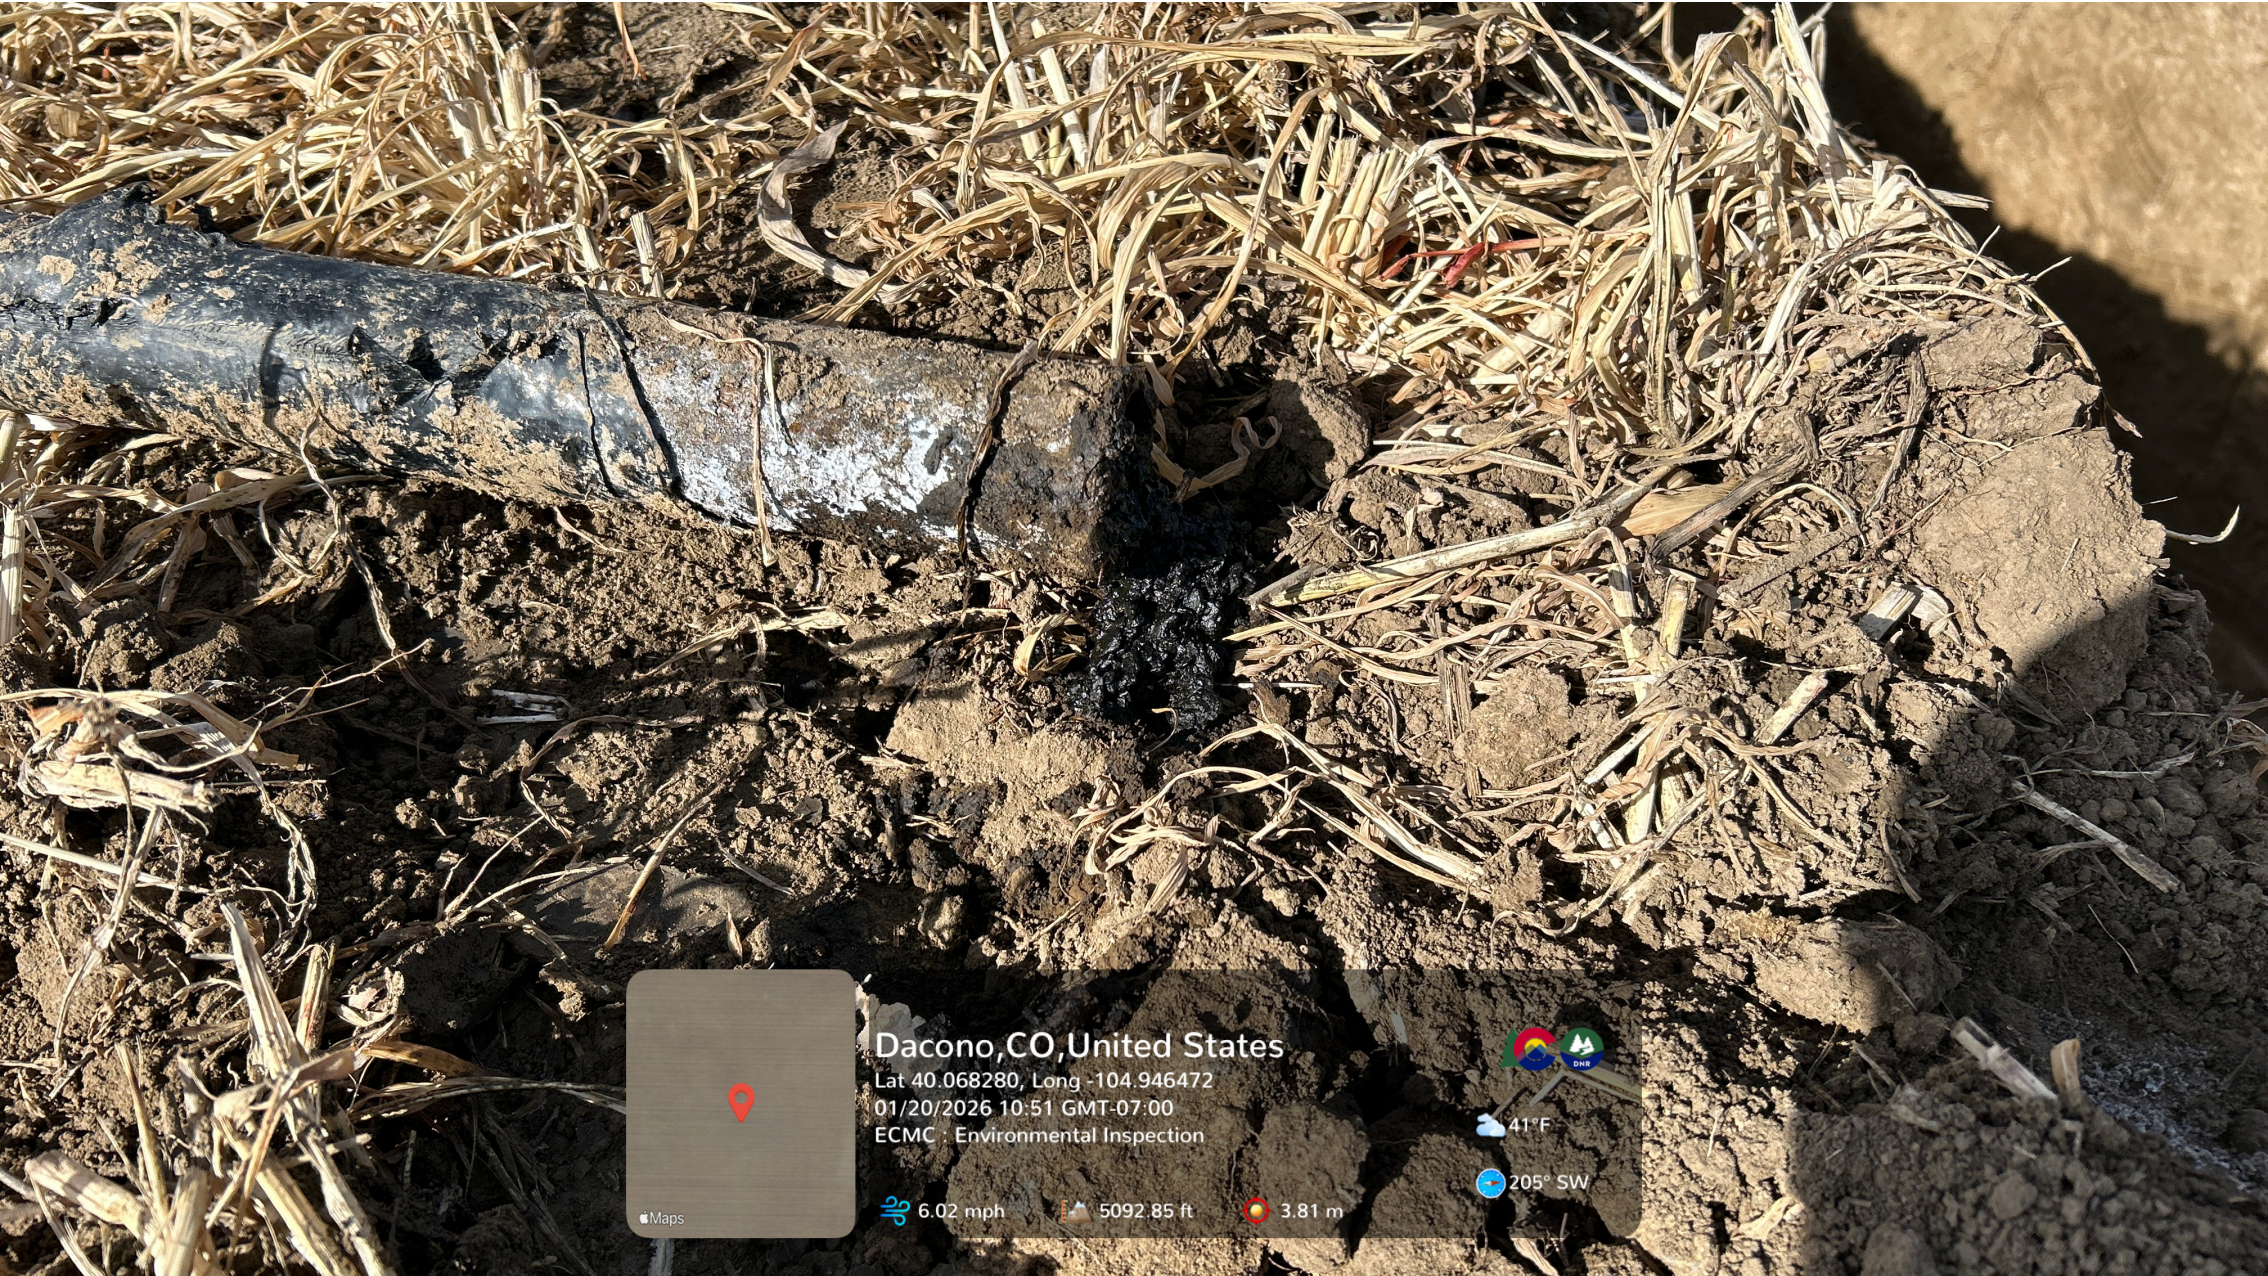
(Closer view of flowline from previous photo). Petroleum hydrocarbon residue is visible on the ground surface at the end of the removed segment of flowline.
