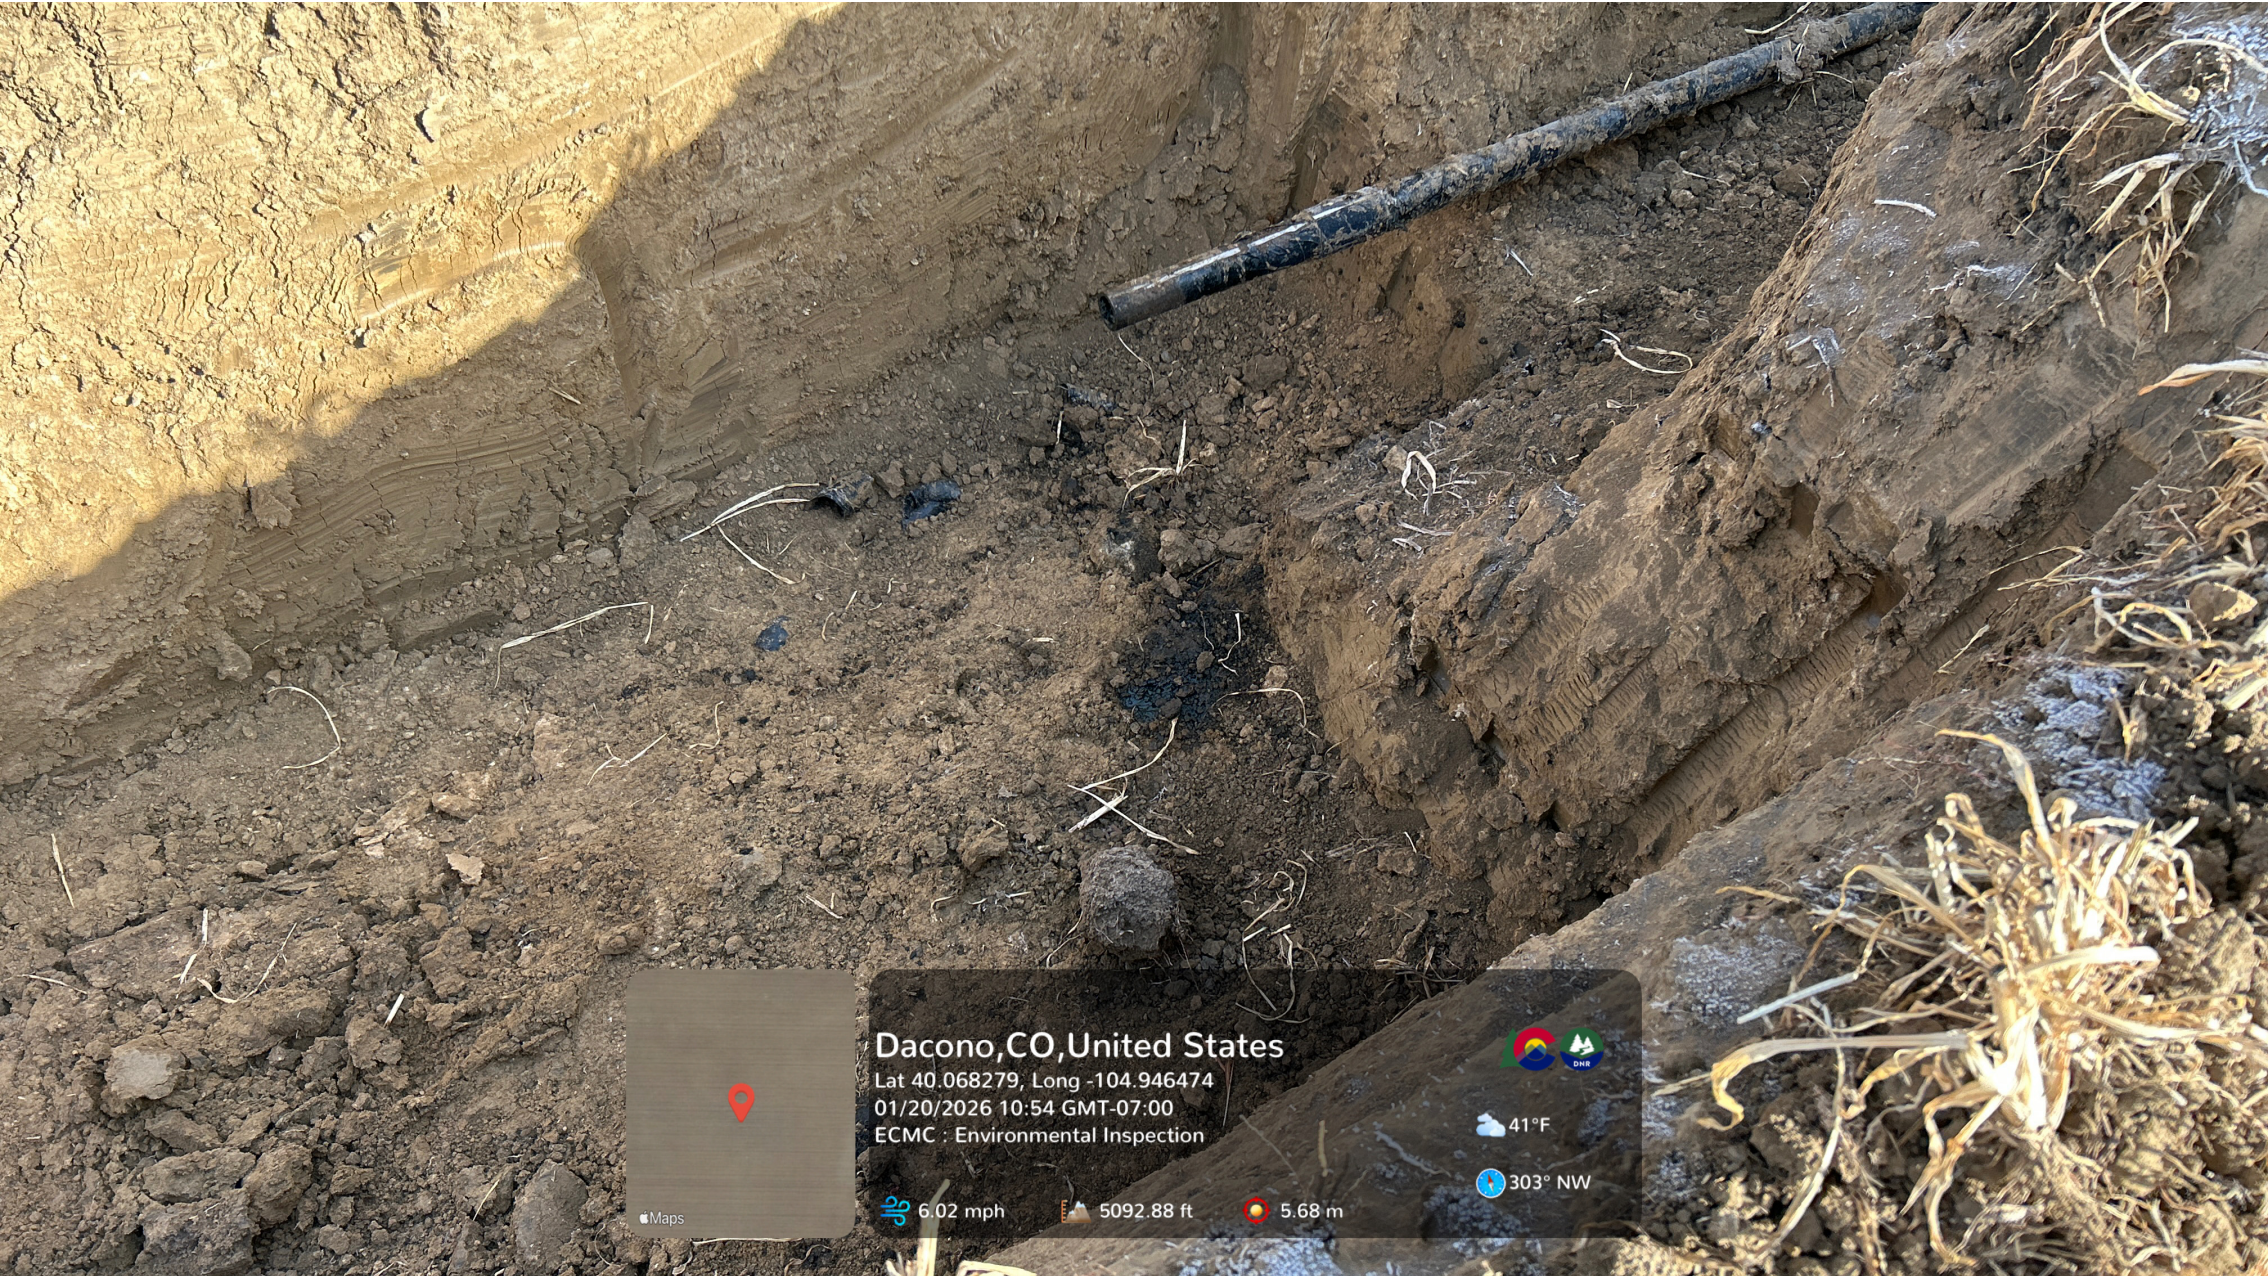
Looking at a third area of impacts to soil. Pooled petroleum hydrocarbon fluid is visible under a cut segment of flowline.
