Inspection Photos  
Location Name: Facility 5 Gas Line  
Spill ID: 492917

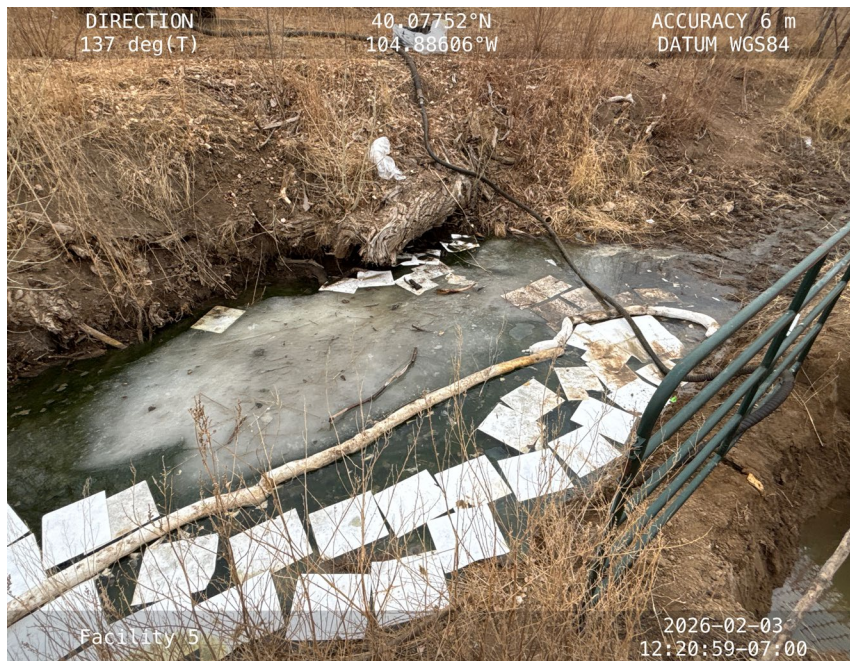
Impacted waters and inadequate mats

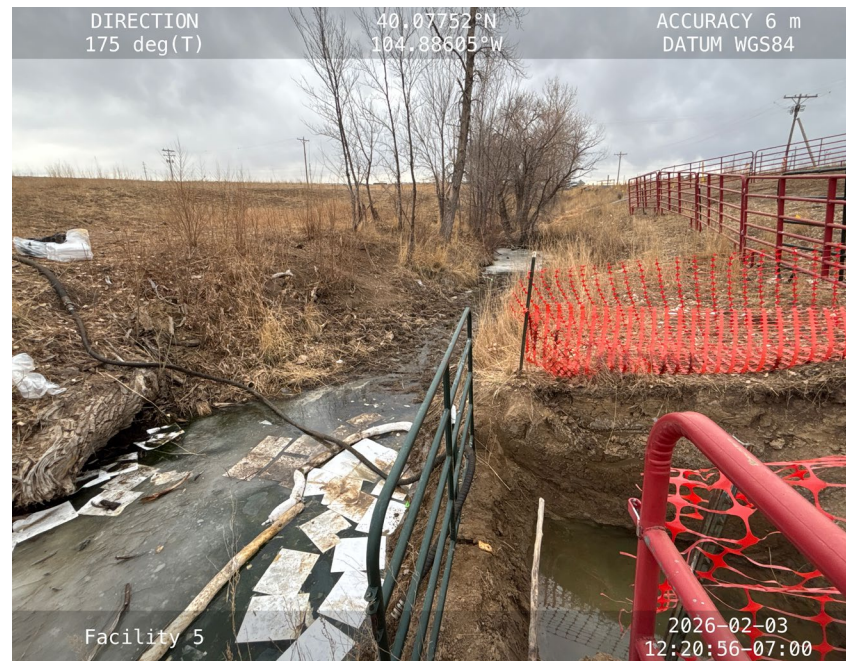
Impacted waters and inadequate mats

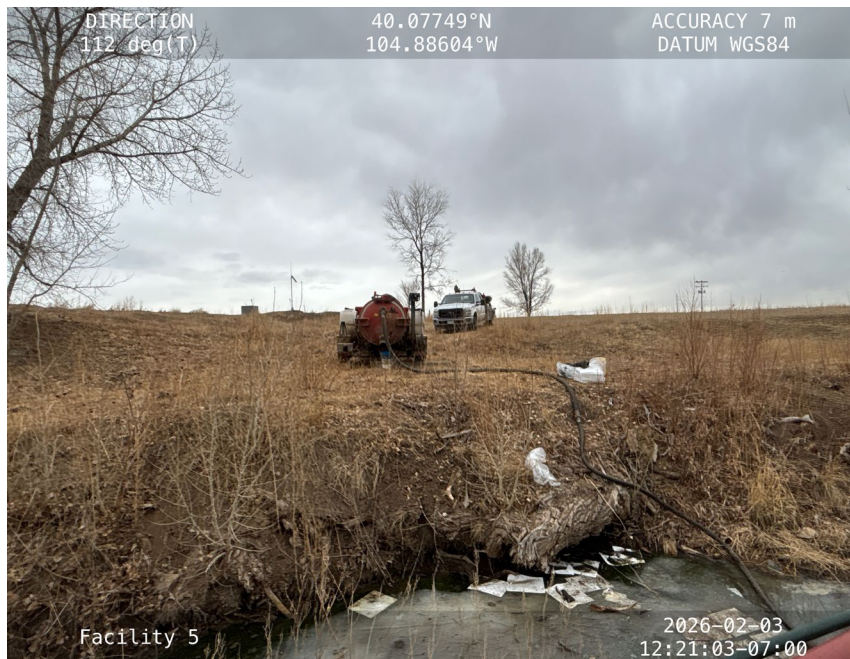
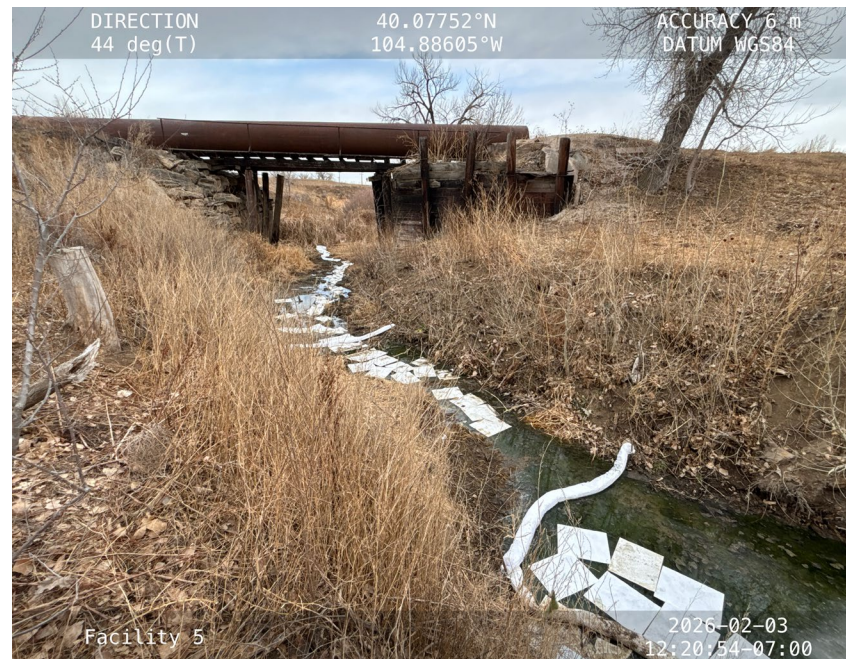
**Absorbent mats downstream**

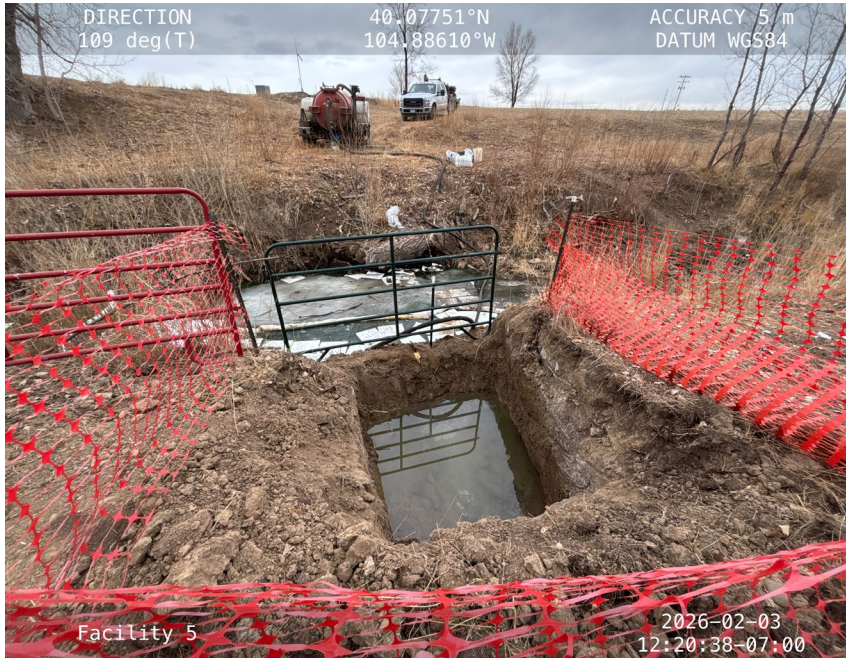
Presumed release point location excavation

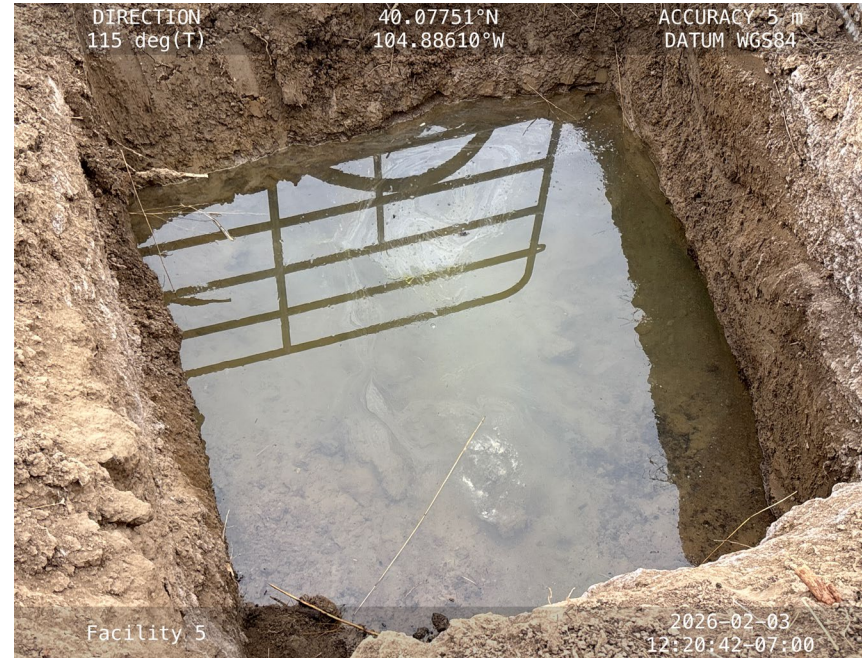
Presumed release point location excavation. Oily sheen observed on water within excavation.

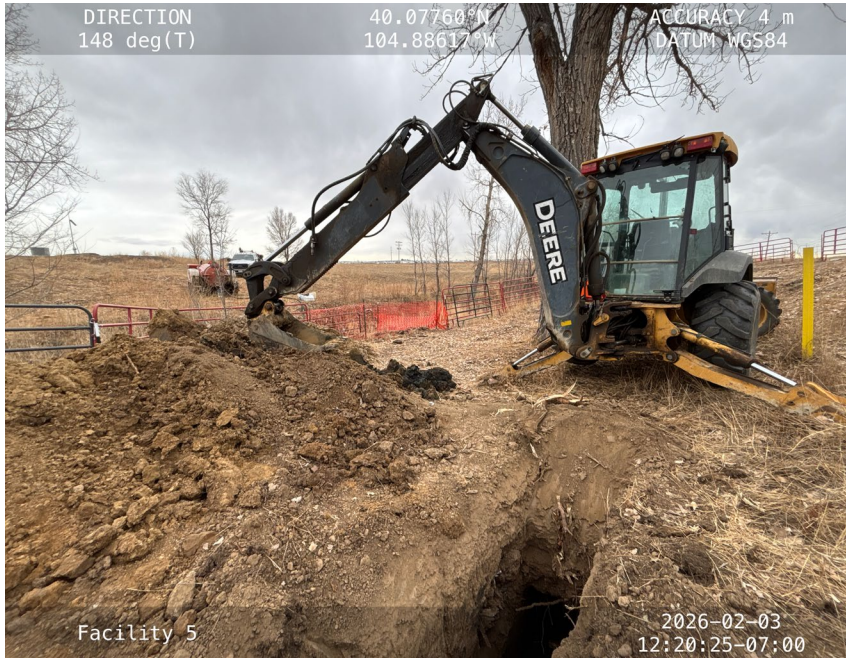
**Stained oily soil. Location of submitted sample**

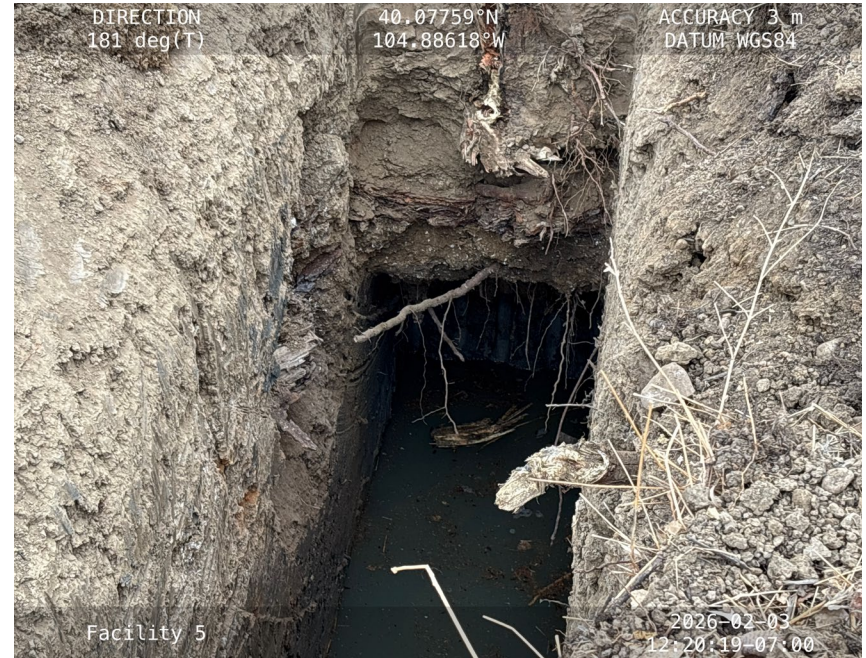
**Stained oily soil. Location of submitted sample**

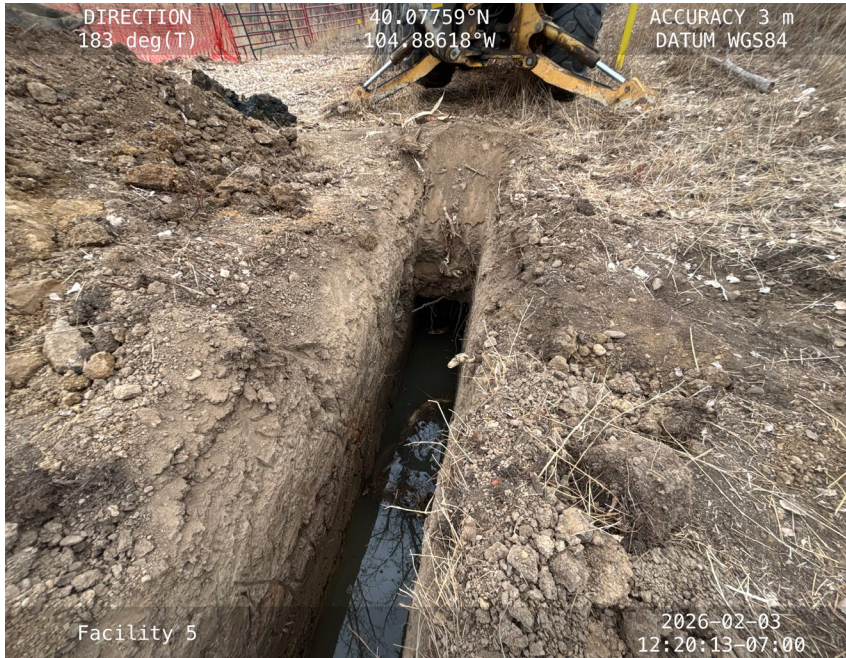
Stained oily soil. Location of submitted sample

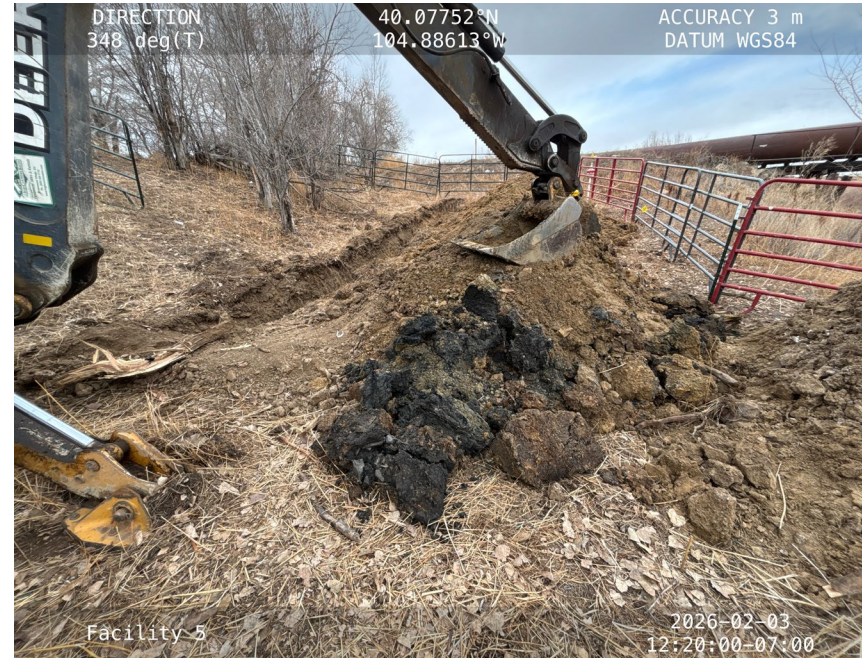
Stained oily soil. Location of submitted sample

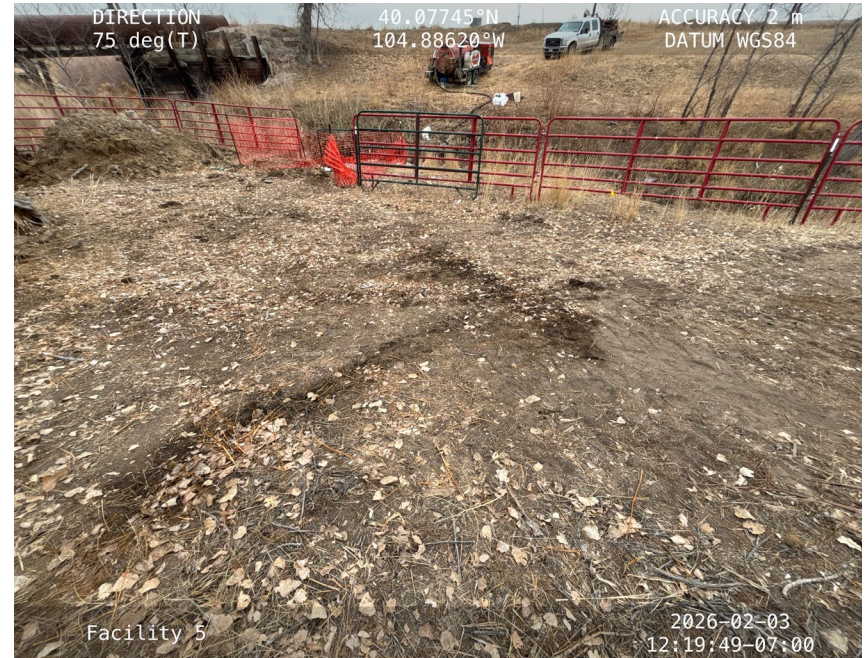
**Impacted soil beneath hauled off soil stockpile**

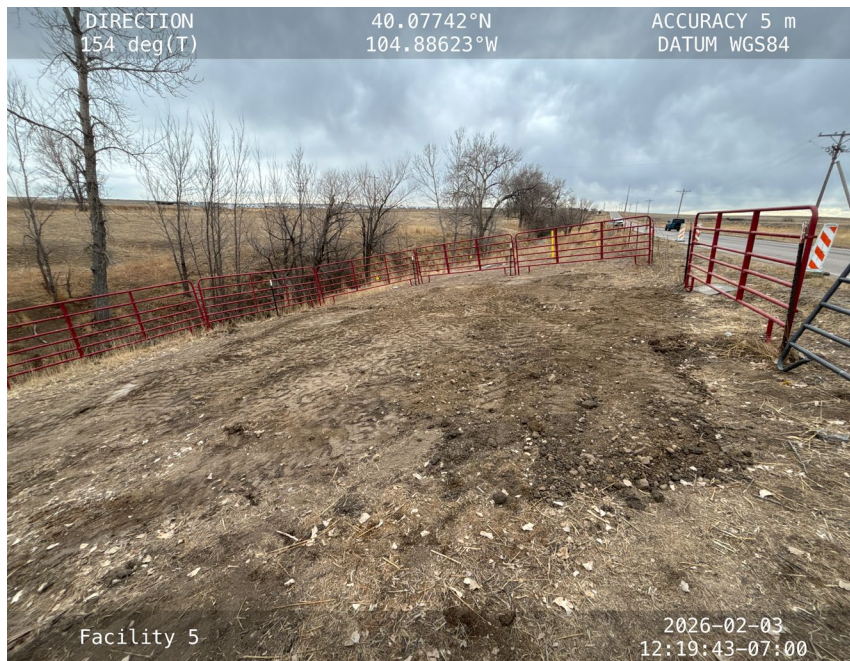
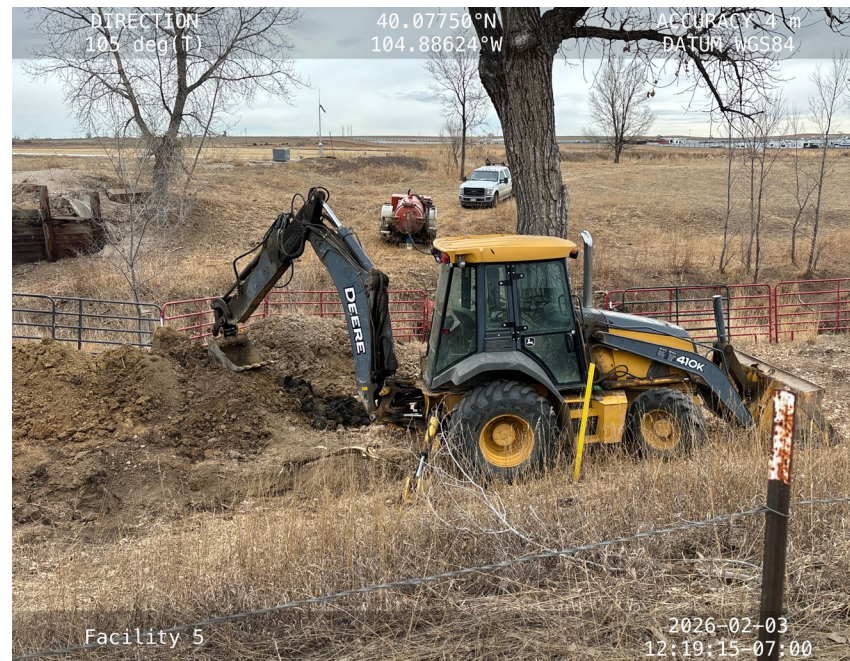
Impacted soil beneath hauled off soil stockpile

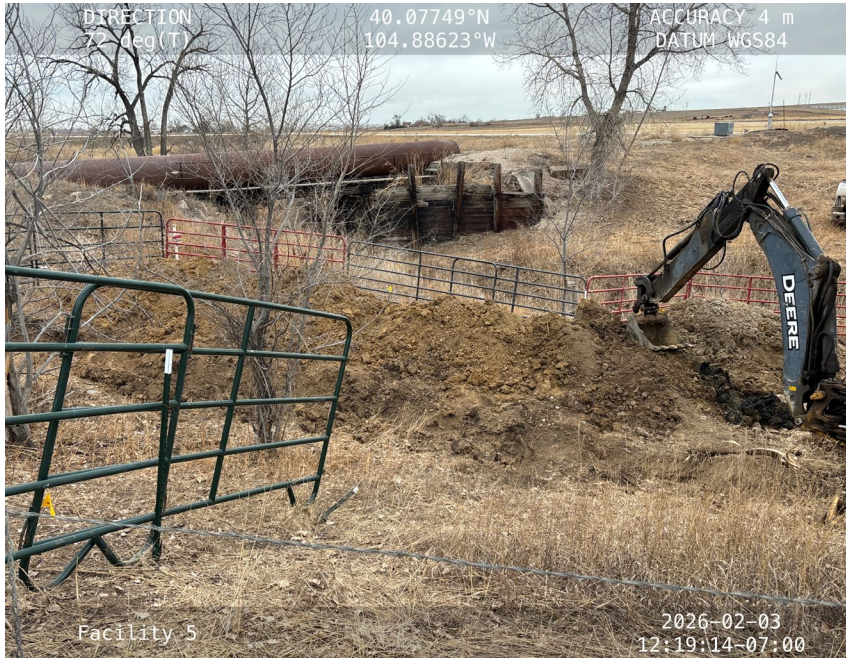
**Impacted oily stockpile**

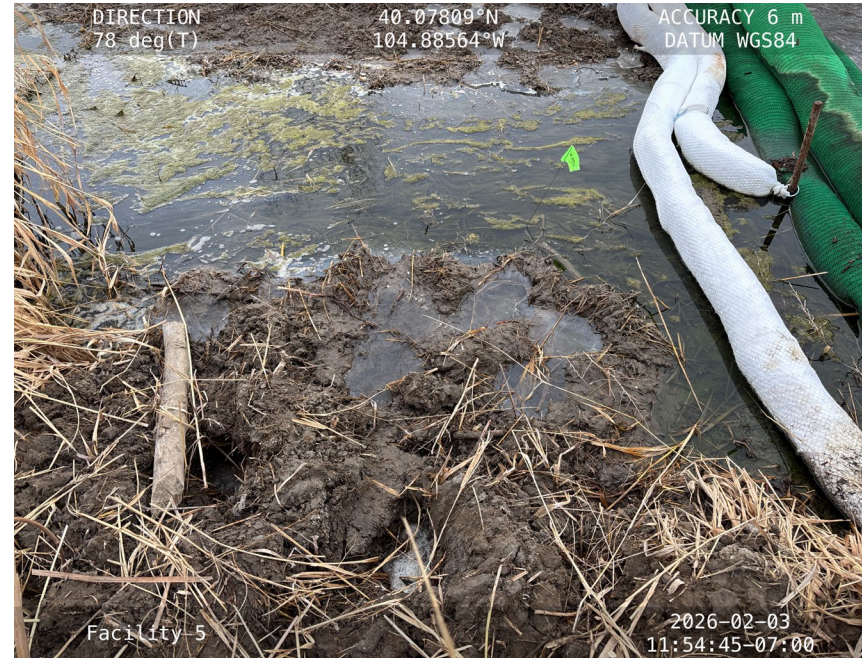
**Possible sheen location just beyond boom**

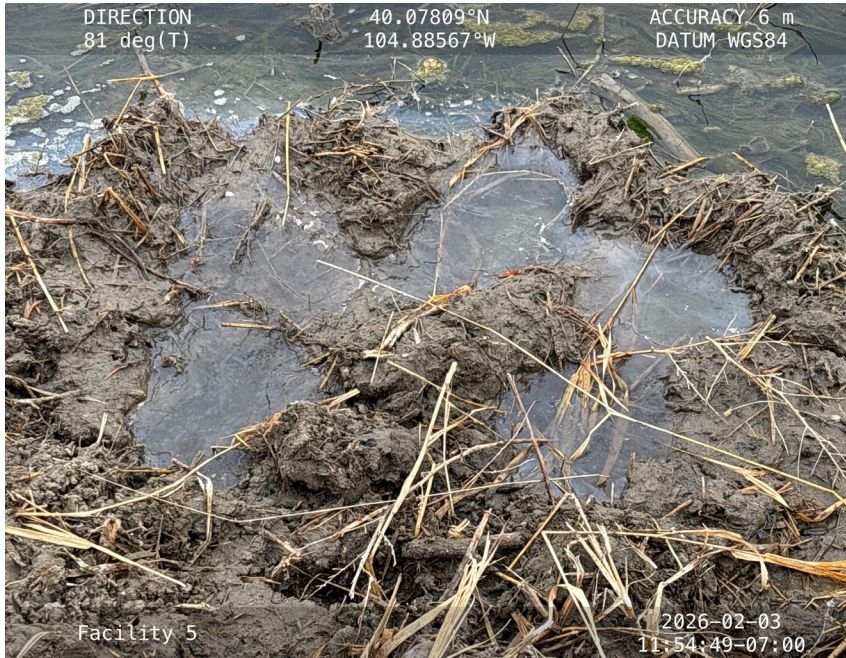
Possible sheen location just beyond boom

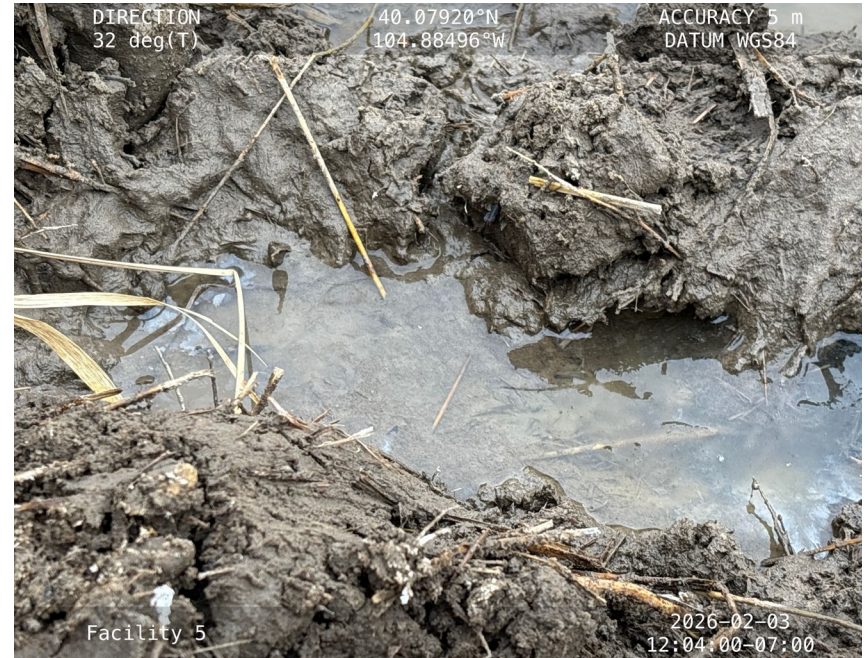
Possible sheen

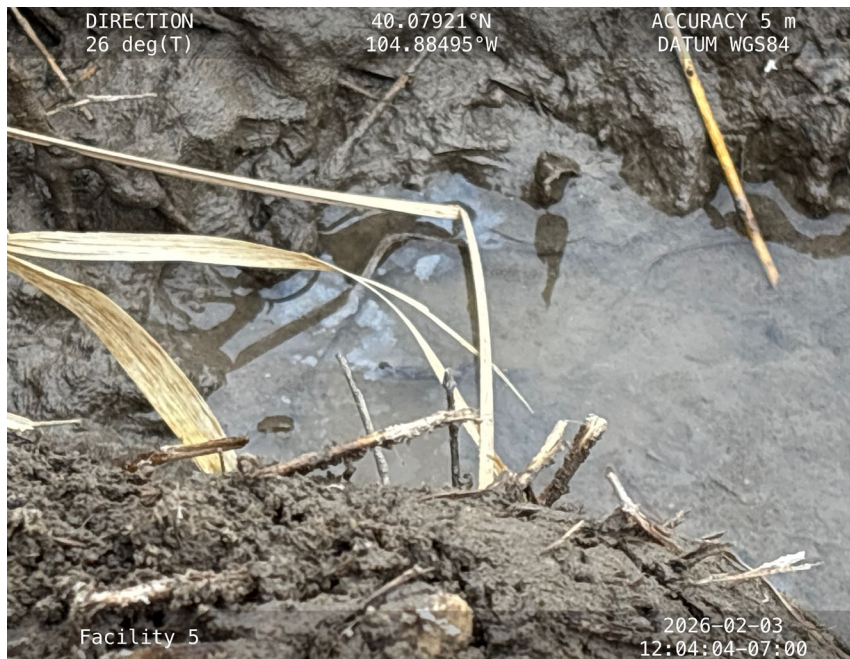
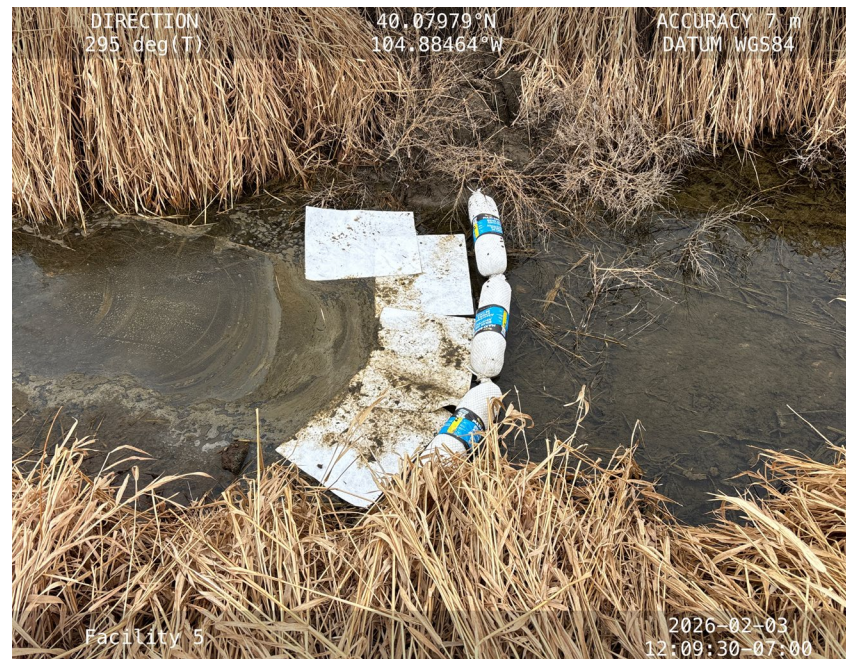
Possible sheen
