Inspection Photos

Loc: 324881

Operator: RAMPIKE RESOURCES LTD

Inspection Date: 2/2/2026

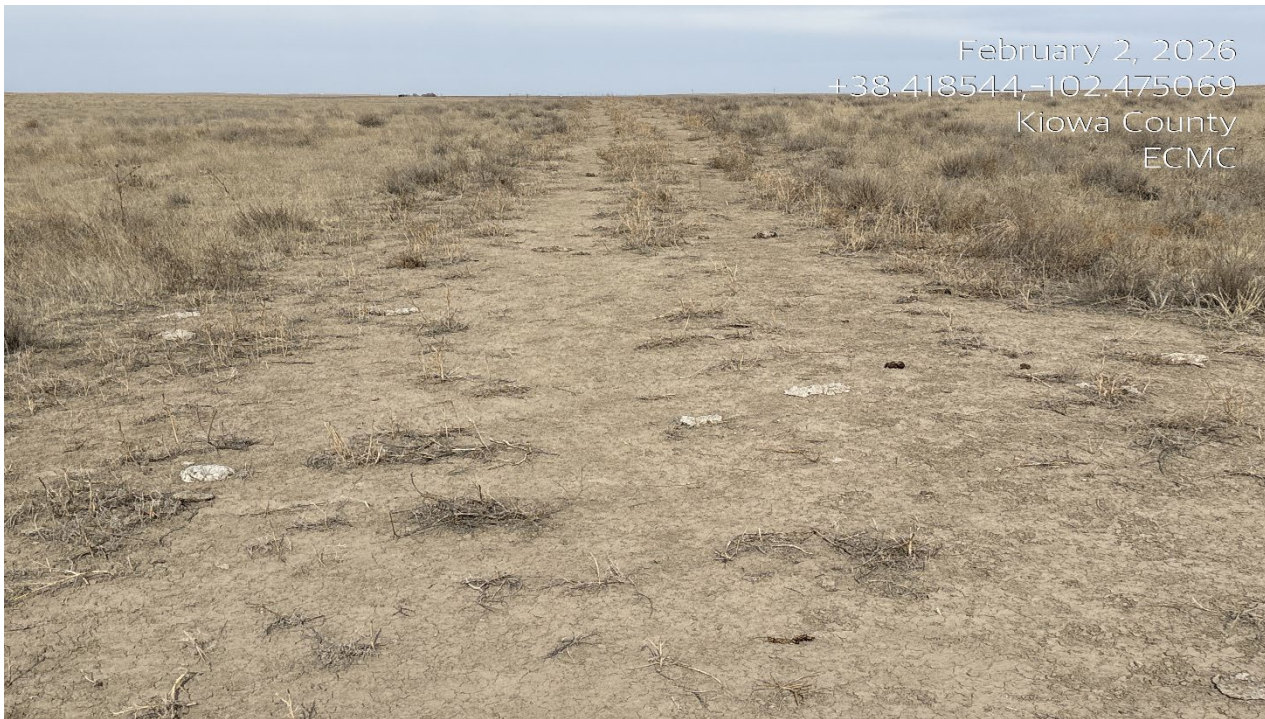
Photo 1. Facing north along the former access road. The vegetation is not establishing and disturbed soils need to be reseeded.

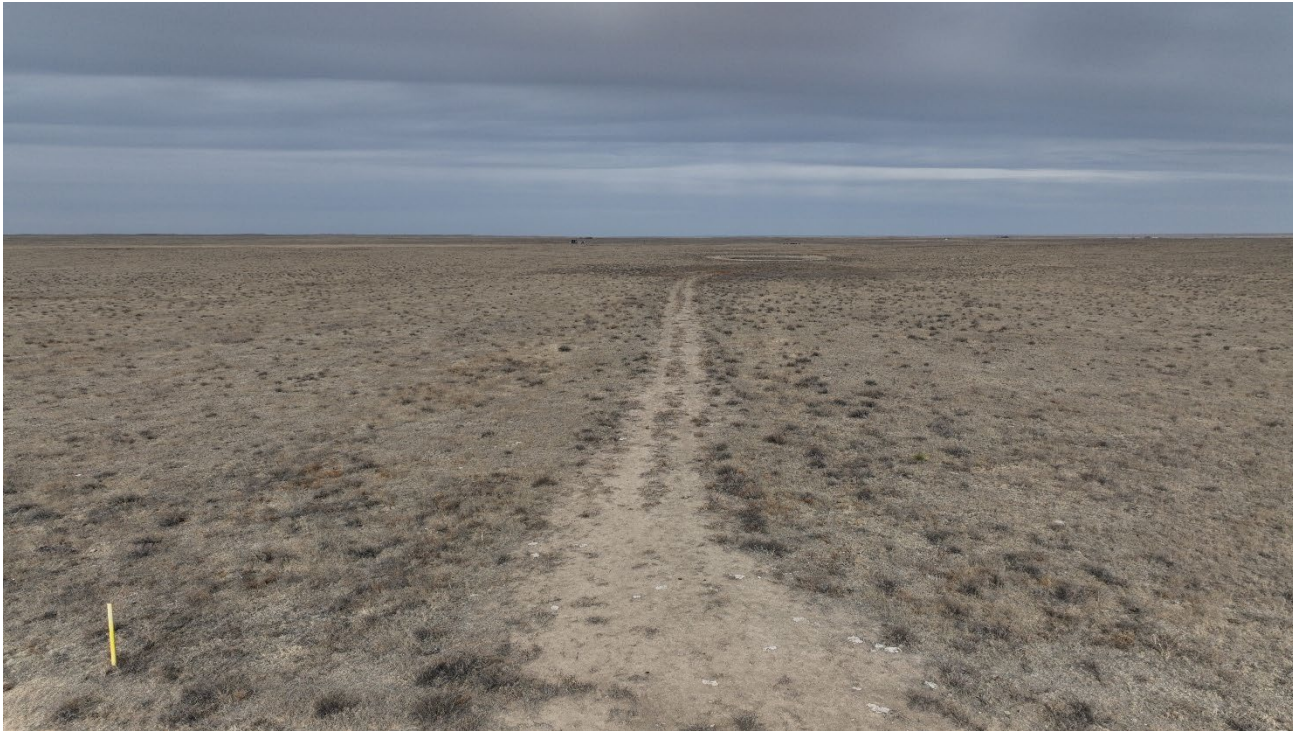
Photo 2. Drone aerial photo facing north. The road has not revegetated and must be reclaimed.

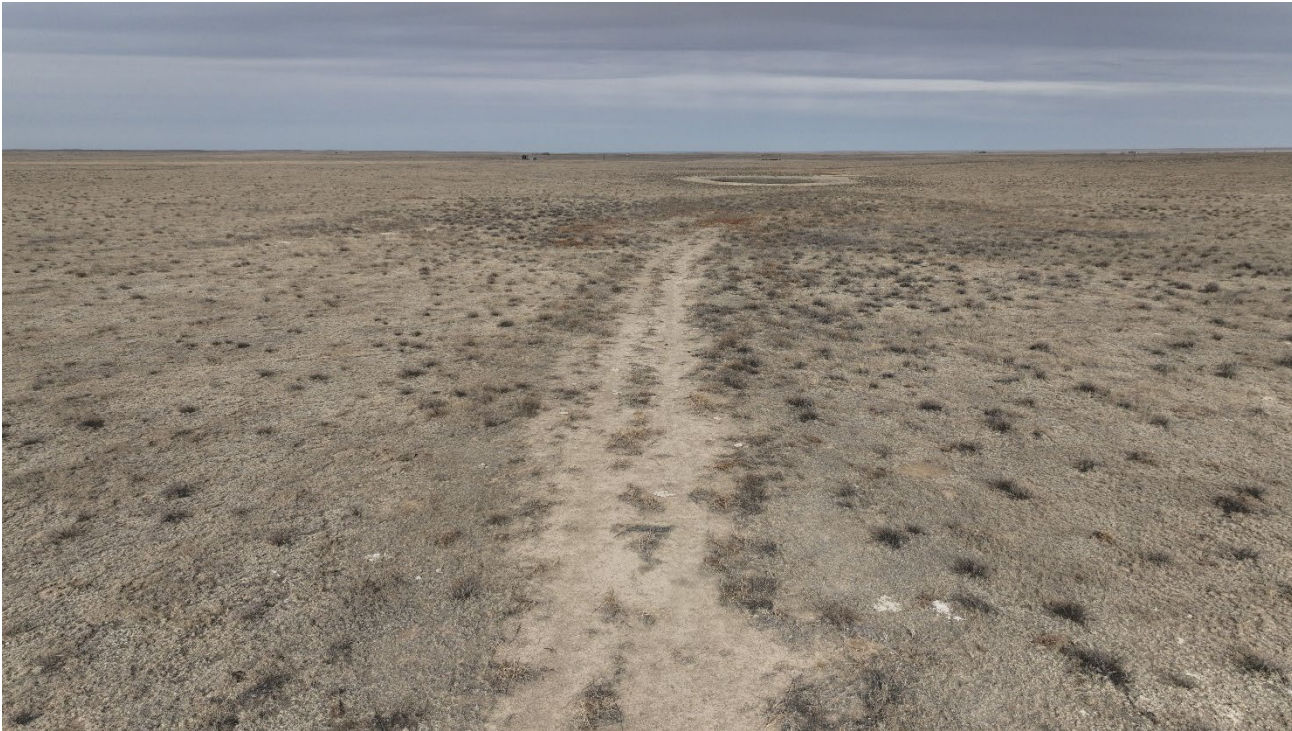
Photo 3. Drone aerial photo shows bare soils along the road that have not revegetated.

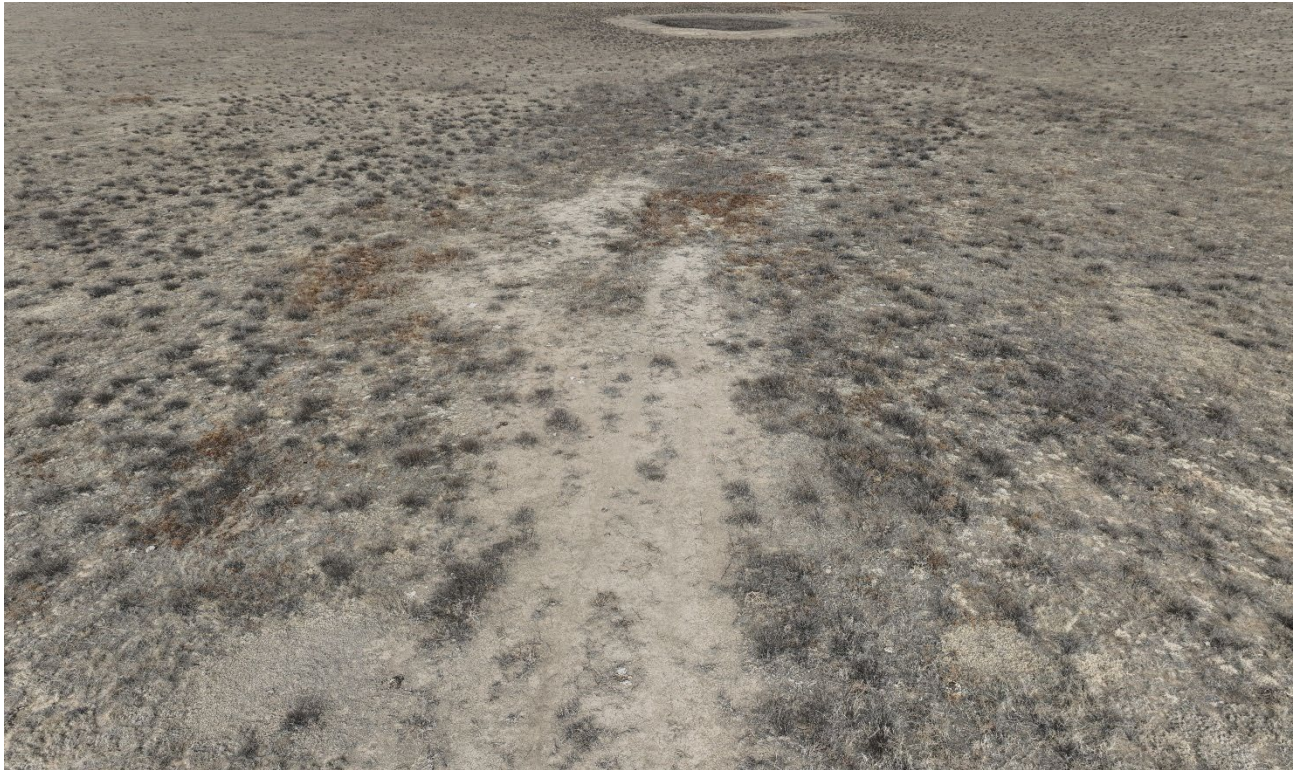
Photo 4. Drone aerial photo facing down toward the abandoned wellsite. There are areas bare of vegetation that need to be reseeded.
