Inspection Photos

Company: Simcoe LLC. – Well: Opal Lechner

API # 05-067-07336

Inspection Doc #:721100104

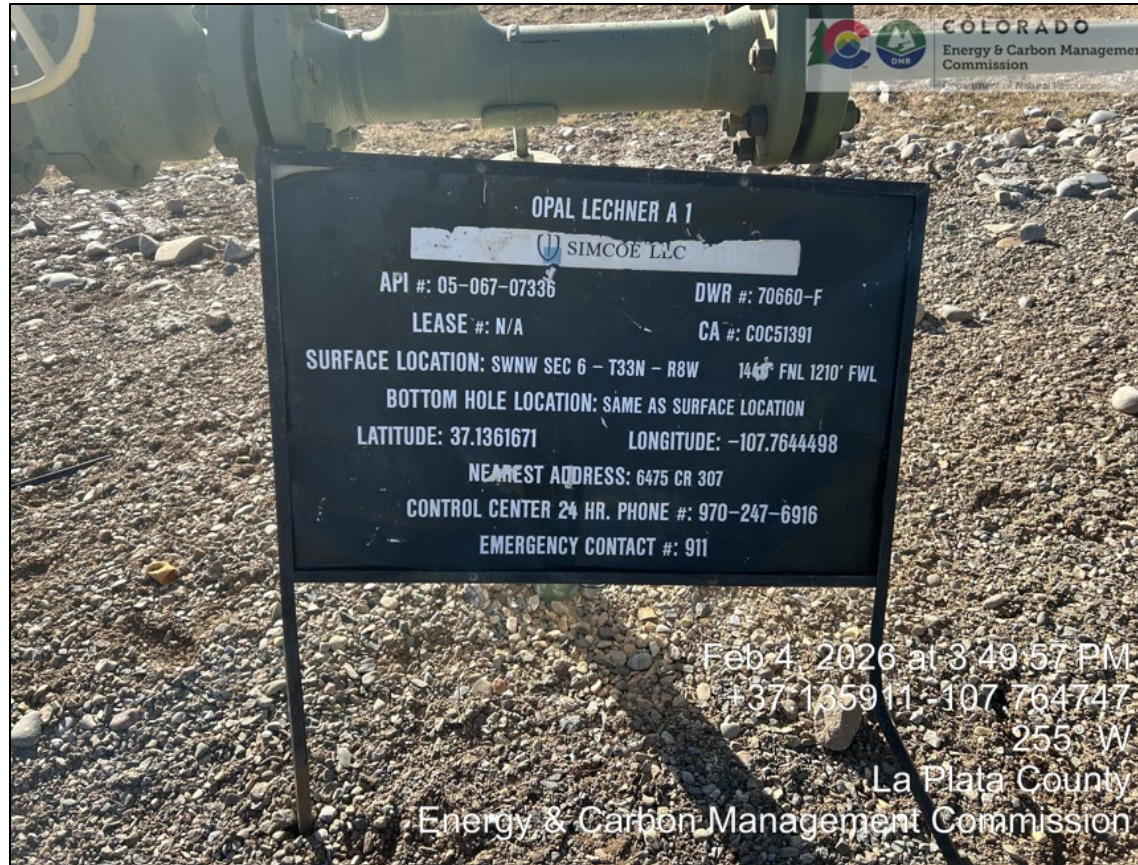
1. Well sign. Sign was laying face down upon arrival. Should be secured in upright fashion in visible location.

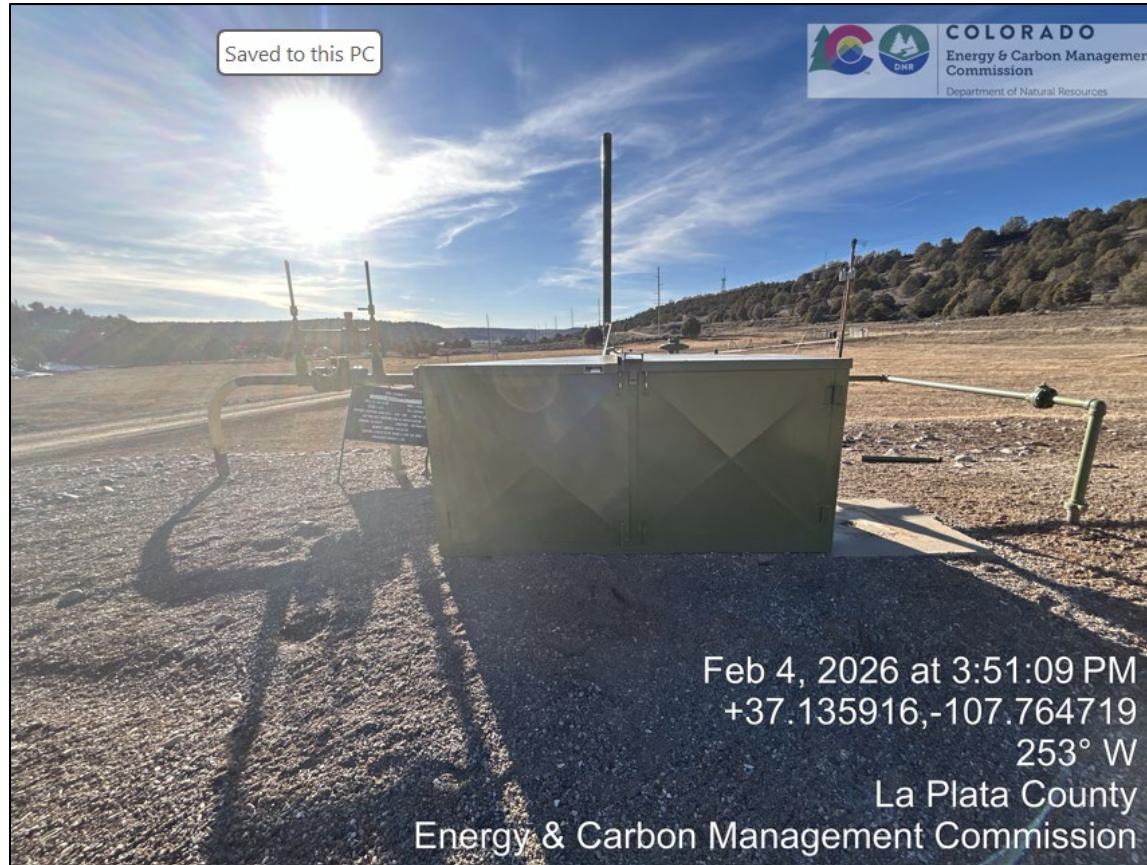
2. Direct pump controller.

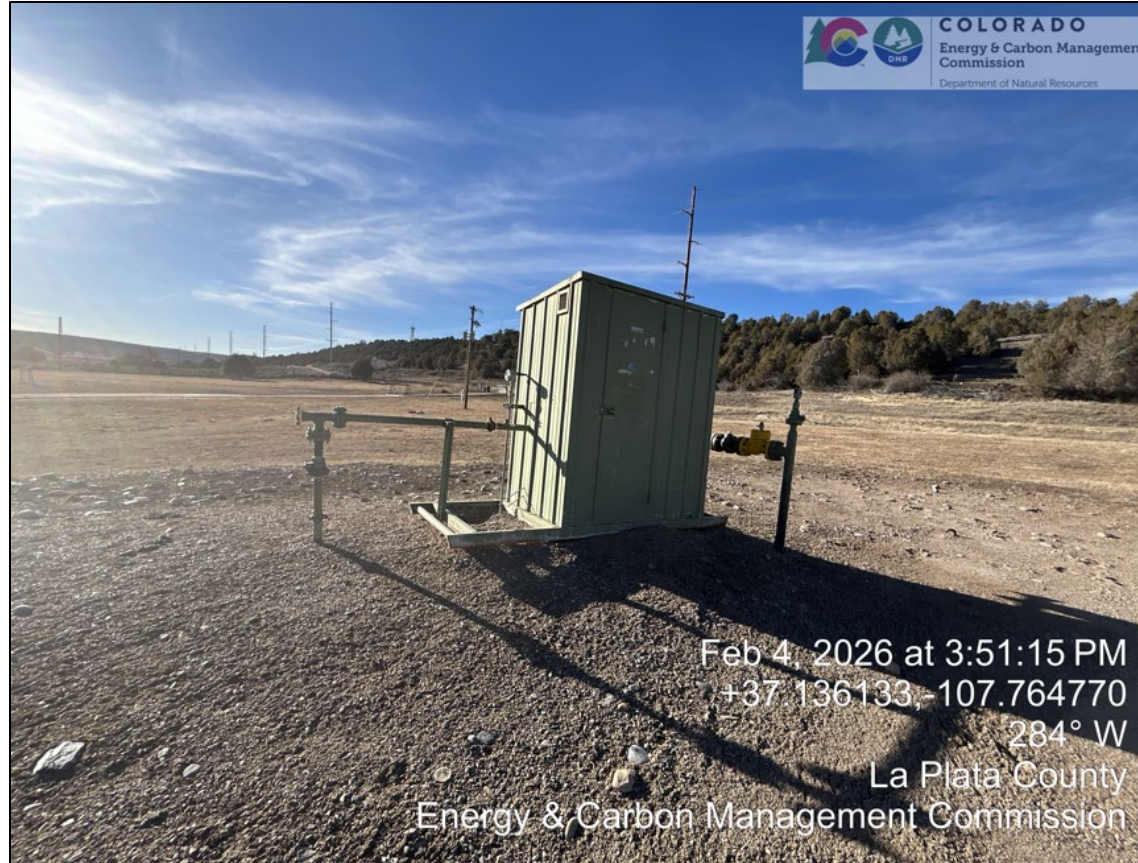
3. Meter run structure.

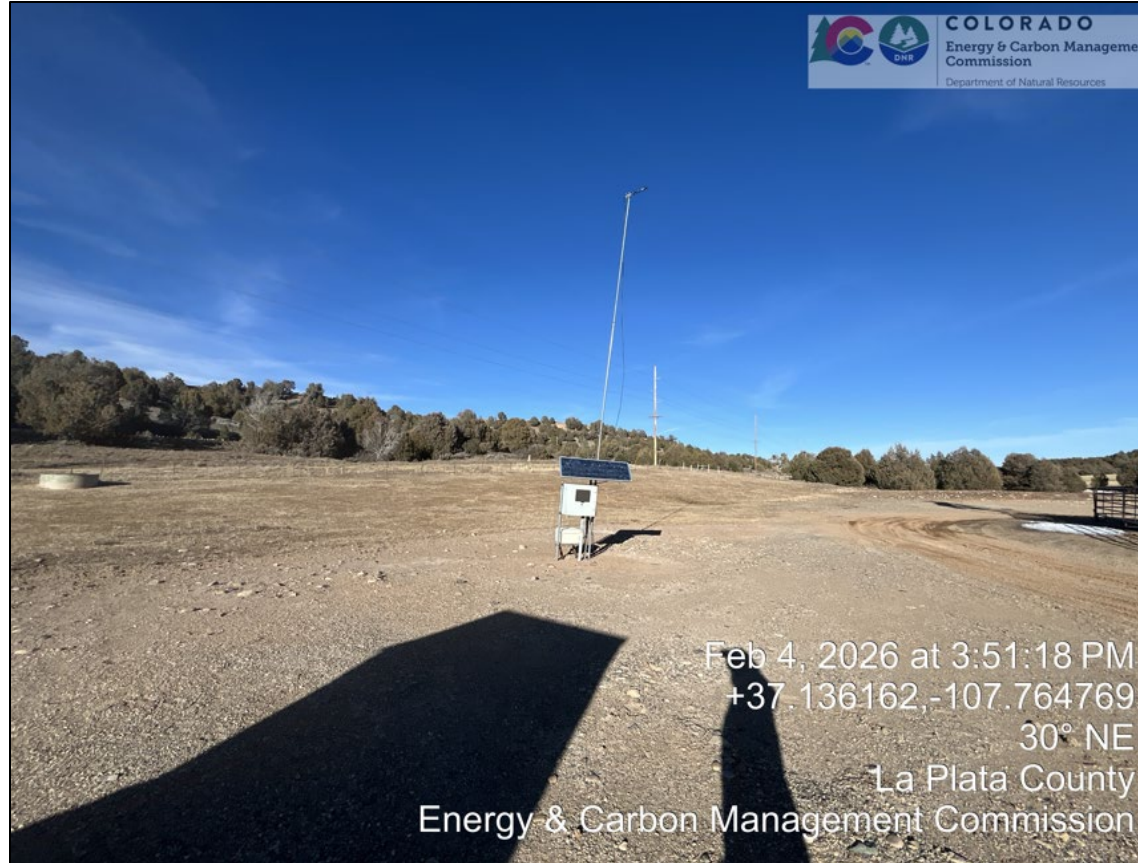
4. Telemetry.

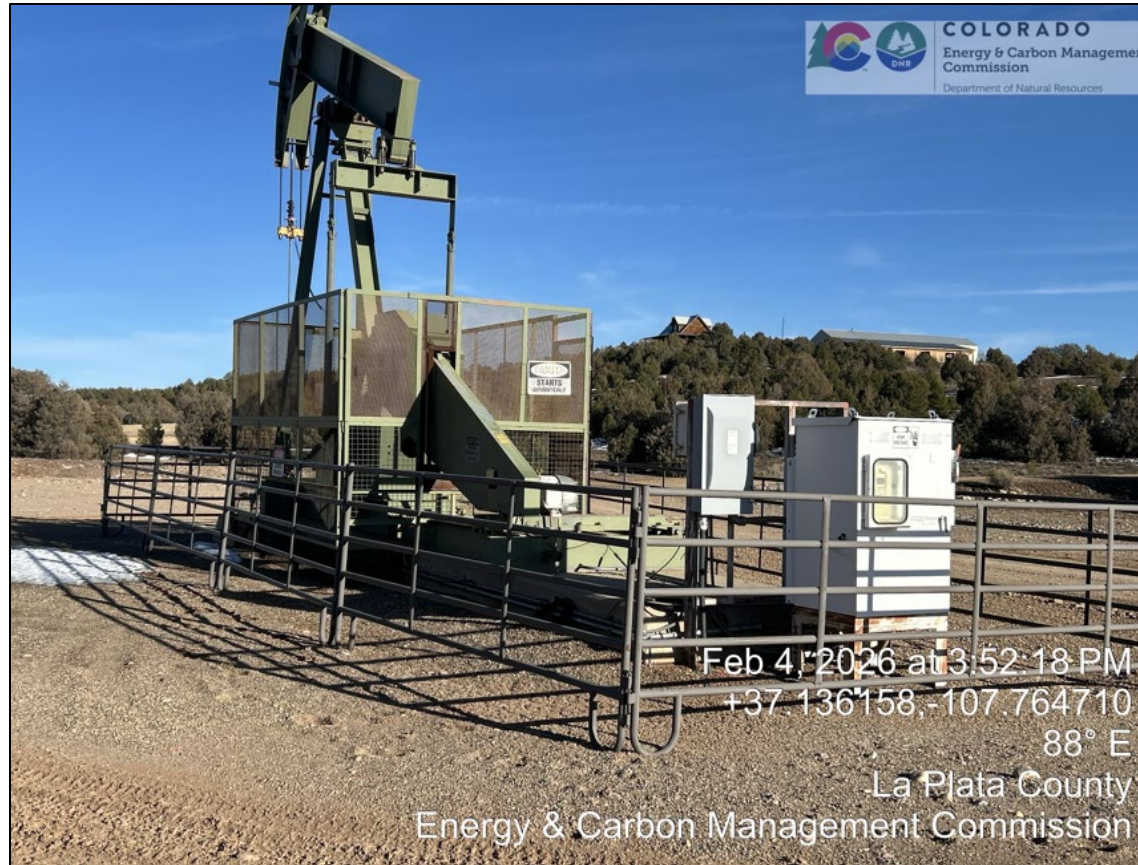
5. Pumpjack and electric prime mover behind cattle panel fence.

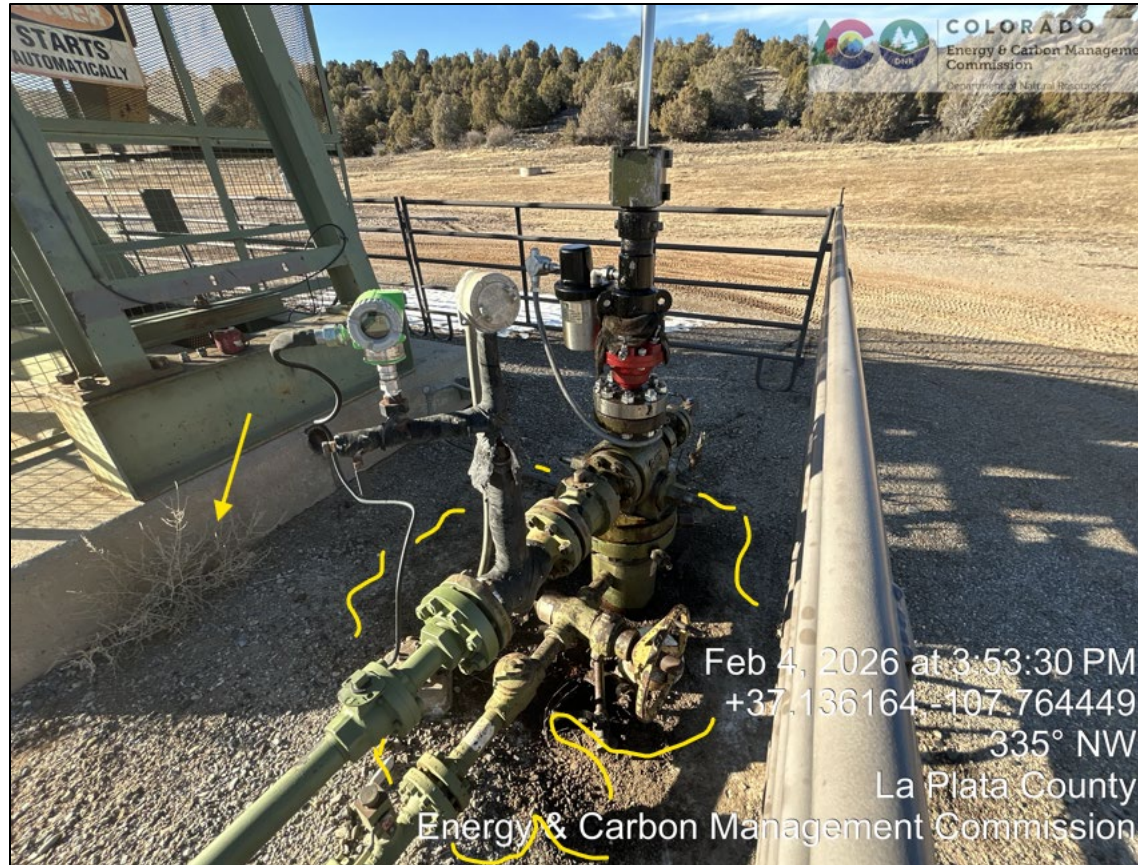
6. Wellhead. Note oil stain on ground (outlined in yellow) and dead vegetative debris (arrow). View looking north. Staining appears to be from excessive rod-oiler lubrication.

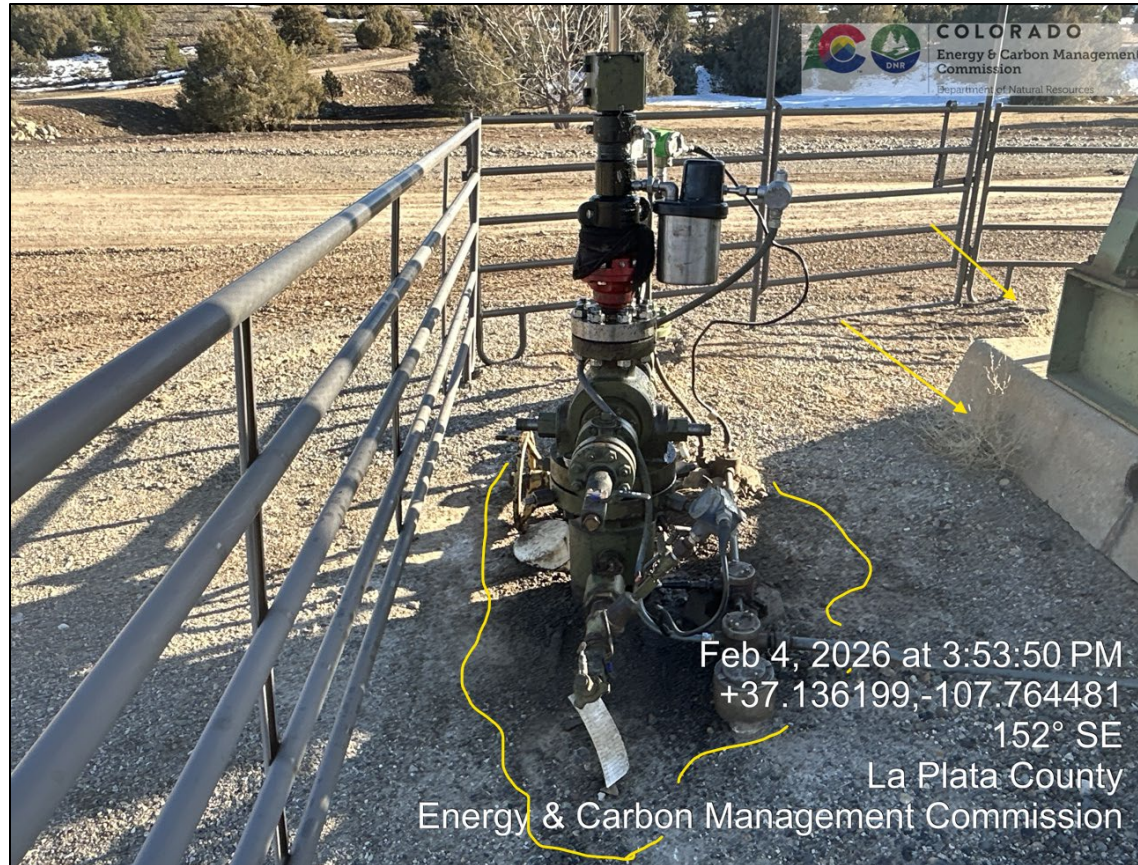
7. Wellhead. Note oil stain on ground (outlined in yellow) and dead vegetative debris (arrow). View looking south.

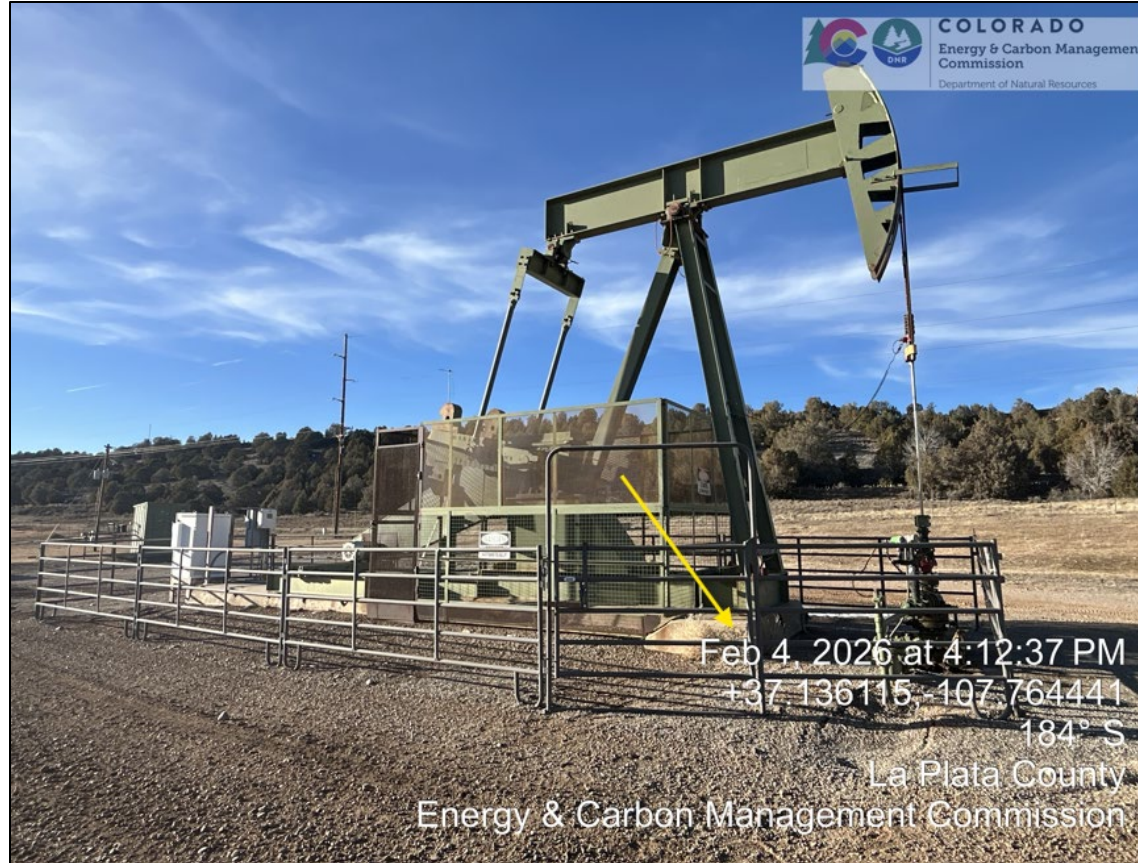
8. Pumpjack and wellhead. Dead vegetative debris near wellhead.
