Inspection Photos

Loc: 324901

Operator: RAMPIKE RESOURCES LTD

Inspection Date: 2/2/2026

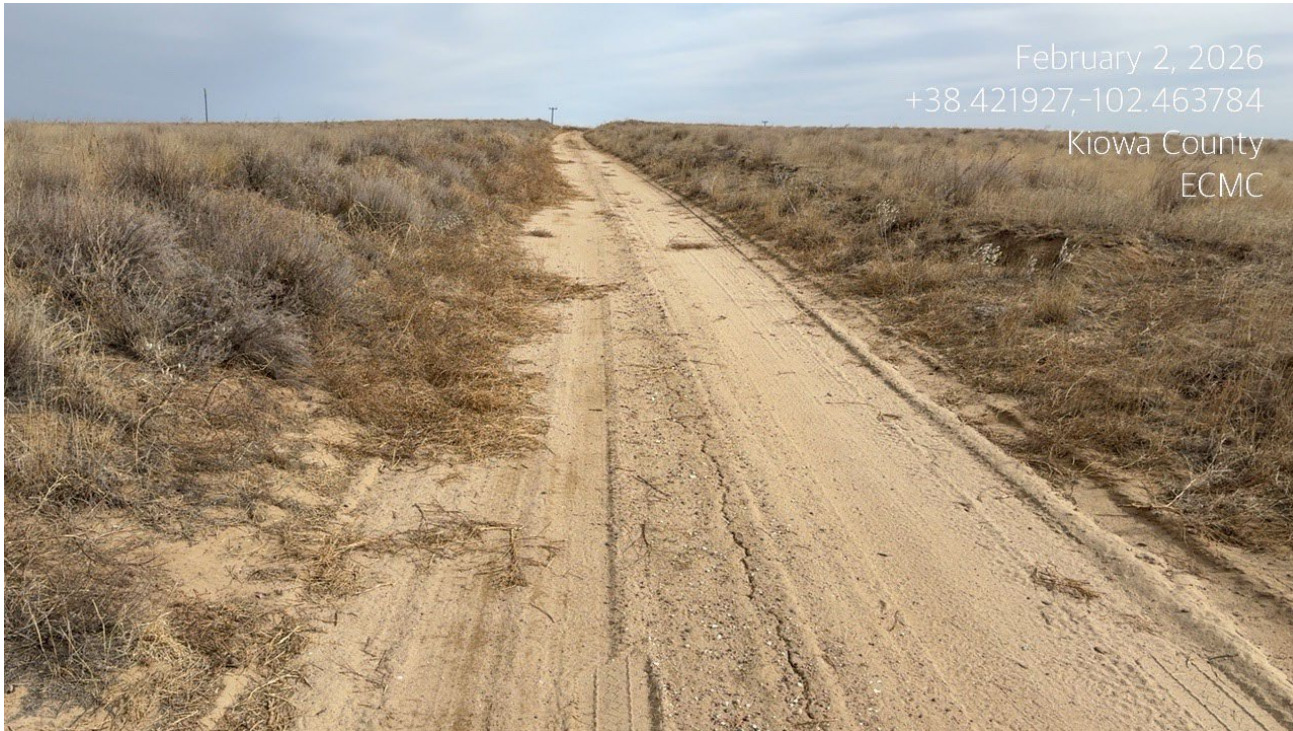
Photo 1. Facing east along the main road. The road is swaled and below the original grade of the terrain. There is concern for winter snow to blow onto the road impeding vehicle passage.

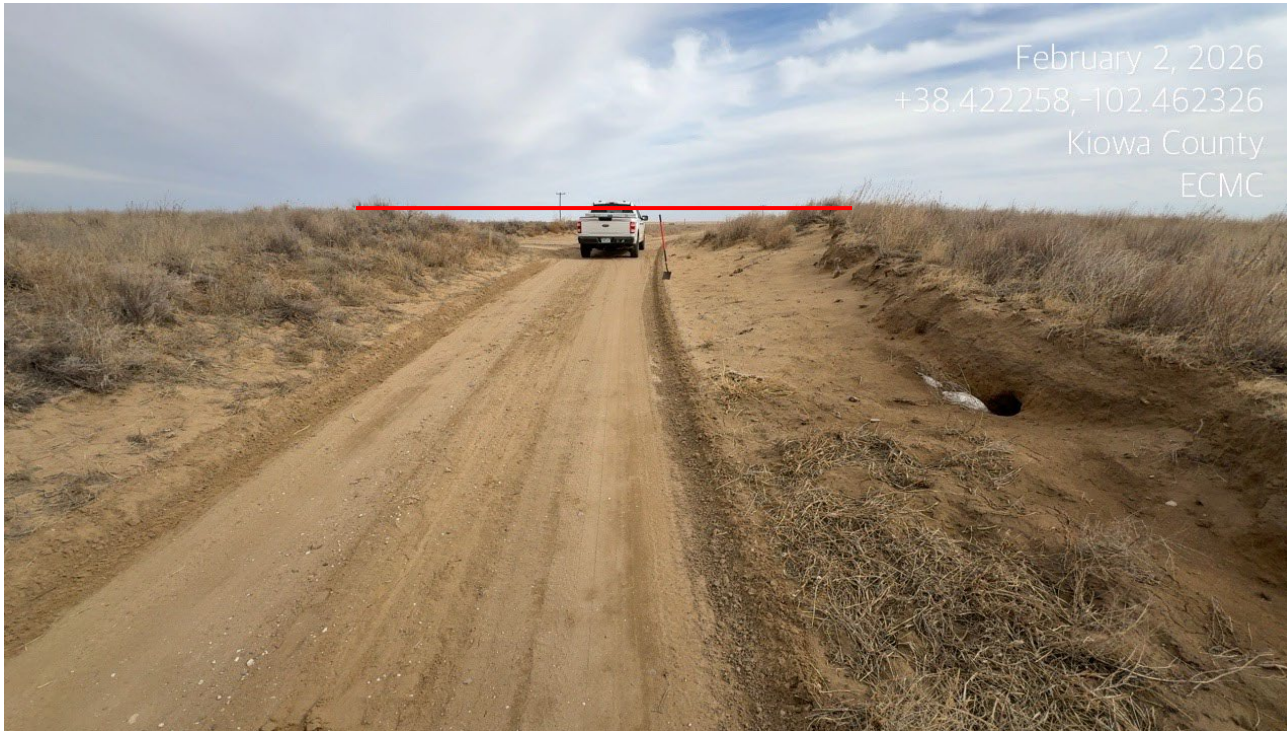
Photo 2. Facing east along the main access road. Red line is the approximate original grade and the shovel is 4.5 feet for scale. There is concern for winter snow to blow onto the road impeding vehicle passage.

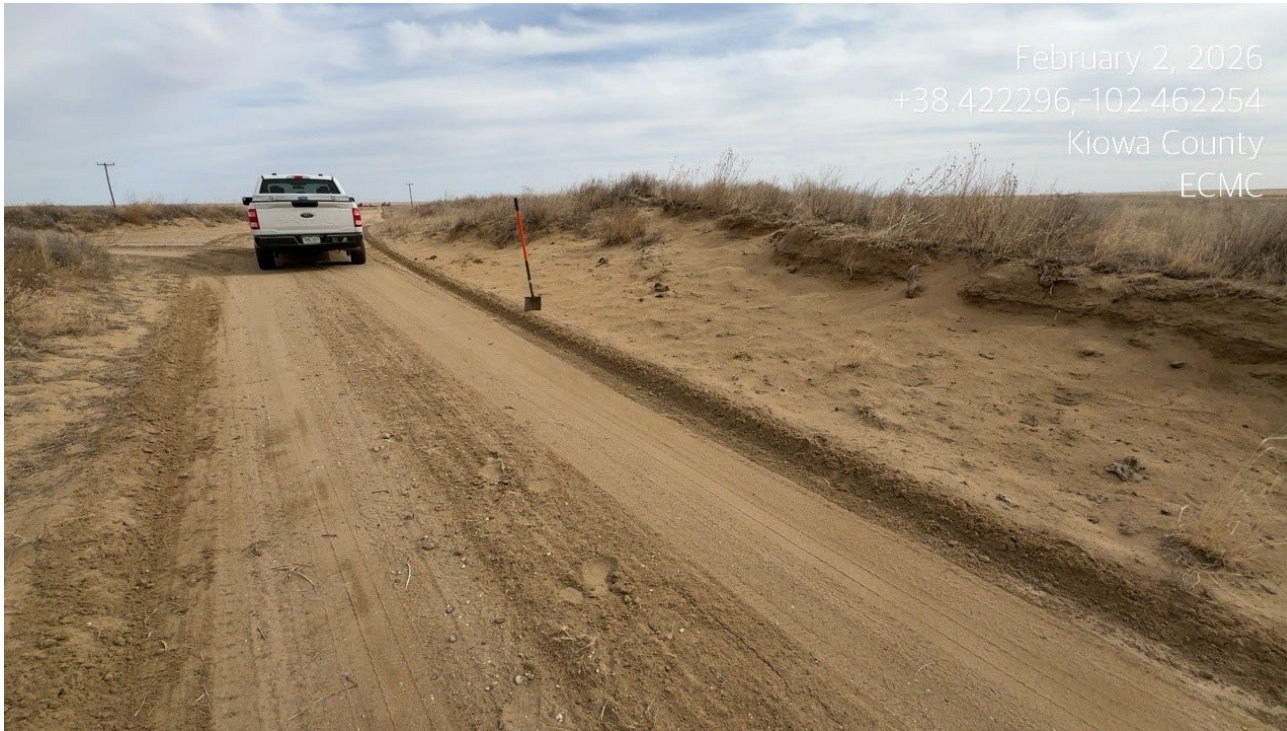
Photo 3. The roadside has eroded and is not stabilized with vegetation. The sandy soils are susceptible to further erosion. This area needs to be repaired and stabilized.

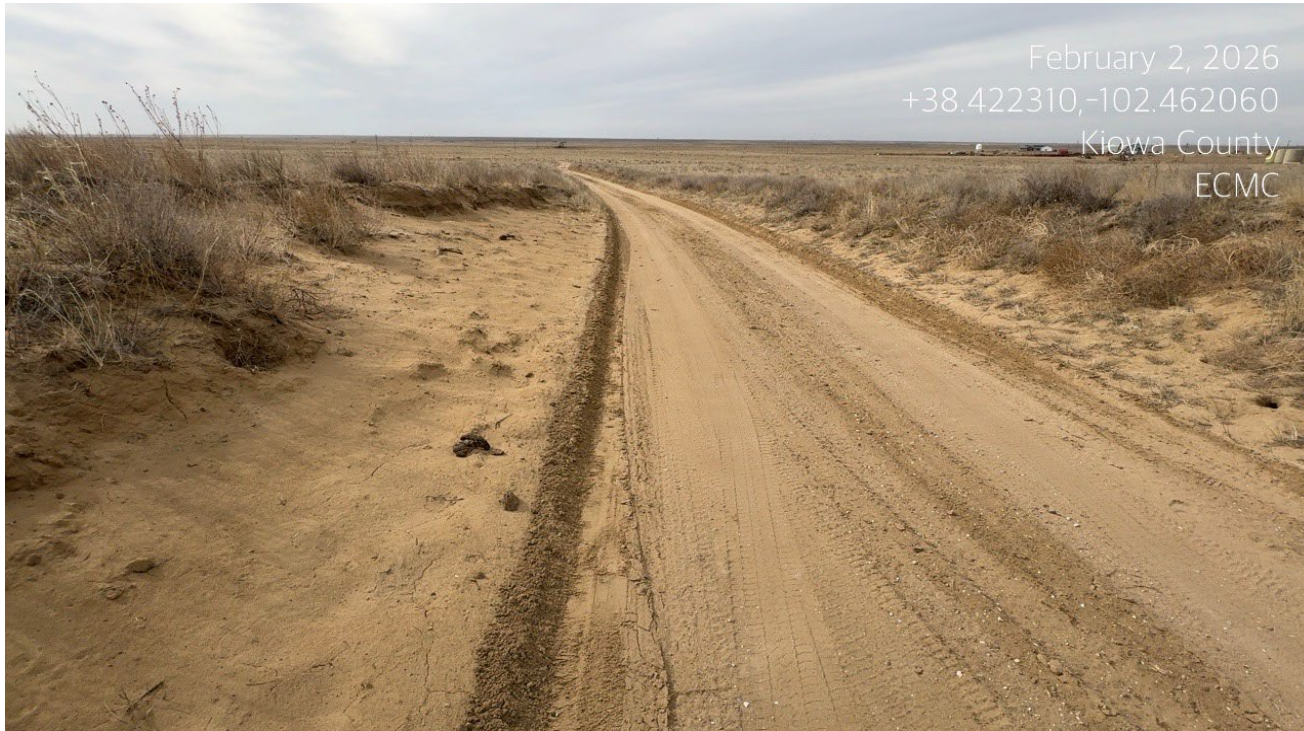
Photo 4. Facing back to the west. The sandy soils are susceptible to further erosion. This area needs to be repaired and stabilized.

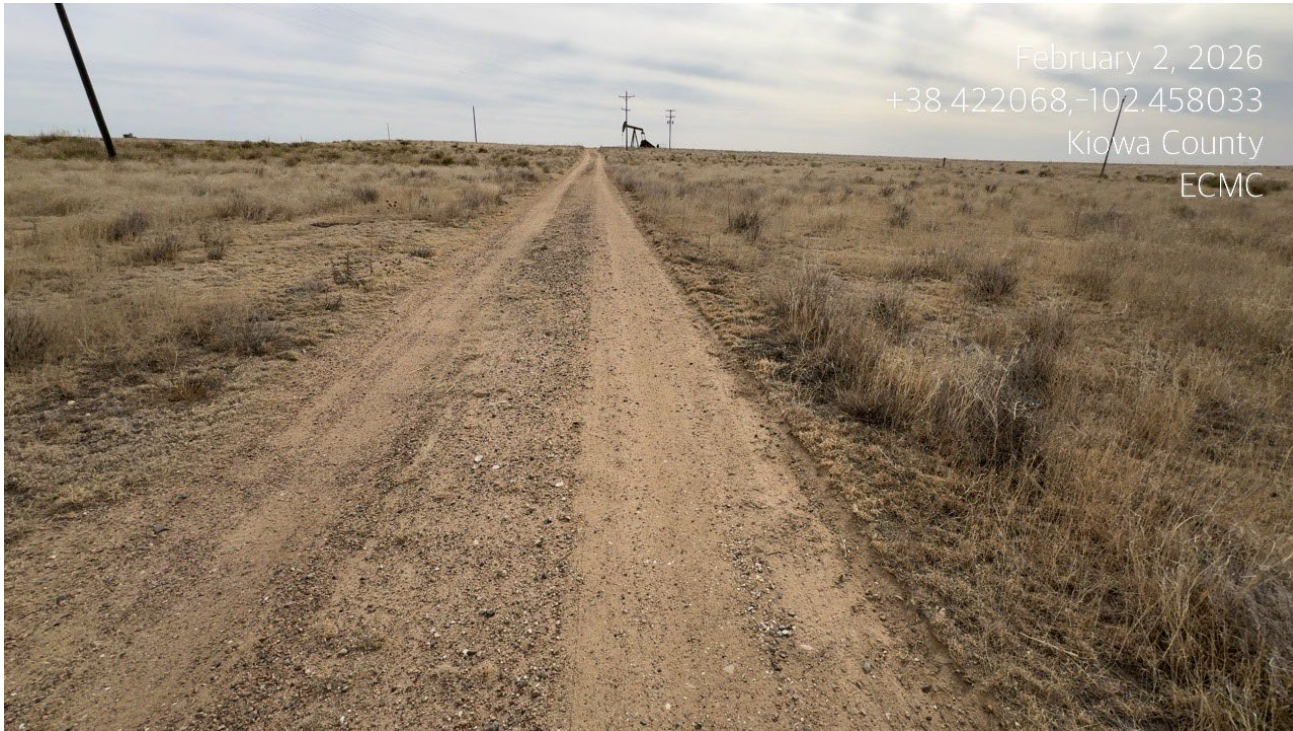
Photo 5. Facing south along the access road.

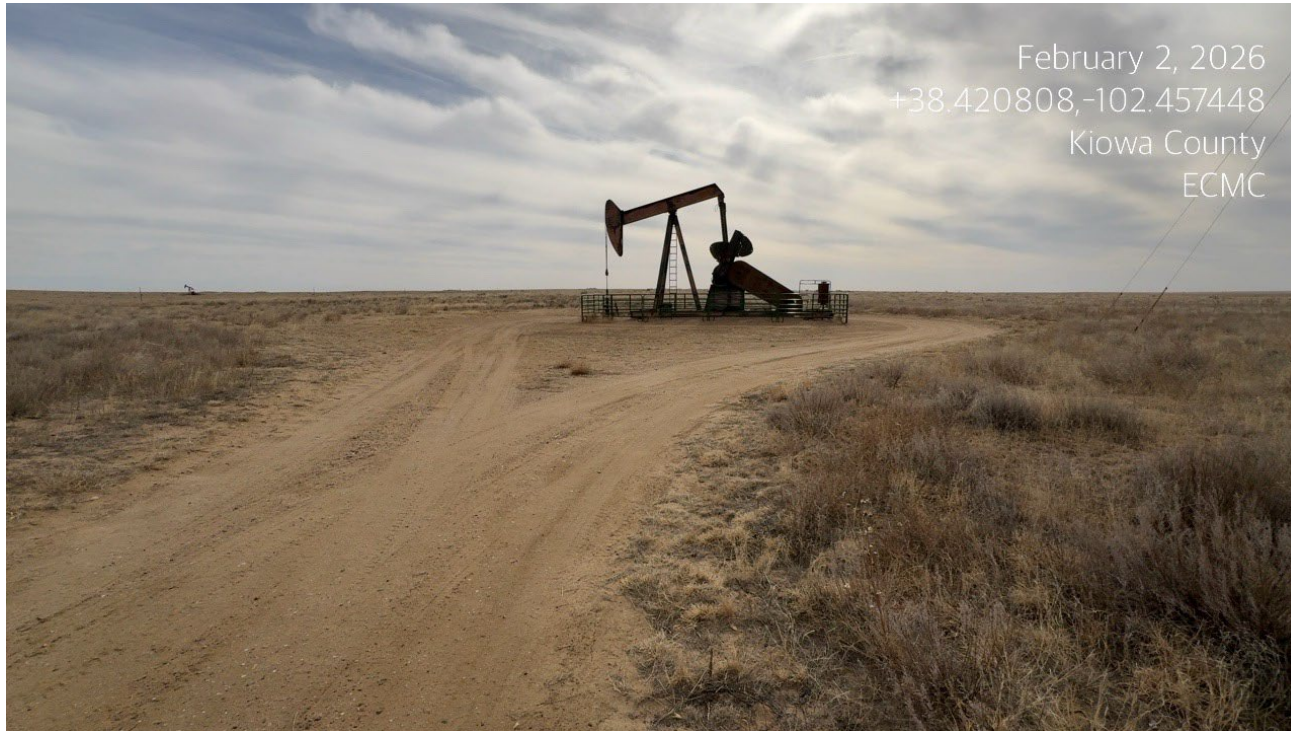
Photo 6. Facing south toward the wellsite.

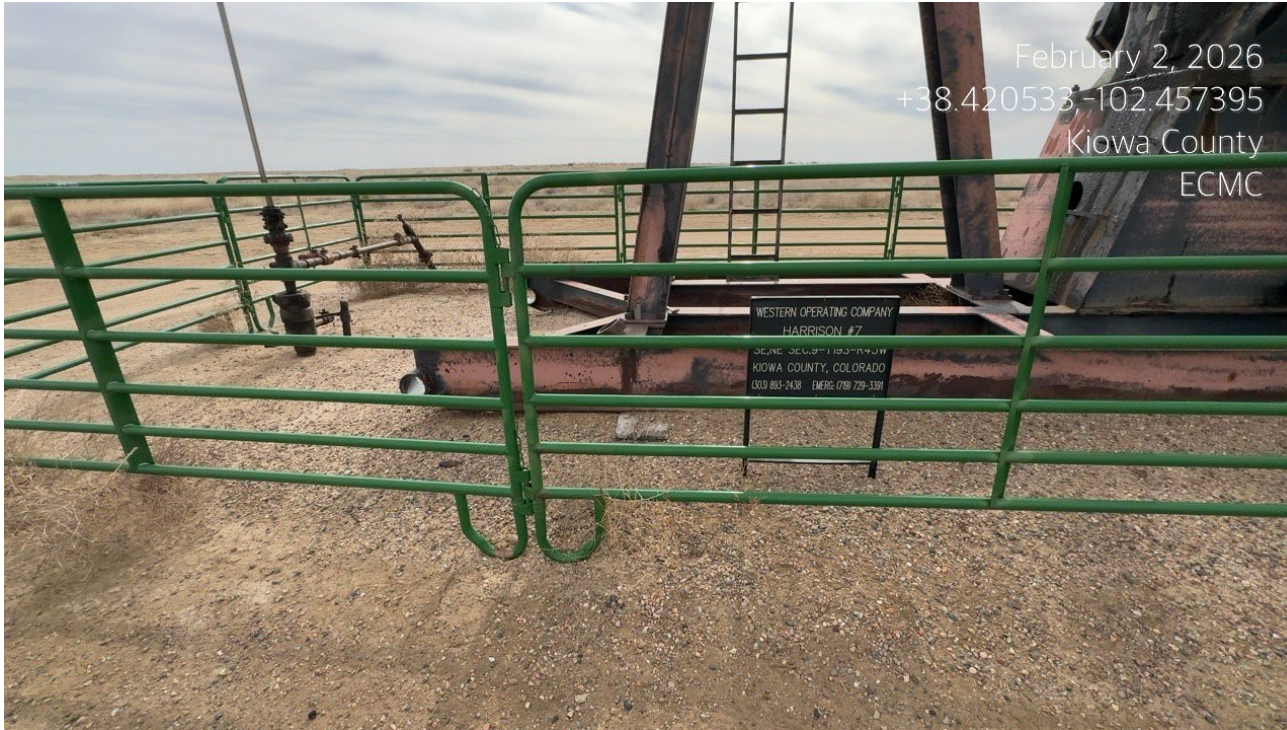
Photo 7. The operator sign will need to be updated to reflect the new Operator.
