# Inspection Photos

Loc: 324800

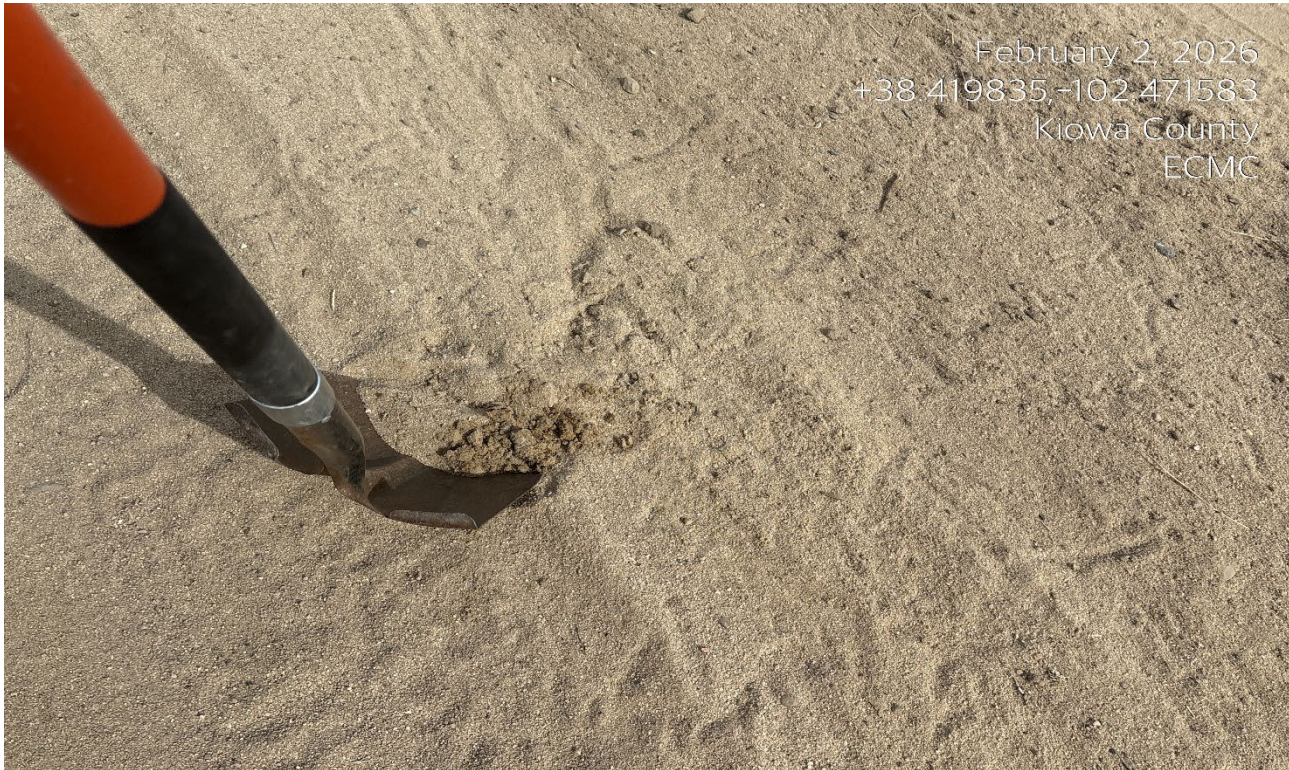
**Photo 7.** The road consists of loose sandy soil which is susceptible to further erosion.
