Inspection Photos
Location: King Pyles 1
Location ID: 384246
API # 05-061-06017

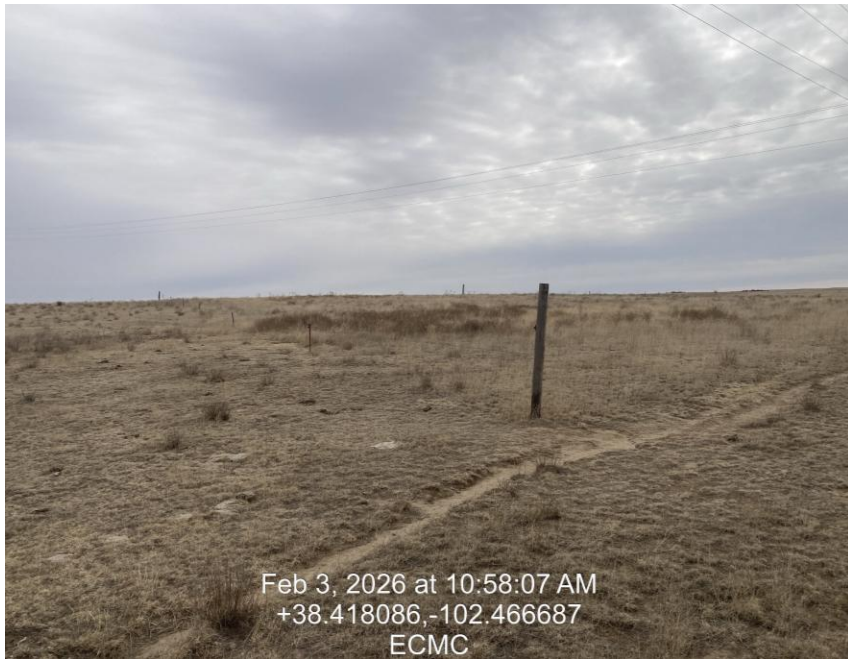
Photo 1 – Fenced area north looking south

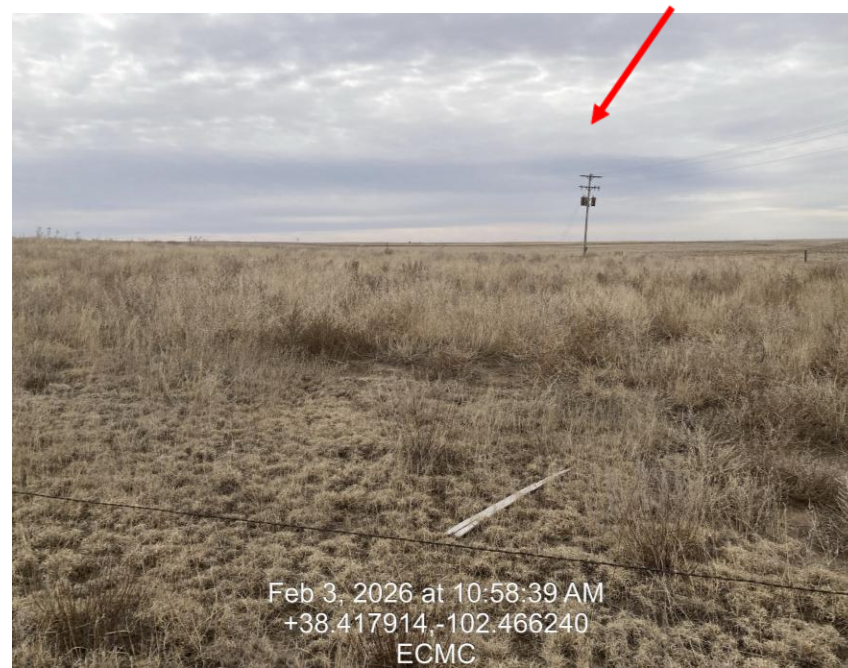
Photo 2 – Fenced area north looking south

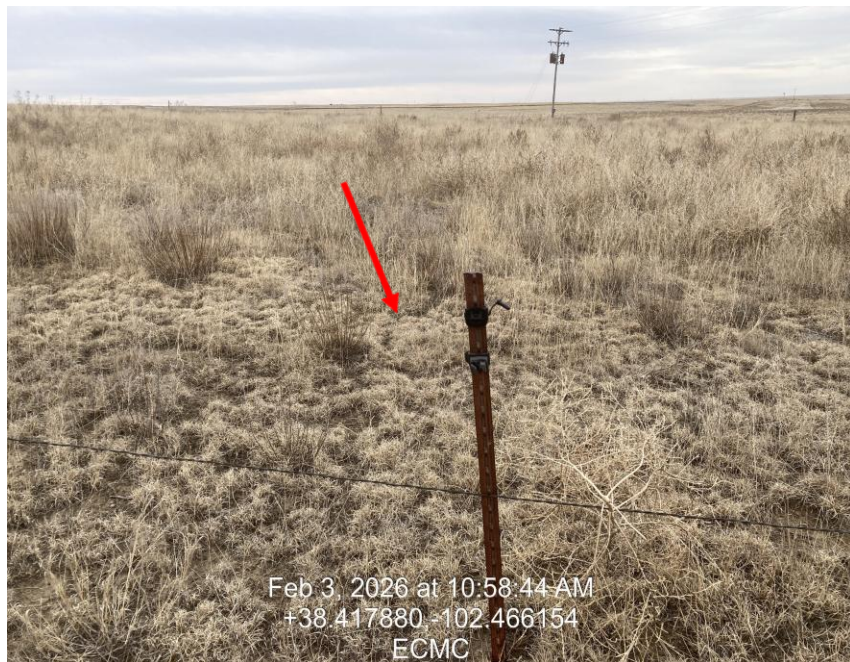
Photo 3 – Fencing not secured

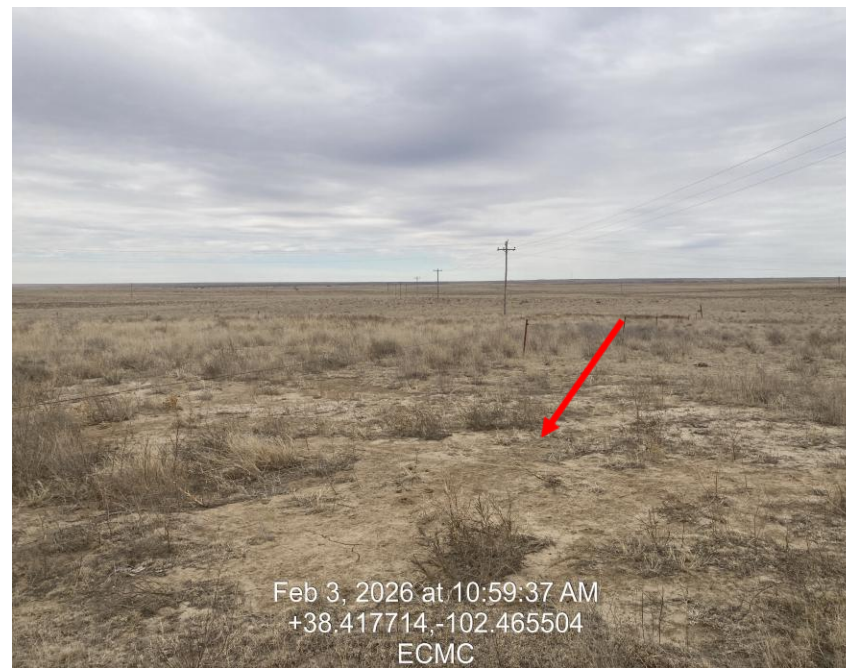
Photo 4 – Bare area

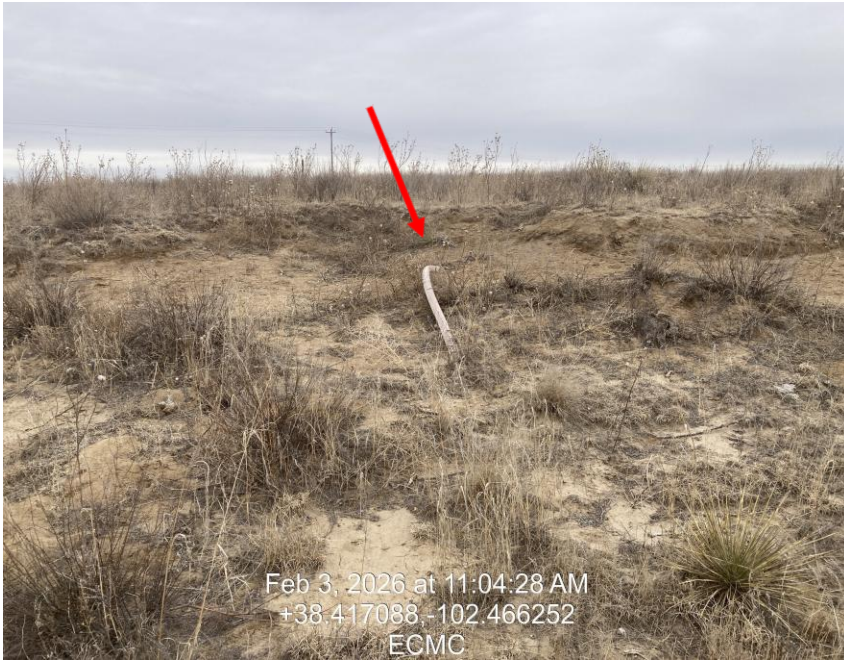
Photo 5 – Area with red piping, subsidence

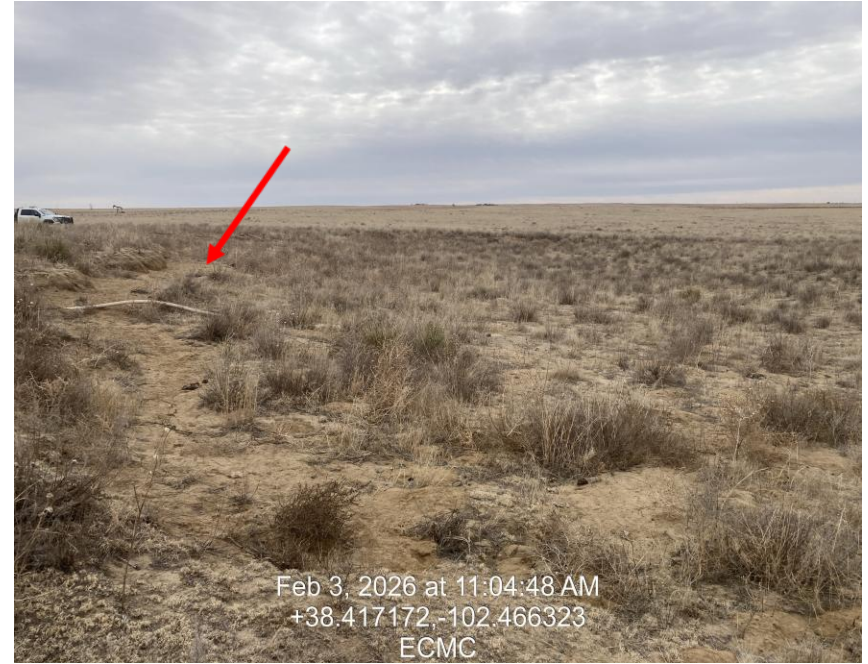
Photo 6 – Area with red piping, subsidence

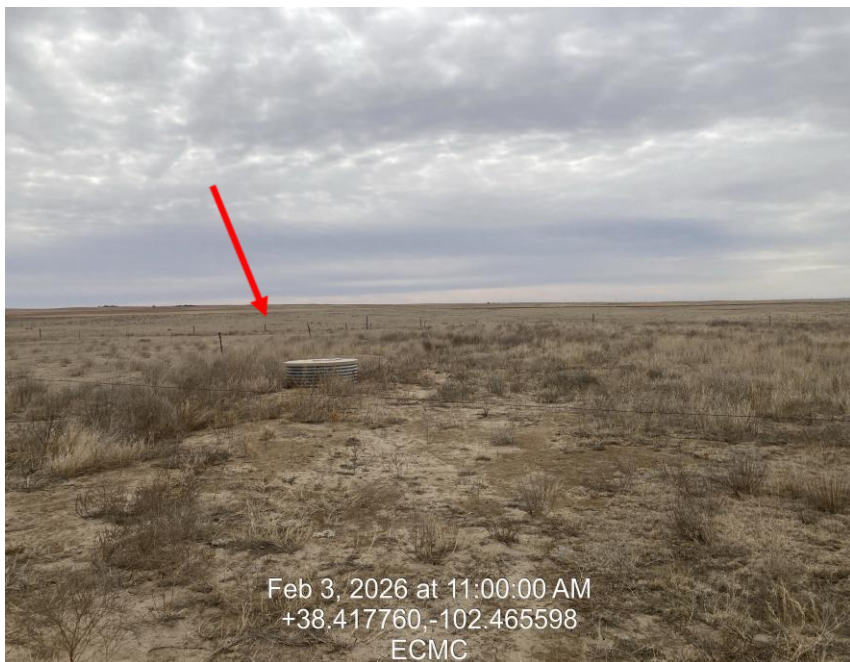
Photo 7 – Valve can, light vegetation

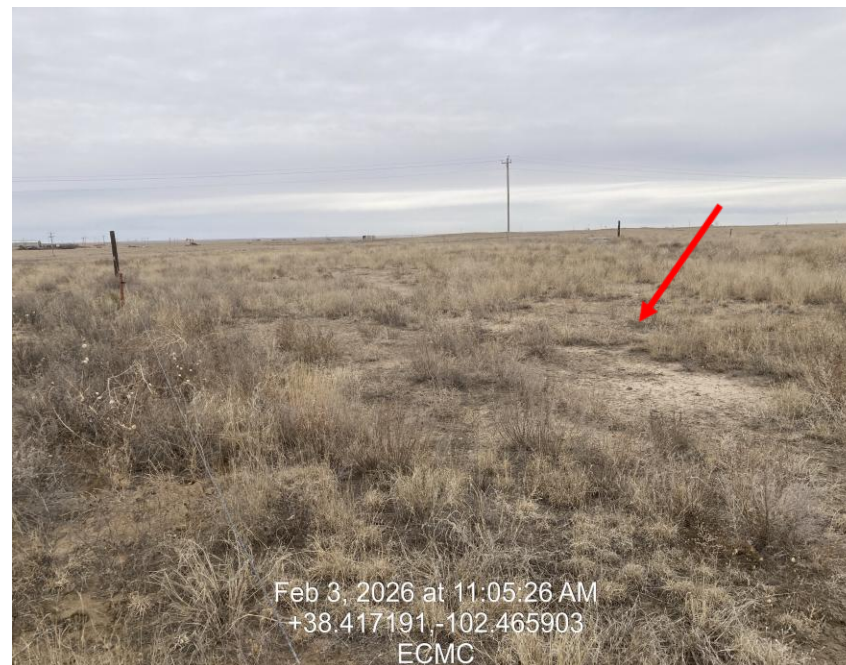
Photo 8 – Fenced Area light vegetation
