Inspection Photos
Location: Dawson Unit 1
Location ID: 384227
API # 05-061-05142

Facility Name/ Number	
DAWSON UNIT 1	
DAWSON UNIT-619S45W 4SWSE	
DAWSON UNIT 1

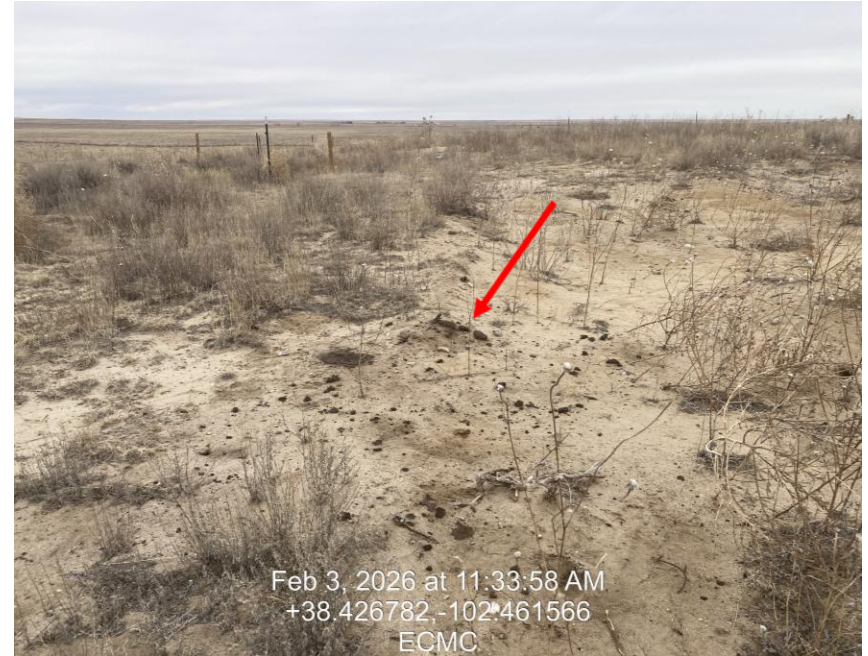
Photo 1 – Well information

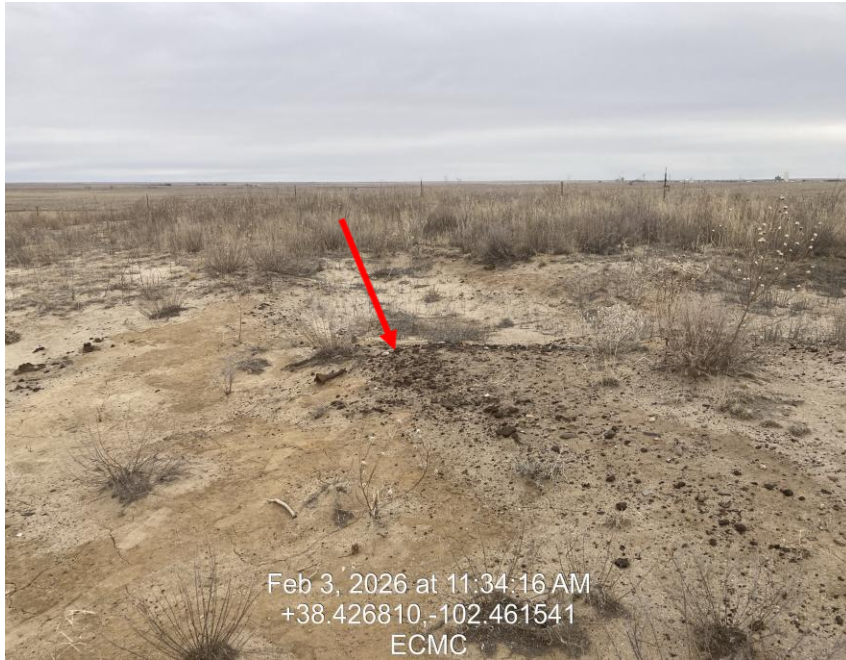
Photo 2 – Distressed Vegetation. Impacted soils

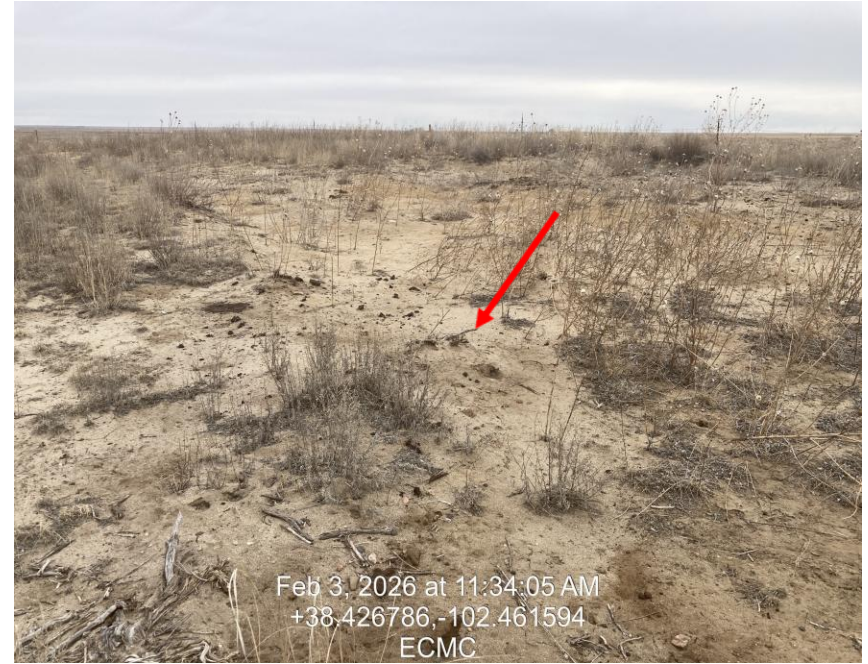
Photo 3 – Distressed Vegetation. Impacted soils

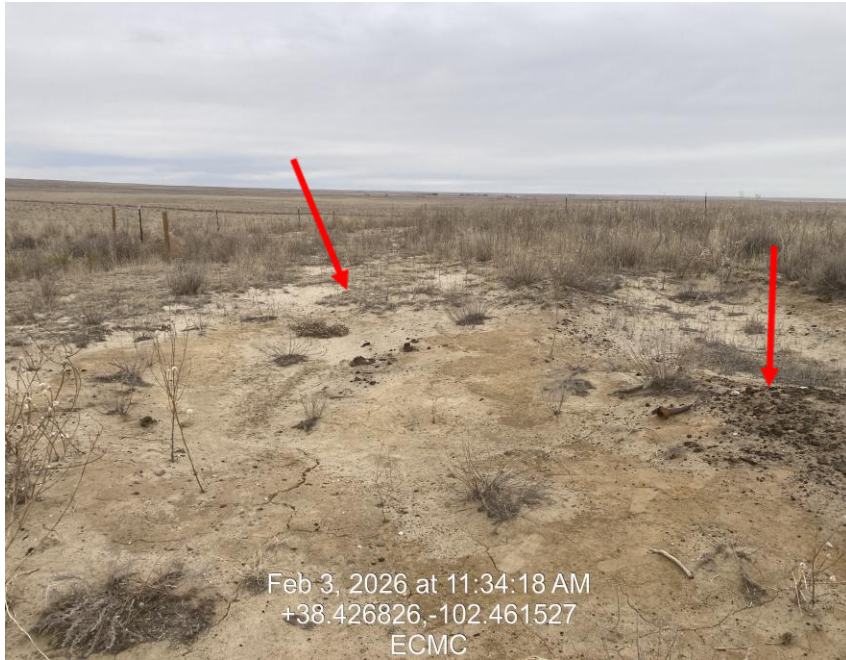
Photo 4 – Distressed Vegetation. Impacted soils

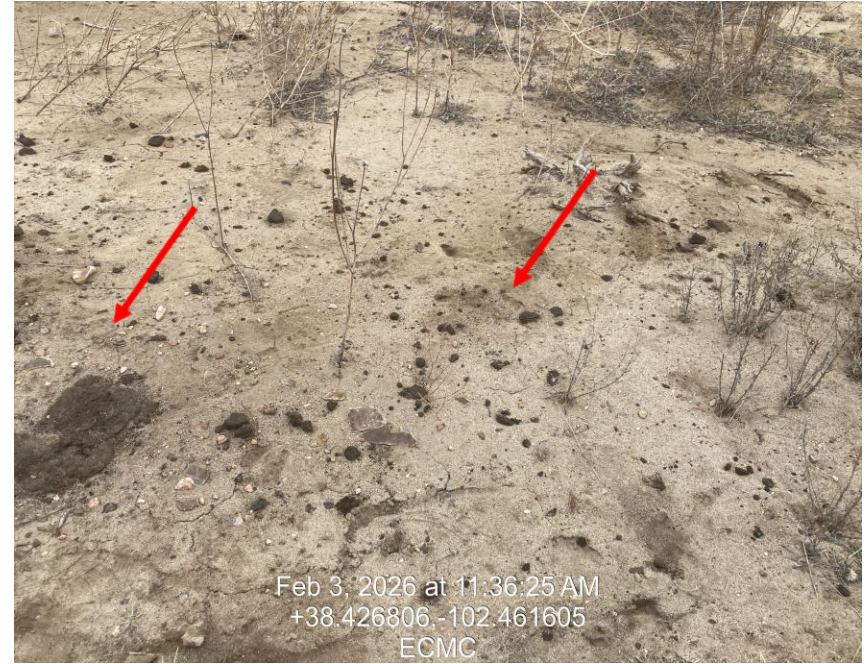
Photo 5 – Distressed Vegetation. Impacted Soils

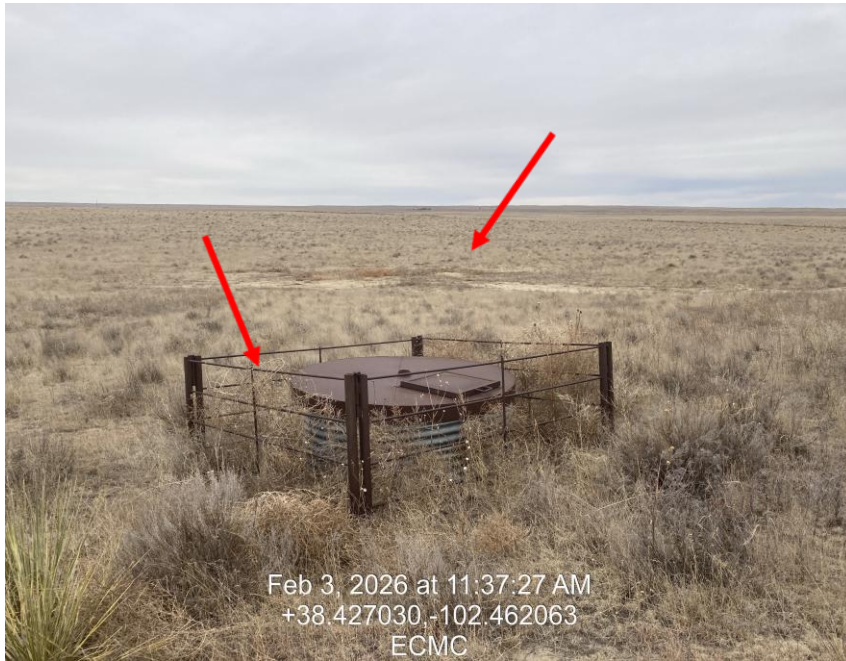
Photo 6 – Impacted soils, remnants of oilfield equipment.

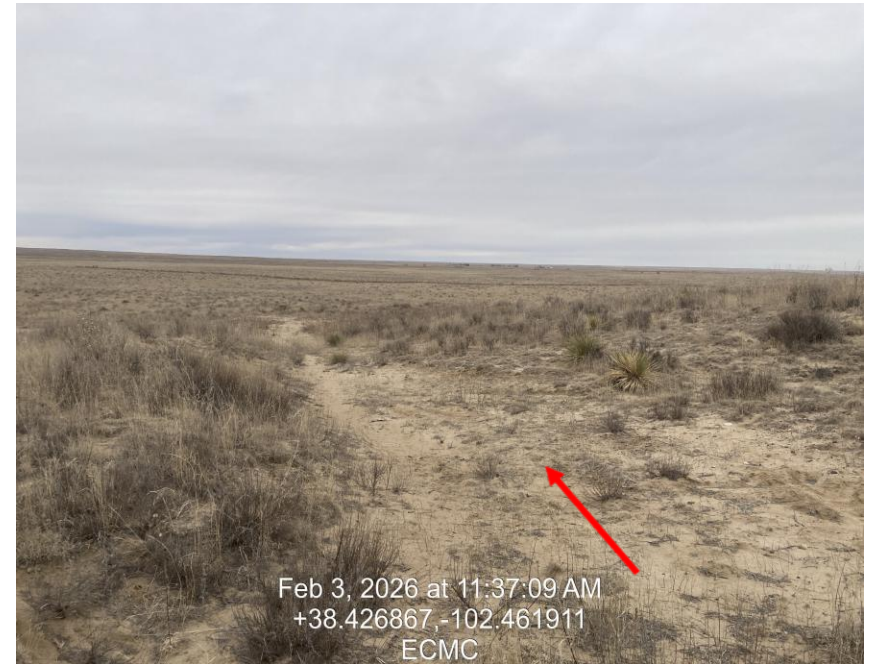
Photo 7 – Flowline Valve Box, area in distance is sandy material identified in Reclamation Inspection Document no. 713600600
