Inspection/Audit Photos

Location: GRAND VALLEY RESOURCES INC ANDERSON-GOVERNMENT #17-1 PAD

Location ID: 316695

Date: 02/5/2026

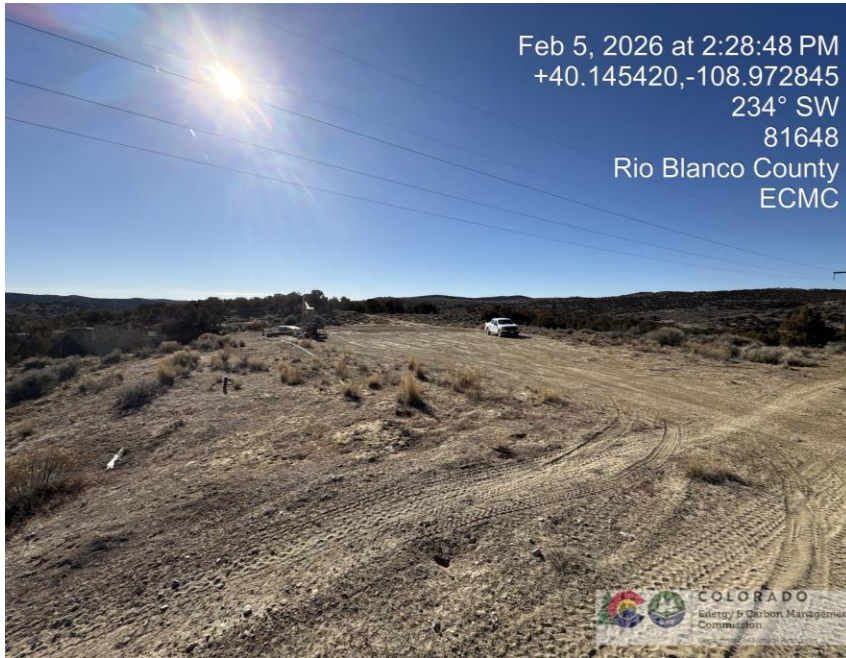
Photo # 1735 Entrance to location

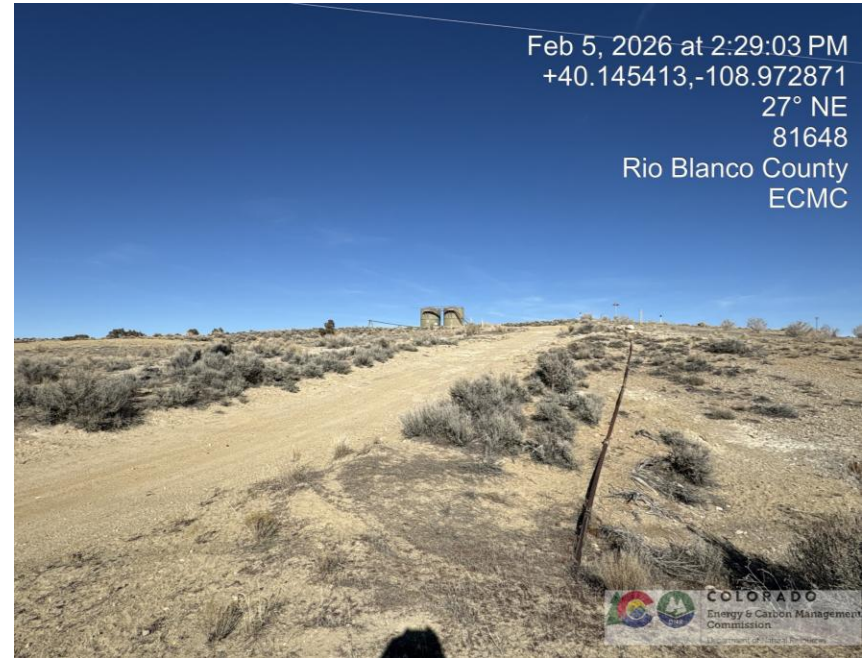
Photo # 1736 Entrance to location

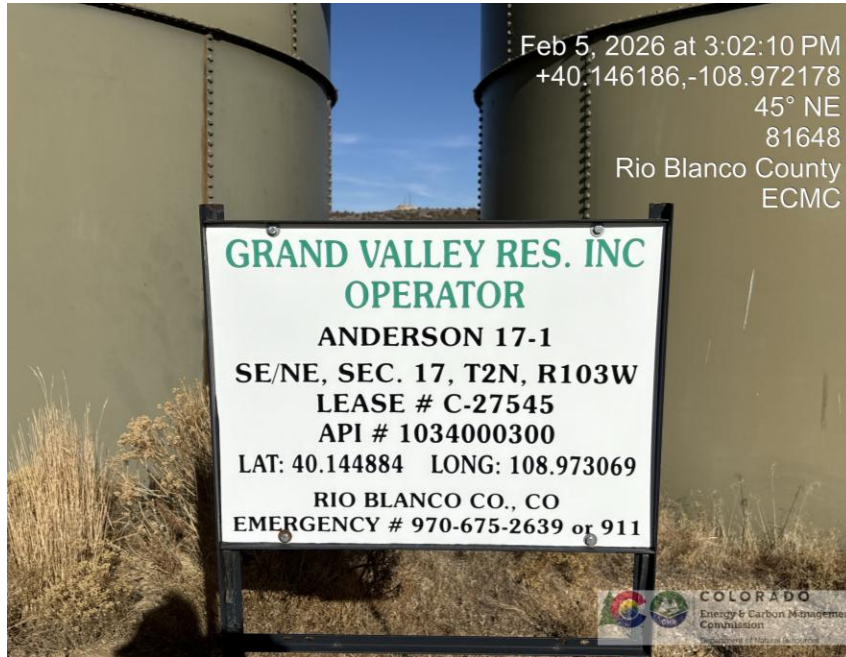
Photo # 1789 Operator emergency Contact Number is not in service

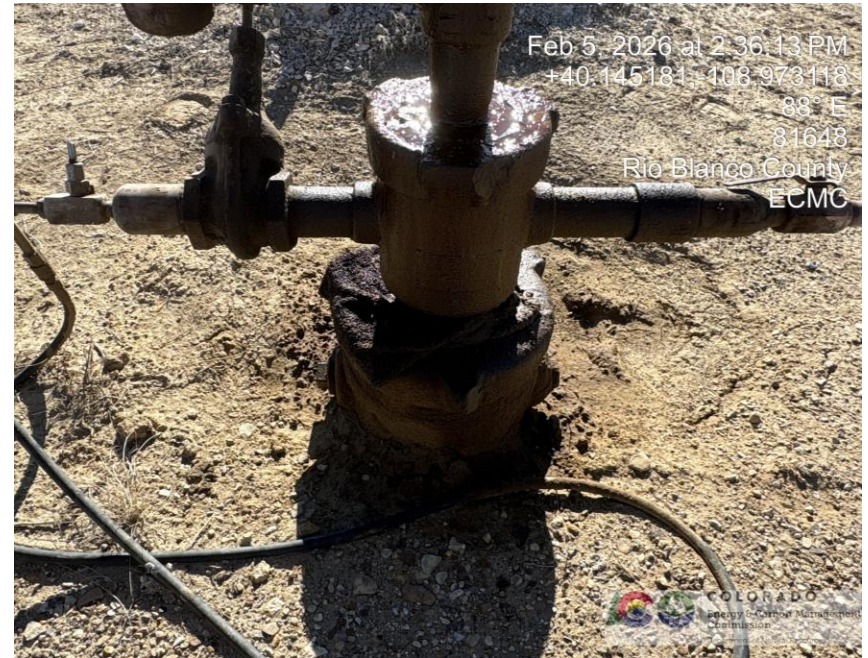
Photo # 1749 Bradenhead inaccessible

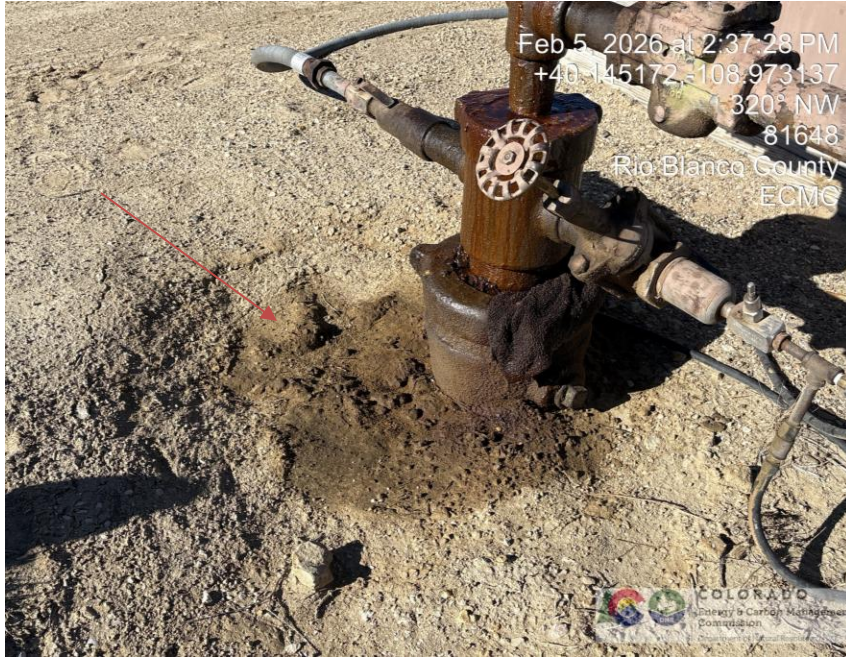
Photo # 1754 Staining

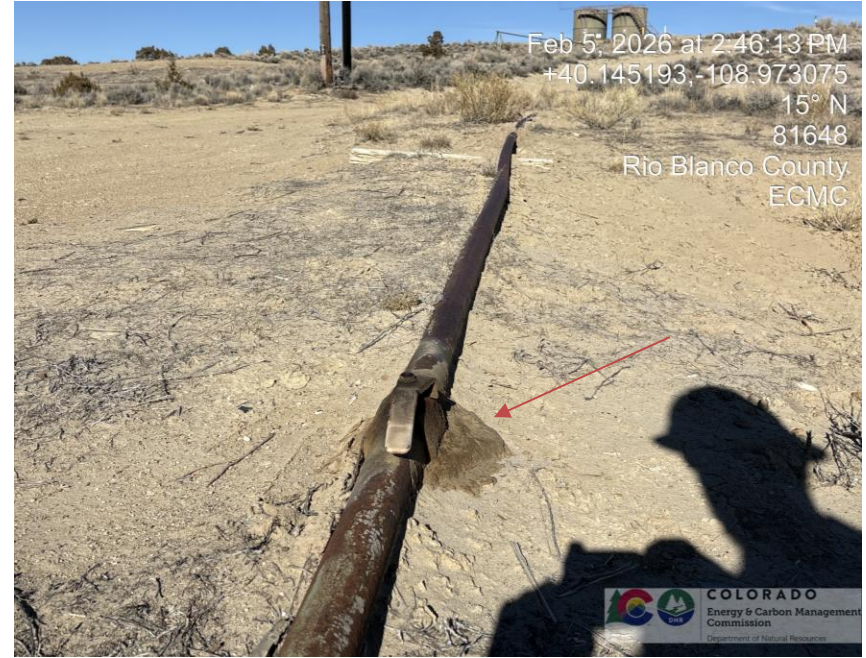
Photo # 1770 Staining

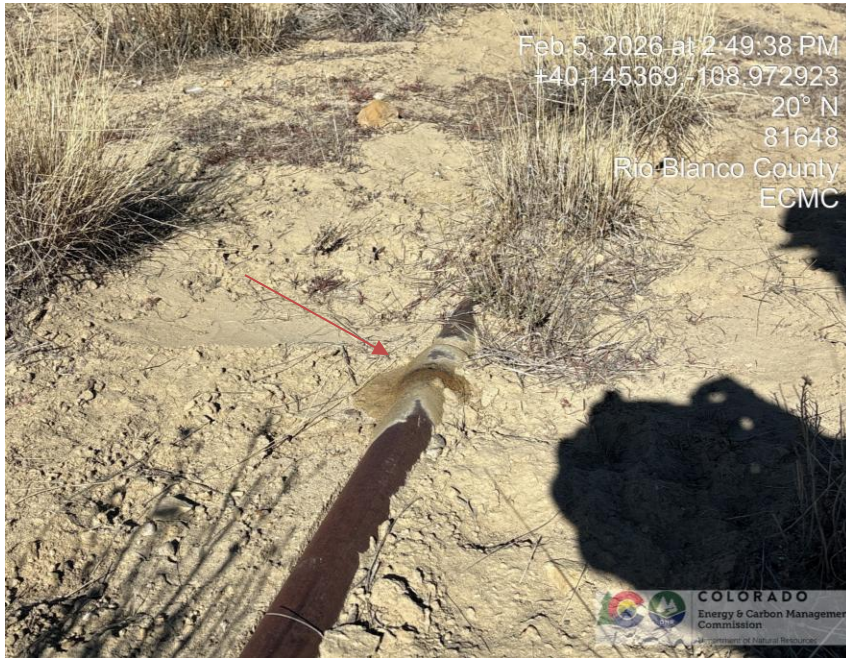
Photo # 1772 Staining/Weeds/undesirable plant species presents a potential fire hazard

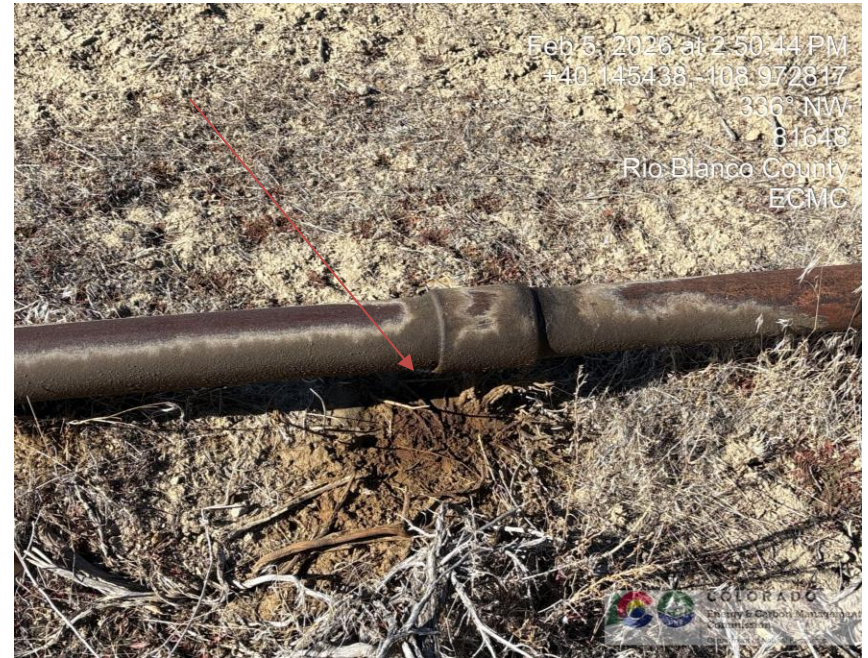
Photo # 1774 Staining/Weeds/undesirable plant species presents a potential fire hazard

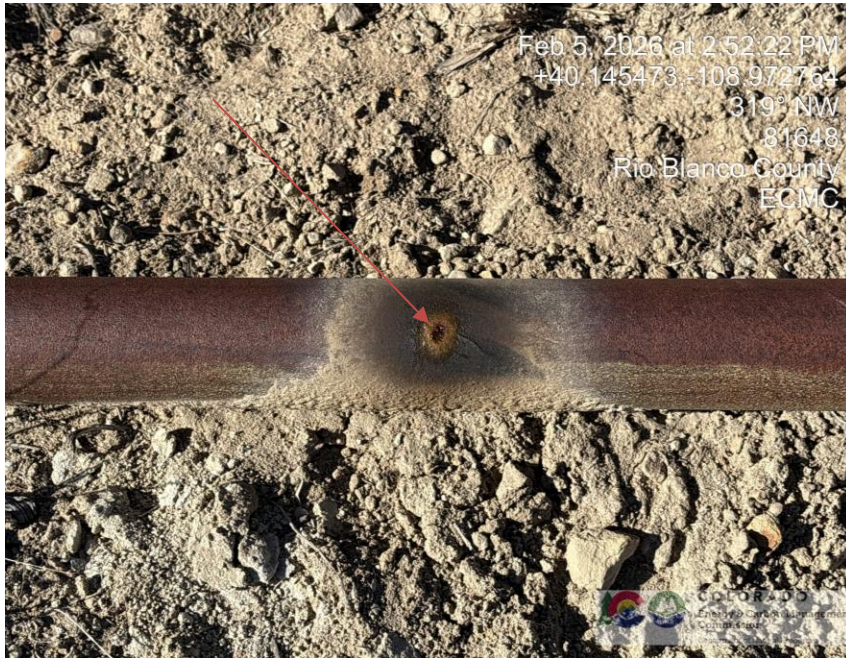
Photo # 1776 Possible flowline lacks integrity

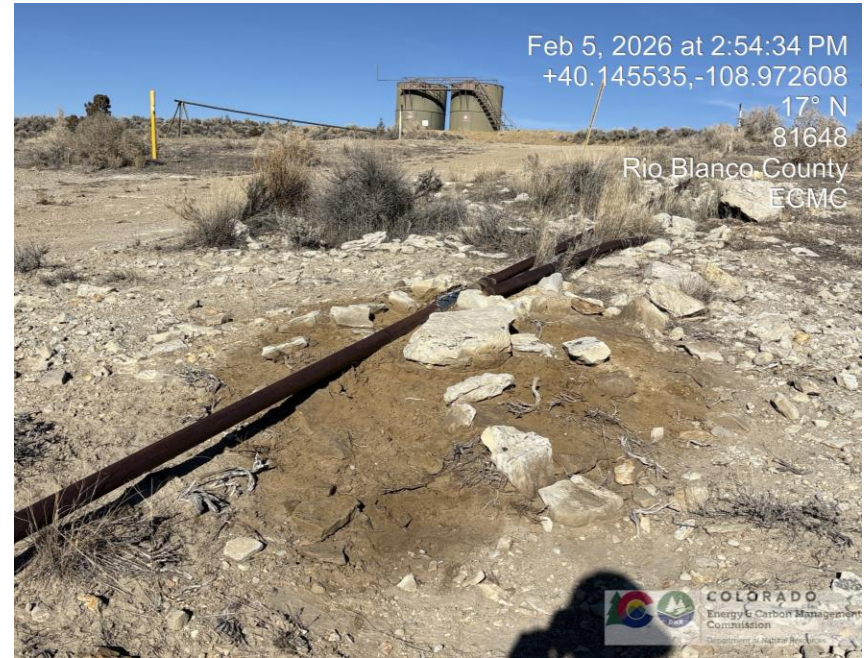
Photo # 1779 Staining/Weeds/undesirable plant species presents a potential fire hazard

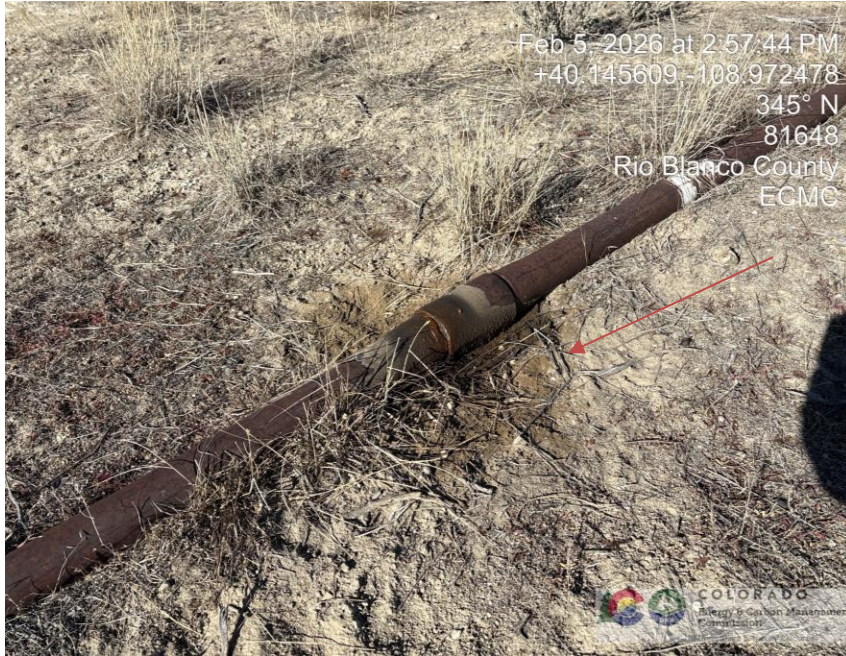
Photo # 1784 Staining/Weeds/undesirable plant species presents a potential fire hazard

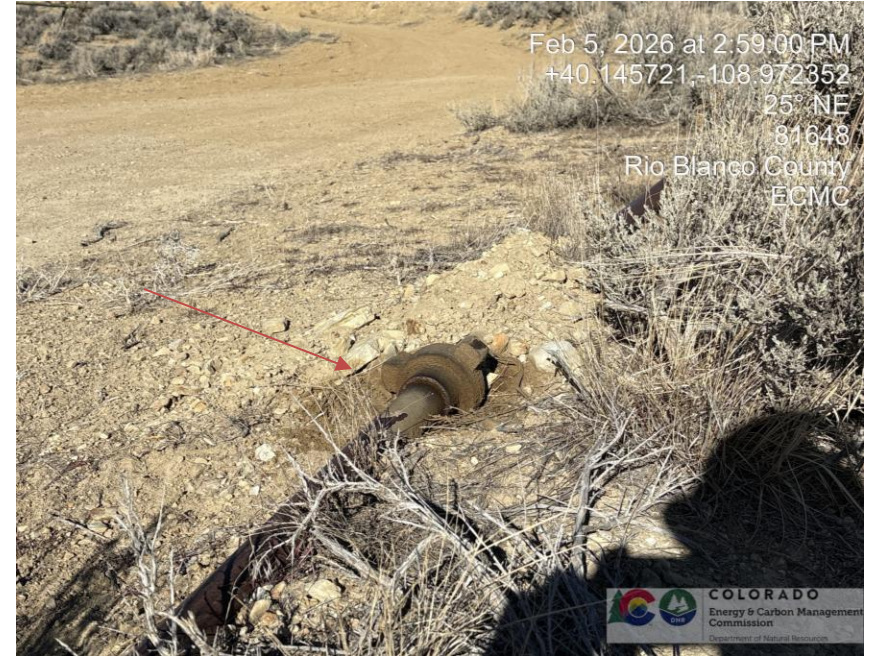
Photo # 1785 Staining/Weeds/undesirable plant species presents a potential fire hazard

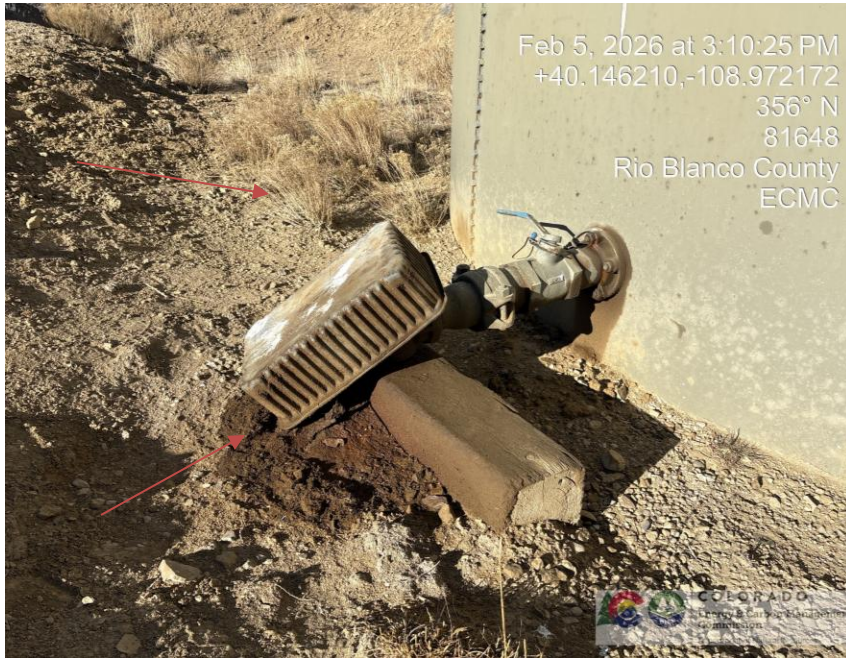
Photo # 1800 Staining/Weeds/undesirable plant species presents a potential fire hazard

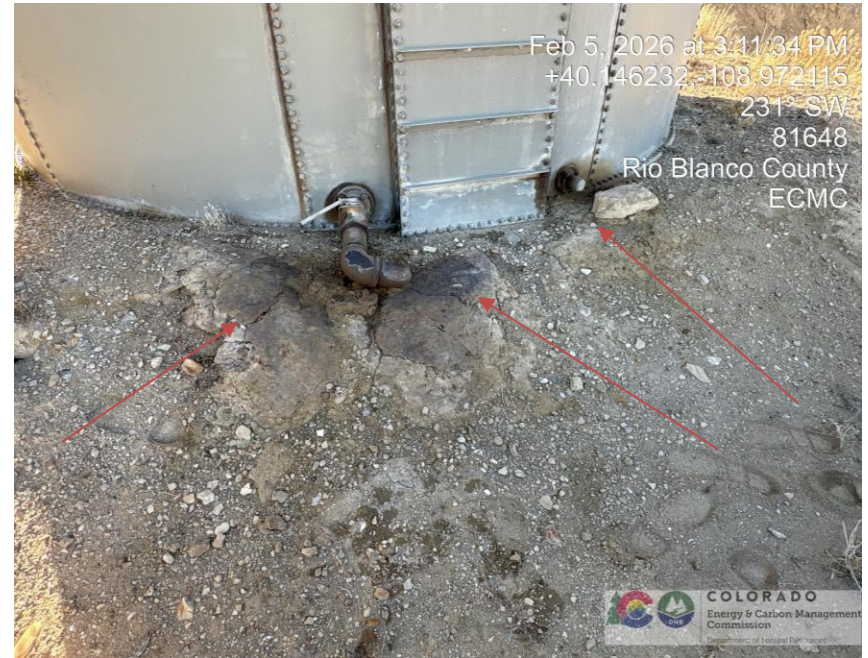
Photo # 1803 Staining

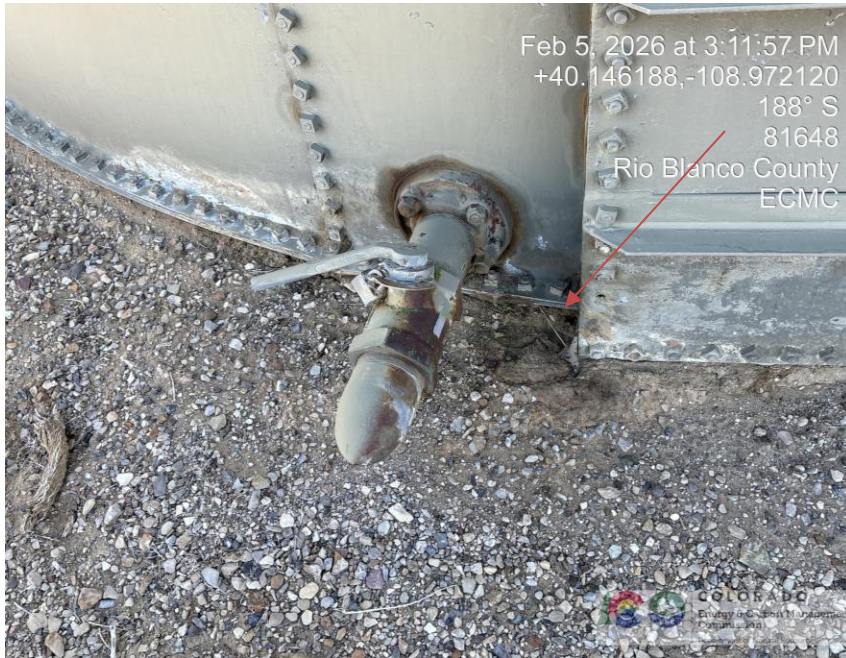
Photo # 1805 Staining

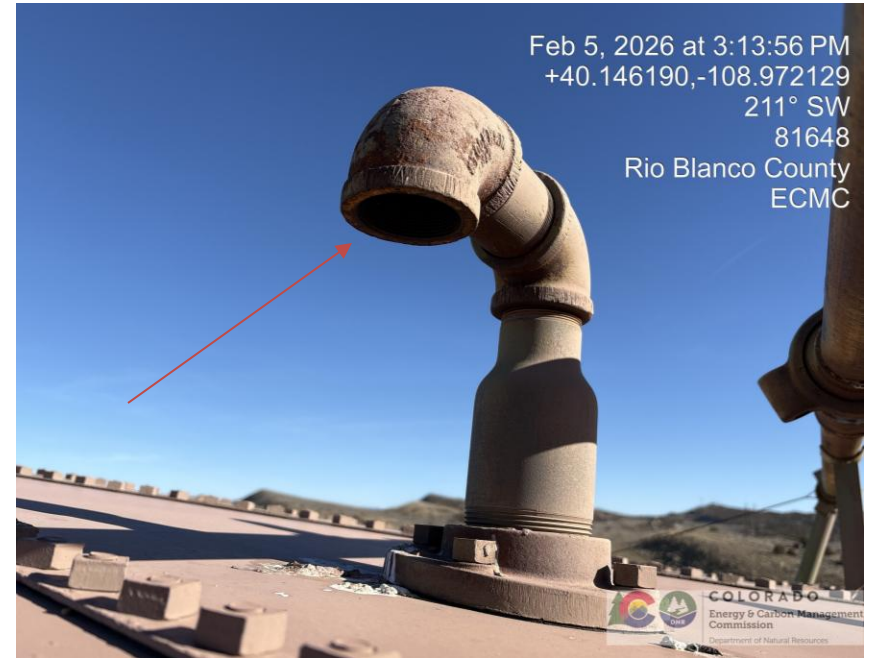
Photo # 1808 Open ended piping/wildlife hazard/available for entry by wildlife

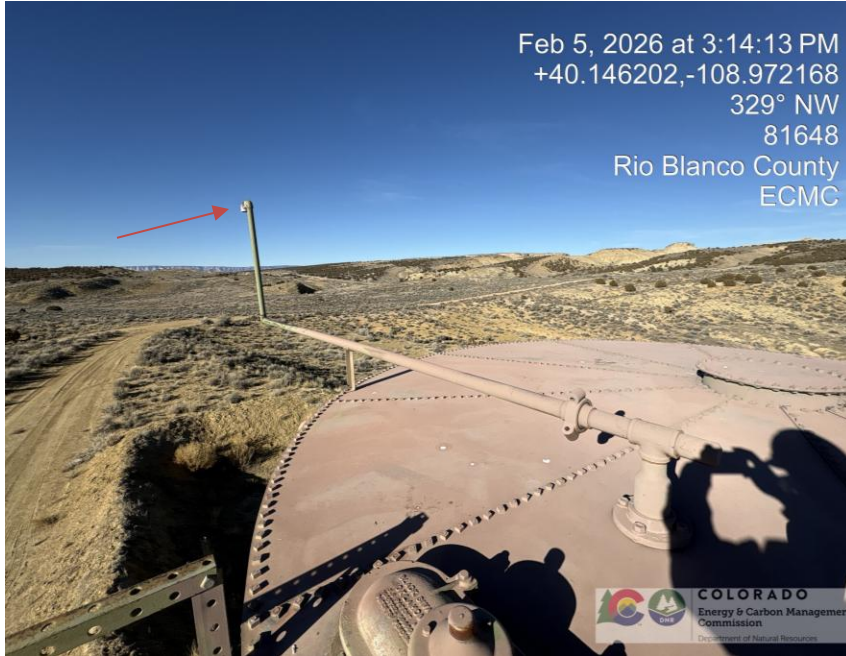
Photo # 1810 Open ended piping/wildlife hazard/available for entry by wildlife

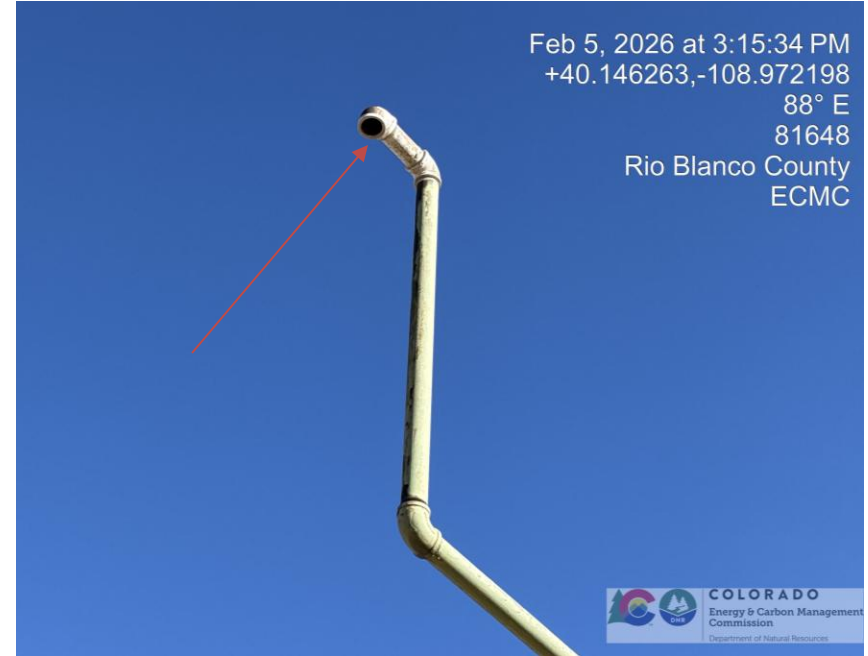
Photo # 1813 Open ended piping/wildlife hazard/available for entry by wildlife

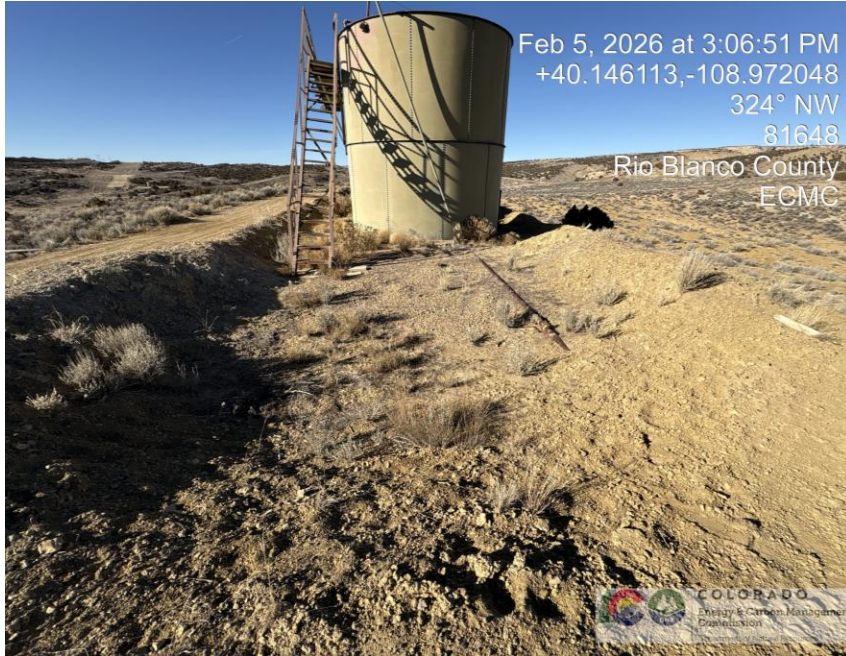
Photo # 1794 Weeds/undesirable plant species presents a potential fire hazard

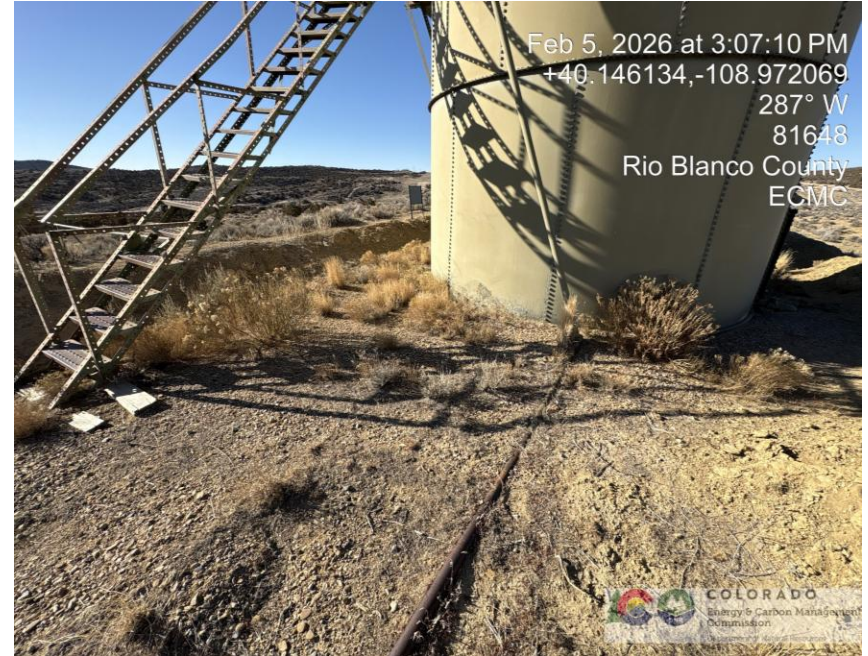
Photo # 1795 Weeds/undesirable plant species presents a potential fire hazard

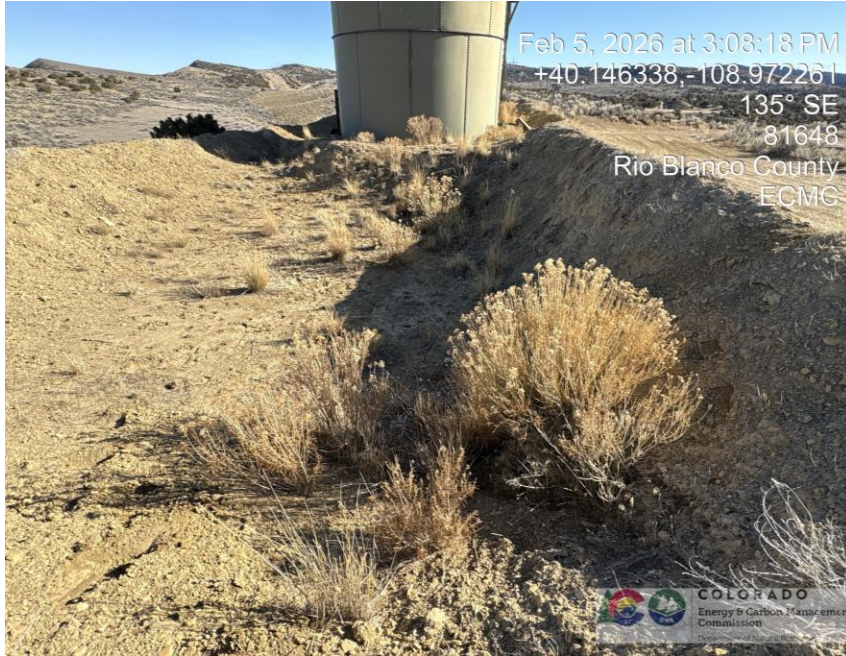
Photo # 1796 Weeds/undesirable plant species presents a potential fire hazard

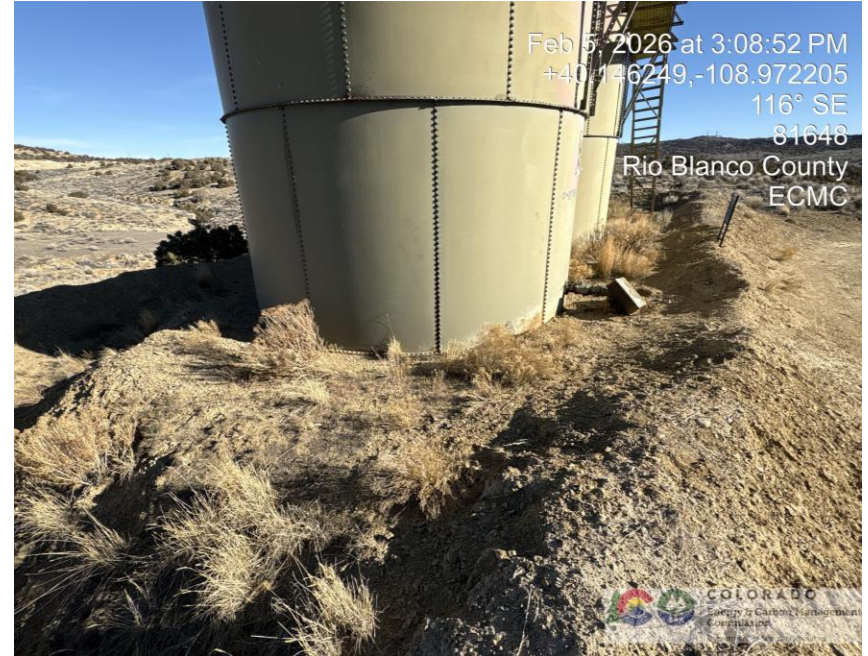
Photo # 1798 Weeds/undesirable plant species presents a potential fire hazard

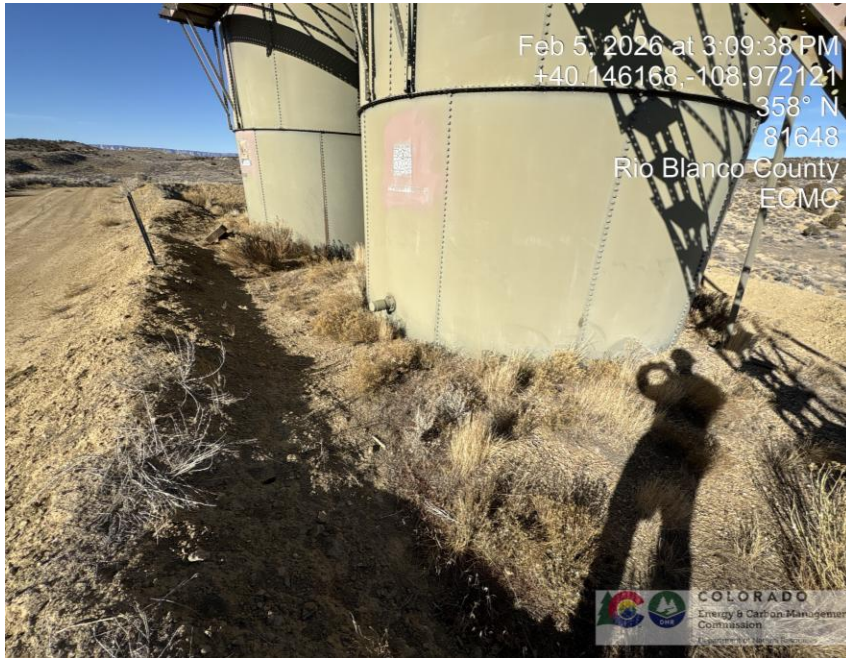
Photo # 1799 Weeds/undesirable plant species presents a potential fire hazard

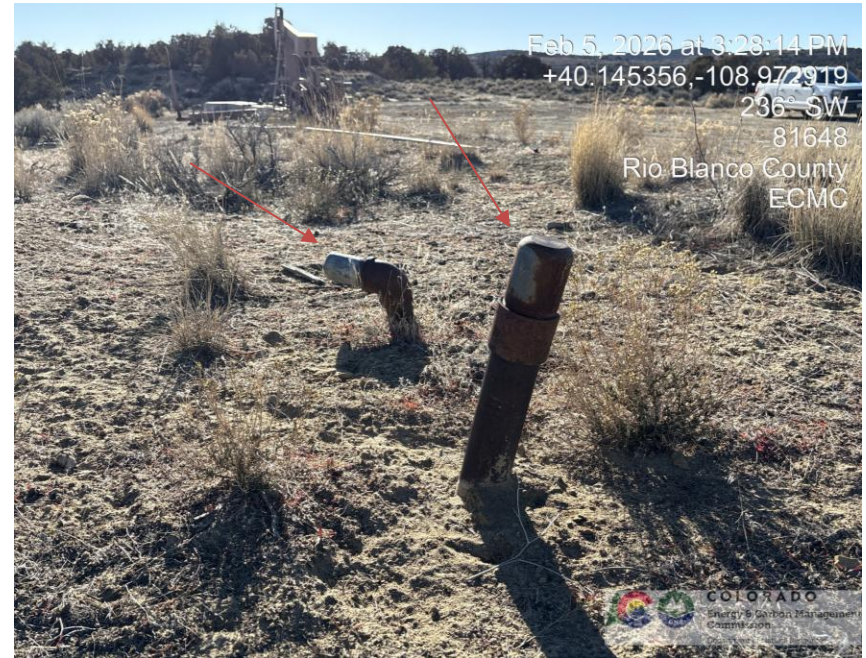
Photo # 1827 Unused flowlines lack lockout tagout (OOSLAT)

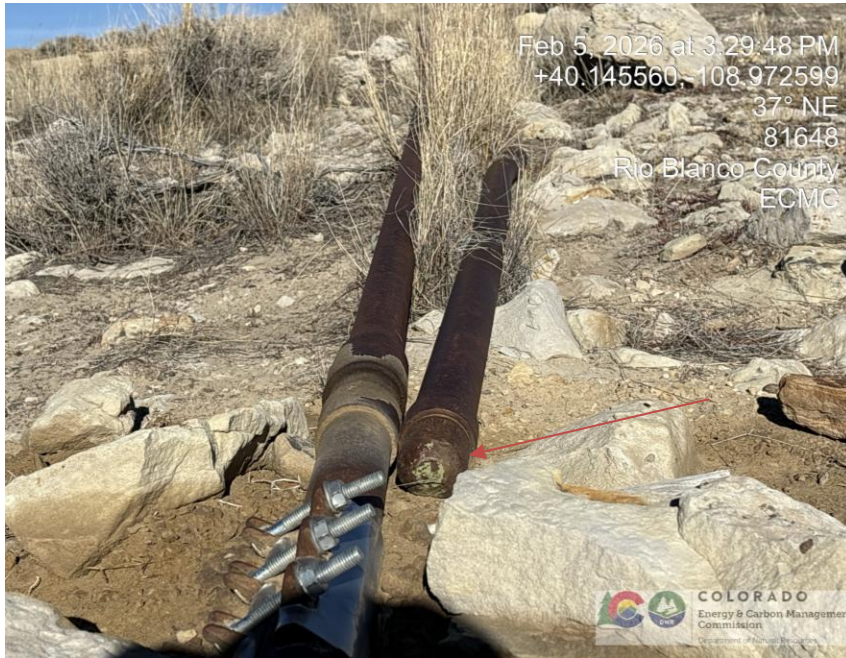
Photo # 1829 Unused flowline lacks lockout tagout (OOSLAT)

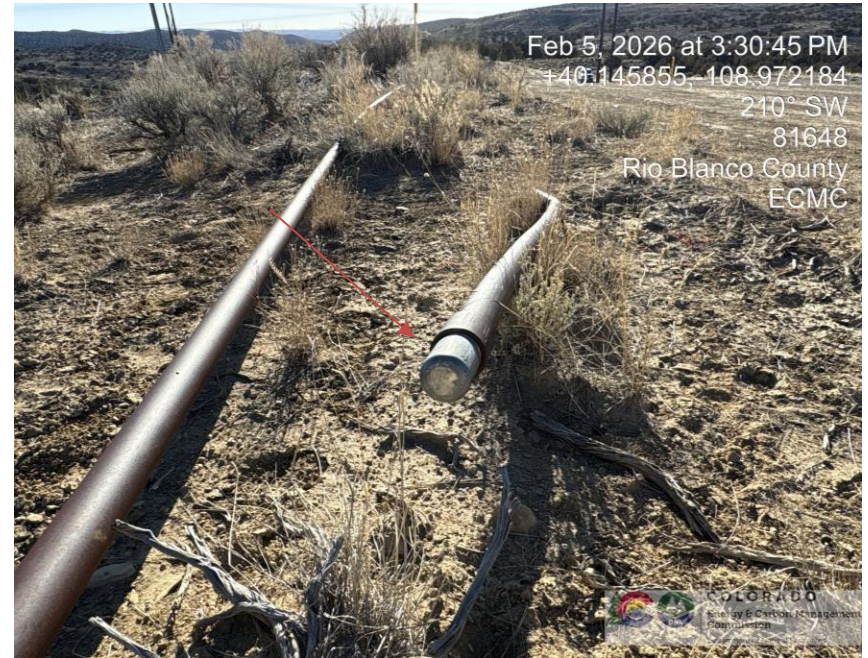
Photo # 1830 Unused flowline lacks lockout tagout (OOSLAT)

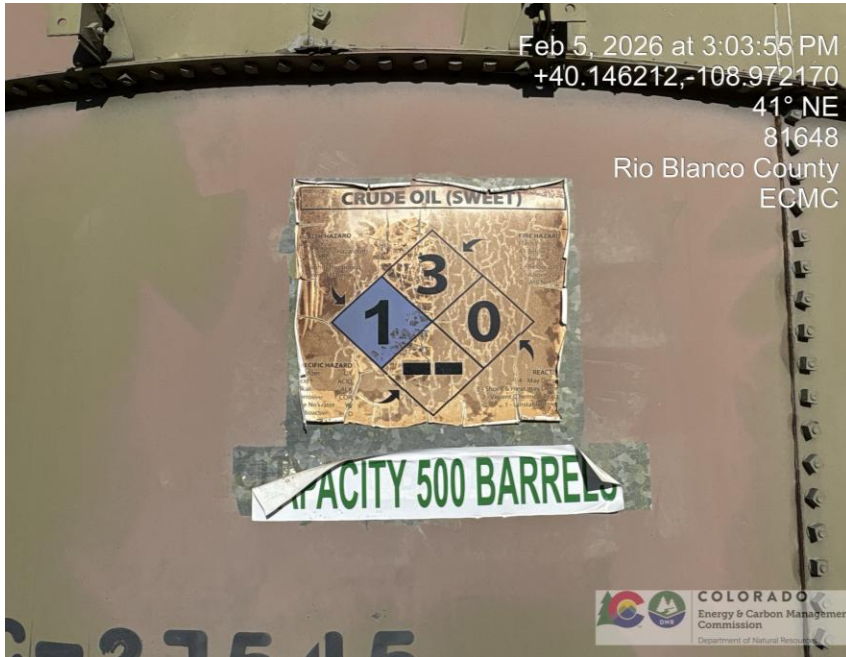
Photo # 1790 Production tank labels not legible & lack required labeling/not in compliance with CECMC rules

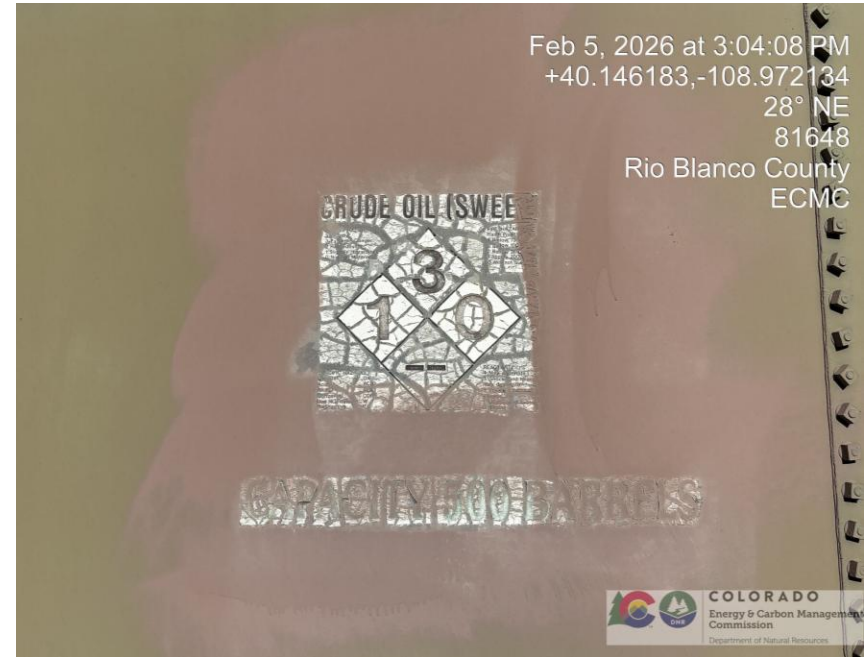
Photo # 1791 Production tank labels not legible & lack required labeling/not in compliance with CECMC rules

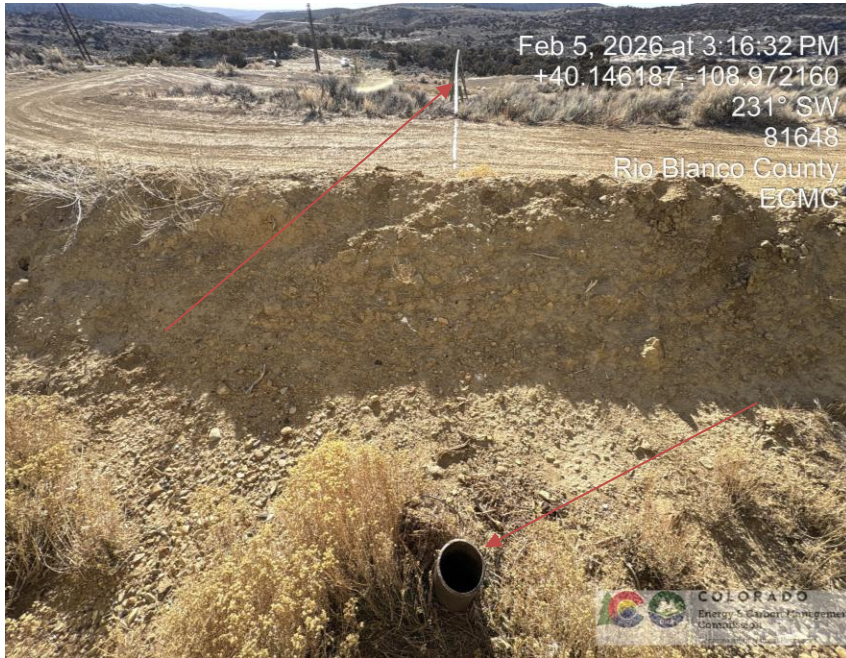
Photo # 1815 Unused unload line near tank battery not necessary for use on location

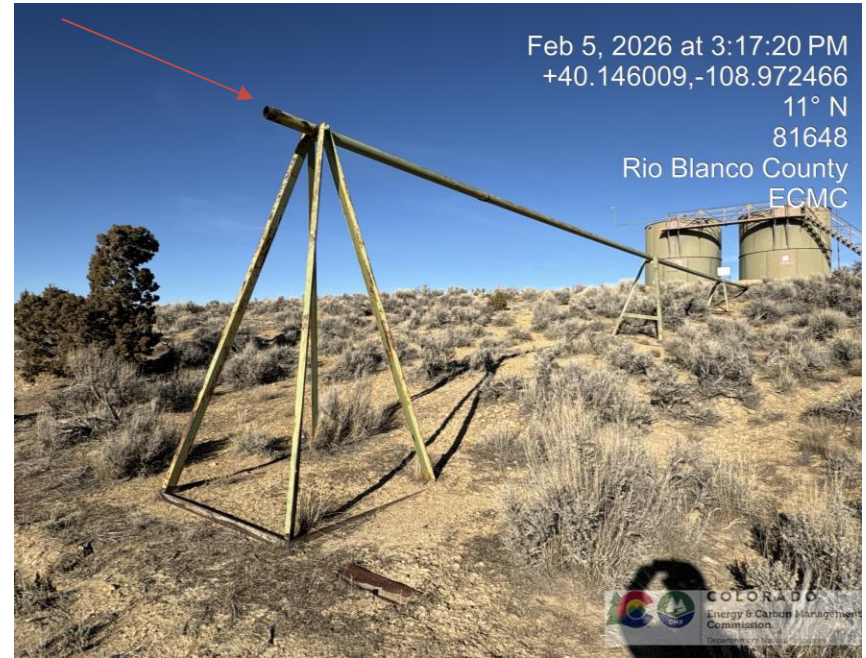
Photo # 1816 Unused unload line near tank battery not necessary for use on location

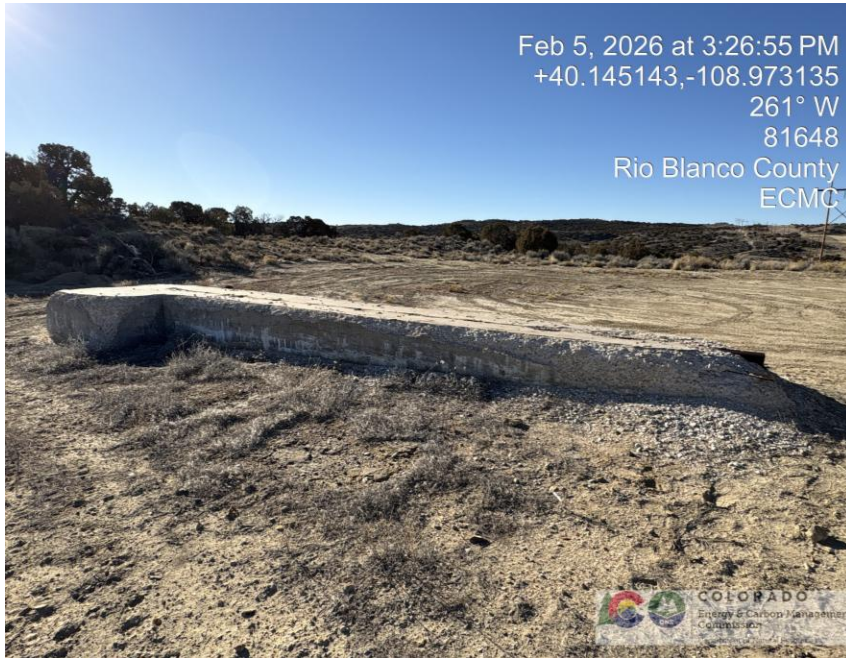
Photo # 1825 Debris

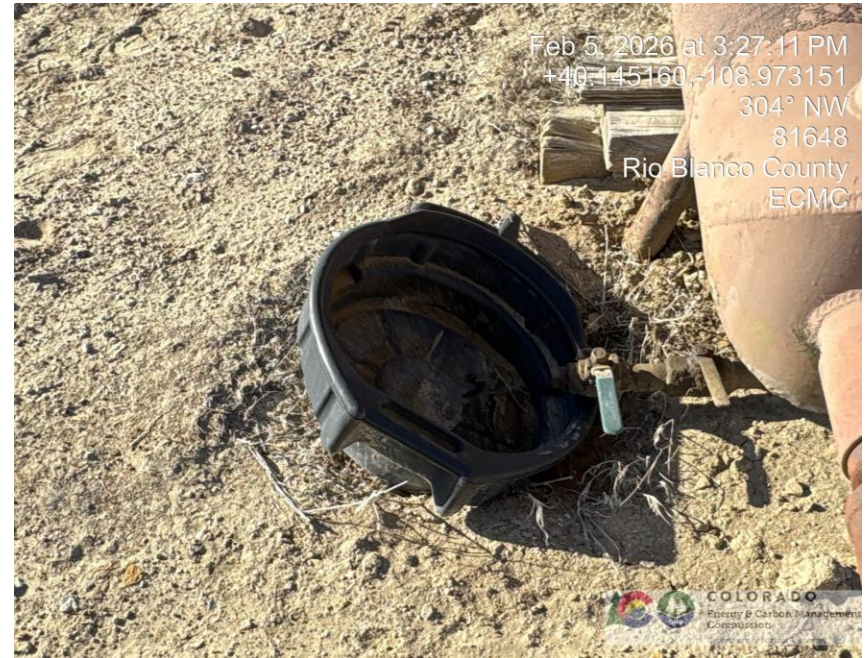
Photo # 1826 Debris

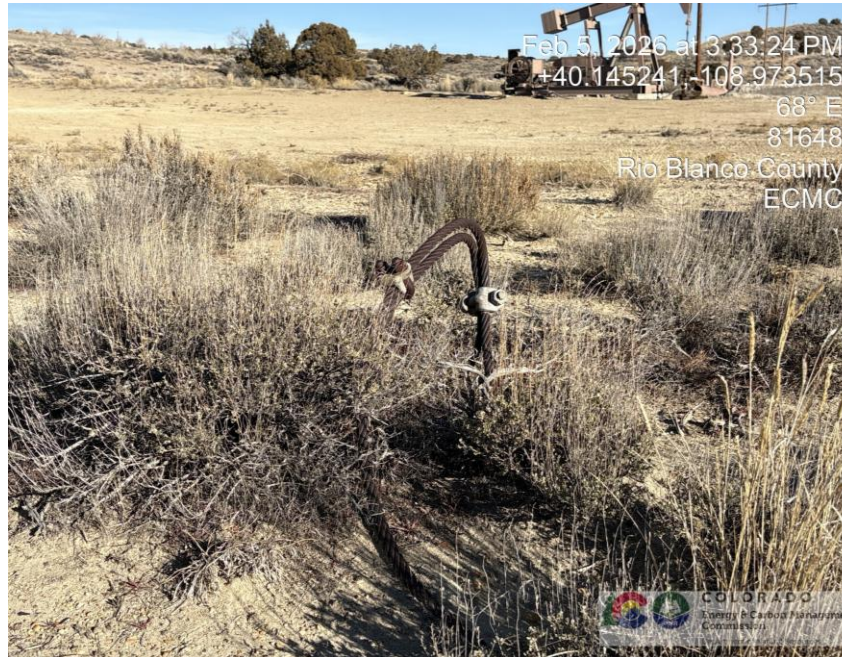
Photo # 1838 Unmarked deadman
