Inspection Photos  
Location Name: Facility 5 @ 42 Pan Am E  
Spill ID: 488117

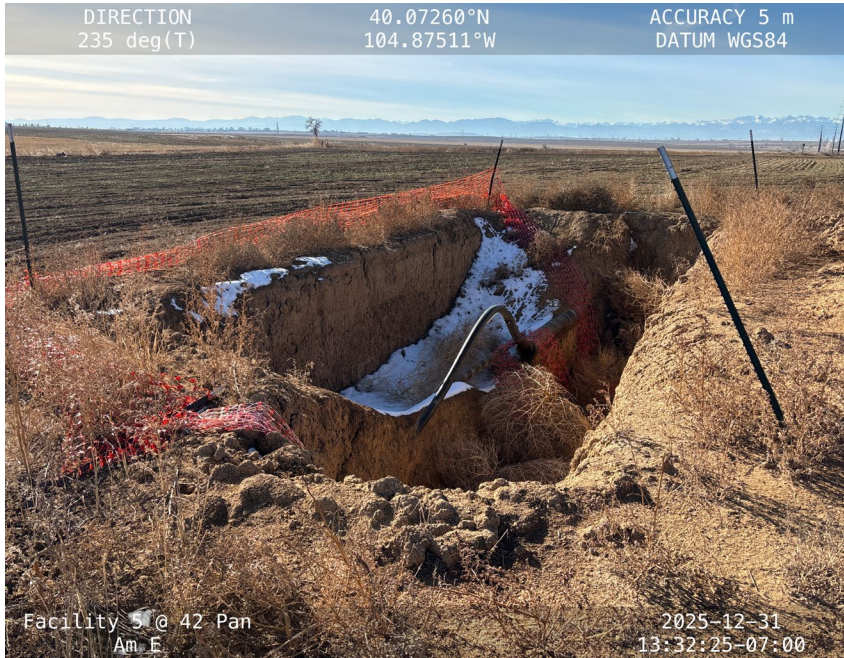
Excavation. Torn fencing, weeds

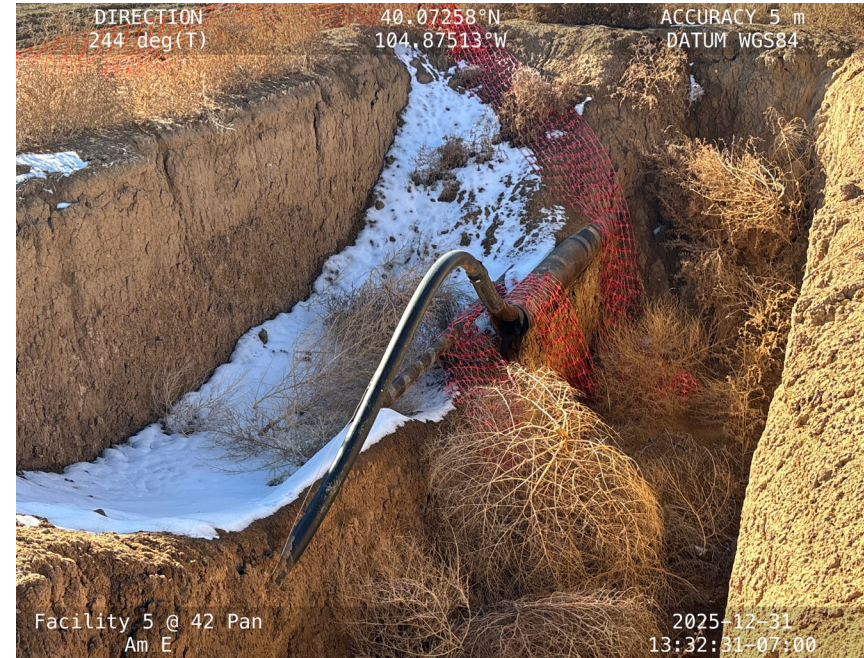
Excavation. Torn fencing, weeds

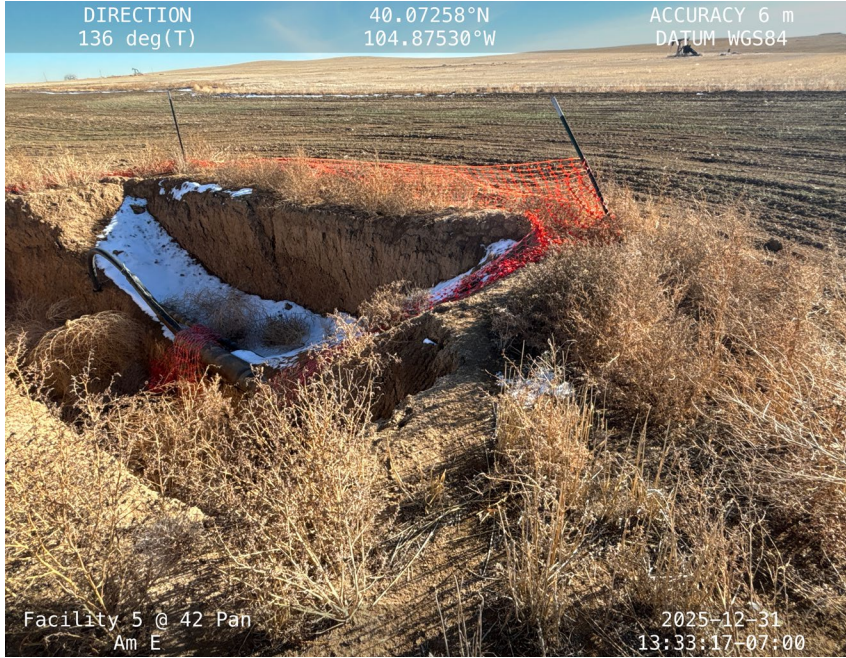
Excavation. Torn fencing, weeds

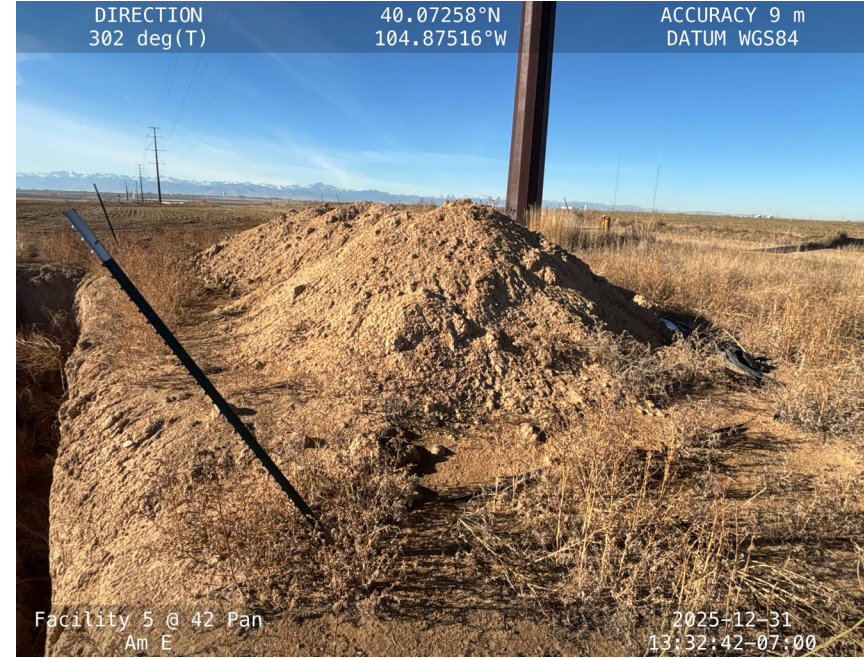
Stockpile with no stormwater BMPs

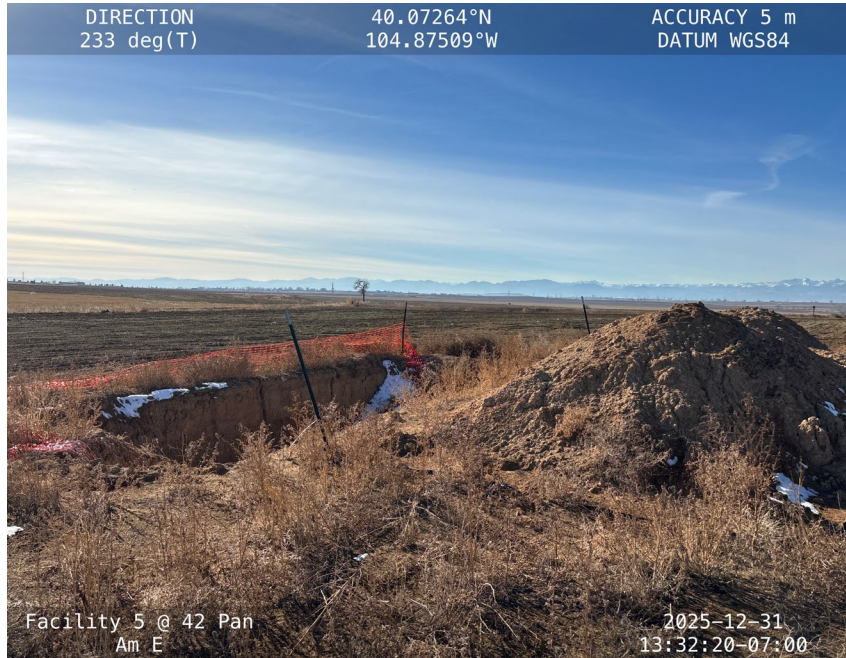
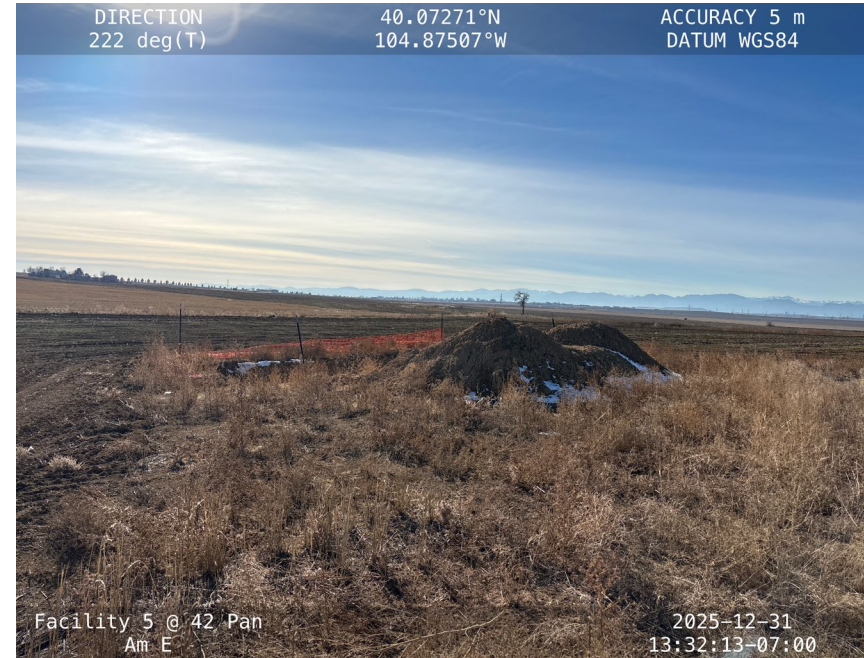
**Excavation. Torn fencing, weeds. Stockpile with no stormwater BMPs**
