INSPECTION PHOTOS

Well: Golden Eagle 34-13

INSPECTION DOC #: 716301955

Inspection date: 2/10/2026

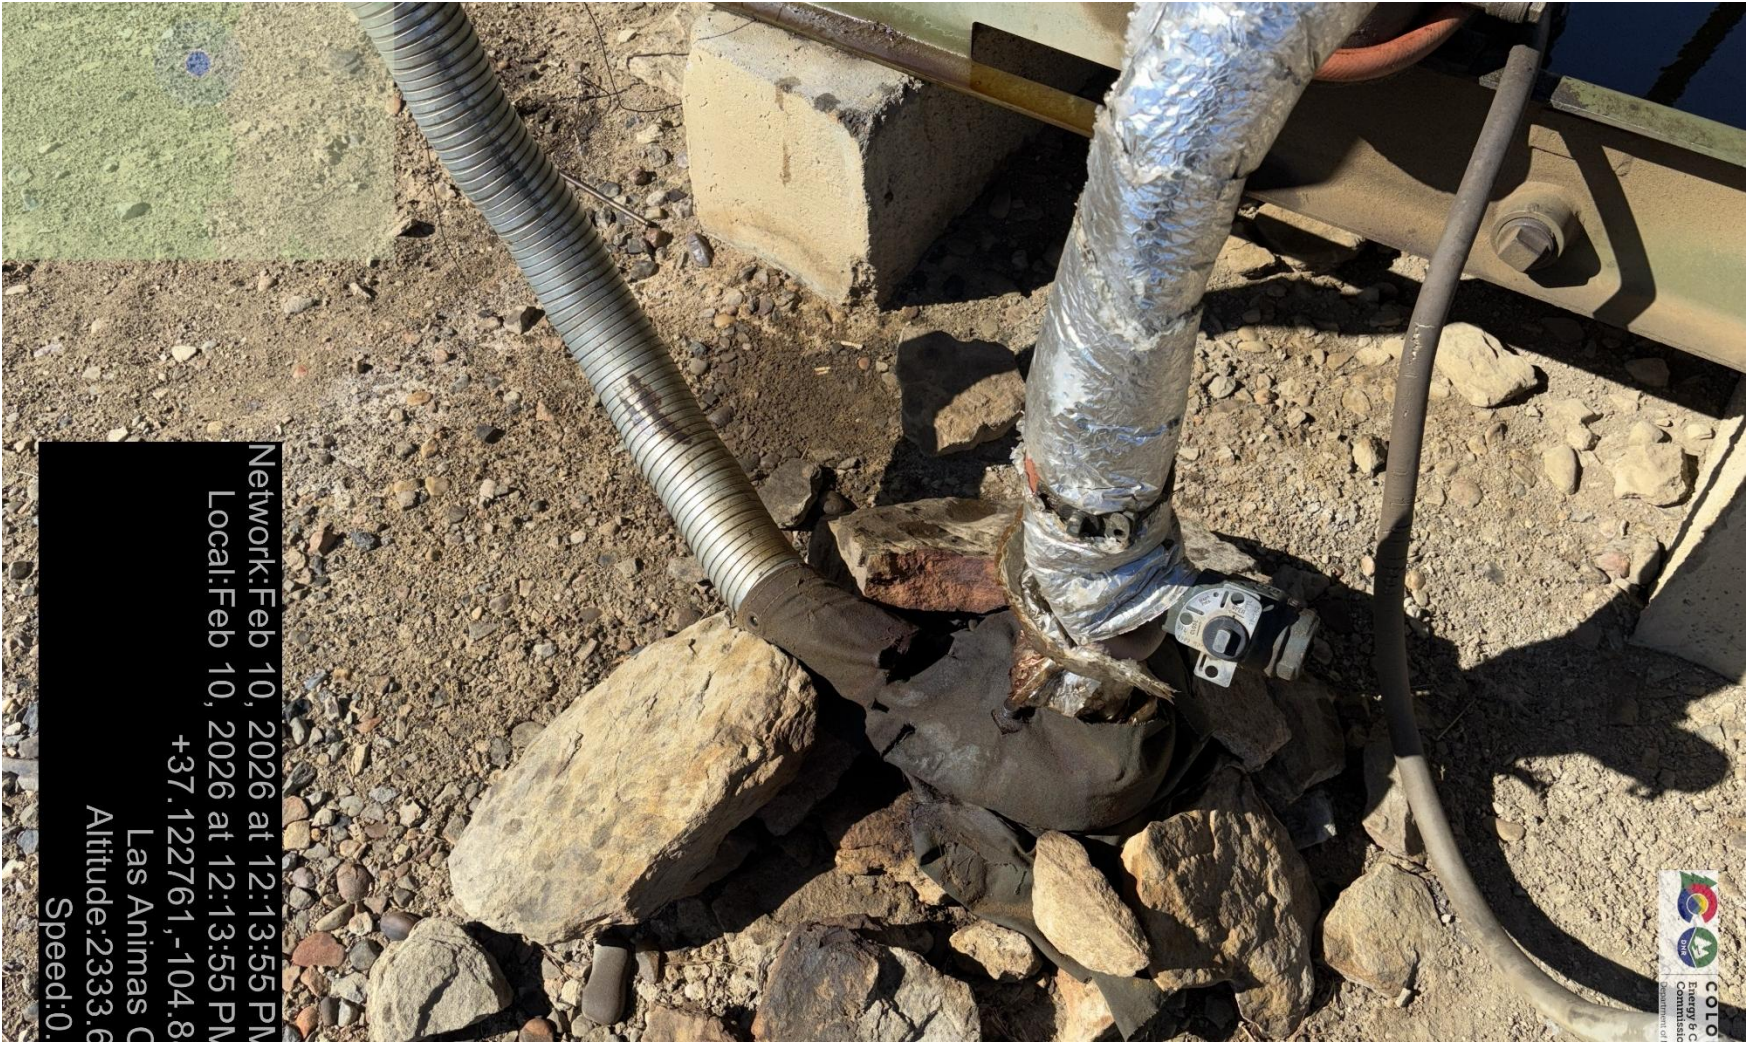
PHOTO 4: area of impacted soil near wellhead appears to be from leaking hydraulic hoses. Conduct maintenance on equipment, cleanup stained material and review self inspection processes. COMPLY WITH RULE 1002,(2).D. ca date 2/23/2026.

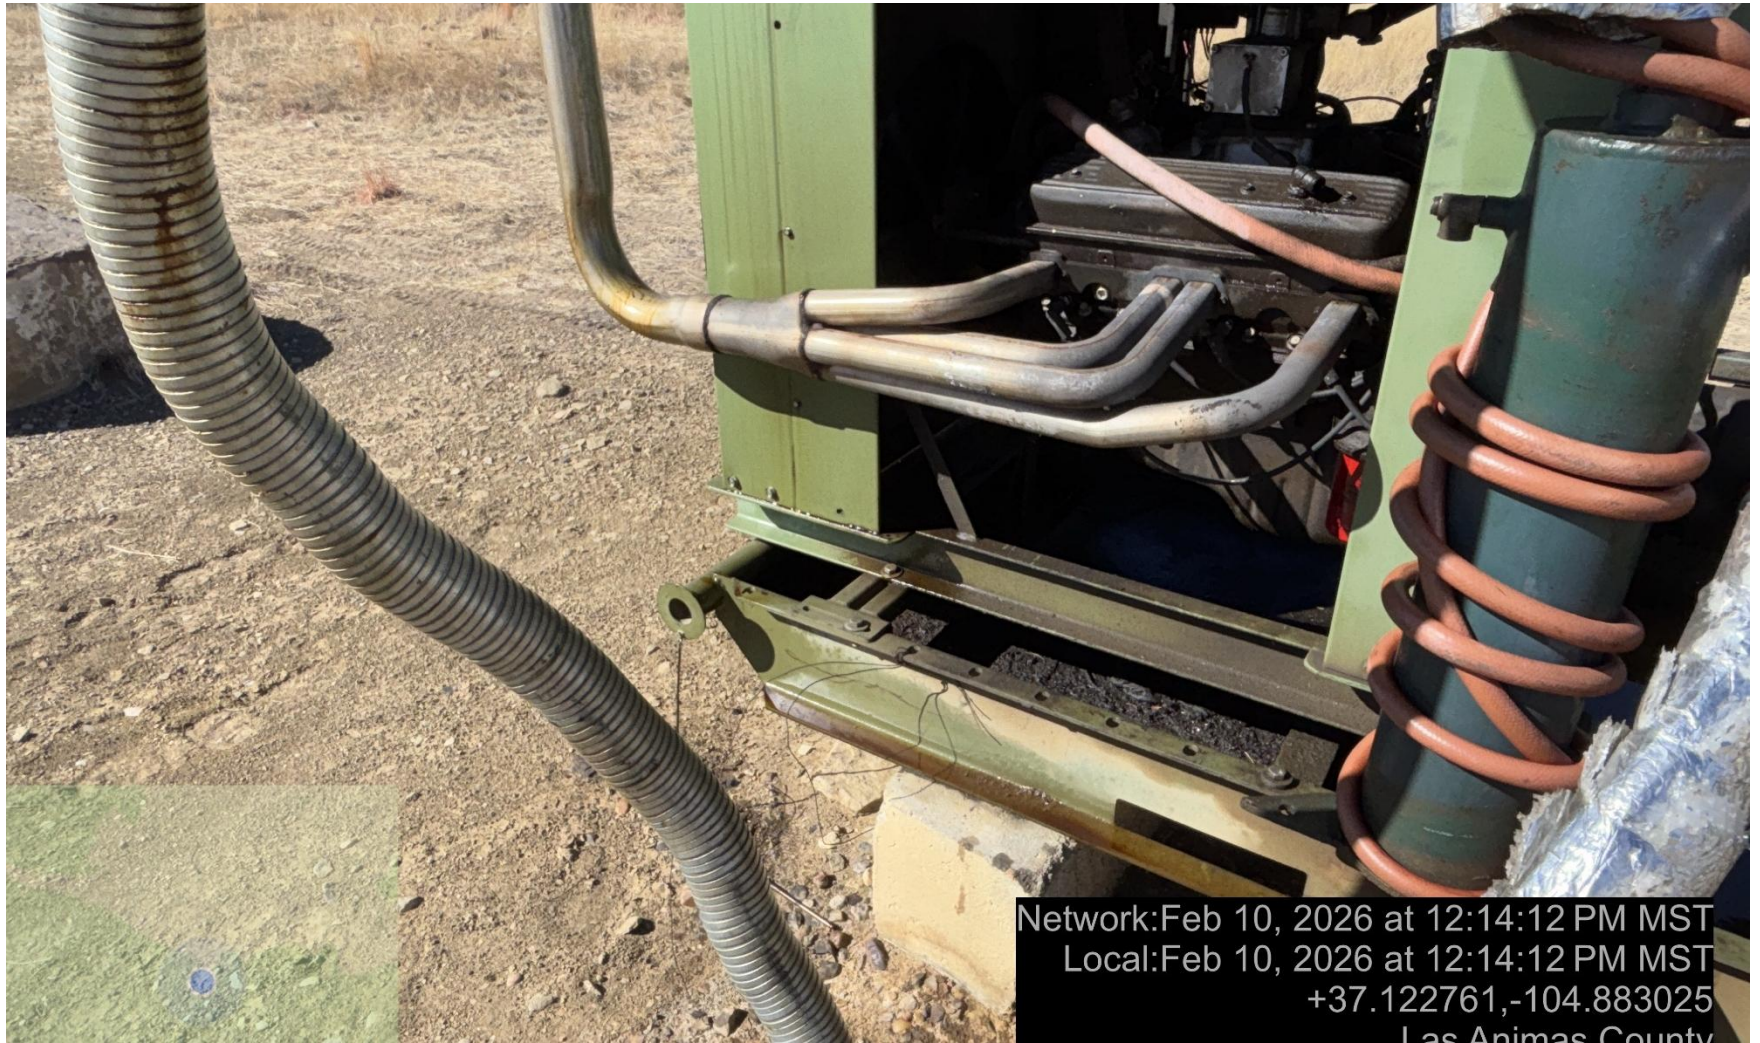
PHOTO 5: area of impacted soil near prime mover skid appears to be used oil leaking out of exhaust. Conduct maintenance on equipment, cleanup stained material and review self inspection processes. COMPLY WITH RULE 1002,(2).D. ca date 2/23/2026.

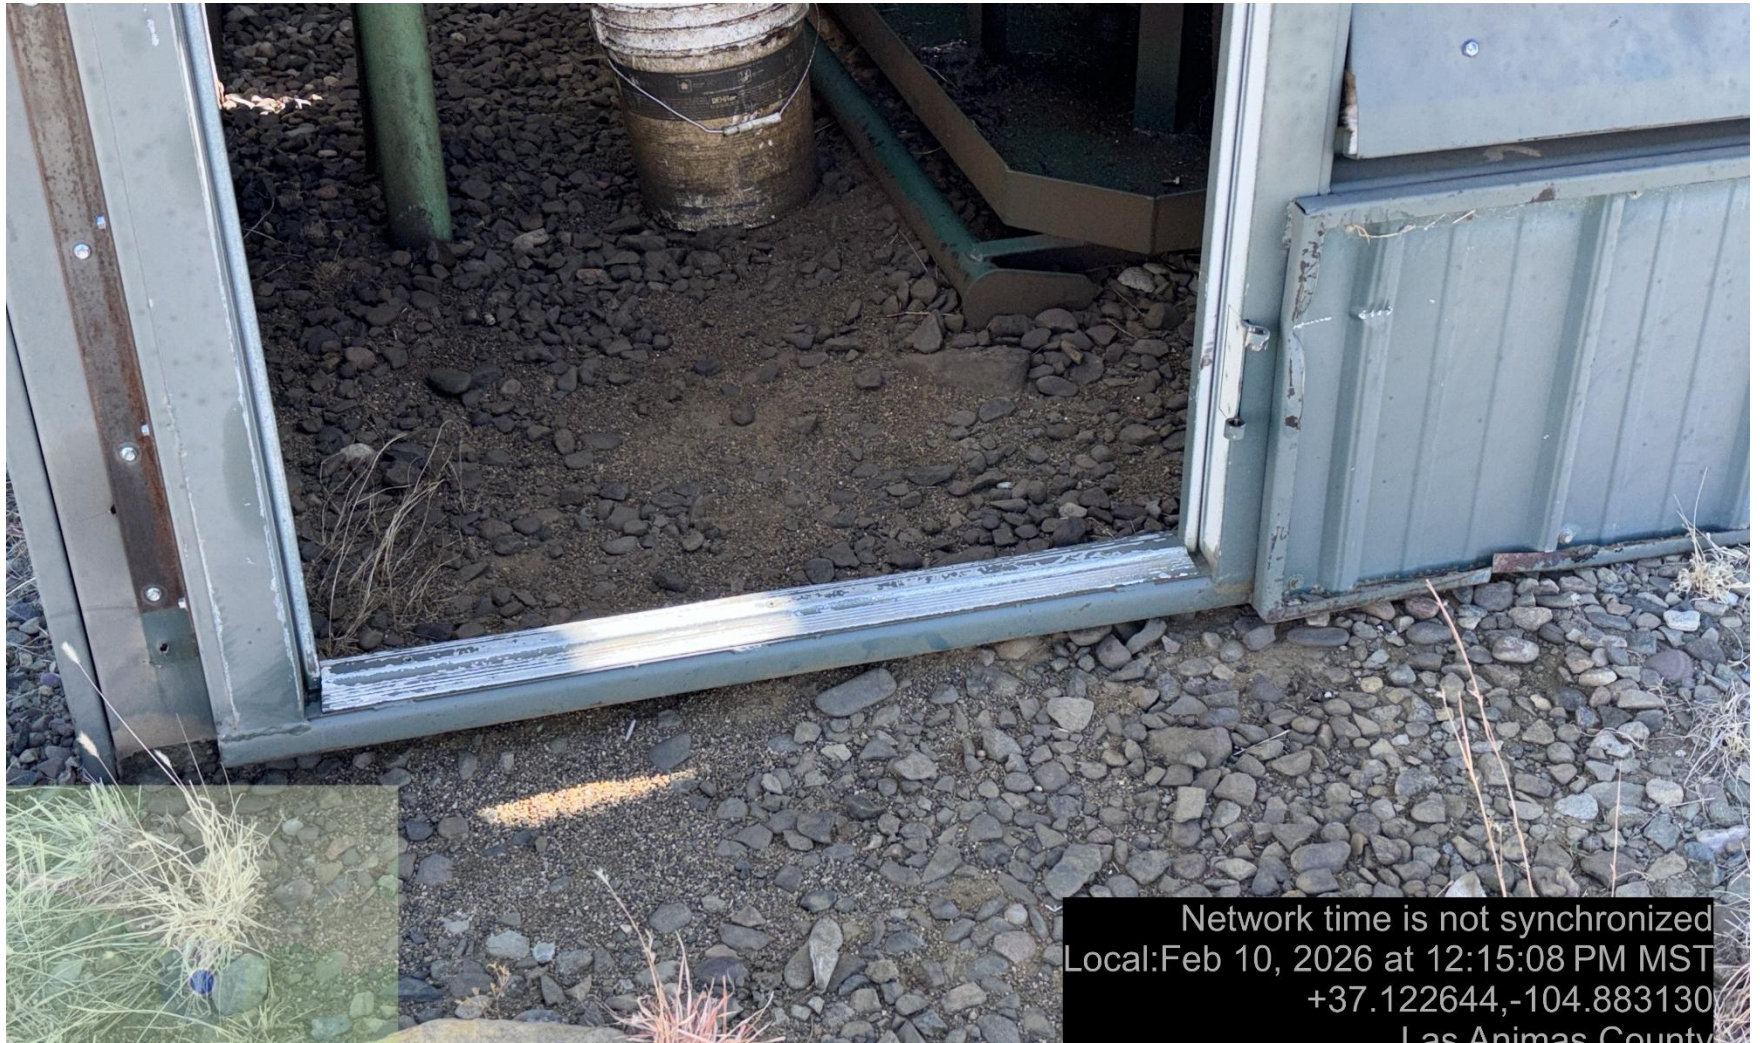
PHOTO 6: area of impacted soil near prime mover skid appears to be used oil leaking out of exhaust. Conduct maintenance on equipment, cleanup stained material and review self inspection processes. COMPLY WITH RULE 1002,(2).D. ca date 2/23/2026.

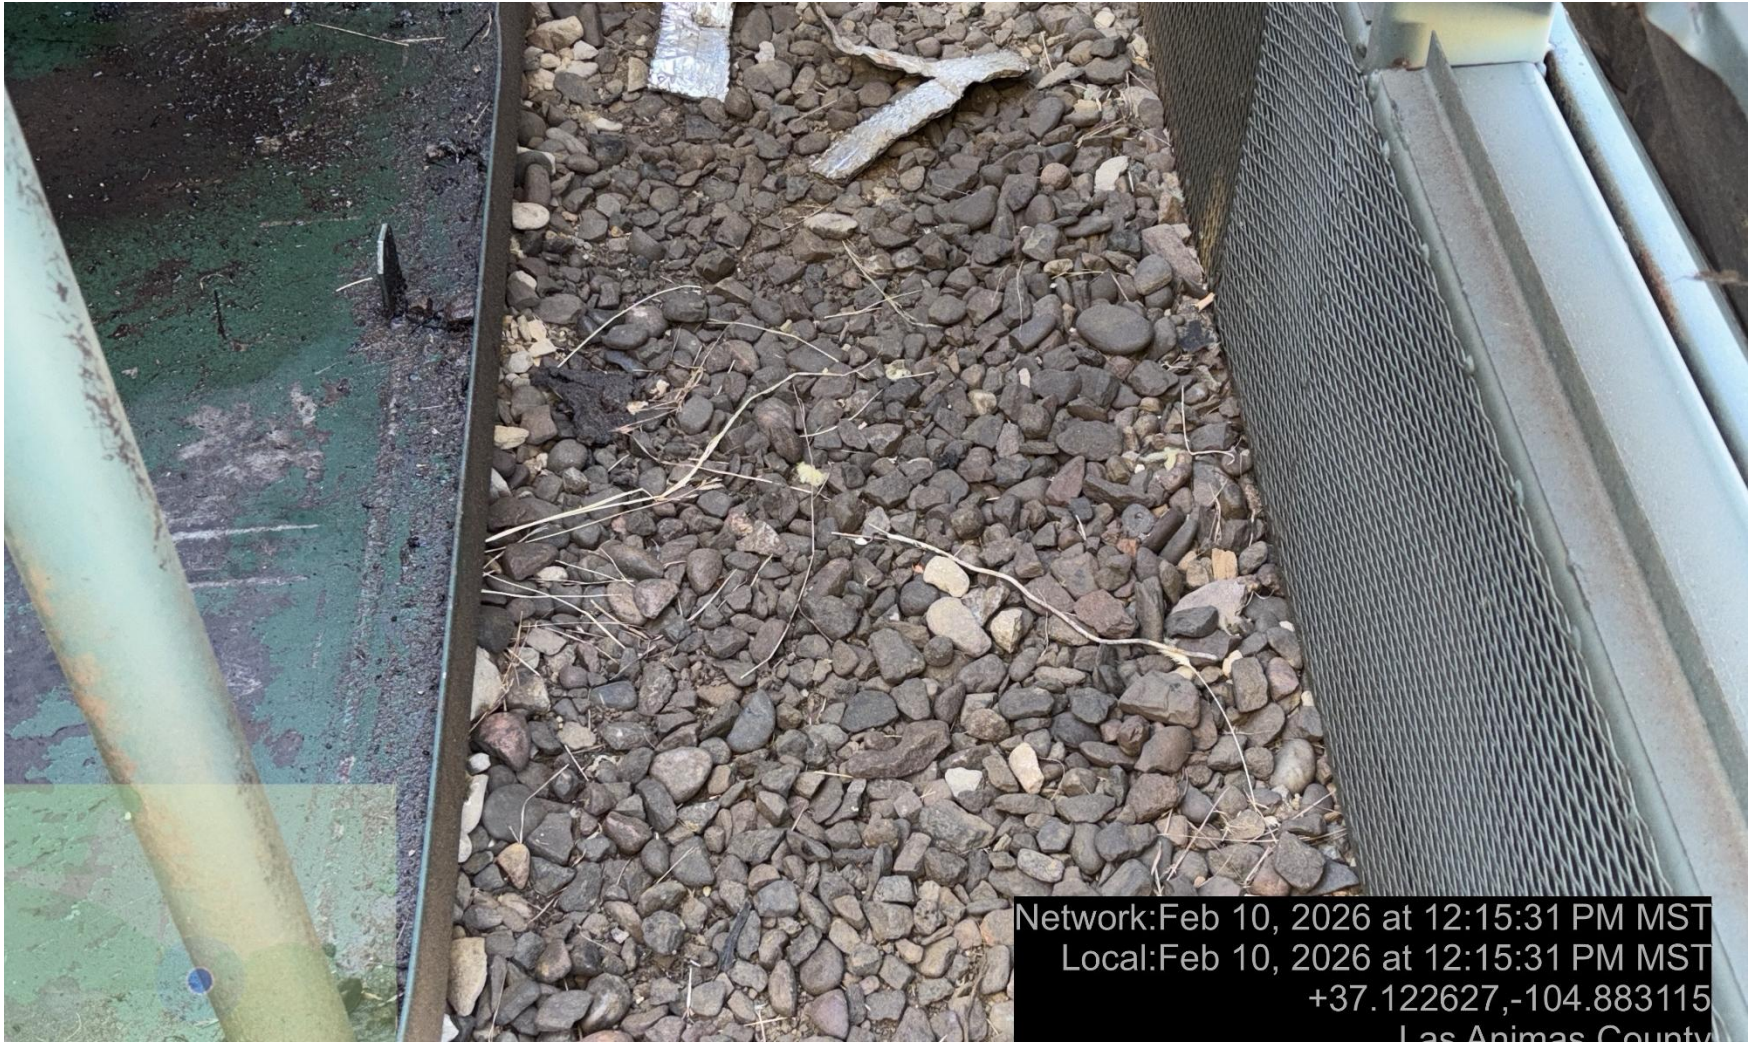
PHOTO 7: area of impacted soil near compressor appears to be from leaking equipment over an extended period of time. Conduct maintenance on equipment, cleanup stained material and review self inspection processes. COMPLY WITH RULE 1002,(2).D. ca date 2/23/2026.

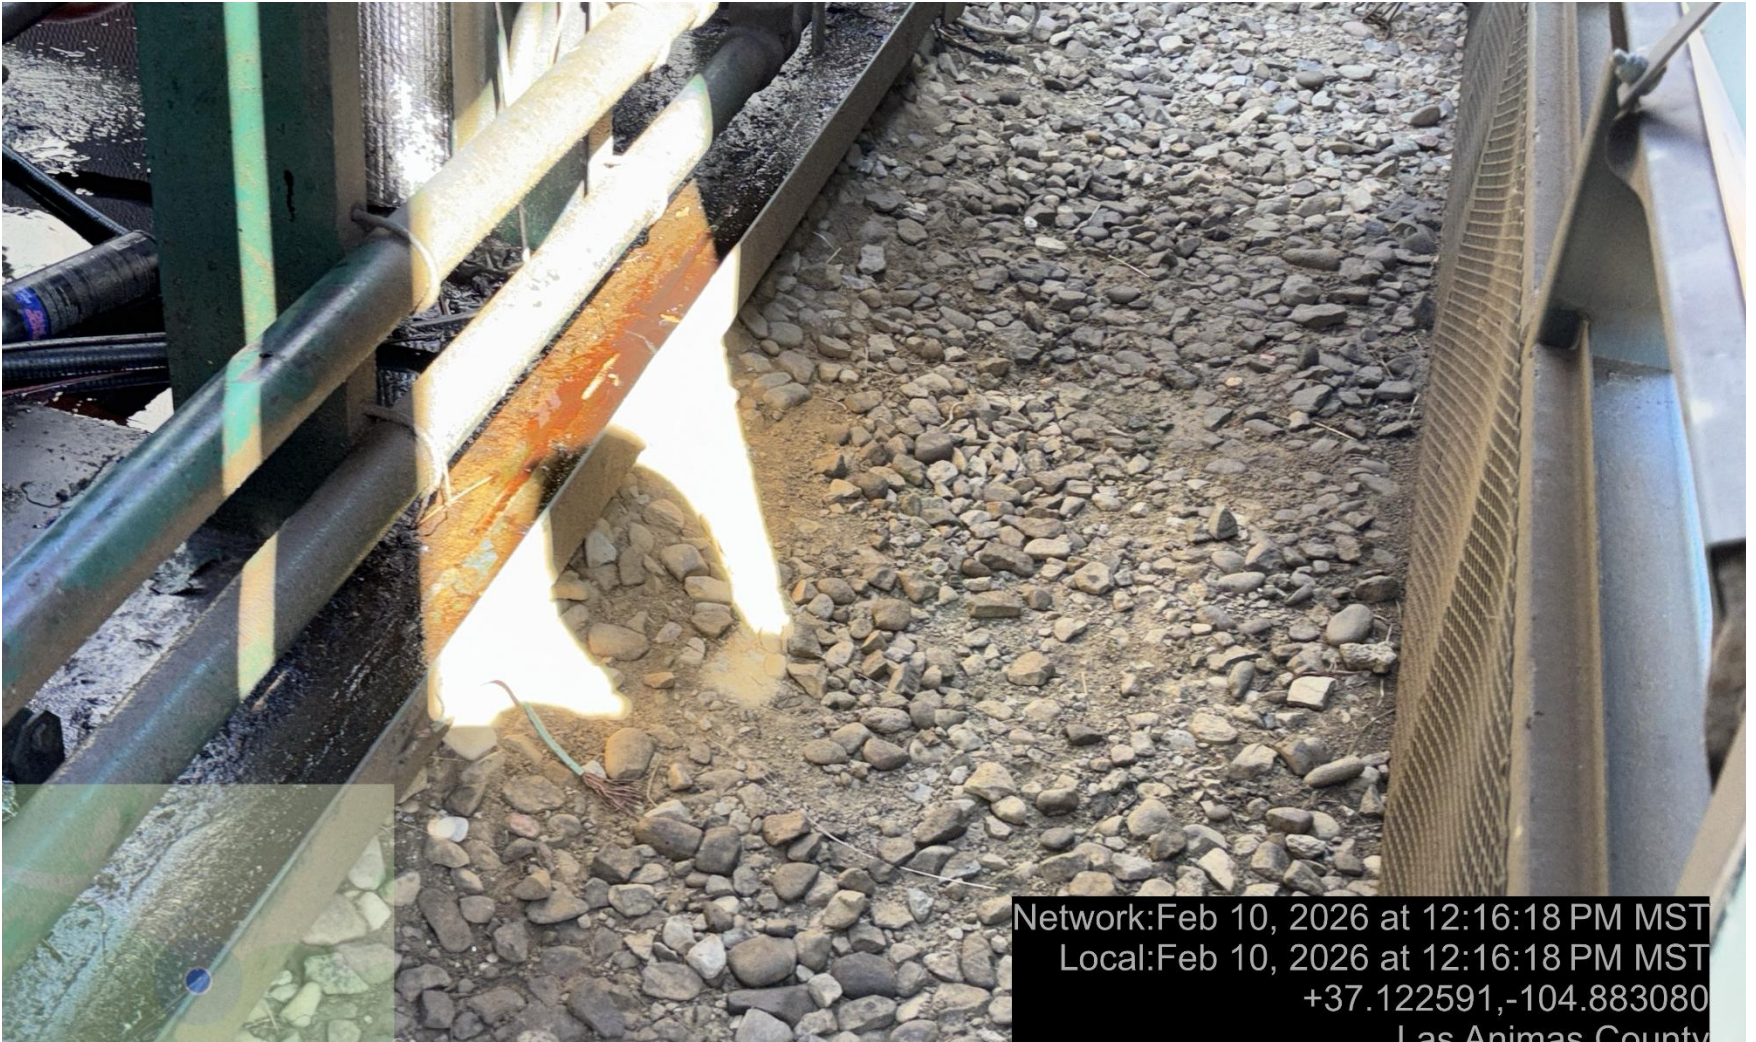
PHOTO 8: area of impacted soil near compressor appears to be from leaking equipment over an extended period of time. **Conduct maintenance on equipment, cleanup stained material and review self inspection processes. COMPLY WITH RULE 102,.(2).D. ca date 2/23/2026.**

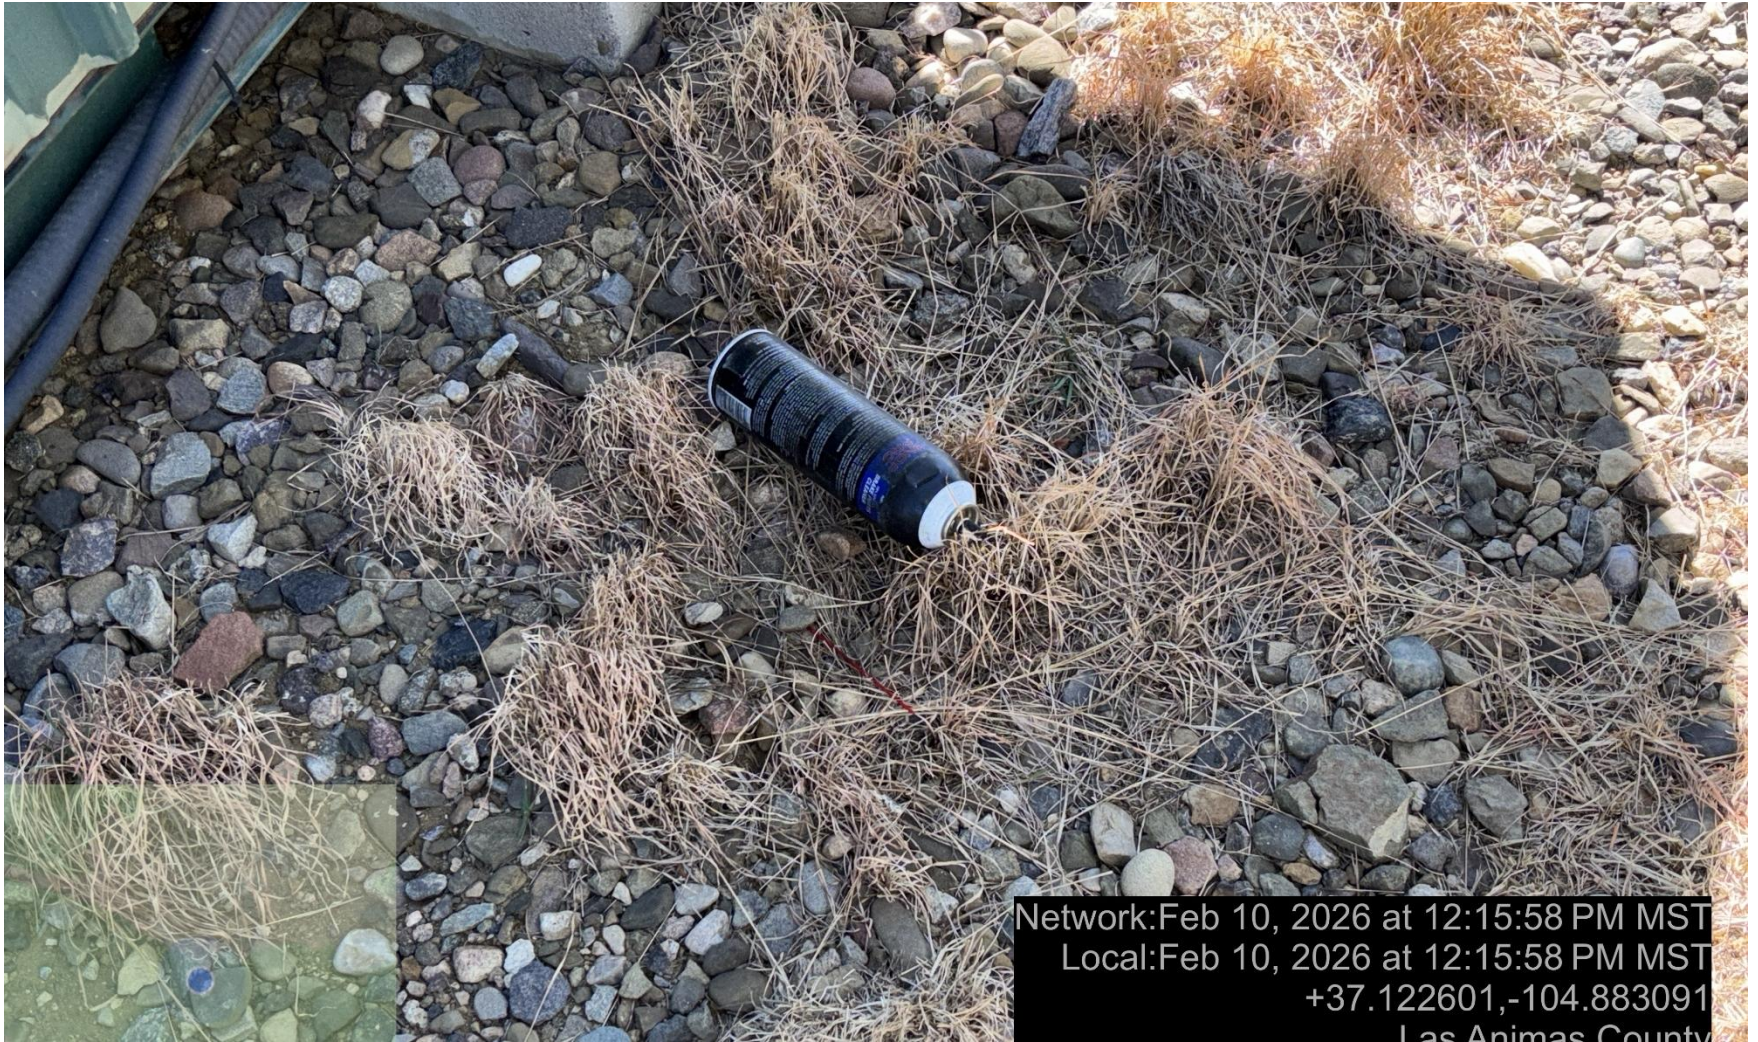
PHOTO 8: area of impacted soil near compressor appears to be from leaking equipment over an extended period of time. **Conduct maintenance on equipment, cleanup stained material and review self inspection processes. COMPLY WITH RULE 1002,.(2).D. ca date 2/23/2026.**
