Audit Photos

Location Name: QB ENERGY OPERATING LLC, CHEVRON/O36A 596

Location ID: 335583

Date: 2/5/2026

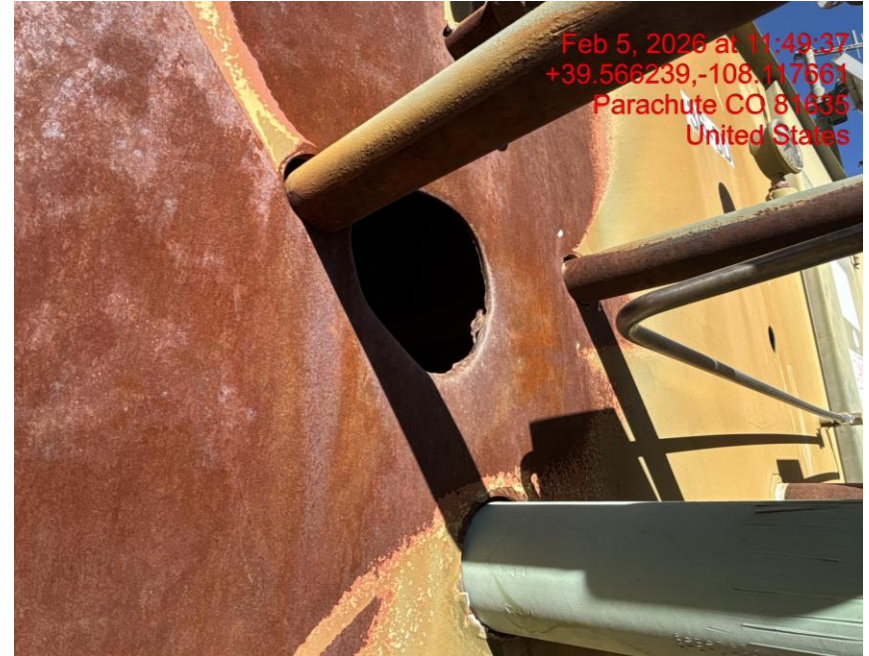
Wildlife Entry Hazard – Photo #02636

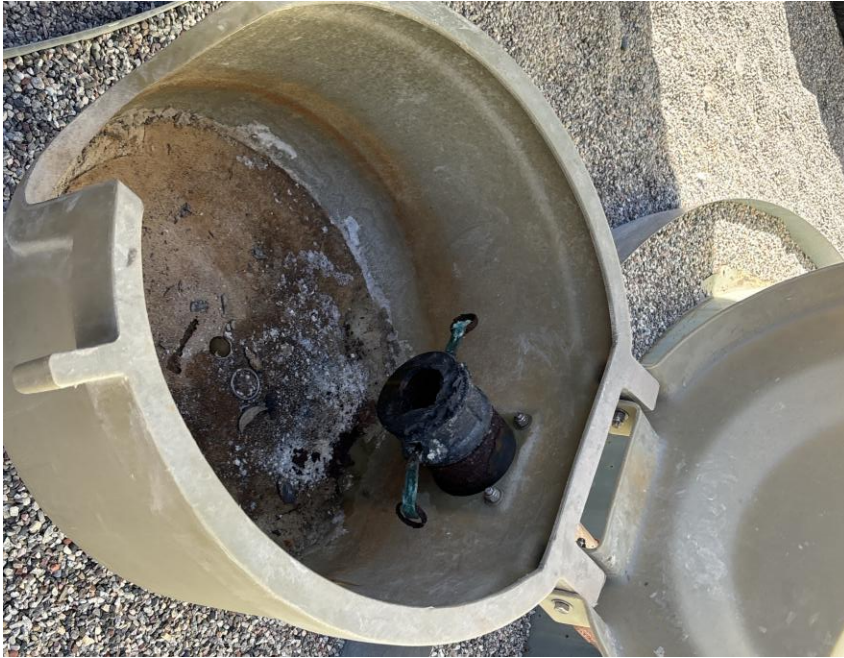
Open-Ended Load Line – Photo #02643

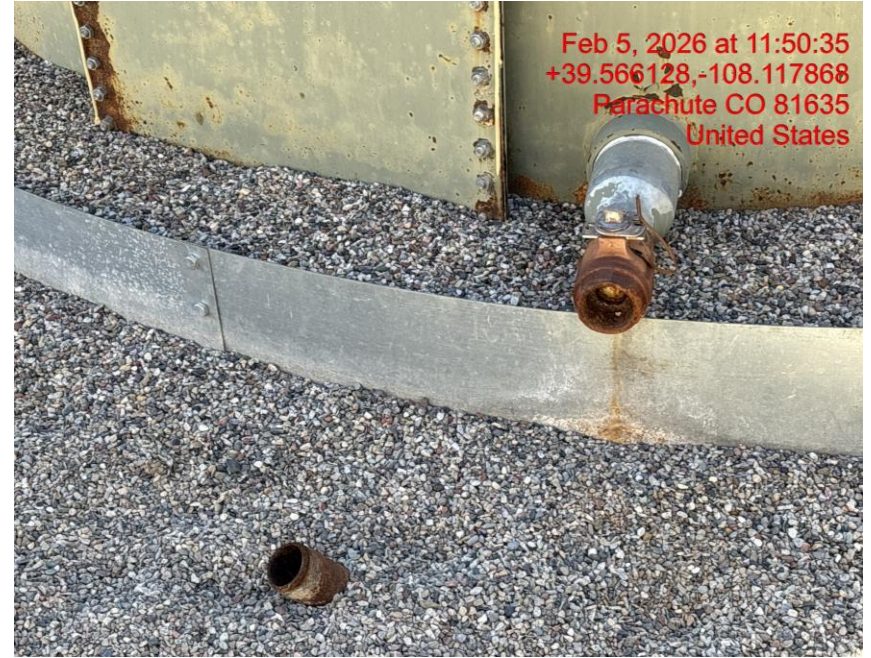
Unplugged Line – Photo #02640

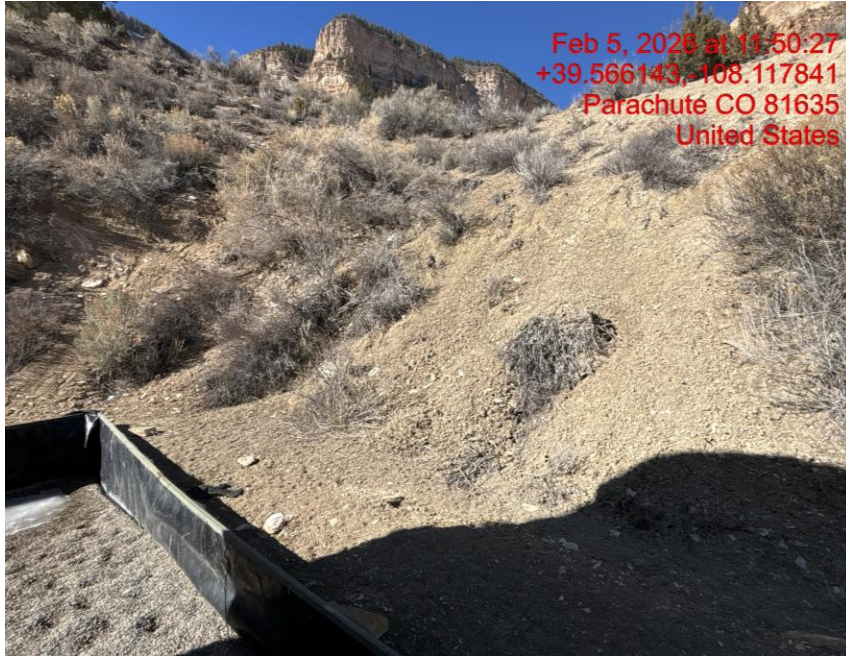
Insufficient Erosion Controls on Cut Slope – Photo #02639

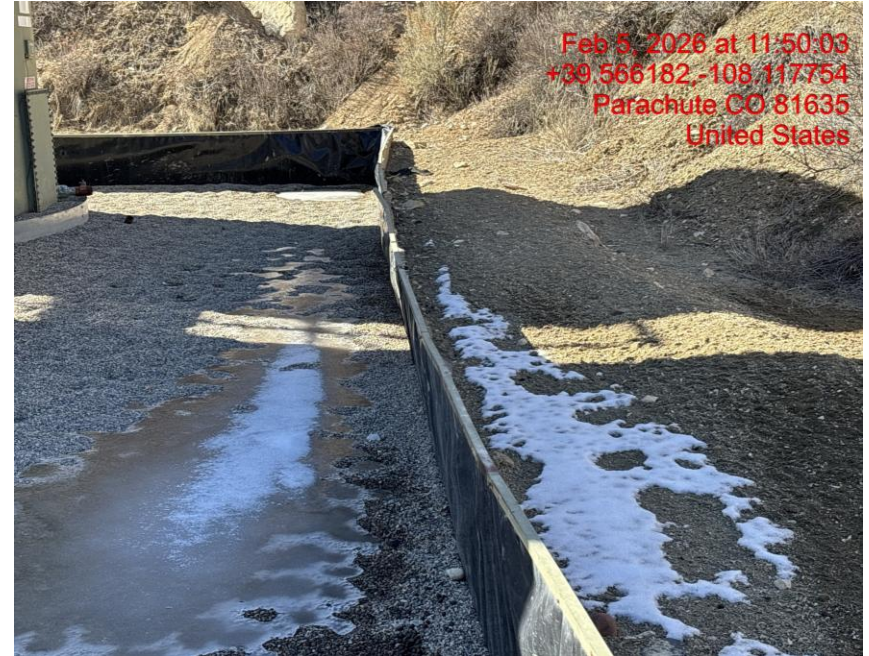
Cut Slope Erosion Encroaching into Secondary Containment – Photo #02637

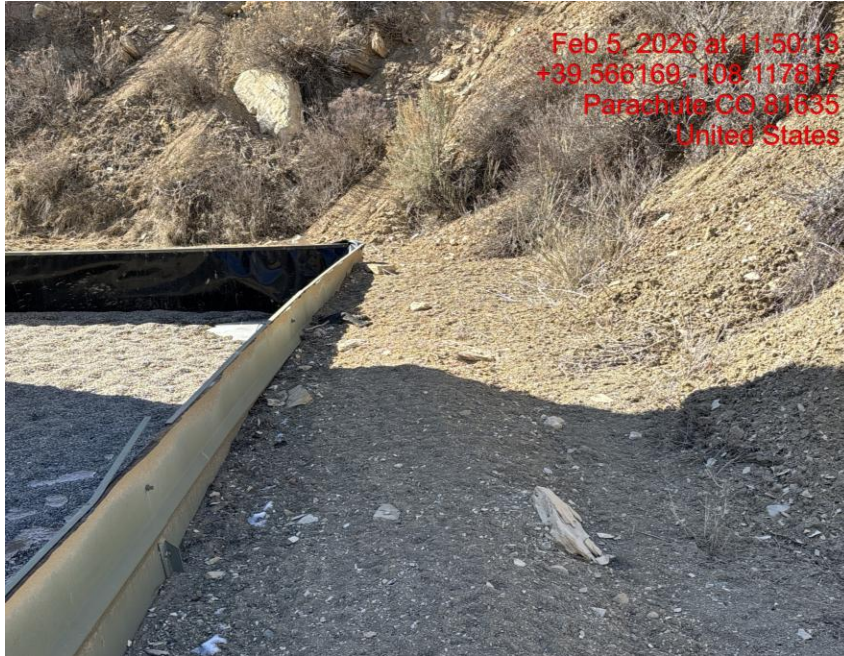
**Cut Slope Erosion Encroaching into Secondary Containment
– Photo #02638**

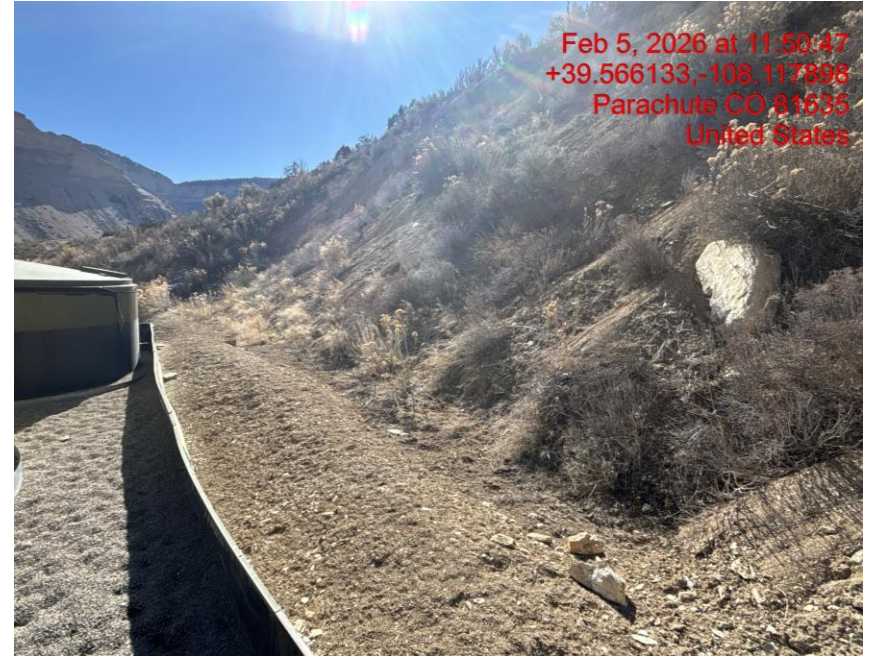
**Cut Slope Erosion Encroaching into Secondary Containment
– Photo #02641**

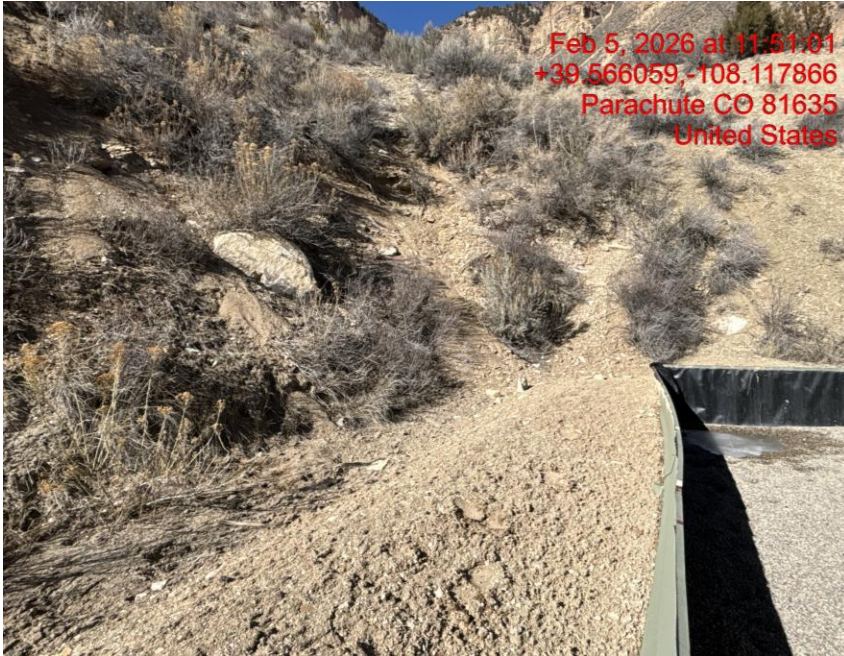
**Cut Slope Erosion Encroaching into Secondary Containment
– Photo #02642**
