Inspection Photos  
Kinder Morgan Goodman Point 20 and Goodman Point 21. Loc. # 419732  
API # 05-083-06686, 05-083-06687  
Inspector Name: James Blair. Inspection Date: 02/10/2026  
Inspection Doc #:72110021

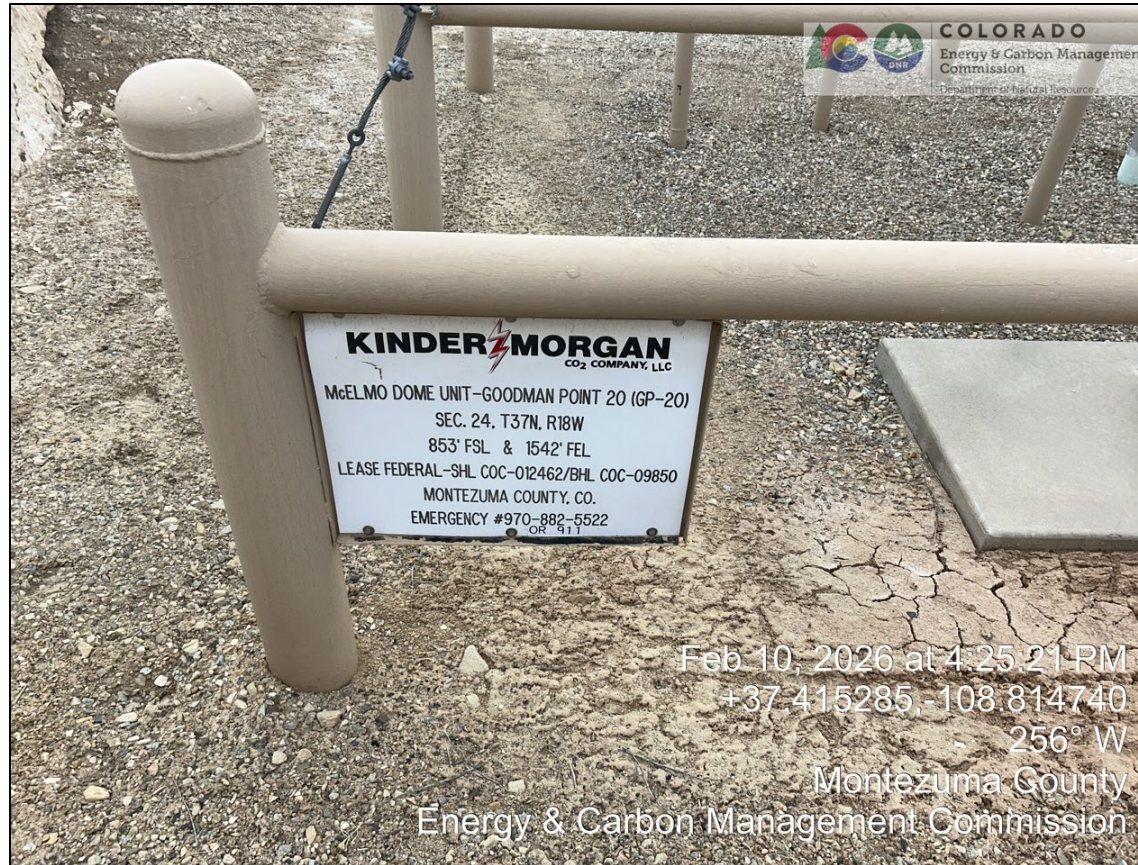
1. GP-20 Well Sign.

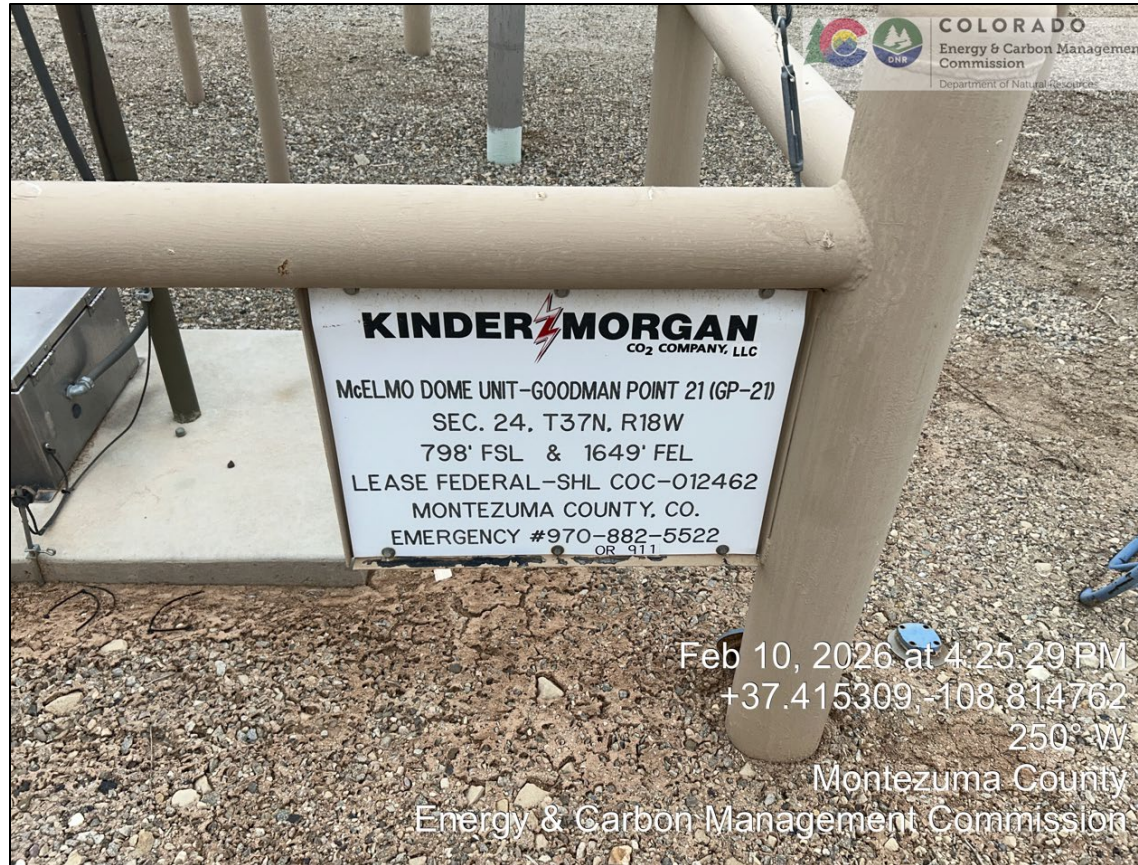
2. GP-21 Well Sign.

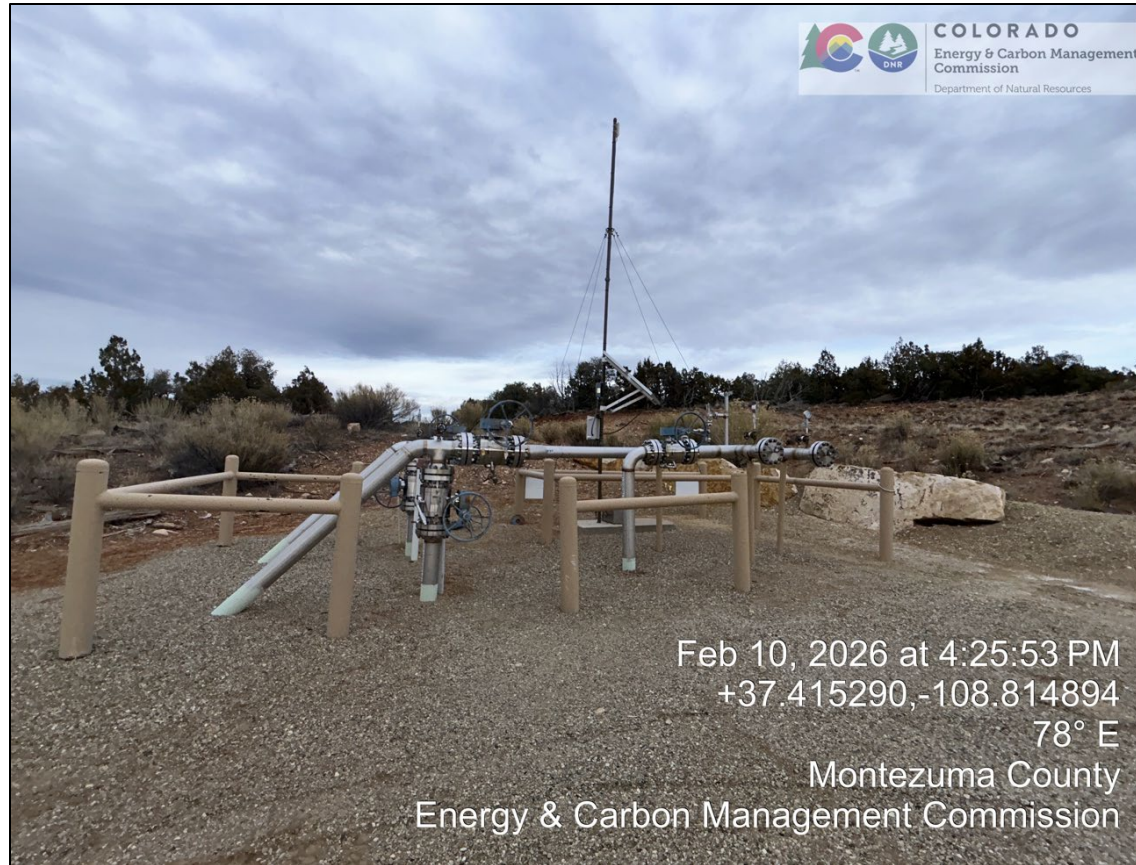
**3. Flow line assembly for GP 20 and GP 21 and telemetry. Pipes on blanked-off flanges have printed labels, however “tags” are absent or have been UV decayed and are broken/illegible.**

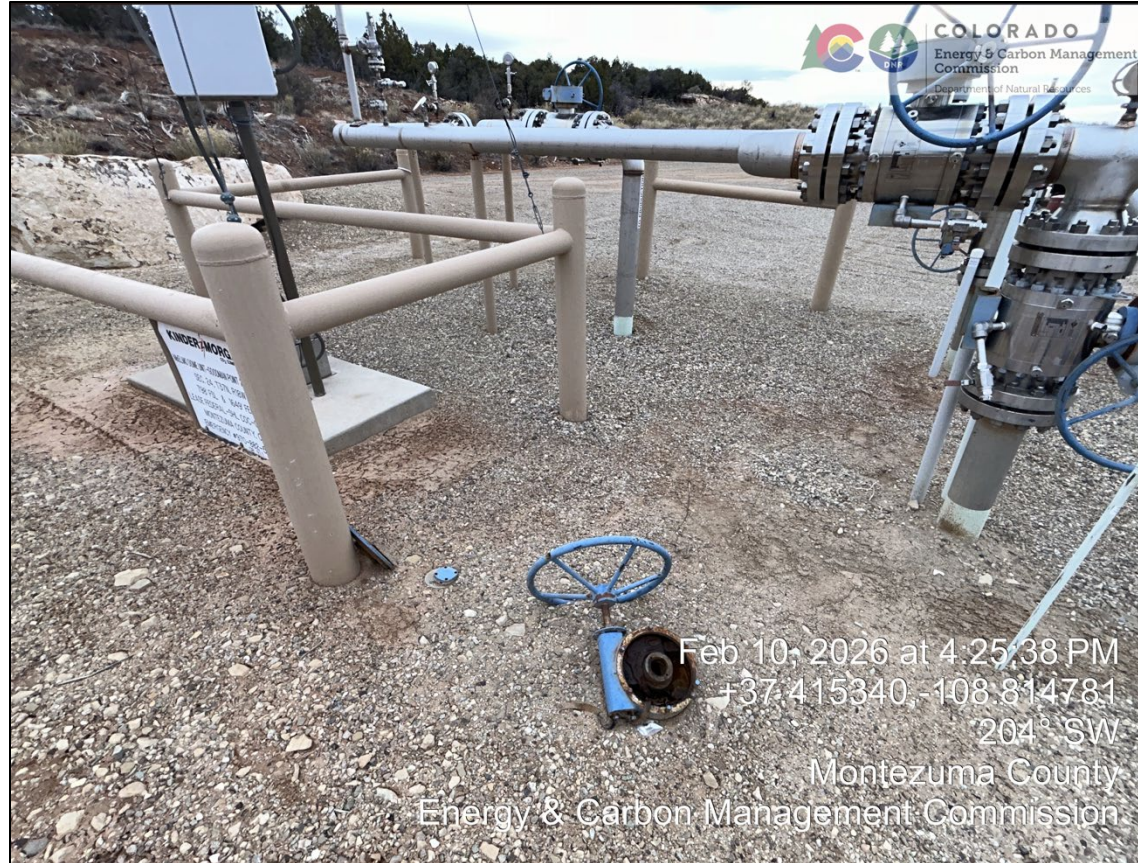
4. Broken gate valve left on site.

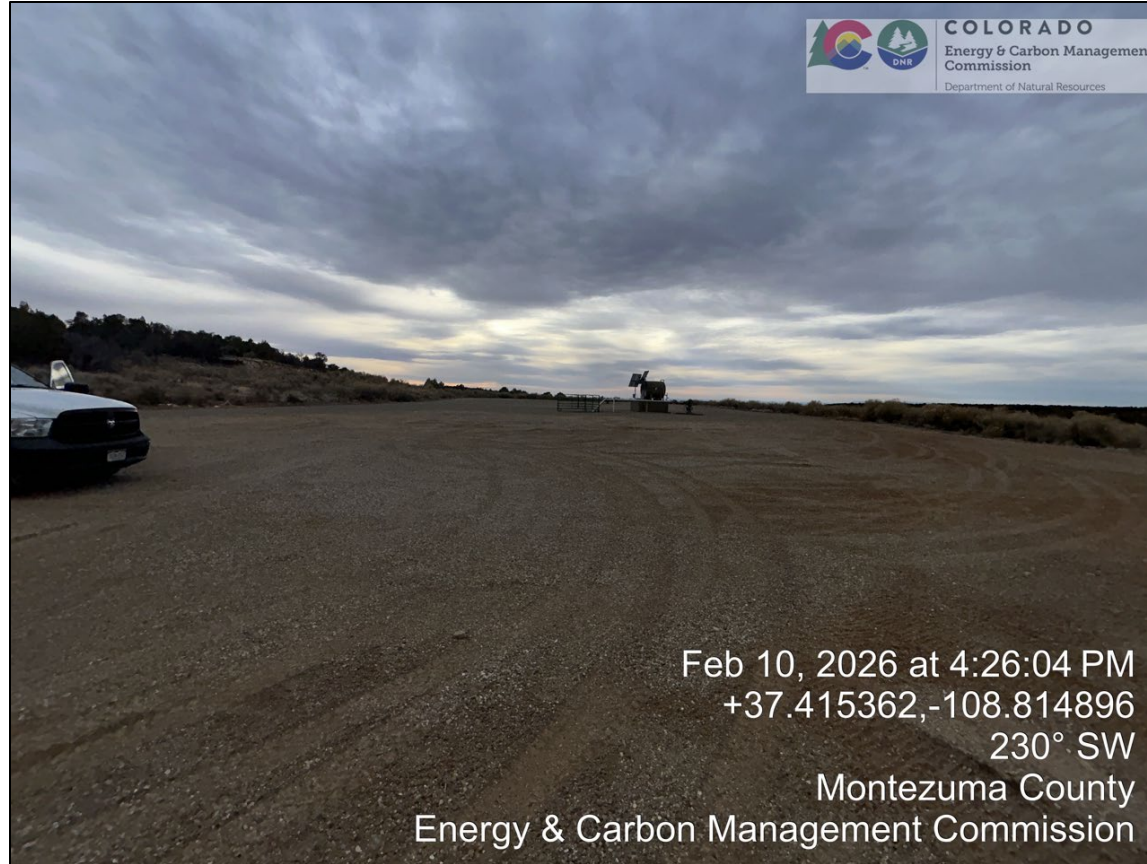
5. Well pad looking southwest from flow line assembly.

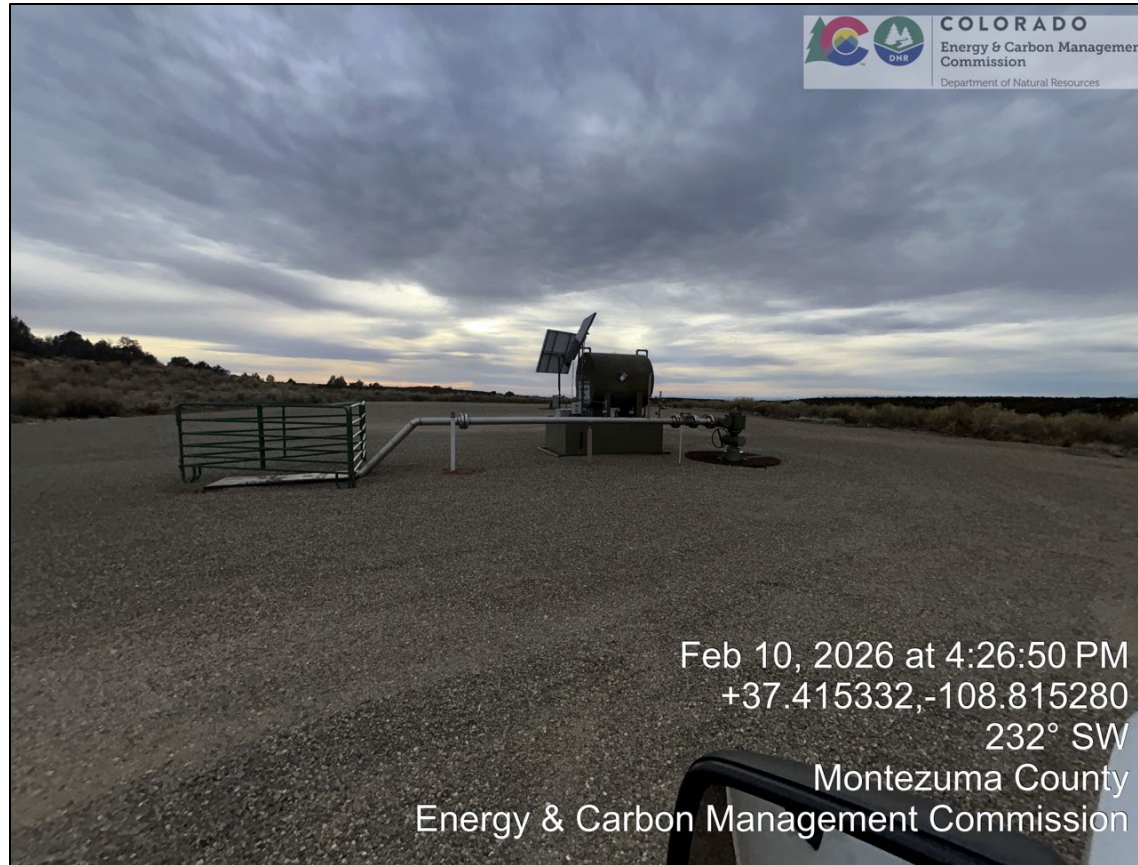
**6. GP-20 wellhead, flow line and 1000 gallon diethylene glycol/produced water tank. Pump in tank was heard operating during inspection. Secondary containment below tank is adequate.**

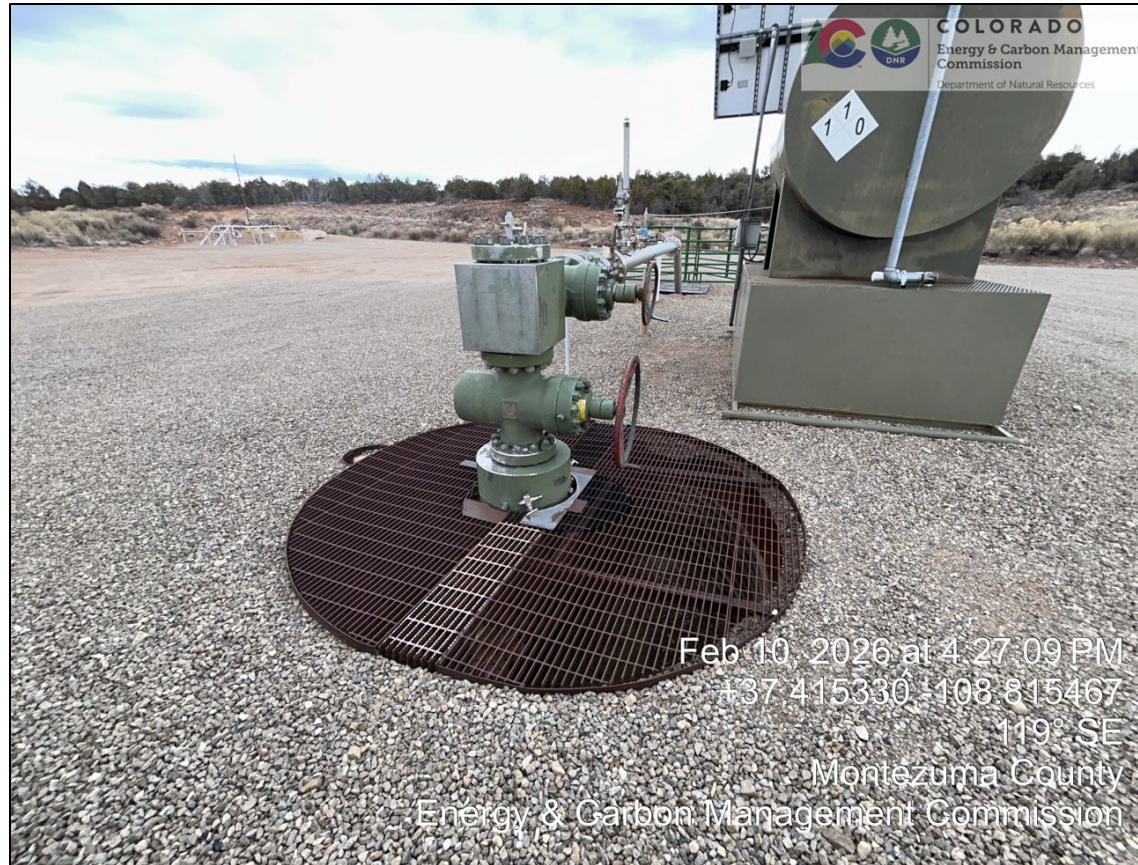
**7. GP-20 wellhead, flow line and 1000-gallon diethylene glycol/produced water tank. Pump in tank was heard operating during inspection. Secondary containment below tank is adequate. Marked with hazcom placard.**

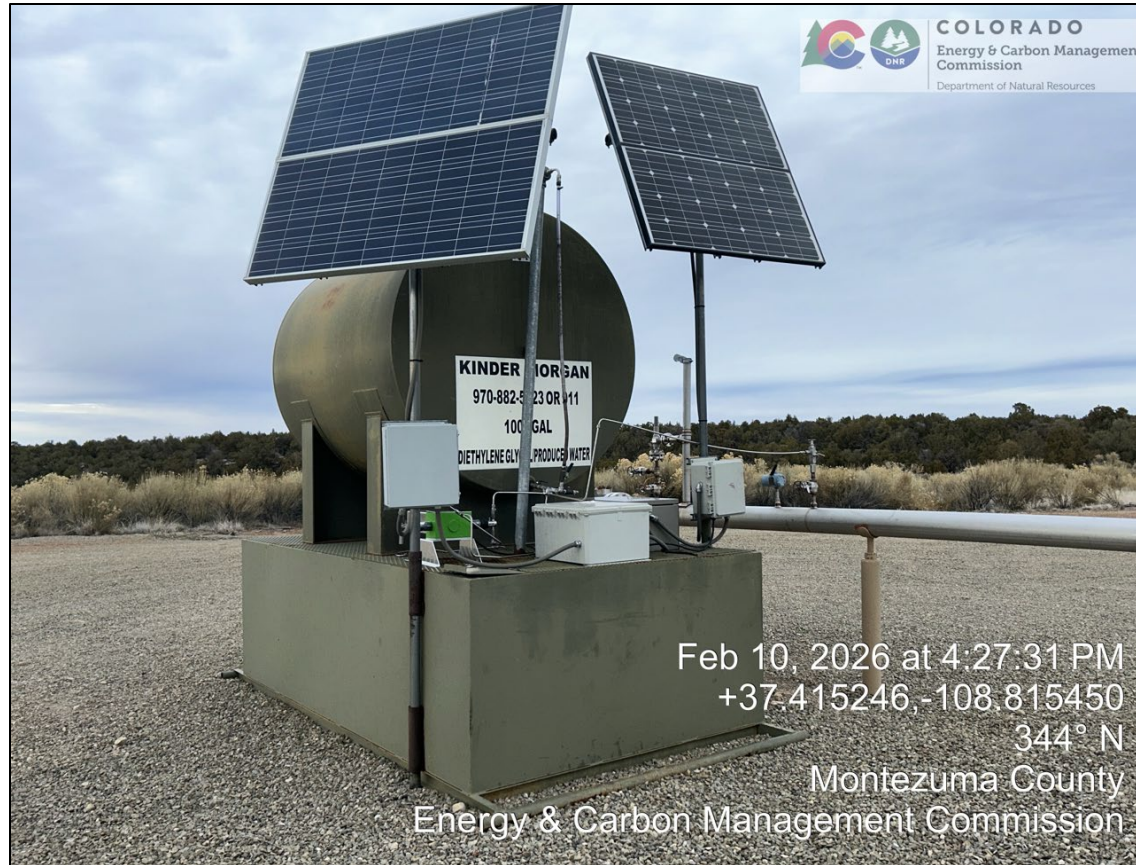
8. Diethylene glycol/produced water tank on skid-mounted secondary containment tank. Solar-array/telemetry. Secondary containment is adequate.

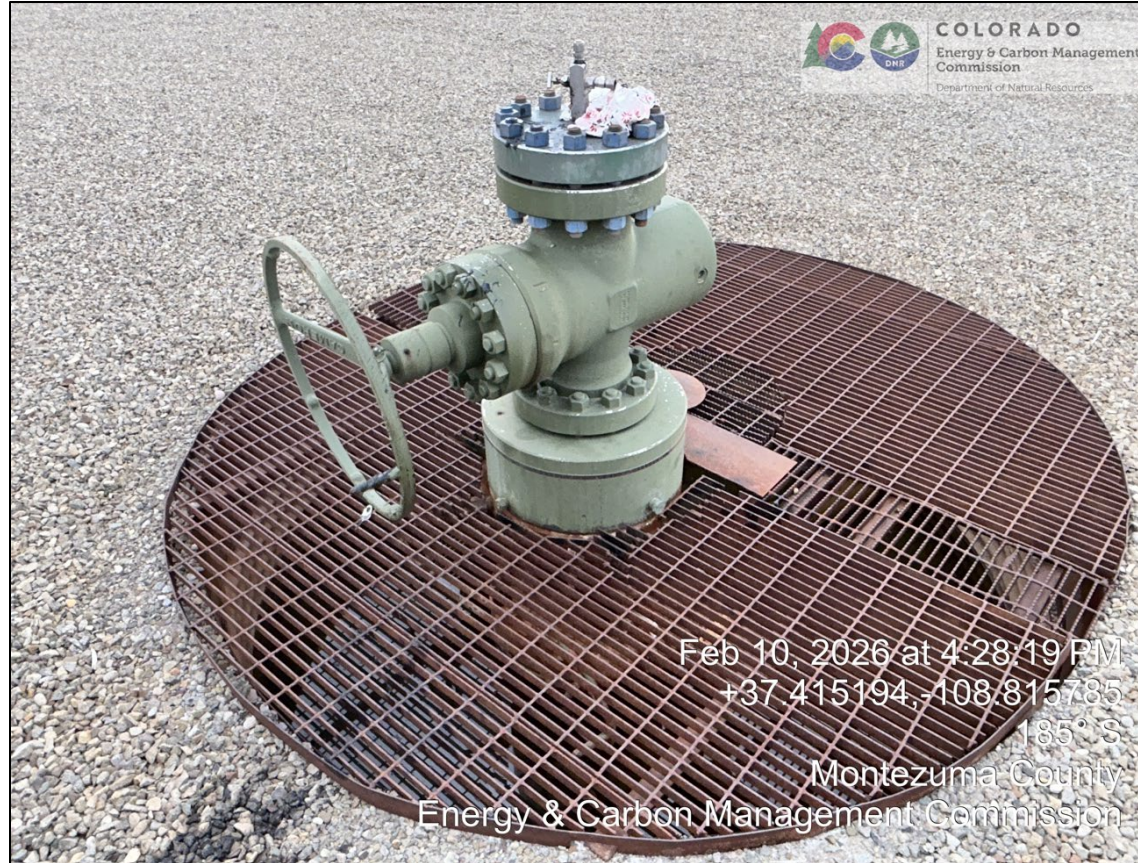
9. GP-21 wellhead and cellar. Bradenhead is accessible beneath grate. Note rag on top.

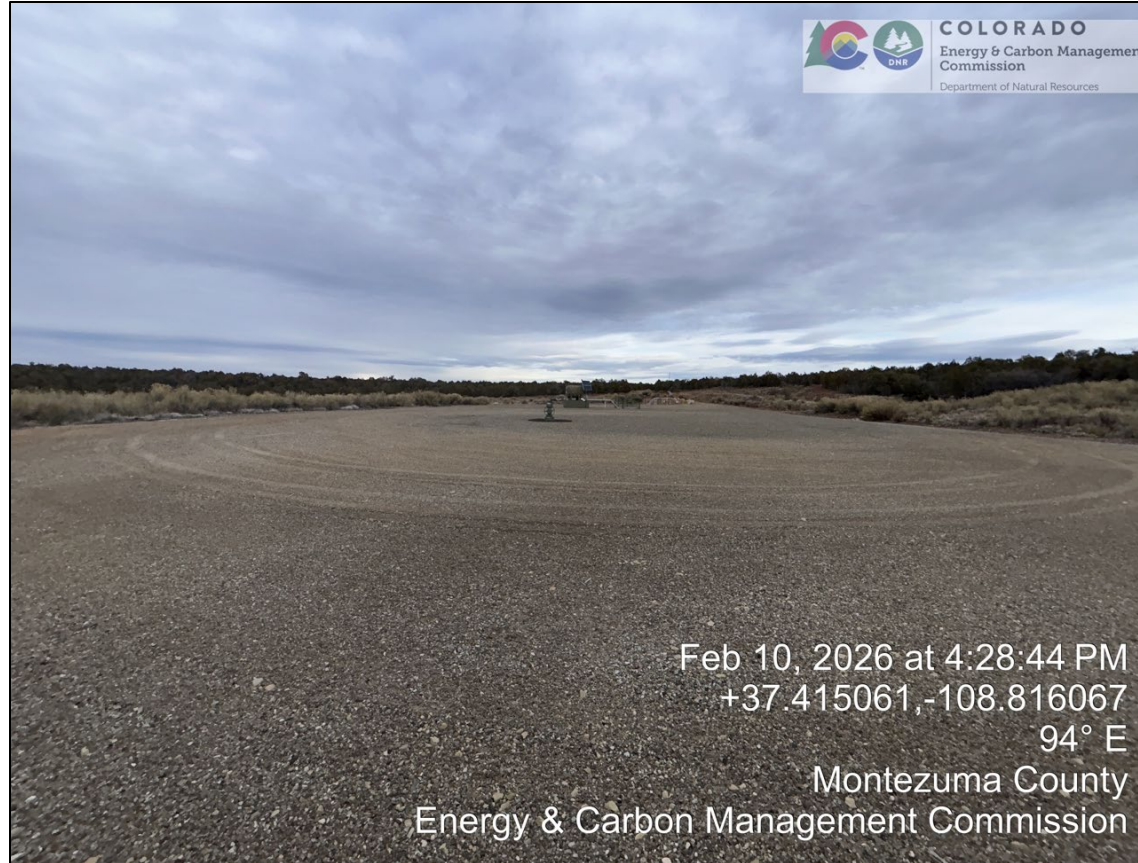
10. Well pad looking east from west end.

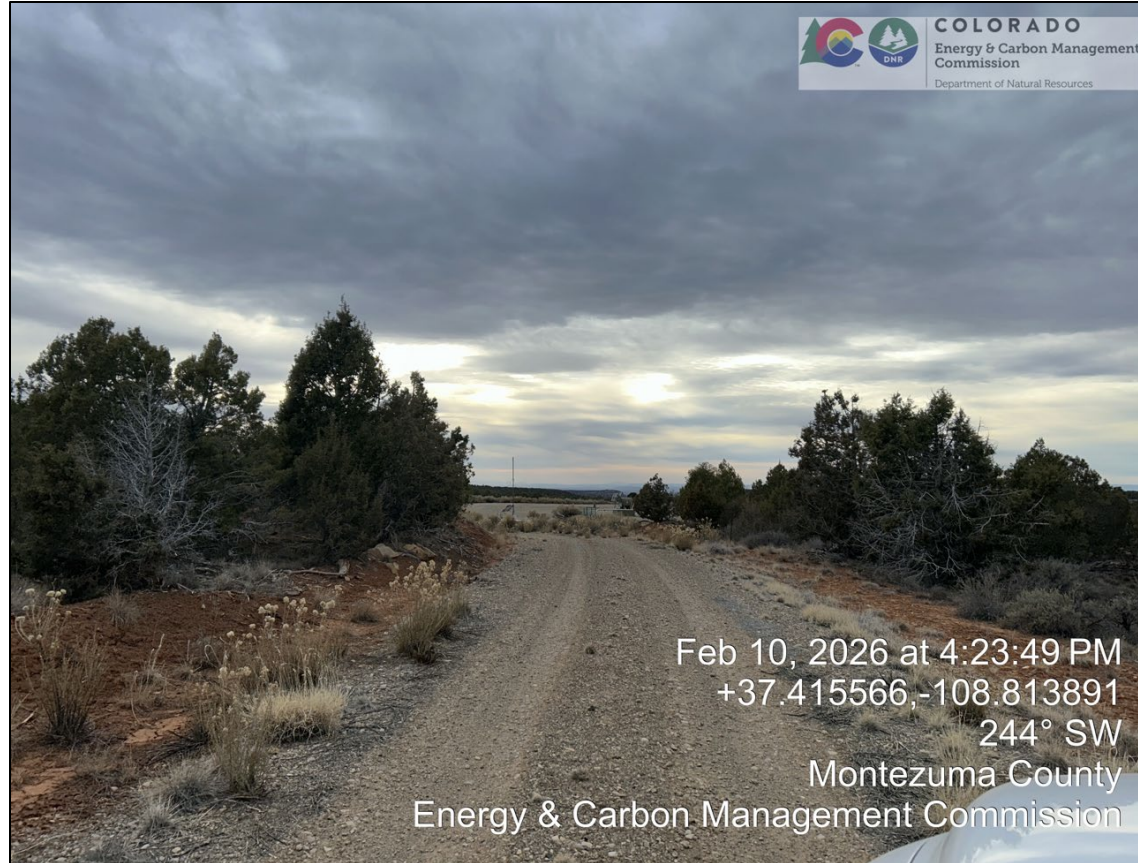
11. Access road.

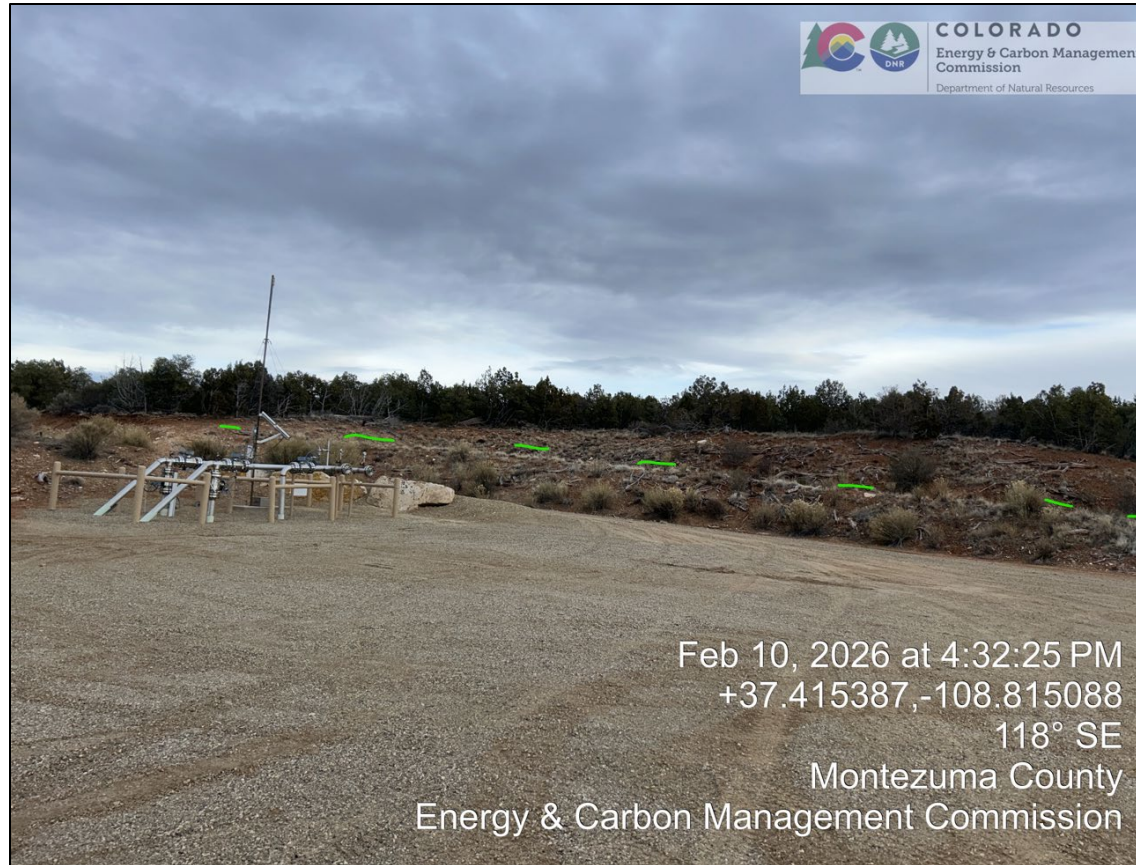
12. Run-on control ditch in cut slope on east side of pad indicated with dashed green line.

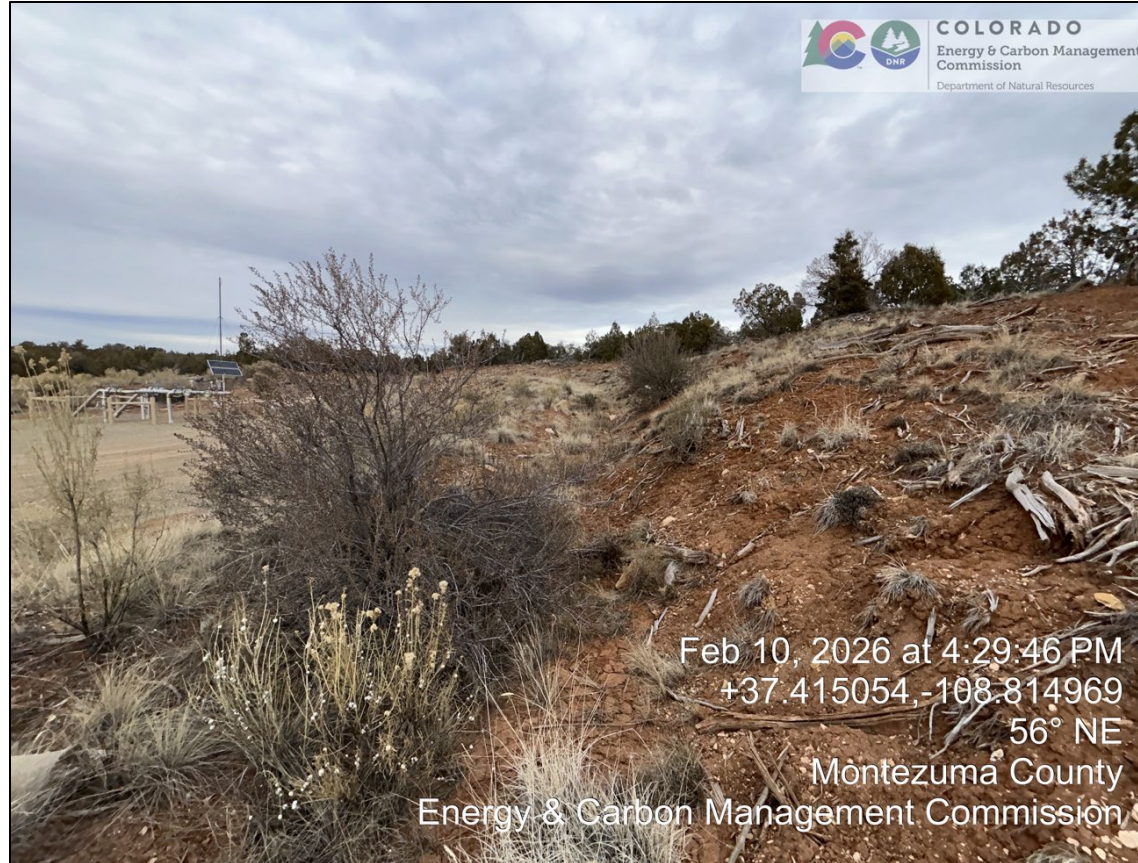
13. Run-on diversion ditch on east side of pad looking north.

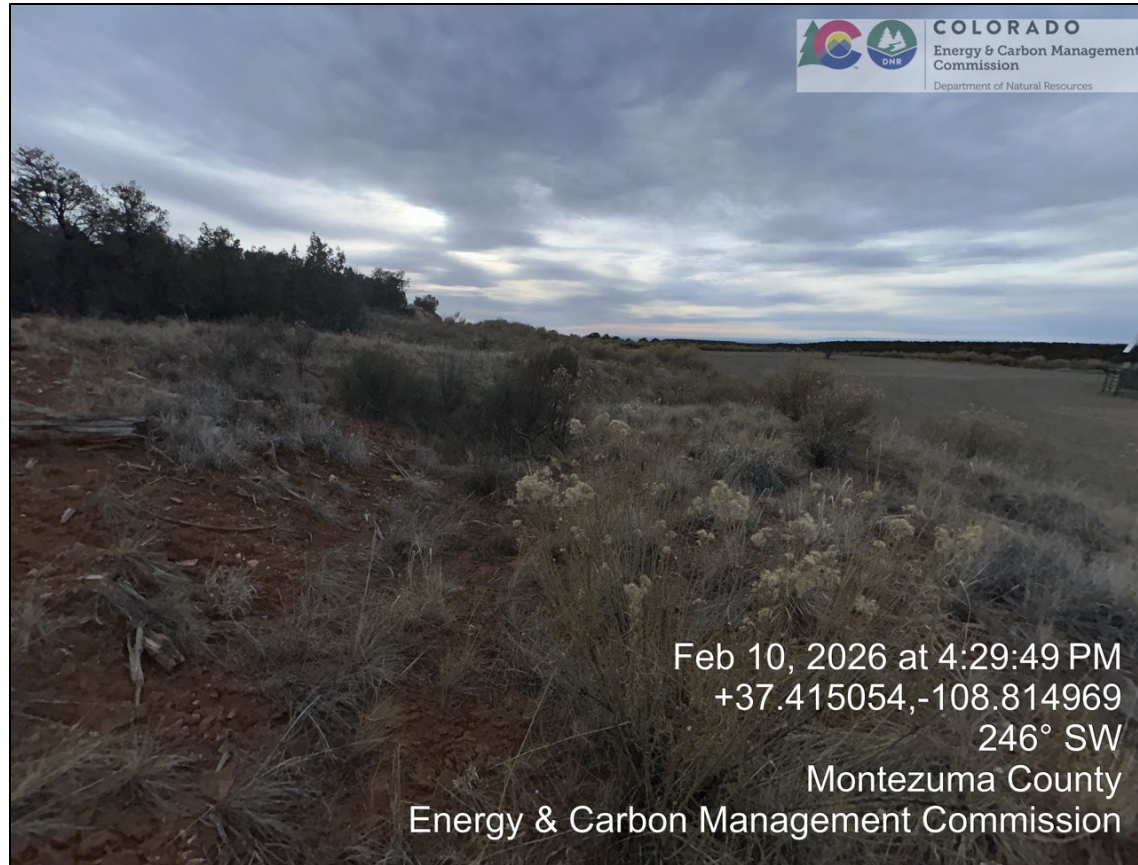
14. Run-on diversion ditch on east side looking south.

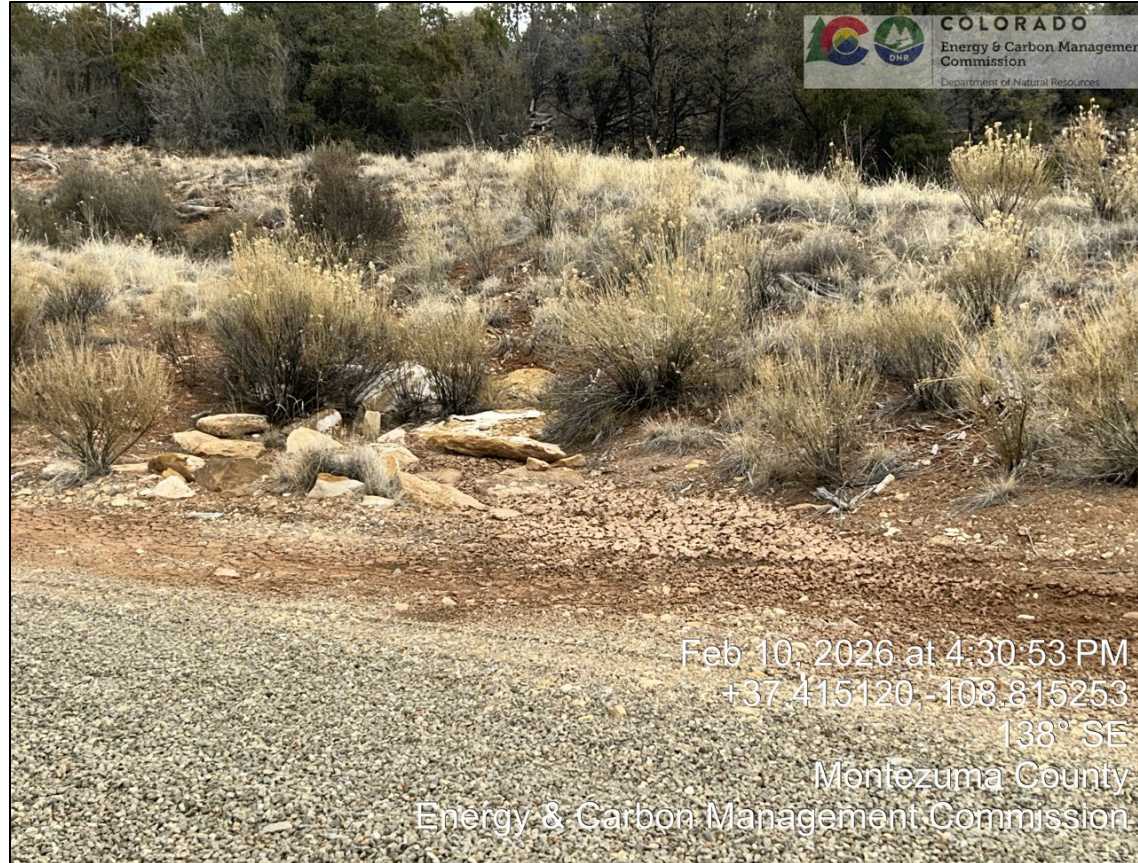
15. Location where run-on diversion ditch meets well pad.

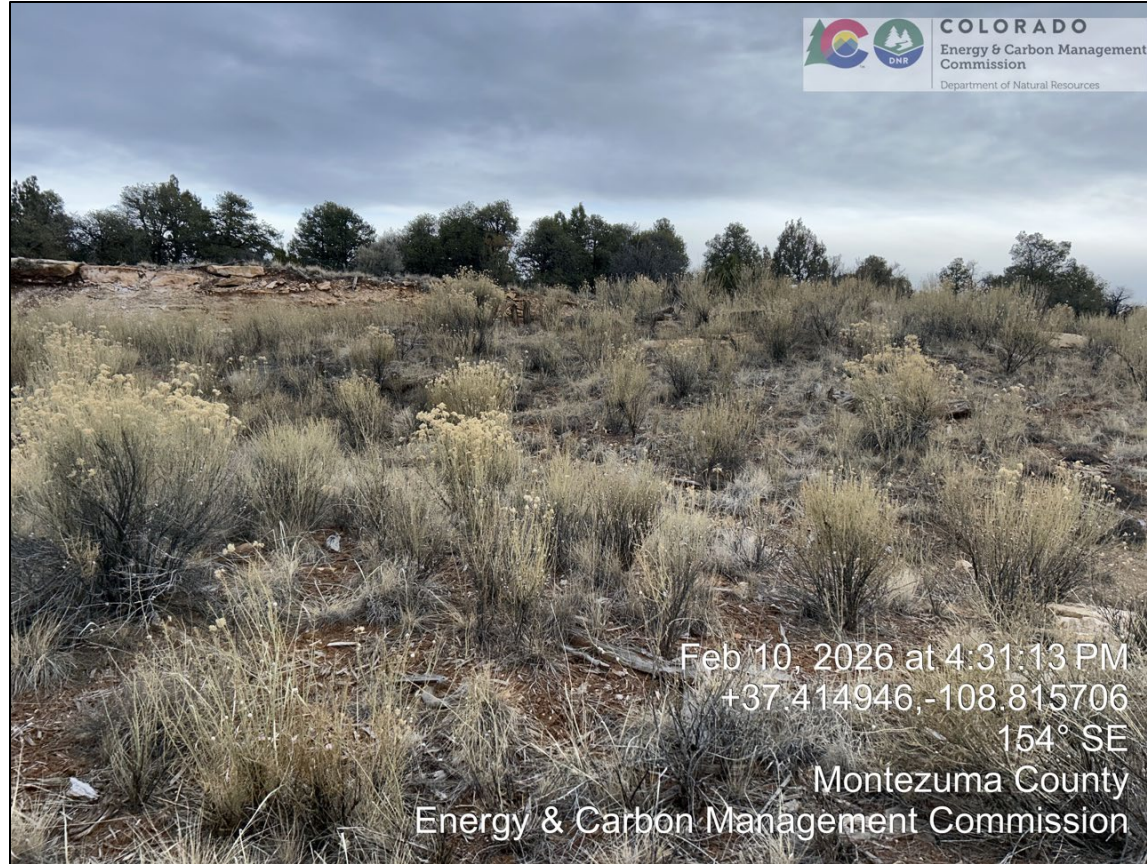
16. Reclamation vegetation near southeast corner of pad.

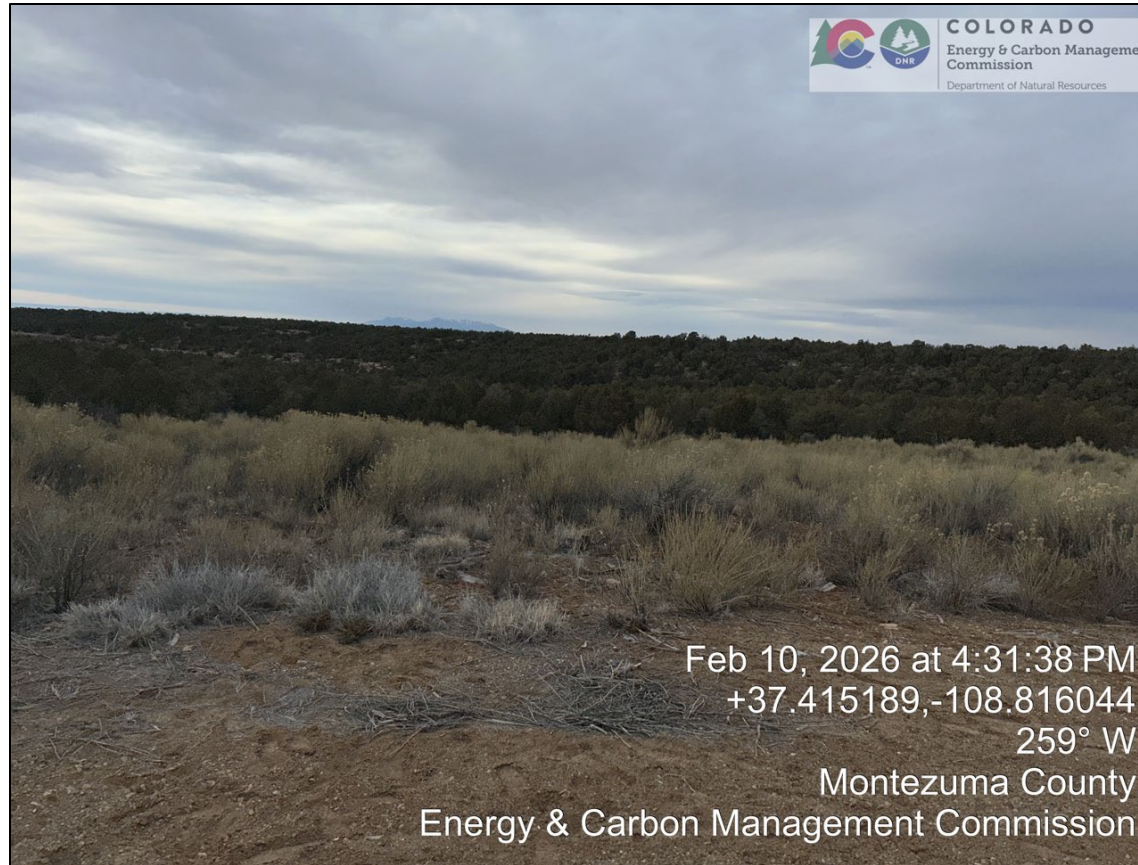
17. Reclamation vegetation on west side of pad.

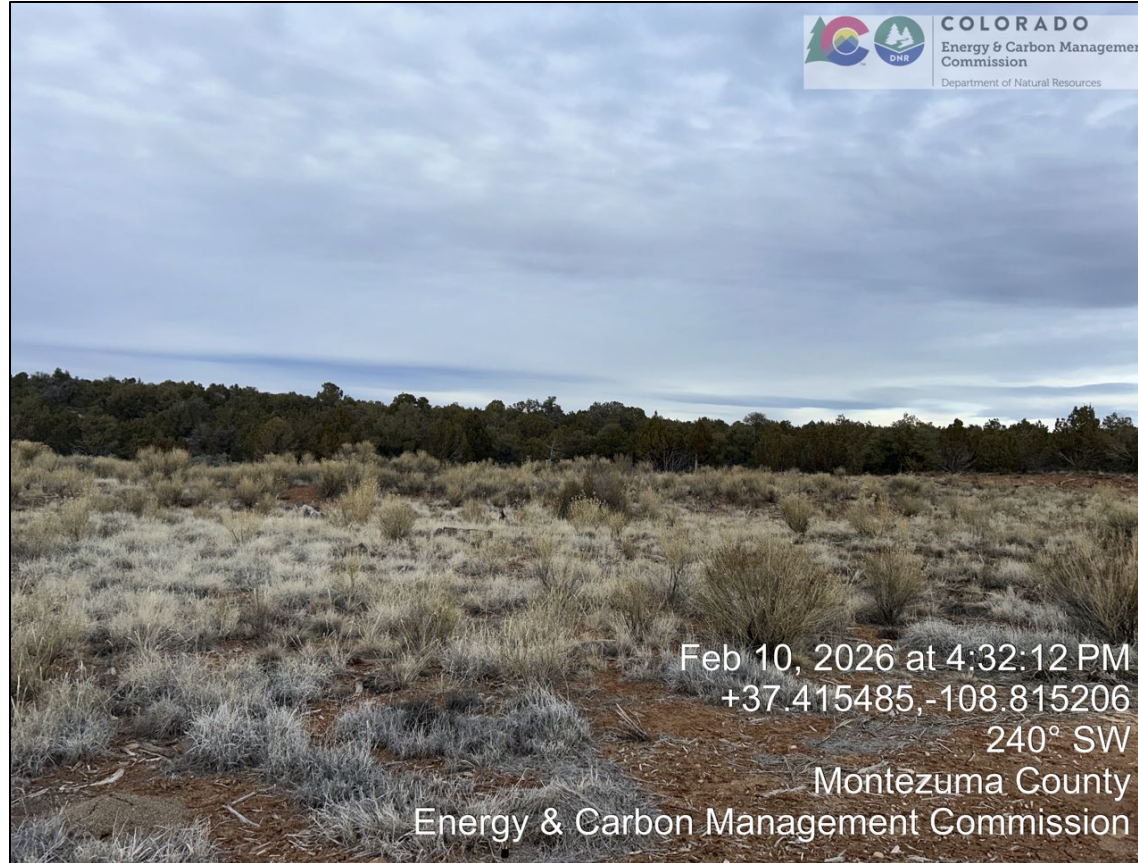
18. Reclamation vegetation on south edge of pad.
