Final Reclamation and Stormwater Inspection

Operator: KP KAUFFMAN COMPANY INC

Well Name: CHAMPLIN 86 AMOCO B #3

Inspection Document #: 718601359

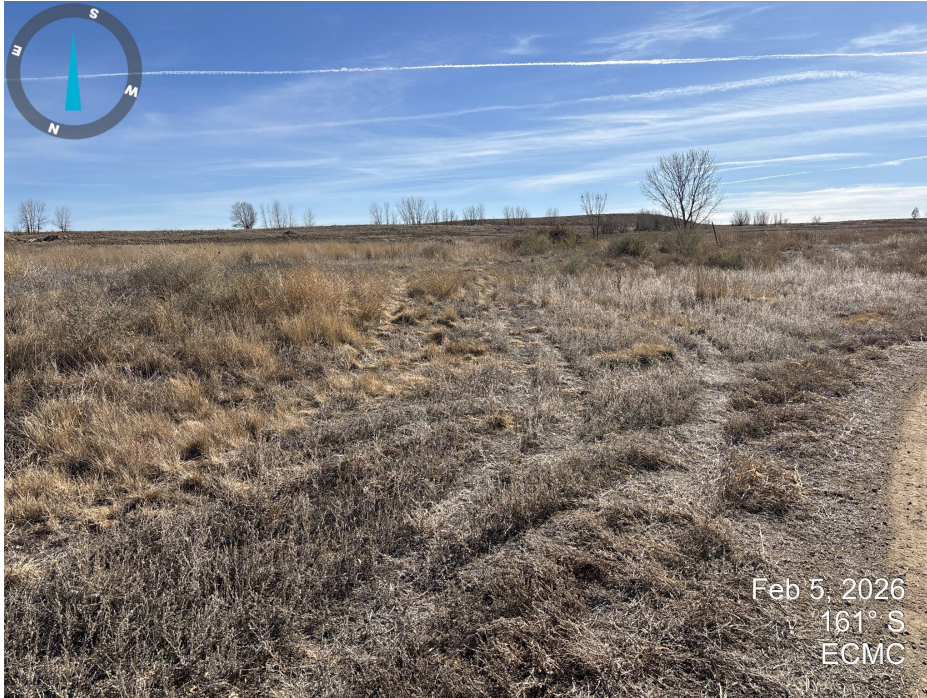
Photo 1. Looking south down the former access road. A stormwater ditch now runs through the access road. See photo 14.

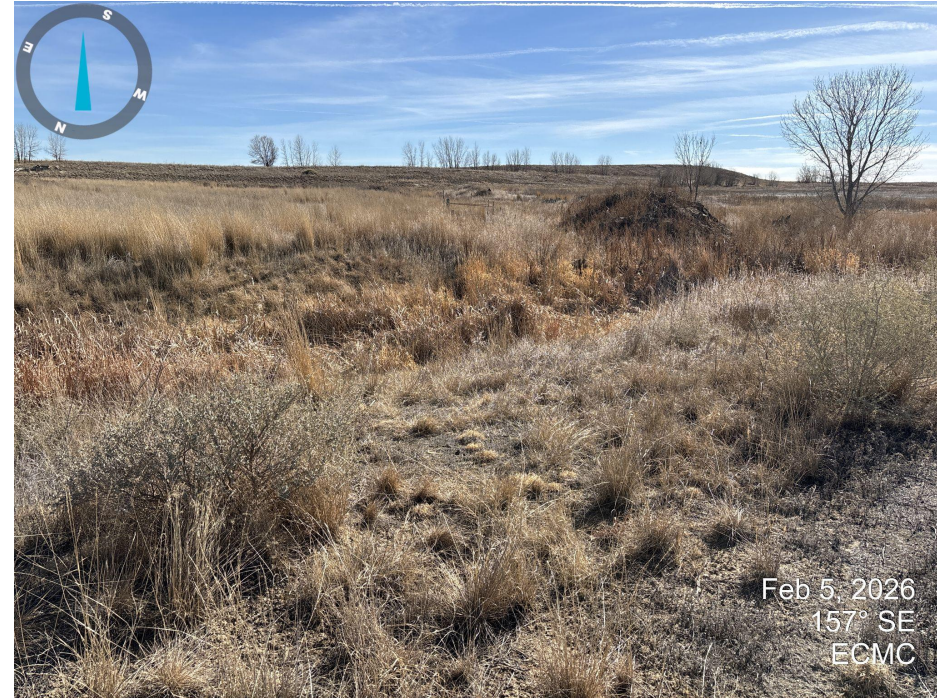
Photo 2. Looking south down the former access road path. this area has been disturbed subsequent to oil and gas development. See photo 14.

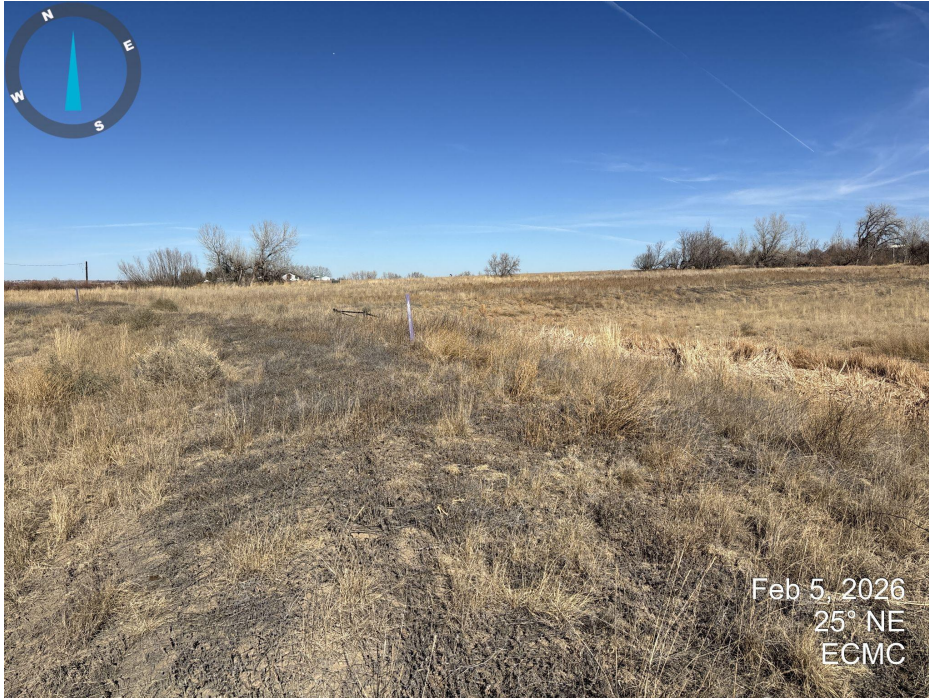
Photo 3. Ditch and detention pond.

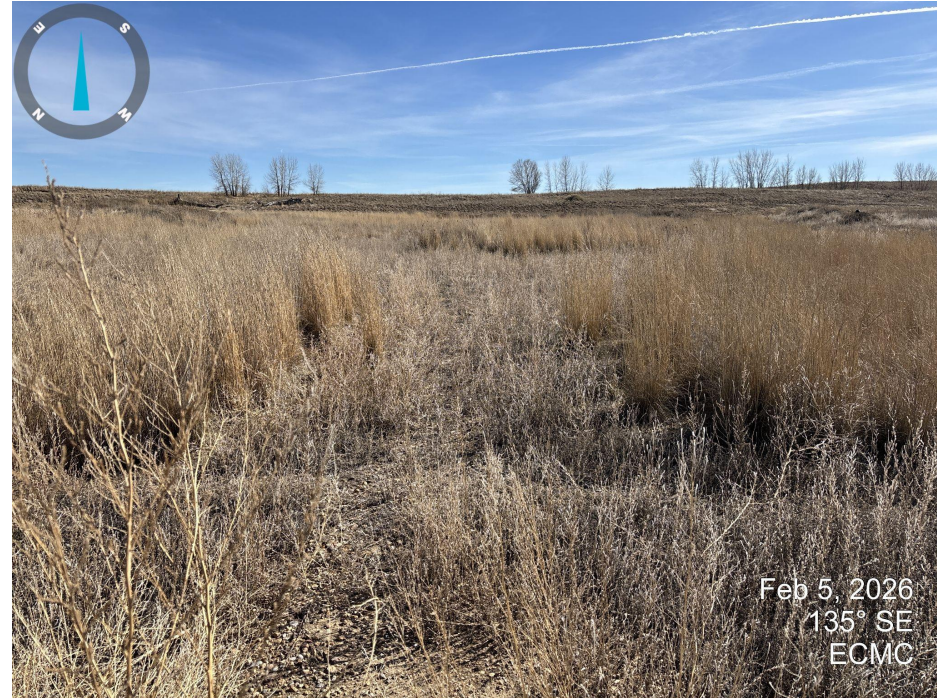
Photo 4. Looking southeast down the access road towards the well location. Gravel remains on the access road. Very little desirable vegetation is present on the access road. Undesirable weed kochia is present throughout the access road and not reflective of the surrounding vegetation.

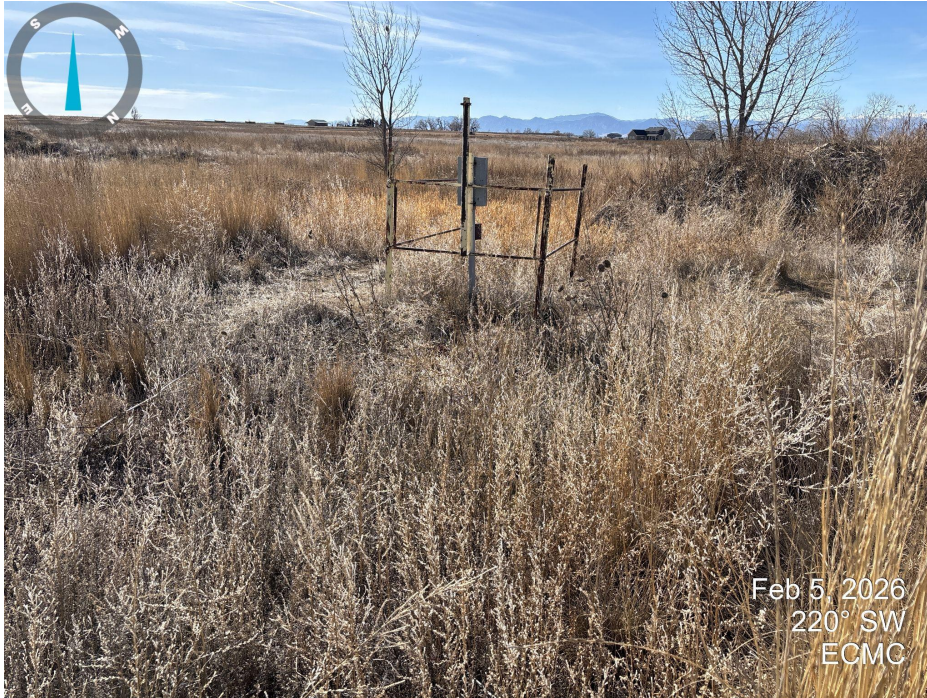
Photo 5. Looking west from the access road near the wellhead. A metal fence, electrical meter and post remain on the location.

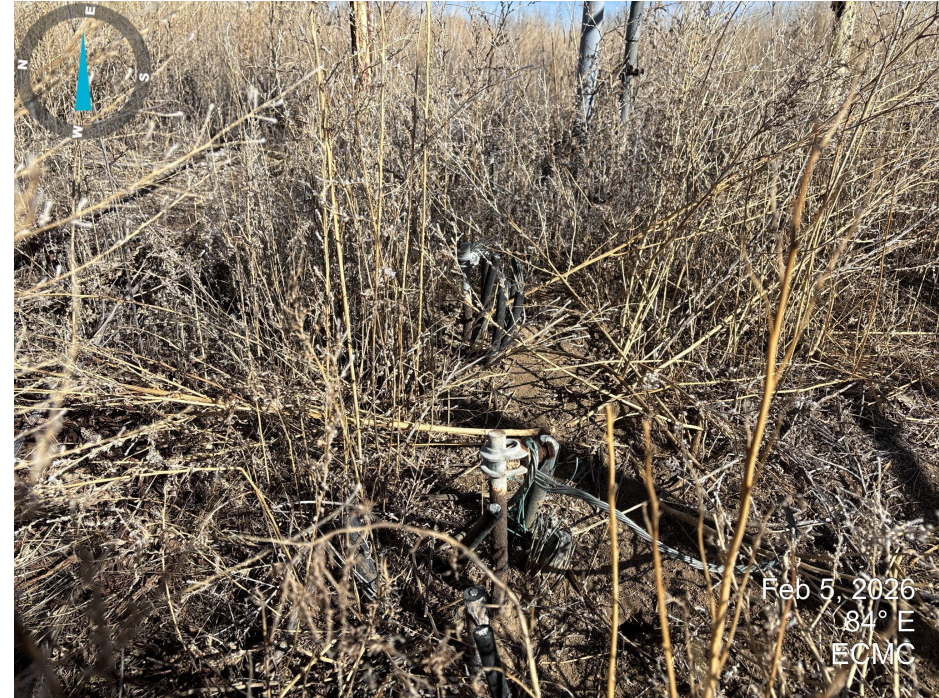
Photo 6. Photo taken in side the metal fence near the electric box. Cut off and exposed wires are present sticking out of the ground.

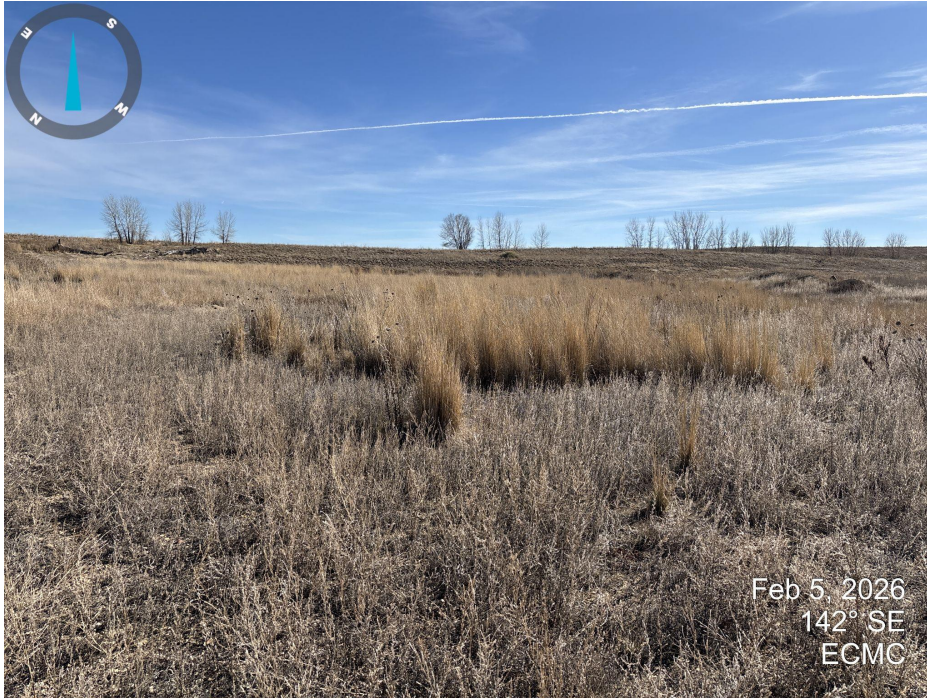
Photo 7. Looking southeast across the location. Vegetation on the location is primarily undesirable weed kochia and is not reflective of the surrounding reference area. A patch of desirable perennial vegetation such as *Thinopyrum intermediumis* present around the wellbore. Gravel remains on the former access road.

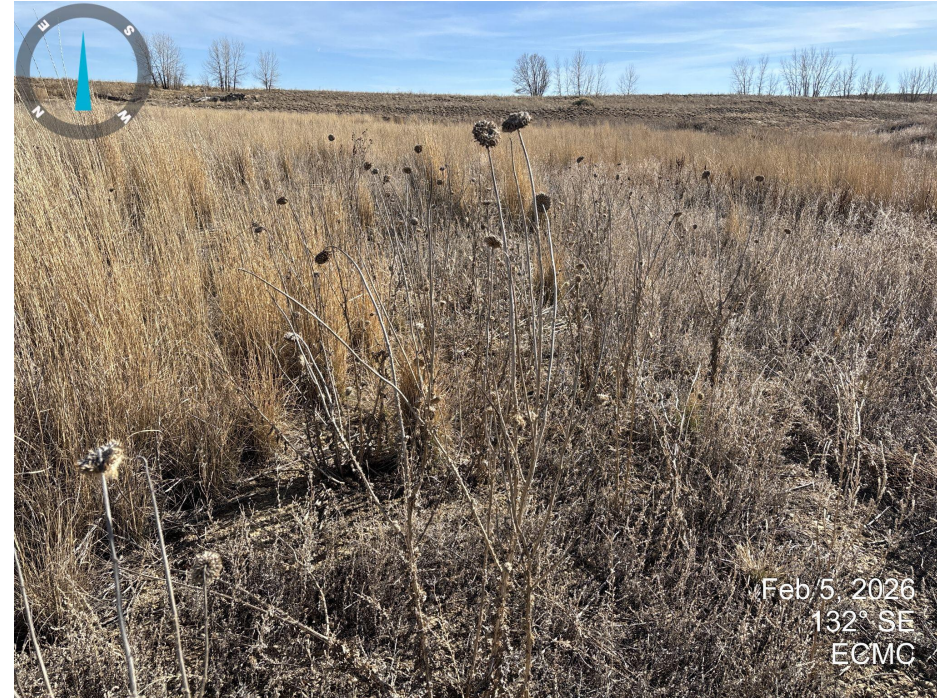
Photo 8. Photo taken on the access road to the southwest of the wellbore. List B noxious weeds *Carduus nutans* (musk thistle) and *Onopordum acanthium* (scotch thistle) are present throughout the location, including live rosettes.

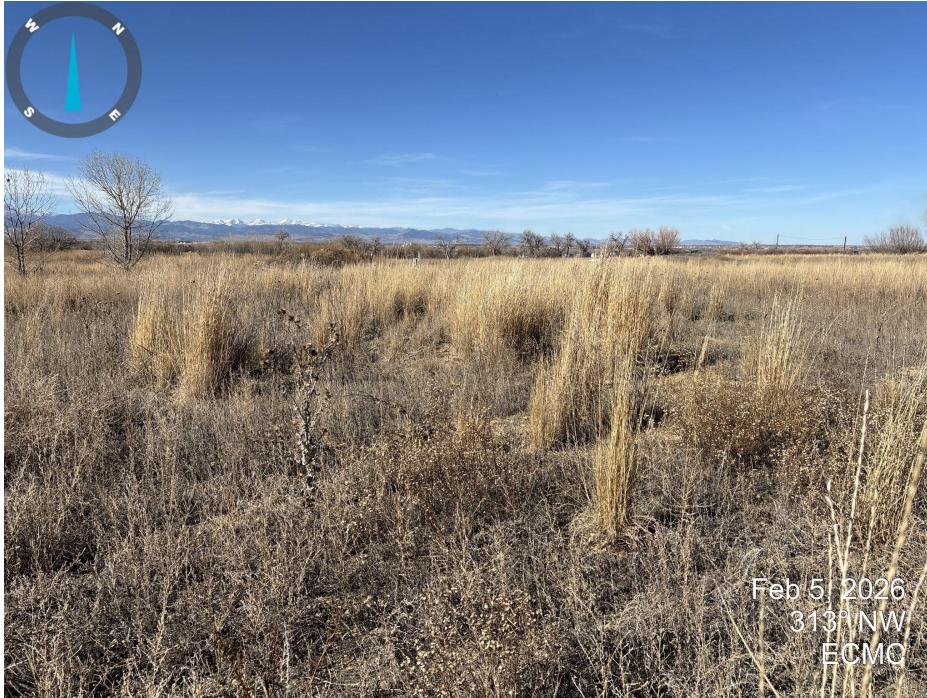
Photo 9. Looking northwest across the location from the southeast edge. See photo 7 comments. List B noxious weed scotch thistle is visible in this photo.

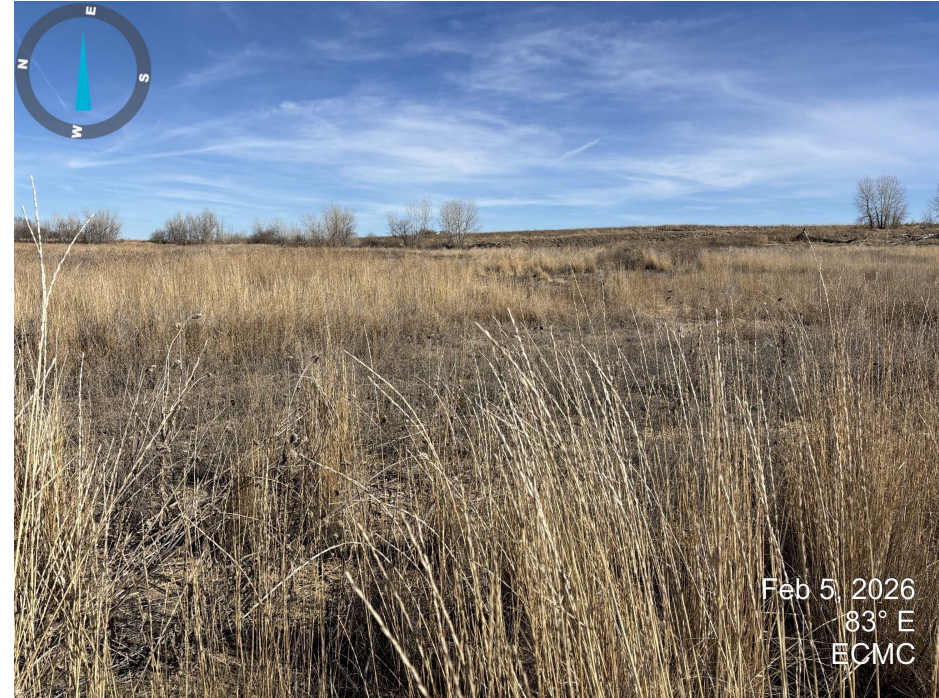
Photo 10. Looking east from the wellbore. See photo 7 comments.

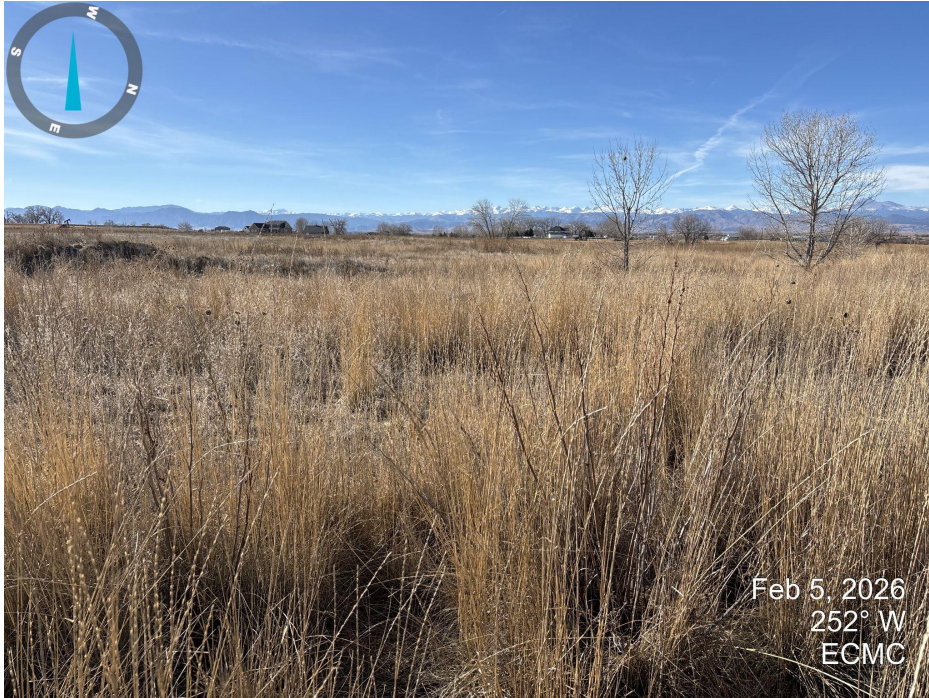
Photo 11. Looking west from the wellbore. See photo 7 comments.

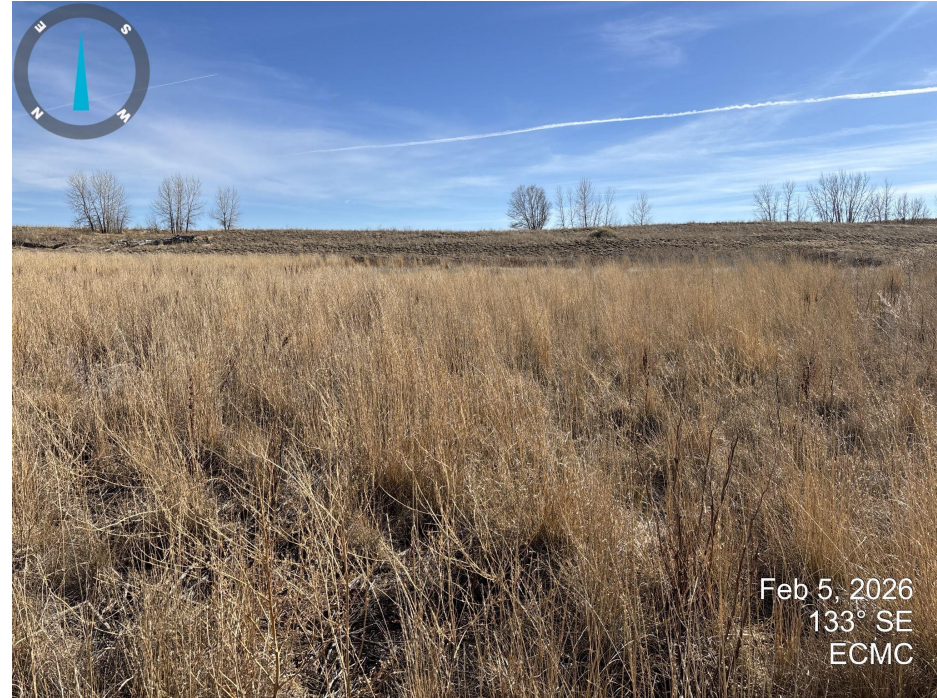
Photo 12. Reference vegetation to the southeast of the well location.

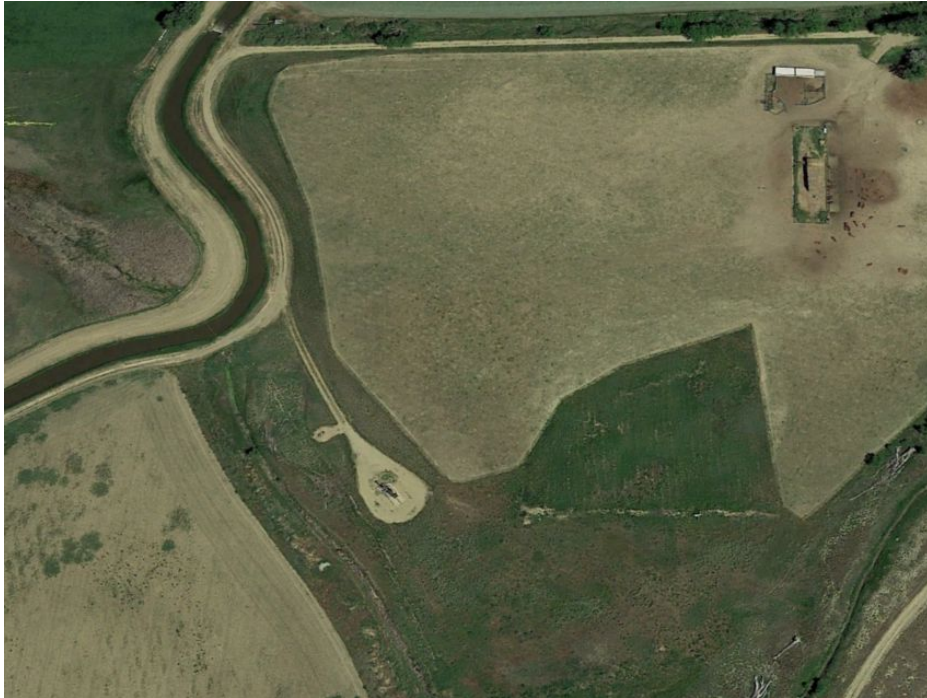
Photo 13. Google earth aerial imagery taken 05/2018.
Illustration location access road while the well was active.

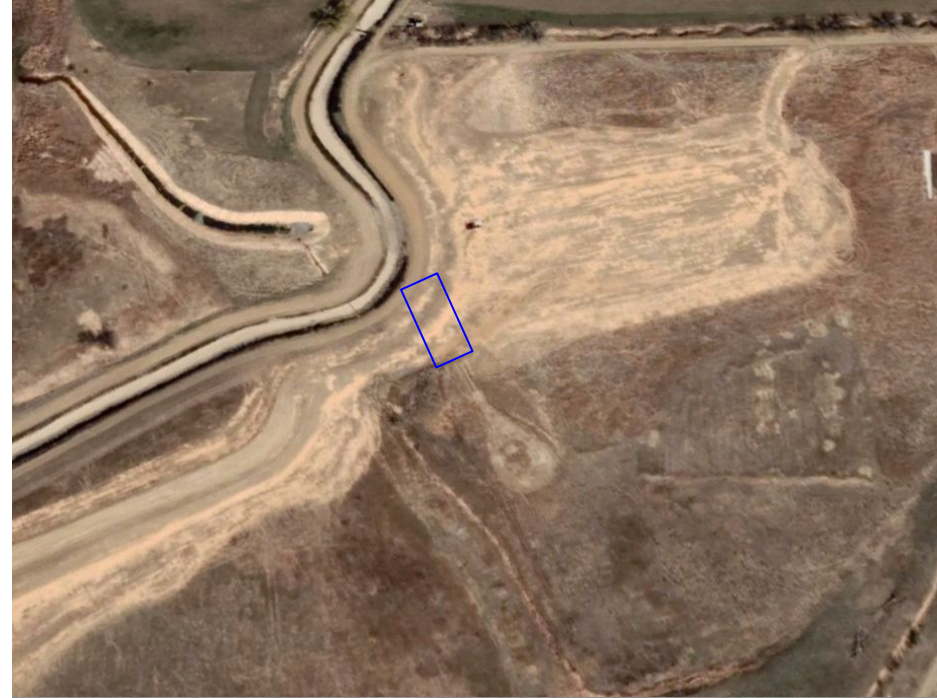
Photo 14. Google earth aerial imagery taken 04/2022. A stormwater ditch and basin unrelated to oil and gas was installed near the location. A 130' portion of the former access road (blue box) has been disturbed by non oil and gas activities.
