Final Reclamation and Stormwater Inspection

Operator: KP KAUFFMAN COMPANY INC

Location ID: 317696

Well Name: CHAMPLIN 86 AMOCO B #1

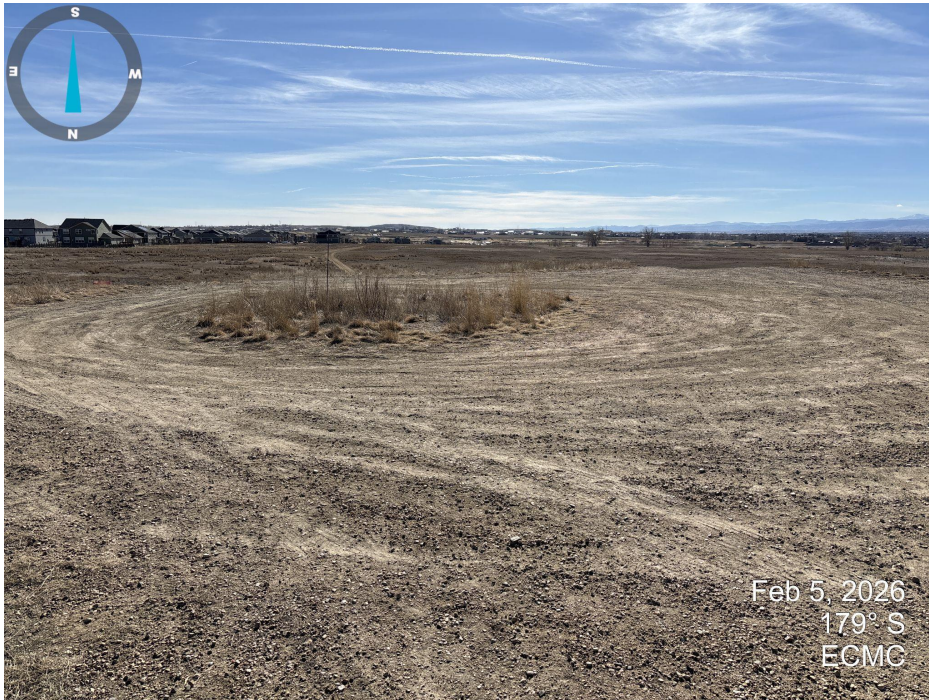
Photo 1. Looking south across the location. Gravel remains on the location and it does not appear that reclamation was conducted.

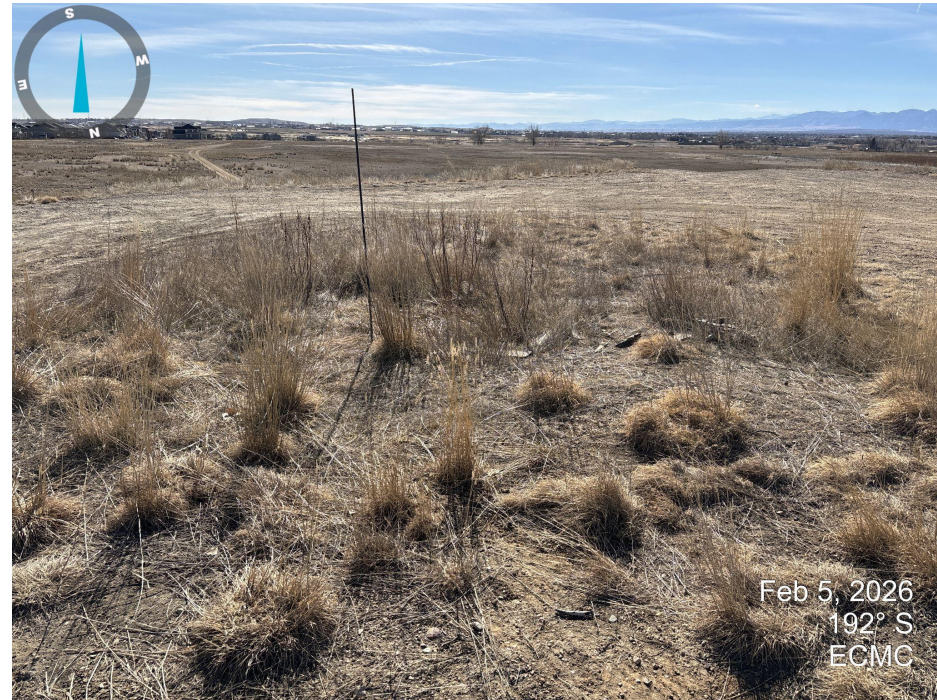
Photo 2. Looking south across the wellhead. Equipment and debris remains on the location including rebar, pipe joint, boards and a pipe in the ground.

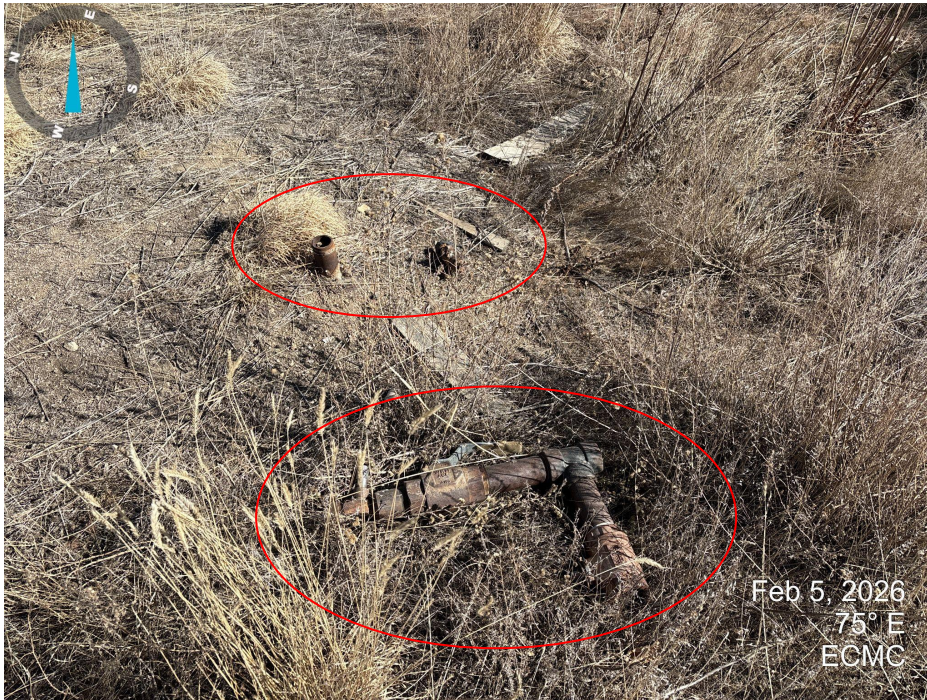
Photo 3. Oil and gas equipment and open pipe (red circle) remains on location.

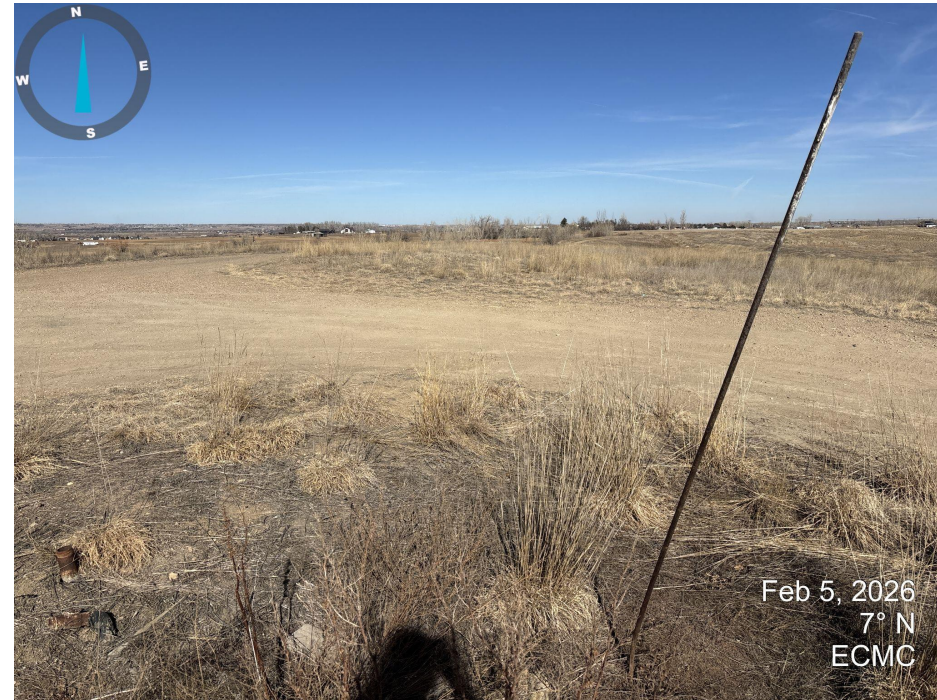
Photo 4. Looking north from the wellbore. Gravel remains on the location and the location size has not been reduced. It does not appear that reclamation was conducted on location.

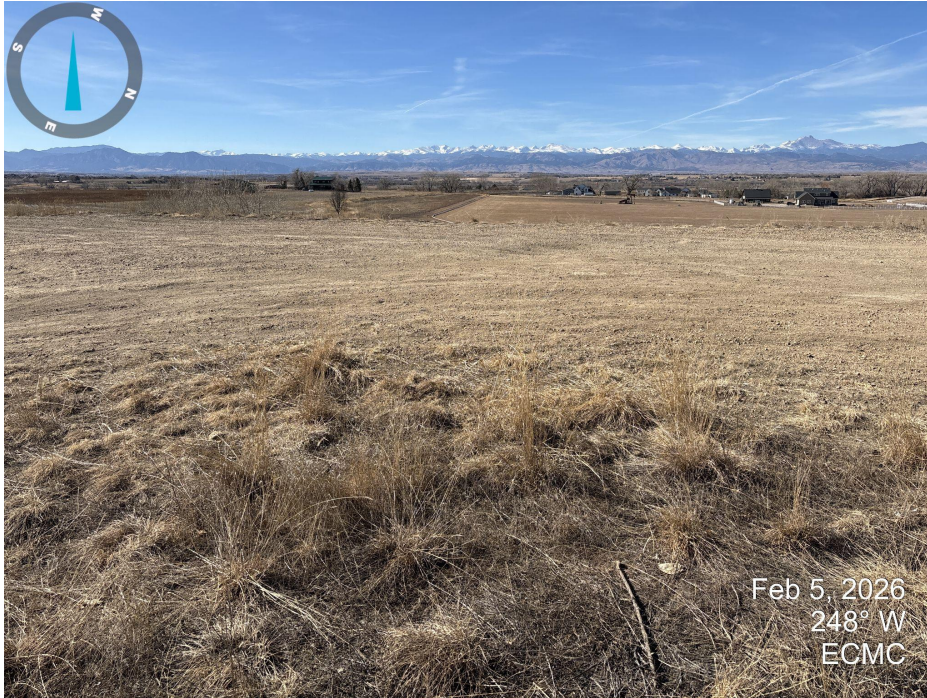
Photo 5. Looking west from the wellbore. See photo 4 comments.

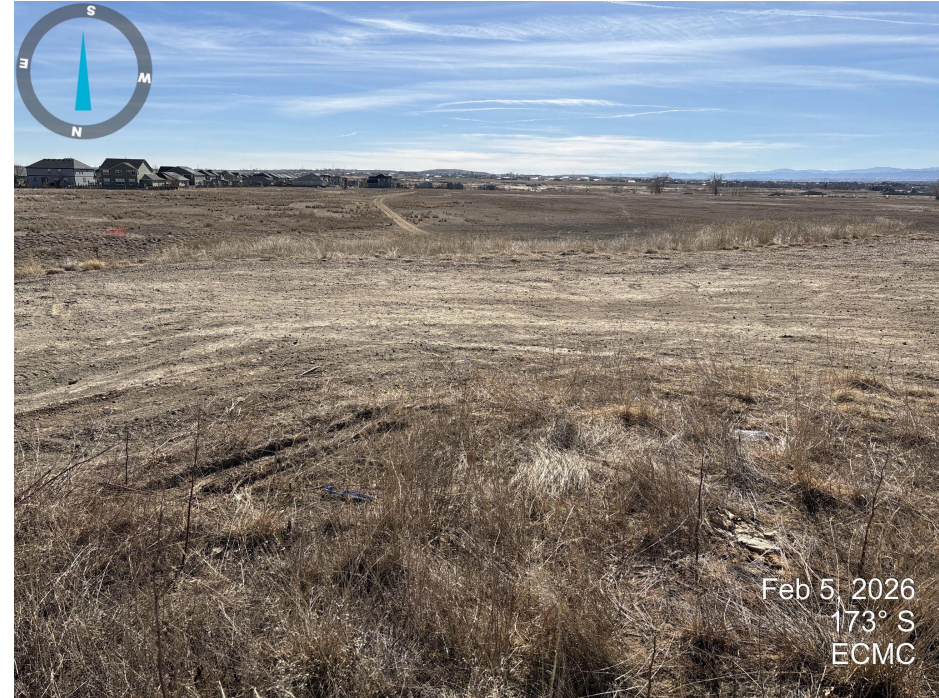
Photo 6. Looking south from the wellbore. See photo 4 comments.

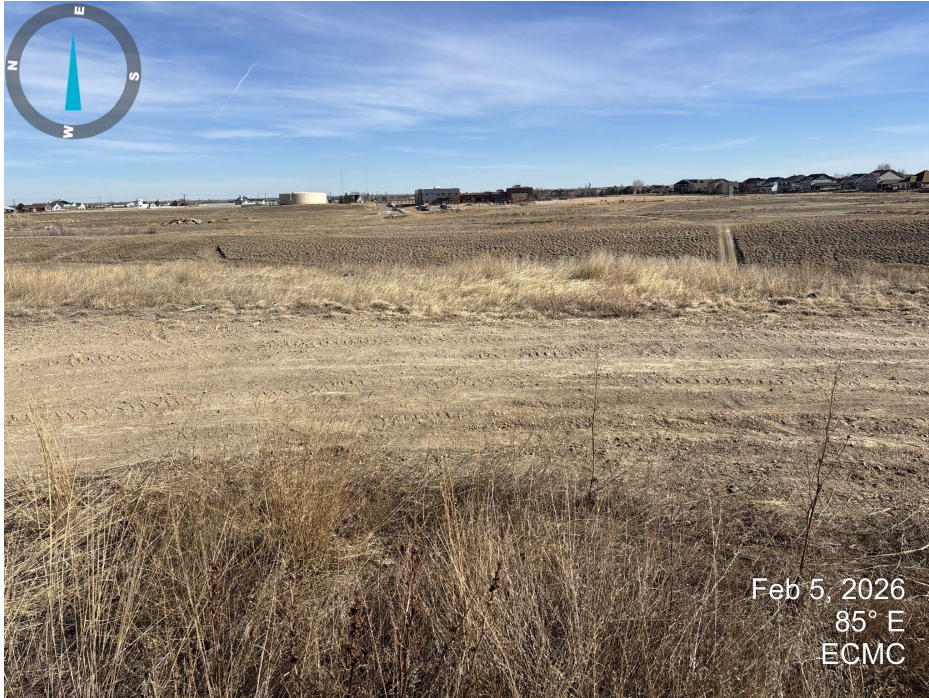
Photo 7. Looking east from the wellbore. See photo 4 comments.

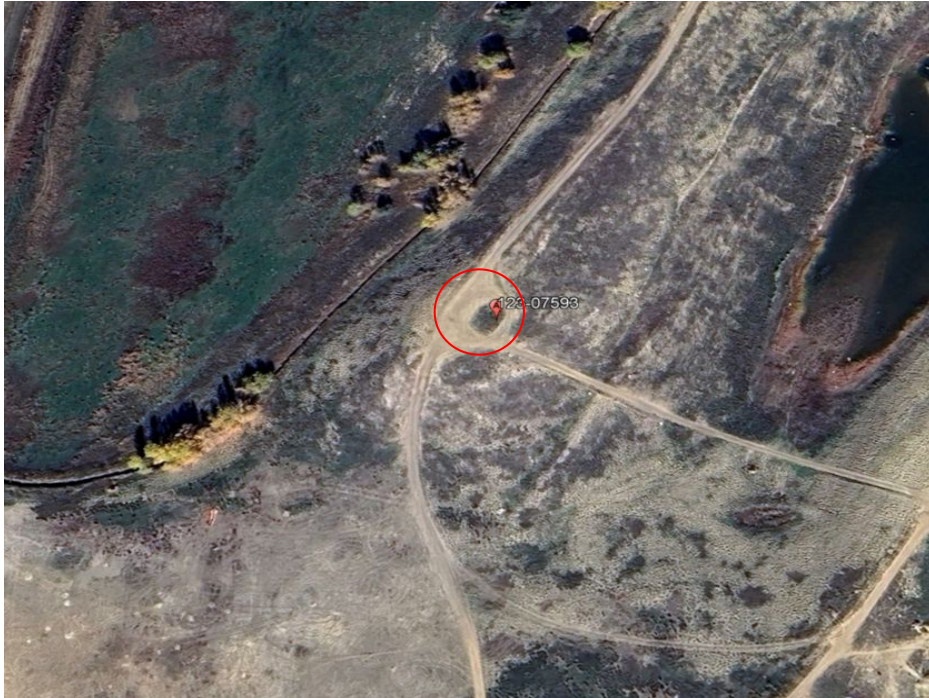
Photo 9. Google earth aerial imagery taken 11/2025. Location (red circle) should be reclaimed leaving roads at pre disturbance width (two track width).

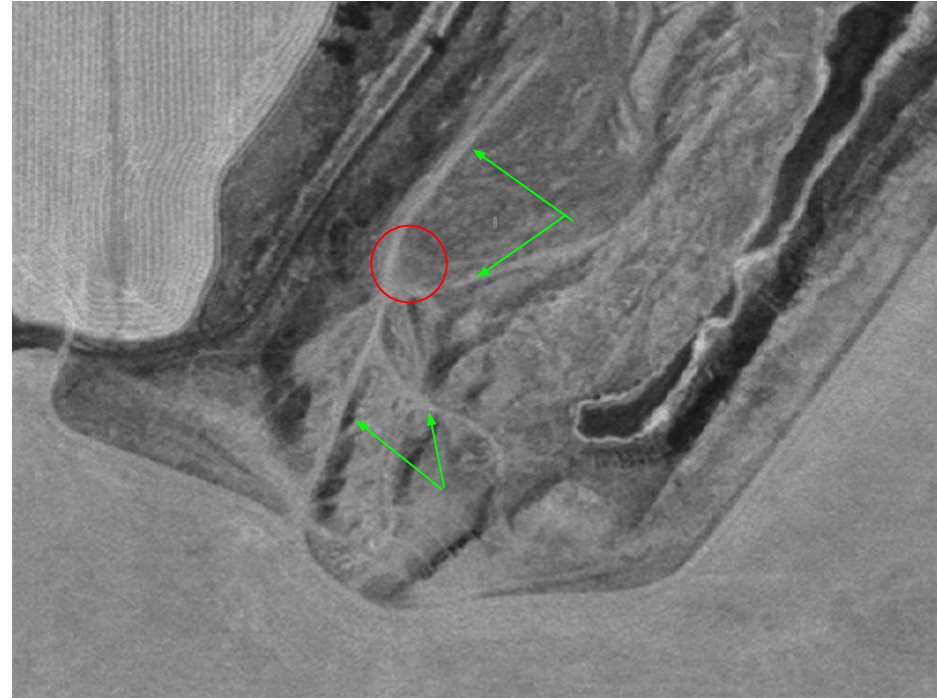
Photo 10. Historical imagery taken 08/1971. Access roads appear to be preexisting to oil and gas (green arrows) . The wide hilltop location/area is not observed in pre-oil and gas imagery. Approximate location (red circle).
