Interim Reclamation and Stormwater Inspection

Operator: KP KAUFFMAN COMPANY INC - 46290

Location ID: 475443

Inspection Document #: 718601369

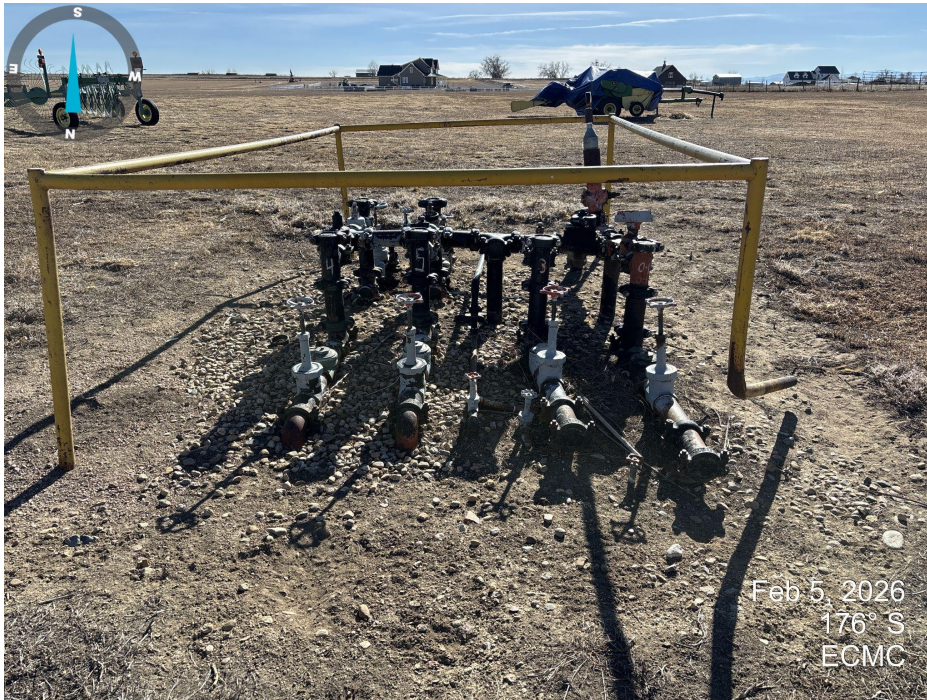
Photo 1. Looking south at the flowline riser station. The equipment is located approximately 250ft northwest of well API 123-07779.

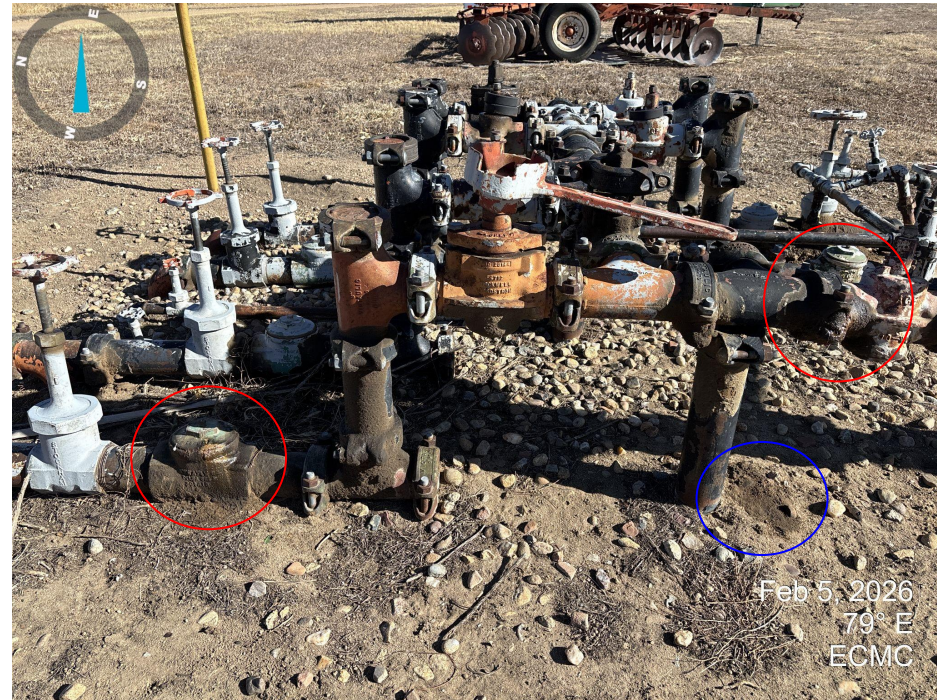
Photo 2. Photo taken looking east at the west side of the equipment. Leaking joints (red circle) and stained soil (blue circles) are present on the equipment.

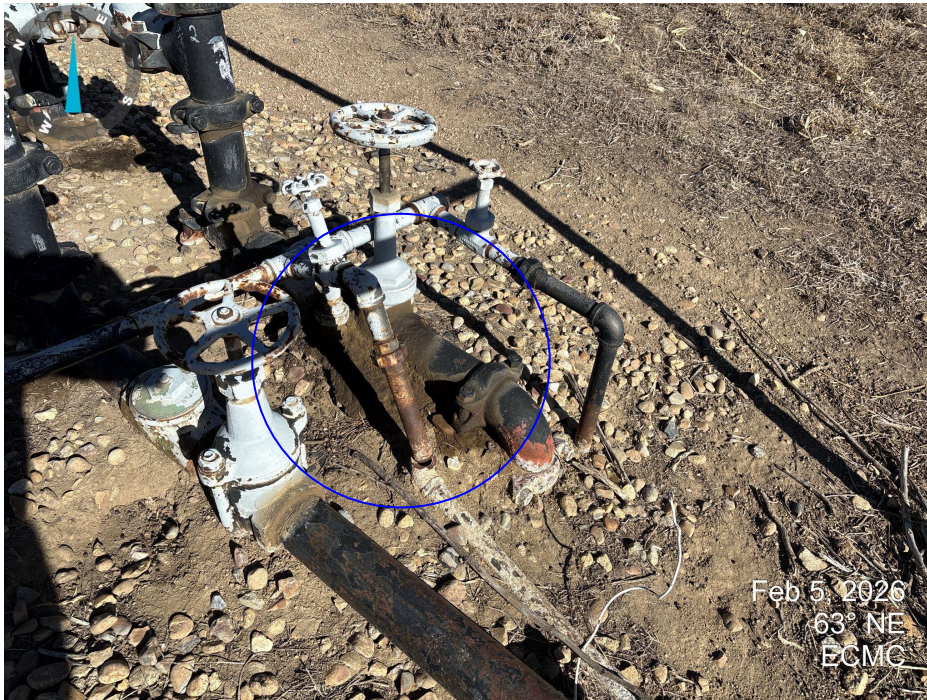
Photo 3. Photo taken at the south side of equipment. Stained soil/ oily buildup around joint (blue circle).

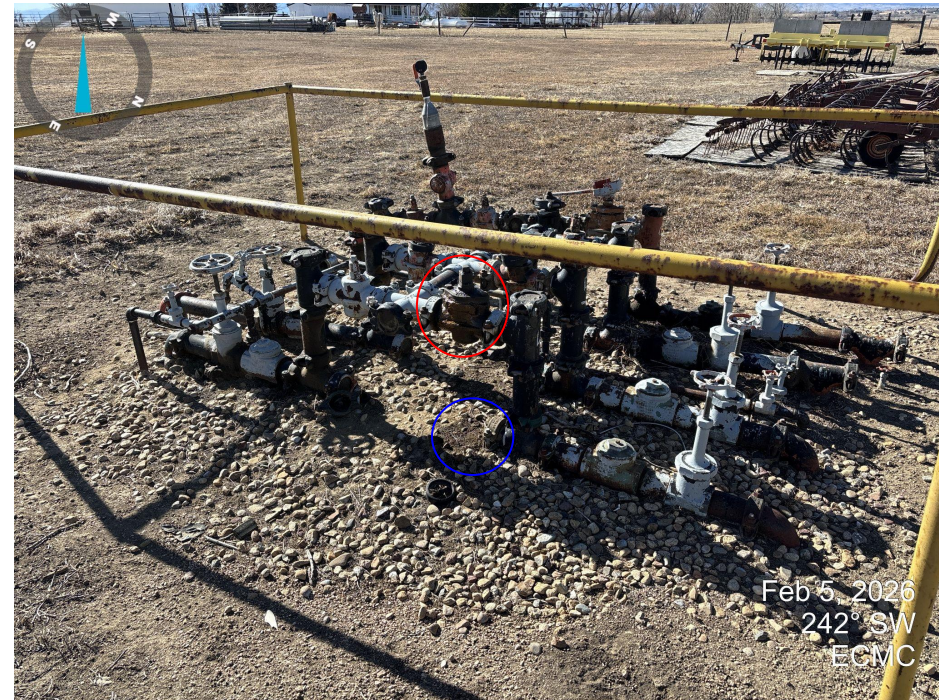
Photo 4. photo taken looking west at south side of equipment. Leaking joints (red circle) and stained soil (blue circles) are present on the equipment.
