Inspection/Audit Photos

Location: KT RESOURCES LLC ANT HILL UNIT WYATT #25-34 PAD

Location ID: 316334

Date: 02/9/2026

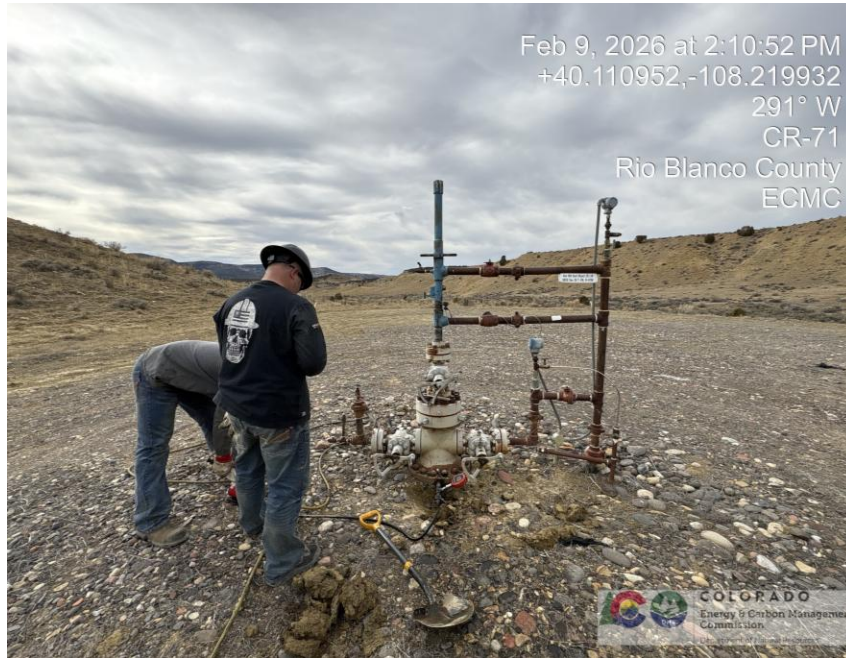
Photo # 1937 Wellhead seal test using Additel681AEx pressure gauge

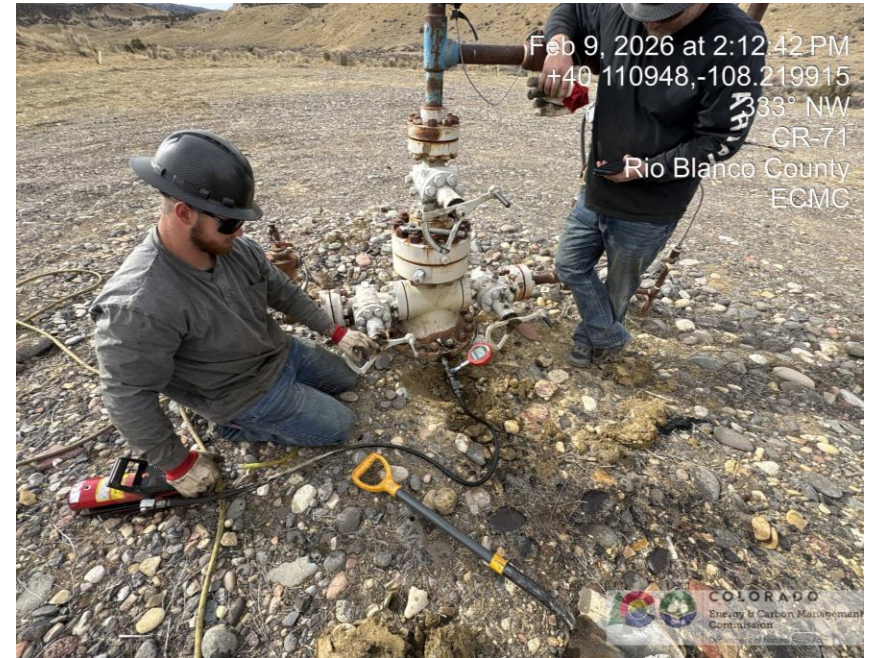
Photo # 1941 Wellhead seal test using Additel681AEx pressure gauge

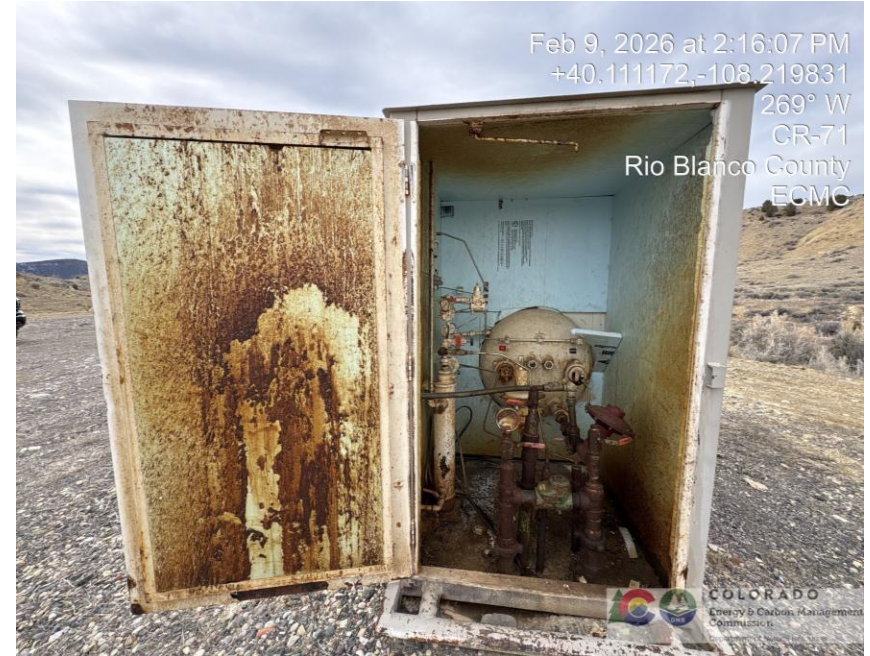
Photo # 1949 Staining at heater treater

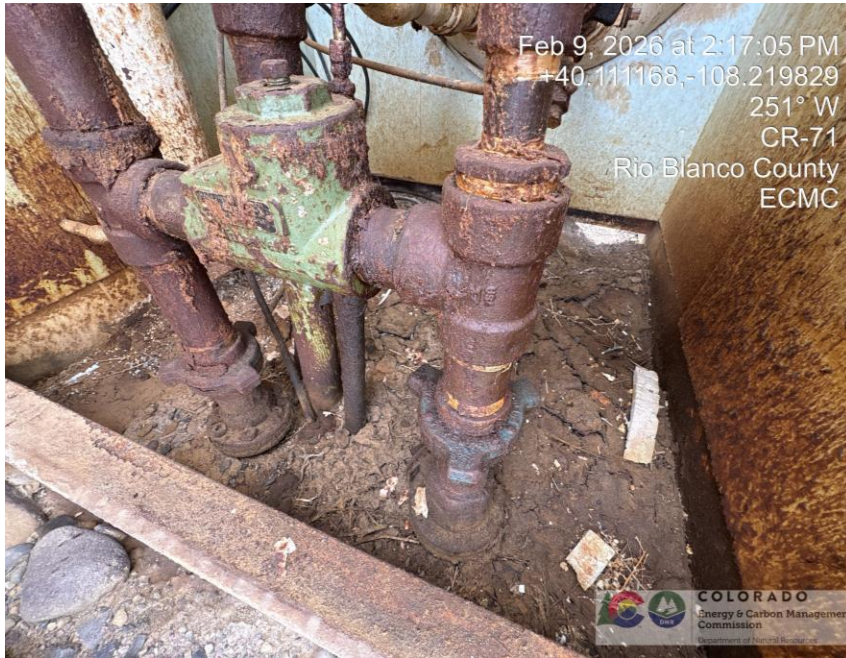
Photo # 1953 Staining at heater treater

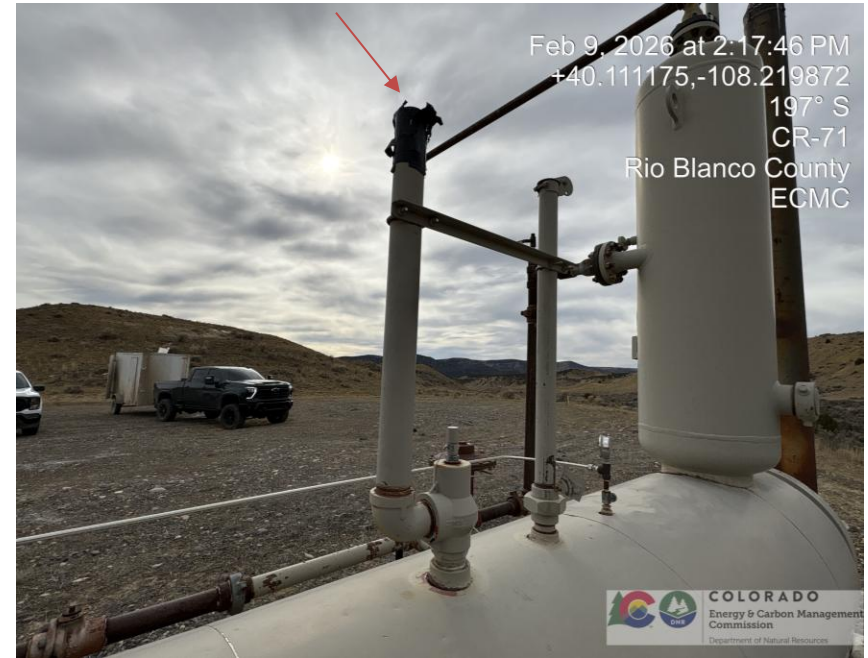
Photo # 1955 PRV vent line does not comply with CECMC pressure safety device rules

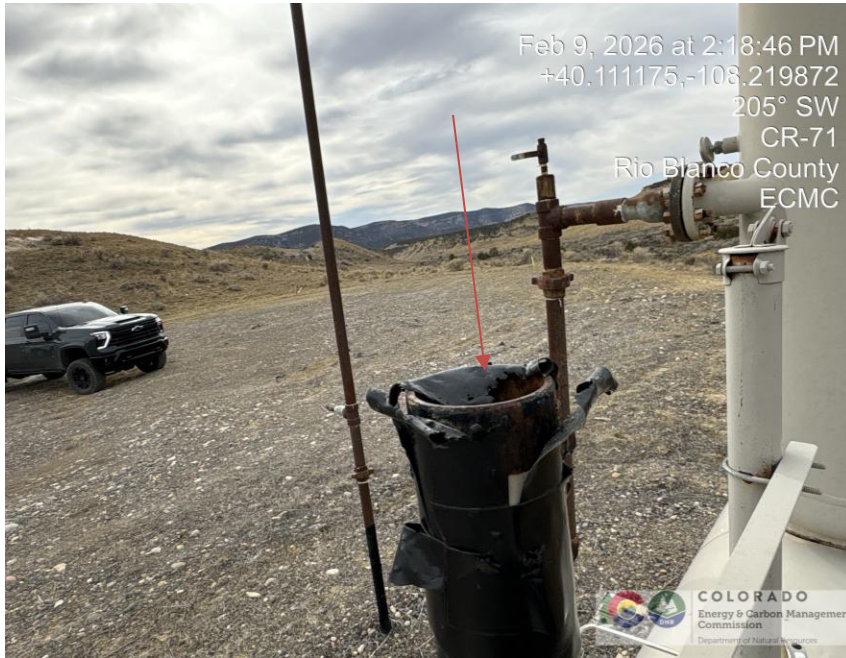
Photo # 1958 PRV vent line does not comply with CECMC pressure safety device rules

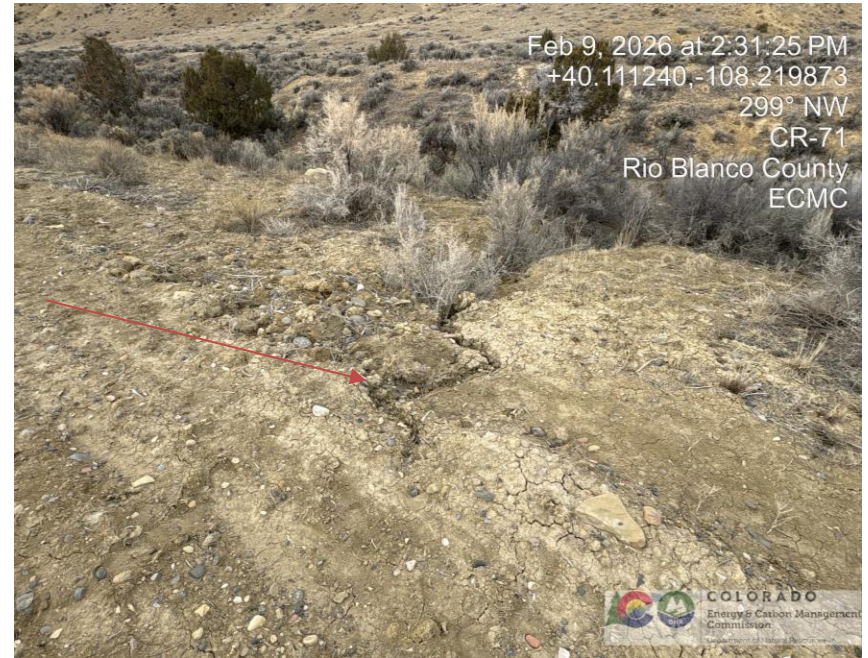
Photo # 1978 Failure to minimize erosion & transport of sediment off location/insufficient BMP's

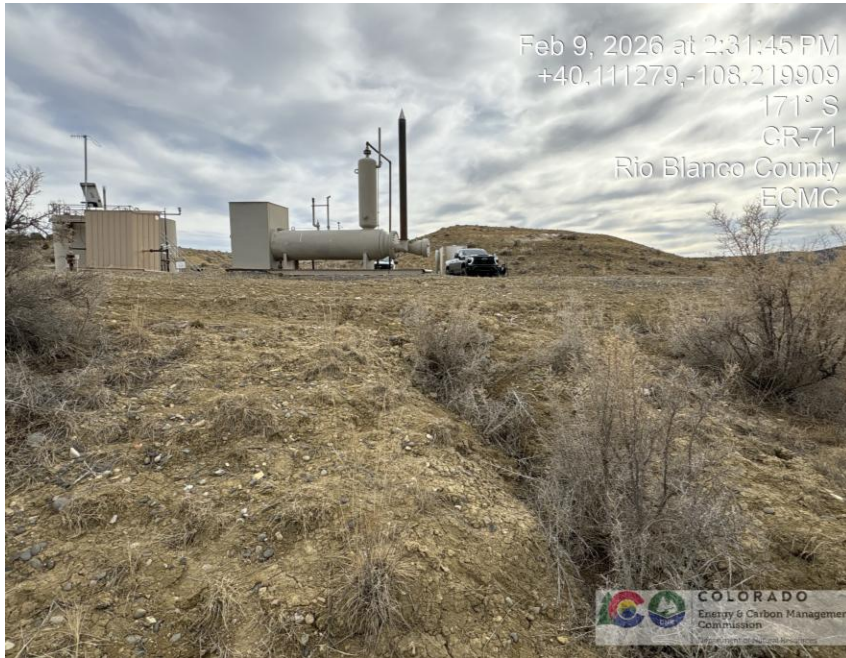
Photo # 1979 Failure to minimize erosion & transport of sediment off location/insufficient BMP's

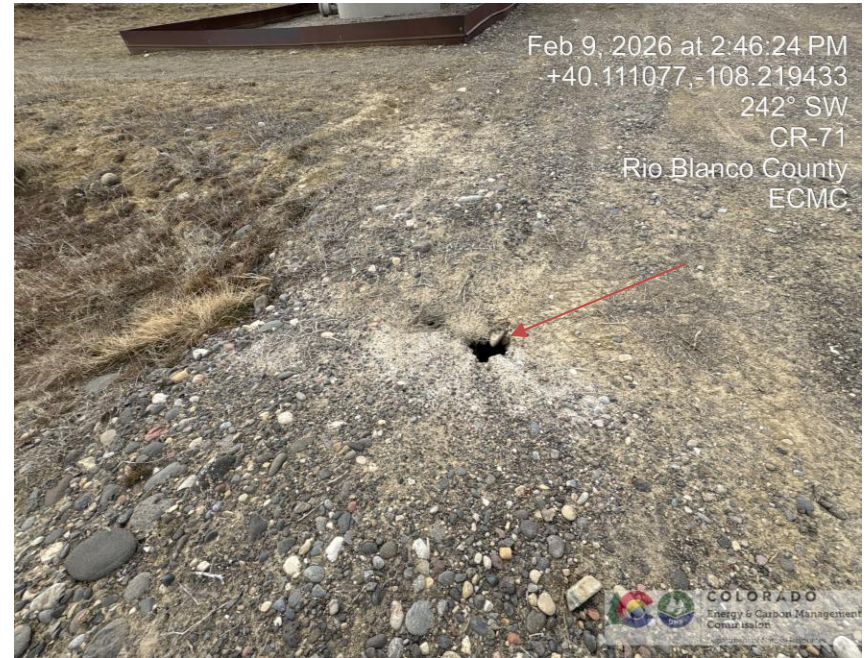
Photo # 1994 Tunnel erosion near entrance to location

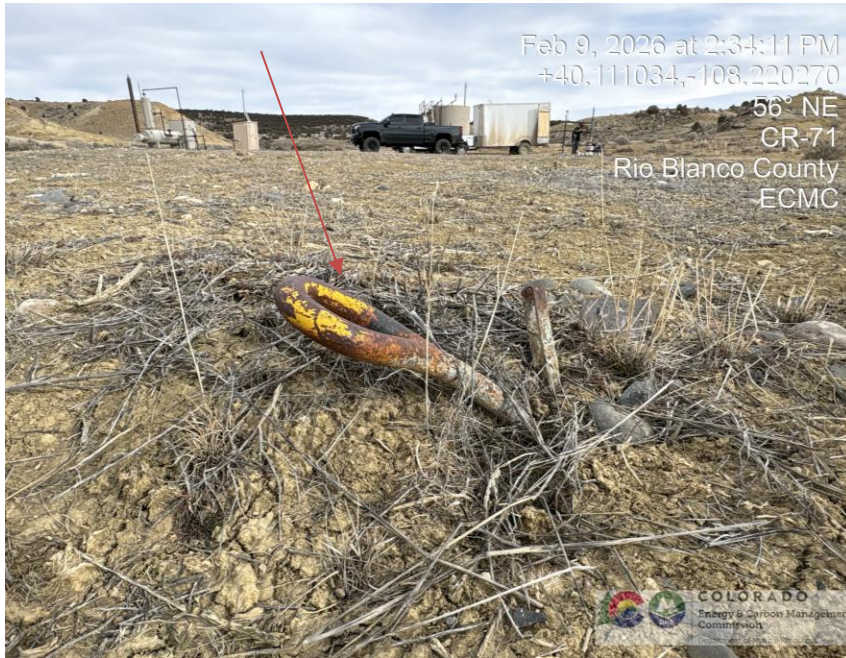
Photo # 1983 Unmarked deadman

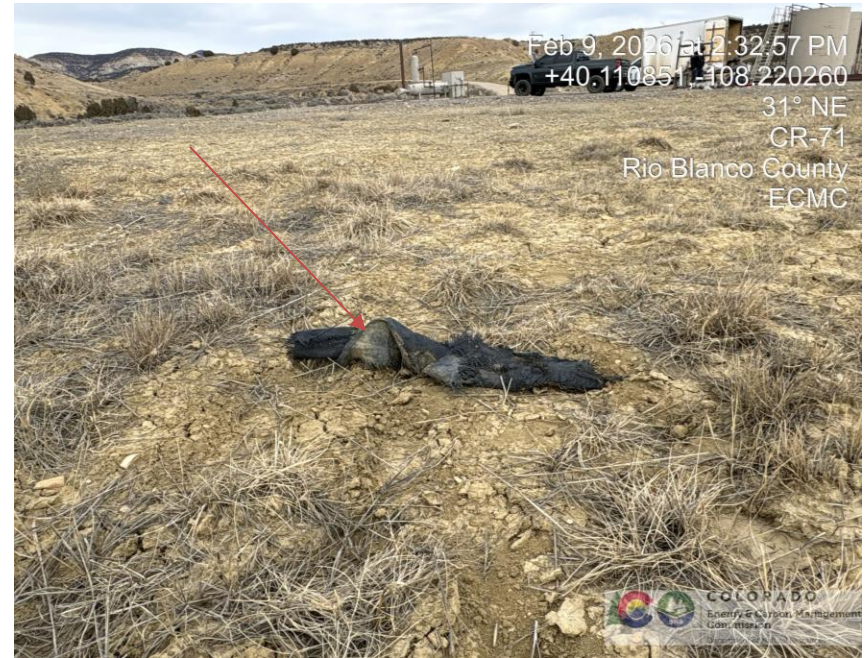
Photo # 1980 Debris

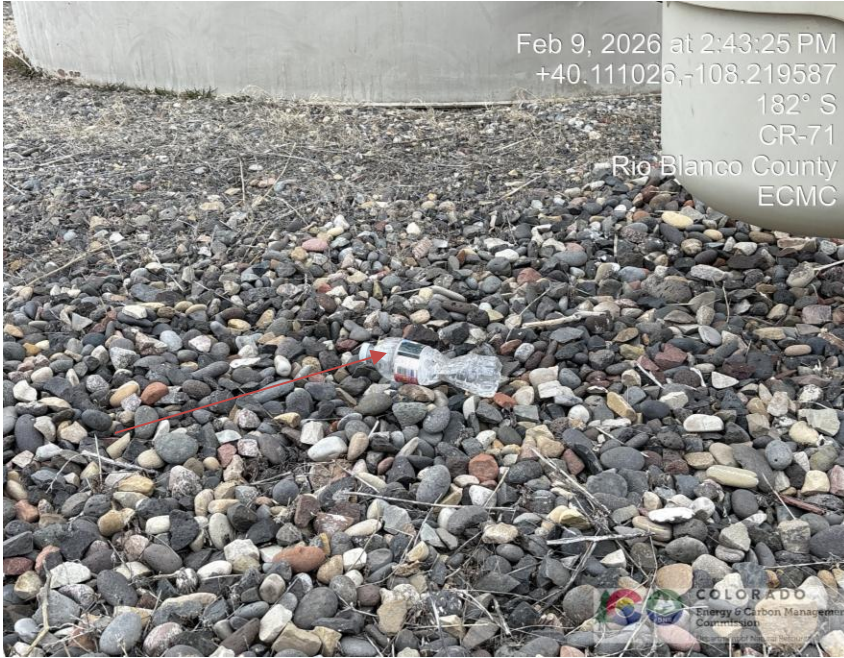
Photo # 1984 Debris

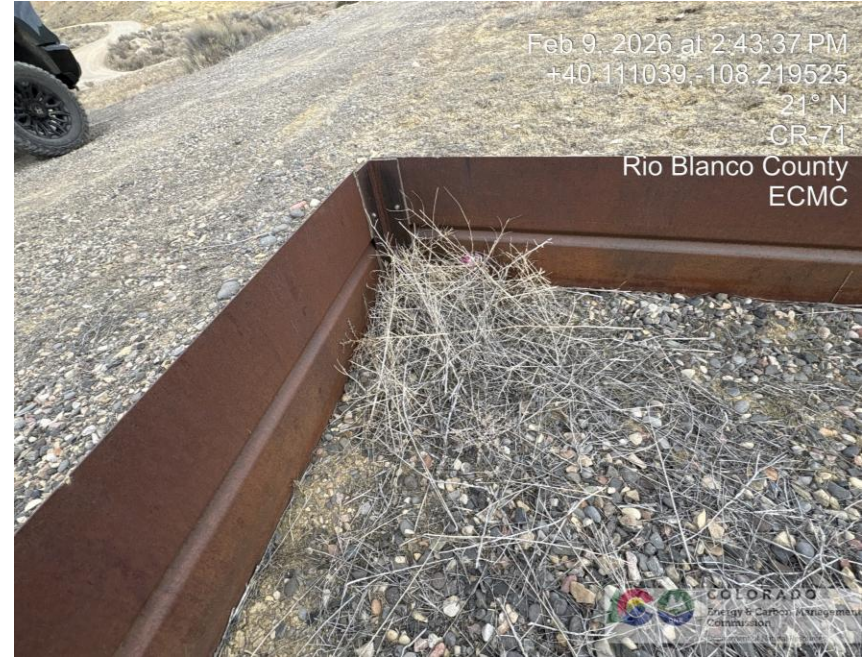
Photo # 1985 Debris

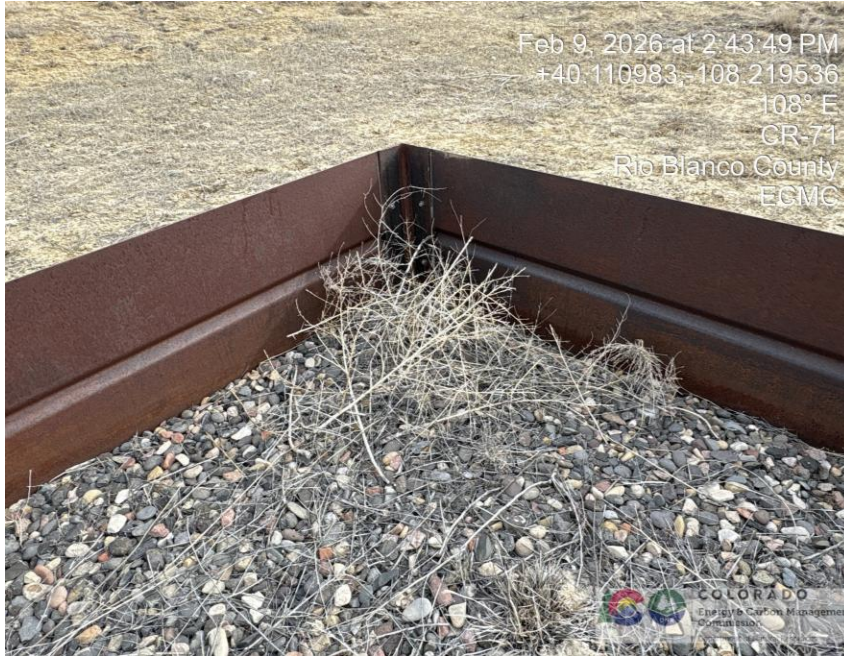
Photo # 1986 Debris

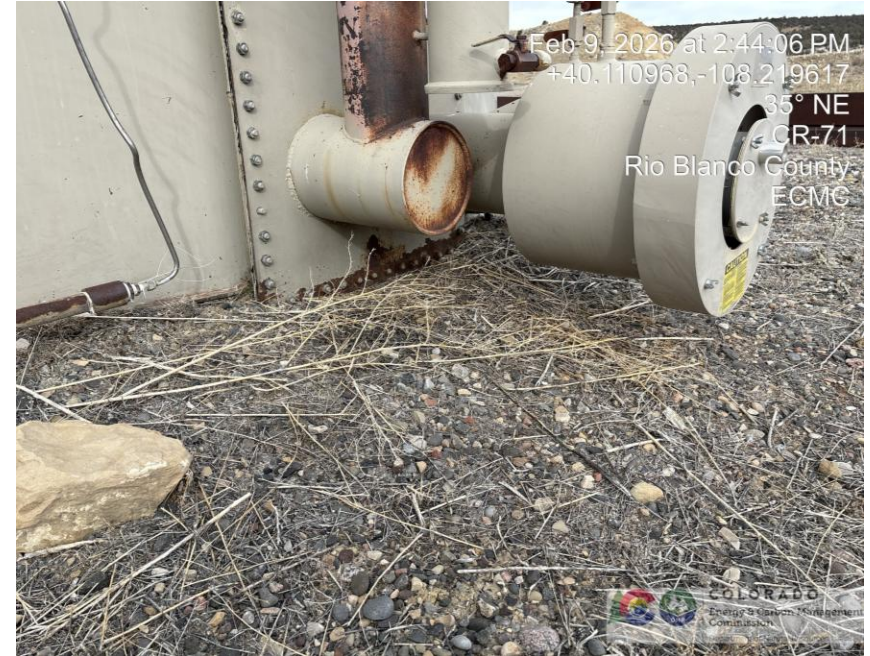
Photo # 1987 Debris

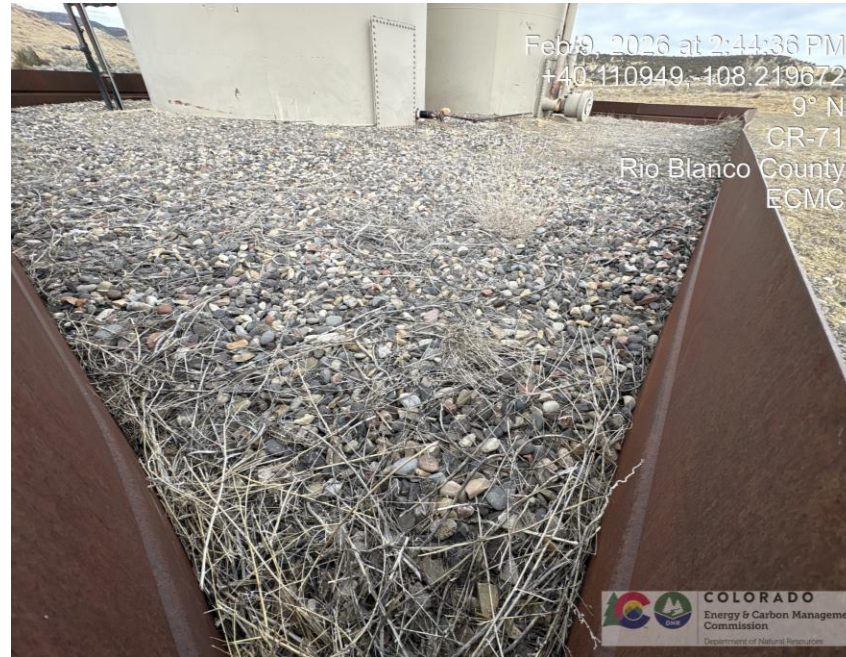
Photo # 1988 Debris
